OREGON DEPARTMENT OF TRANSPORTATION

AGGREGATE SITES DISTRICT 3

JUNE 2002

List of Sites in District 3

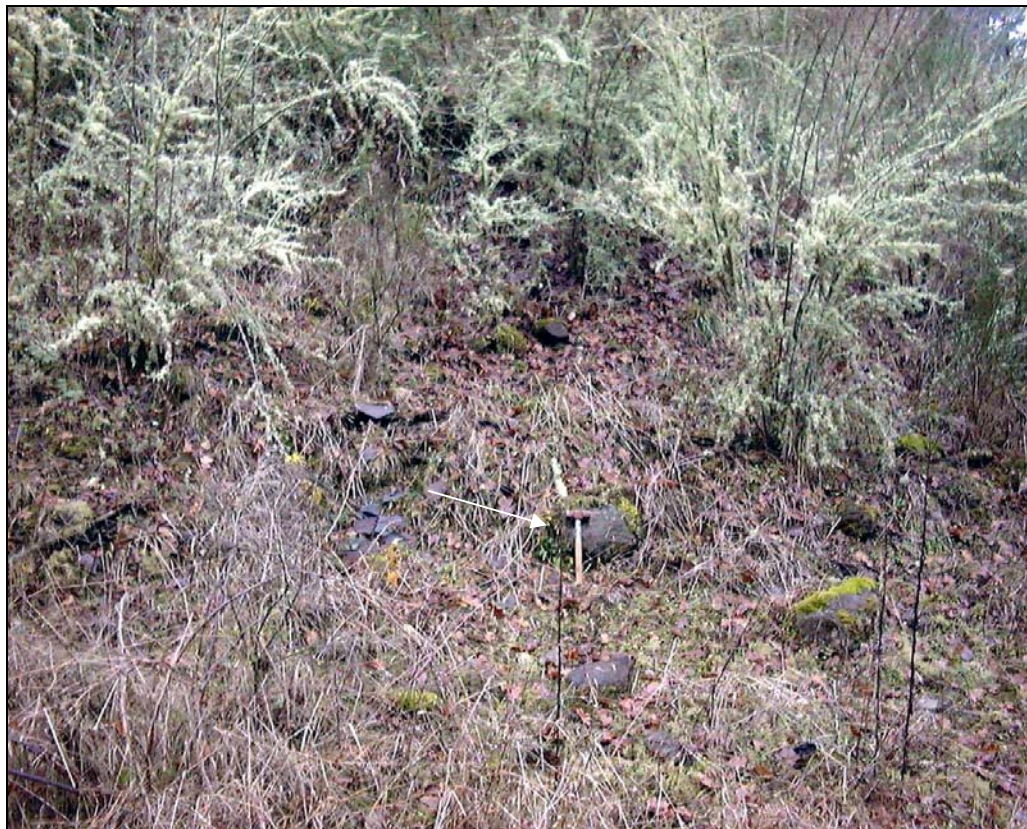
This site is west of Highway 213 about 250 meters. This ground is all natural with no past disturbance. The site has no exposures to examine the rock but the basalt float appears to be of marginal quality. There could be up to 6 feet of overburden at this location. There is some screening from Highway 213 and room to work. The terrain is fairly flat and partially fenced. This site has wetland/mitigation potential on the southern boundary. There is a winery to the north about 400 meters. Large grove of 2nd growth firs and wetland adjoins the property to the south.										
202B	203B	211	206 Fine	206 Coarse	208 F	208 F Ht.	208 C	208 C Ht.		
Material Use

View of the area with the basalt exposed along a cat-cut.

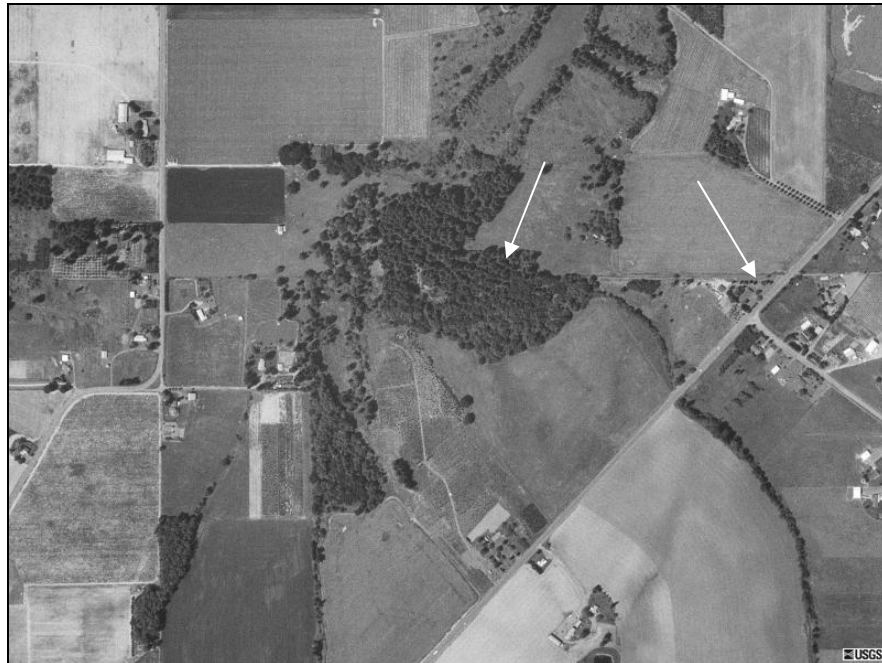
Aerial view of the site (left arrow) and the surrounding area.
Arrow on the right side is the start of the access road.

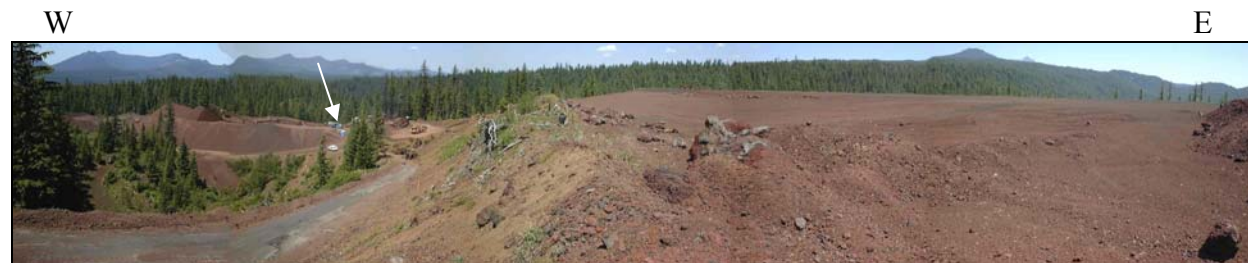
County	Site Name				Dist	Hwy	Mile Pt	TWP	RGE	Sect
Linn	Junction Cinder Pit				03	0016	73.9	13S	07.0E	15
File ID		Source #	Date Visited	Map #			Type of Site			
NA		22-011-2	7/29/1999	1R-4-389			Cinder Pit			
Latitude	Longitude	Elev. (m)	Acreage	Pit Size	DOGAMI Permit #					
44 26'12.96159"	121 57'26.1303"	1193.321	70	<20	22-0066					
Comments										
GPS acquired in the pit on the crusher level.										
Rock Type	Unit	Color		Weathering			Jointing			
Cinder	QTp	NA		NA			NA			
Quality			Hardness	lbs./cu ft.	Reserve (cy)	Reserve (Tons)				
Very Good			NA	120	1,750,000	2,835,000				
Potentially Significant Site	Why				Open/Closed	Direction				
No	Good close sanding source for Highway's 20 and 22.				Closed	NA				
Adjacent Land Use										
Forest										
Remarks										
This is a cinder cone that we lease from the Forest Service located at the junction of Highway's 22 and 20. There is good screening and ample room to work. The quantity calculation is based on a 100 foot lift to a base level of 3900 feet. There was a private contractor crushing some scoriaceous basalt for Maintenance. He informed me that he was going to crush 100,000 cubic yards. This site is one of the only sanding sources for Region 2. It is very important that we keep this site open.

Looking to the north at the upper cinder pit.
At the arrow is a portable crusher making sanding material for the winter of 2000.

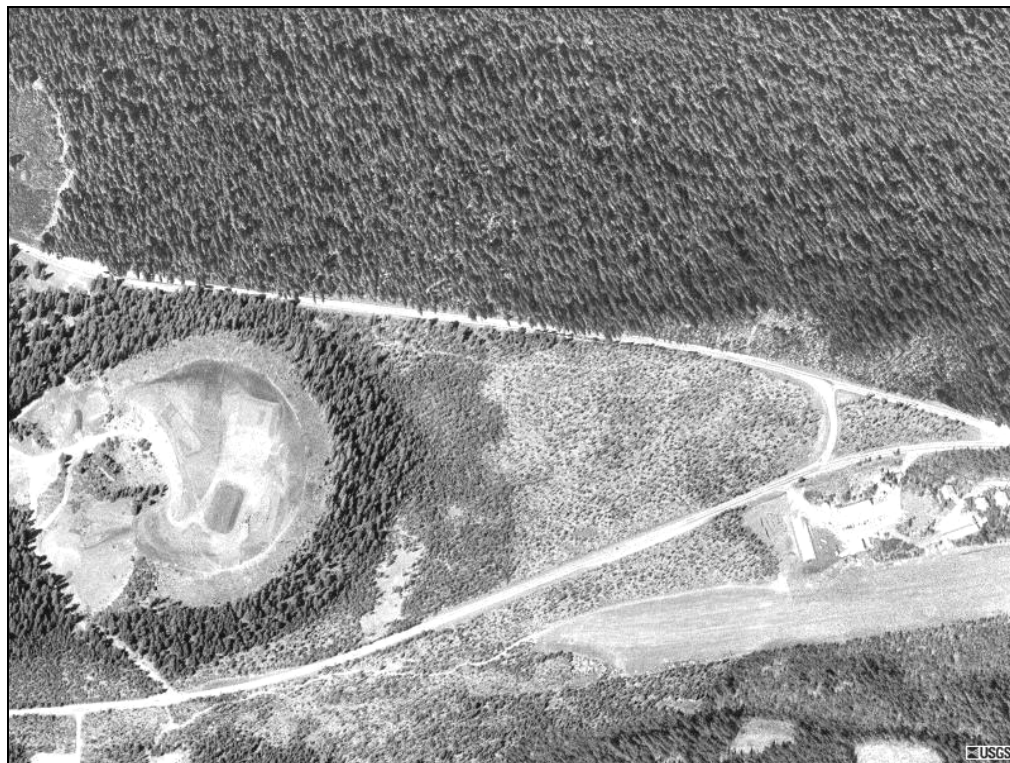
Aerial view of the cinder pit in relation to Highway's 22 and 20.

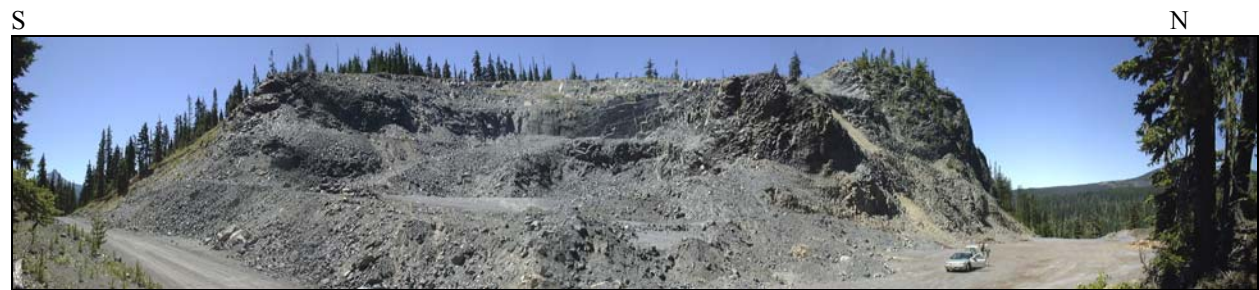
County	Site Name				Dist	Hwy	Mile Pt	TWP	RGE	Sect
Linn	Hog Pass Quarry				03	0016	79.4	13S	07.5E	23, 26
File ID		Source #	Date Visited	Map #			Type of Site			
28793		22-040-2	7/26/2001	1R-5-1195			Quarry			
Latitude	Longitude	Elev. (m)	Acreage	Pit Size		DOGAMI Permit #				
44 25'30.82693"	121 52'09.95543"	1468	10	<2						
Comments										
GPS acquired in the pit.										
Rock Type	Unit	Color	Weathering				Jointing			
Andesite	Tus	Med. Grey	Fresh				Highly Fractured			
Quality			Hardness	lbs./cu ft.	Reserve (cy)	Reserve (Tons)				
Good			R3+	182	140,000	539,055				
Potentially Significant Site	Why			Open/Closed	Direction					
No	USA ground.			Closed	NA					
Adjacent Land Use										
Open Space										
Remarks										
This site is located north of Highway 20/126 approximately 250 meters. The rock here is a fine to medium-grain highly fractured andesite. A large portion of the rock at this location is very platy and brittle. The terrain is moderate to very steep, with good screening and limited room to work. You can rip the rock and acquire minor rip rap. 150,000 cubic yards have been removed. USA ground.

View of the quarry site looking west across the access road.

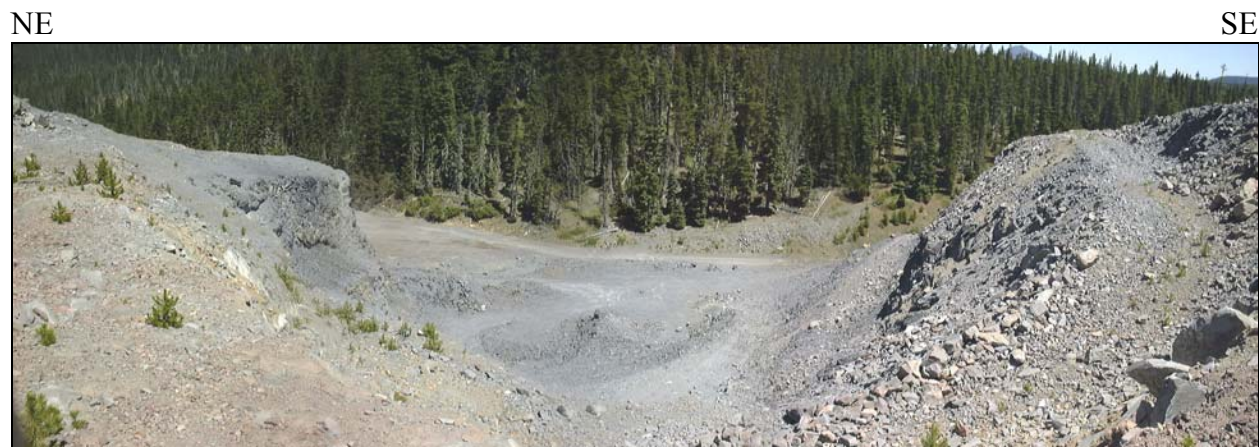
View looking east from the top of the quarry down to the access road.

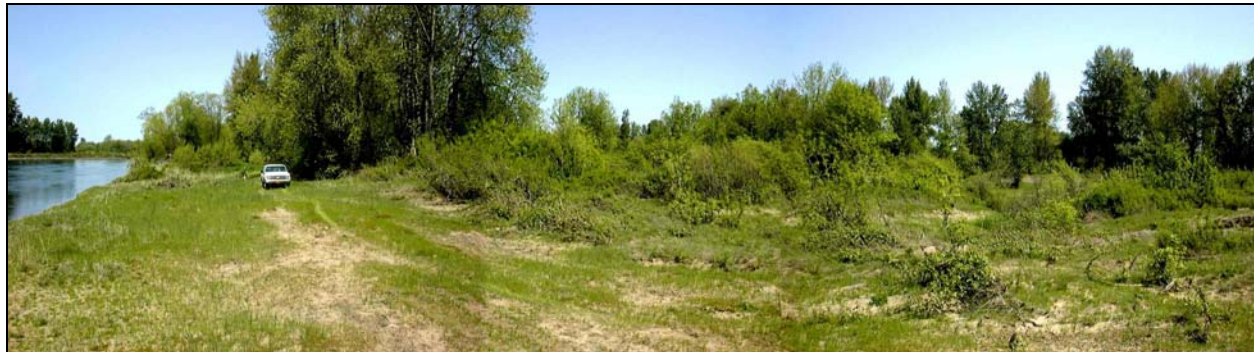
County	Site Name			Dist	Hwy	Mile Pt	TWP	RGE	Sect
Marion	Mahony Bar Quarry			03	0140	0	05S	03.0W	11
File ID		Source #	Date Visited	Map #		Type of Site			
21189, 21188		24-009-2	4/29/1999	1R-5-474		Gravel			
Latitude	Longitude	Elev. (m)	Acreage	Pit Size		DOGAMI Permit #			
45 08'46.34337"	123 01'52.40309"	30.549	25.6	NA		24-0019			
Comments									
GPS acquired along the river.									
Rock Type	Unit	Color		Weathering		Jointing			
Volcanic Gravel	NA	NA		NA		NA			
Quality			Hardness	lbs./cu ft.	Reserve (cy)	Reserve (Tons)			
Good			NA	120	300,000	486,000			
Potentially Significant Site	Why			Open/Closed	Direction				
No	Narrow piece of ground, potential wetland/salmon mitigation site, large proportion of sands.			Closed	Adjacent to the Willamette River.				
Adjacent Land Use									
Farming									
Remarks									
This site is located about 5 miles south of St. Paul on the Willamette River. The gravel here is composed of well-rounded to sub-rounded clasts with the dominant size around 4 centimeters. There is a high percentage (40%) of sand/organics at this location. The river is deeper with less energy here and tends to deposit more sand than gravel at times of high water. There is little to no evidence of past disturbance and the site is overgrown with vegetation. There is some room to work and great screening. The haul road bisects a farm and is open to the public. This location could be a site for wetland and/or salmon mitigation. The property is within the flood plain.

View looking north at the site and the surrounding area. Most of the light-colored area is composed of sand.

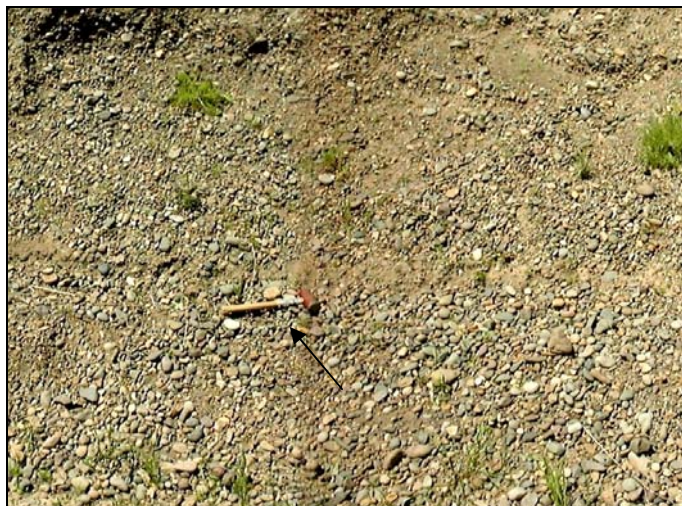
Close-up view of the gravel with the hammer for scale.

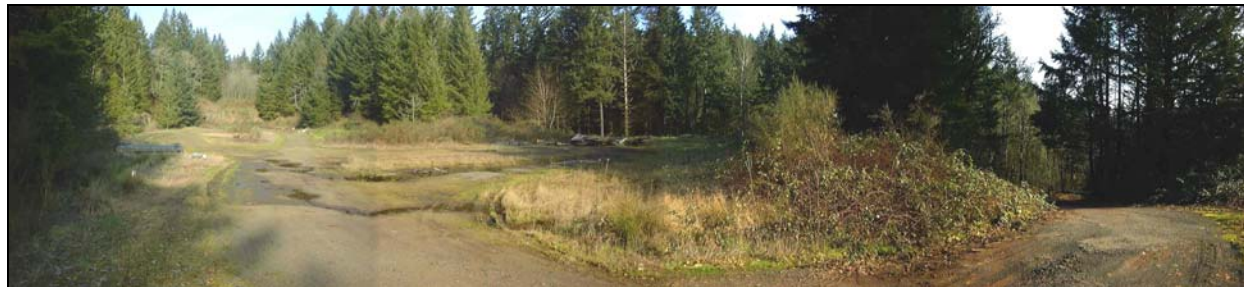
Adjacent Land Use										
Residential										
Remarks										
This site is located about 2 miles south of Salem on Battle Creek Road. The property is being used as a waste site/bone-yard. The rock at this location a fine-grain basalt of good quality. You would need to drill and blast the rock. There is very little overburden to deal with but plenty of trees. There is good screening from all vantage points and plenty of room to work or stage from. The site is surrounded by homes on acreage. A draw with seasonal water bisects the property and would need to be handled if the pit were to be expanded. The terrain is moderately steep. Access to this site should be evaluated for safety reasons as the county road has a blind corner here that could pose a problem. This site is used by Maintenance now for a bone-yard, waste area. This is a good site with good rock and room to work. Encroachment of homes in this area has reduced this property to minor status.

Looking to the north at the quarry site and stockpile location.

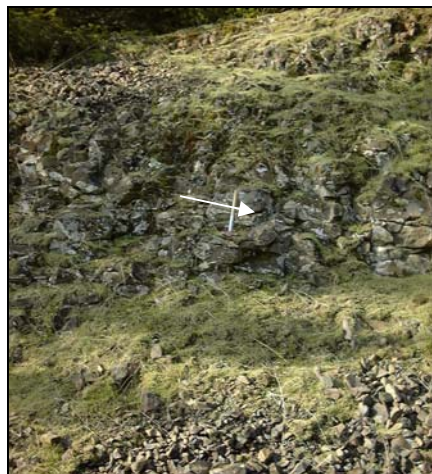
View of the fracture pattern of the basalt at the site with the hammer for scale.

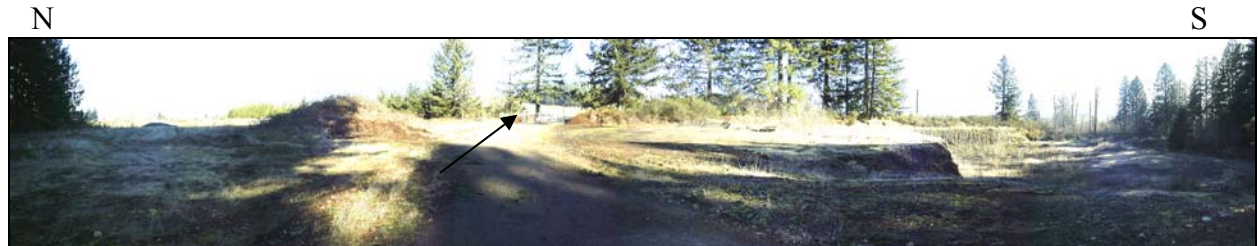
County	Site Name				Dist	Hwy	Mile Pt	TWP	RGE	Sect
Marion	Drift Creek Quarry				03	0163	0	08S	01.0E	17
File ID		Source #	Date Visited	Map #		Type of Site				
03298		24-024-2	12/09/1999	1R-1-1561		Quarry				
Latitude	Longitude	Elev. (m)	Acreage	Pit Size	DOGAMI Permit #					
44 52'40.43947"	122 43'11.84412"	282.361	10.36	<4	24-0020					
Comments										
GPS acquired at the access point.										
Rock Type	Unit	Color		Weathering		Jointing				
Basalt	Tc	Medium Dark Grey (N4)		Fresh		Highly Fractured				
Quality			Hardness	lbs./cu ft.	Reserve (cy)	Reserve (Tons)				
Good to Very Good			R4+	185	100,000	249,750				
Potentially Significant Site	Why			Open/Closed	Direction					
No	Not much rock left.			Closed	Adjacent is the West Fork of Drift Creek.					
Adjacent Land Use										
Farming										
Remarks										
This site is located just north of the intersection of Highway 214 and Drift Creek Road. The rock here is a fine-grain basalt from the Columbia River Group. It is highly fractured and has very little weathering. You will need to drill and blast the rock here due to its competency. There is little to no overburden to deal with. The site has some room for work and very limited screening from the roadway. The property is not fenced and has no gate to protect the site. This could pose a danger with the pit about 15 feet below ground level. Most of the rock has been used and a site plan to extract the remaining reserve should be developed. There is a good berm between Drift Creek and the pit floor which is flat. Future plans for this site could be for a staging area or waste site after all of the rock is removed. The quality of the rock in this area is very good and the surrounding area should be evaluated for future quarry sites.

Looking to the east at the access point (center) and the pit to the right side of the image.

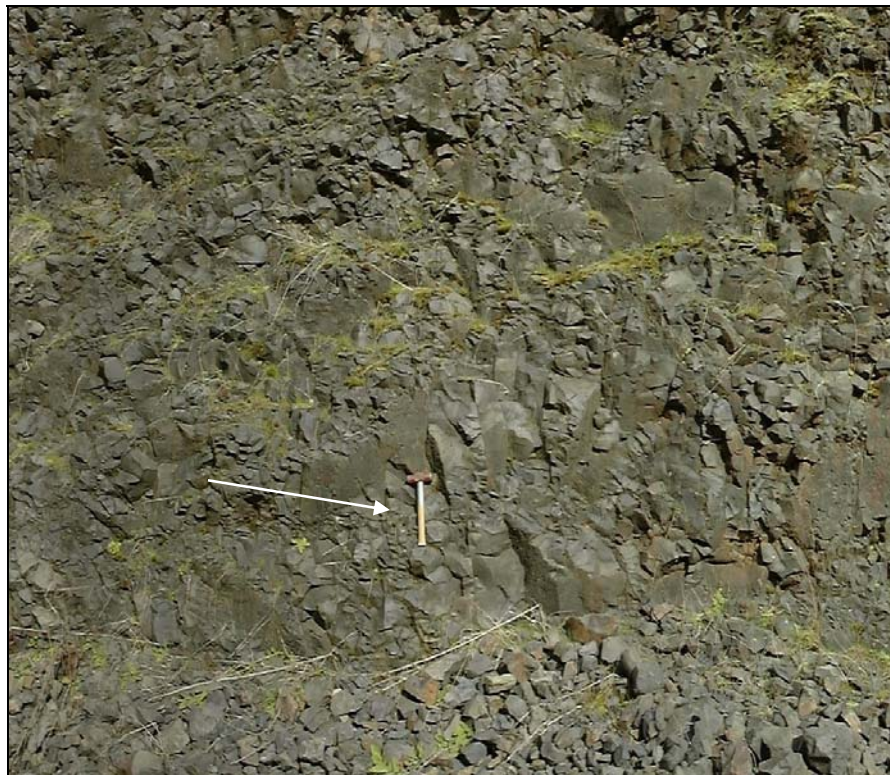
Close-up view of the fracture pattern with the 4lb. maul for scale.

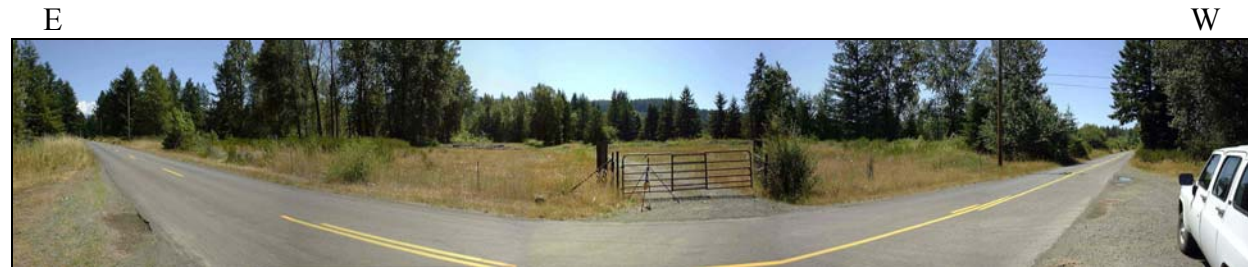
County	Site Name			Dist	Hwy	Mile Pt	TWP	RGE	Sect
Marion	Mill City Pit			03	0162	0	09S	02.0E	25
File ID		Source #	Date Visited	Map #			Type of Site		
06448		24-029-2	3/15/2000	1R-2-763			Gravel		
Latitude	Longitude	Elev. (m)	Acreage	Pit Size		DOGAMI Permit #			
44 45'16.02786"	122 30'08.56265"	235.822	24.76	NA		24-0050			
Comments									
GPS acquired at the access gate.									
Rock Type	Unit	Color		Weathering			Jointing		
Volcanic Gravel	NA	NA		NA			NA		
Quality			Hardness	lbs./cu ft.	Reserve (cy)	Reserve (Tons)			
Fair to Good			NA	120	360,000	583,200			
Potentially Significant Site	Why			Open/Closed	Direction				
No	This is a good location along Highway 22 with a large quantity of gravel here.			Closed	The Santiam River is to the south about 50 meters.				
Adjacent Land Use									
Rural residential, one residential home to the east about 400 meters.									
Remarks									
This site is adjacent to and south of the Mill City road. From the surrounding ground the rock is a heterogeneous mix of fine to porphyritic volcanic gravel. The size ranges from small boulder (10%), cobble (40%), pebble (30%), and sand (20%) sizes. There is fair screening and plenty of room to work here. The ground is about 15 feet above the Santiam River. This property is all over grown in vegetation and has some timber value. The property is used for a minor waste site.

Looking to the south at the access gate and the site beyond.

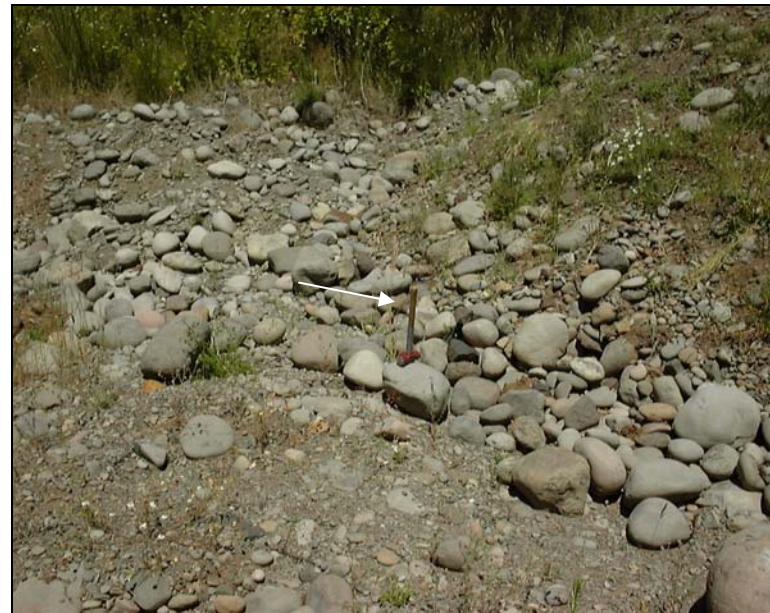
Close-up view of the igneous boulders with the hammer for scale.

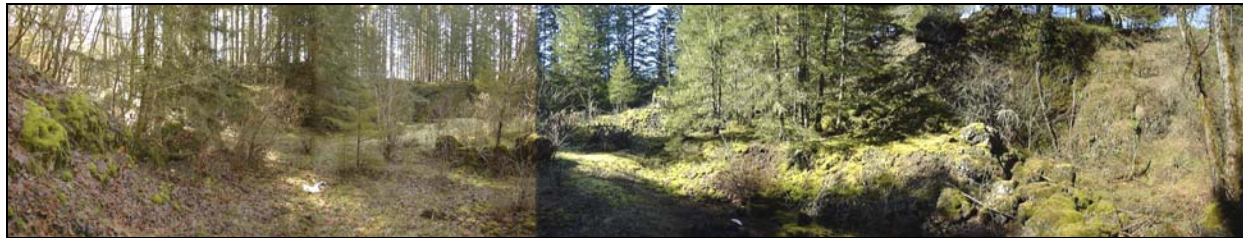
This site is located off of Highway 214 up near Drakes crossing. It is a small piece of ground with limited rock left. The rock is a fine-grain basalt of the Columbia River Group that has very little weathering. You will need to drill and blast at this location. The past disturbance has produced about 32,000 cubic yards of rock here. There is some screening and limited room to work. One residence is adjacent to the northern property boundary. We have a small pit approximately 80 meters square that is pushed up to our north property line. A small seasonal draw bisects the property near the eastern boundary. A small stock pile remains near the west side of the property. The terrain is fairly flat and should pose no problem. Minor amount of timber.										
202B	203B	211	206 Fine	206 Coarse	208 F	208 F Ht.	208 C	208 C Ht.		
	3	14.0		2.0	9.8	.3				
Material Use										
AC (1992)

180 degree view of the pit looking west.

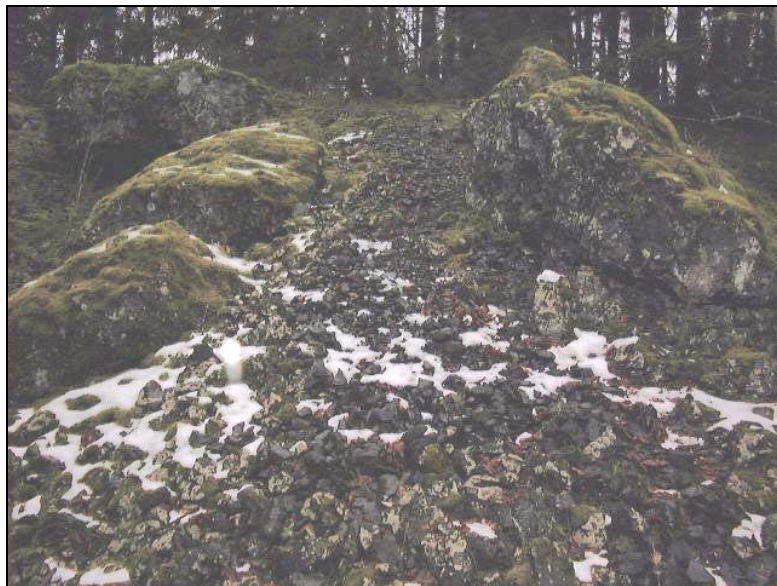
Close-up view of the basalt rock.

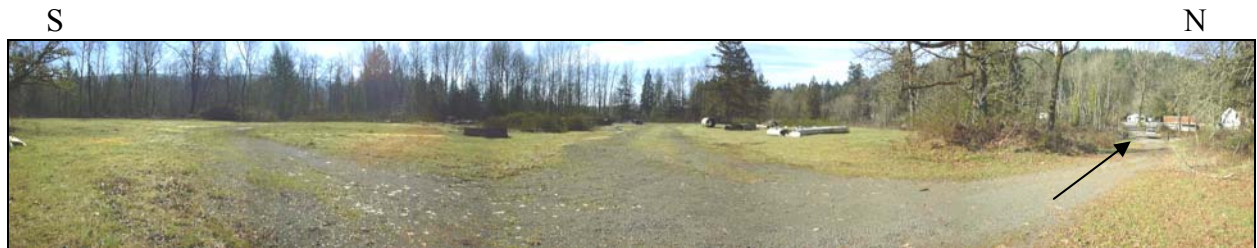
County	Site Name				Dist	Hwy	Mile Pt	TWP	RGE	Sect
Marion	Stout Creek Quarry				03	0162	16.8	09S	01.0E	14
File ID		Source #	Date Visited	Map #			Type of Site			
19341		24-033-2	12/07/1998	1R-5-290			Gravel			
Latitude	Longitude	Elev. (m)	Acreage	Pit Size		DOGAMI Permit #				
44 47'16.75928"	122 38'42.28207"	185.951	21.04	NA		24-0094				
Comments										
GPS acquired at the access gate.										
Rock Type	Unit	Color		Weathering			Jointing			
Volcanic Gravel	NA	NA		NA			NA			
Quality			Hardness	lbs./cu ft.	Reserve (cy)	Reserve (Tons)				
Fair to Good			NA	120	80,000	129,600				
Potentially Significant Site	Why			Open/Closed	Direction					
No	Limited rock, and in an area of rural homes.			Closed	Adjacent to the Santiam River.					
Adjacent Land Use										
Residential										
Remarks										
This site is located about 2 miles west of Mehama on the Santiam River. The property is within the flood plain and has standing water at various locations. The gravel estimate is based on a 5 acre pit 10 feet deep. There are no exposures to evaluate the rock, but from the surrounding area I have classified it as fair to good quality. Most of the gravel along the Santiam River is a volcanic porphyry. The ground is used as a bone-yard and waste site area now. There is no screening but plenty of room to work. There are residential homes adjacent to the north and west here. This site could be used for wetland mitigation due to the standing water. The County Assessors office has the property listed at 48.25 acres. This discrepancy between our records and theirs could be accounted for by the movement of the Santiam River. Possible wetland mitigation.

Looking to the west at the stockpile site. The access gate is to the far right center of the image.

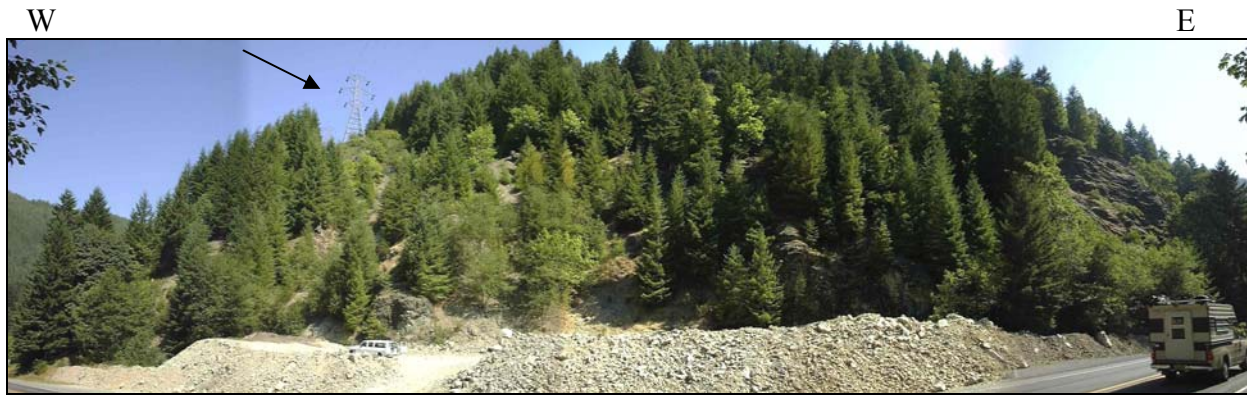
County	Site Name			Dist	Hwy	Mile Pt	TWP	RGE	Sect
Marion	Big Cliff Quarry			03	0016	0	10S	04.0E	01
File ID		Source #	Date Visited	Map #			Type of Site		
15387		24-900-2	8/10/1999	1R-2-1922			Road Cut		
Latitude	Longitude	Elev. (m)	Acreage	Pit Size		DOGAMI Permit #			
44 44'21.52918"	123 03'14.56952"	55.581	20.78	NA					
Comments									
GPS acquired in a small pit/roadcut									
Rock Type	Unit	Color	Weathering			Jointing			
Diorite	Thi in Tu	NA	Slight to Moderate			Highly to Moderately Fractured			
Quality			Hardness	lbs./cu ft.	Reserve (cy)	Reserve (Tons)			
Fair to Good			R4	120					
Potentially Significant Site	Why		Open/Closed	Direction					
No	Too narrow/very steep, no room to work.		Closed	To the south across Highway 22 approximately 150 meters is Big Cliff Reservoir.					
Adjacent Land Use									
Forest									
Remarks									
This is a fine to medium-grain diorite that is highly fractured along Highway 22. The site is across the road from the entrance to the boat ramp for the Big Cliff Reservoir. The terrain is very steep with no screening and no room to work. What limited space there is being used for waste rock disposal. There are high power transmission lines that bisect the property on our northern boundary. The ground has little to no overburden. This site would be very difficult to develop. A better classification for this site would be Right of Way along Highway 22.

Looking to the north at the site along Highway 22. Note the high power lines in the upper left center of the image.

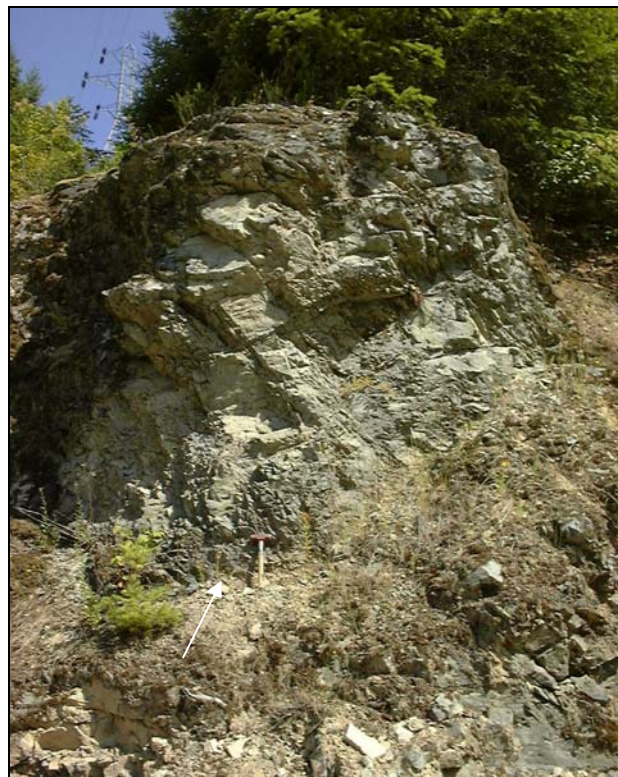
Close-up view of the fracture pattern with the hammer for scale.

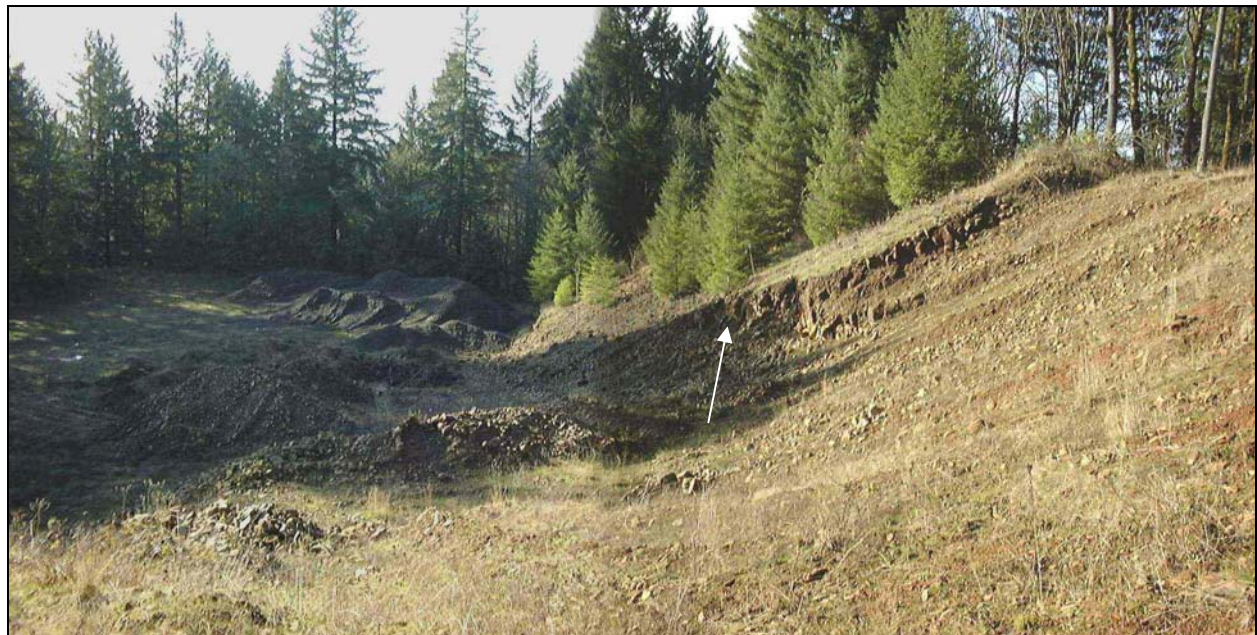
Farming										
Remarks										
This site is located north of Lafayette about 2 miles. The site has had limited work done to open up the ground to expose a medium-grain basalt. There is some slight to moderate weathering here. You can rip the material now, but would need to drill and blast once you start to work in fresher rock. There is good screening with ample room to work. You could have up to 6 feet or more of overburden here. There is some timber value here. There is a small amount of crush rock here (1000 cubic yards).										
202B	203B	211	206 Fine	206 Coarse	208 F	208 F Ht.	208 C	208 C Ht.		
Material Use

Looking to the west at the pit with some crushed aggregate stockpiled.
Close-up image is area shown with arrow.

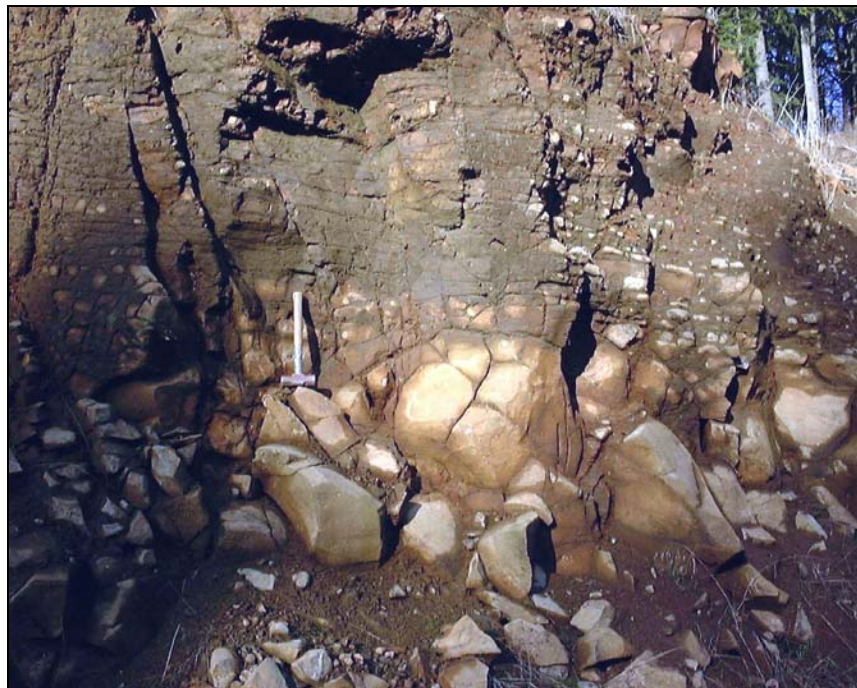
Close-up view of the basalt showing the weathered horizon and the fracture pattern.

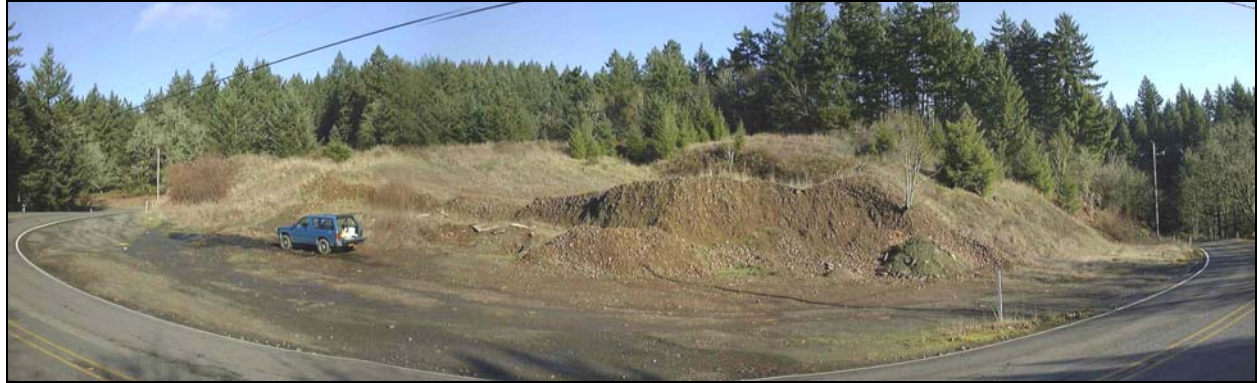
County	Site Name			Dist	Hwy	Mile Pt	TWP	RGE	Sect
Yamhill	Chehalem Mountain Quarry			03	0140	17.3	03S	02.0W	06
File ID		Source #	Date Visited	Map #			Type of Site		
16050		36-052-2	12/14/1998	1R-2-2514			Quarry		
Latitude	Longitude	Elev. (m)	Acreage	Pit Size		DOGAMI Permit #			
45 20'18.3674"	122 58'24.8976"	163.591	3.92	<1					
Comments									
GPS acquired along Highway 219									
Rock Type	Unit	Color		Weathering			Jointing		
Basalt	Tc	Medium Dark Grey (N4)		Slight			Highly Fractured		
Quality			Hardness	lbs./cu ft.	Reserve (cy)	Reserve (Tons)			
Poor to Fair			R3	155	18,000	37,665			
Potentially Significant Site	Why					Open/Closed	Direction		
No	No room to work, limited amount of rock, no screening from the road and in an area of residential homes.					Closed	NA		
Adjacent Land Use									
Residential									
Remarks									
This site is about 1 mile north of Newberg on Highway 219. The rock is a medium-grain basalt with limited exposures. There is no room to work, and no screening from the highway. You can rip the rock. This site is used as a waste rock location. The adjacent property owner to the north uses our ground for his yard. Overall this is a small piece of ground, right on the highway and in an area of residential homes.

Looking to the north at the site along Highway 219.
