OREGON DEPARTMENT OF TRANSPORTATION
AGGREGATE SITES
DISTRICT 5
JUNE 2002

List of Sites in District 5

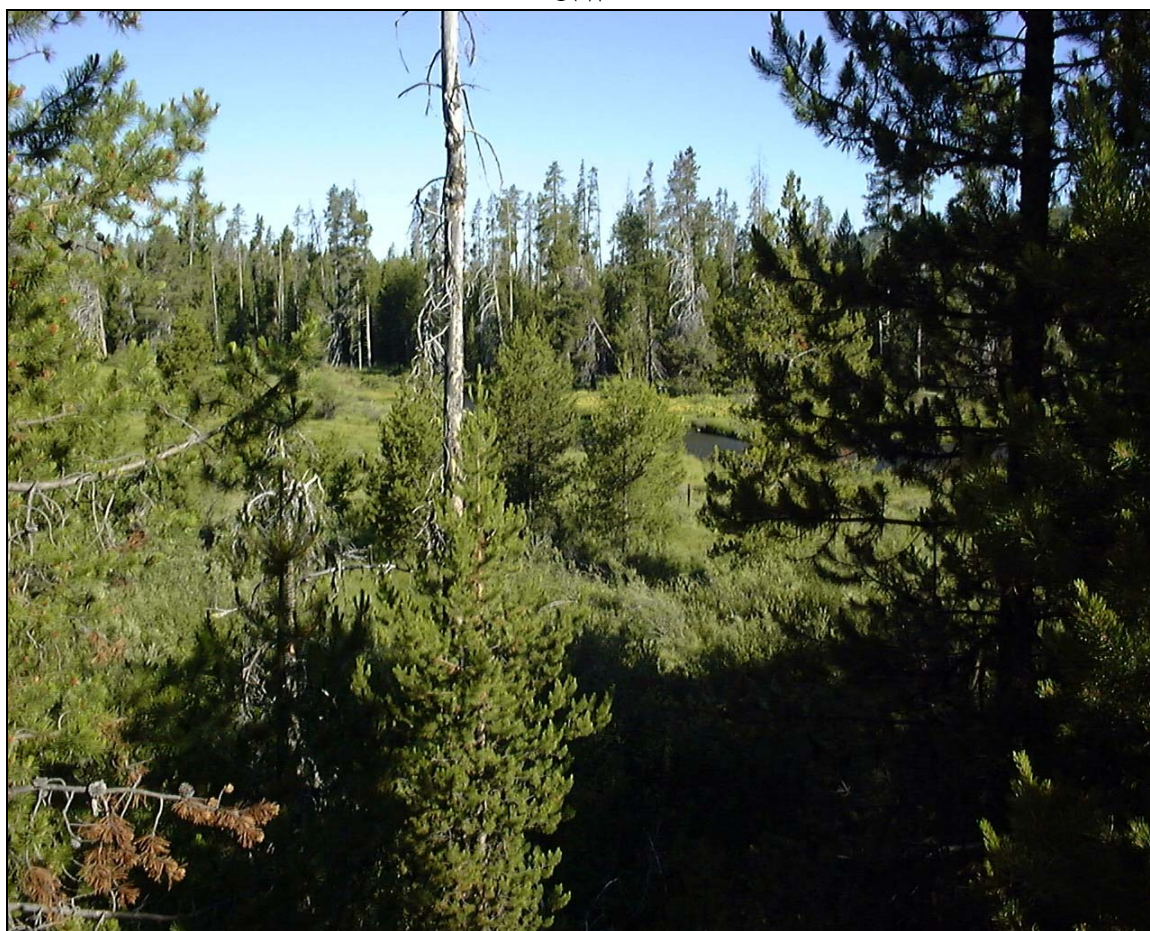
NA																												
Remarks																												
I tried to reach the site along Crescent Creek. There was a locked gate 1/4 mile in from Highway 58. From the map it appears the area is in a marsh. From a visual inspection of Crescent Creek this site could be used for wetland mitigation. This site should be assessed for surplus.																												
202B	203B	211	206 Fine	206 Coarse	208 F	208 F Ht.	208 C	208 C Ht.																				
Material Use

View of the terrain near the gravel site on Crescent Creek.

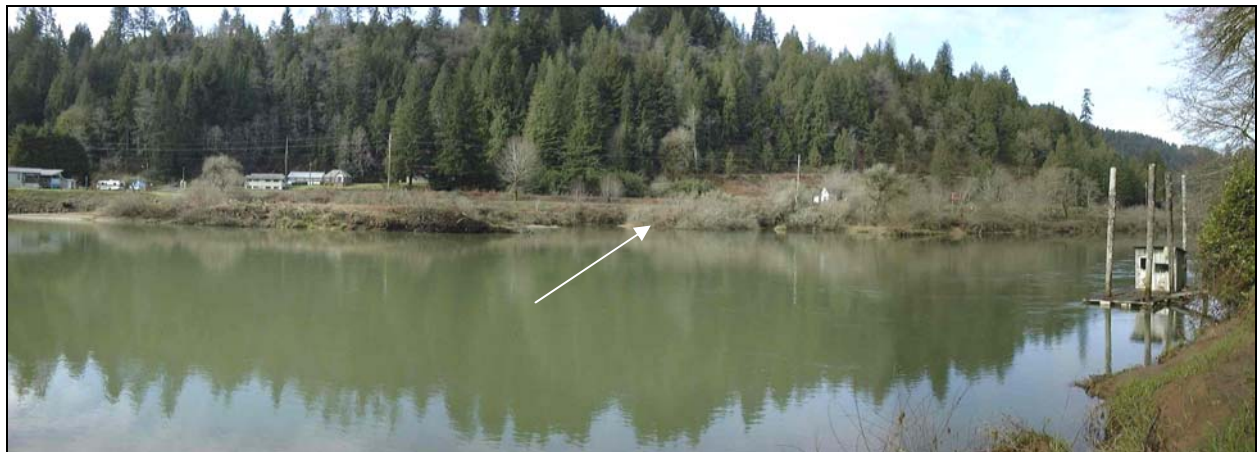
Adjacent Land Use																								
Residential in the town of Mapleton																								
Remarks																								
The property is located on the Siuslaw River at the outskirts of Mapleton. The site appears to be all silt with no evidence of any gravel. Records point to tidal action at this site. Wetland potential, good spot for a park or river access.																								
202B	203B	211	206 Fine	206 Coarse	208 F	208 F Ht.	208 C	208 C Ht.																
Material Use

Looking west across the Siuslaw River at the gravel site.

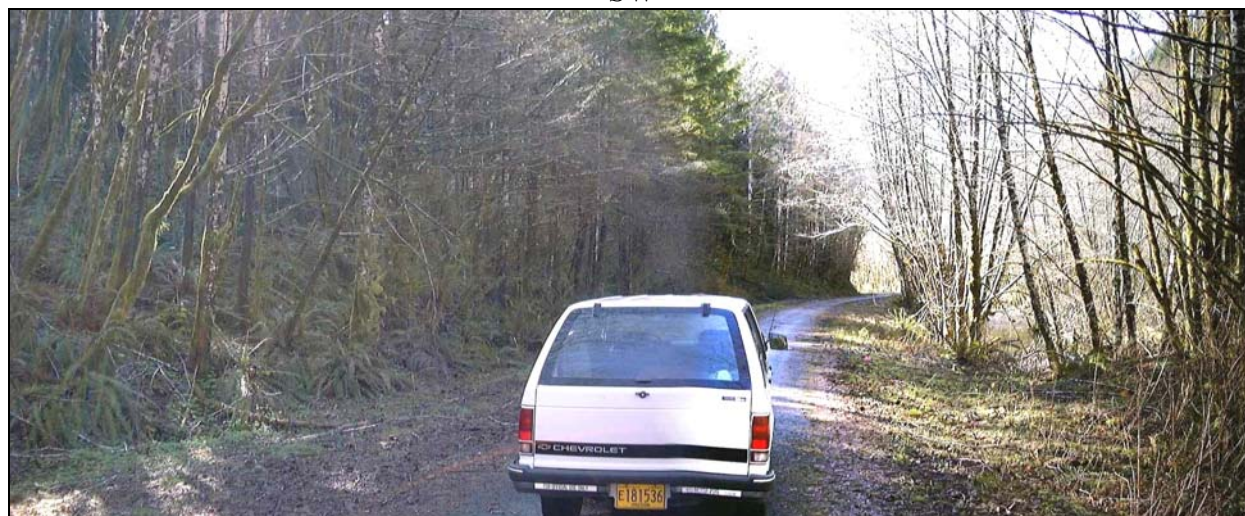
Adjacent Land Use																								
Forest																								
Remarks																								
This site is located south of Highway 126 about 3.2 km on Whittaker Creek. The property is long and narrow and is adjacent to the creek. It is raw land with no prior disturbances. The site has been drilled. The rock is a fine-grain andesite with massive fracture. ODOT would need to drill and blast. There could be up to 3 m of overburden in this area. The terrain is moderately steep with limited room to work and no screening. The property is bisected by two BLM roads. There appears to be a small BLM quarry adjacent to the north. Some in-stream work has been done adjacent to this ground for what appears to be Salmon Recovery. The BLM roads above and below our site make it difficult to do any work at this location.																								
202B	203B	211	206 Fine	206 Coarse	208 F	208 F Ht.	208 C	208 C Ht.

Looking southwest along the BLM road.
Whittaker Creek is just to the right and the quarry site is on the left side of the road.

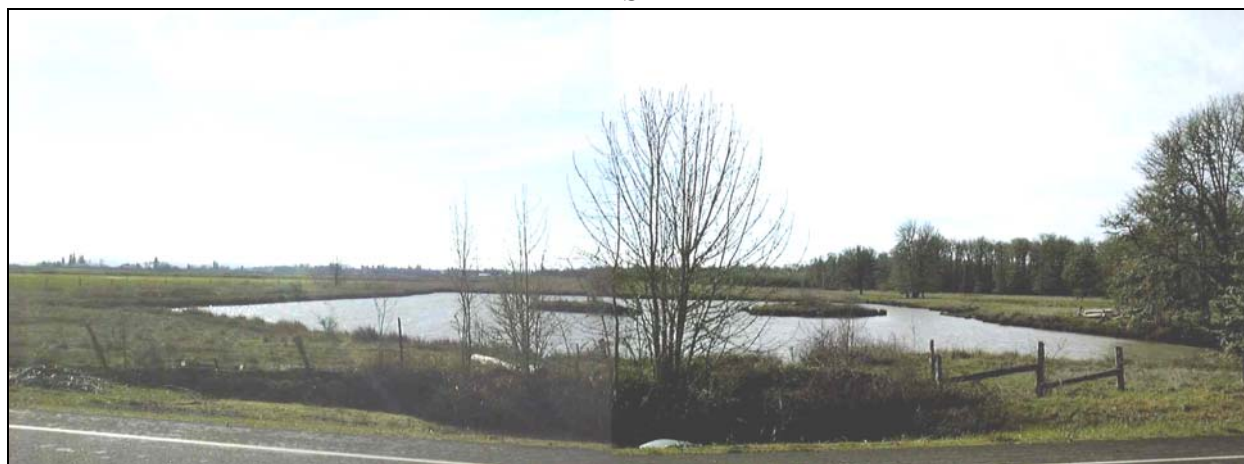
Adjacent Land Use																								
Farming																								
Remarks																								
This site is located adjacent to and south of Franklin Road. The property has had past production at the front of the site up by the county road. The pit has filled in with ground water. You could remove terrace gravel on the southern portion of the property. There would be limited room to work and access to the ground would need to be addressed. There is no screening from the county road. Wetland potential.																								
202B	203B	211	206 Fine	206 Coarse	208 F	208 F Ht.	208 C	208 C Ht.																
Material Use

Looking south from Franklin Road at the borrow site.
The pond is from the last removal of gravel.

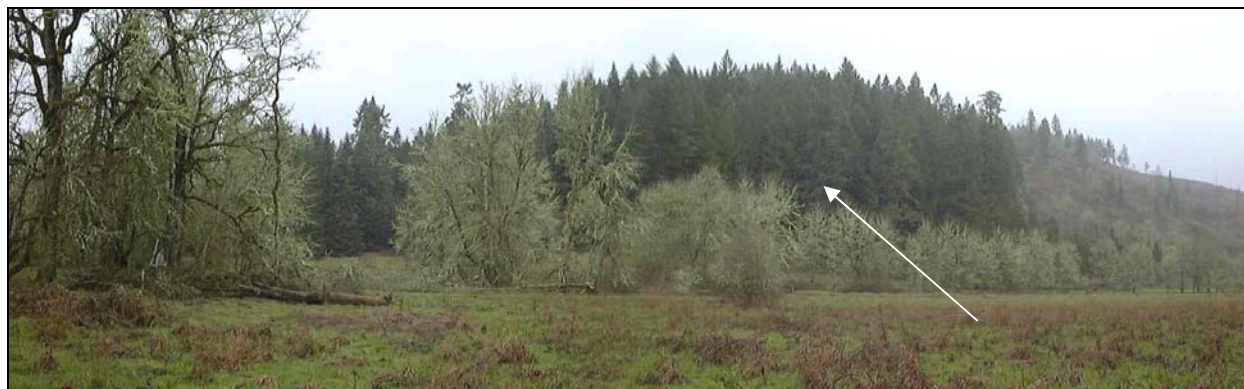
Adjacent Land Use																								
Farming																								
Remarks																								
This site is located east of Territorial Highway about 200 meters. The rock here is a very fine-grained basalt that has platy fracture and breaks into very sharp angular pieces. There could be up to 10 feet of overburden on the side of the hill. Past exploration has one small cat cut half way up the hill. There would be limited screening from the highway with some room to work. There is some timber value at this site. The adjacent property owner expressed interest in this site. The easement is not evident with all of the new cross fencing in this area. Good timber, would need to develop the easement. Few, if any sites in this area.																								
202B	203B	211	206 Fine	206 Coarse	208 F	208 F Ht.	208 C	208 C Ht.

Looking east at the quarry site, across the field.

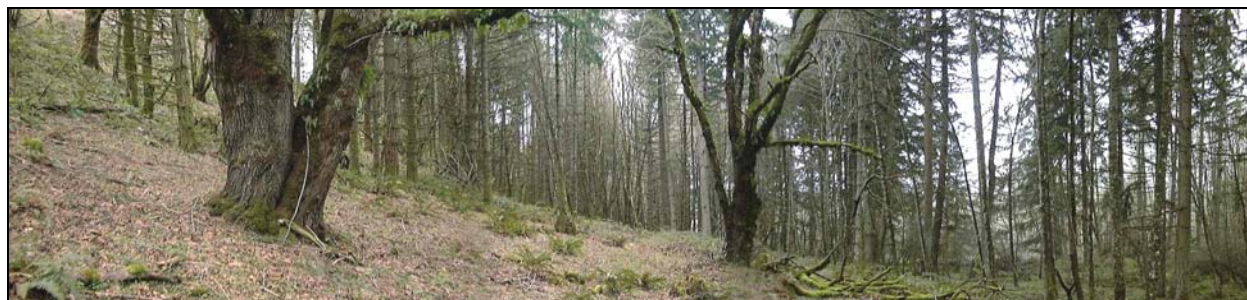
Remarks																	
No good exposures to evaluate the rock. I acquired rock samples from the roots of a fallen fir. Overburden could be up to 10 feet deep at this property. There is no access to this site from any road except I-5. The ground with the rock on it has been sold, and we are left with the bottom flat site. I see no value in the ground here. Property is landlocked. Adjacent property sold for timber value. There is some timber value at this site. Easement was from I-5 and is no longer evident. The property is flat with no good exposures here. Lab results were from test holes on the side of the hill that we sold. Results for P.I. is 2% and the L.L. is 27%.																	
202B	203B	211	206 Fine	206 Coarse	208 F	208 F Ht.	208 C	208 C Ht.

Looking northwest at the potential quarry site adjacent to the hillside.

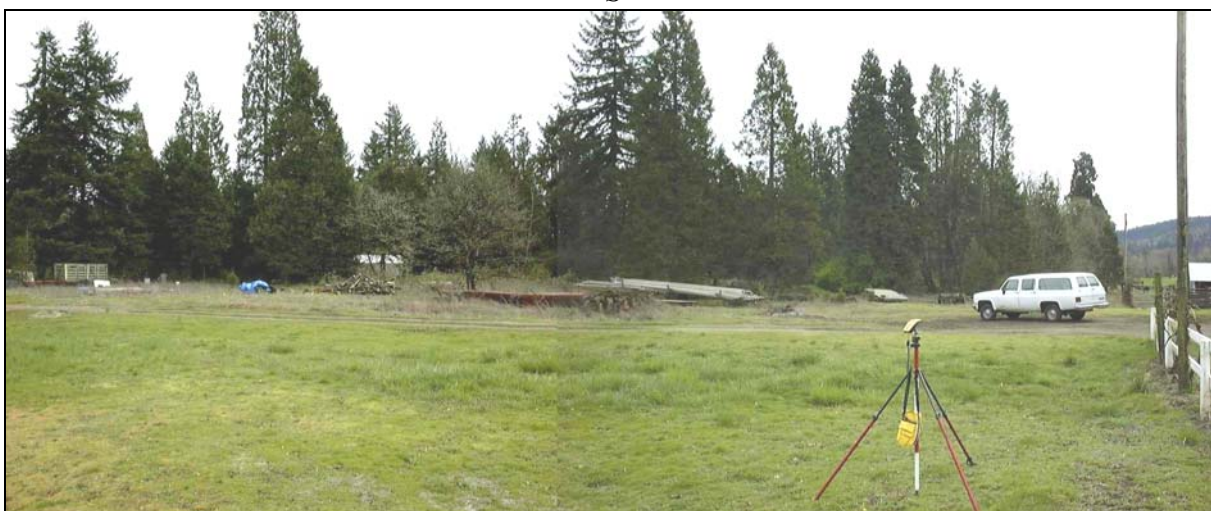
Looking south at the site within the trees.

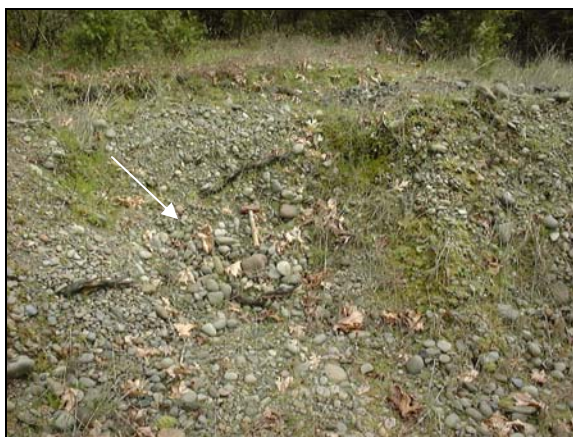
This site is located south of Jasper Road about 100 meters. The material is composed of a volcanic gravel that is about cobble size (10cm) and less. The ground has been worked in the past by the evidence of the hummocky terrain. It appears that there are about 10% sand/organics to 90% gravel. There is limited room to work and no screening at this location. The access to this site is on a private drive that is shared by the home owners adjacent to this ground. There is a good grove of cedar trees on this property, easement would need to be developed if we want to use this site.																		
202B	203B	211	206 Fine	206 Coarse	208 F	208 F Ht.	208 C	208 C Ht.

Close-up view of the gravel with the hammer for scale.

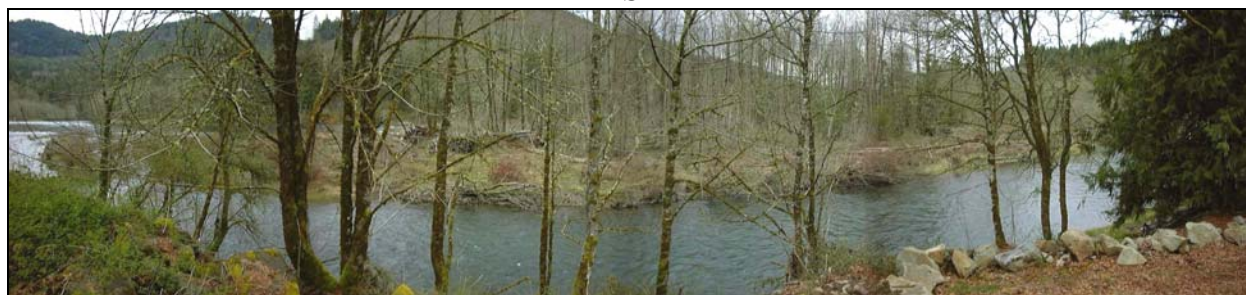
Adjacent Land Use																								
Residential/Forest																								
Remarks																								
This property is an island in the middle of the McKenzie River. There is a stock pile site that is adjacent to the property. There is no screening and some room to work at the stockpile site. There is no access to the island from the highway. This site has potential for Salmon Recovery, Wetland Mitigation.																								
202B	203B	211	206 Fine	206 Coarse	208 F	208 F Ht.	208 C	208 C Ht.																
Material Use

Looking south across the McKenzie River at the gravel site on the island.

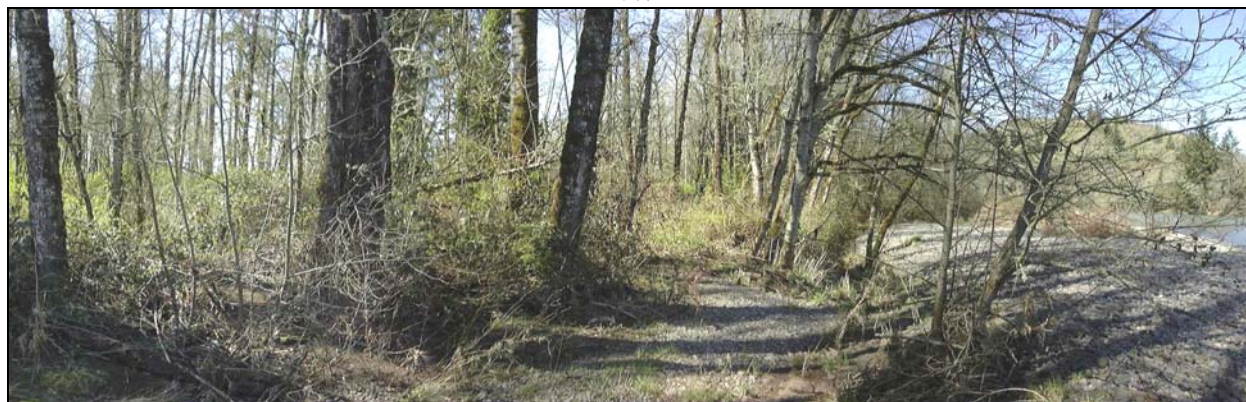
Adjacent Land Use																								
Farming																								
Remarks																								
This site is located southeast of Springfield on the Middle Fork of the Willamette River. The property is within the floodplain of the river. There is no disturbance at this location. The gravel exposed here is cobble size and less with the dominant size about 10 centimeters. There is about 40% organics/sand size particles at the site. The property is all overgrown in vegetation. The easement is through a private farm. There is some screening and room to work at this site. This site has potential as a wetland/salmon mitigation site. This site is quite large, with potential for rock removal. The adjacent property owner has expressed interest in purchasing the ground for expansion of his Christmas tree farm.																								
202B	203B	211	206 Fine	206 Coarse	208 F	208 F Ht.	208 C	208 C Ht.

Looking northwest at the gravel bar along the Middle Fork of the Willamette River.

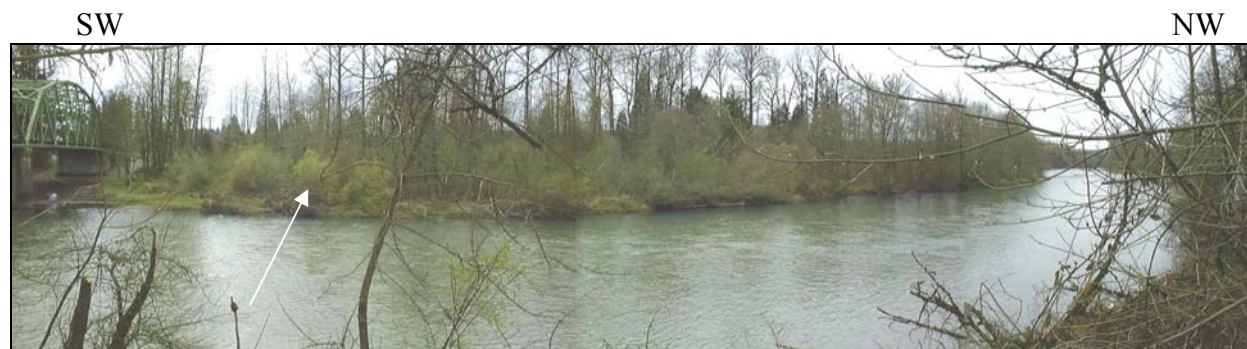
Adjacent Land Use																								
Residential																								
Remarks																								
This site is located on the west side of the Middle Fork of the Willamette River. A new bridge at this location bisects the ground. There is a very high percentage (80%) of sand and organics here. Most of the property is over grown with vegetation. There is a new residential development adjacent to the south and the entrance to the County park is adjacent to the north. This site might have wetland mitigation/salmon recovery potential. This site is open and used by the public under the bridge. There is no screening and limited to no room to work. The results for the Liquid Limit test was 23%.																								
202B	203B	211	206 Fine	206 Coarse	208 F	208 F Ht.	208 C	208 C Ht.

Looking west at the site across the Middle Fork of the Willamette River.

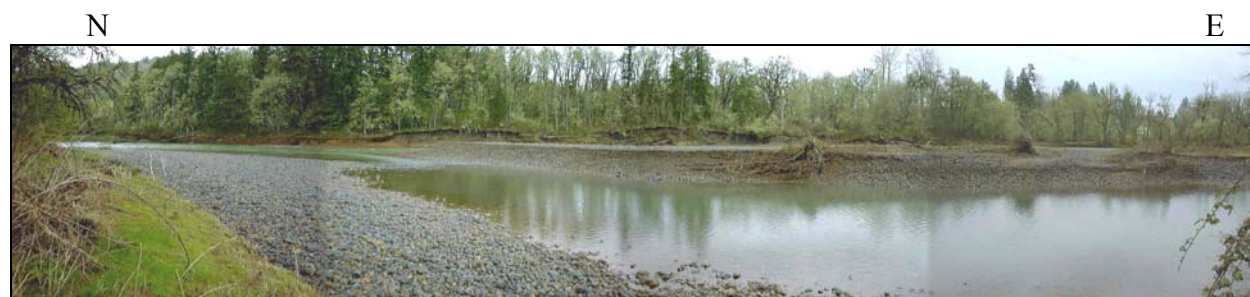
Adjacent Land Use																								
Residential																								
Remarks																								
This site is located on the inside radius of the Coast Fork of the Willamette River. The property is partially in the river. We would need a new survey to determine accurate boundary locations. There is a large clean gravel bar there now. The dominant size is cobble and less, with virtually no sand. There is good screening but no room to work at this location. The property is bordered by residential homes. The ground that the easement is through is on the market to be sold. This site has mitigation potential. Bedrock is very close to the surface here. The results for the Sand Equivalent was 90.																								
202B	203B	211	206 Fine	206 Coarse	208 F	208 F Ht.	208 C	208 C Ht.

Looking to the northeast at the gravel bar in the Coast Fork of the Willamette River.

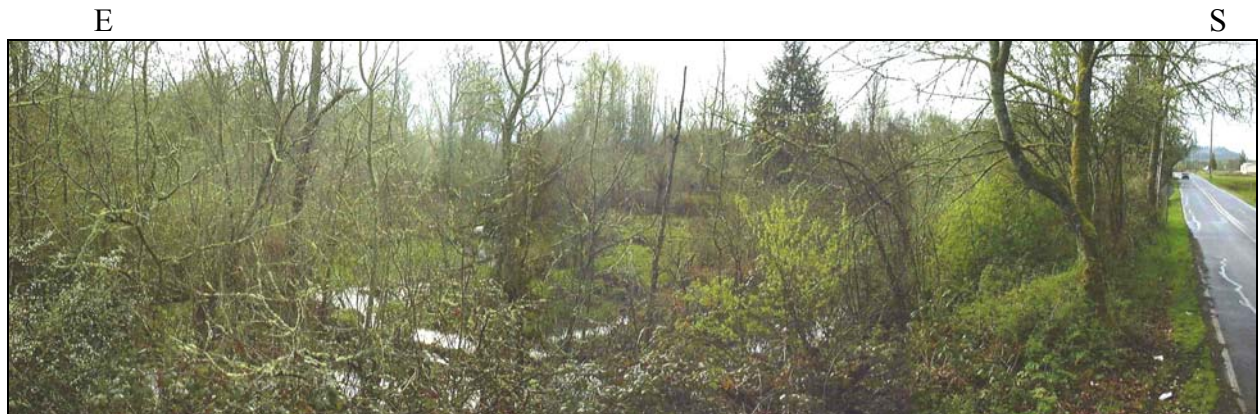
Remarks																							
This site is located just north of Highway 58 and the I-5 junction. It is surrounded by residential homes, and appears to be depleted. Wild Hog Creek bisects the property that is all overgrown with vegetation. This is a classic example of a wetland site. The result for the Plasticity Index was 11% and Liquid Limit was 35%.																							
202B	203B	211	206 Fine	206 Coarse	208 F	208 F Ht.	208 C	208 C Ht.

Looking southeast at the gravel site around Wild Hog Creek.

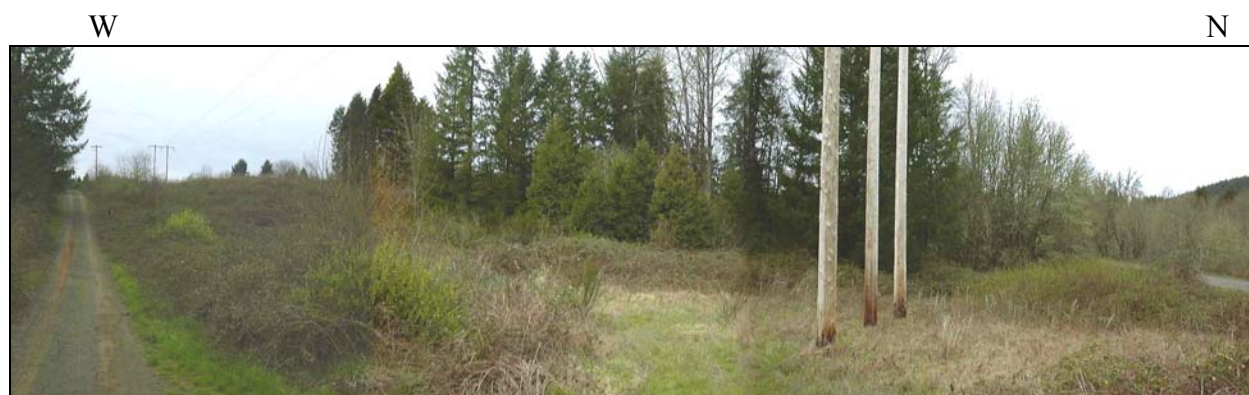
Adjacent Land Use																								
Residential																								
Remarks																								
This site is being cleaned up for environmental concerns. Right of Way has wanted to surplus this property once the clean up has been finished. This file was found in the RW designation. The local public is using this site as their dump. The results for the Liquid Limit test was 21%.																								
202B	203B	211	206 Fine	206 Coarse	208 F	208 F Ht.	208 C	208 C Ht.

Looking northwest at the quarry site. Note the power lines that bisect a portion of the property.

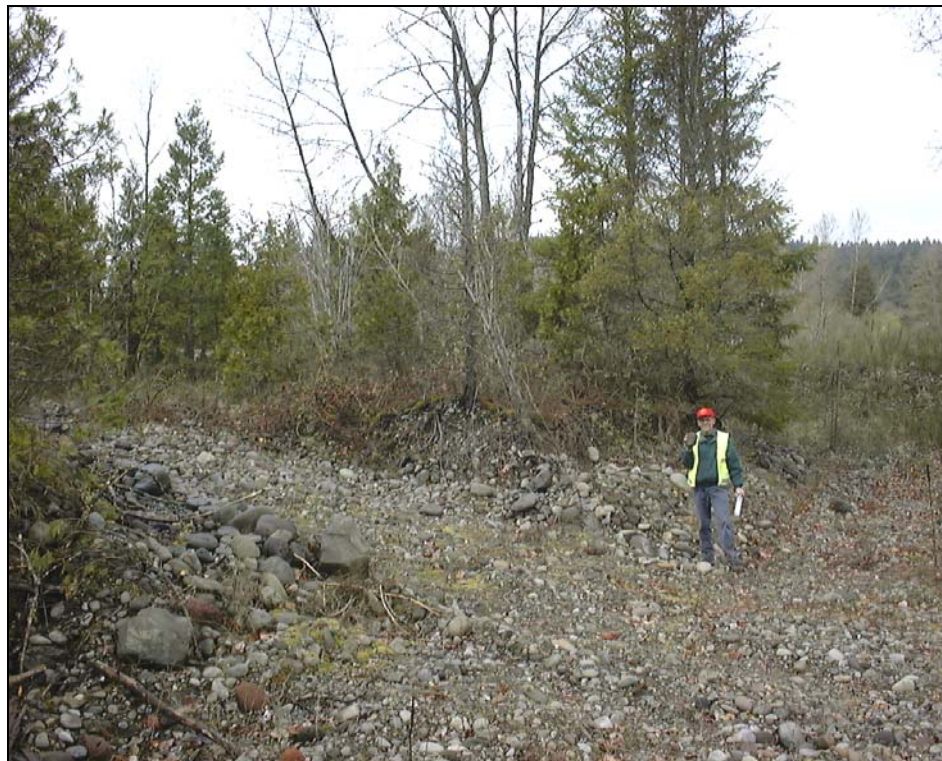
Image of the gravel at the site.

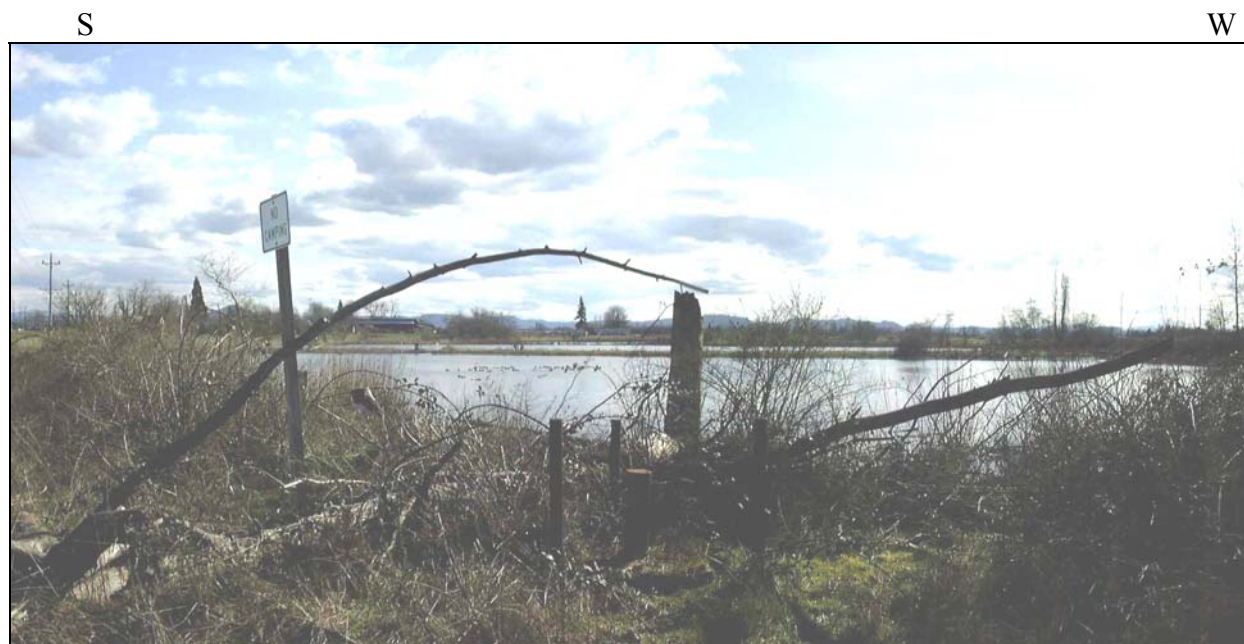
Remarks																								
This site is on Highway 99 just northwest of Eugene. It appears to be mostly depleted of gravel. There are 3 ponds on the property now with some ground water issues about contamination. These ponds might have potential for wetland mitigation.																								
202B	203B	211	206 Fine	206 Coarse	208 F	208 F Ht.	208 C	208 C Ht.																
Material Use

Looking southwest at the gravel site along Highway 99.
