**REMAINING LIFE OF  
REINFORCED CONCRETE  
BEAMS WITH DIAGONAL-  
TENSION CRACKS**

**Final Report**

**SPR 341**

**April 2004**

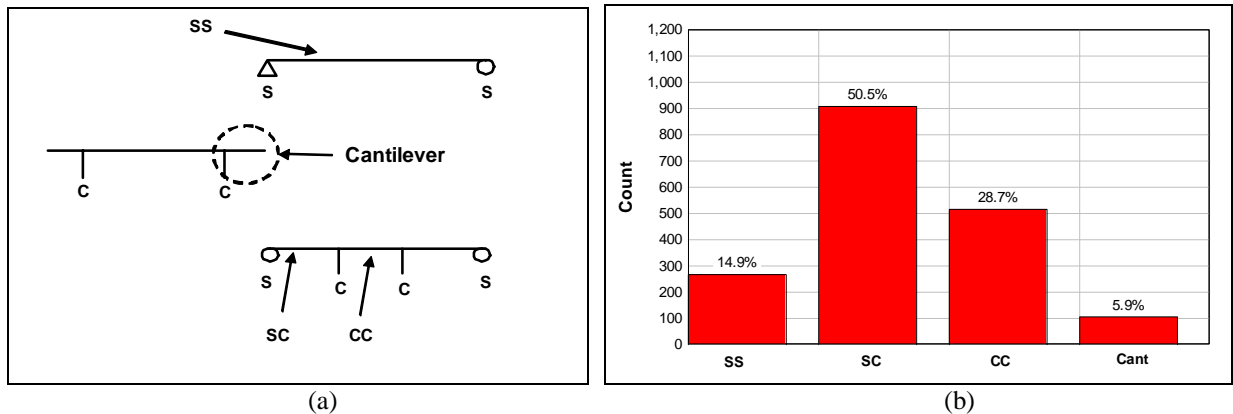
A span could have two simply supported ends (SS), a simply supported end in combination with a continuous support on the other end (SC), continuous supports on both ends (CC), and the span could be a cantilever (Figure 2.3a). Most of the spans (51%) were found to be of the SC type (Figure 2.3b).

Figure 2.3: Span indeterminacy – (a) Types of span indeterminacy; (b) Frequency of span indeterminacy types

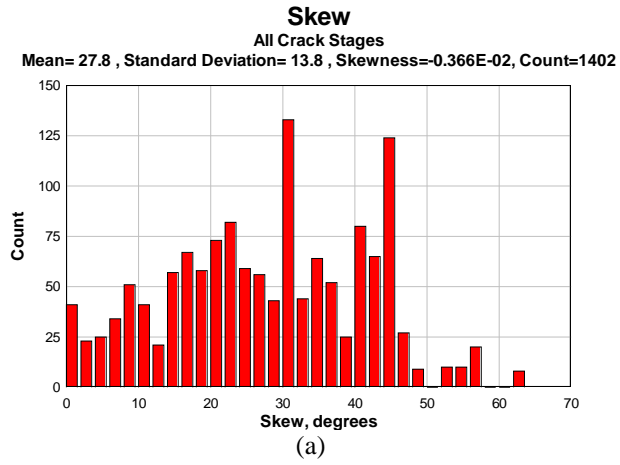
The same ranges of skew angle were predominant for spans of Crack Stage 1 and 2. The range of 30 to 32 degrees occurred at a rate of 11% for Crack Stage 1, and 9% for Crack Stage 2. For spans of Crack Stage 1 and 2, the range of 44 to 46 degrees occurred with a frequency of 9%, as shown in Figures 2.5b and 2.5c. The peak range of skew angle for spans of Crack Stage 3 was between 44 and 46 degrees occurring at a rate of 14%, as shown in Figure 2.5d.

Figure 2.5: Skew – (a) All crack stages; (b) Crack Stage 1; (c) Crack Stage 2; (d) Crack Stage 3

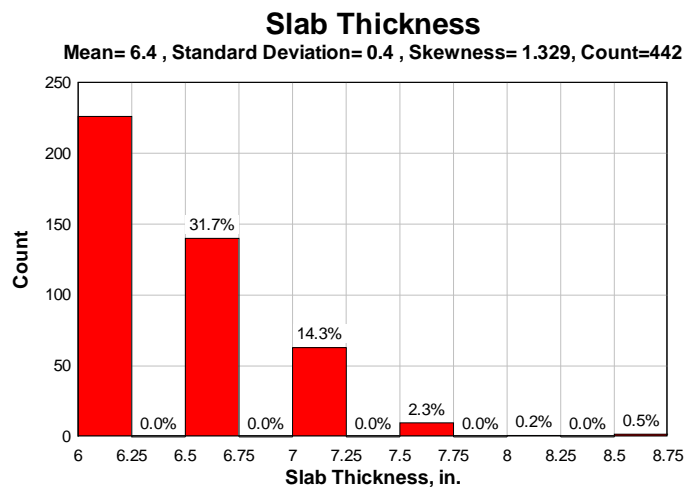
Based on design drawings of the bridge cross-section, the slab thickness was determined. Typically, bridges had slab thickness between 6 and 6.5 in., although slab thicknesses up to 8 in. were observed, as shown in Figure 2.7. The 6 in. slabs accounted for 51% of the total number of bridges and 6.5 in. thick slabs accounted for 32%.

Figure 2.7: Slab thickness

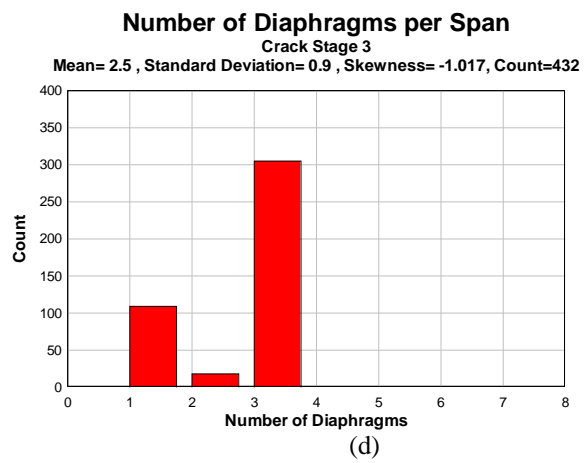
For each span, the number of diaphragms was determined from the plan view of the overall bridge drawing. For spans with diaphragms, about 53% had 3 diaphragms per span and 43% had 1 diaphragm, nearly an even split, as shown in Figure 2.12a. When the data set was grouped by crack stage and analyzed, the nearly even split between the number of spans with 1 and 3 diaphragms was seen for Crack Stages 1 and 2, but not for Crack Stage 3. The large majority, 71%, of the Crack Stage 3 spans had 3 diaphragms per span. This resulted in a slightly higher average number of diaphragms per span for Crack Stage 3 as compared to Crack Stages 1 and 2, as shown in Figures 2.12b, 2.12c, and 2.12d. This may imply that the additional diaphragms do not provide any considerable increase in load distribution compared with fewer diaphragms.

Figure 2.12: Number of diaphragms per span – (a) All crack stages; (b) Crack Stage 1; (c) Crack Stage 2; (d) Crack Stage 3

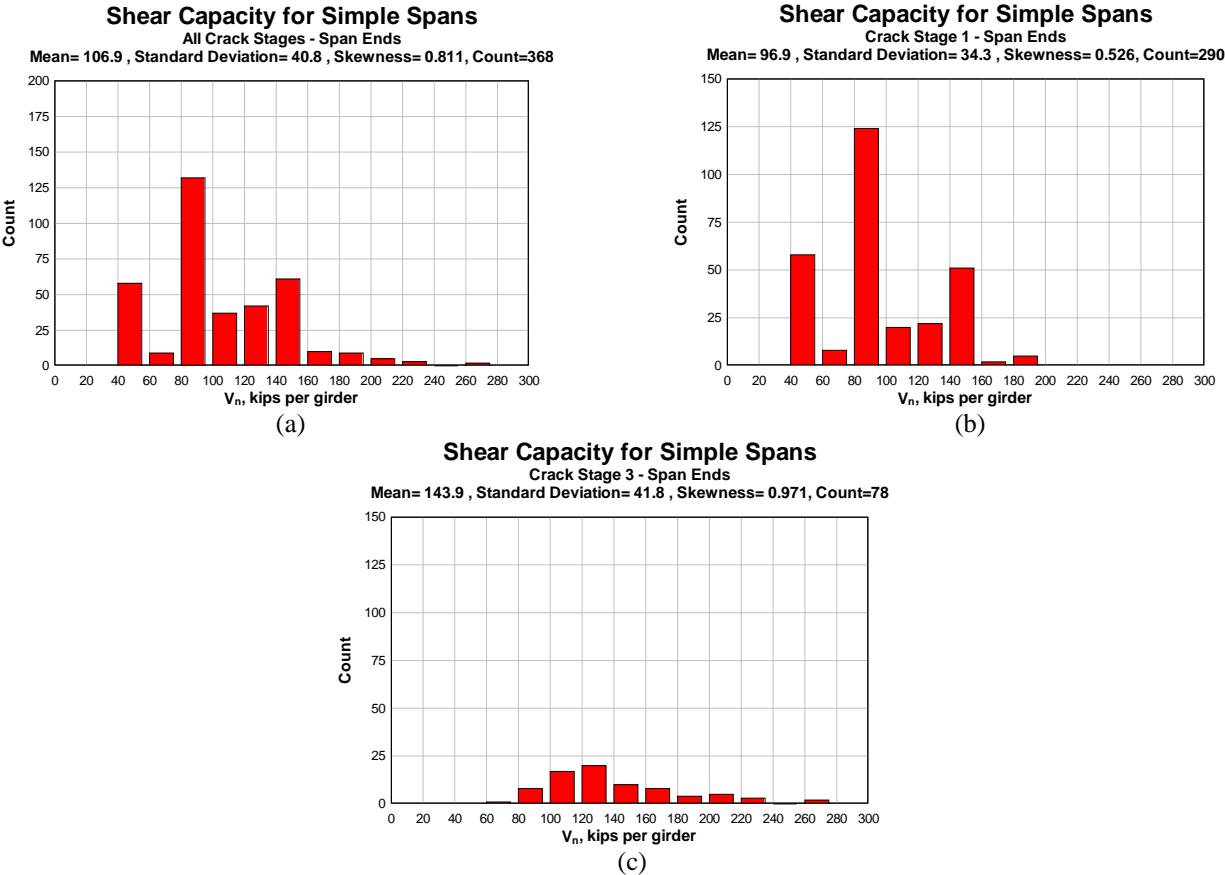
The range of nominal shear capacity at span ends for simple spans was between 47 and 270 kips per girder, with an average of approximately 107 kips per girder. The most frequently occurring range of nominal shear capacity at midspan of the simple spans was between 80 and 100 kips per girder and accounted for approximately 36% of the simple span ends, as shown in Figure 5.4a. The average nominal shear capacity for the span ends of the simple spans for Crack Stage 3 was 144 kips per girder, while for Crack Stage 1 the average was about 97 kips per girder, as shown in Figures 5.4b and 5.4c. For Crack Stage 3 simple span ends, the most frequently occurring range of shear capacity was between 120 and 140 kips per girder, accounting for 26% of the Crack Stage 3 spans. For Crack Stage 1 simple span ends, the most frequently occurring range of shear capacity was between 80 and 100 kips per girder, accounting for 43% of the Crack Stage 1 spans.

Figure 5.4: Shear capacity at span-ends of simple spans – (a) All crack stages; (b) Crack Stage 1; (c) Crack Stage 3

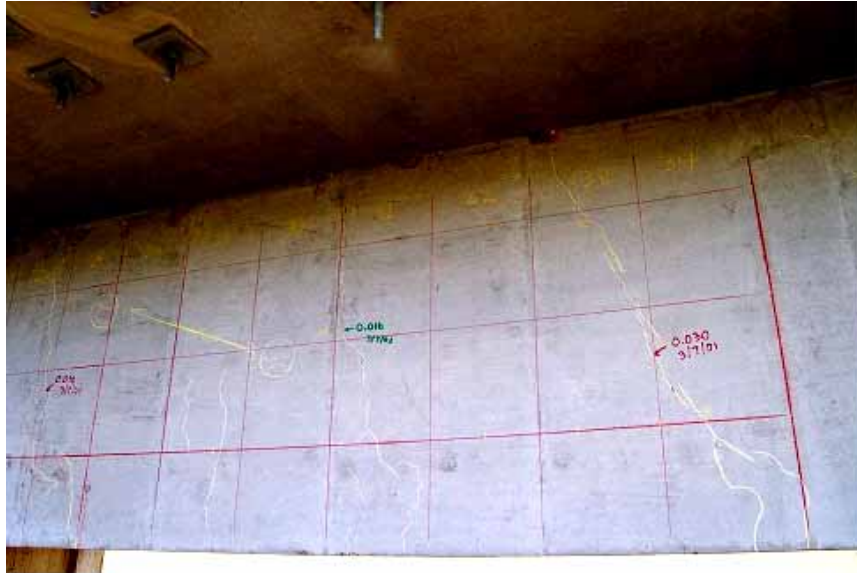
Figure 9.1: Example diagonal cracks and crack and stirrup mapping

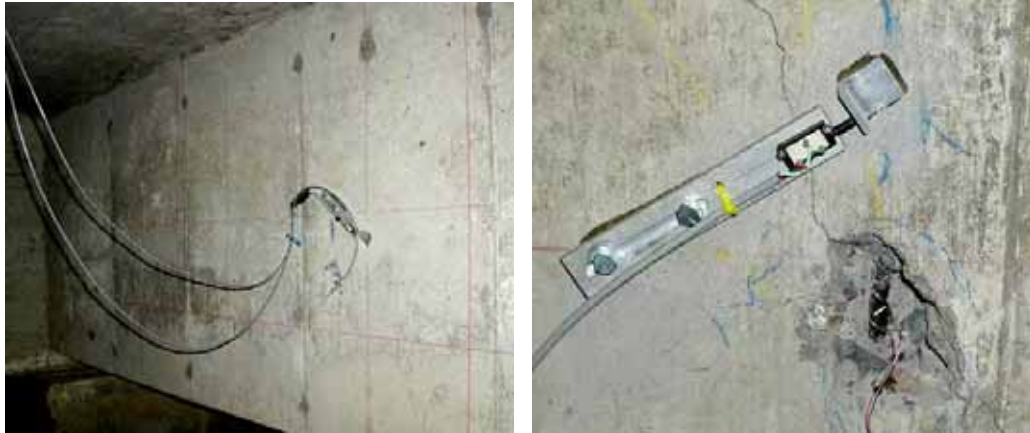
Strain gages (6.4mm (0.25 in.) gage length) were placed on the steel stirrups at locations where stirrups crossed a diagonal crack. Concrete cover was removed and the stirrup surface was prepared before applying the strain gage. A spring return linear position sensor was installed near the strain gage to measure associated crack displacements. A typical instrumented location is shown in Figure 9.2.

Figure 9.2: Example instrumented location of stirrup crossing diagonal crack

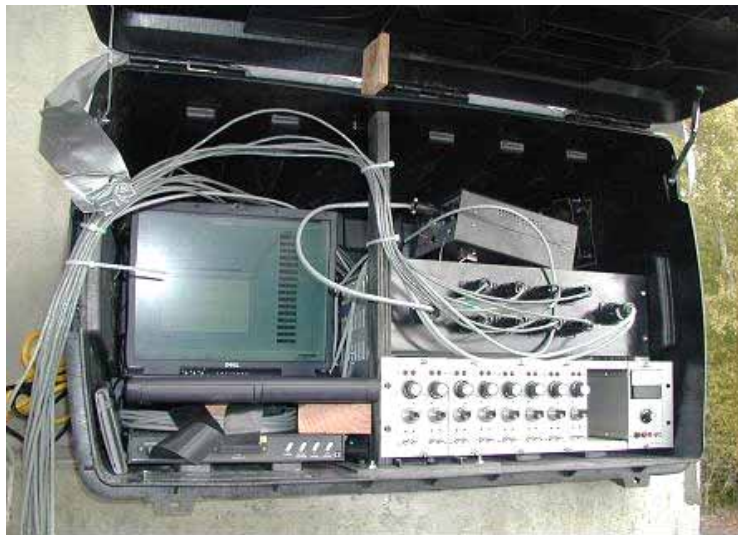
The strain gages and displacement sensors were connected to a data acquisition system controlled by a personal computer. Data from all sensors were acquired at a rate of 50 Hz. Higher rates were also evaluated but the selected rate was adequate to capture the dynamic and impact responses of the structure. The data acquisition system was placed in an enclosure and anchored to the pier as shown in Figure 9.3, for long-term monitoring of ambient traffic load effects.

Figure 9.3: Instrumentation enclosure on pier

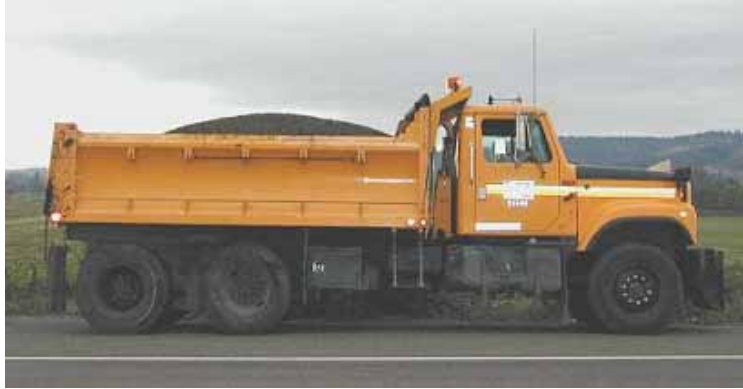
Figure 10.7: Test truck configuration used for controlled loading of bridge

An ODOT maintenance truck filled with gravel was used to perform controlled truck loading of the bridge. The truck had a gross vehicle weight of 227 kN (51 kip) with axle loads shown in Figure 10.7. ODOT flagging crews prevented other vehicles from being on the bridge simultaneously with the control truck. Eight truck passages were performed, five in the northbound direction and three in the southbound direction. Test truck velocities varied from creep to posted and traveling speeds to capture dynamic and impact effects. Truck speeds were determined from the truck speedometer and reported by the driver.

Truck loading consisted of a group of six point loads applied to the bridge model. The locations of the point loads followed the footprint of the test truck shown in Figure 10.7. Twenty-eight positions of truck wheel loads were separately applied to the bridge model in the bridge longitudinal direction to simulate test truck Passage #2 (passenger-side wheels located on the fog line). The distance from the fog line to the edge of the bridge was approximately 1753 mm (69 in). The driver-side truck wheel loads were applied to the bridge model at a distance of 1676 mm (66 in) from the edge. Result locations in the FE model were taken from positions close to the instrumented locations in the bridge and are shown in Table 9.1.

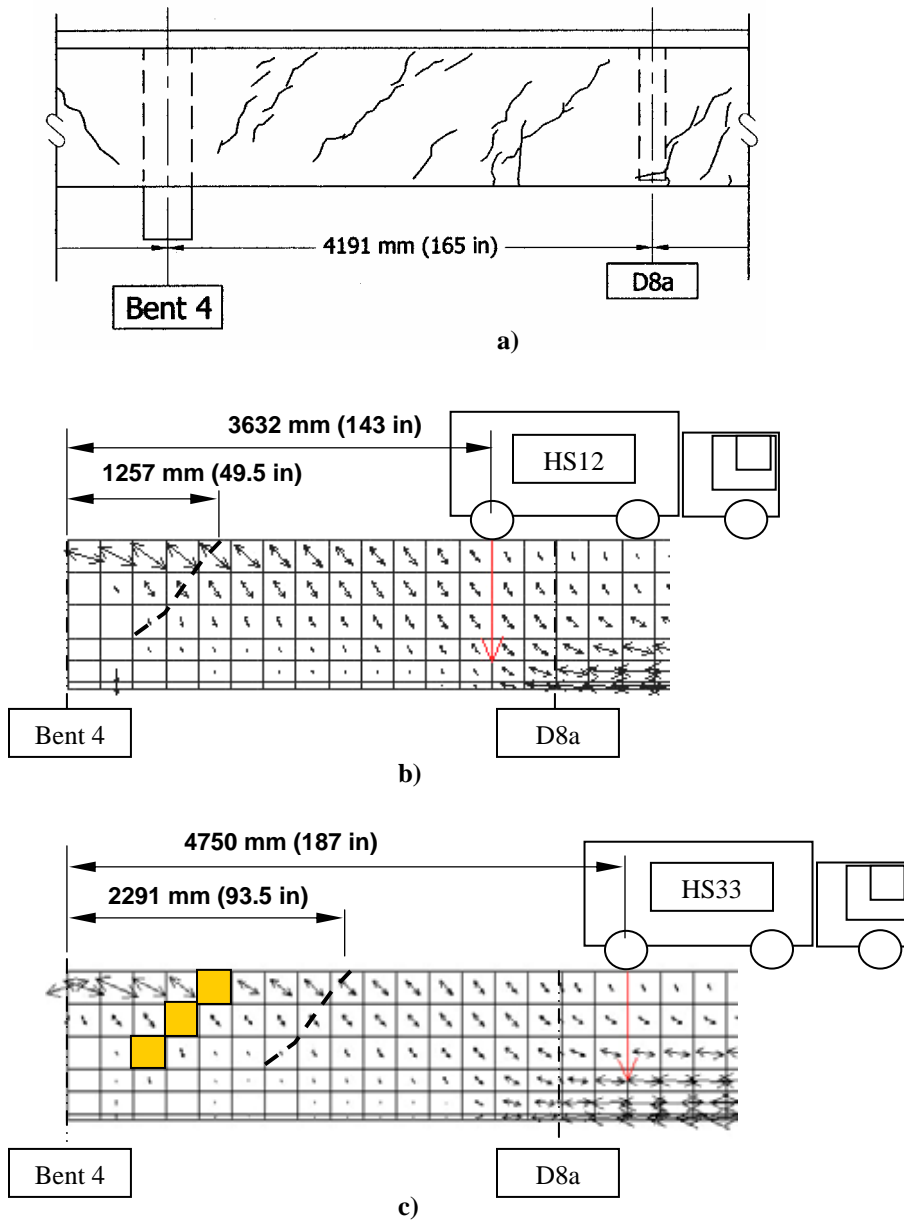
Figure 13.2: Diagonal-tension cracking prediction using finite element analyses – a) crack pattern existing in the bridge exterior girder; b) first cracking prediction; c) second cracking prediction
