**EVALUATION OF ASPHALT ADDITIVES:
LAVA BUTTE TO FREMONT HIGHWAY JUNCTION**

The Dalles - California Highway
Deschutes County, Oregon

Final Report

FHWA Experimental Project No. 3

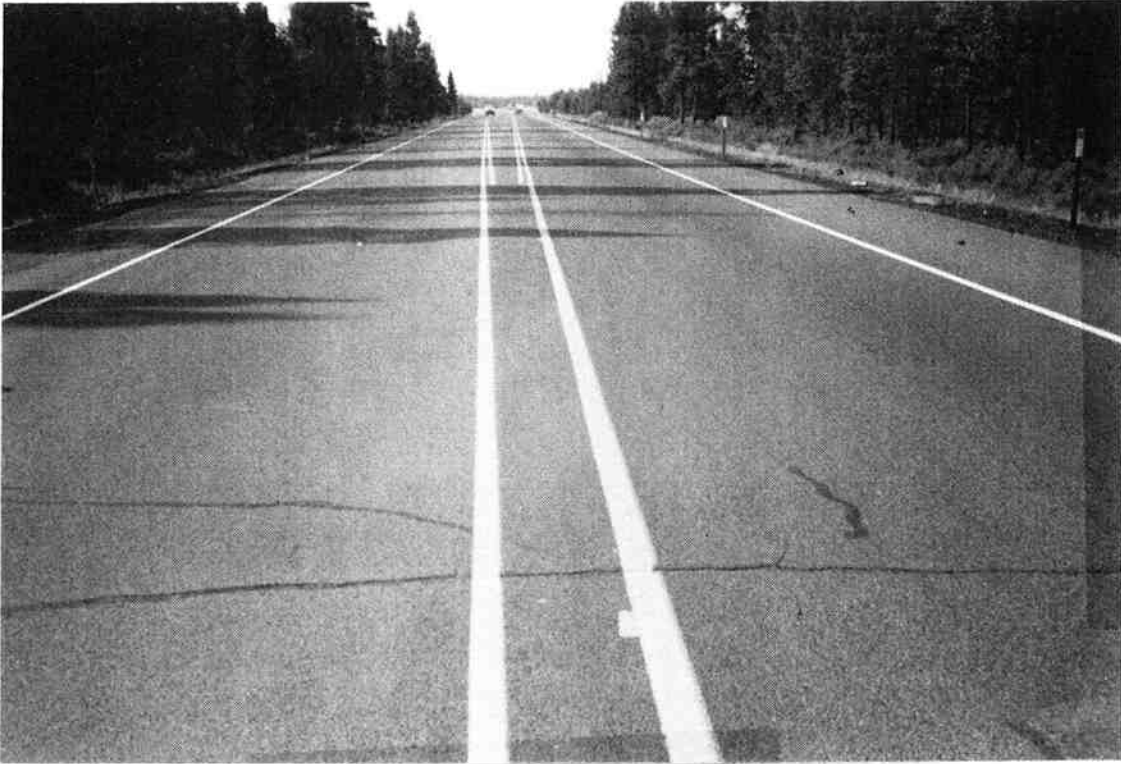
Figure 3.2: Pavement Distress - Cracking

For this study, transverse cracks that originated at the shoulder and extended into the travel lane were included in the count. Most of these cracks extended across the road from shoulder to shoulder (Figure 3.2a).

(a) Typical transverse crack in overlay during 1989. Crack has been covered with sealer.

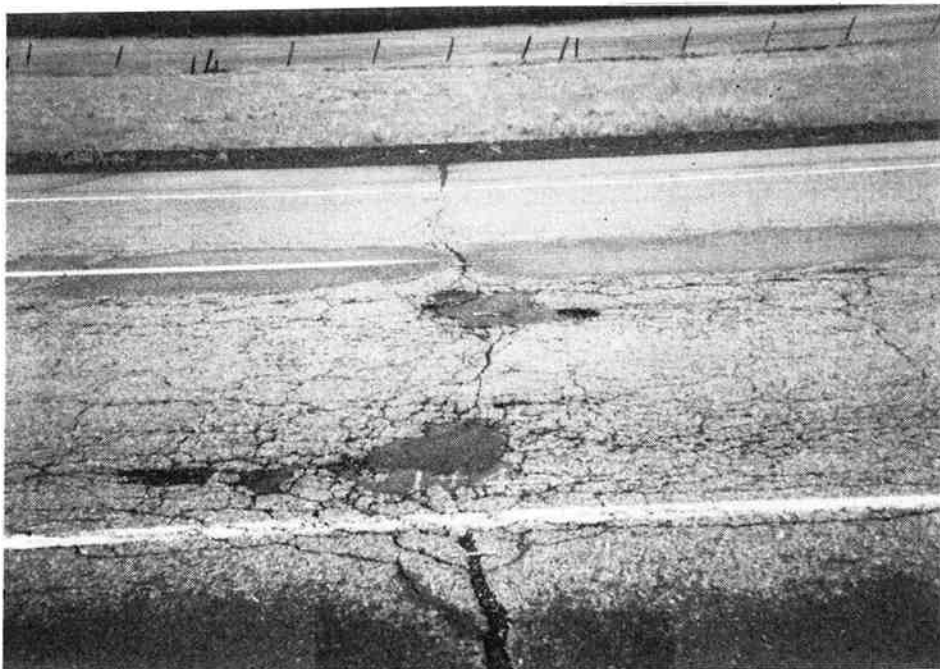
(b) Typical transverse crack in pavement before construction.

extended the full pavement width (Figure 3.2b). Although none of the sections had the crack severity or frequency of the original pavement, after four years there were major differences between the sections.

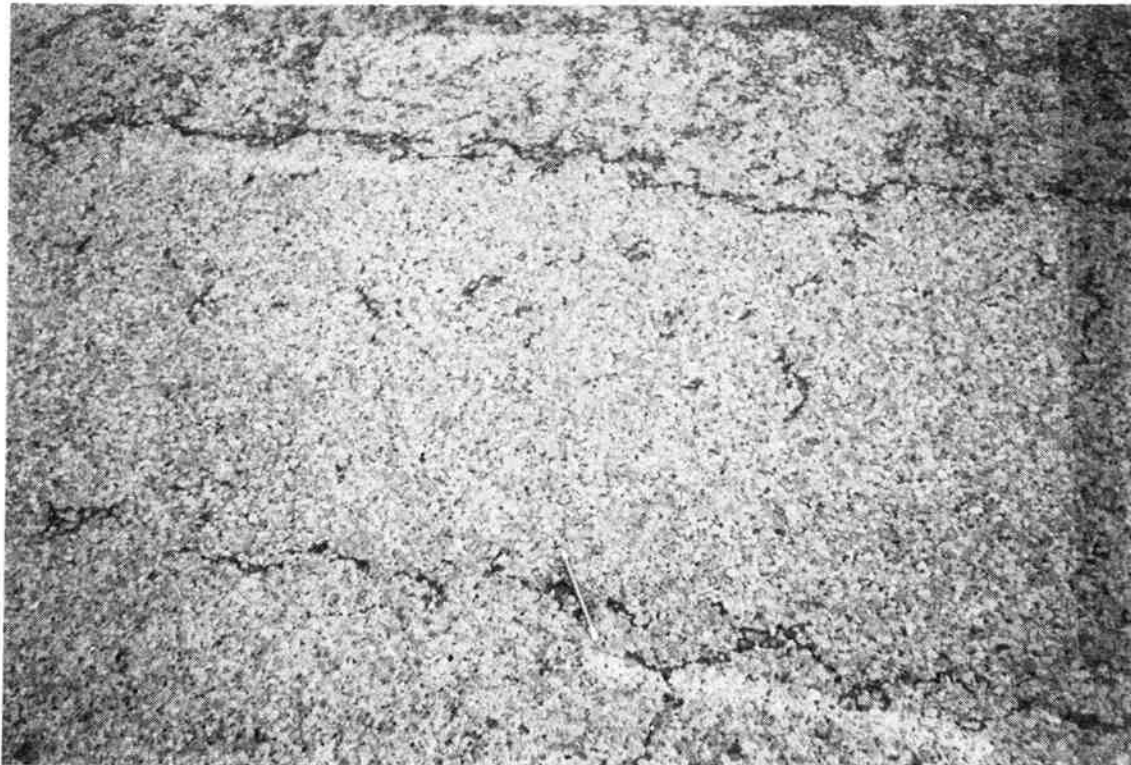
On Section 1 (Plus Ride with Pave Bond), there was very slight ravelling throughout the wheeltracks with a sporadic loss of coarse aggregate (Figure 3.3a). About 6% of the total wheeltrack length was moderately ravelled, with the north and south ends of the outer northbound wheeltrack having the most distress. In these moderately ravelled areas the surface erosion was 1/2 to 3/4 inches deep due to the loss of aggregate and fines. The exposed surface was cracked (Figure 3.3b). This ravelling was getting worse year-by-year.

(b) Cracking and ravelling typical of 6% of wheeltrack length. Pits and cracks have retained moisture and appear as dark areas.

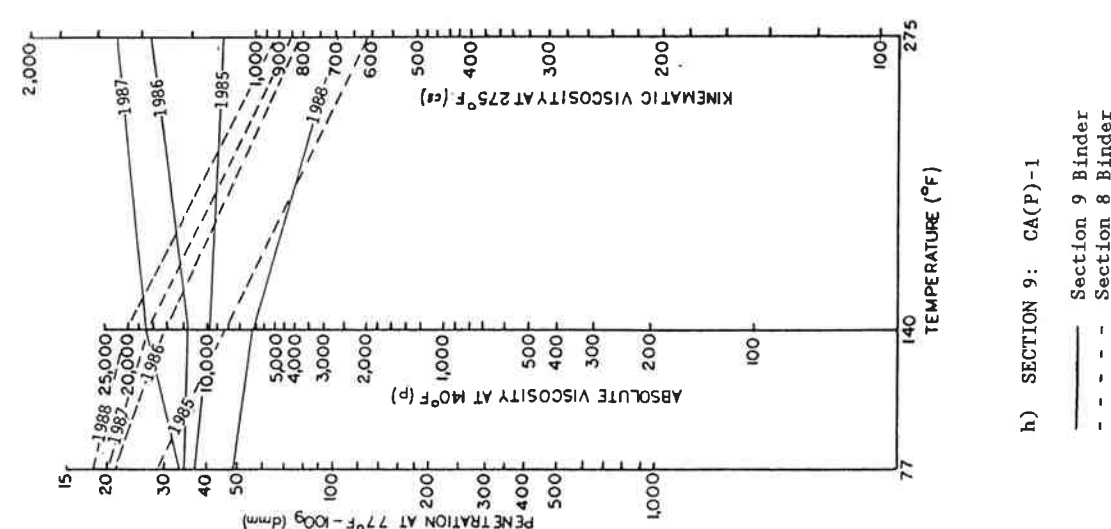
Figure 4.1: Temperature - Viscosity Relationships

The temperature susceptibility of each binder is shown by the slope of the temperature-viscosity curves in Figure 4.1. On the temperature-viscosity graphs used in this study, conventional asphalt cements usually have straight and downward sloping curves. The following binder characteristics are noted:

- 1) The Arm-R-Shield and the two CA(P)-1 binders did not soften as much at elevated temperatures as the conventional AC-20 (Figures 4.1 b, h, and i). This behavior is commonly seen in binders containing rubbers or other polymers in solution.
- 2) The addition of the Plus Ride rubber, Fiber Pave and Boni Fiber fibers, Pave Bond, lime, or Pave Bond and lime together, had little effect on the slopes of the temperature-viscosity curves (Figures 4.1 a, c, d, e, f, and g).

All binder recovered from cores.

The following was noted (Figures 4.1 and 4.8):

The CA(P)-1 asphalt concrete was mixed at 340°F., while the conventional Class "C" material was mixed around 300°F. These elevated mix temperatures may have excessively aged the CA(P)-1. The hardening resulting from this aging is shown by the recovered binder penetration and viscosity test results (Table 4.2). Note that the binders recovered from the mix had aged much more than the rolling thin film oven (RTFC) residues of the original binders. These excessively aged and hard binders could have made the two CA(P)-1 sections susceptible to cracking.
