Interim Report  
on  
Evaluation of Asphalt Additives:  
Lava Butte Road - Fremont Highway Junction

July 1986

1. Report No. FHWA-OR-RD-87-03		2. Government Accession No.		3. Recipient's Catalog No.	
4. Title and Subtitle Evaluation of Asphalt Additives: Lava Butte Road - Fremont Highway Junction				5. Report Date June 1987

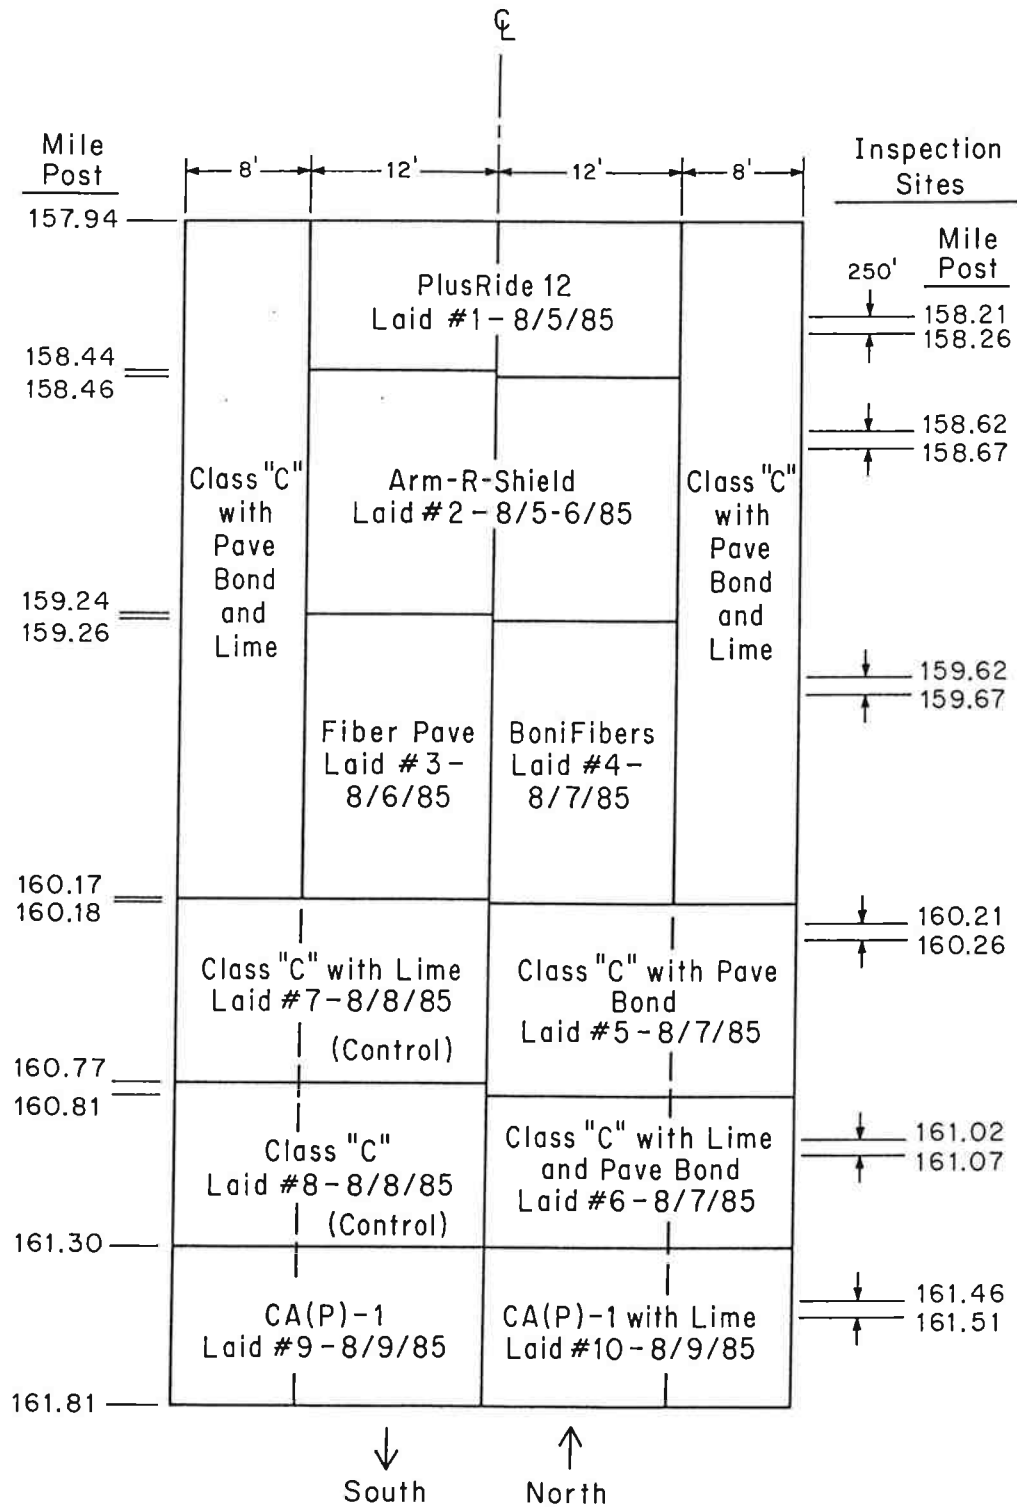
Figure 2.3 - Layout of Test Sections

An asphalt concrete overlay was selected to correct the present deficiencies. Instead of using conventional asphalt concrete throughout the project, ten sections with experimental features were selected for evaluation. Each test section was a minimum of one-half mile in length and included a 12-ft. wide travel lane. A one-half mile section of dense-graded hot mix with no additive served as the control. A layout of the test sites as they were actually constructed is given in Figure 2.3. The one-half mile sections were selected for the following reasons:

conditions for the entire section. For each 250-ft. inspection site, photos and a record of distress types, including a map of all cracks, were recorded. Figure 2.3 also shows the general location of the inspection sites.

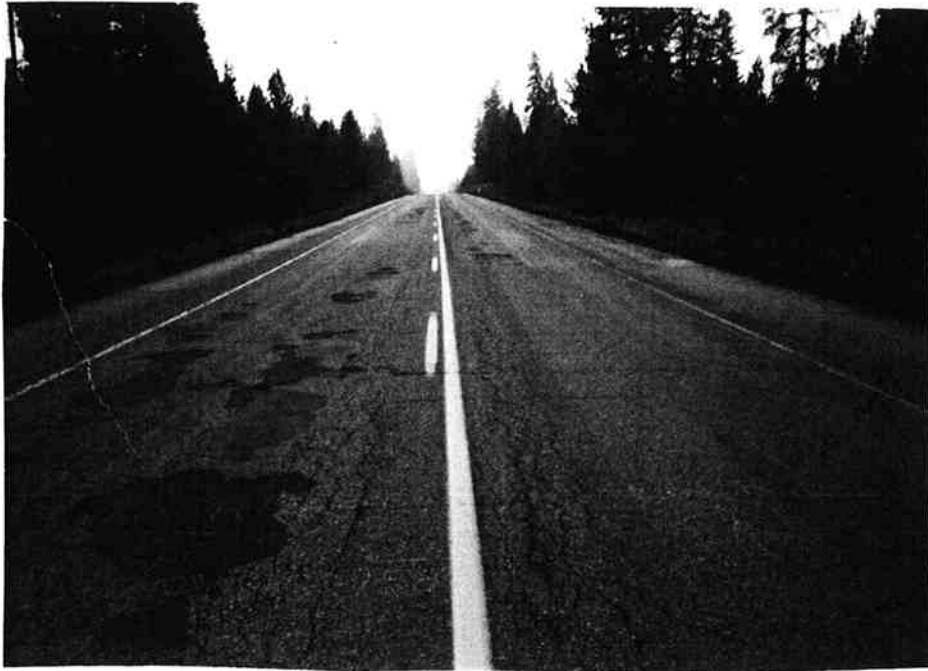
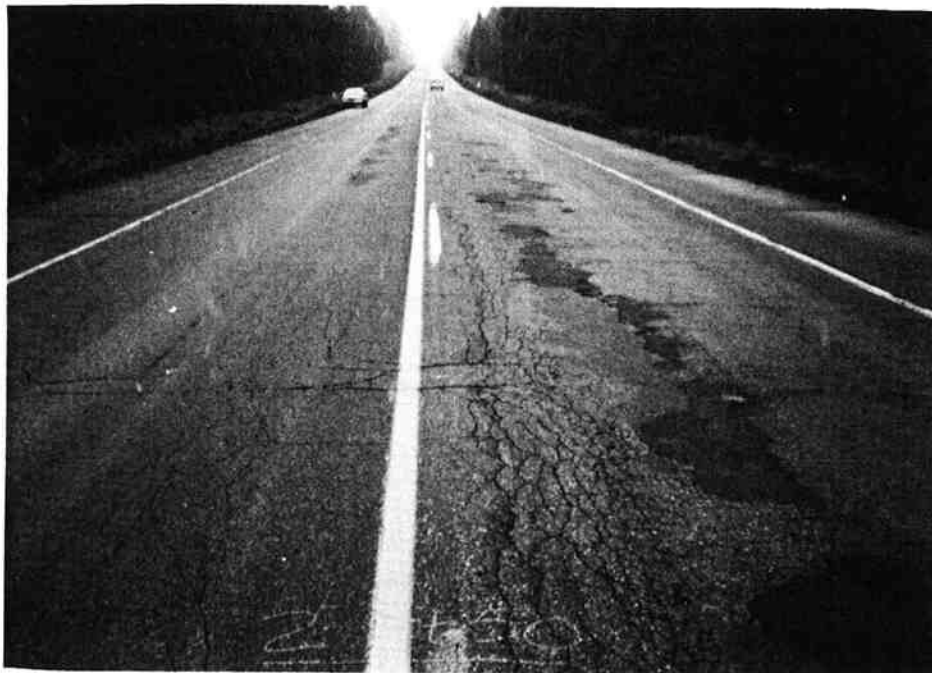
(a) MP 158.21 Looking South

(b) MP 158.26 Looking North

Figure 2.4 - Typical Pavement Condition Before Overlay

Figure 2.4 through 2.9 are photos of the original pavement before overlay. The photos show there was considerable alligator and thermal cracking as well as patching. The overall condition rating for the project was poor. Table 2.2 summarizes, by distress type, the extent of distress for each inspection site during the May 31, 1985, survey.

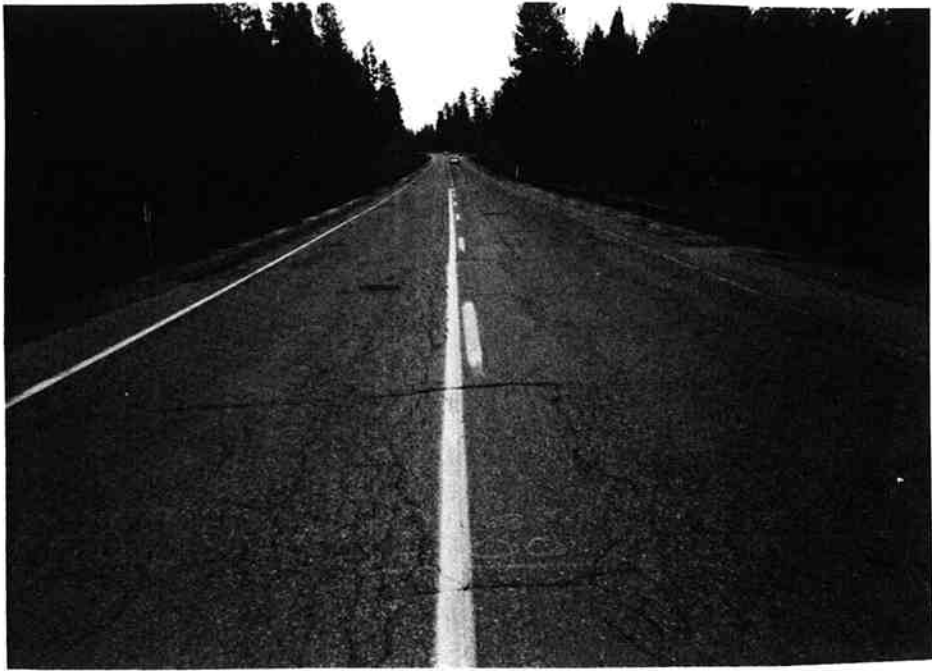
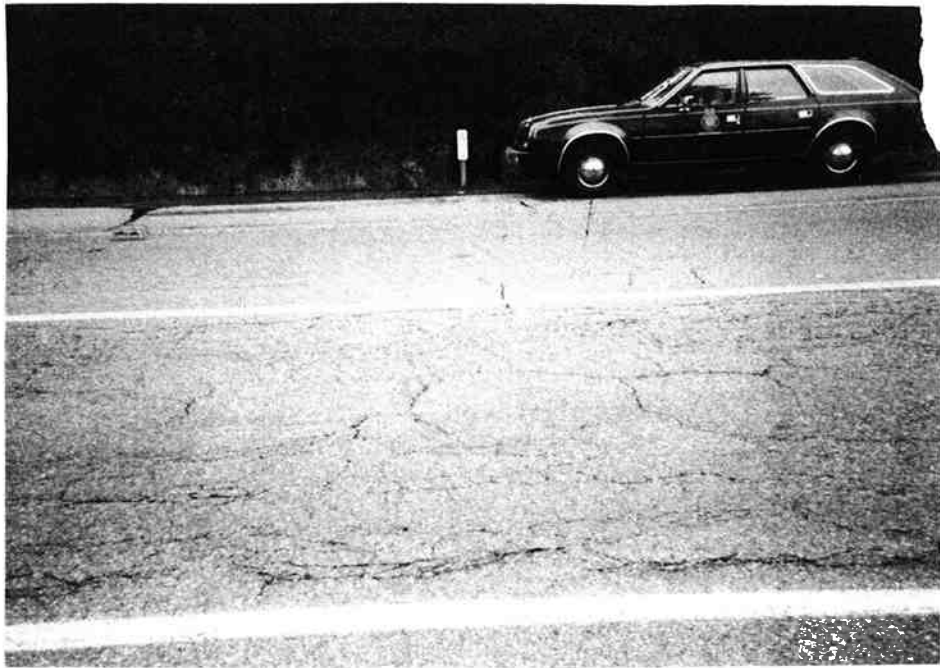
(a) MP 158.62 Facing South

(b) MP 158.62 Looking West

Figure 2.5 - Typical Pavement Condition Before Overlay

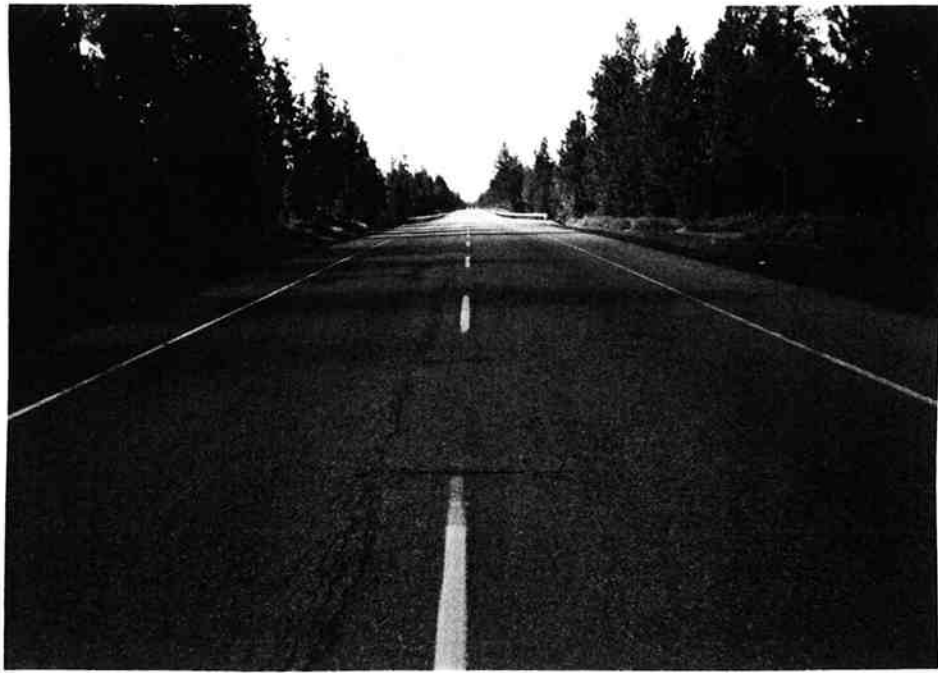
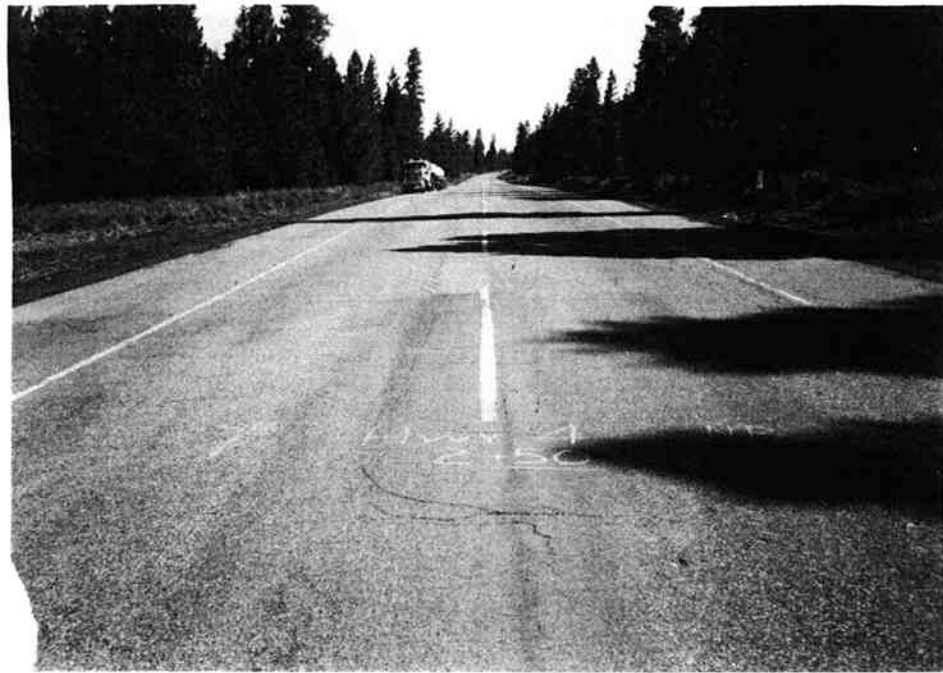
(a) MP 159.62 Facing South

(b) MP 159.67 Facing North

Figure 2.6 - Typical Pavement Condition Before Overlay

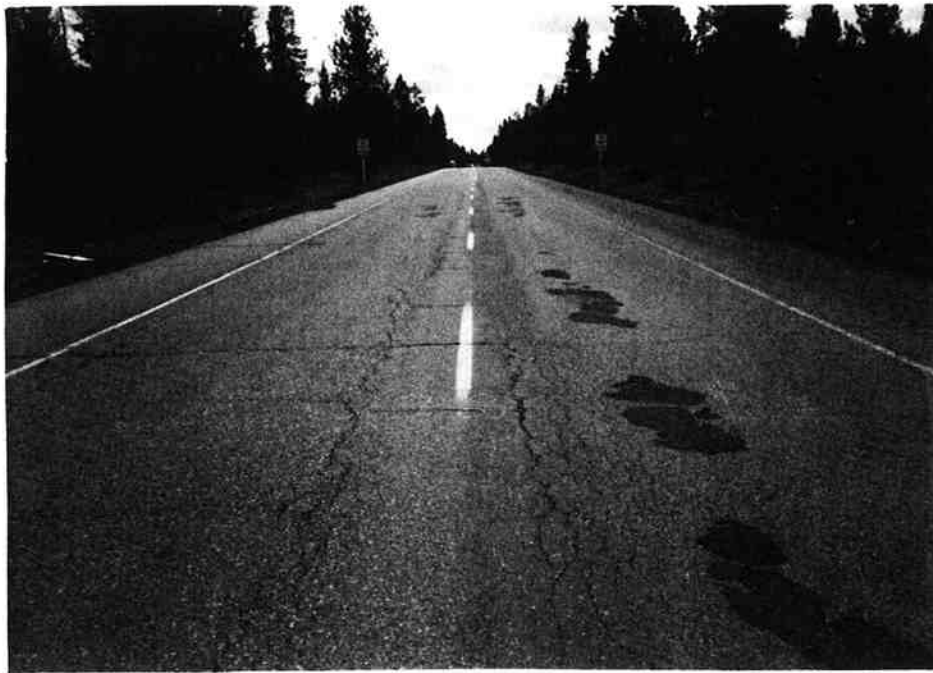
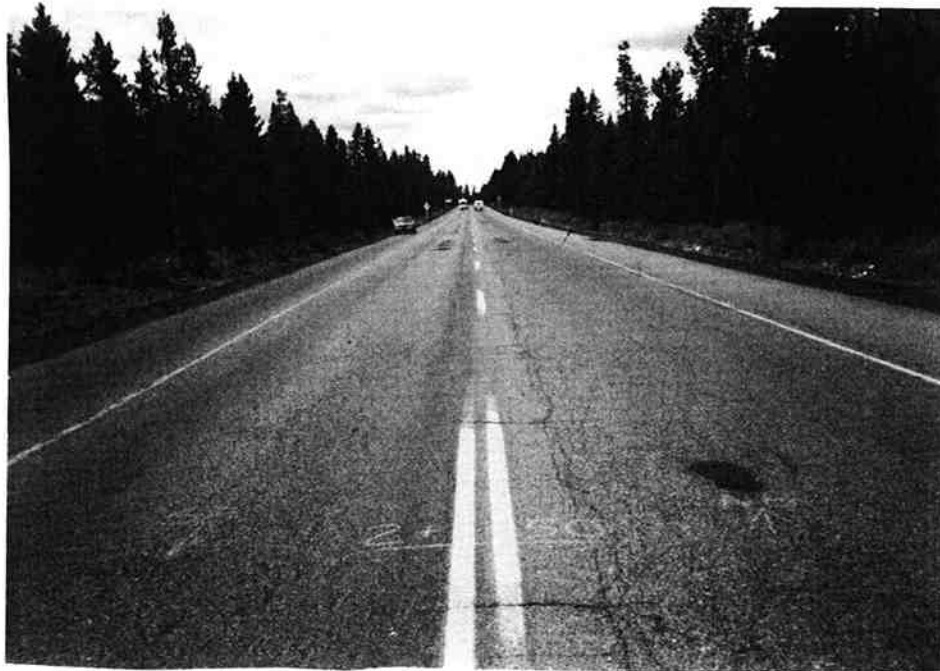
(a) MP 160.21 Facing South

(b) MP 160.26 Facing North

Figure 2.7 - Typical Pavement Condition Before Overlay

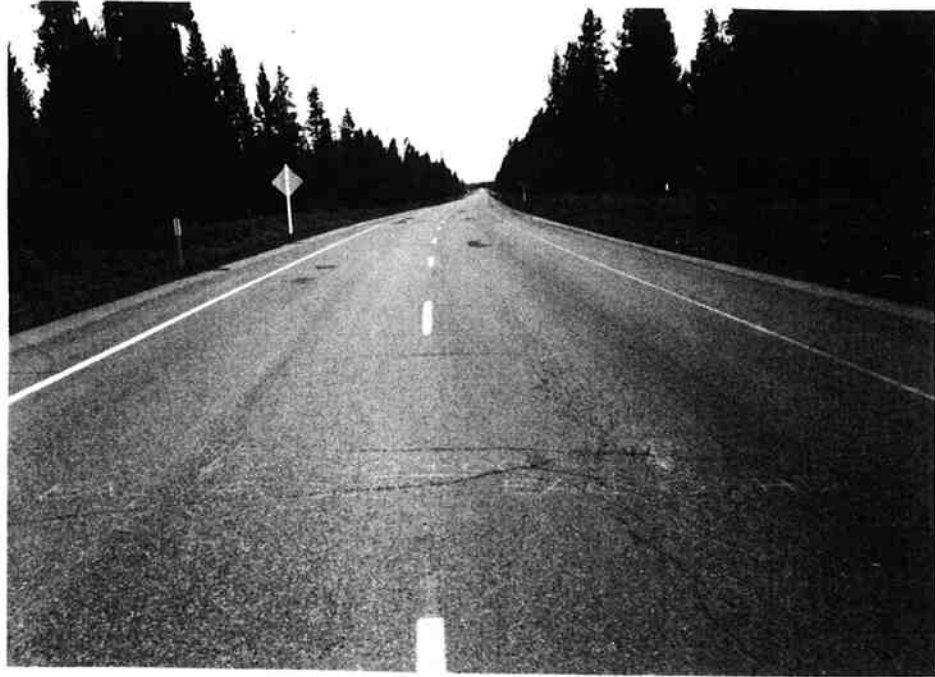
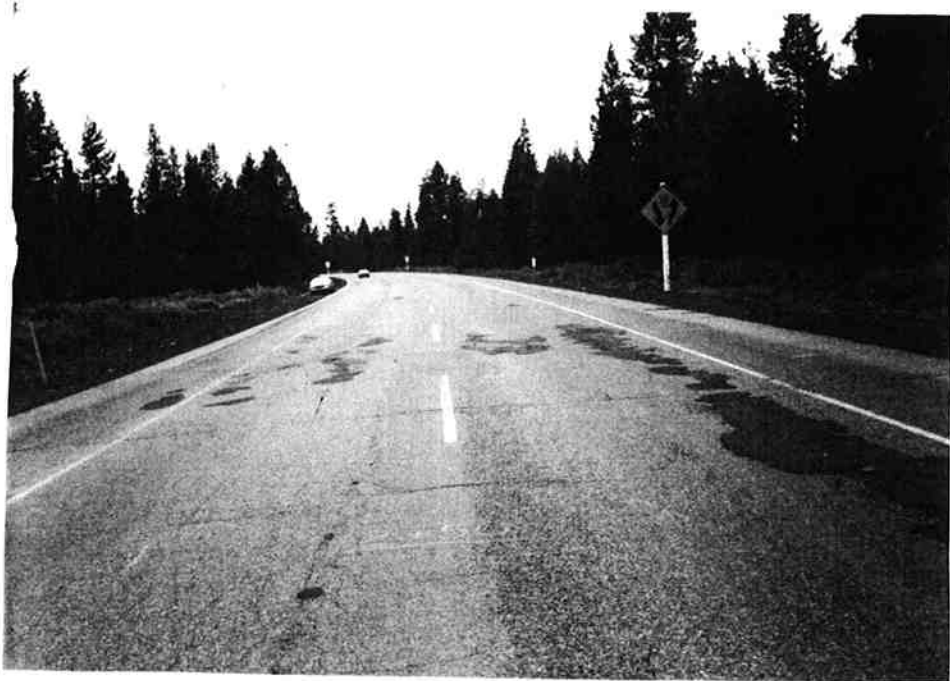
(a) MP 161.02 Facing South

(b) MP 161.07 Facing North

Figure 2.8 - Typical Pavement Condition Before Overlay

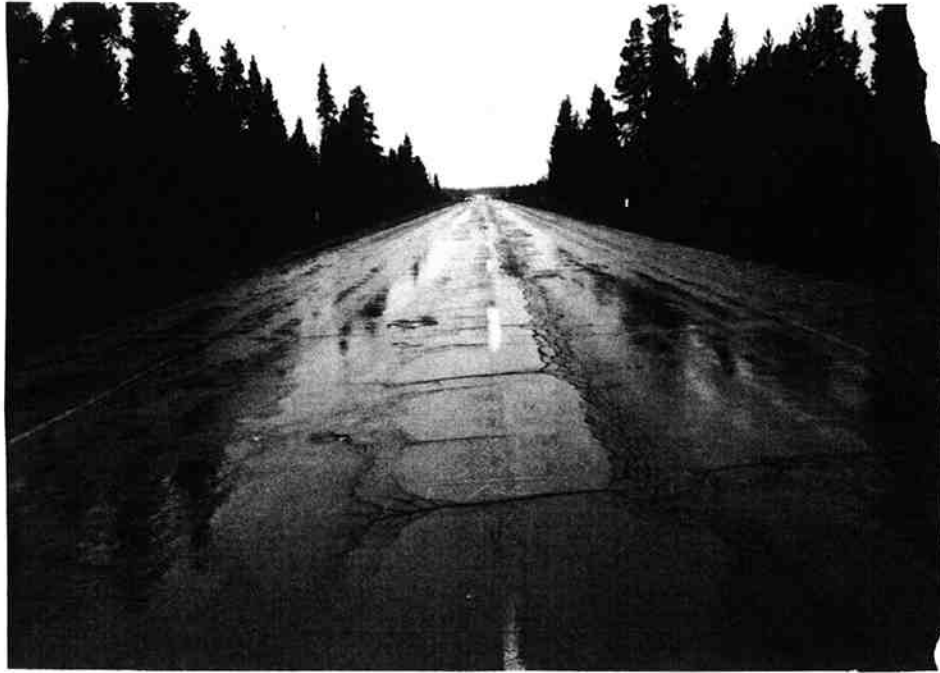
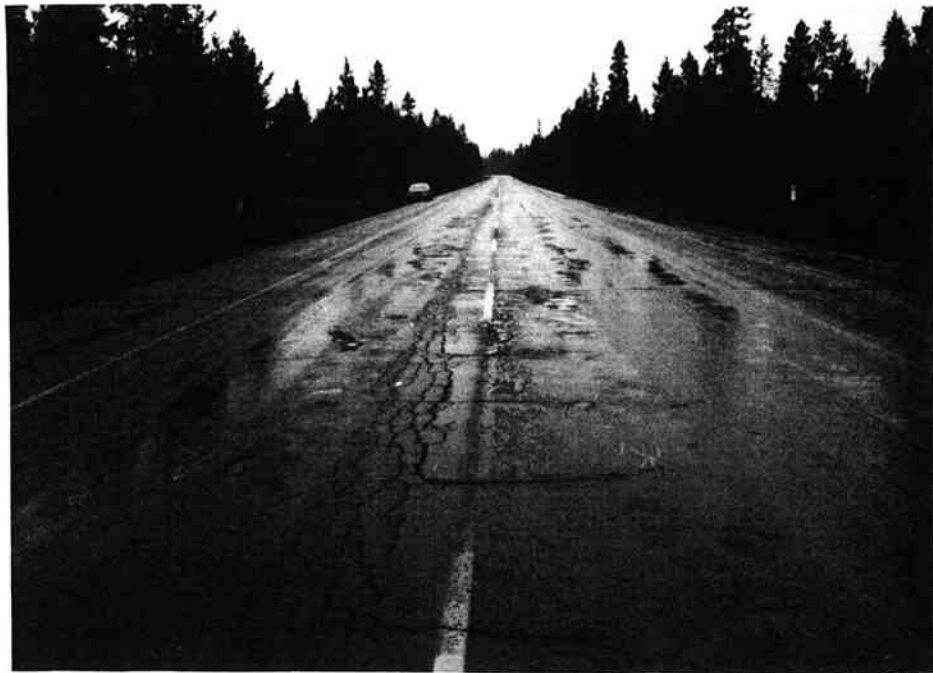
(a) MP 161.46 Facing South

(b) MP 161.51 Facing North

Figure 2.9 - Typical Pavement Condition Before Overlay, Wet Surface

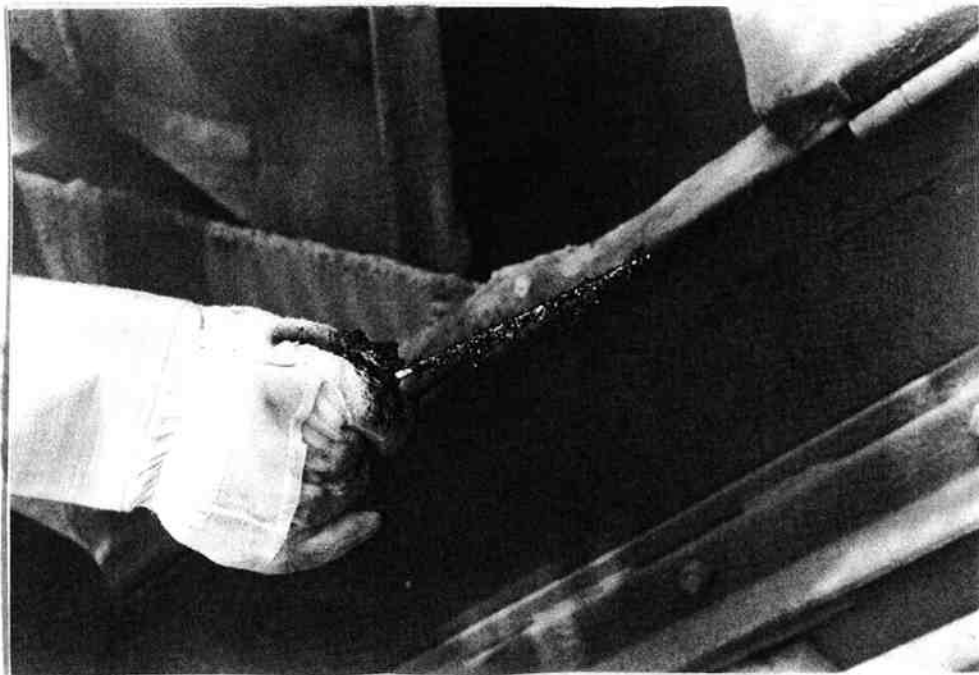
(a) Stringy Nature of Fiber

(b) Mix Too Hot - Fibers Melting

Figure 4.8 - Unique Features of Polypropylene Fiber Mix

The specification for use of this material stated that the mix temperature could not be above 290°F. The addition of fiber and a 0.3% increase in the liquid asphalt content were the only deviations from normal Class "C" mix components. The technical representative from Hercules was on-site to oversee production. He used a thermometer to test the mixture at the pug mill exit. The mixture should have a stringy texture as shown in Figure 4.8(a). If the mix temperature is too hot, the fibers will melt and not produce the desired consistency, Figure 4.8(b). The stringy texture made the mix difficult to rake.

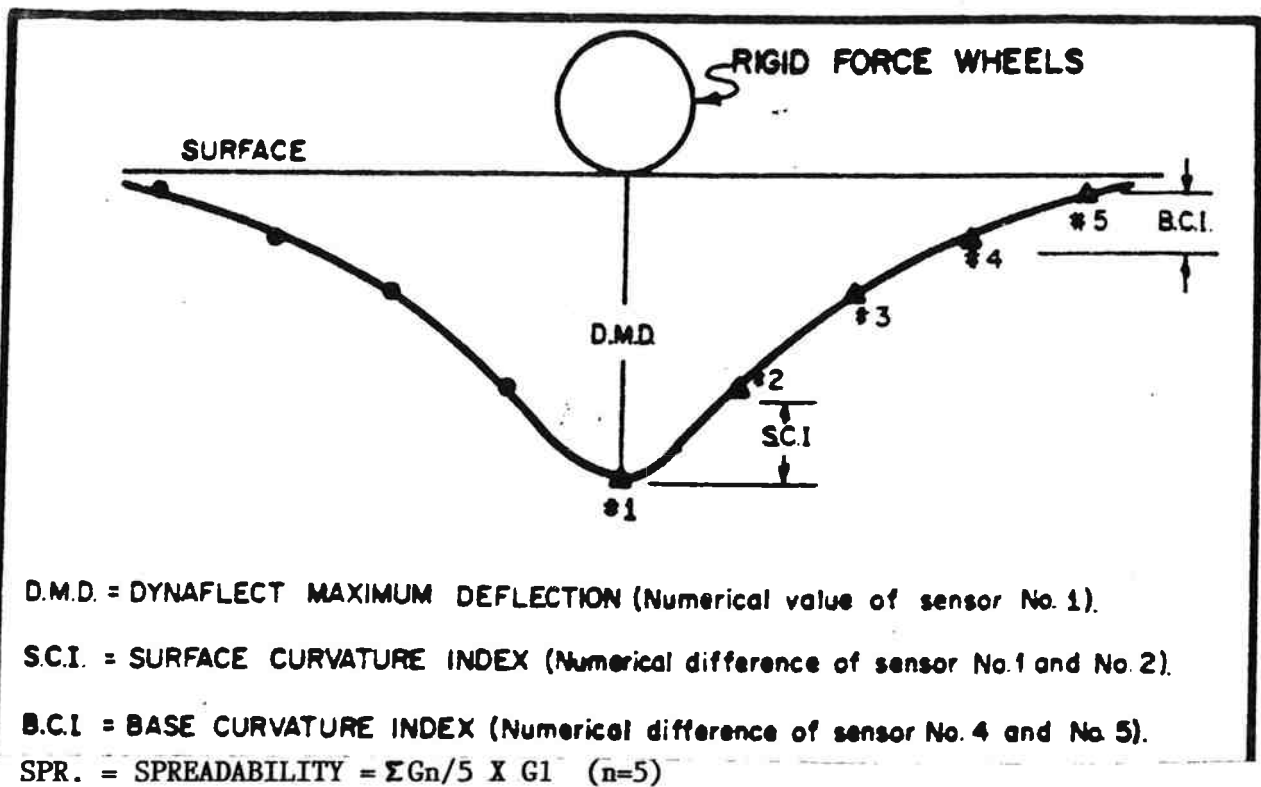
(a) Dynamic Deflection Determination System (Dyanflect)

(b) Deflection Basin Parameters

Figure A.1 - Dyanflect System and Basin Parameters

- 4) Using the geophone designation and definition of SCI, BCI, and SPR shown in Figure A.1, the following generalities can be made. A high G1 reading (greater than 0.7 for T, and greater than 1.5 for t) indicates a weak pavement structure. A high G5 reading (greater than 0.3 for T and t) indicates a poor subgrade. A low spreadability factor, SPR (less than 0.6), can mean a weak pavement layer for thick structures. The SPR has little significance for pavements less than 6 in. For thick pavements, a high G5 (greater than 0.3) and low SPR (less than .06) indicates both the support and the pavement layers are weak. In flexible pavements (generally asphaltic concrete), SCI values of 0.25 to 0.35 indicates the pavement structure is within a transition zone from satisfactory to poor performance. BCI values of greater than 0.15 generally correspond to support conditions of less than 1,000 psi and should be treated with concern.

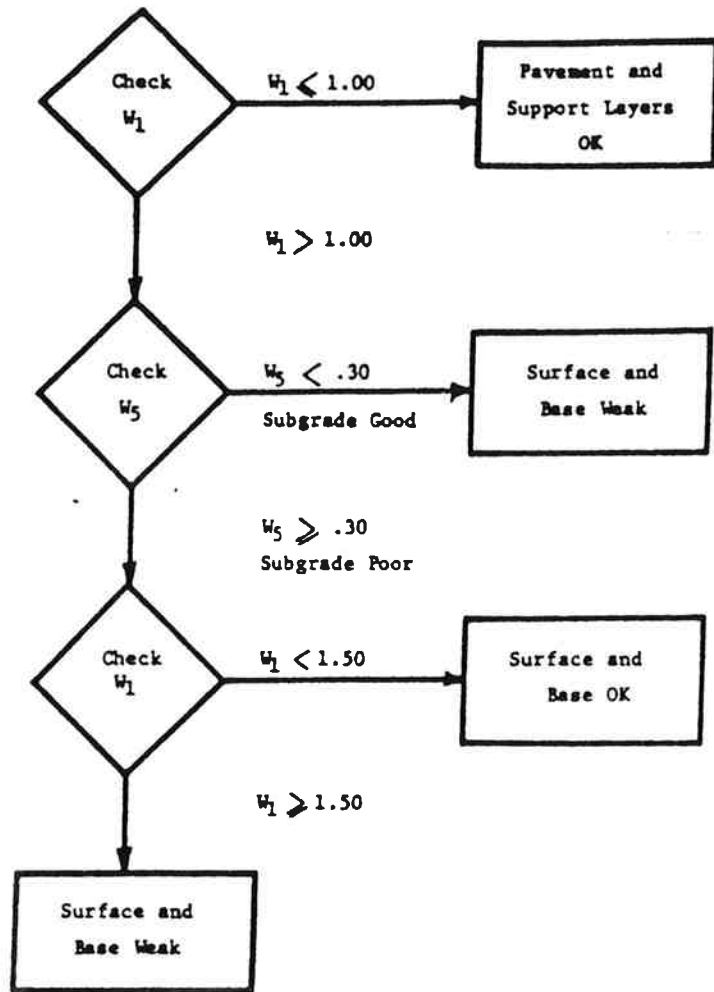
Figure A.2 - Evaluation of Thin Flexible Pavements (t = 4-6-in)  
from Dyanflect Measurements (Majidzadeh, et al., 1983)
