# Research Notes

Oregon Department of Transportation

RSN 06-02

## Measuring the Strain of the Road

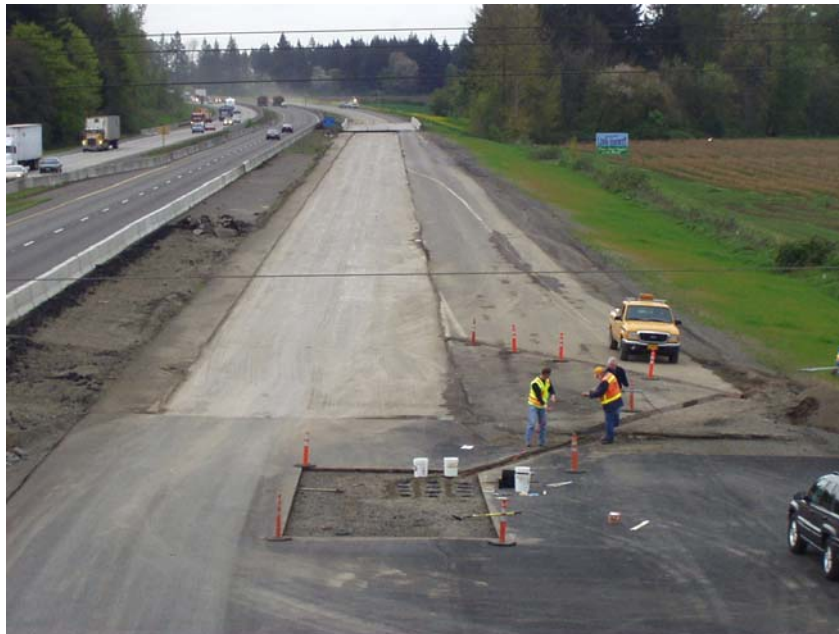
Overlooking the instrumentation site in the southbound lane of I-5 at milepost 239

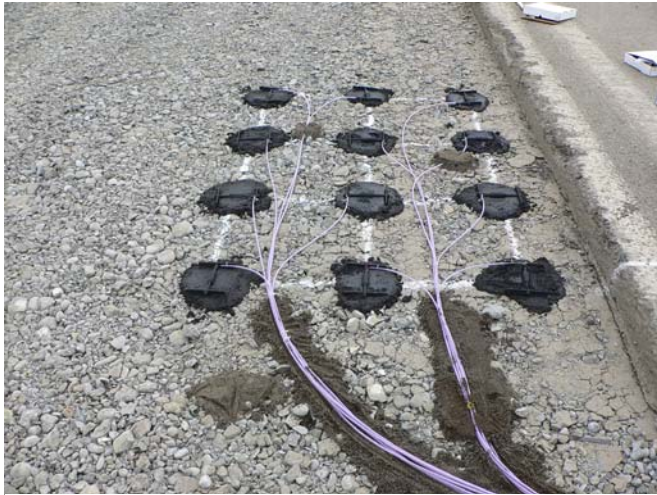
Strain gage layout over the rubbilized concrete base

Using NCAT report 04-01, "*Design and Instrumentation of the Structural Pavement Experiment at the NCAT Test Track*" as an installation guide, the strain gages and temperature sensors were installed in the pavement. A matrix of 12 strain gages was installed over the rubbilized PCC base, and a second matrix of 12 strain gages was installed over an aggregate base. The four temperature sensors were installed at depths of 2, 4, 6 and 8 inches. The layout for each set of strain gages was six longitudinal and six transverse, as seen in the following image. All of the strain gages were tested before and after installation to ensure proper data

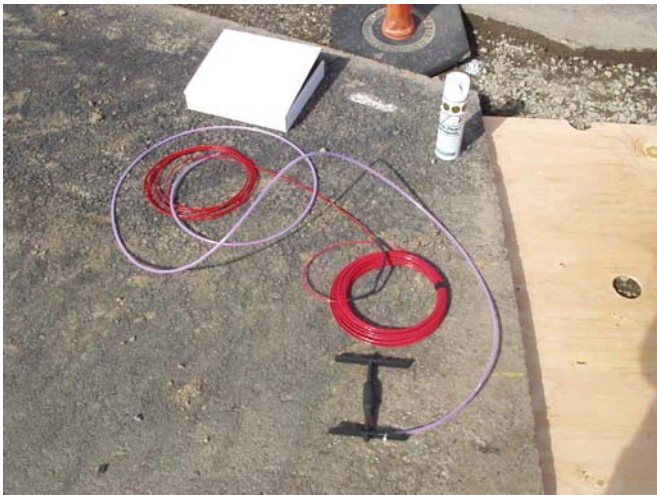
Strain gage with protective nylon sheath installed on the first 12 ft of the lead-in wire

The strain gages used for this project were, Asphalt Strain Gage ASG-152 from Constuction Technology Laboratories. The lead-in wires connected to the gages were prepared for installation by adding a protective nylon sheath to the first 12 feet to protect it from temperature and abrasion.

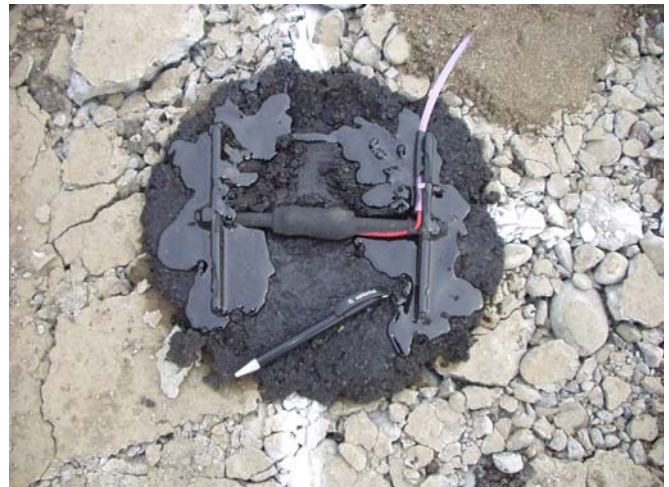
Strain gage on build-up of mastic mix over the rubbilized concrete base

Each gage was placed on a mastic mix consisting of a mixture of CSS-1 and aggregate passing the No. 10 sieve. This was done to prevent damage from the base rock and to hold the gage in the proper orientation during paving. Approximately 2 inches of HMAc was placed over and around each gage. Light compaction

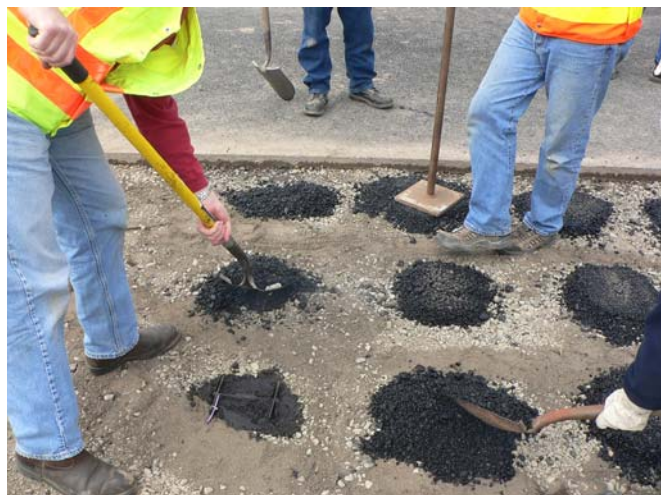
Placement of asphalt over the strain gages with light compaction to minimize gage movement during the paving

was performed by hand using a 1 ft sq. tamping plate. For the rubbilized concrete base, additional material was placed around the gages and a light rolling was performed prior to the paver passing over them. For the aggregate base, the trench was filled with asphalt and rolled.

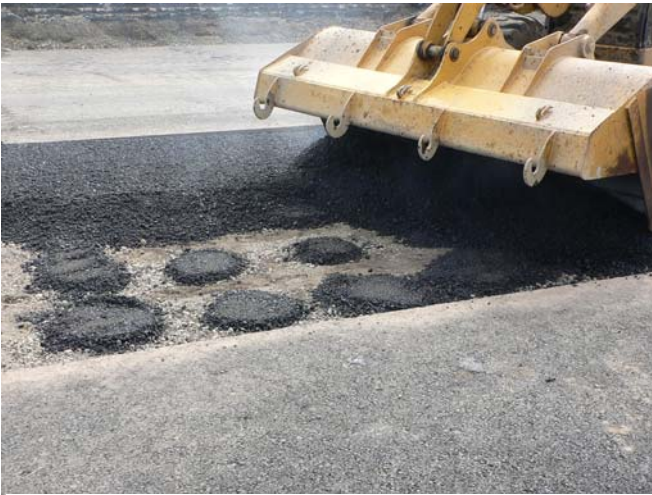
Completing the trench fill of asphalt over the strain gages on the aggregate base

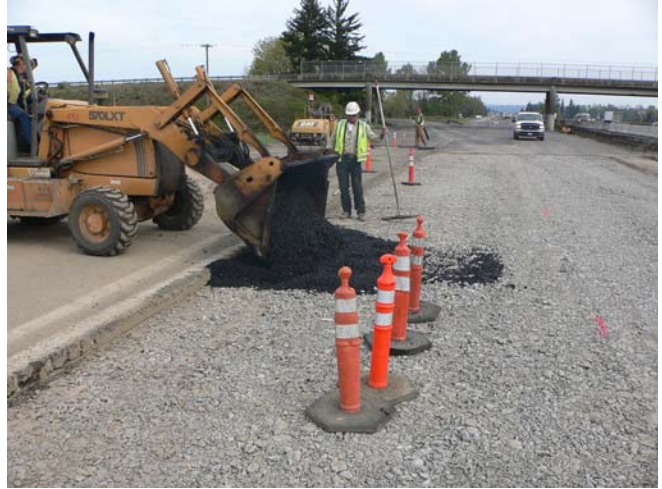
Additional asphalt being placed over the gages prior to paving over the rubblized concrete base

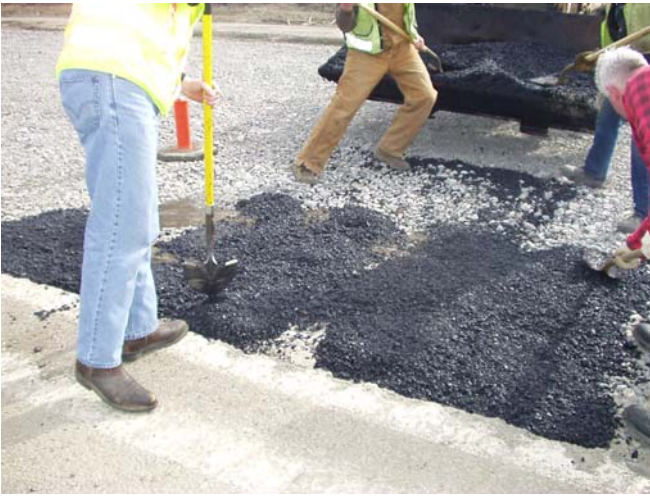
Placement of asphalt over the strain gages to minimize movement during paving over the rubblized concrete base

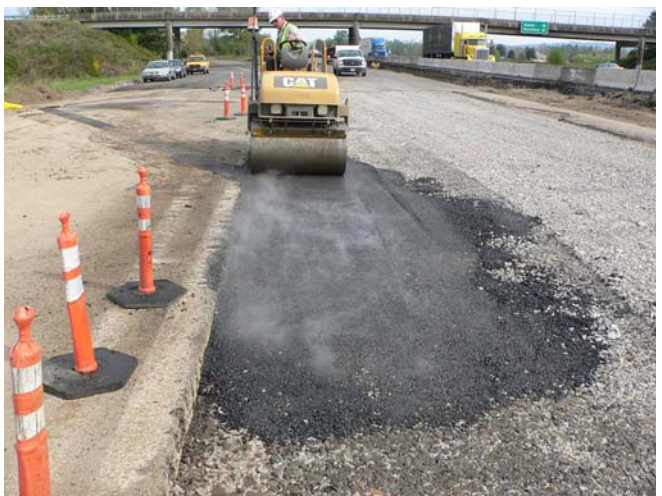
Initial compaction of the asphalt over the strain gages prior to paving over the rubblized concrete base

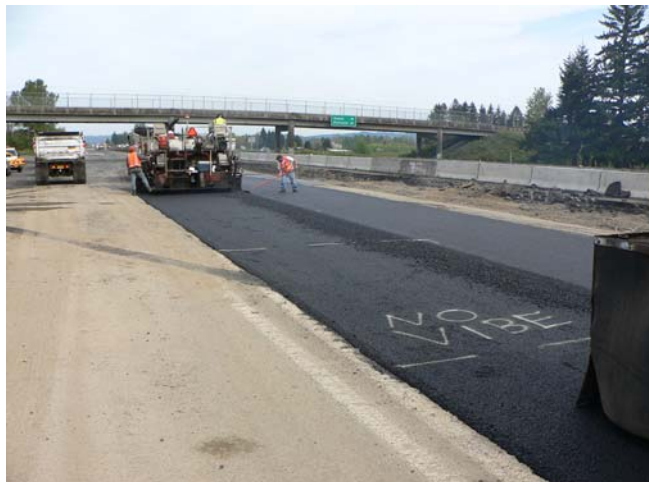
After the first lift of asphalt over the rubblized concrete base. Notice that vibratory rollers were not used over the gages.

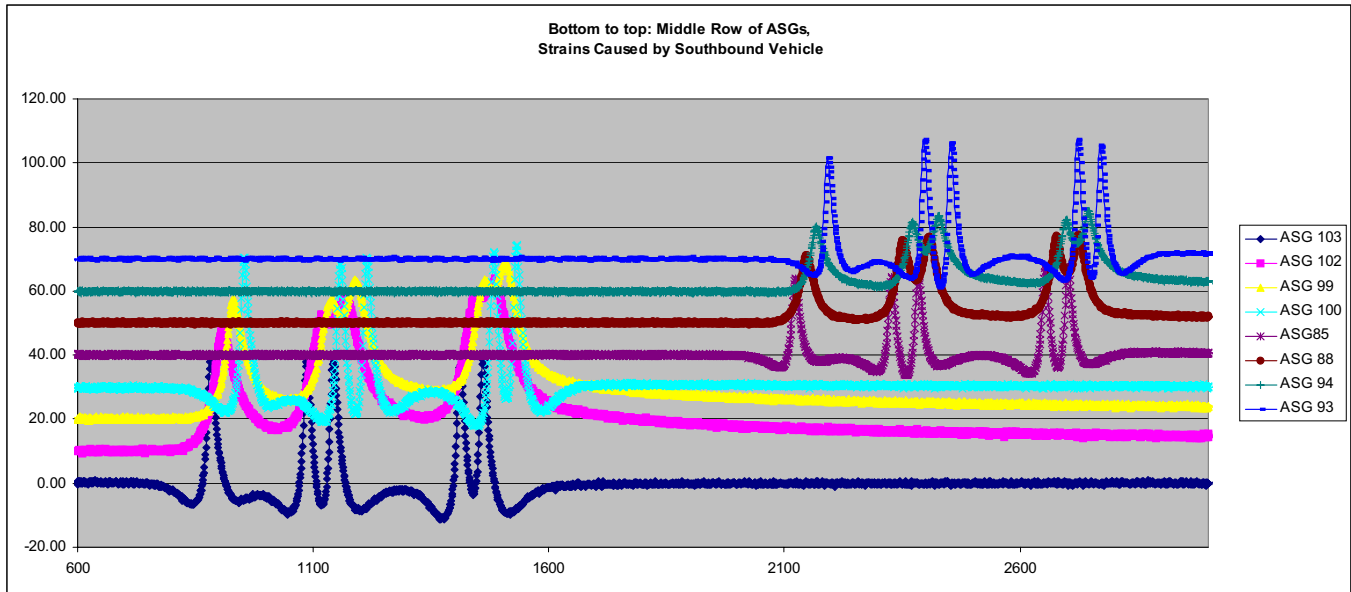
The strain gages were tested after all of the construction was completed. The following is a plot of a typical log truck, developed from the initial testing of the gages.
