## Three-Cable Barrier Still a “Hit”

The three-cable barrier on I-5 between Salem and Wilsonville is still providing for safe travel by preventing median crossover crashes. A total of 35.2 km (21.9 miles) of three-cable barrier is in place. In December 1996, 14.5 km (9.0 miles) of the barrier was installed. Another 20.7 km (12.9 miles) was installed by April 1998.

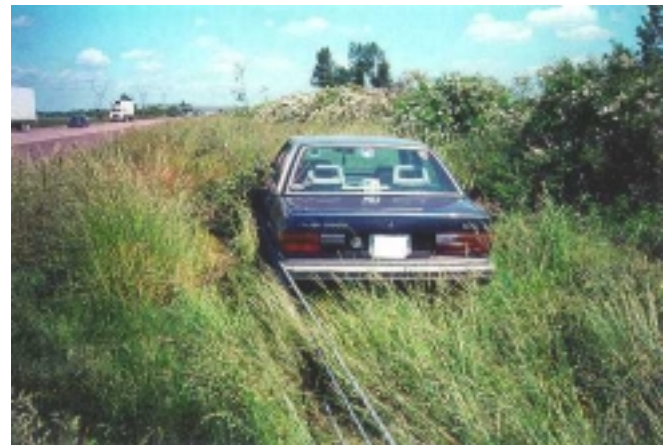
Vehicle prevented from crossing into oncoming traffic.

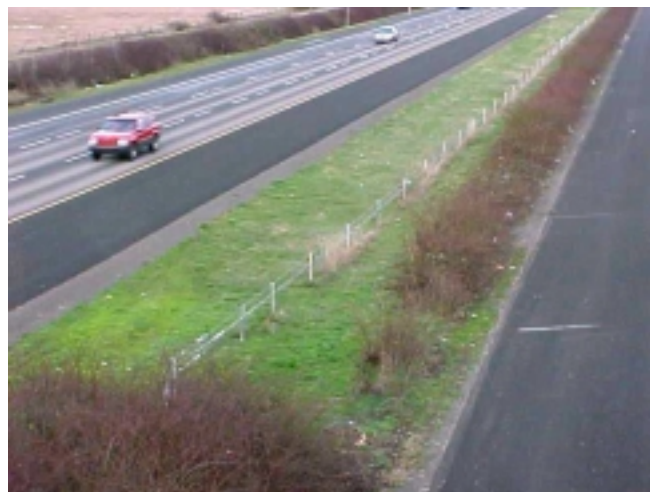
Three-cable median barrier system on I-5.

The cable system is recommended for use in locations where there is enough room for lateral deflections of up to 3.5 m (11.5 ft). The width of the median needs to be at least 7 m (23 ft) for a cable system centered in the median. Cable systems should not be used on sharp curves or where curbs exist or in areas where it is likely to be hit frequently.
