Three-Cable Barrier Makes I-5 Safer

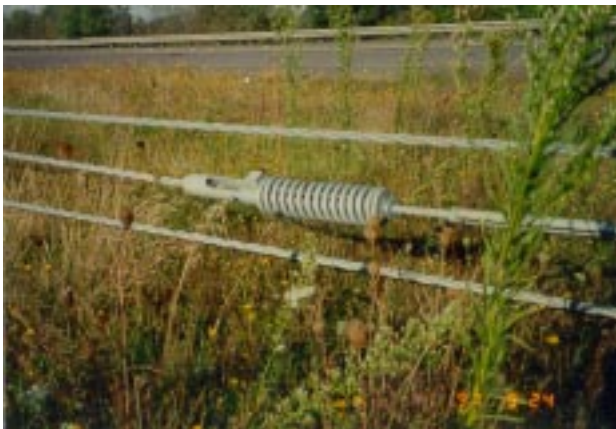
Three-cable median barrier system with spring turnbuckle

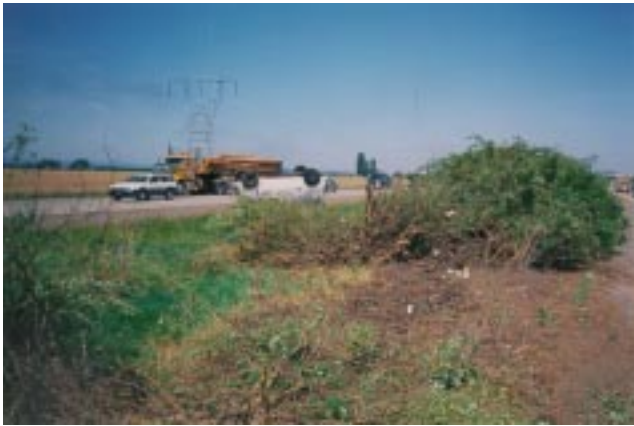
Flipped van restrained by the cable system

The cable median barrier system has been effective in preventing crossover accidents at the selected location, from December 1996 through March 1998. Of the 53 barrier impacts, 21 potential crossovers were restrained from entering the opposing traffic lanes. Only three vehicles went through the cable barrier system. The two that underrode the cables did not crossover into the opposing traffic lanes. The third vehicle, a semi-truck, went through the cable barrier, crossing over into the opposing traffic lanes. None of the median barriers used in Oregon are designed to stop these larger vehicles, as it is not cost effective.
