IN-DEPTH STUDY OF COLD IN-PLACE  
RECYCLED PAVEMENT PERFORMANCE

INTERIM REPORT

April 1990

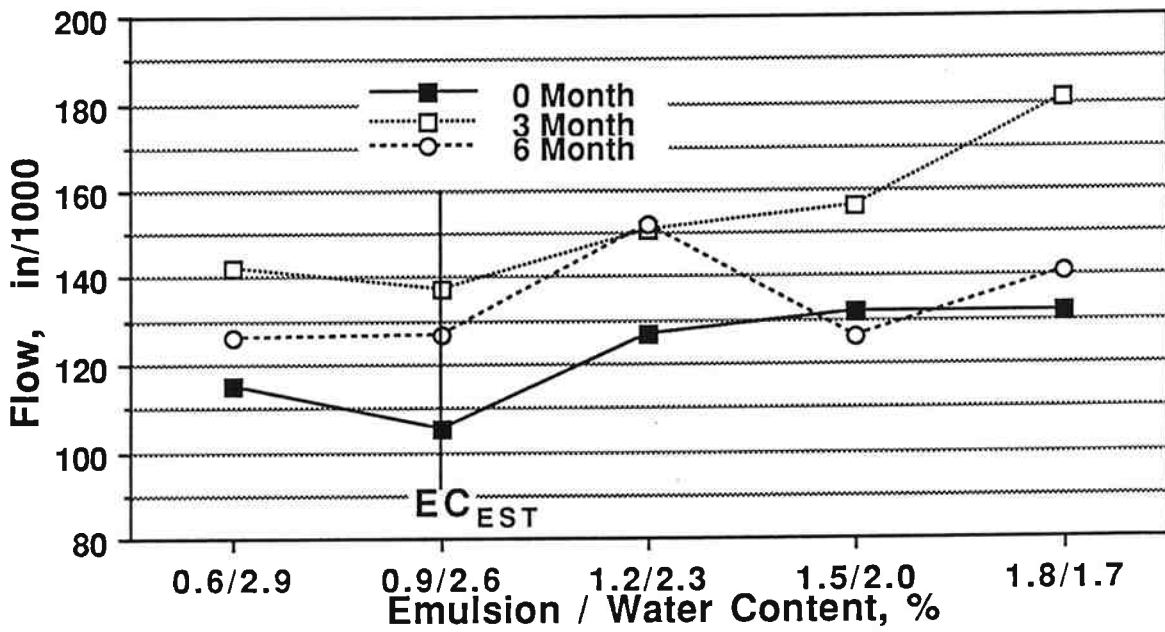
a) Stability

b) Flow

Figure 2.6. Marshall Stability for Mix Design Samples - East Diamond Lake Hwy

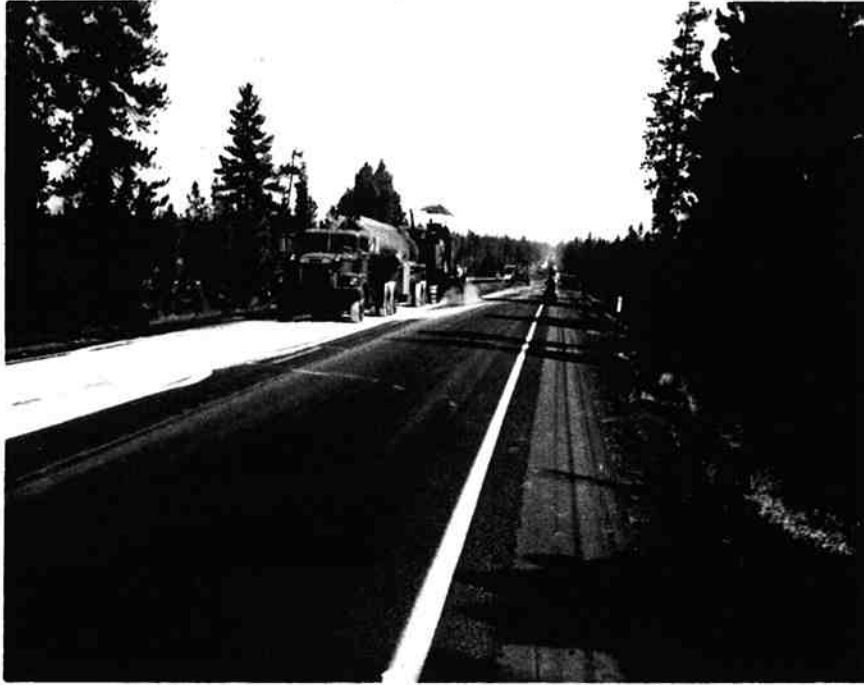
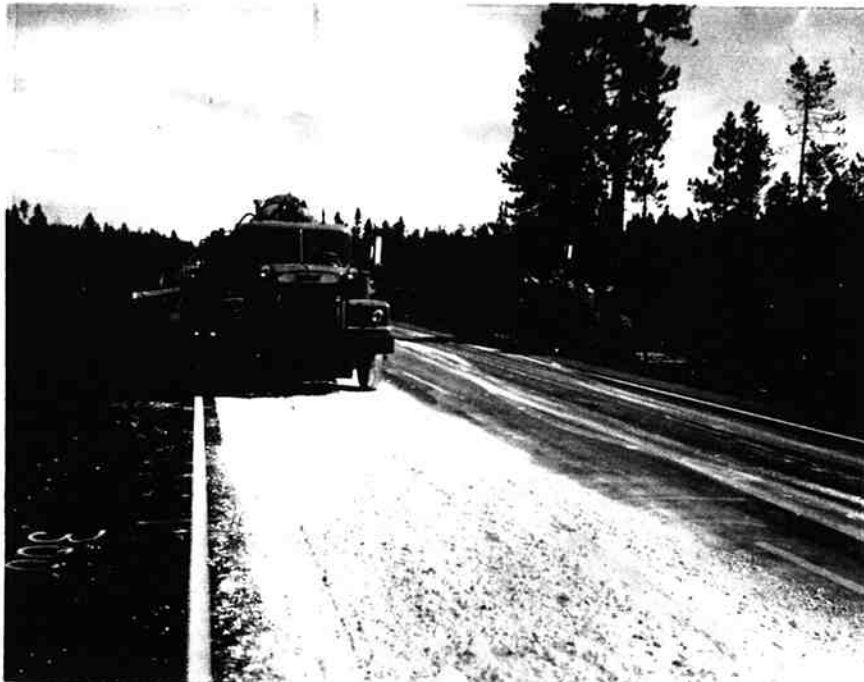
a) Overview of Lime Addition Process

b) Closeup of Lime on Surface Prior to Milling

Figure 4.2. Method of Lime Addition - Hackett Dr to Crescent.

drawback noted during the recycling process was that the lime created problems with the paving equipment.
