# RESEARCH NOTES

## BRUGG CABLE MESH ROCKFALL FENCE

Shellrock Mountain Section  
Lower Columbia River Highway (I-84)  
Hood River County

RSN 92-6

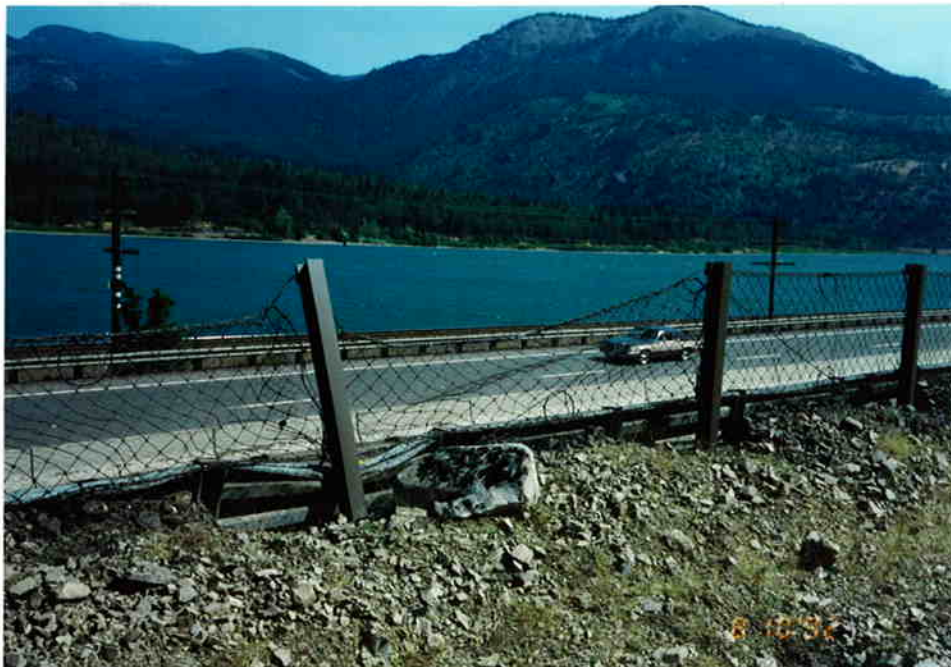
On August 8, 1992, a 1.7 ton rock impacted the Brugg Cable Mesh Rockfall Fence installed at Shellrock Mountain (See Figure 1). The rock dislodged from the cliffs above the talus slope, and bounded down the talus slope in five to fifty foot bounces. Its final bounce was in the fallout area, then it went eight vertical feet and hit the near west edge of a 6.5 foot mesh section about mid-height at Station 567+80 and was retained in the rock fallout area.

Figure 1: Brugg Cable Mesh Rockfall Fence after August 8, 1992 rockfall.

There was minor damage to the fence as it dissipated the rock's energy. On the section impacted, the upper friction brake was pulled twenty-two inches, the lower was pulled one inch, the lacing rope was pulled five inches, and three cable clamps were opened. The foundation and its post nearest the impact rotated twenty degrees without damaging any attachment bolts. The post then bent the upper section of the bin wall. The bolt to hold the flange holding the lower perimeter cable was bent.

The calculations to estimate the rocks energy at impact have not been completed, but the rock is near the size used to estimate the 75 ft. tons design energy. Therefore, the fence stopped a rock at or above its design energy with only minor damage. This rock would have entered the eastbound travel lanes near the skip line if the fence was not there.
