CONSTRUCTION ZONE DELINEATION  
RAISED REFLECTIVE MARKERS

Final Report

Project 1: 25th Street - Lancaster Drive  
Interchange Section, Santiam Highway

Oregon Department of Transportation  
Highway Division

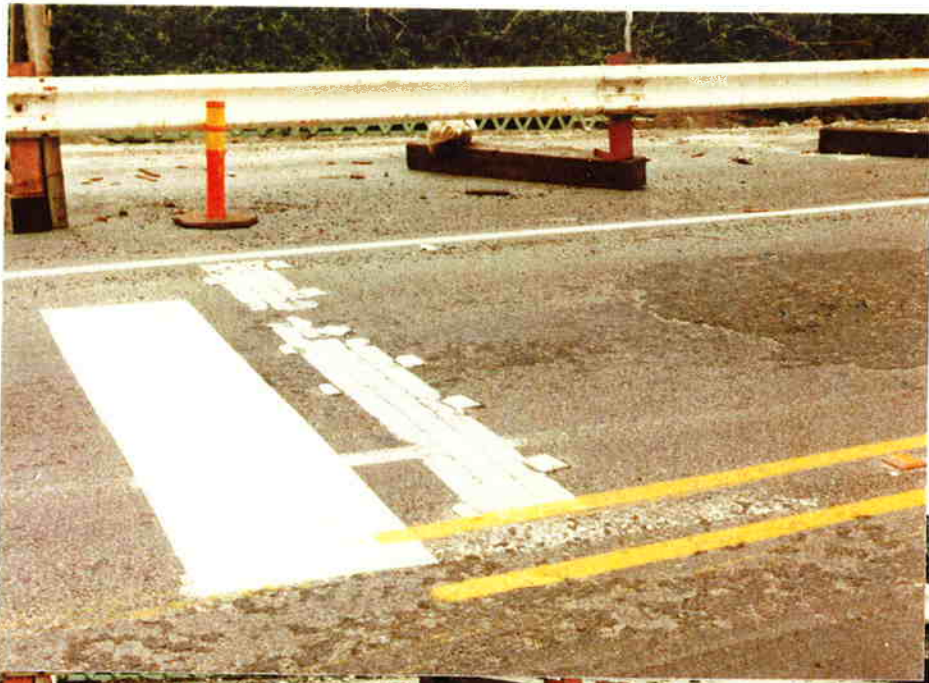
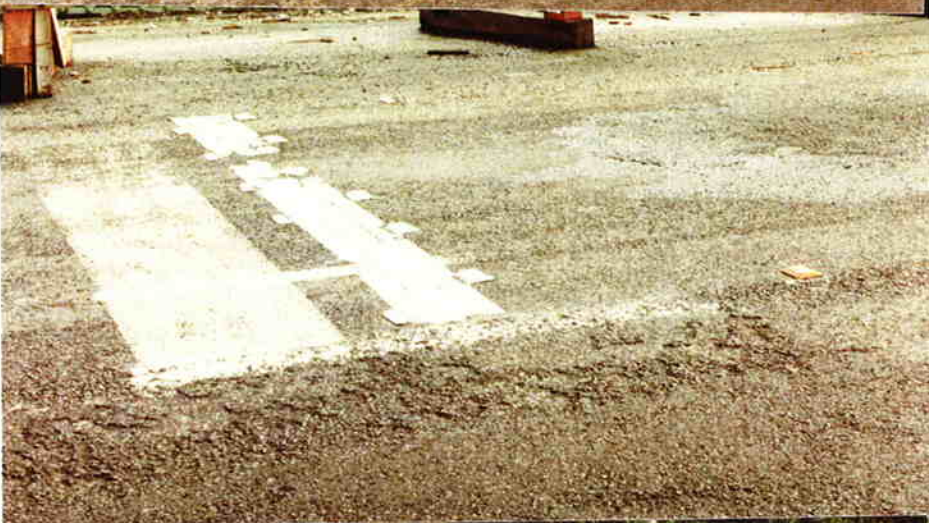
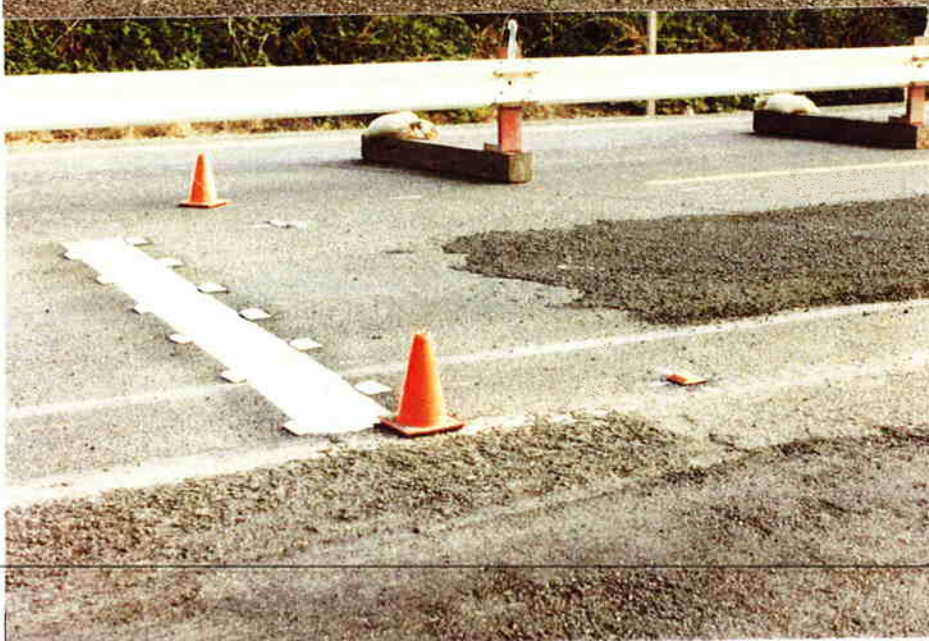
Details of northbound stop bar. Signal detector loop is under the pavement patch. Bar is of metallic tape.

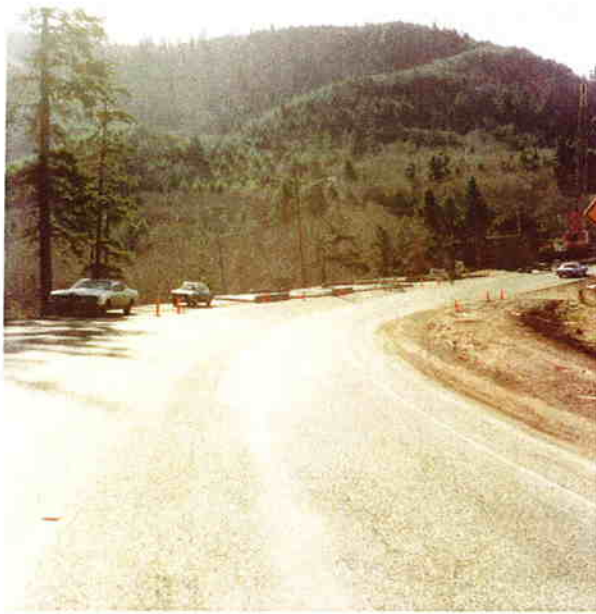
2/14/77 Looking south from 1869 at centerline reflectorized buttons on sunny day. Buttons barely visible.

As to the markers daytime effectiveness in traffic lane delineation, the story is shown in the accompanying photographs. Cloudy or sunny, the markers were all but invisible on the 13-degree curve and only slightly better in the straighter sections. The traffic was constantly driving into the oncoming lane and/or missing the traffic detector loops for the temporary traffic signal. As one photo indicates, just a few pieces of reflective tape were required to keep the traffic in the right lane, at least in the stop bar area. As soon as the visibility problem was evident, the markers were supplemented with 1-ft strips of reflective tape. This helped to some extent, but eventually the striping crew was called upon to stripe the project.

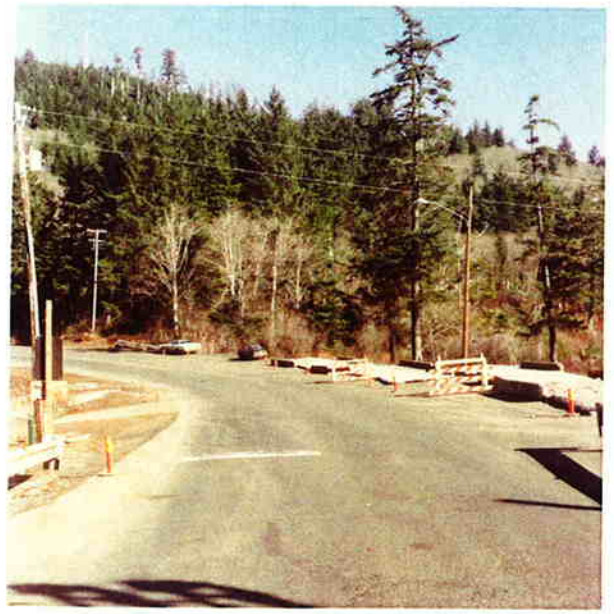
2/14/77 Looking north from 1873 at reflectorized buttons. Very faint.

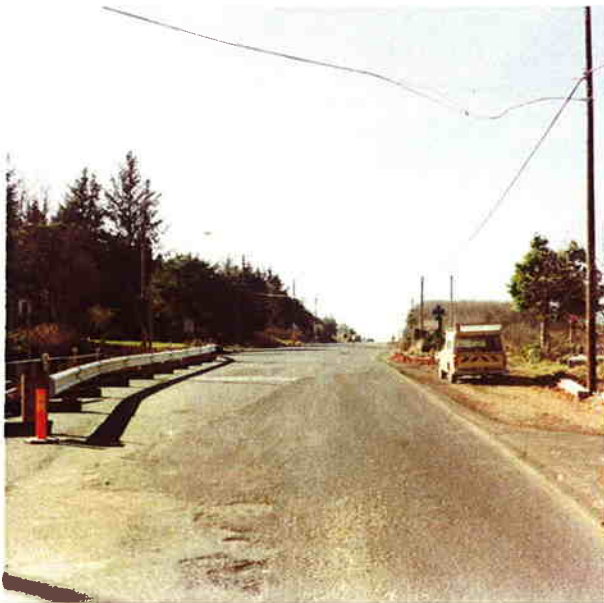
2/14/77 Looking south from 1875+50 Reflectorized buttons barely visible (weather sunny).

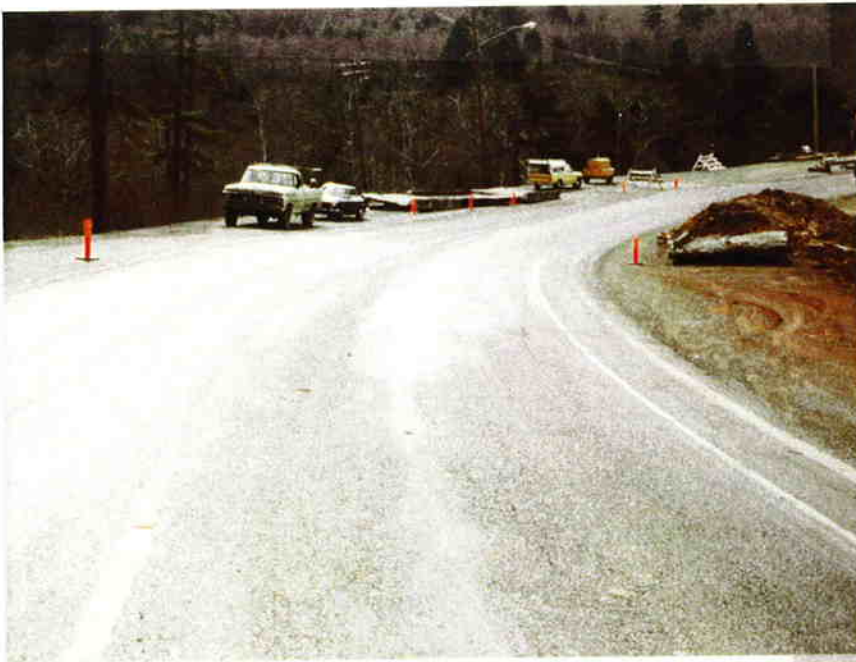
3/22/77 Looking south from  
sta 1869 at reflectorized buttons  
(overcast day). Buttons barely  
visible.

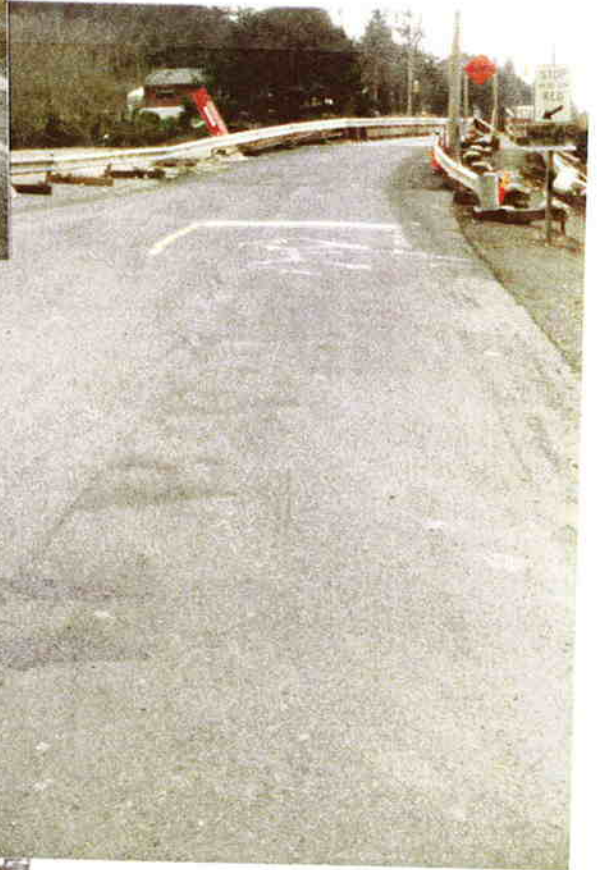
3/22/77 Looking south at temporary  
striping (tape) at north traffic  
signal stop line near sta 1872.  
Note faintness of reflector buttons  
compared to striping. Prior to this  
stripe vehicles would pull into the  
oncoming lane to line up with structure  
and thereby miss the signal detector  
loops.

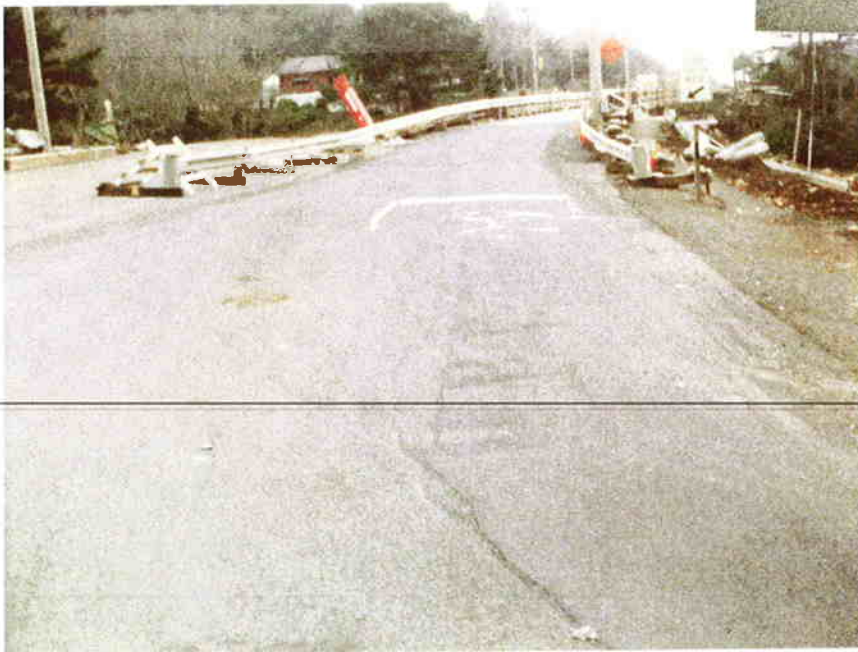
3/22/77 Temporary stripe to  
identify lanes more clearly at  
north traffic signal stop line near  
sta. 1872.

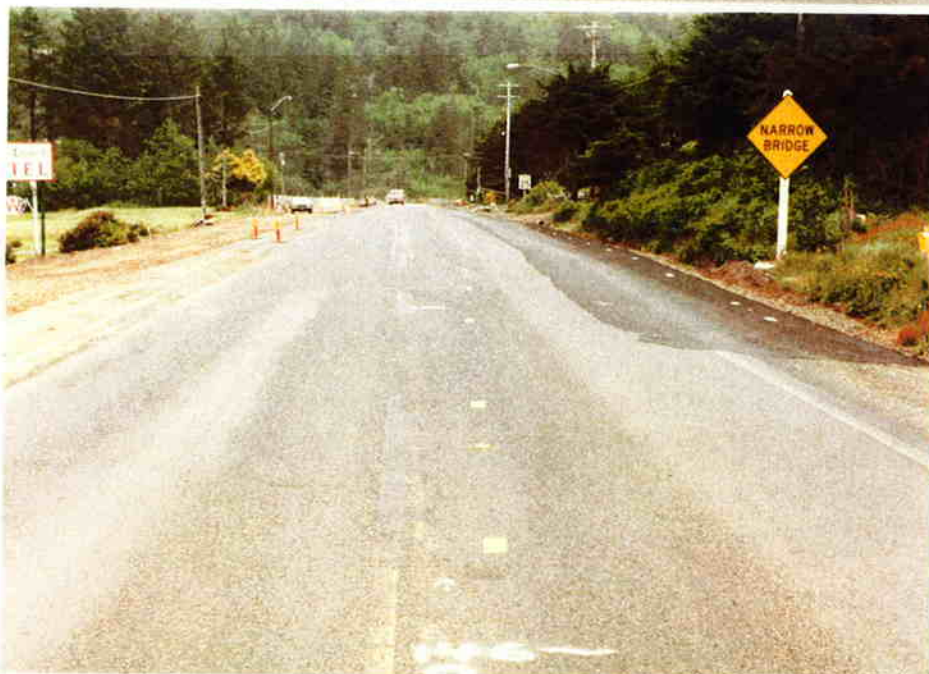
6/10/77  
Northbound view from sta.  
145. Spacing on center-  
line is 10 ft.  $\pm$ .

Different spacings were tried and we found that 10' centerline and 20' fog line intervals were effective and not overly time consuming. This spacing was used throughout the project except in critical areas where a closer spacing was used.

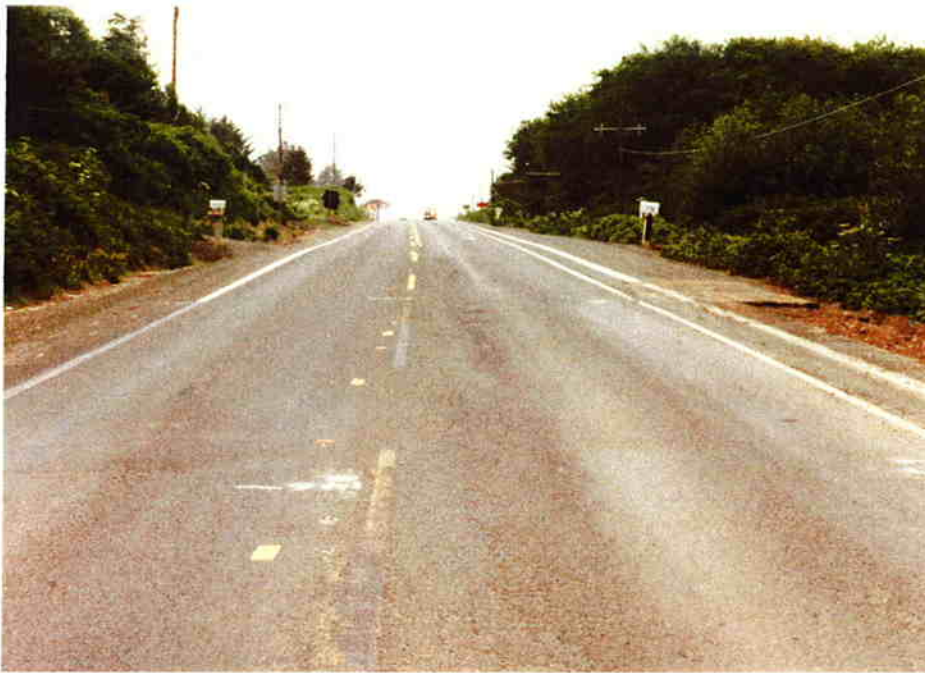
6/10/77  
Southbound view from  
near sta. 146. Note  
use of reflective tape  
and faintness of the  
raised markers.

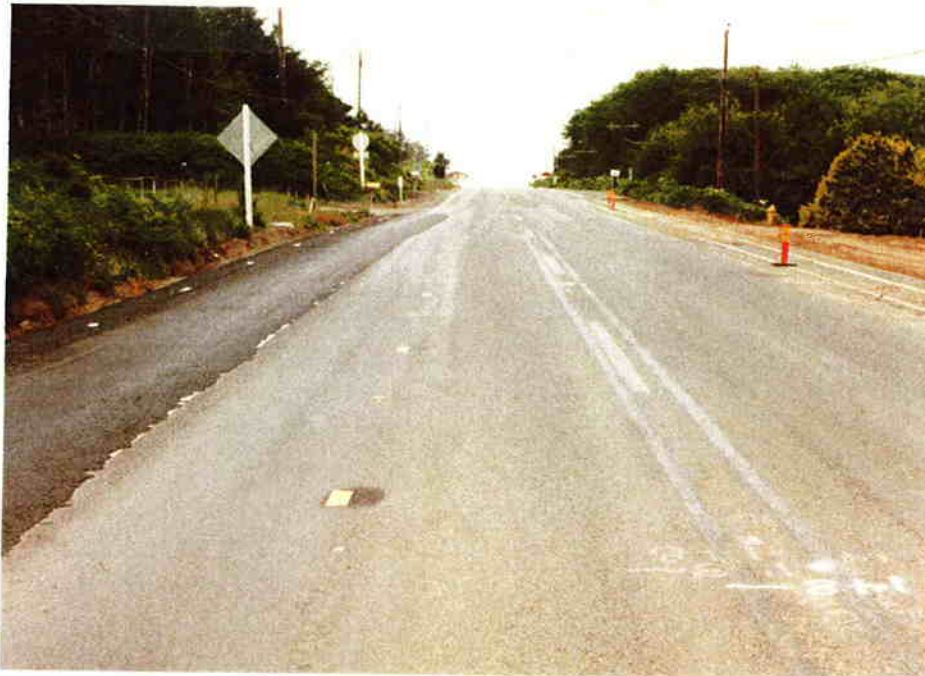
6/10/77  
Southbound view from  
sta. 148. Raised  
markers and reflective  
tape are being used  
alternately.

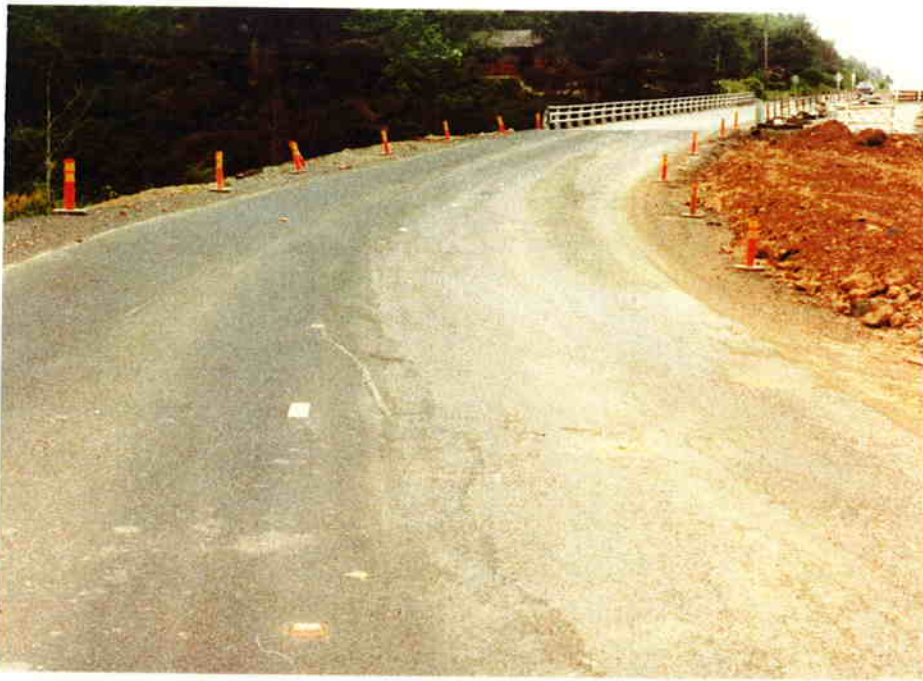
6/10/77  
Southbound view from  
near sta. 1872. Note  
nailed reflector in  
foreground and use of  
reflective tape.

Nailed reflectors used  
in this area due to  
dirty pavement.
