**REPAIR OF STUDED TIRE DAMAGE
I-5 PILOT PROJECT
M.P. 276 - 278 NORTHBOUND SECTION**

Construction Report

**State Planning and Research
Project Number 5276, Phase 3**

May 1997

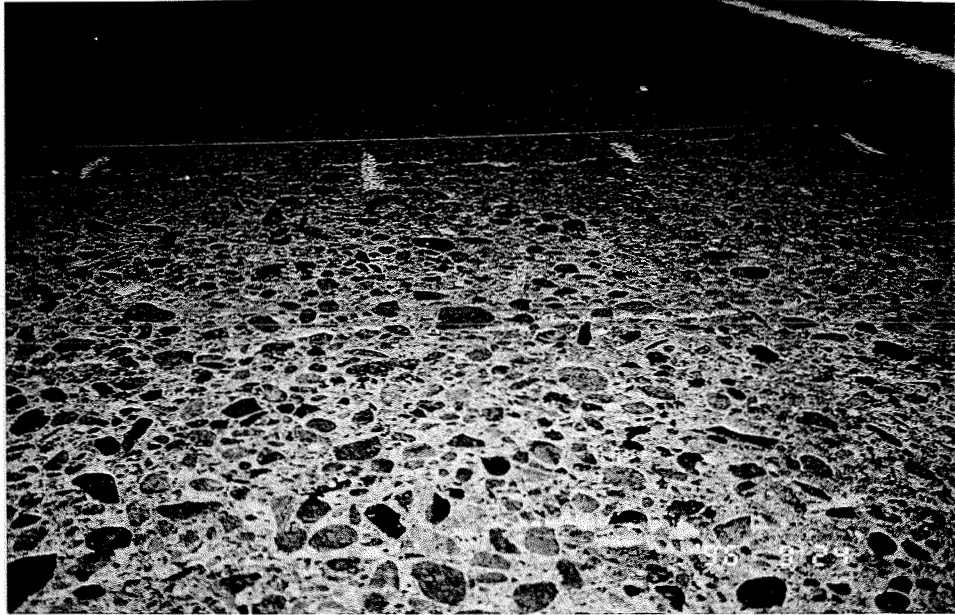
Transverse profiles were taken in each section by stretching a string line across the lane and measuring down to the pavement in 30 cm (12 in.) intervals (see Figure 2.3).

Figure 2.3 Rutting in CRC Pavement.

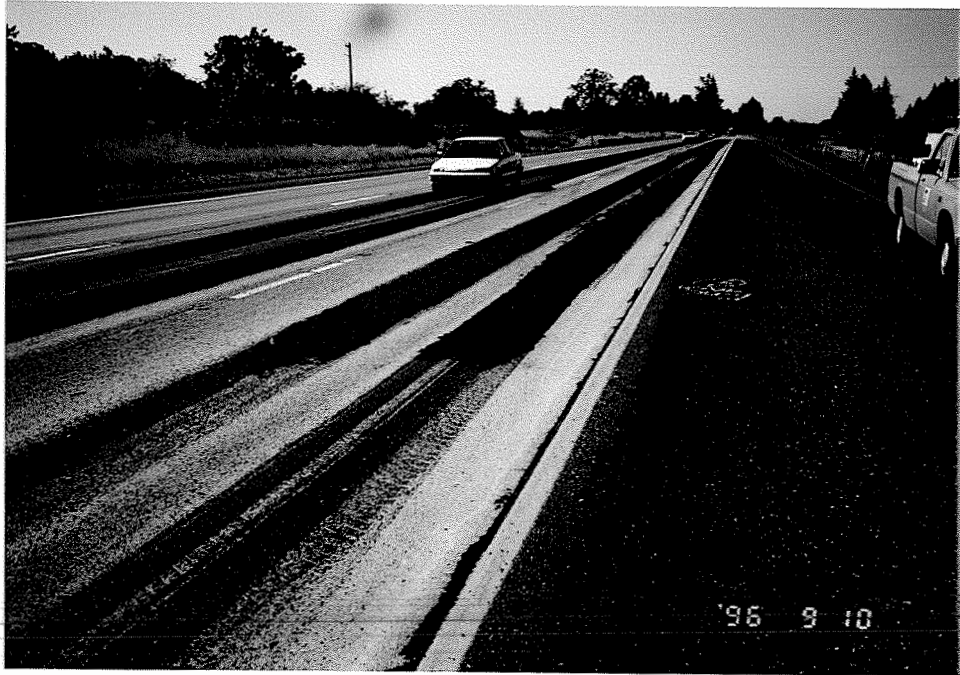
Ruts in the center lane were filled with a leveling course of D-mix (13mm-minus) (.51 in.-minus). This fine graded mix was applied by a spreader box attached to an 11 m^3 (12 yd.^3) end dump truck. Modifications to the spreader box enabled the operator to pave one wheel path at a time. Compaction of the 1 m (4 ft.) wide strip was first attempted using a pneumatic tired roller. Because the mix was being picked up and scattered by the rubber tires, a smaller steel wheel roller was substituted. The final compacted lift was about 1 m (4 ft.) wide and 6.4 mm (.25 in.) higher than the CRC. A 244 m (800 ft.) section of the left lane was also leveled. This effort was later abandoned because it caused a hump worse than the rut being filled (see Figure 3.1).

Figure 3.1 Leveling course on center and left lane.

SEPTEMBER 9TH: Work included milling the butt joints for 962+00 and 831+00 on the left shoulder and left lane. The left lane was leveled from 962+00 to 958+00 with D-Mix. The work was halted by Ron Clay, the project manager, when he decided that level would cause a hump rather than help level the ruts.

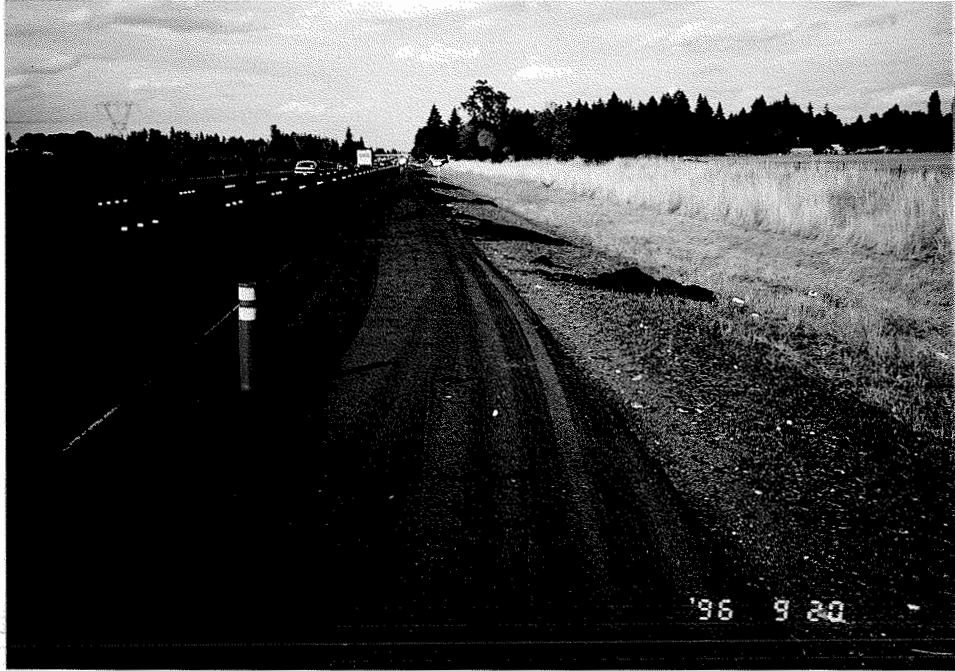
The asphalt mixture was hauled from the batch plant in 23 m³ (25 yd.³) belly dump trucks. Each truck load was dumped in a windrow in front of the paving machine, and spread by the paver before the next load was dumped. This was done to keep the mix from cooling too rapidly and gave the paving crew a chance to check the windrow for cooled lumps of poorly mixed asphalt. The backhoe became an important tool in the paving operation, removing much of the bad mix (see Figure 3.2). Even with the help of the backhoe, clean-up took time so that the paving operation was not continuous. This happened in all four sections, but was particularly bad in the first section of conventional F-mix. Much of the lumping in the F-mix was caused by low temperatures (see Tables 3.1 and 3.2). The lumps were found near the end of each dumped load where the top layer had been exposed to the cold night air (see Figure 3.3). The drivers later were instructed to cover the loads with a tarp.

Figure 3.3 Lumpy asphalt mix was removed from the windrow and piled on shoulder.

Starting the job earlier in the summer could eliminate much of the cold weather paving. July and August nights have air temperatures of about 16°C (60°F) rather than the low 4°C (40°F) temperatures found in late September. Truck drivers should also be required to cover their loads with a tarp to reduce the lumping at the top surface of the mix.
