DESERT VARNISH (PERMEON™) EVALUATION

Final Report

SPR 306.211

Oregon Department of Transportation
Research Group

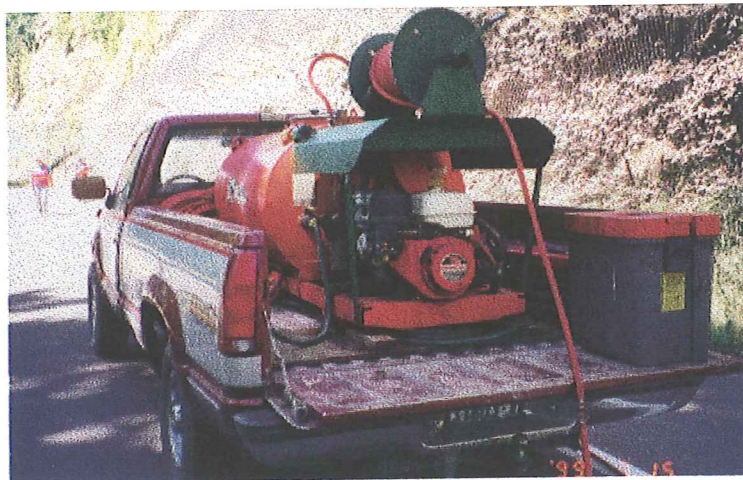
Figure 3.1: Spraying equipment to apply desert varnish

The PERMEON™ (desert varnish) had been mixed with water in a 1:5 solution, 75.7 liters (20 gal) of PERMEON™ to 378.5 liters (100 gal) of water. The mix was carried in the back of a pickup truck in a 946-liter (250-gal) tank. A compressor was used to pressurize the spray to about 14 kg/cm² (200 psi). (see Figure 3.1) The sub-contractor, Livingston, Inc., used a 61 m (200 ft) hose and an agricultural type handheld nozzle to spray the shotcrete-coated cliff.

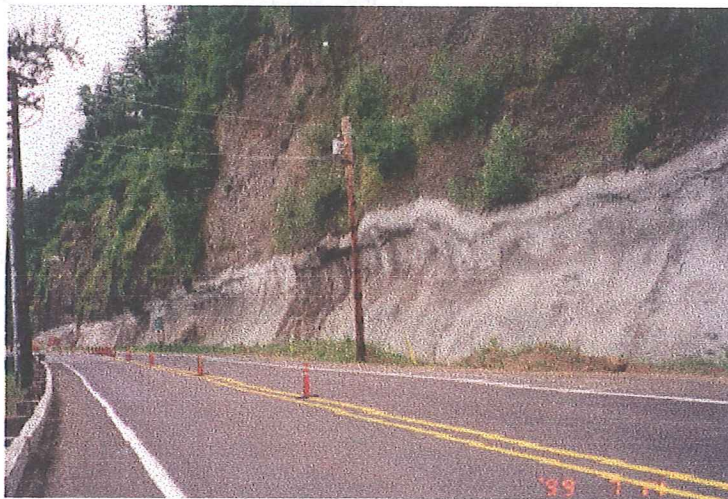
Figure 3.2: Dark streaks on shotcrete caused by irrigation water from above

Two possible problems were noted: water running over the cliff in a few areas from a local land owner's irrigation effort on the hill above the site (see Figure 3.2), and mineral stains from an unknown source appearing on some of the rocks just above the shotcrete. It was decided that these two areas should be closely monitored.

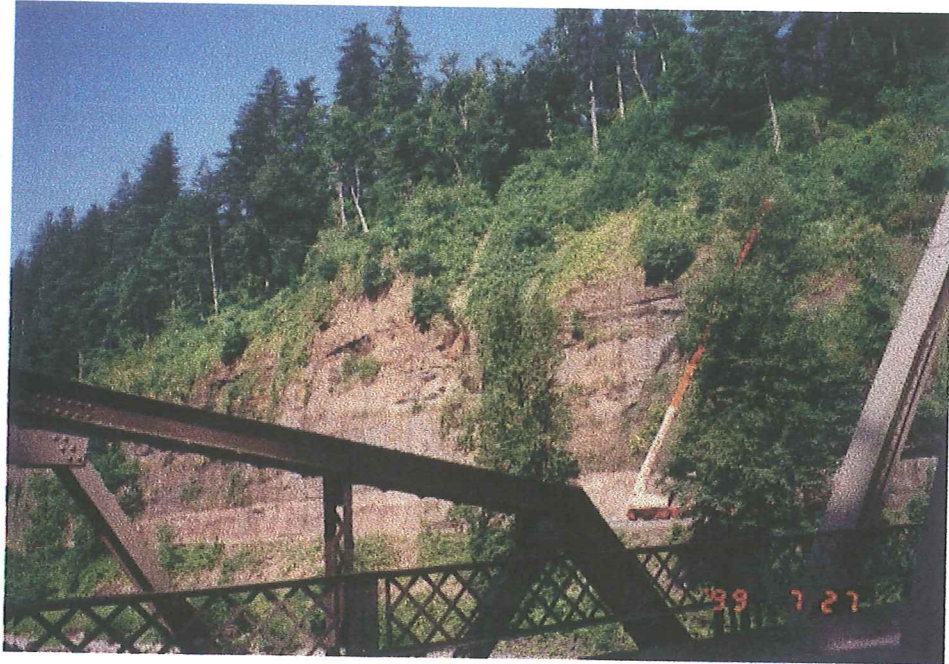
Figure 4.2: Shotcrete 2 weeks after application of desert varnish - West of Sandy River Bridge

After two weeks, half of the shotcrete with the desert varnish was starting to blend well with the surrounding cliff. The section west of the Sandy River Bridge was well matched, as shown in a comparison of Figures 4.1 and 4.2. East of the bridge, the section was still lighter than the cliff, as shown in Figures 4.3 and 4.4. This section was closely monitored, with the expectation that it would darken with age. After six months, the lighter patches were no longer noticeable. Figures 4.5 through 4.8 show the sections West and East of the Sandy River Bridge at one- and six-month intervals respectively.

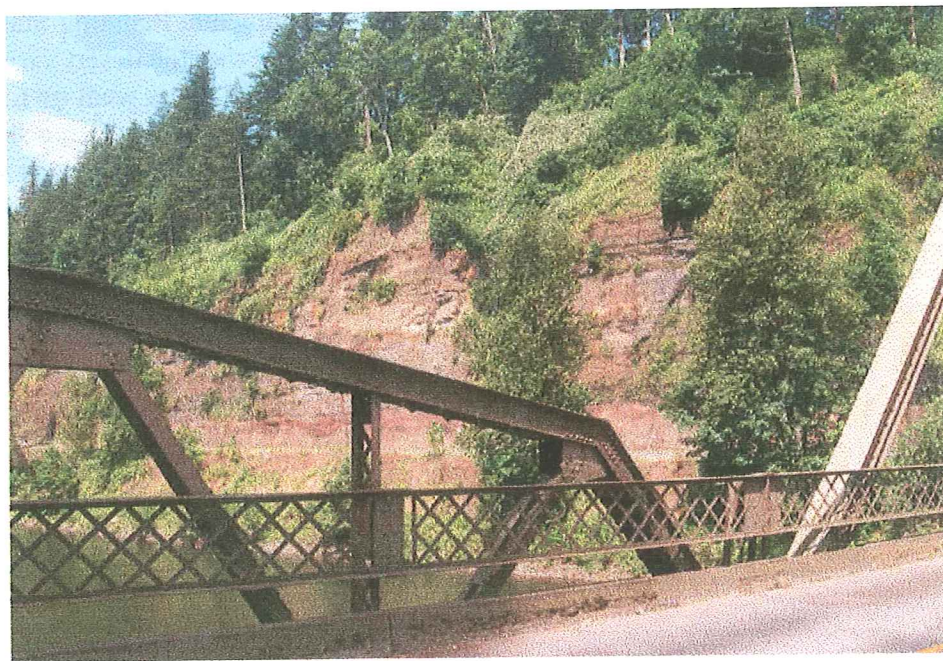
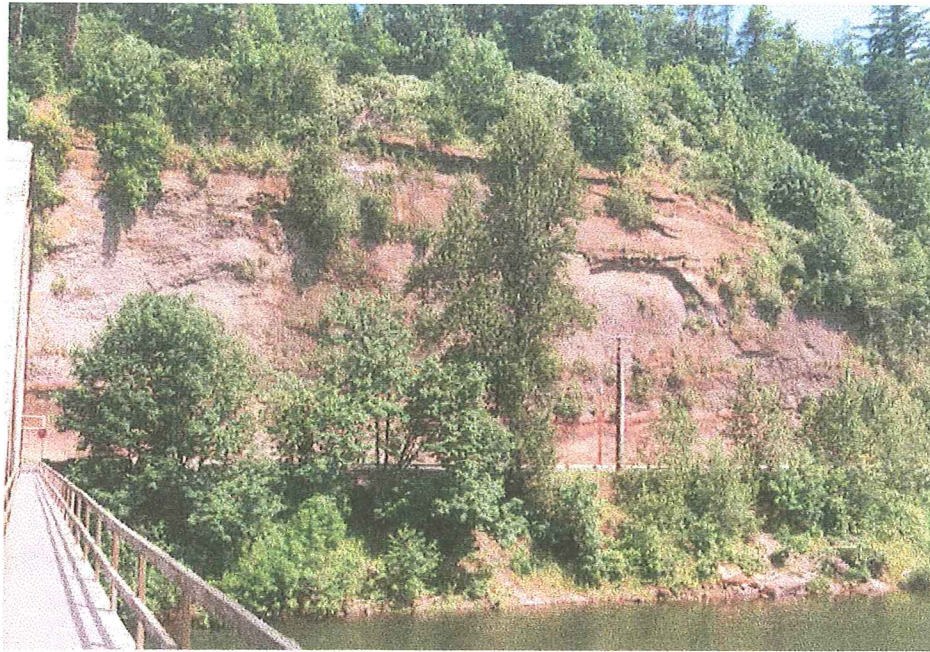
Approximately eleven months after application – on June 14, 2000 – the dark brown shade of the desert varnish remained on most of the shotcrete. Figures 4.9 and 4.10 show that the coloring is consistent with the surrounding slopes, as the desert varnish begins to develop a naturally weathered appearance.

Figure 4.9: Shotcrete 11 months after application of desert varnish - West of Sandy River Bridge

Figure 4.10: Shotcrete 11 months after application of desert varnish - East of Sandy River Bridge

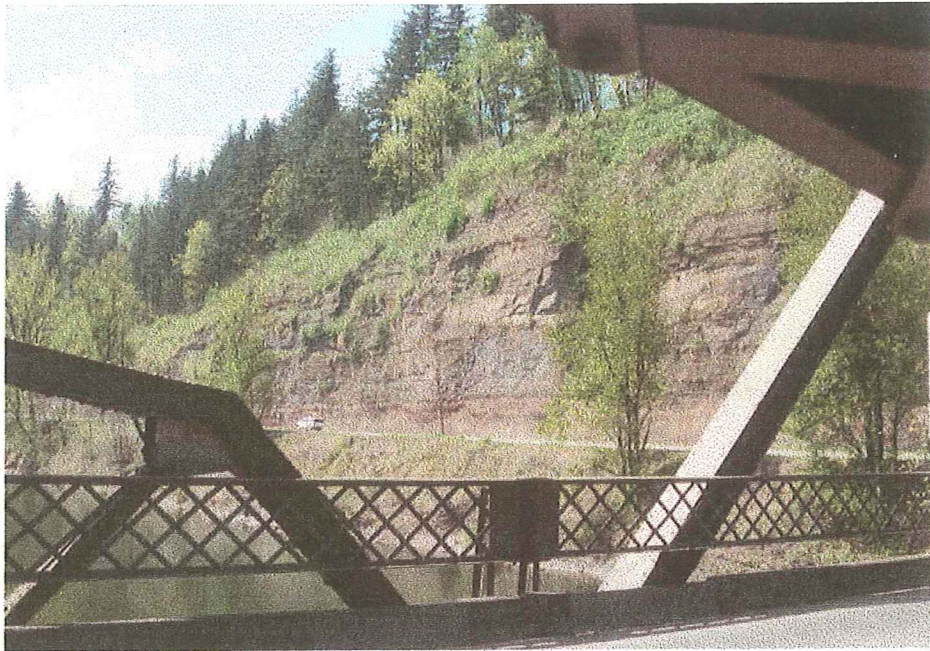
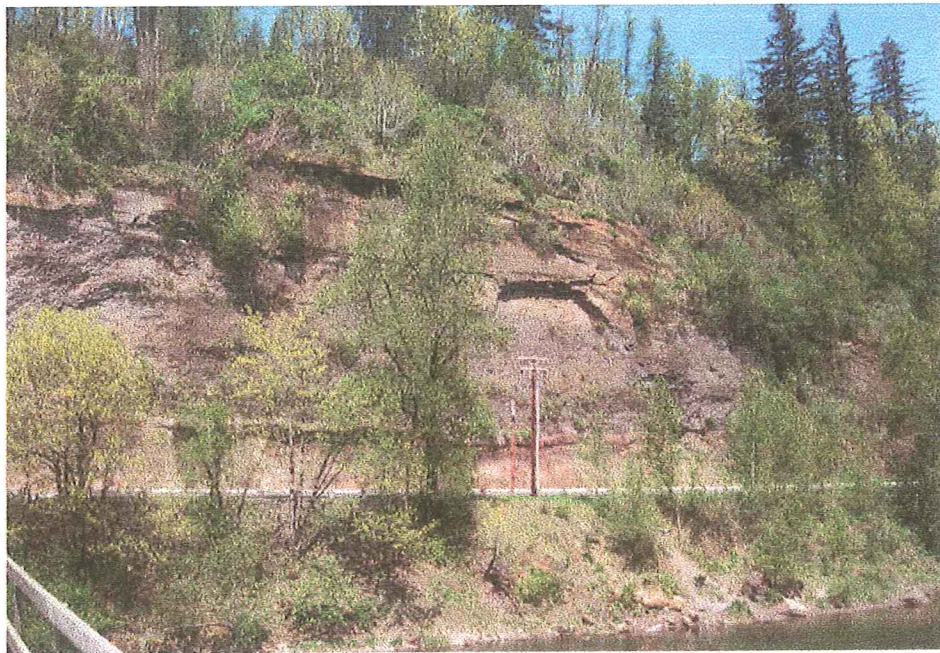
A final inspection of the desert varnish at Dabney State Park was made on April 24, 2001. Figures 4.11 and 4.12 show that the shotcrete applied with desert varnish completely blends into the natural view. Jurgen Hess, Landscape Architect and Environmental Planning Staff Officer with the Columbia River Gorge National Scenic Area commented that the desert varnish had a positive mitigating effect on the shotcrete at Dabney State Park. Mr. Hess went on to state that he noticed a significant decrease in contrast between the shotcrete and surrounding slopes over the twenty-one months the project area was monitored and that the project meets the visual subordinate requirements of the Columbia River Gorge Scenic Area Management Plan. Figures 4.13 through 4.18 provide additional evidence of how the desert varnish naturally weathered and blended into the natural surroundings over time.

Figure 4.11: Shotcrete 21 months after application of desert varnish - West of Sandy River Bridge

Figure 4.12: Shotcrete 21 months after application of desert varnish - East of Sandy River Bridge

3. It should be noted that desert varnish does not provide a lasting coloring effect. Because of the continuous change in the desert varnish coloration, it is recommended that sections applied with this treatment be periodically monitored for changes in coloration as the natural weathering process occurs.

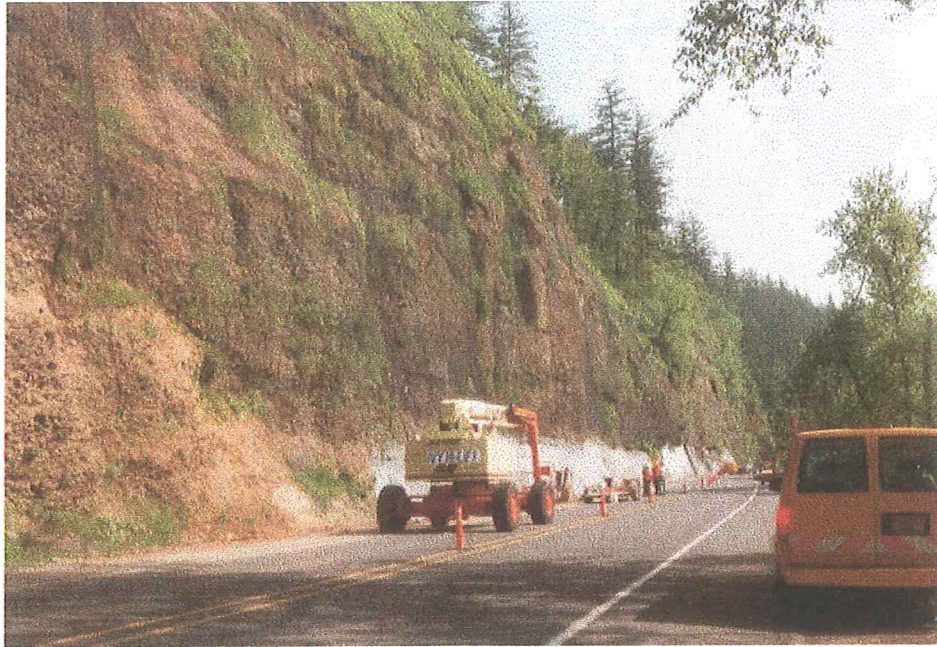
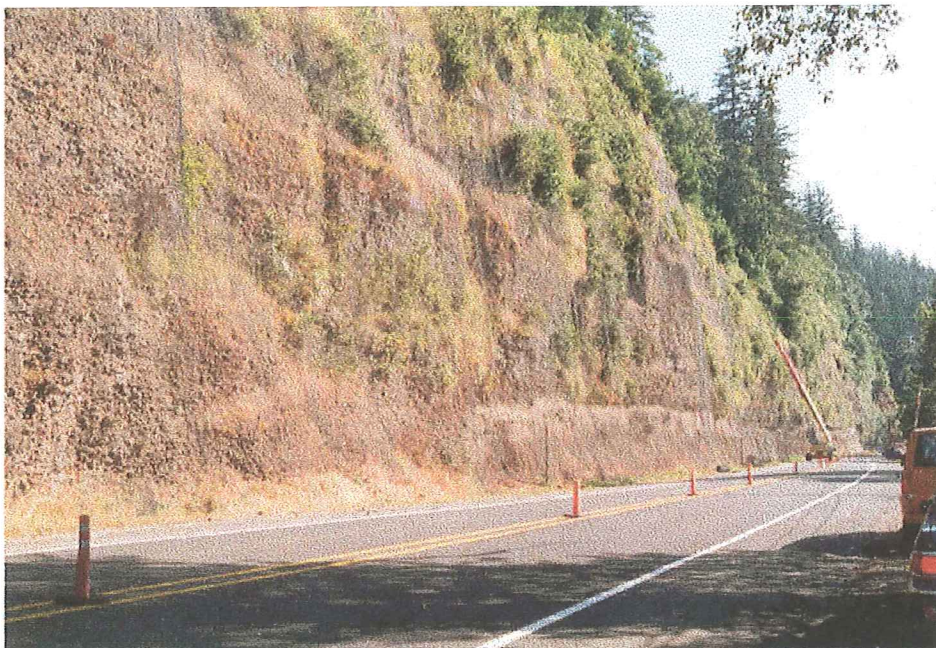
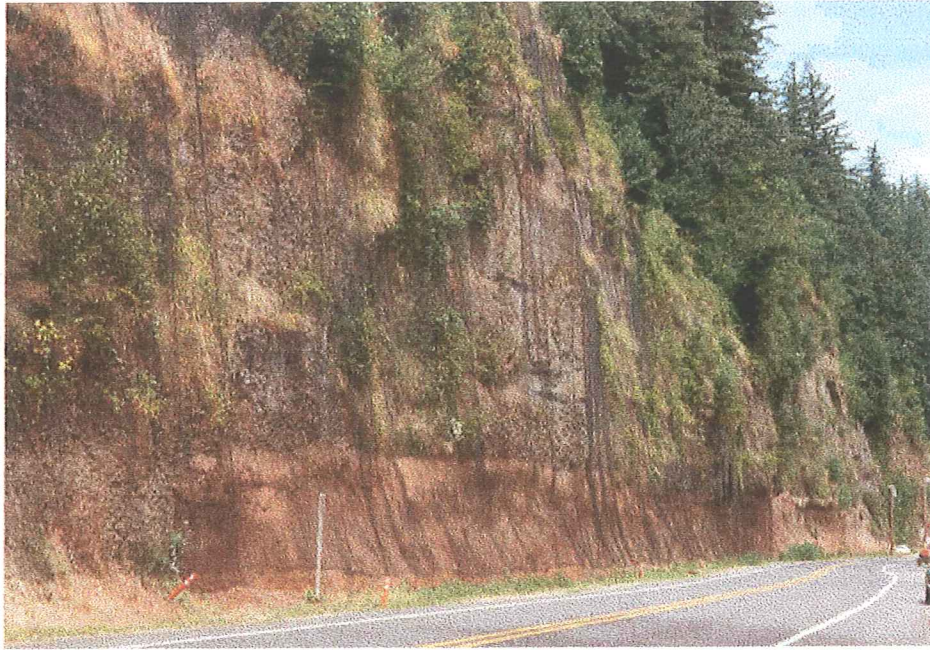
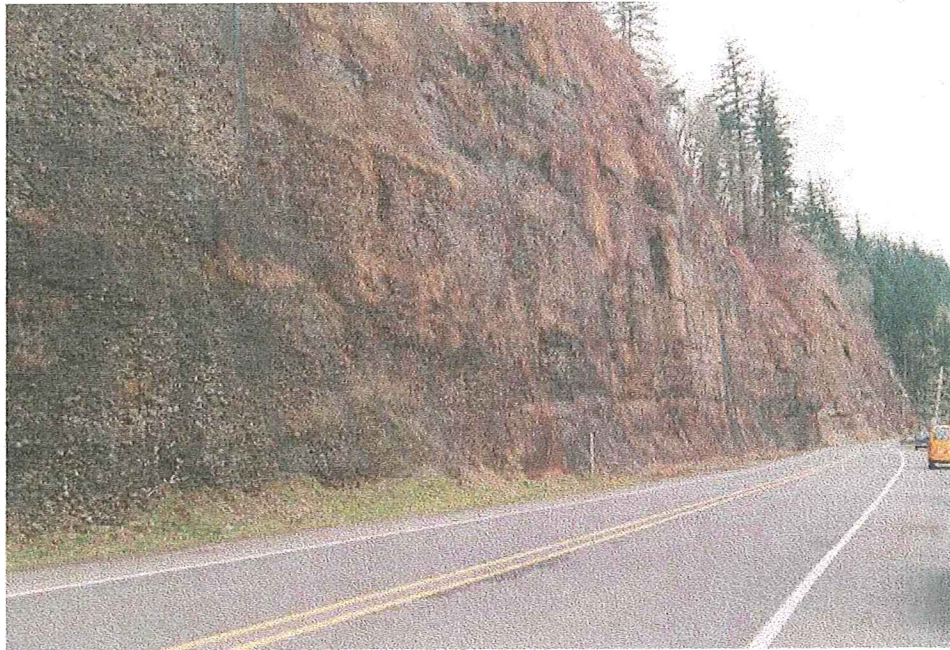
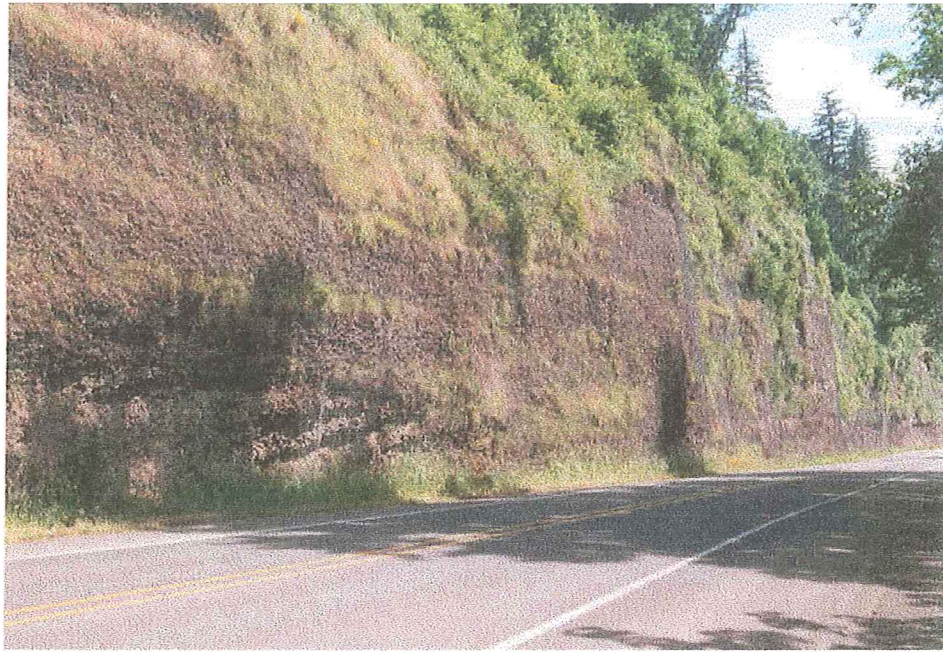
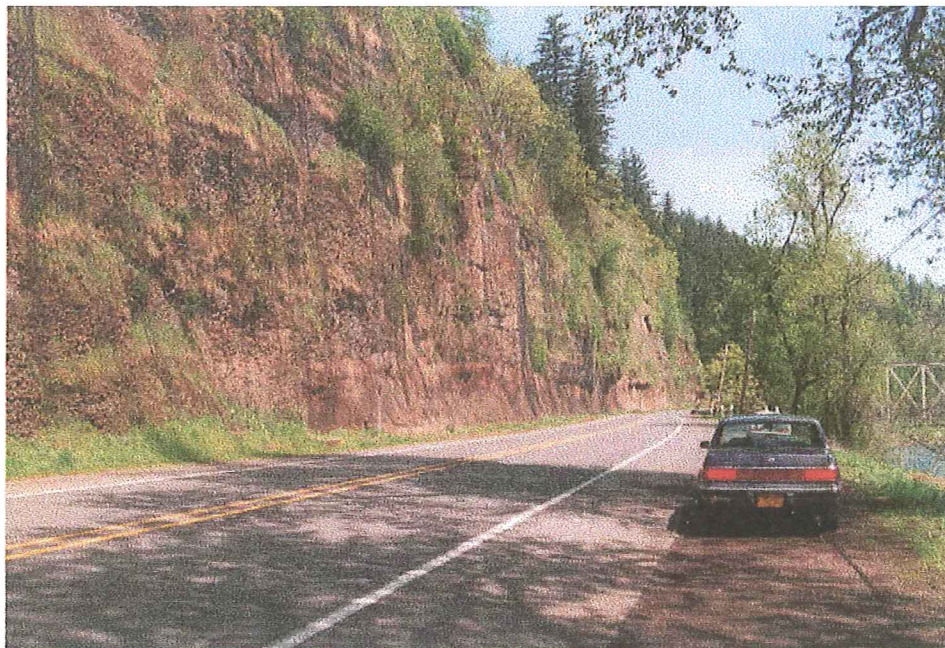
Figure 4.13: Close-up view of shotcrete before application of desert varnish - West of Sandy River Bridge

Figure 4.14: Close-up view of shotcrete 2 weeks after application of desert varnish - West of Sandy River Bridge

Figure 4.15: Close-up view of shotcrete one month after application of desert varnish - West of Sandy River Bridge

Figure 4.16: Close-up view of shotcrete 6 months after application of desert varnish - West of Sandy River Bridge

Figure 4.17: Close-up view of shotcrete 11 months after application of desert varnish -
West of Sandy River Bridge

Figure 4.18: Close-up view of shotcrete 21 months after application of desert varnish -
West of Sandy River Bridge

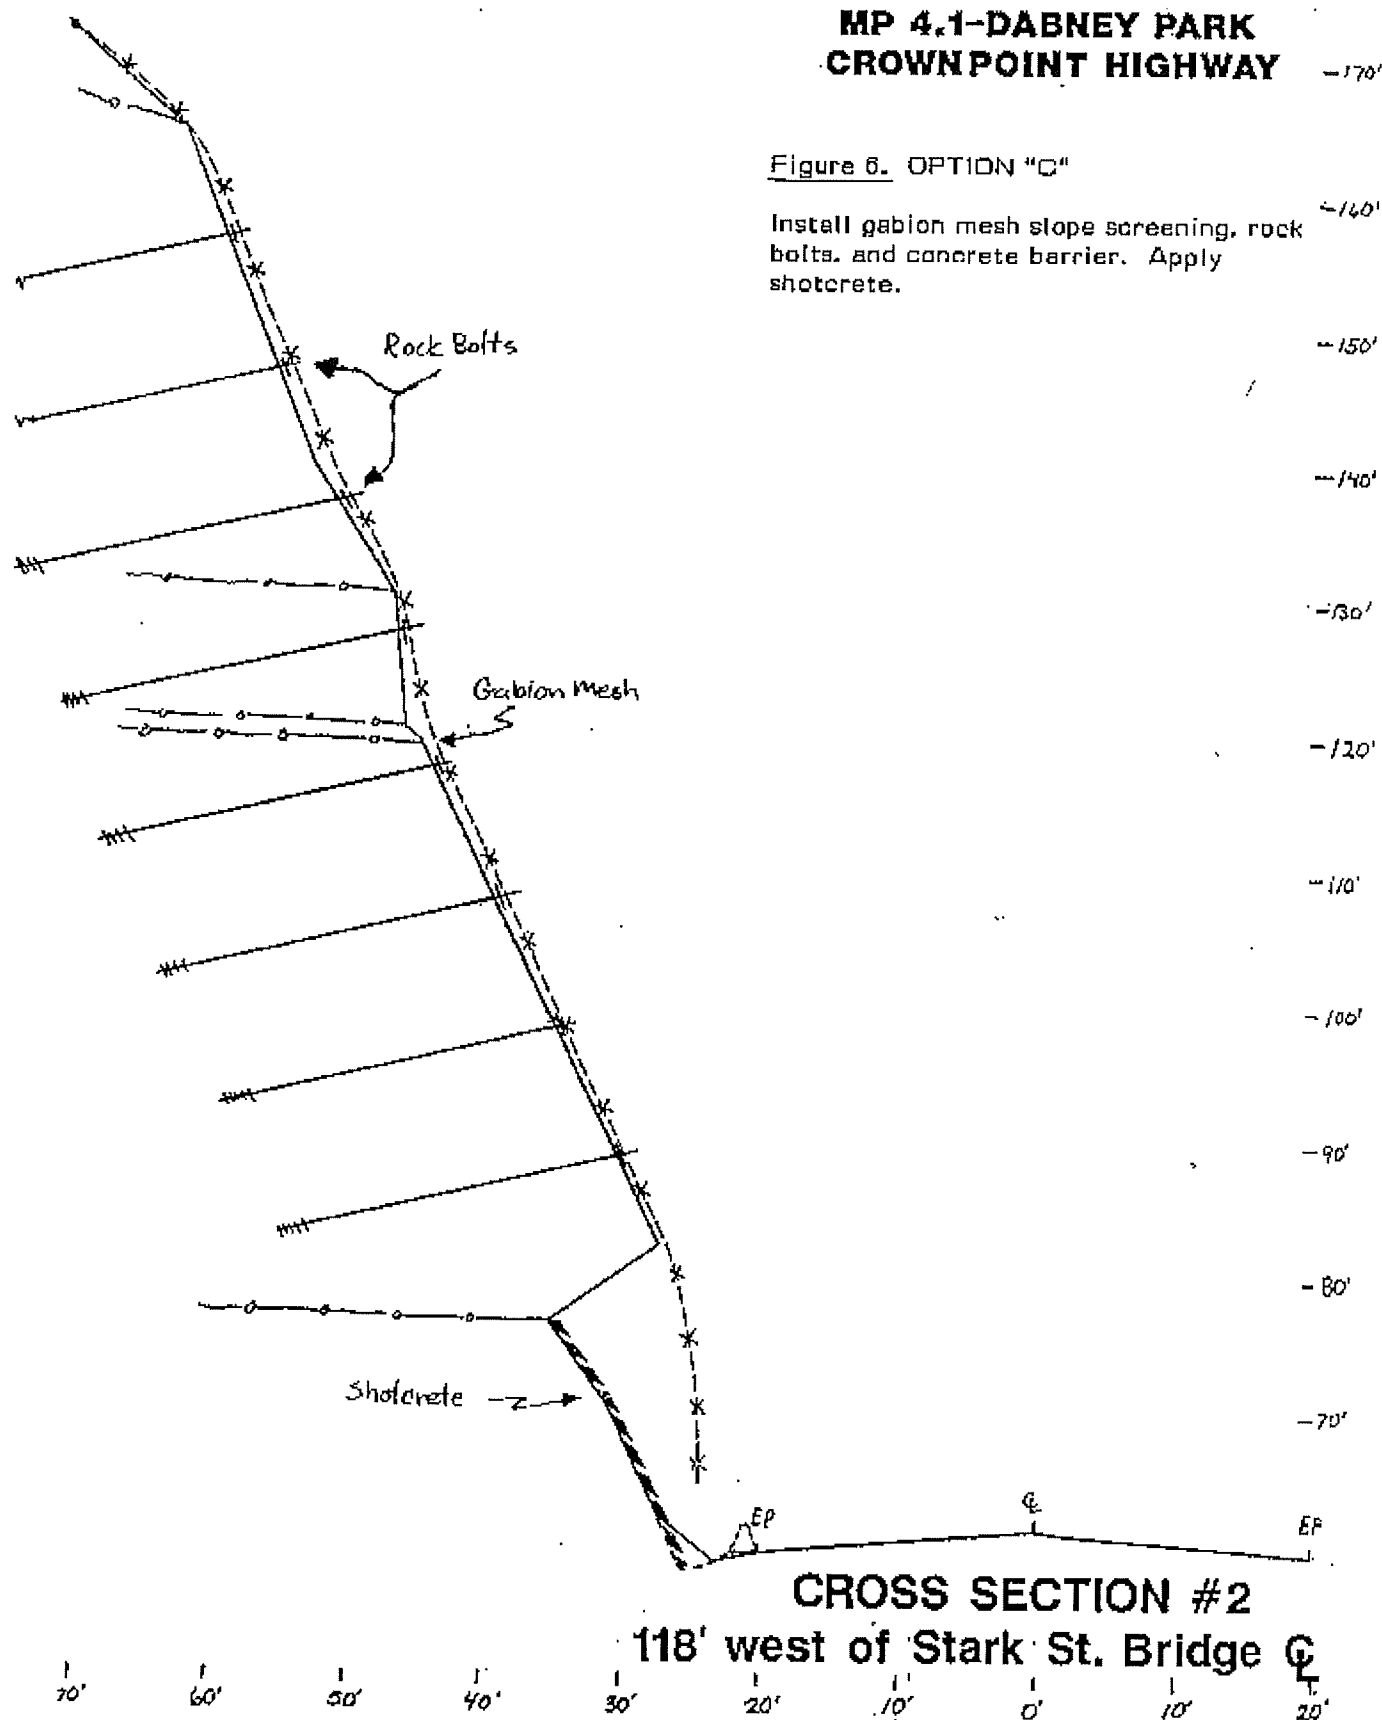
MP 4.1-DABNEY PARK CROWNPOINT HIGHWAY

Figure 6. OPTION "C"

Install gabion mesh slope screening, rock bolts, and concrete barrier. Apply shotcrete.

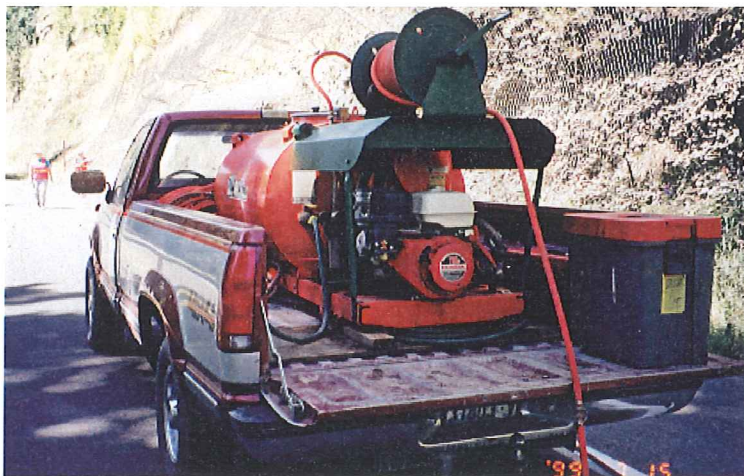
Figure 3.1: Spraying equipment to apply desert varnish

The PERMEON™ (desert varnish) had been mixed with water in a 1:5 solution, 75.7 liters (20 gal) of PERMEON™ to 378.5 liters (100 gal) of water. The mix was carried in the back of a pickup truck in a 946-liter (250-gal) tank. A compressor was used to pressurize the spray to about 14 kg/cm² (200 psi). (see Figure 3.1) The sub-contractor, Livingston, Inc., used a 61 m (200 ft) hose and an agricultural type handheld nozzle to spray the shotcrete-coated cliff.

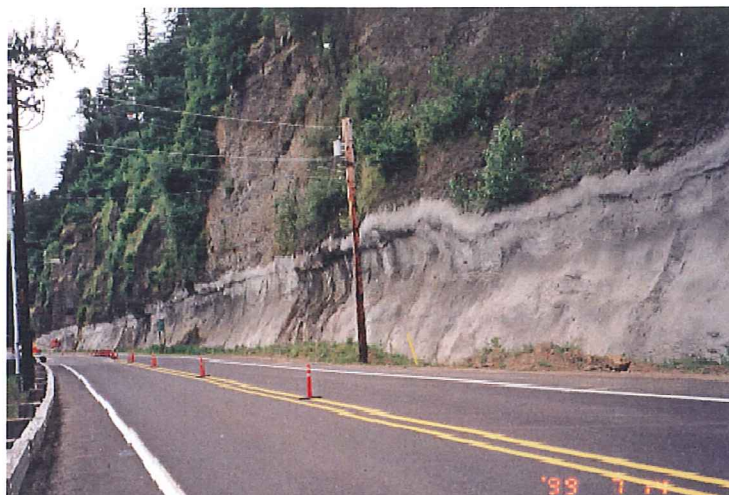
Figure 3.2: Dark streaks on shotcrete caused by irrigation water from above

Two possible problems were noted: water running over the cliff in a few areas from a local land owner's irrigation effort on the hill above the site (see Figure 3.2), and mineral stains from an unknown source appearing on some of the rocks just above the shotcrete. It was decided that these two areas should be closely monitored.
