QUALITY AND MONITORING OF STRUCTURAL REHABILITATION MEASURES

Part 1: Description of Potential Defects

REPORT SUBMITTED TO THE OREGON DEPARTMENT OF TRANSPORTATION
UNDER CONTRACT NUMBER 18347

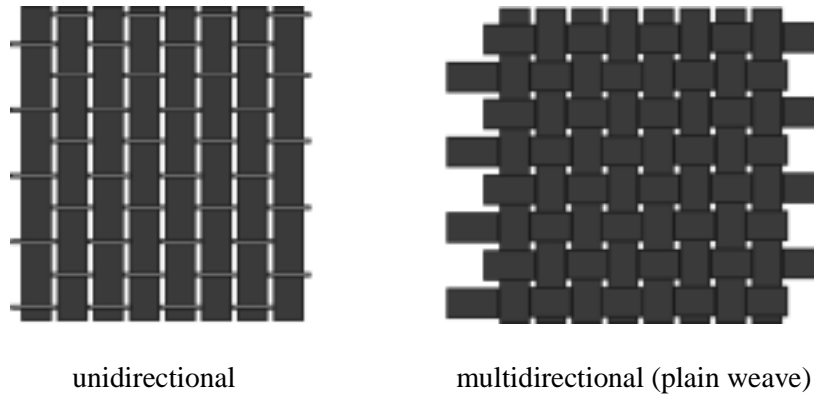
To provide the user with a manageable fiber structure, yarns are arranged in specific reinforcement formations. Possible methods of integrating fiber tows include weaving, braiding, knitting or randomly oriented fiber mats. Depending on the intended use, fibers can be aligned in an almost infinite amount of variations to resist stresses in multiple directions. Some basic patterns include unidirectional (UD) or multidirectional weaves, schematically shown in Figure 1-1.

Figure 1-1: Geometry of Common Weave Patterns

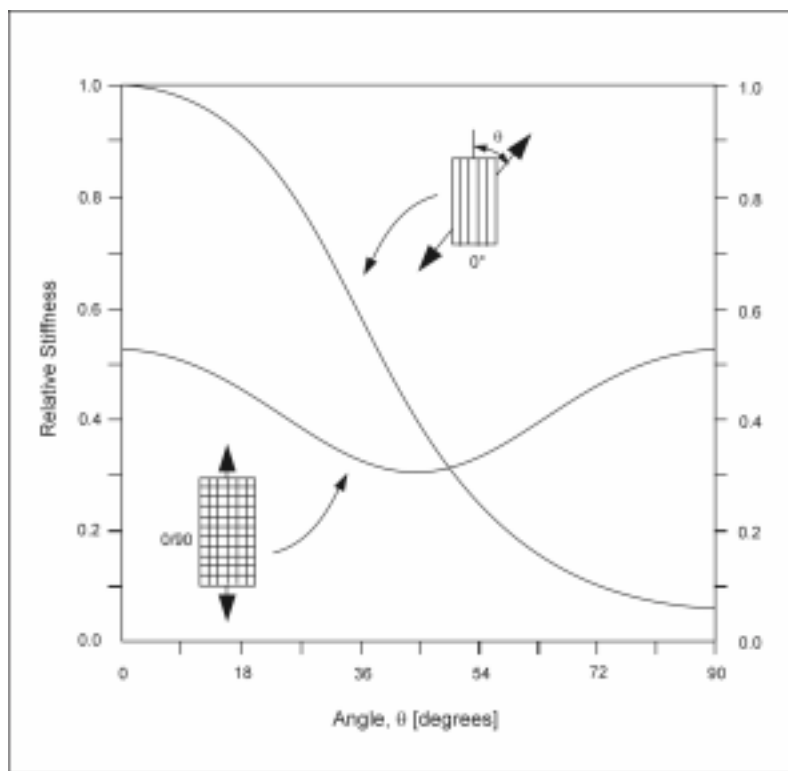
Both mechanical and thermal properties of composite materials are governed by the properties of the individual components. Unlike steel, composites are anisotropic materials as they show significantly different properties in longitudinal and transverse directions, with respect to the fiber axis. Figure 1-2 indicates the rapid decrease of tensile stiffness with increasing off-axis angles for unidirectional and woven composite materials. A quasi-isotropic material, i.e. with similar properties in all directions, can only be obtained by using chopped strand mats with randomly oriented fibers, however, chopped fiber materials are not nearly as stiff and strong as their continuous counterparts. Although fibers are the main contributors to strength and stiffness, good adhesion between fibers and matrix as well as stress transfer between adjacent fibers is an absolute necessity for high material performance. In composite design, mechanical properties are mostly governed by the ratio of fiber volume to overall material volume, V_f . An increase in V_f results in a composite with higher strength and stiffness. Nevertheless, in practical applications, V_f is limited to roughly 55-65% for prepreg material and only 30 to 55% for wet layup, depending on weave geometry, resin viscosity, stacking order, degree of layer compaction as well as cure conditions.

Figure 1-2: Effect of Test Angle upon In-Plane Stiffness of Unidirectional and Biaxial Laminates [2]

lower the elastic modulus and result in inferior properties (compare Figure 1-2). Waviness originates from improper rolling in opposite directions towards one point of the laminate. Instead, rolling should be performed from mid-length towards both ends of a strengthening strip.

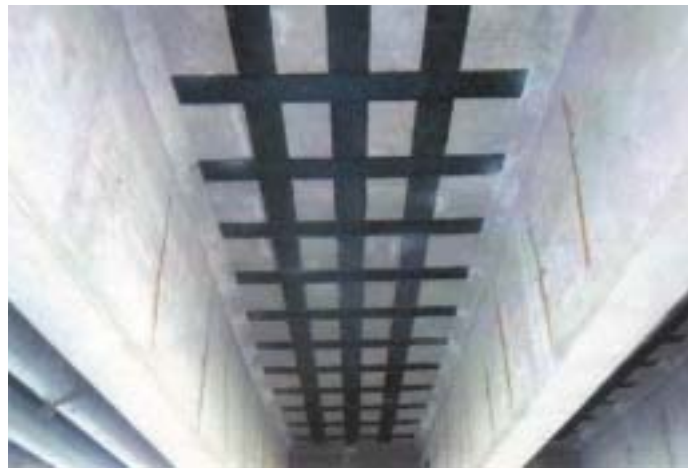
To date, a large number of concrete rehabilitation measures have involved the application of external reinforcement schemes, typically in form of epoxy bonded steel plates [3,4]. Recently, researchers have focused on using fiber reinforced polymer (FRP) composites for external strengthening, to make use of their high strength and stiffness as well as excellent environmental resistance [5-7]. Figure 1-3 depicts a typical application scheme for composite materials on concrete surfaces.

Figure 1-3: Strengthening of Concrete Bridge Deck

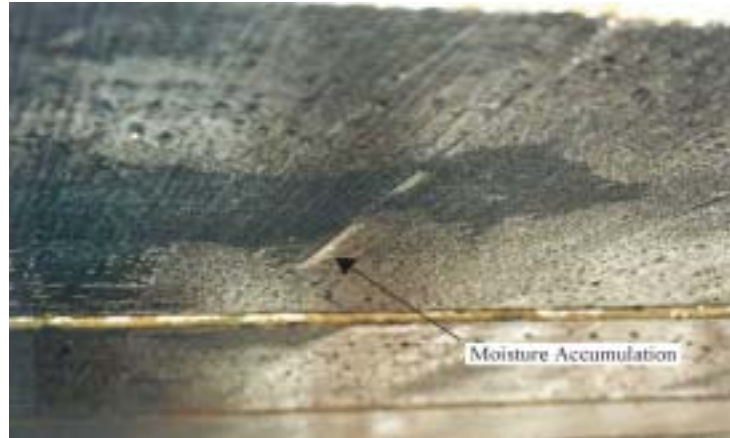
Structural rehabilitation methods have already encountered several of the previously addressed material flaws, which have led to a substantial amount of material degradation as well as deterioration of the entire rehabilitation scheme. A typical example is shown in Figure 1-4, where moisture, propagating from inside the concrete, has become entrapped at the concrete/composite interface. The result was loss of intimate bond over a large area in the externally strengthened deck slab. Here, encapsulation of an entire area without incorporation of ventilation gaps has restricted the escape of moisture.

Figure 1-4: Delamination Due to Entrapped Moisture

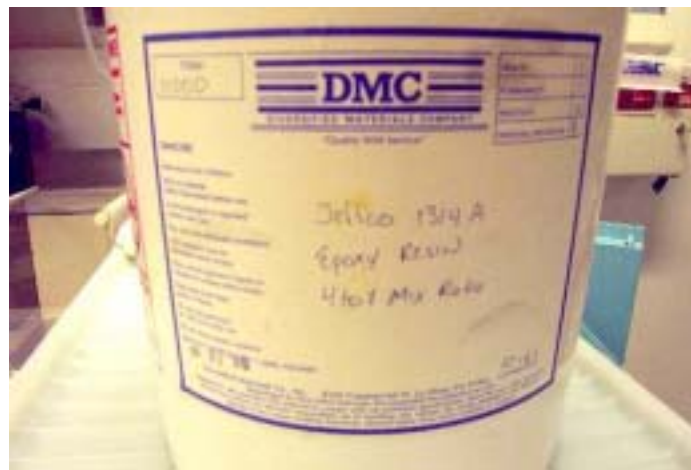
(Figure 3-1). Typically, resin shelf life ranges between 3 to 8 months. If stored in warm environments, resin tends to pre-cure inside the container, thus decreasing shelf life. Although reactive agents have not been introduced to the resin, the constituents slowly cure, as the material is stored. If expired, resins should not be used. An overaged resin system shows lower reactivity, resulting in lower strength and elastic modulus. Also, viscosity increases with time, leading to difficulties during fiber infiltration. These properties can be checked through use of viscosity tests and differential scanning calorimetry (DSC).

Figure 3-1: Resin Label

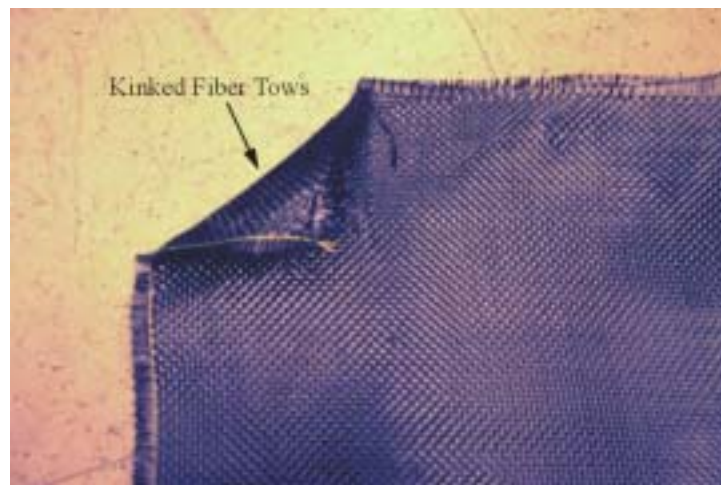
3.1.2.2 Kinked or Wavy Bundles: Fibers inside a fabric may be kinked or wavy, as shown in Figure 3-2. If kinked, fibers may easily break during handling or installation. Wavy fiber bundles do not run in the principle loading direction, hence they are not capable of resisting equally high loads along this direction. As a result, adjacent, straight fiber bundles have to account for higher stresses (stress concentrations). Also, a loss in stiffness is likely to be encountered.

Figure 3-2: Kinked Fibers

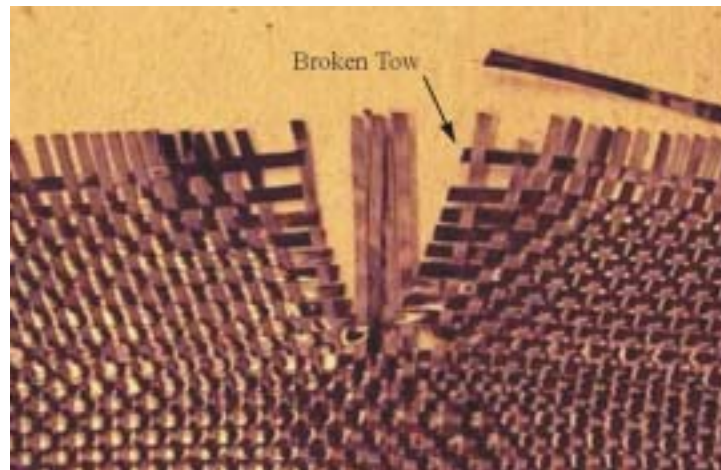
3.1.2.3 Broken Fibers: While a single broken fiber is difficult to detect, broken fiber strands (Figure 3-3) are more critical and should be noticed. Although each fiber bundle contains a large number of fiber discontinuities (due to the manufacturing process), these discontinuities differ in location throughout a bundle. Therefore, stress concentrations

Figure 3-3: Broken Fiber Tows

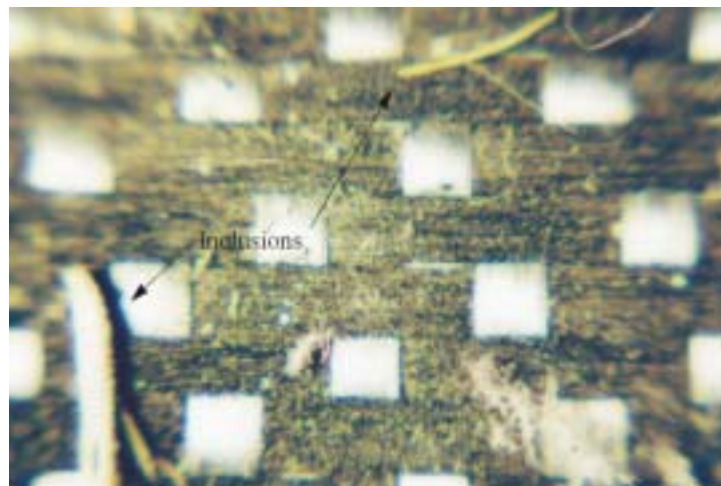
3.1.2.4 Contaminations/Inclusions: The fiber surface may contain impurities in form of chemicals or small objects, as depicted in Figure 3-4, which can harm both fiber- and bond strength. While carbon fibers are rather inert to chemicals, glass fibers are highly susceptible to alkali attack. Sizing chemistry, a measure for resin/fabric bond capability, can be affected by certain chemicals and thus reduce bond strength. Small objects are likely to be trapped near the fiber surface to form a void and serve as a potential debond. In case of sharp-edged inclusions, fibers may be severely damaged upon infiltration.

Figure 3-4: Fabric Inclusions

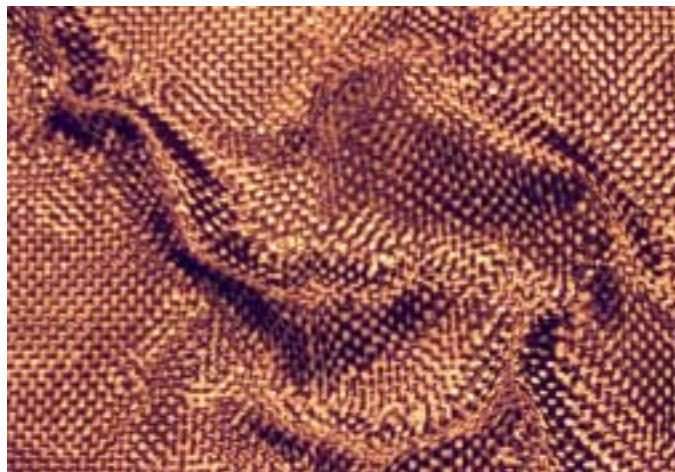
3.1.2.5 Fabric Wrinkles: During processing and handling of fabric, fiber wrinkles may be induced. Shown exaggerated in Figure 3-5, such wrinkles should be straightened as

Figure 3-5: Wrinkled Fabric

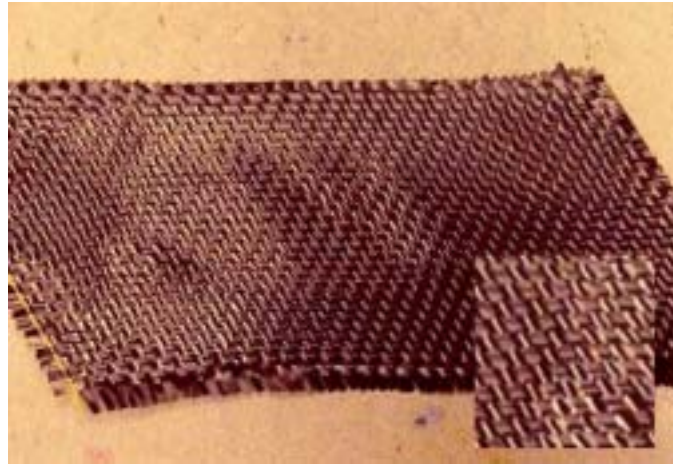
Figure 3-6: Sheared Fabric

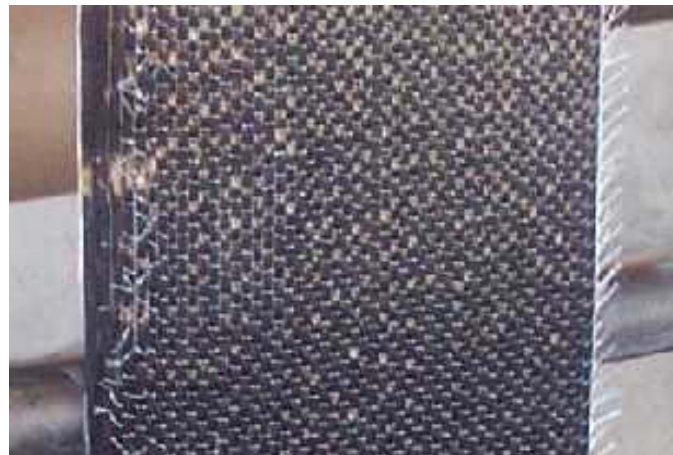
3.1.2.7 Damage to Free Edges: During handling of fabric rolls, damage to free edges is likely to occur. Because a fabric structure does not exhibit the same integrity around edges as inside the woven area, edges are also more likely to decompose during resin infiltration. Material shown in Figure 3-7 utilizes additional rows of stitching along the material edges that are effective in preventing such decomposition. However, if the stitching is damaged or missing, as shown on the left, the affected portion must be discarded. In case of multiaxial fabrics, the removal or damage of tows can cause change in local reinforcement ratio.

Figure 3-7: Damaged Edges

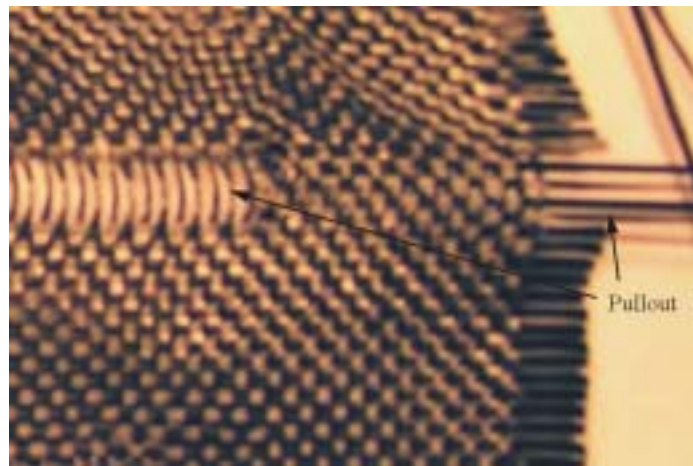
3.1.2.8 Loose Fibers: Pullout of single fibers or fiber bundles (Figure 3-8) may occur during processing, as well as handling in the field. Loose material does not exhibit the same intermediate contact to nearby fibers and is more likely to be sheared during resin infiltration. Furthermore, resin rich areas tend to form in these regions, resulting in low stress transfer capabilities between adjacent fiber strands.

Figure 3-8: Fiber Pullout

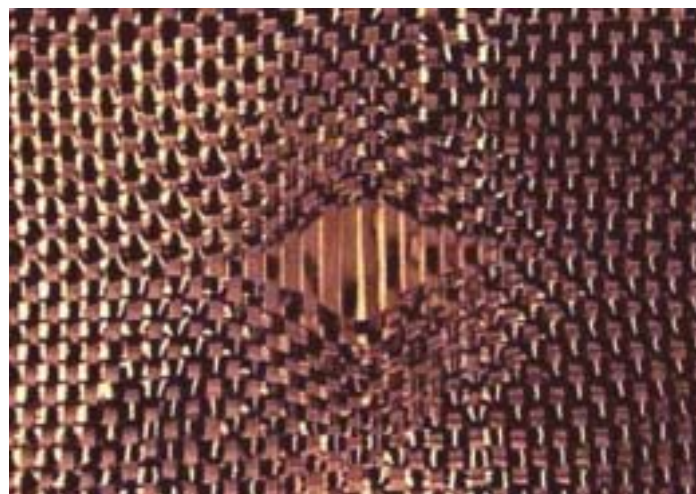
Figure 3-9: Large Fiber Gap

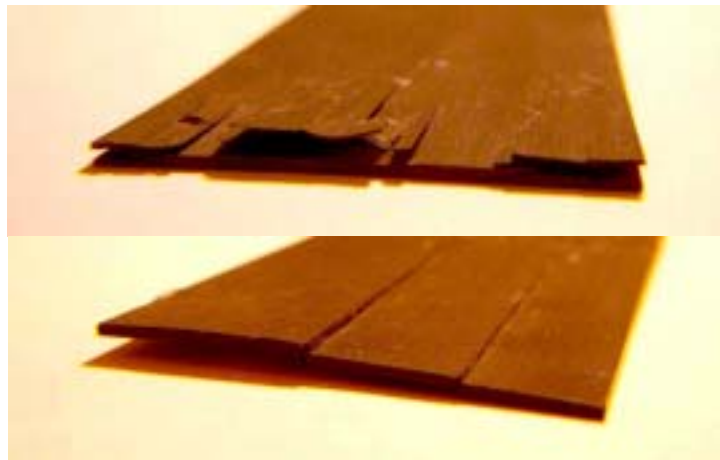
3.1.3.2 Transportation/Handling Damage: Damage to prefabricated material may be induced during storage, transportation or handling. Typical defects include splitting, delamination, matrix cracking, scratched surfaces, etc. Once the material has left the processing facility, the installer must determine whether it has experienced additional damage and make assessments towards the suitability for installation. Figure 3-10 shows typical composite strips with delamination of several layers (top) as well as longitudinal splitting (bottom). It must be emphasized, however, that these forms of material damage are not a common occurrence.

Figure 3-10: Damaged Prefabricated Material

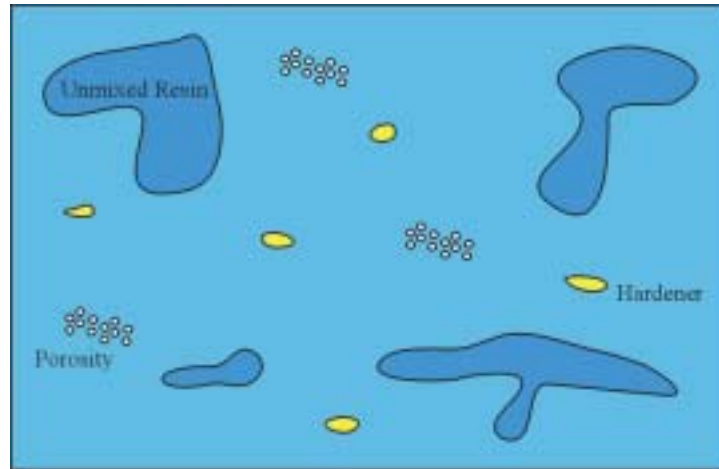
in the case of a sealed resin container. If visual detection shows a significant amount of moisture accumulation on the fiber surface, they must be discarded. When a moist fabric is infiltrated, it will experience a weak bond to the surrounding matrix. Debonding and subsequent delamination are likely to be the result.

Figure 3-11: Results of Incorrect Mixing

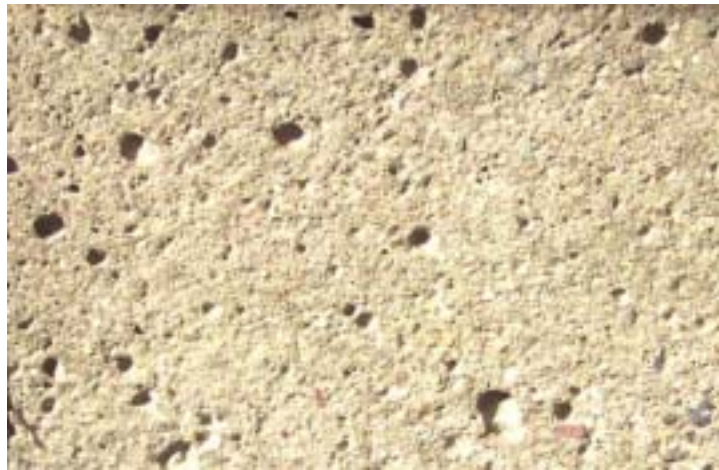
Figure 3-13: Concrete Surface Irregularities

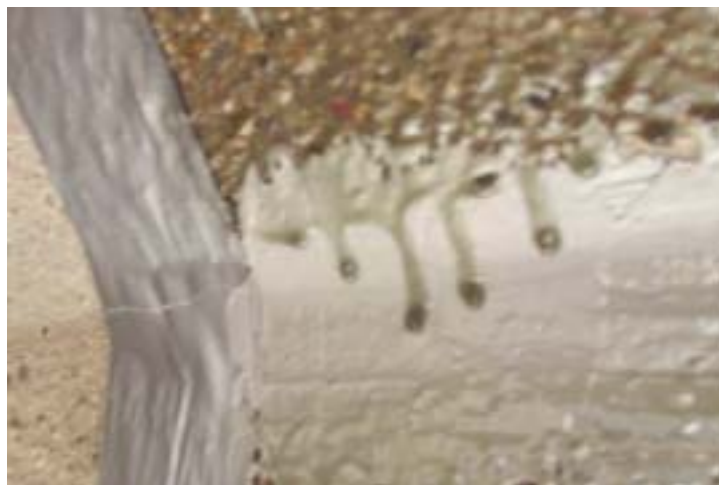
Figure 3-14: Primer Dripping

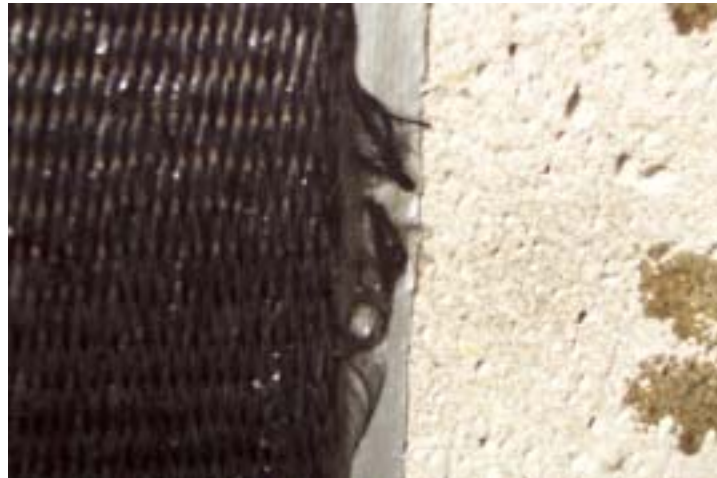
as a “marker line”. Here, edge disbonding at the concrete/composite interface was more likely to be encountered.

Figure 3-15: Fiber Placement over Duct Tape

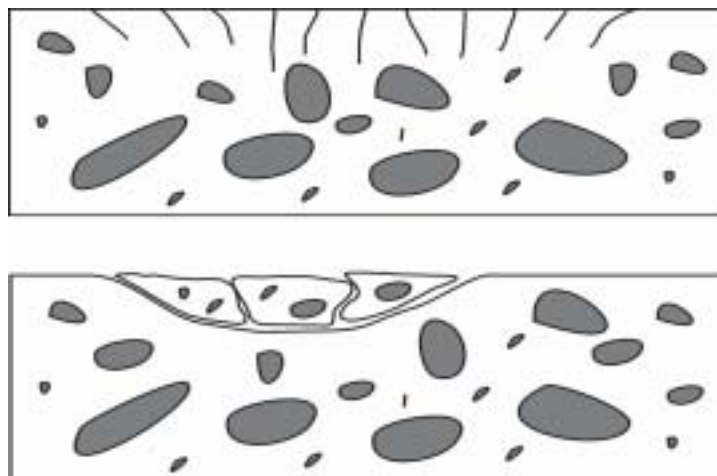
3.2.3.3 Degradation at Imperfections: If the concrete substrate displays a high degree of microcracking at its surface, the composite overlay must bond to an initially weak base material. In extreme cases the poor cover material may need to be completely removed and replaced by appropriate fillers, prior to rehabilitation. Two forms of typical substrate degradation are depicted in Figure 3-16.

Figure 3-16: Microcracking and Spalling of Concrete Substrate

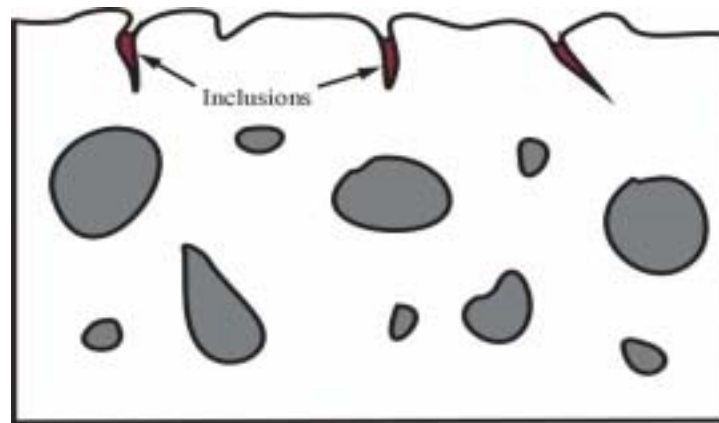
3.2.3.4 Inclusions at Imperfections: Naturally, many structures in need for rehabilitation already show a large number of cracks, which may have opened to a significant degree and thus accumulated moisture, dirt or other foreign material over time. By applying a primer coating, inclusions may become permanently encapsulated within the surface to serve as weak spots (Figure 3-17) for future crack initiation and propagation at the interface level. As a preventive measure, cracks should be cleaned and injected with appropriate filler materials, depending on depth and diameter of the crack.

Figure 3-17: Inclusions at Imperfections

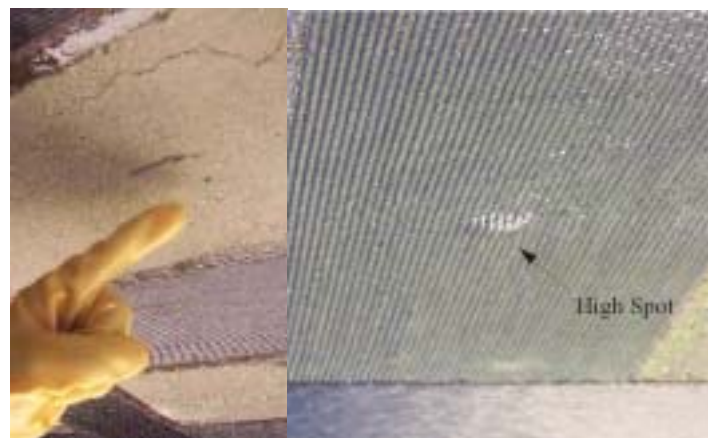
3.2.3.5 Inadequate Grinding of Substrate: To provide a smooth surface for bonding, any irregularities such as form lines or protruding aggregate should be ground down. If a composite laminate is applied to concrete surfaces that contain high spots, as depicted in Figure 3-18, the laminate will tend to form an air pocket. Similarly, large, hollow regions, which may result from high spots in the formwork, must be filled prior to composite application. Figure 3-19 illustrates the effect of composite placement over hollow regions.

Figure 3-18: Air Entrapment over High Spots

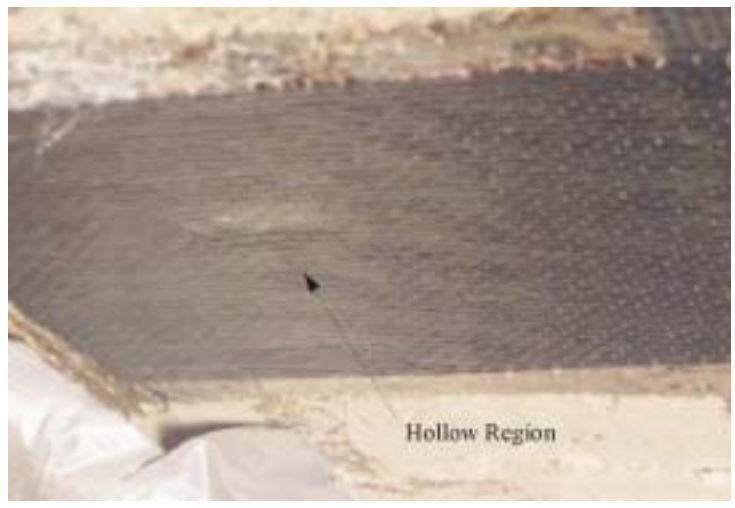
Figure 3-19: Air Entrapment over Hollow Regions

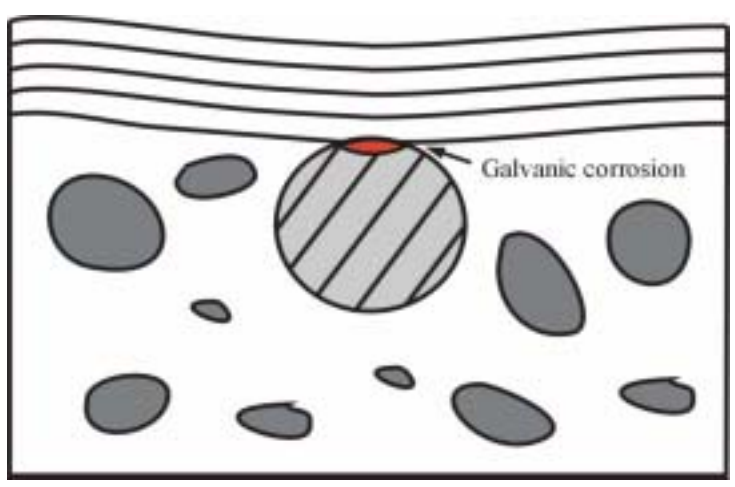
3.2.3.6 Galvanic Corrosion: On spalled or otherwise heavily degraded members, the embedded steel reinforcement may be exposed to the environment. As a result, the composite strengthening system is likely to come into direct contact with the reinforcement (Figure 3-20). Due to the galvanic corrosion potential of carbon fibers, deterioration of the steel as well as the matrix material would be the result [17]. Thus, intimate contact between carbon composites and steel must be prevented, possible by application of suitable polymeric systems that serve as an insulator (e.g. GFRP, primer coating).

Figure 3-20: Galvanic Corrosion

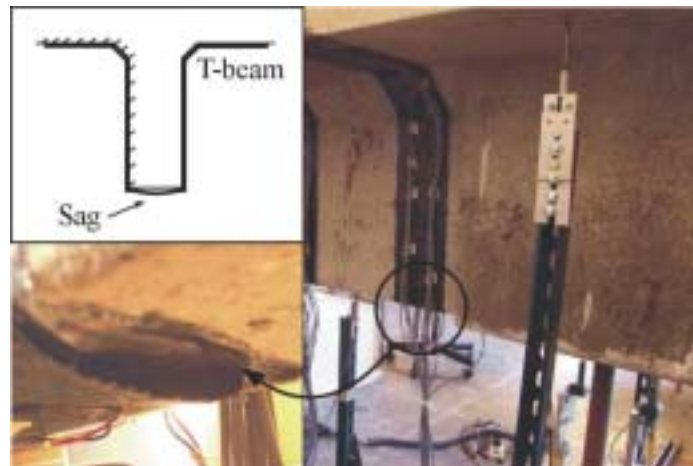
3.3.1.1 *Sagging of Infiltrated Material:* Until the resin has developed adequate tackiness, i.e. turns into a gel, the infiltrated material tends to separate from the concrete, especially in vertical and overhead regions (Figure 3-21). To prevent large-scale debonding, the most susceptible areas must be rolled repeatedly until resin tack can be confirmed. If the material sags there is no bond or intimate contact between the composite and the substrate, thus stress transfer capabilities are severely reduced. Moreover, air pockets promote the accumulation of moisture as a long-term effect.

Figure 3-21: Sagging of Infiltrated Composite Material

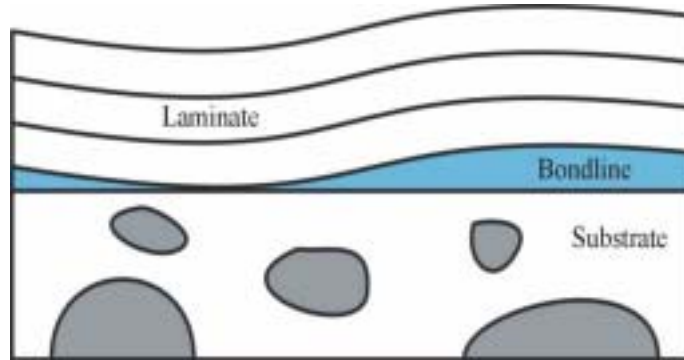
3.3.1.2 *Non-uniform Concrete/Composite Interface:* Insufficient amounts of resin/adhesive can lead to a weak interfacial bond. While resin-rich regions experience low stress transfer, resin-starved areas tend to favor disbonding of the composite material

Figure 3-22: Resin-rich and Resin-starved Interface Regions

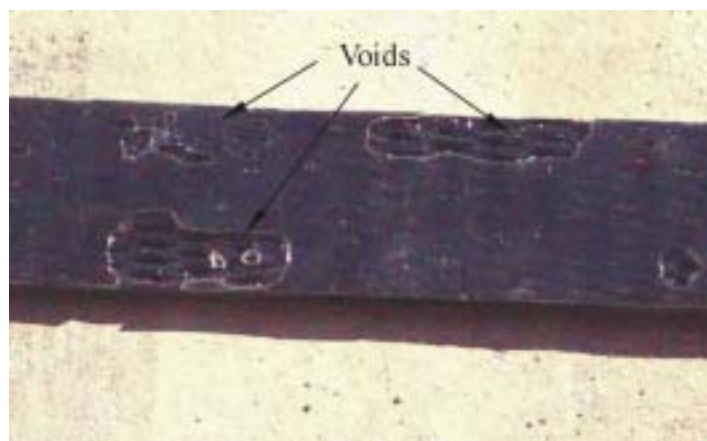
3.3.1.4 Voids: Voids are typically caused by air entrapment during the lay-up process. Other factors contributing to void formation are entrapped air from mixing, volatiles/gasses, an insufficient amount of resin applied, and inclusion of foreign particles. Also, if laminate is placed over high spots, which can occur as a result of formwork irregularities, air is likely to become entrapped around it. Thus, careful grinding of irregularities after sandblasting is advisable. Both porosity and voids cause internal stress concentrations. Examples of voids at the concrete/composite interface are shown in Figure 3-23.

Figure 3-23: Typical Voids at the Concrete/Composite Interface

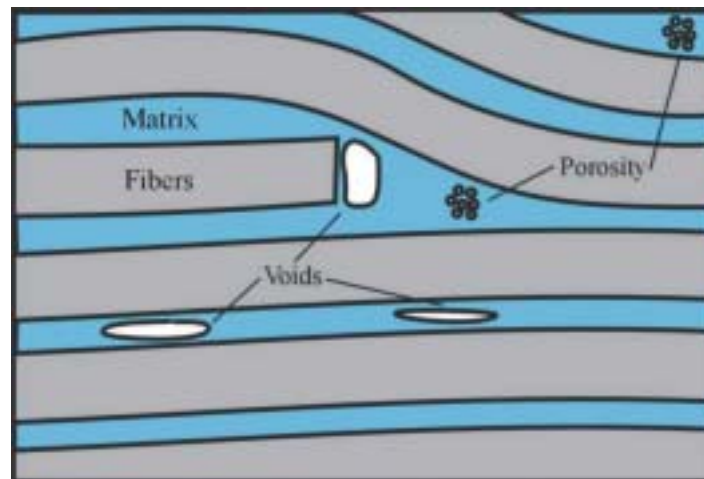
3.3.2.2 *Voids:* If multiple layers of fabric are placed on top of each other, air usually becomes entrapped between them. Rollers can be used to ‘work out’ most of the air. In addition, overlapping of layers promotes the formation of voids, since additional resin is needed to fill the gap formed at the overlap. For instance, voids in unidirectional composites exist as tubular pores, which run along adjacent fiber direction, almost exclusively at the fiber/matrix interface. Figure 3-24 shows the common forms of air entrapment inside the matrix material.

Figure 3-24: *Voids and Porosity Inside Composite Laminates*

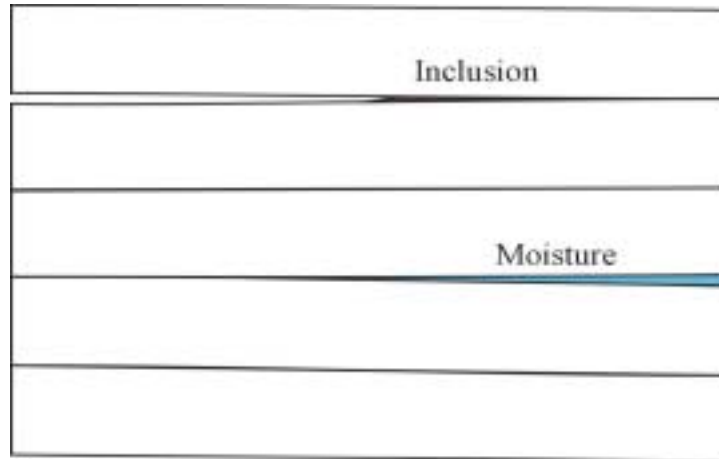
Figure 3-25: Delamination in Laminates

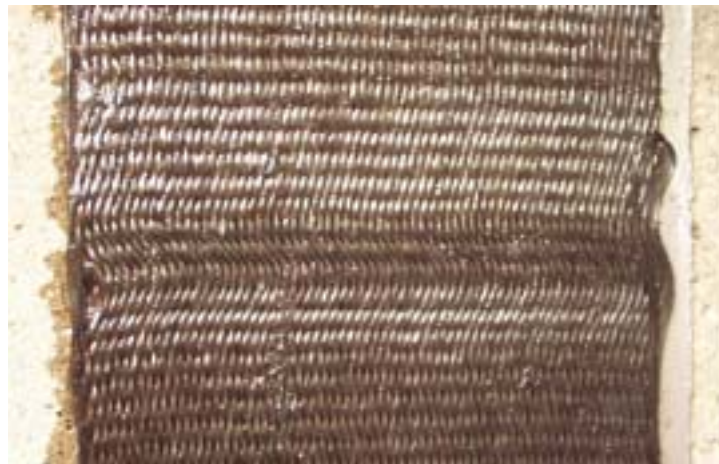
Figure 3-26: Waviness Caused by Improper Rolling

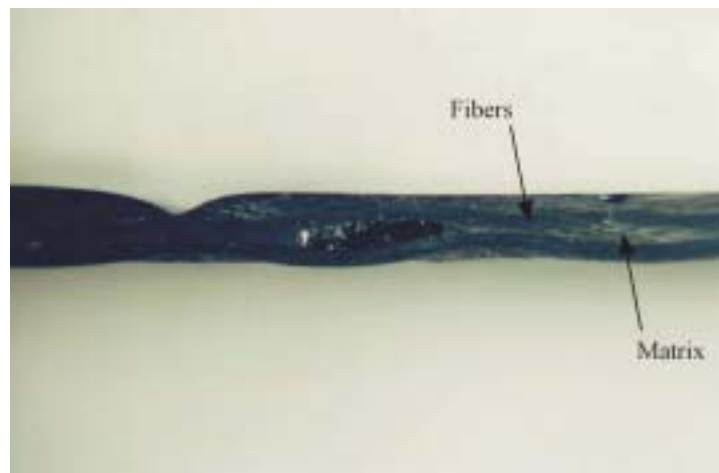
3.3.2.6 Resin Richness/Poorness: Resin rich areas result from the use of excessive amounts of resin during fiber infiltration. Proper rolling/squeezing of the fibers may contribute to lower void volume, higher uniformity, and removal of resin rich areas. Resin starved areas (resin poorness) are caused by an insufficient amount of resin. Consequently, no interlaminar bond will be present in those areas. Also, resin poor areas serve as a potential initiator for delamination. This material flaw is illustrated in Figure 3-27.

Figure 3-27: Variation in Matrix Thickness

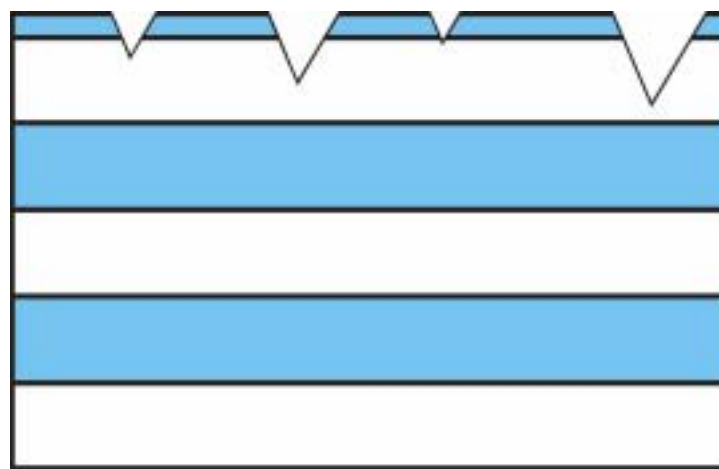
Figure 3-28: Indentations

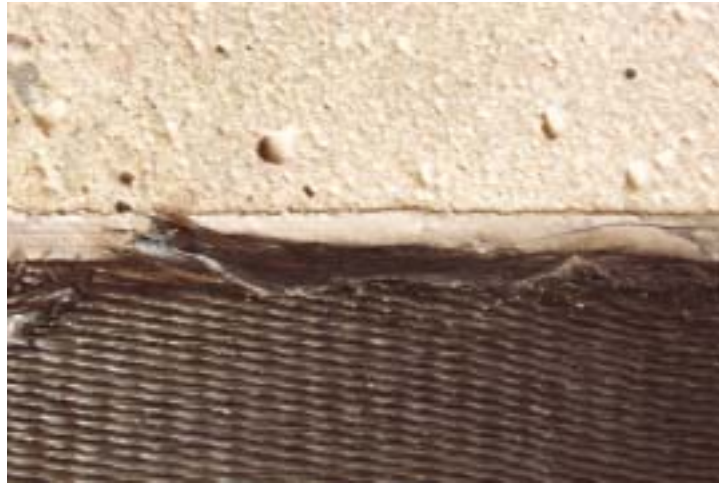
3.3.2.8 *Damaged Edges:* Damage to edges mostly occurs in regions where fibers have already been pulled out of the fabric in the dry state. Upon infiltration, the weave loosens and allows fibers to be pulled from the fabric, as shown in Figure 3-29. This will cause reduction in strength and stiffness and increase the likeliness of material separation at the concrete/composite interface.

Figure 3-29: Pullout of Loose Fiber During Infiltration

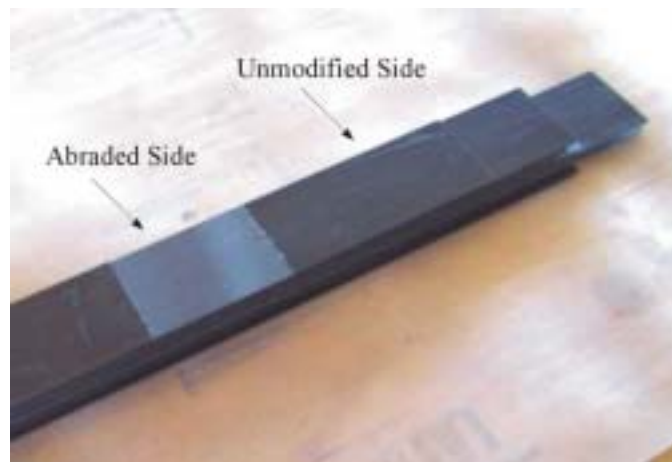
Figure 3-30: Differences in Texture of Various Pultruded Strips

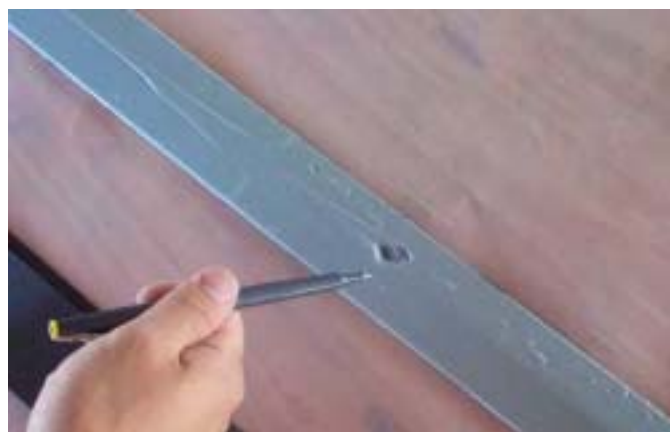
Figure 3-31: Formation of Void During Putty Application

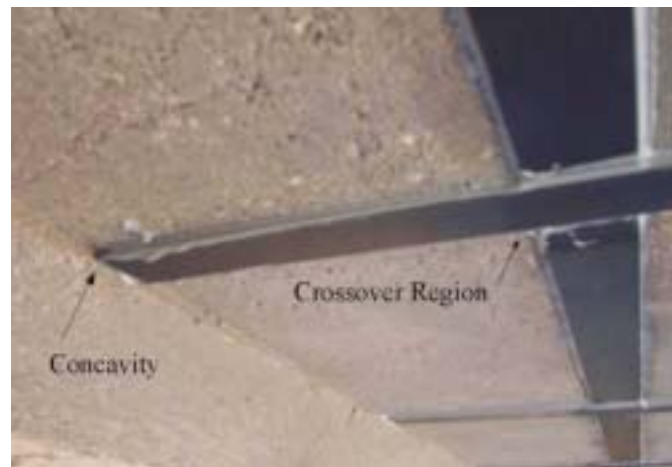
Due to a natural tendency of composite strips to retain their straight orientation, regions of overlapping are usually critical. This includes utilization of grid patterns, which often result in excessive bondline thicknesses, which leads to a higher load being borne on the adhesive causing its premature failure. If strips are excessively rolled in an attempt to reduce bondline thickness, much of the resin becomes removed from underneath the strip, resulting in resin-poor areas once the composite has returned to its natural orientation. A concave, hollow bondline as shown in Figure 3-32 can be observed. In other areas the ends sag downwards/outwards resulting in increased adhesive thickness at ends, which can result in premature peeling or cracking within the adhesive layer itself under load.

Figure 3-32: Bondline Concavity in Critical Applications

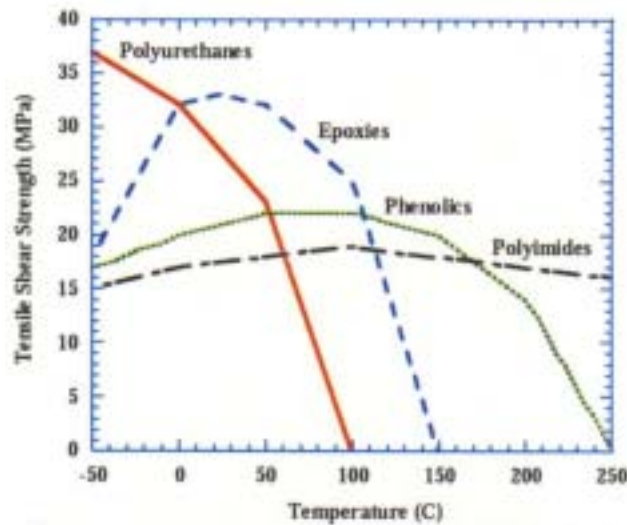
Figure 3-33: Typical Working Temperature Ranges for Structural Adhesives

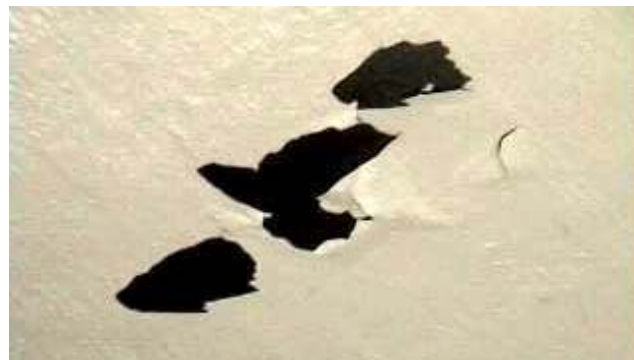
Figure 3-34: Damaged Surface Coating

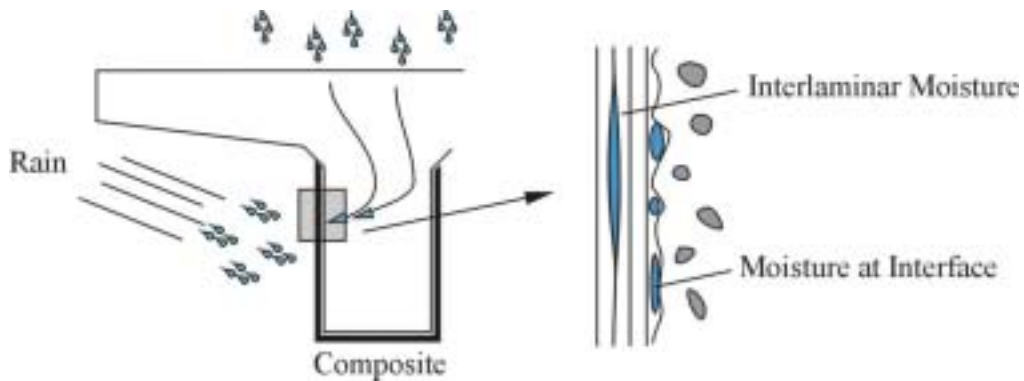
moisture and serve as a depository. Figure 3-35 shows moisture accumulation at interlaminar- and concrete/composite interface regions.

Figure 3-35: Penetration of Moisture

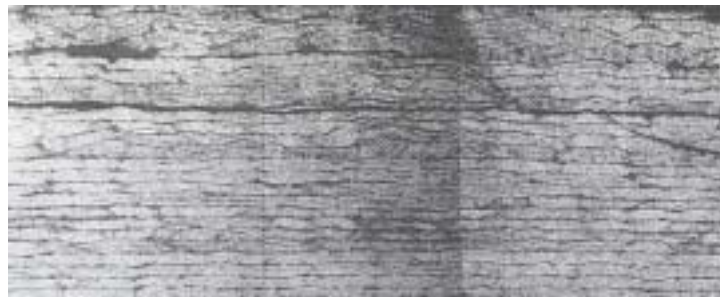
Figure 3-36: Microscopic View of Interlaminar Cracking

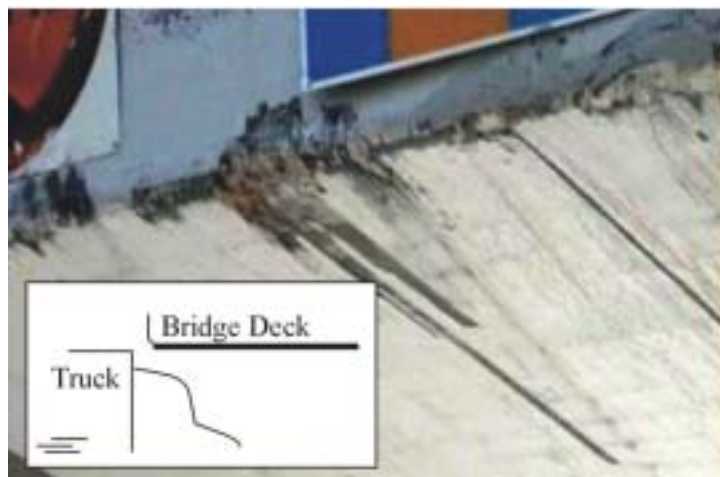
3.4.2.4 Surface Scratches: Unless they propagate deep into the fibers, scratches can be considered a benign flaw that has a negligible influence on strength and stiffness. However, if scratches are caused by impact of an object, internal damage in forms of subsurface delamination can result. Figure 3-37 displays a severe form of surface damage as found on a bridge after rehabilitation through the application of composites in Sweden.

Figure 3-37: Severe Form of Surface Scratching Caused by Trucks
