**PRECAST CONCRETE
BARRIER CRASH TESTING**

Final Report

SPR 330

December 2001

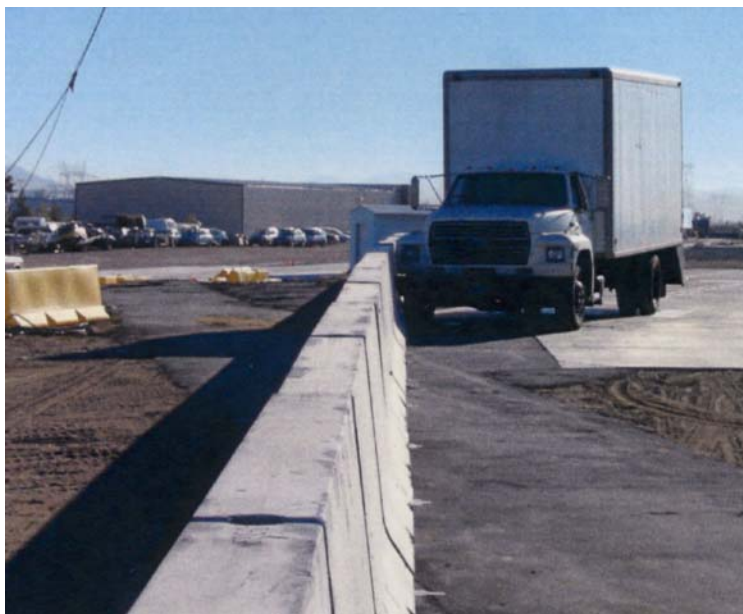
The test vehicle provided by KARCO Engineering was a 1995 Ford F 600 box truck (Figure 3.5) with a curb weight of 4,312 kg (9,506 lb), with added ballast bringing it to a gross static weight of 7,917 kg (17,454 lb). This weight was within the allowable range of ± 200 kg, as specified in NCHRP Report 350 (Ross, *et al.* 1993). The truck was connected by nylon line to a tow cable, which was embedded in a track. The truck was towed toward the barrier, and at the point of impact it had achieved a speed of 76.06 km/h (47.3 mph). This velocity was within the allowable range of ± 5 km/h, as specified in NCHRP Report 350 (Ross, *et al.* 1993).

Figure 3.5: Test vehicle prior to Crash Test 3, showing angle of impact

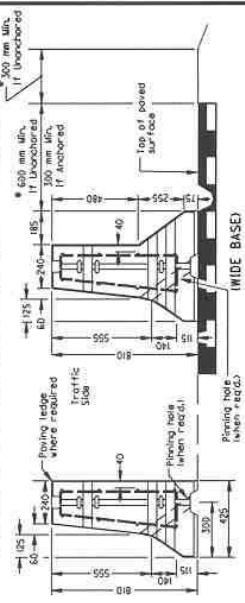
SHOULDER BARRIER

For assembly details and dimensions, see median barrier of left.
 * Barrier used as shoulder barrier and placed in areas where these dimensions cannot be obtained shall be pinned or otherwise anchored.

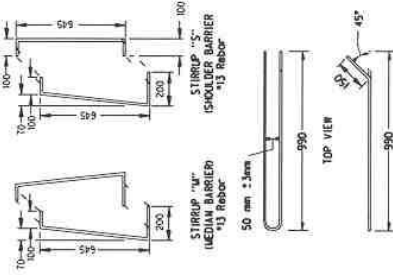
ALTERNATE PIN DETAIL

- #### Pin Notes:
1. Washer shall be forged as integral part of pin or shall be welded as shown.
 2. Pin shall be deoxidized after fabrication.
 3. Pins that conform to critical dimensions, pin length & diameter shall be used. If an approved top configuration for lifting the pin is provided.
 4. Pins shall conform to ASTM A449.

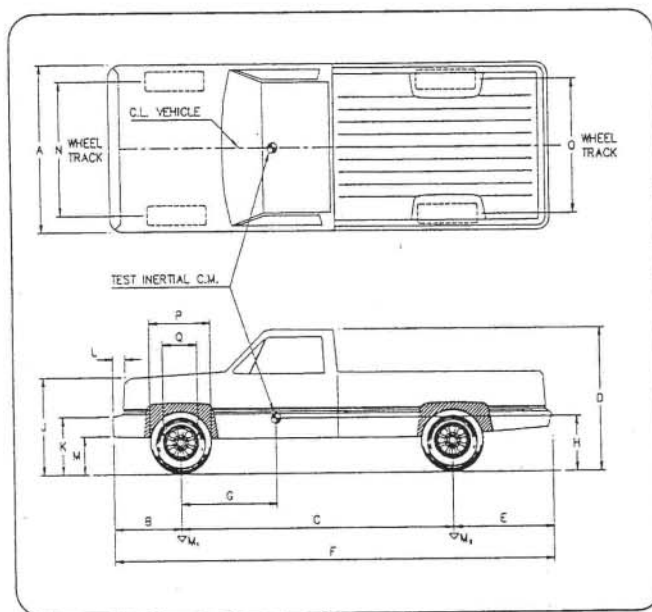
TEST VEHICLE GEOMETRY (mm)							
A	1890	E	1323	J	1032	N	1597
B	914	F	5577	K	671	O	1620
C	3344	G	n/a	L	86	P	775
D	1838	H	n/a	M	451	Q	444

MASS DISTRIBUTION							
LEFT FRONT	604 kg (1332 lb)	RIGHT FRONT	589 kg (1298 lb)	LEFT REAR	493 kg (1086 lb)	RIGHT REAR	480 kg (1058 lb)
MASS (kg)		CURB		TEST INERTIAL		GROSS STATIC	
FRONT AXLE		1193 kg (2630 lb)		1024 kg (2258 lb)		1024 kg (2258 lb)	
REAR AXLE		973 kg (2144 lb)		881 kg (1942 lb)		881 kg (1942 lb)	
TOTAL VEHICLE		2165 kg (4774 lb)		2041 kg (4500 lb)		2041 (4500 lb)

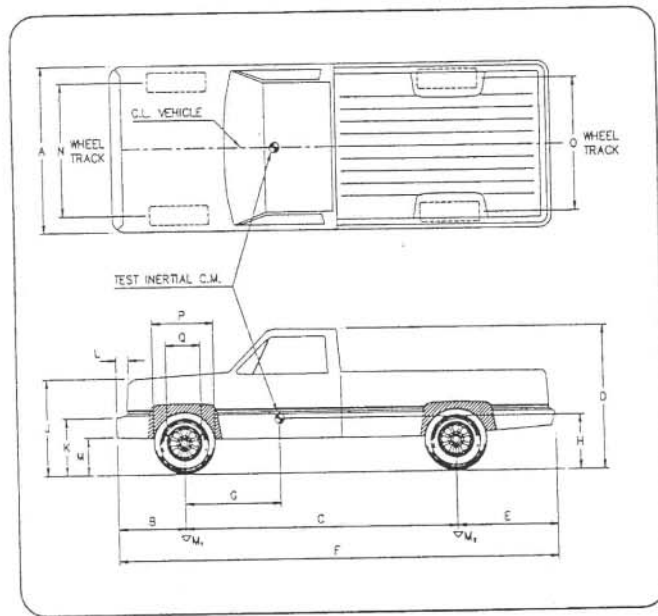
TEST VEHICLE GEOMETRY (mm)							
A	880	E	1330	J	1075	N	620
B	860	F	5518	K	650	O	620
C	3328	G	1963	L	98	P	760
D	1830	H	760	M	500	Q	445

MASS DISTRIBUTION							
LEFT FRONT	539 kg (1188 lb)	RIGHT FRONT	584 kg (1288 lb)	LEFT REAR	480 kg (1058 lb)	RIGHT REAR	421 kg (928 lb)
MASS (kg)		CURB		TEST INERTIAL		GROSS STATIC	
FRONT AXLE		1193 kg (2630 lb)		1123 kg (2476 lb)		1123 kg (2476 lb)	
REAR AXLE		973 kg (2144 lb)		901 kg (1986 lb)		901 kg (1986 lb)	
TOTAL VEHICLE		2165 kg (4774 lb)		2024 (4462 lb)		2024 (4462 lb)

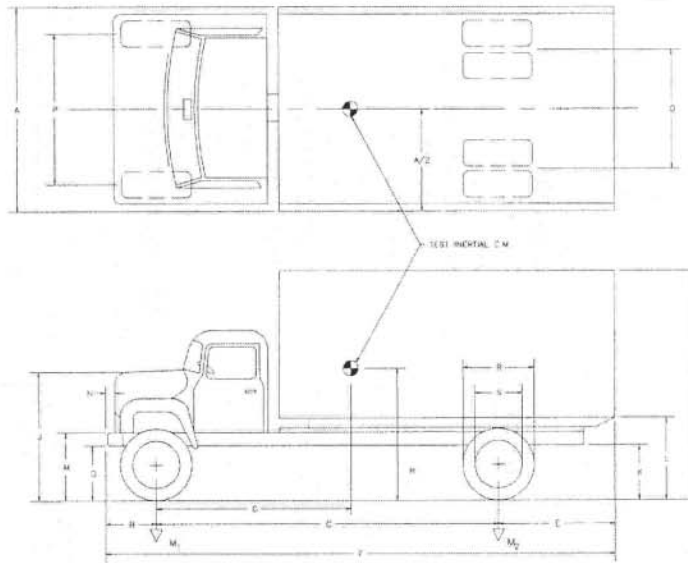
TEST VEHICLE GEOMETRY (mm)							
A	2650	F	8750	L	940	Q	2050
B	860	G	3068	M	730	R	970
C	5290	H	N/A	N	50	S	580
D	3530	J	1530	O	420	-	-
E	2600	K	620	P	2050	-	-

MASS DISTRIBUTION							
LEFT FRONT	971 kg (2140 lb)	RIGHT FRONT	963 kg (2122 lb)	LEFT REAR	1228 kg (2708 lb)	RIGHT REAR	1150 kg (2536 lb)
MASS (kg)		CURB		TEST INERTIAL		GROSS STATIC	
FRONT AXLE		1933 kg (4262 lb)		3359 kg (7406 lb)		3359 kg (7406 lb)	
REAR AXLE		2379 kg (5244 lb)		4558 kg (10048 lb)		4558 kg (10048 lb)	
TOTAL VEHICLE		4312 kg (9506 lb)		7917 kg (17454 lb)		7917 kg (17454 lb)
