THE EVALUATION OF PAVEMENT PATCHING
MATERIALS IN OREGON
Final Report

Oregon Department of Transportation
Highway Division

November 1980

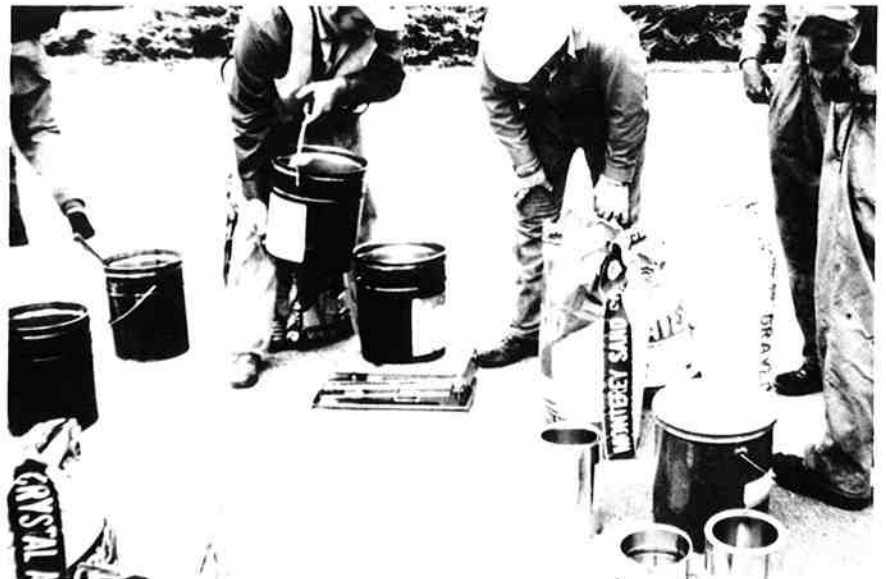
Weighing patching
materials.

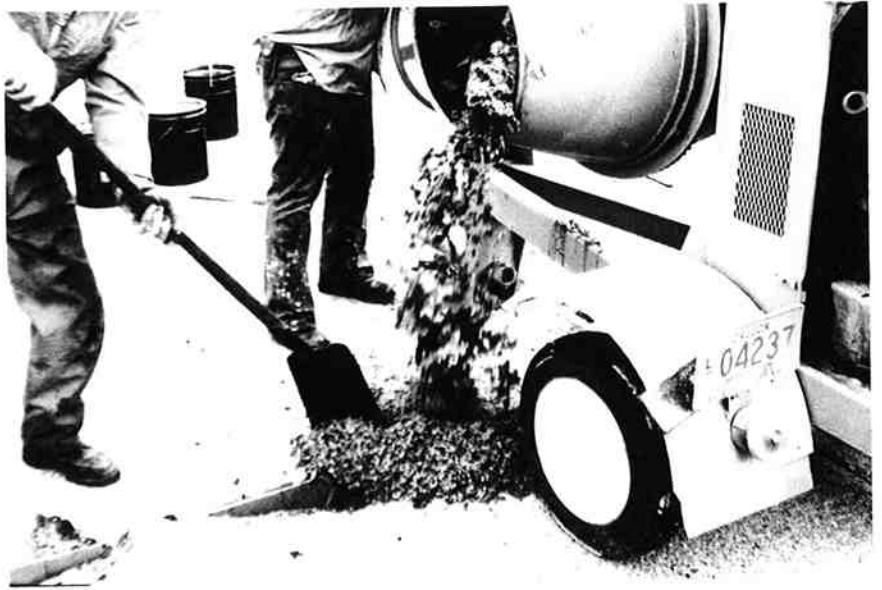
Depositing patching
material in hole.

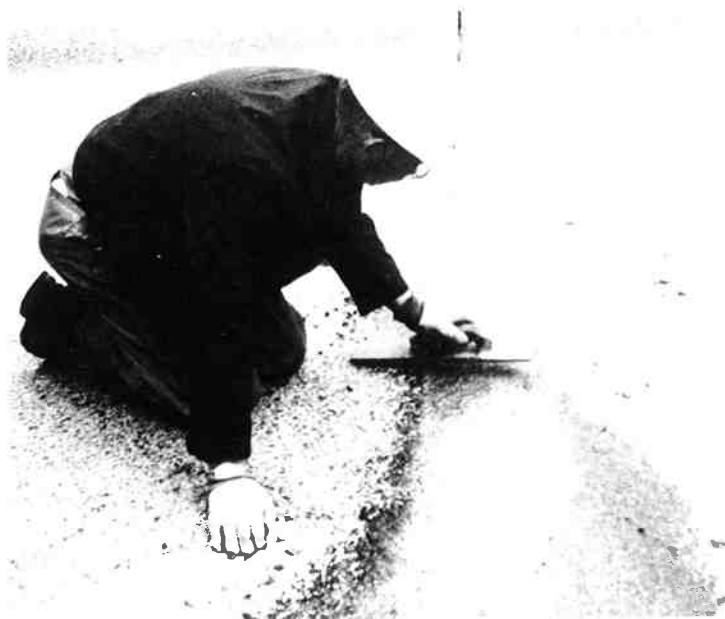
Finishing patch
with trowel.

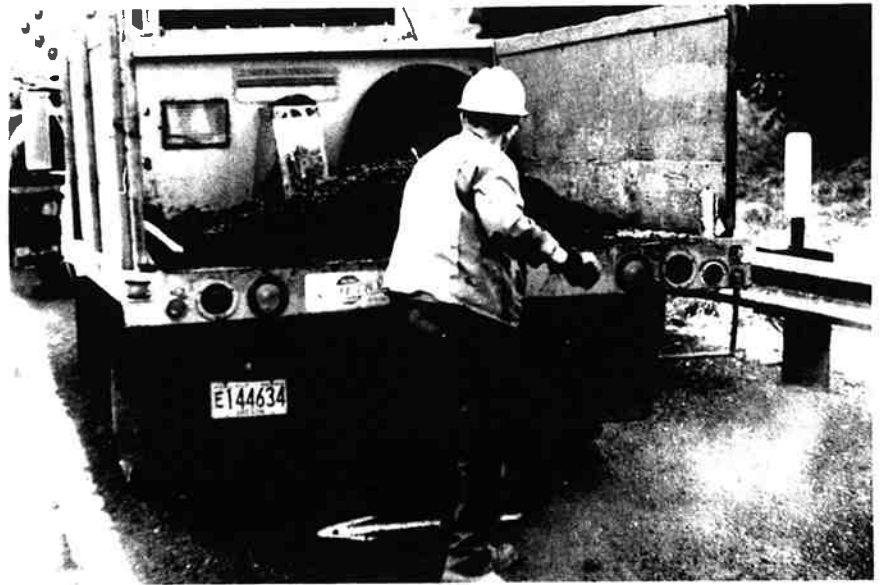
Bituminous concrete
patching material on
truck at site.

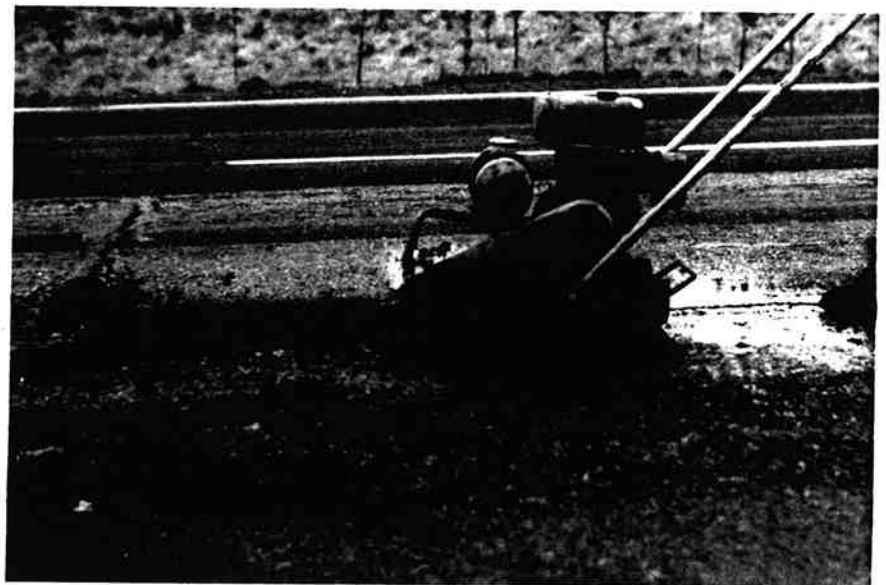
Consolidation of
patching material.
