Exodermic Bridge Deck Performance Evaluation

FINAL REPORT

Exodermic Bridge Deck Performance Evaluation
Research Study # FEP-96-02

Report # FEP-06-10

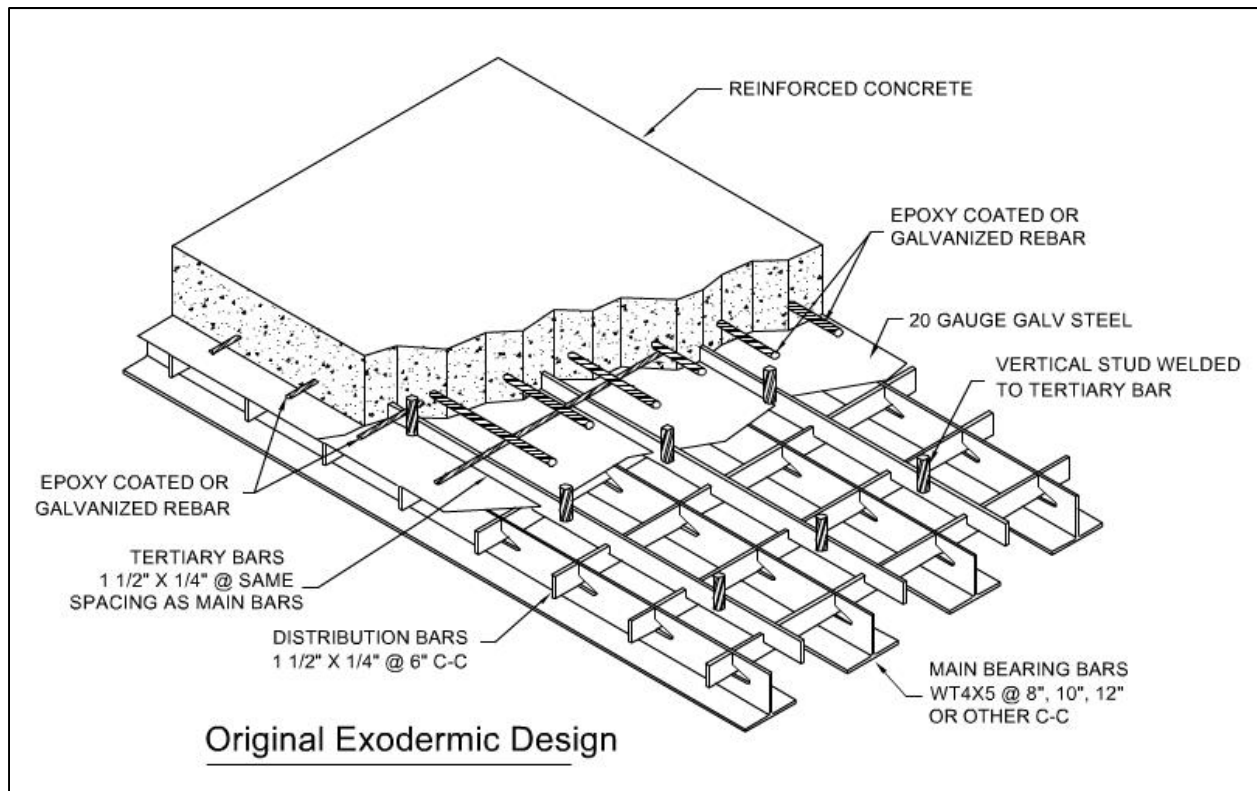
Figure 1. Exodermic deck system used for the Main Street bridge. [3]

In the original exodermic system, which was used for the Main Street bridge project in this study, the steel grid system consisted of main bearing bars, distribution bars and tertiary bars. Short studs were welded to the tertiary bars to provide shear connections and make the steel grid and concrete deck composite (Figure 1). In newer versions of the exodermic design, the tertiary bars and shear studs have been eliminated. To provide shear load transfer and composite action, the main bearing bar is one inch

taller, and 3/4-in diameter holes are punched at the top of the bearing bar. This portion of the main bearing bar is embedded in the concrete deck (Figure 2). [2, 3]

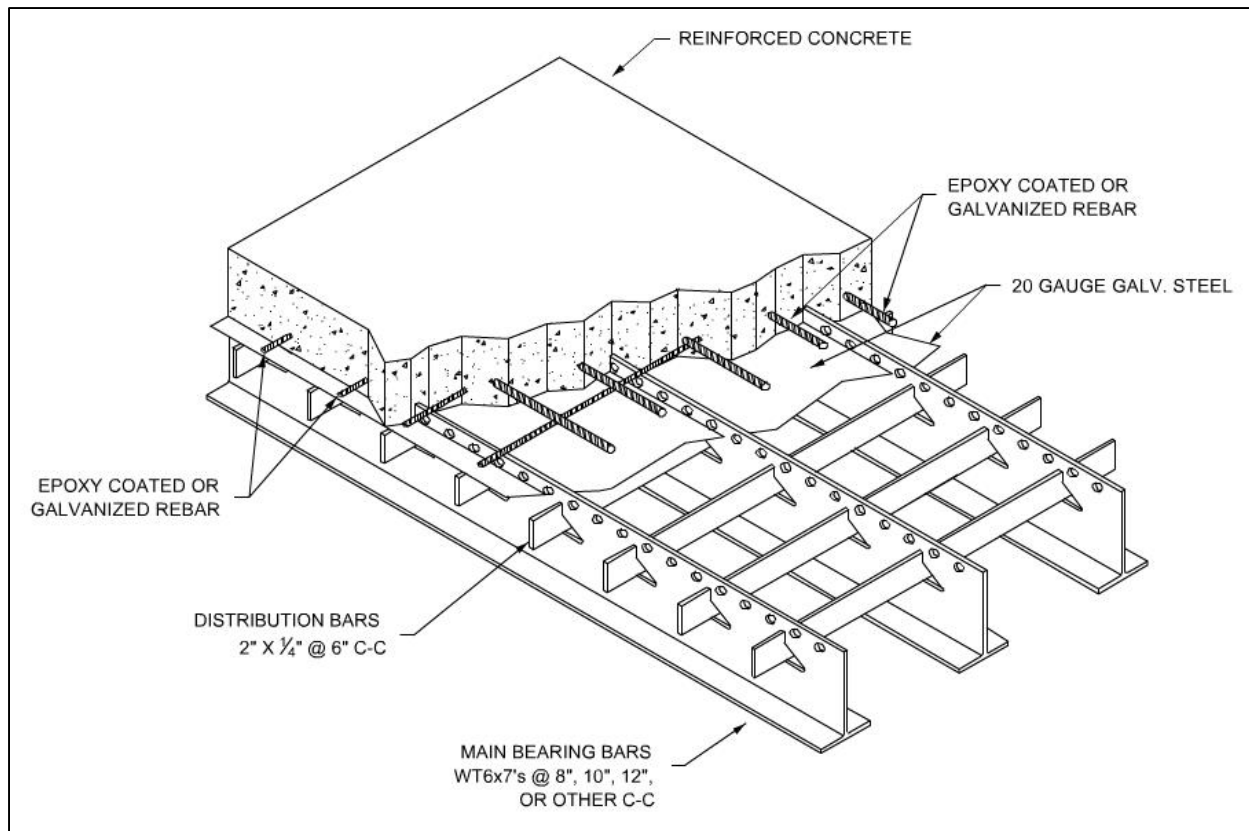
Figure 2. Updated exodermic deck system used in current designs. [2]

A problem noted during construction was that some of the welded shear studs broke off of tertiary bars in the exodermic grid and had to be reattached. Since the time that this study's bridge was constructed, a revised design of the exodermic system has eliminated the vertical shear studs. This modification should lessen similar problems during construction of other bridges.

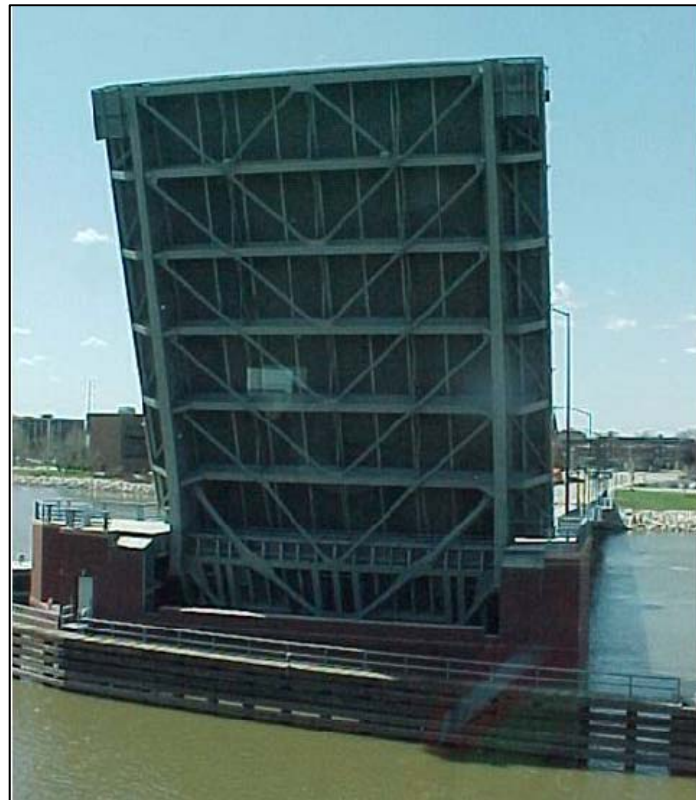
Figure 4. Underside of west leaf of Main Street bridge in open position.

Final construction of the bridge components took place during the summer of 1998, during which time the drawbridge leaves opened and closed for boat traffic on the river. The bridge was opened to traffic in October 1998. The underside of the completed bridge deck is shown in the open position in Figure 4.

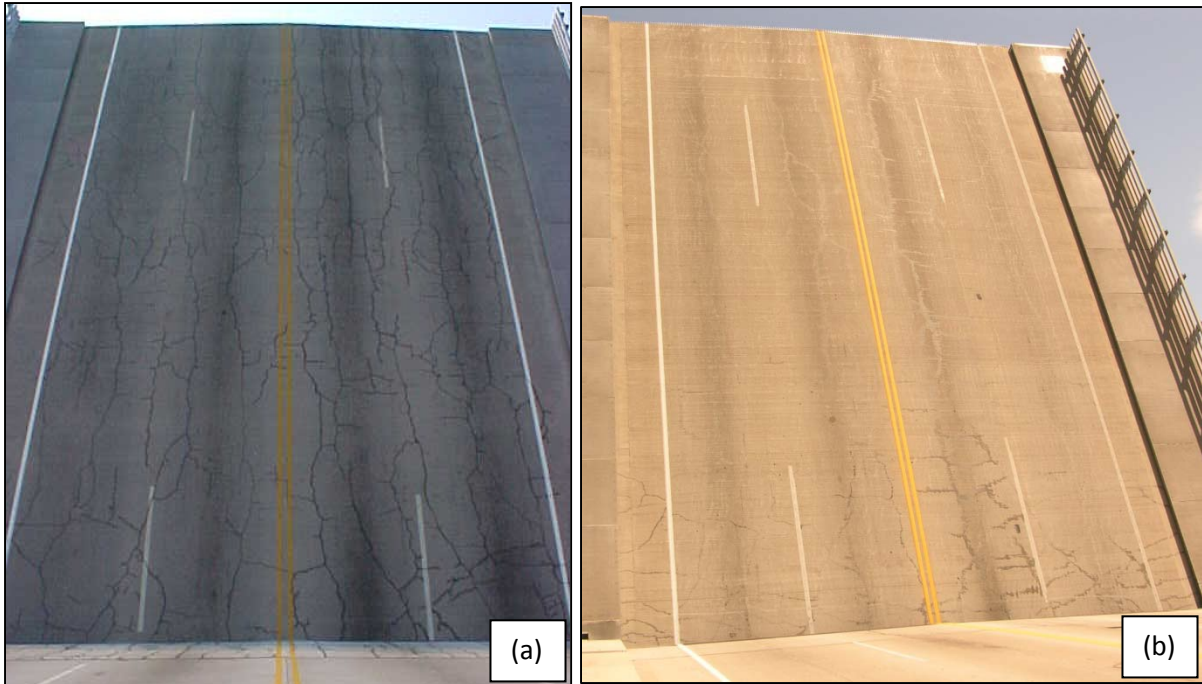
During and immediately following the seven-day wet cure of the concrete deck, random spaced, multidirectional hairline cracks were observed along the entire deck. The number of cracks increased over the next several months and then stabilized. Future site reviews did not note any additional cracking. It is believed that the cracking was due to shrinkage of the concrete and resistance from the steel reinforcement and vertical shear studs. The early cracking could also have been exacerbated by flexure of the concrete during early raising and lowering of the bascule spans. Cracks have been sealed with an epoxy-based material. This material is darker than the concrete deck itself, which reduces the visual appeal of the deck and has resulted in negative feedback from the public. Photographs of the cracking are provided in Figures 5 and 6.

A crack survey was conducted during the September 2003 site review, when the bridge had been in service for five years. The total linear footage of cracking was measured at three random sampling locations. The survey results indicated that an average of 52 linear ft of cracking was present per 100 ft² of deck area. The cracks were not deteriorated, and no secondary distress such as spalling, delamination or dislodgement was observed in the concrete deck during this site review.

A final site review was conducted at the Main Street bridge in June 2010, after 12 years in service. The extent of the deck cracking was unchanged from 2003. The cracks were primarily cosmetic and did not appear to be affecting the structural integrity of the bridge deck. Sealant was still present in the cracks, although sealant has not been re-applied since the 2003 site review. Minor cracking was noted in the approach decks (not exodermic in design), but not to the same extent as in the exodermic deck.

Figure 5. Cracking on exodermic bridge decks: (a) east leaf [September 2003] and (b) west leaf [June 2010].

Care must be taken during the design of the concrete mixture and steel reinforcement layout in the exodermic panels. This will reduce the occurrence of shrinkage cracking, which was a problem on the Main Street bridge. Structural cracking can also be avoided with proper design of the exodermic panels. If cracking does occur, it is critical to routinely seal the cracks to prevent moisture and salts from leaching into the deck system.

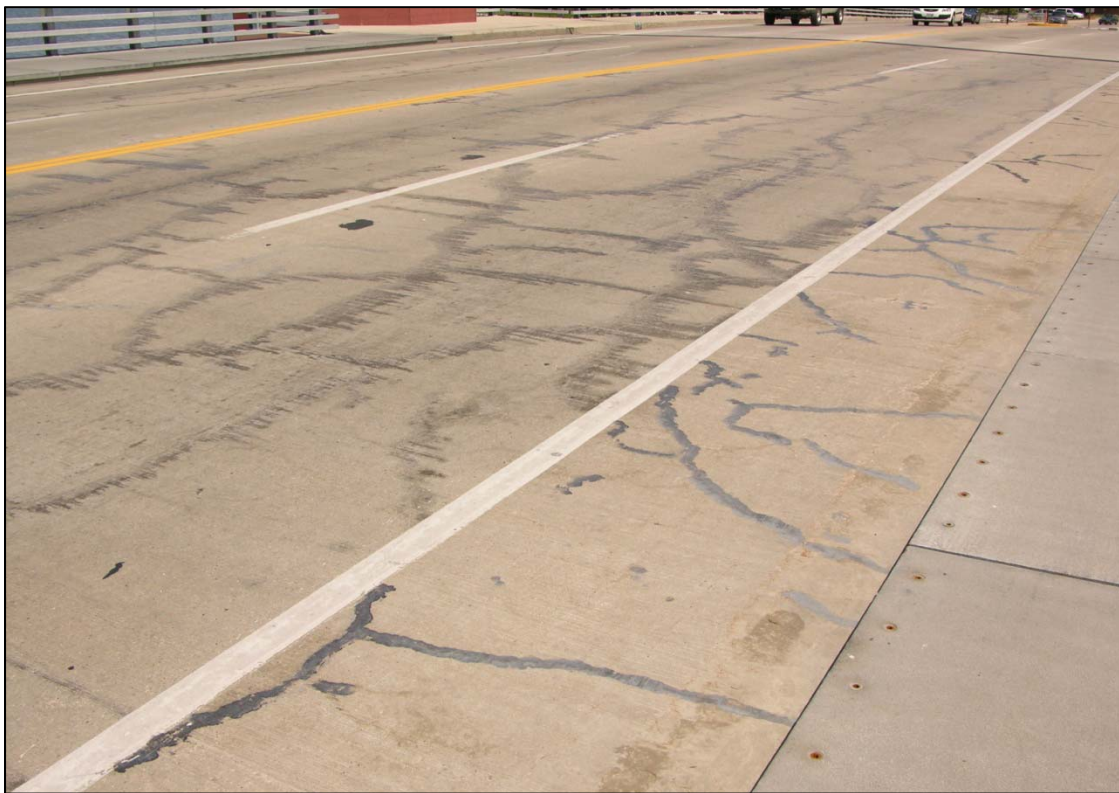
Figure 6. Cracking of exodermic bridge deck, east leaf (June 2010).

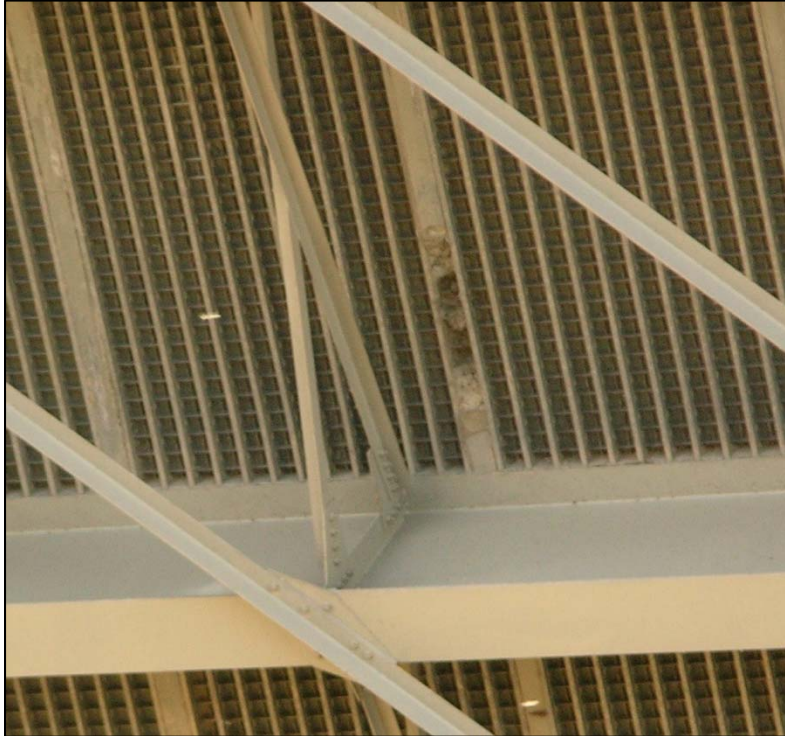
Early site inspections revealed a small piece of concrete missing on the underside of the west leaf, near the tip of the span. The void is located in the channel between steel grid panels, where concrete was cast during construction of the deck (Figure 7). It is believed that the concrete dislodged and fell away during early lifting and lowering of the bascule spans. The void is only partial depth and does not appear to be affecting the structural integrity of the bridge. The June 2010 site review confirmed that the void had not become larger over time.

Figure 7. Void in concrete on underside of west leaf exodermic bridge deck (June 2010).

A void in the concrete channel between exodermic deck panels was noted during the first year after construction. This occurrence is not believed to be related to performance of the exodermic deck and does not appear to affect the structural integrity of the system.

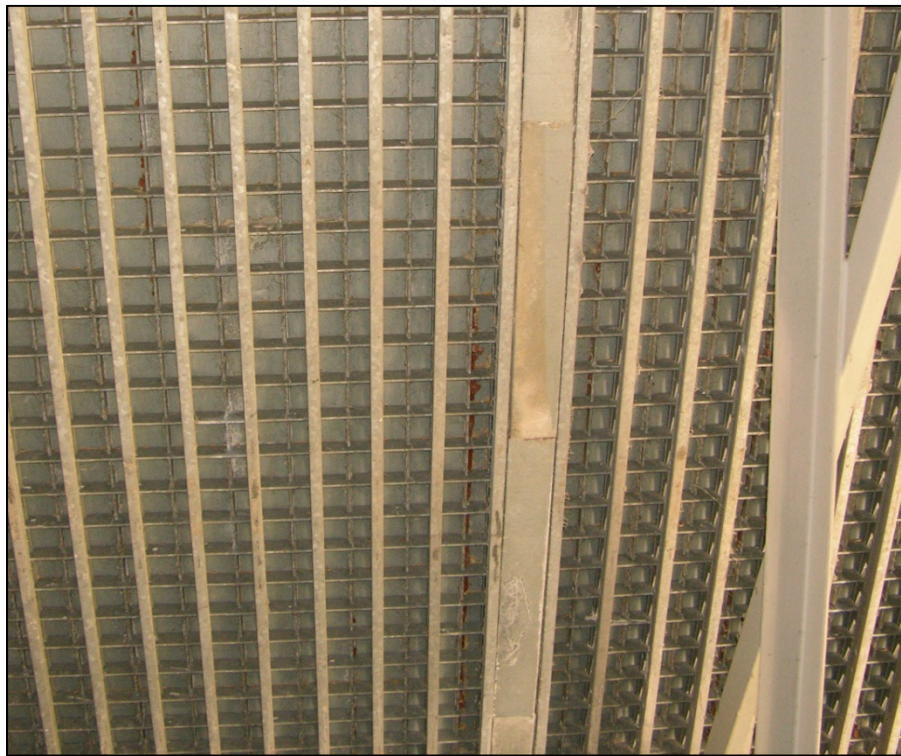
During the September 2003 site inspection, leaching was noted on the underside of the bridge deck. White deposits were present on the underside of the steel grid panel. This occurrence was consistent with water leaking through the deck and subsequent material precipitation. A sample of the white deposit was collected and analyzed for its chemical composition. The analysis results showed that the deposits were composed primarily of zinc oxide (61 percent by mass). Small amounts of calcium oxide and sodium chloride were also recorded (0.73 and 0.56 percent by mass, respectively). The zinc oxide was likely a residue resulting from sacrificial corrosion of the zinc coating on the upper side of the galvanized steel form pan, which is in direct contact with the concrete deck. Chlorides from deicing salts

applied to the bridge deck likely leached through the cracks described in Section 5.1 and came in contact with the galvanized steel.

The leaching process could lead to accelerated corrosion of the steel grid, possibly resulting in increased maintenance costs or a reduced service life of the bridge deck. It is therefore critical that the cracks in the bridge deck remain adequately sealed to keep water out. Some areas of white leached material and small amounts of corrosion were noted on the underside of the exodermic deck during the June 2010 site inspection (Figure 8). It is therefore likely that salts continue to leak through the cracks in the concrete deck. The corrosion indicates that the galvanized layer of the exodermic grid has been depleted in some areas. This condition was not widespread but will worsen over time.

Figure 8. Corrosion and leached material on underside of west leaf exodermic bridge deck (June 2010).

Leaching of salt solution, presumably through the cracks described above, was noted on the underside of the exodermic deck. A sample of the white leached substance was collected and analyzed; its composition was primarily zinc oxide, indicating that sacrificial corrosion of the galvanized steel pan had taken place. The 2010 site survey again revealed this white material along with isolated areas of actual steel corrosion on the underside of the exodermic deck.
