**DYNAMIC REVETMENTS  
FOR COASTAL EROSION  
IN OREGON**

**Final Report**

**SPR 620**

**August 2005**

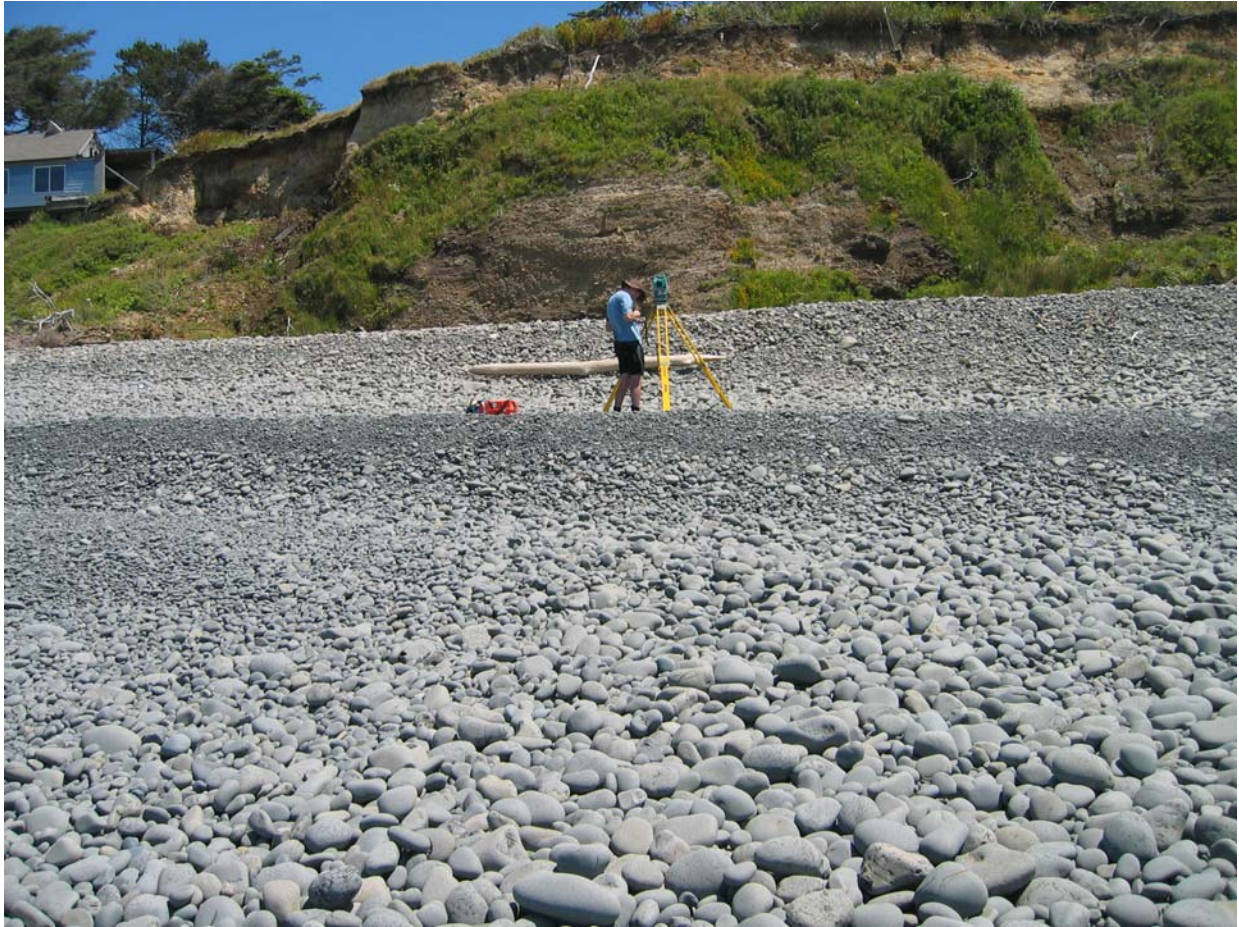
An example of cross-shore sorting of sediments at Cove Beach, Oregon

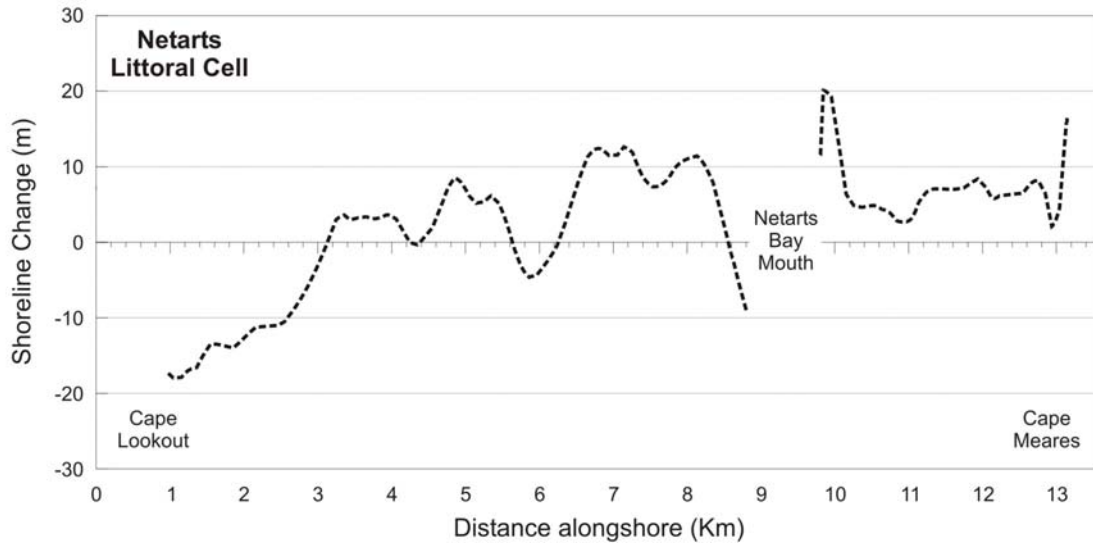
Figure 2.4: Example of the “hotspot” erosion effect identified in the Netarts littoral cell in Tillamook County (after Allan, et al. 2003)

Analyses by Revell, *et al.* (2002) used the fall-1997 versus spring-1998 LIDAR data to measure the vertical and volumetric changes in the beach that occurred during the El Niño winter along the length of the Netarts Littoral Cell in Tillamook County, documenting a clear pattern of northward sand transport in response to the southwest approach of El Niño storm waves. Allan, *et al.* (2003) undertook additional analyses of the LIDAR data in the Netarts cell, quantifying the "hotspot" erosion effect along the south end of the cell (Figure 2.4). Apparent in the figure is the concentrated zone of erosion along the southern 3 kilometers (1.9 miles) of shoreline, where negative values indicate erosion while positive values indicate accretion. The "hotspot" erosion effect is greatest along the southern 1 – 2 kilometers (0.6 – 1.2 miles) of the coast where it reaches about -20 m (-65 ft) and progressively decreases northward along the spit. Figure 2.4 also demonstrates the northward transport of sediment along the cell, as conceptualized in Figure 2.3, with the shoreline having prograded seaward by some 10 m (33 ft) along the northern extent of the spit, and by several meters north of the mouth of Netarts Bay.

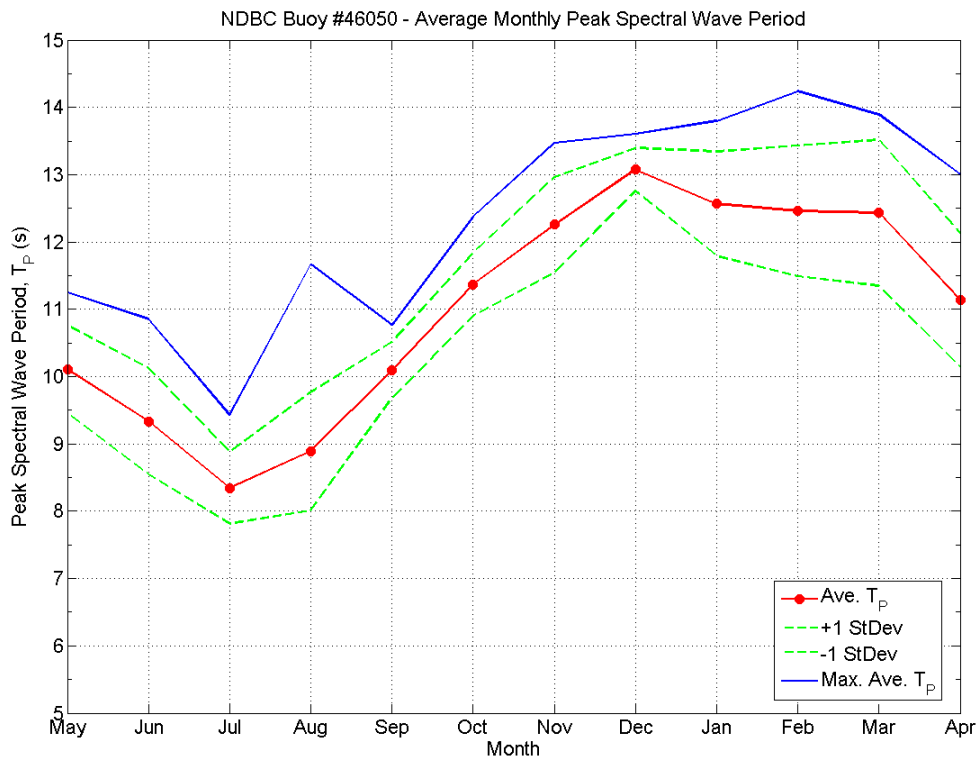
Figure 2.7: Monthly averages of the peak spectral wave period (1987 – 2004). The graph shows the average peak spectral wave period, the monthly average maximum peak spectral wave period, and the range (+/- 1 standard deviation) for each month.

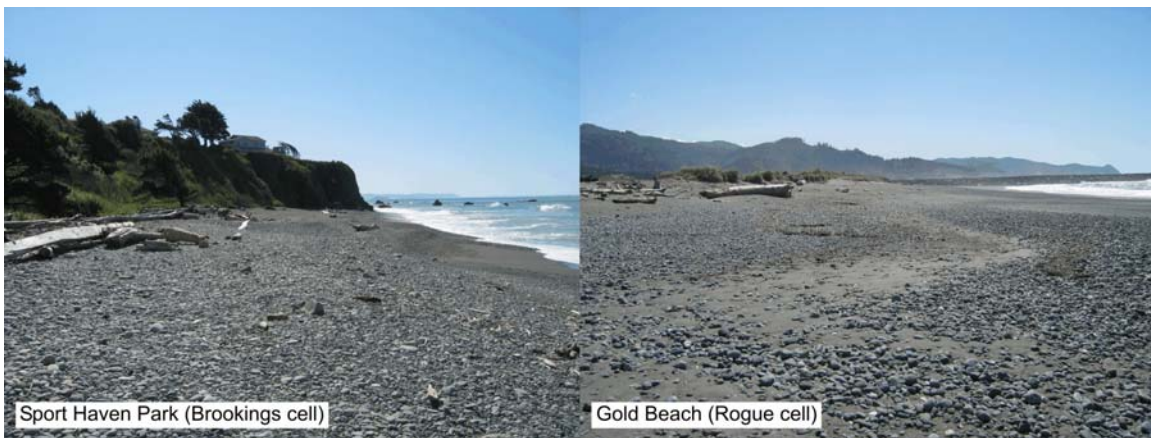
Figure 3.1: Example of a mixed sand and gravel beach that includes a backshore consisting of a gravels, which transitions to a wide, gently sloping dissipative sand beach that is primarily exposed at low tide

component of mixed sand and gravel beaches (**b** and **c**) (Figure 3.1). However, of greatest interest for the purposes of this study are the composite beaches that exhibit a gravel berm or beach ridge composed of pure gravel fronted by a sand beach (**d**) (Figure 3.2). Along the U.S. West Coast, including Oregon, these latter beaches are characterized by a steep sloping [average slopes  $\sim 9.8^\circ$  (1-on-5.8) but may reach as much as  $23^\circ$  (1-on-2.3)] gravel berm or ridge that is fronted by a wide gently sloping sand beach [average slope  $\sim 2.3^\circ$  (1-on-25)], which provides the first line of defense to the backshore by dissipating the incident incoming wave energy. On these beaches, the sandy beachface is exposed at all tidal stages during the summer, only becoming submerged in the winter when storms occur and much of that sand has moved to offshore bars, allowing the waves to reach the gravel ridge at mid- to high-tides (*Allan and Komar 2002; Everts, et al. 2002; Allan and Komar 2004*).

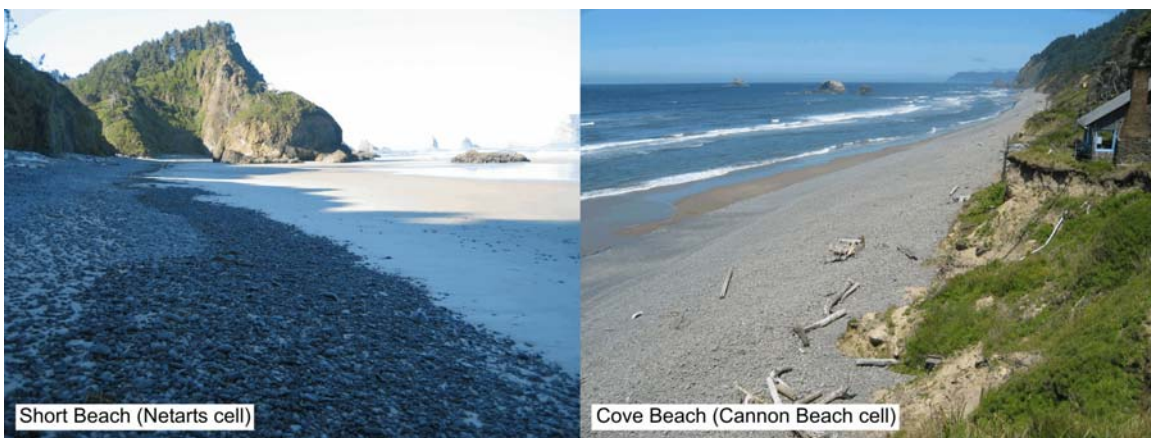
Figure 3.2: Composite beaches on the northern Oregon coast in Tillamook County. The beach includes a backshore consisting of a steep faced gravel berm, which transitions to a wide, gently sloping dissipative sand beach that is exposed at all tidal levels (e.g., Short beach) or at low tide (e.g., Cove Beach).

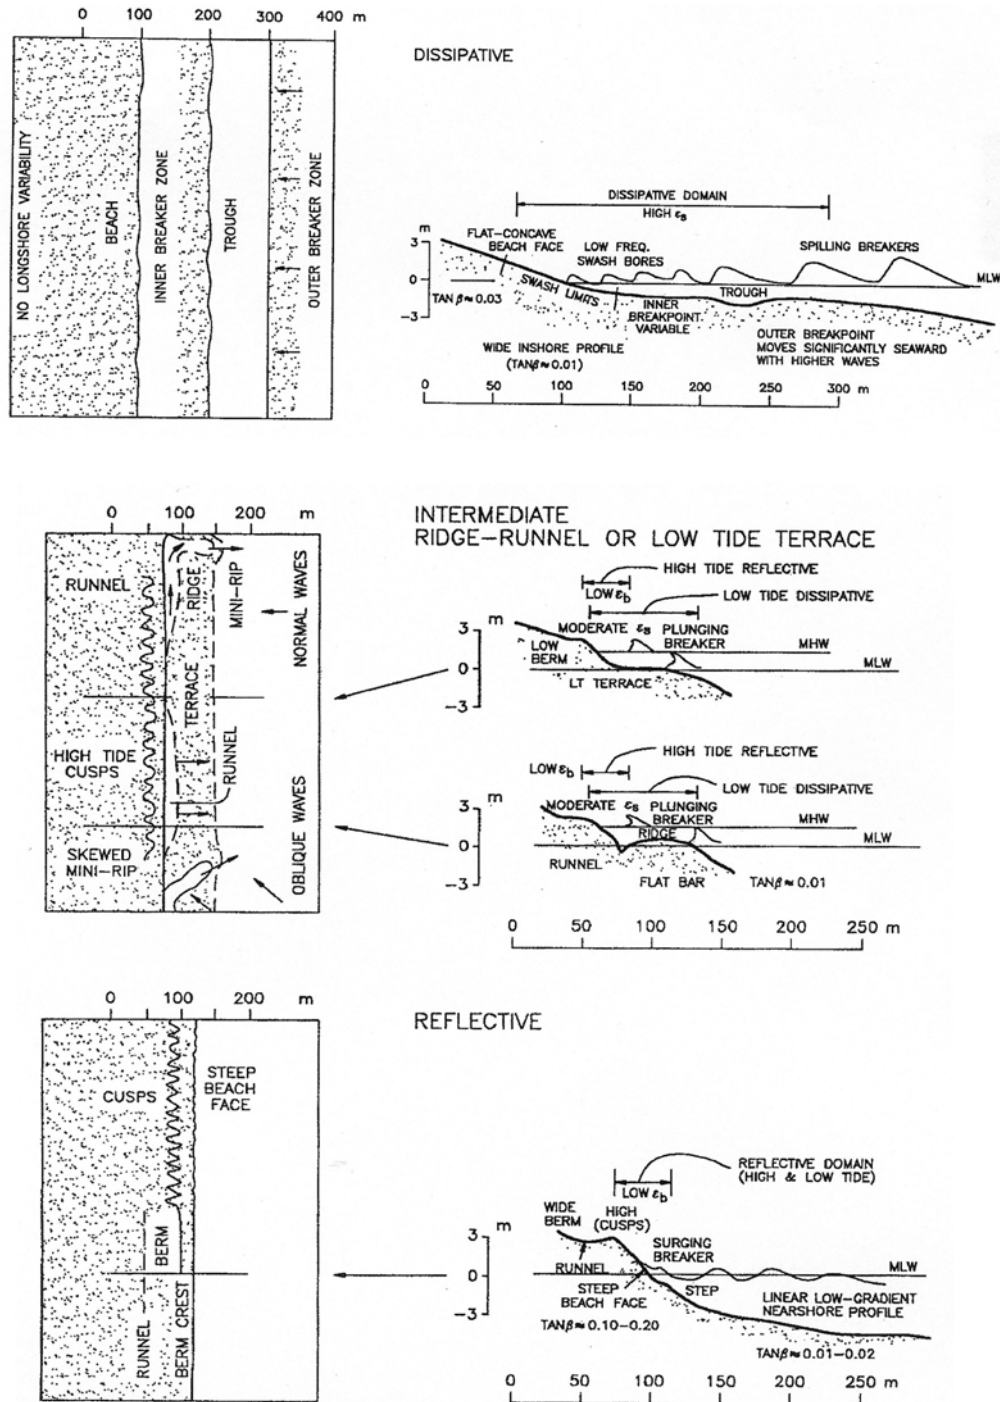
Figure 3.3: The morphodynamics classification of sand beaches (after Wright and Short 1983)

the morphodynamics classification developed by Wright and Short (1983); a modified version of their morphodynamic model is shown in Figure 3.3. The "morpho" portion of the classification refers to the geometry of the beach, both in its two-dimensional profile and in the three-dimensional topography of bars and troughs, while the "dynamics" part refers to how that morphology changes in response to the varying wave conditions.

It is seen in Figure 3.3 that at one end of the spectrum are dissipative beaches, at the other end reflective beaches, with four stages of intermediate categories, although only one of these is shown in Figure 3.3. The average beach slope is seen to progressively steepen from the dissipative to the reflective condition, with the profiles of the intermediate categories tending to be more irregular due to the presence of offshore bars and troughs, or rip-current embayments.

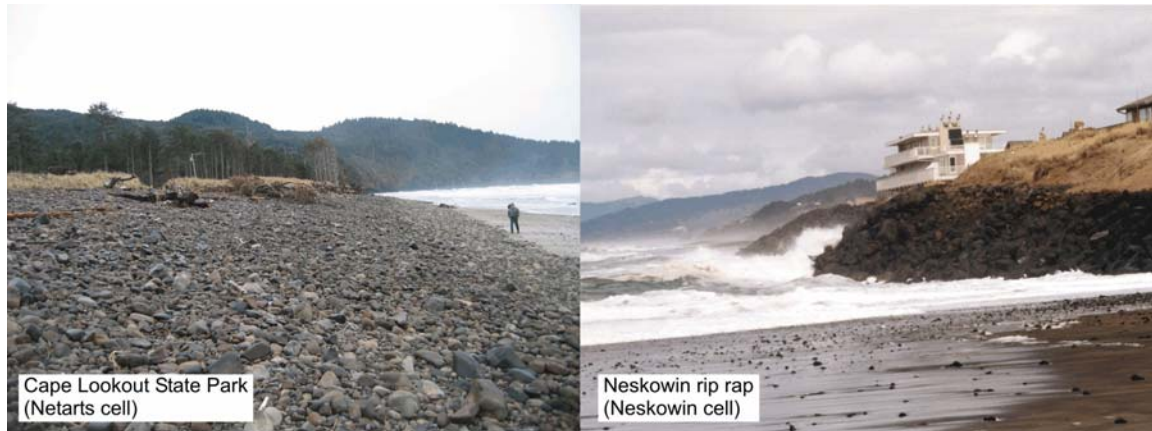
Figure 3.4: Comparison of a dynamic revetment constructed at Cape Lookout State Park (left) versus a conventional riprap revetment constructed at Neskowin (right)

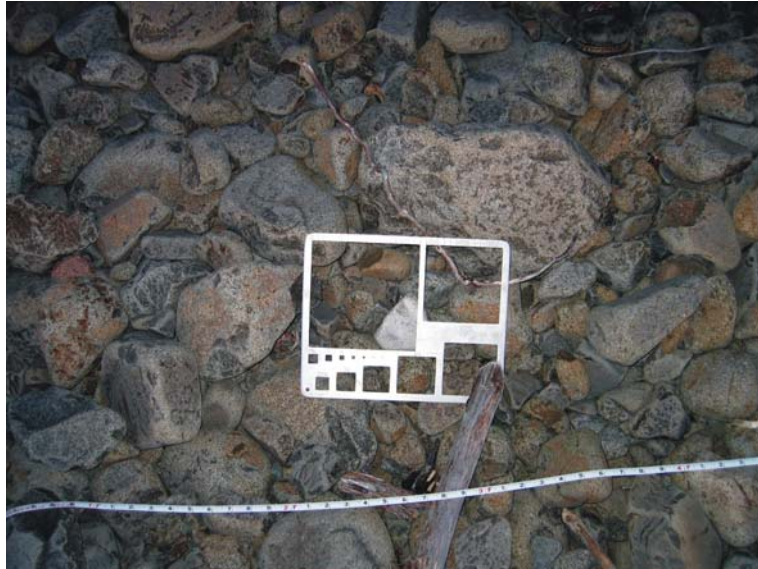
Figure 4.2: Example of a “gravelometer” being used at Neahkahnie to determine grain size statistics on the beach

approach is the use of a “gravelometer” to measure the size of the particles (Figure 4.2). The gravelometer is a 5 mm thick aluminum template with square holes cut out at  $0.5\phi$  intervals and is used to measure the B (intermediate)-axis of the particles. The template is capable of measuring sediments ranging in size from  $-1\phi$  to  $-7.5\phi$  (2 to 180 mm).

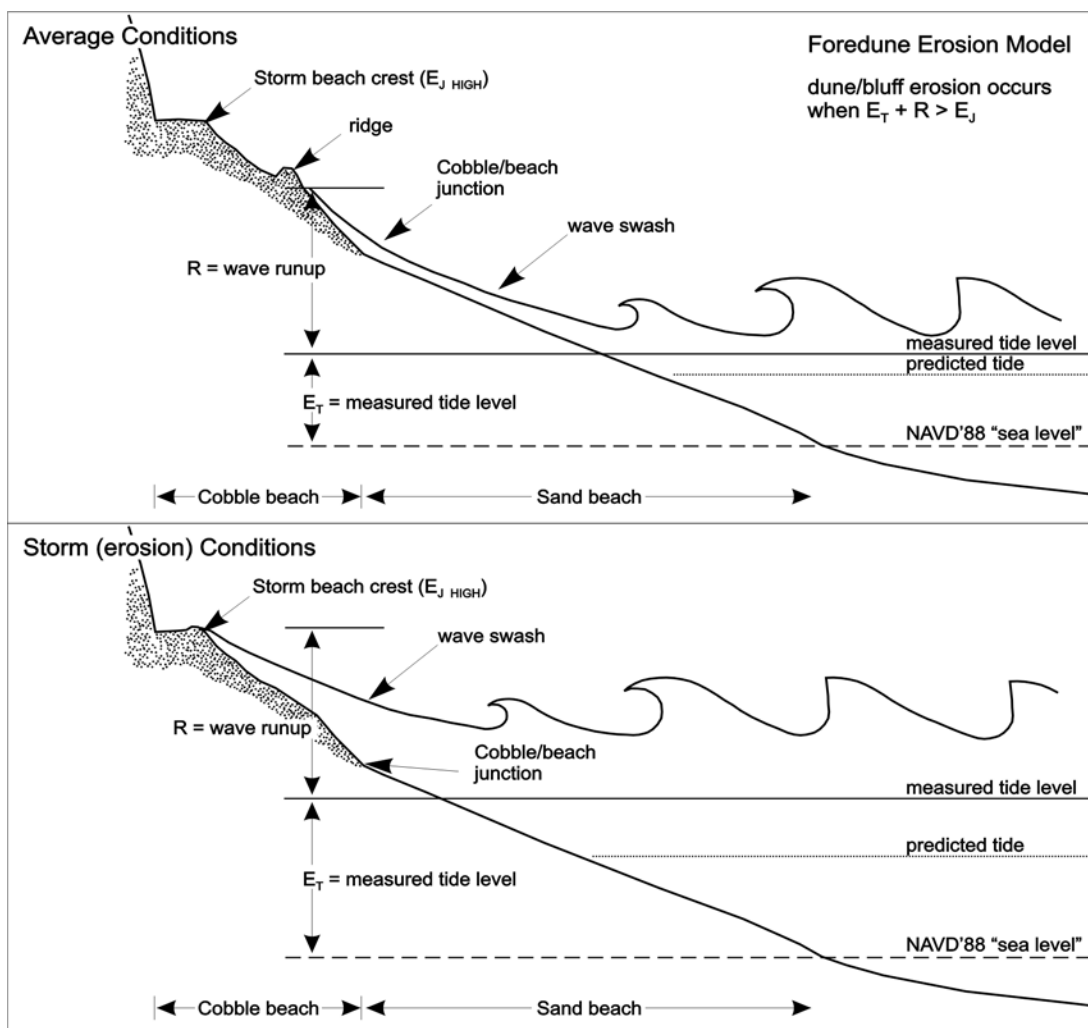
Figure 4.3: (Upper) A typical composite gravel/sand beach exposed to wave runup ( $R$ ) and tidal ( $E_T$ ) conditions, which may result in erosion of the cobble foredune toe ( $E_J$ ) and/or berm development. (Lower) During large storms and elevated water levels, wave runup is able to reach much higher elevations on the backshore ( $> E_{J HIGH}$ ), eroding a bluff or dune that may back the beach. Furthermore, waves may also occasionally overtop the berm crest, depositing material on its crest, raising the elevation of the crest and leeward face (after Komar, et al. 1999).

total water levels produced during a storm ( $R_{HIGH}$  and  $R_{LOW}$ ) relative to the dune crest elevation ( $D_{HIGH}$ ) and the beach-dune junction (termed  $D_{LOW}$  by Sallenger). Based on the ratios of these variables, Sallenger (2000) identified four regimes, which were respectively termed swash, collision, overwash and inundation. During storms, the beaches of Oregon typically fall under the collision regime, which reflects conditions when the wave runup collides directly with the toe of the dune or bluff (i.e., the  $E_{J HIGH}$ ) forcing dune erosion. However, at some locations including on gravel beaches, these same conditions may result in  $R_{HIGH}$  exceeding  $D_{HIGH}$  (i.e., the berm crest) producing overwash (lower diagram in Figure 4.3). Along the U.S. East Coast, overwash of the barrier islands has often resulted in the landward migration of the barrier. While such effects could occur at a few sites on the Oregon coast, in the majority of cases it won't, since most of Oregon's gravel beaches are backed by either a dune or sea cliff, limiting its landward movement.

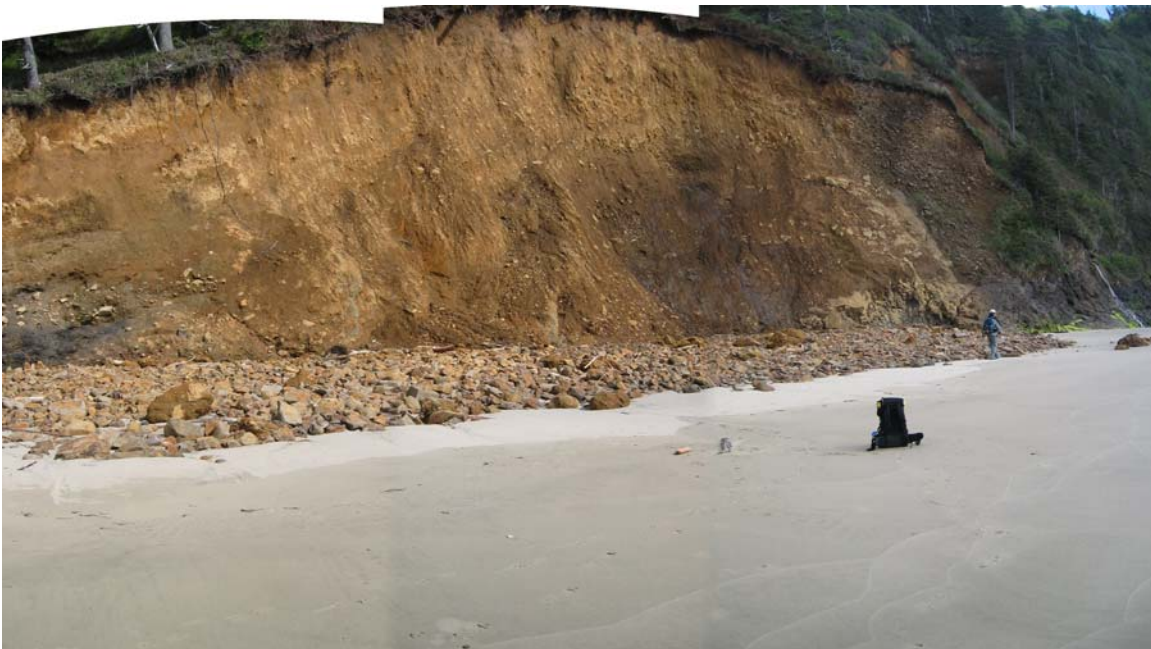
Figure 5.1: A landslide that occurred early in 2003 on the north side of Cape Lookout and adjacent to Cape Lookout State Park. Such events periodically introduce significant quantities of coarse material to the coastal zone where it is then redistributed along the shore to form cobble berms.

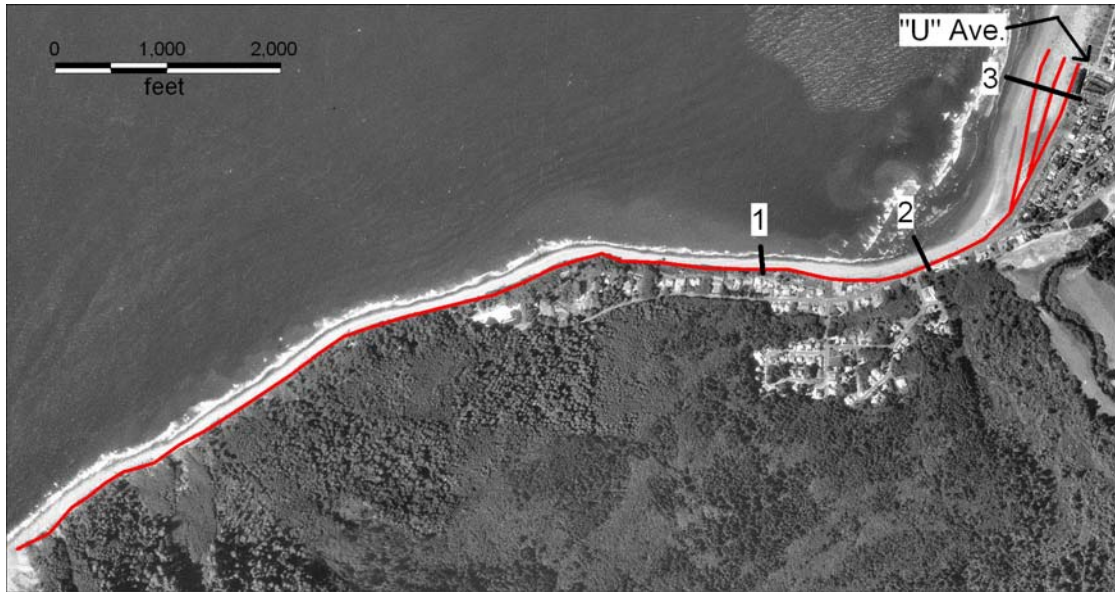
Figure 5.3: The Seaside gravel beach showing the locations of beach profile sites and grain size sampling

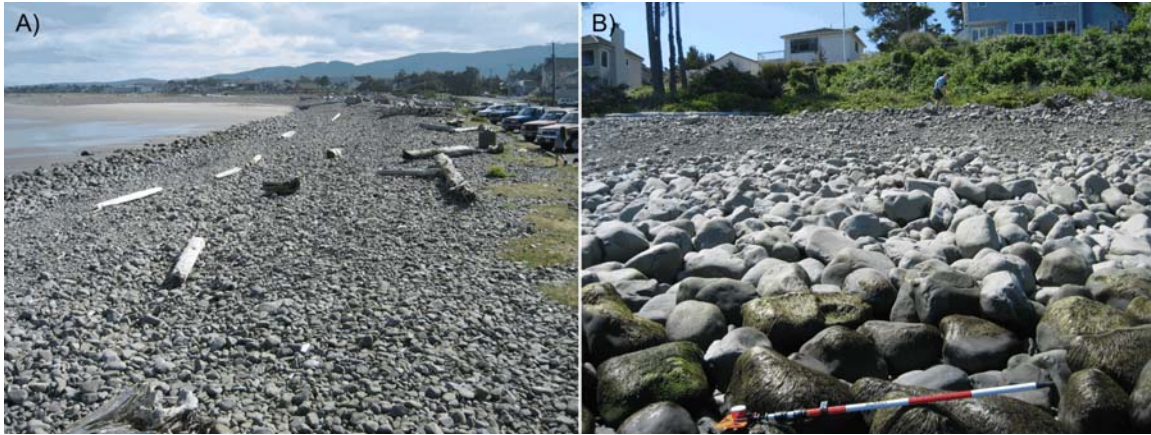
Figure 5.4: The gravel beach at Seaside. A) Adjacent to profile 2. The presence of logs at the crest of the beach indicates the maximum wave runup height (~6 m (19.6 ft)) achieved during the most recent storm event. B) At profile 1, the lower portion of the gravel beach is protected by a boulder toe, with the finer gravels having been pushed up the cobble face to form the crest of the beach. Note the well vegetated backshore and marine cliff landward of the cobble beach. The survey staff near the bottom of the photo shows 1 ft graduations providing an insight on the size of the boulder toe at profile 1.

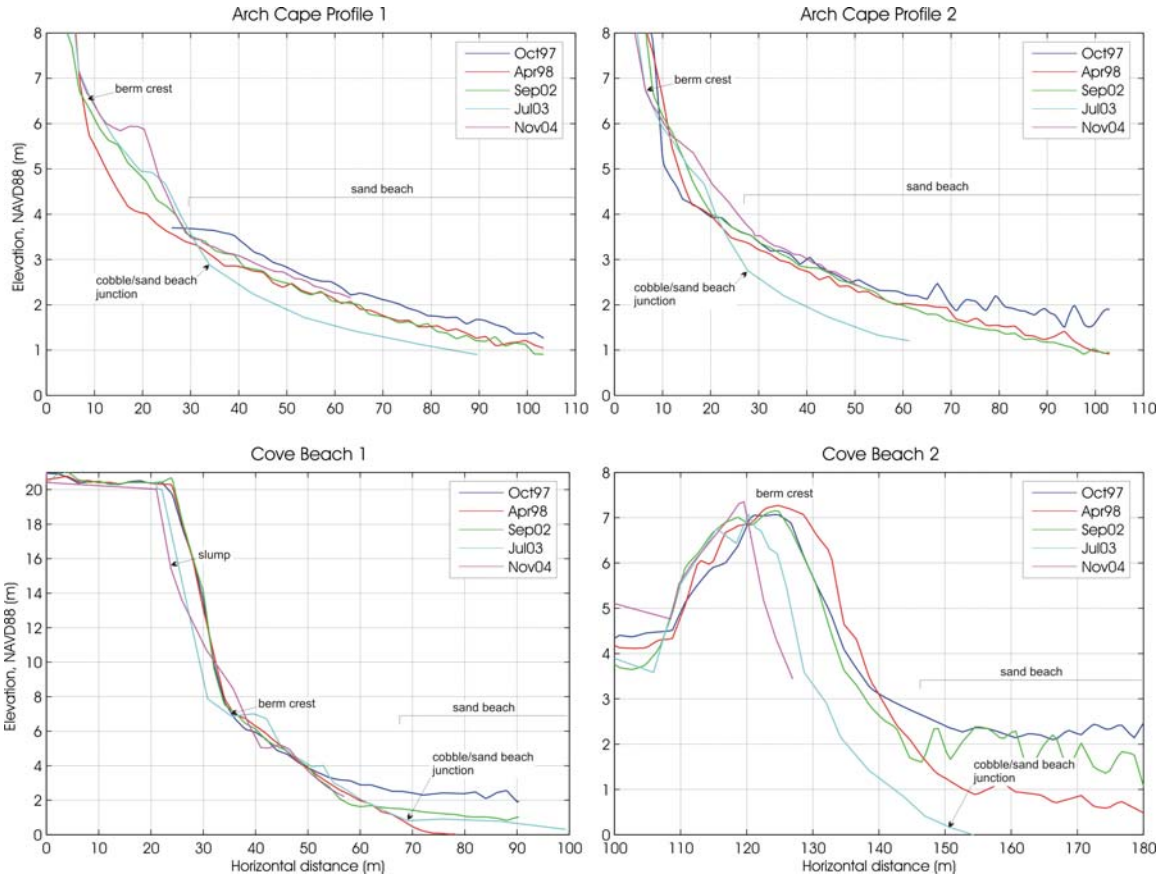
Figure 5.7: Beach profile surveys undertaken along the Arch Cape and Cove Beach gravel beach. The location of the transect sites is shown in Figure 5.6.

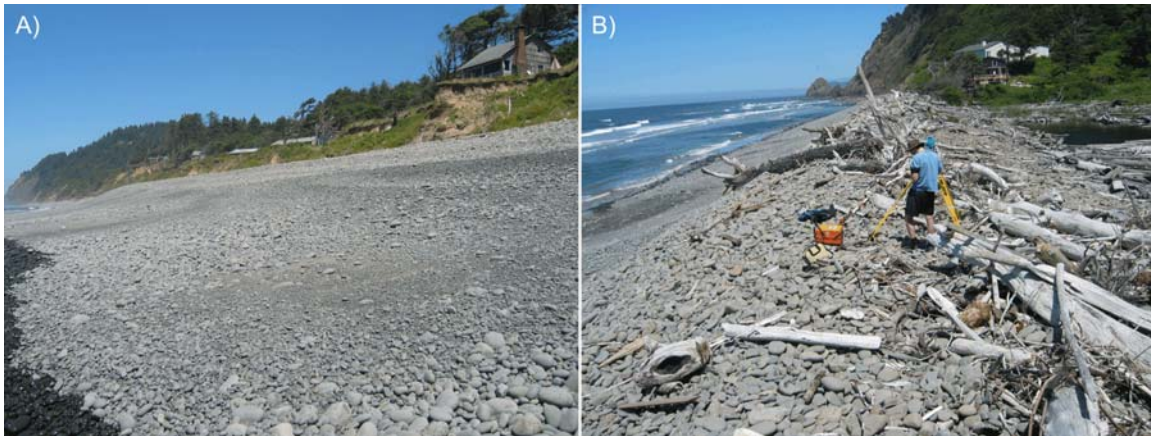
Figure 5.8: The gravel beach at Cove Beach in July 2003. A) The bluffs that back the gravel beach are subject to active erosion to the extent that several homes are in imminent danger of falling onto the beach. B) The gravel barrier at the north end of Cove Beach. Note the numerous logs that have been carried over the crest of the barrier.

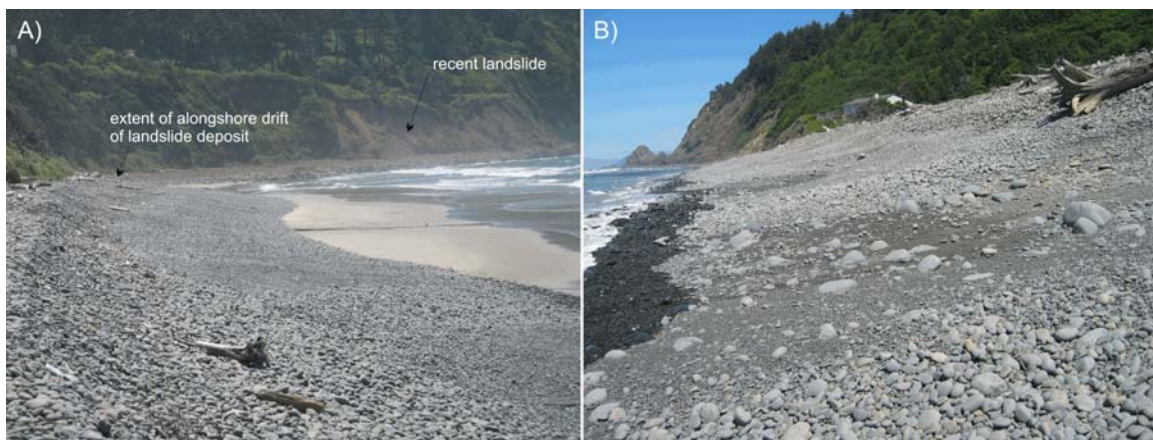
Figure 5.9: A) Sediments from a recent landslide (probably occurred during the 2002/03 winter) off of Cape Falcon have moved some 100 –150 m along the beach. B) Photo showing the extremely steep nature of the gravel beach at the north end of the shore.

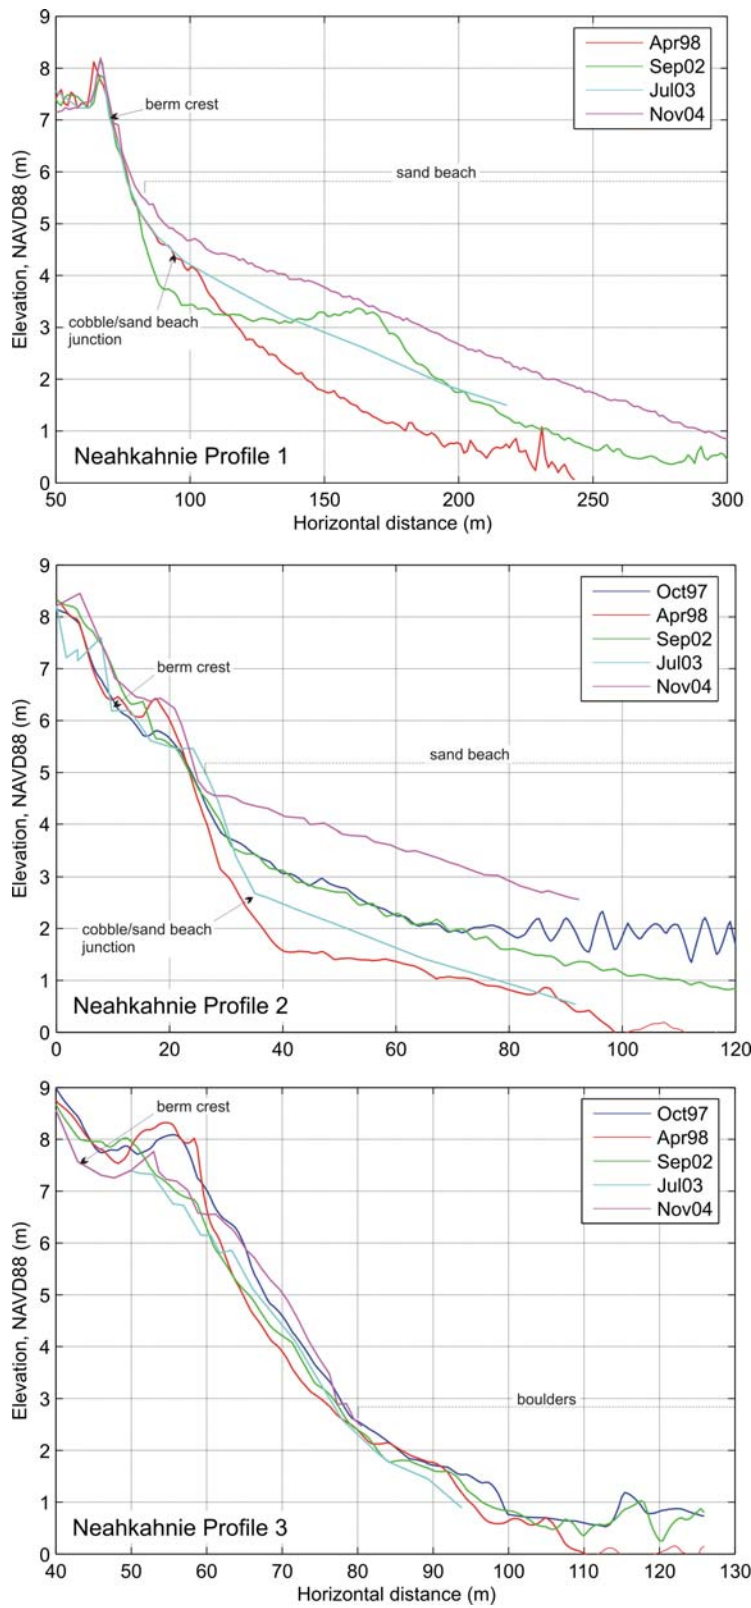
Figure 5.12: Beach profile surveys undertaken along the Neahkahnie gravel beach. The location of the transect sites is shown in Figure 5.10.

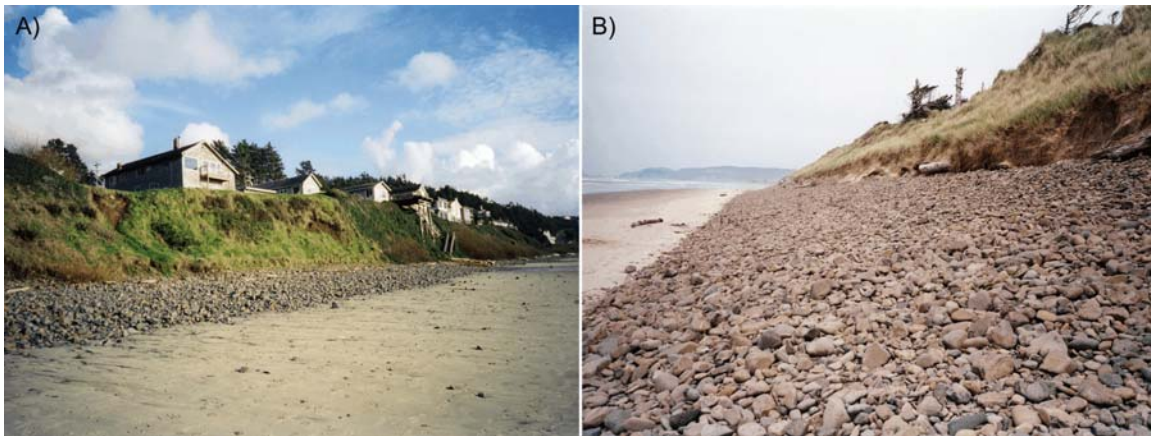
Figure 5.16: A) The Oceanside gravel beach. Note the well vegetated bluff face, which indicates that this site has been stable for some time. B) The gravel beach at CLSP. The photo was taken north of the constructed dynamic revetment and artificial dune. The beach is backed by an eroding scarp, which indicates that wave swash is attacking the toe of the dune during storms.

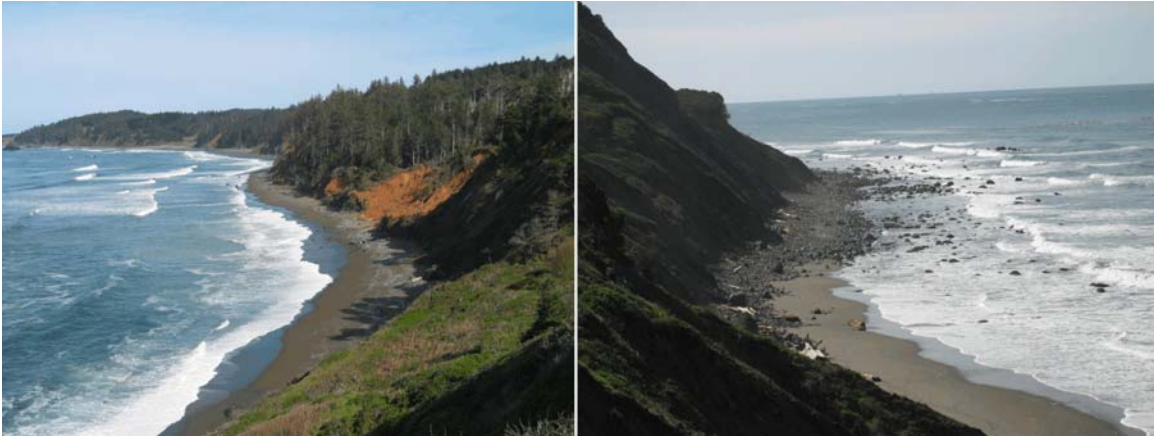
Figure 5.19: (Left) A mixed sand and gravel beach south of Port Orford that is backed by a small amount of gravels. (Right) A coarse sand beach merges into a boulder beach near Humbug Mountain.

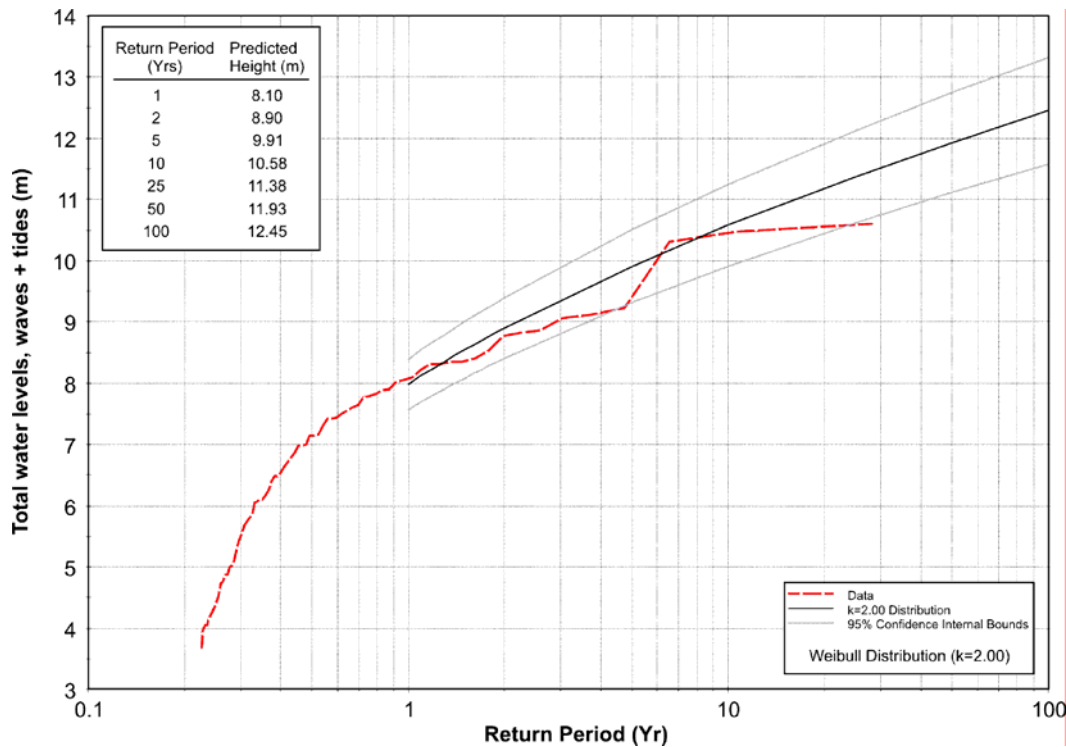
Figure 5.24: An extreme value analysis of total water levels (combined wave runup and tidal elevations) performed for gravel beaches on the Oregon coast ( $N = 76$ )

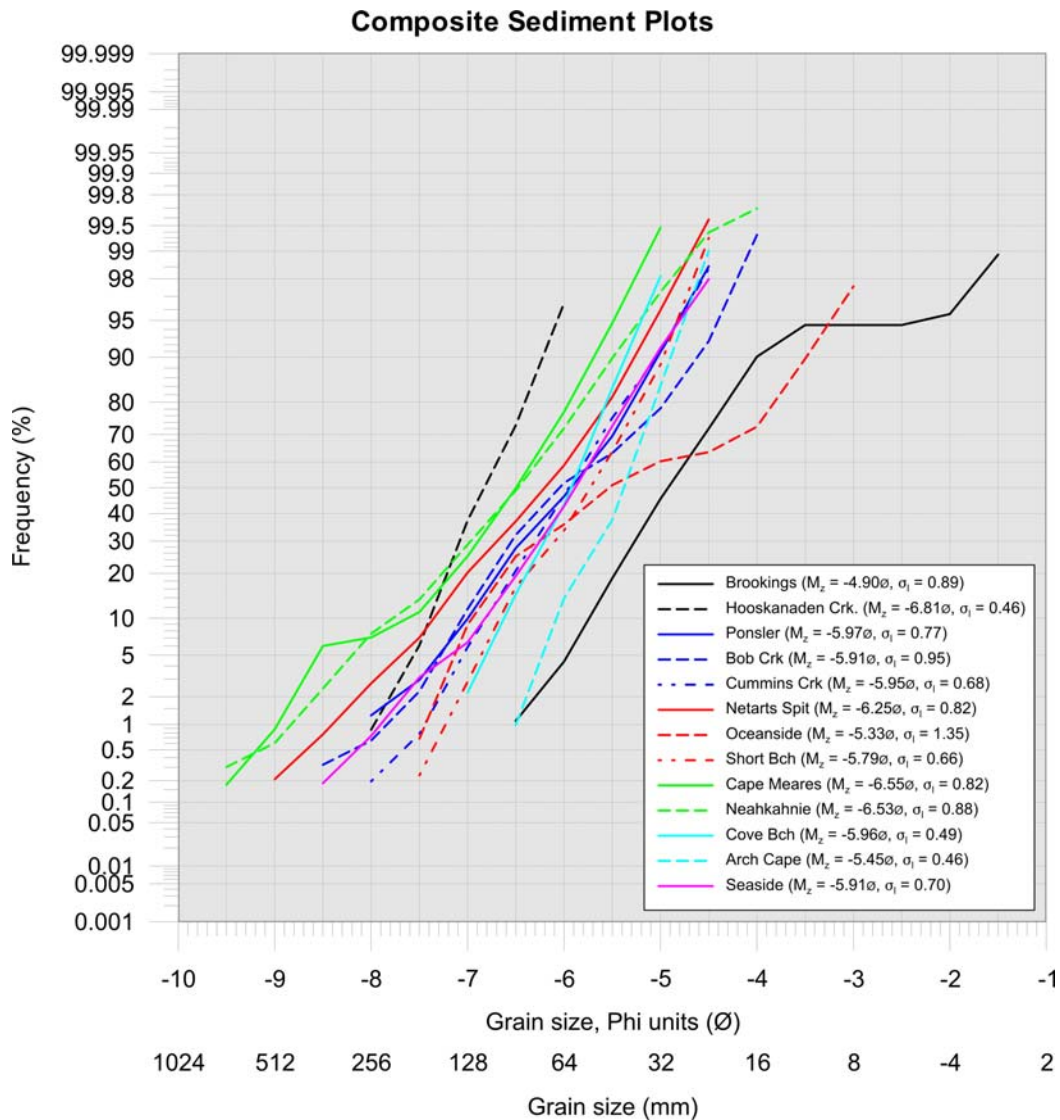
Figure 5.26: Grain size distribution curves derived for various gravel beach sites along the Oregon coast

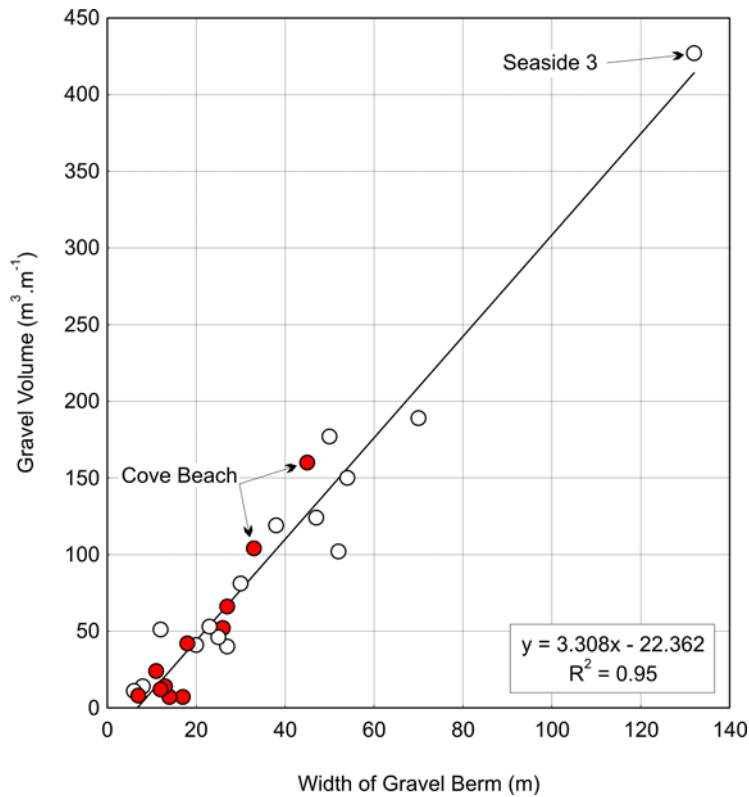
Figure 5.27: A step-wise linear correlation between gravel volume and gravel beach width derived for the Oregon coast. Solid color points are those sites that are currently experiencing erosion.
