**ET-2000
EXTRUDER GUARDRAIL
END-TERMINAL**

Construction Report

**Experimental Features
Project No. 93-06**

Coos Bay - Roseburg Highway
O'Xing S.P.R.R. - I-5
Douglas County

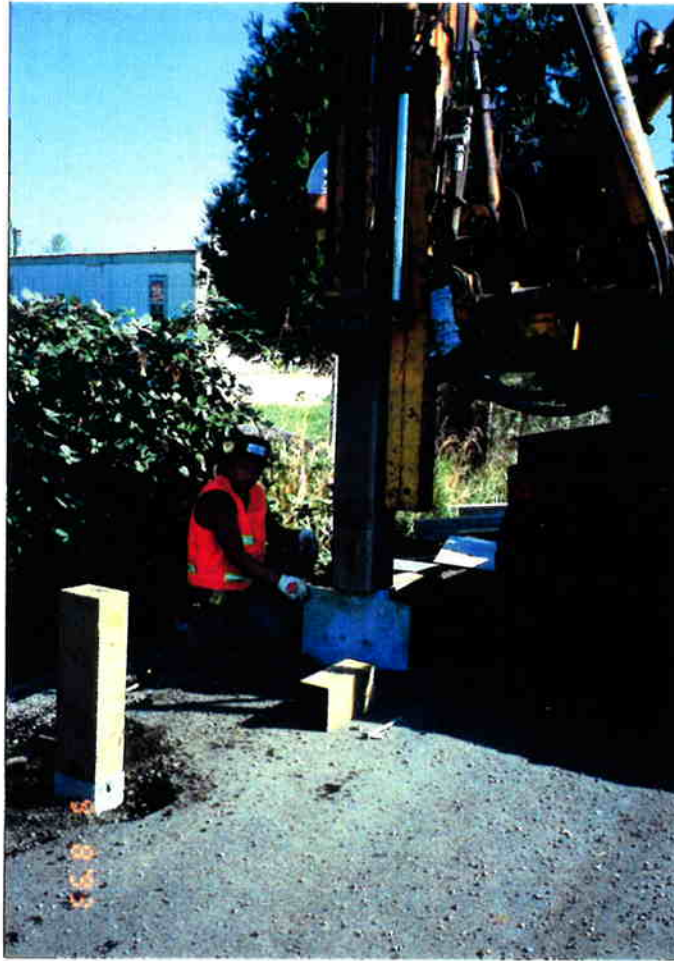
Figure A.1: ET-2000 Soil Plate and Steel Foundation Tube Installation.

Some state agencies have experienced difficulties in installing the Mk-ST steel foundation tubes, however. The foundation tubes are bolted to the Mk-SP soil plates and under certain soil conditions, driving this assembly could create deformations which make it challenging to insert and/or remove the wood posts. In addition, occasionally, "one or both of the bolts that are intended to hold the soil plate to the tube sometimes break, as may be evidenced by the plate's presence at ground level (5)."

When inserted into the tube, the wood posts stand atop these two bolts. The soil level inside the tube after driving is often above the level of the soil plate's bolts. This soil should be scooped out before the post is placed in the tube, for it may otherwise contribute to the bolts' breakage and to the greenwood fractures that sometimes occur alongside of the drilled breakaway hole when the wood post must be driven into place (5).

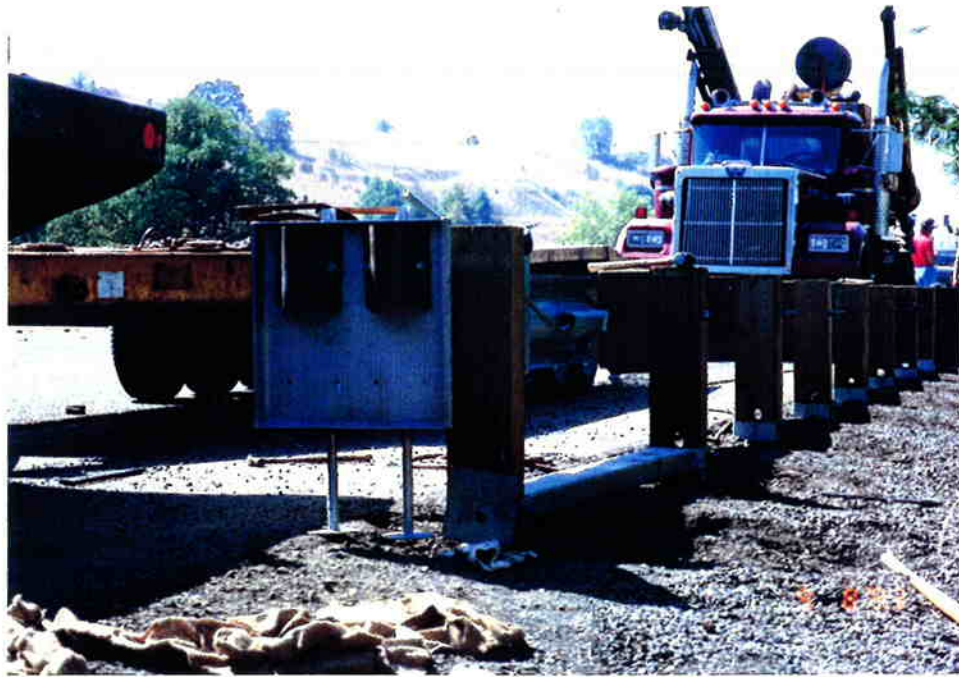
Figure A.2: ET-2000 Guardrail Extruder Head, Offset Strut, and Cable Assembly Installation.

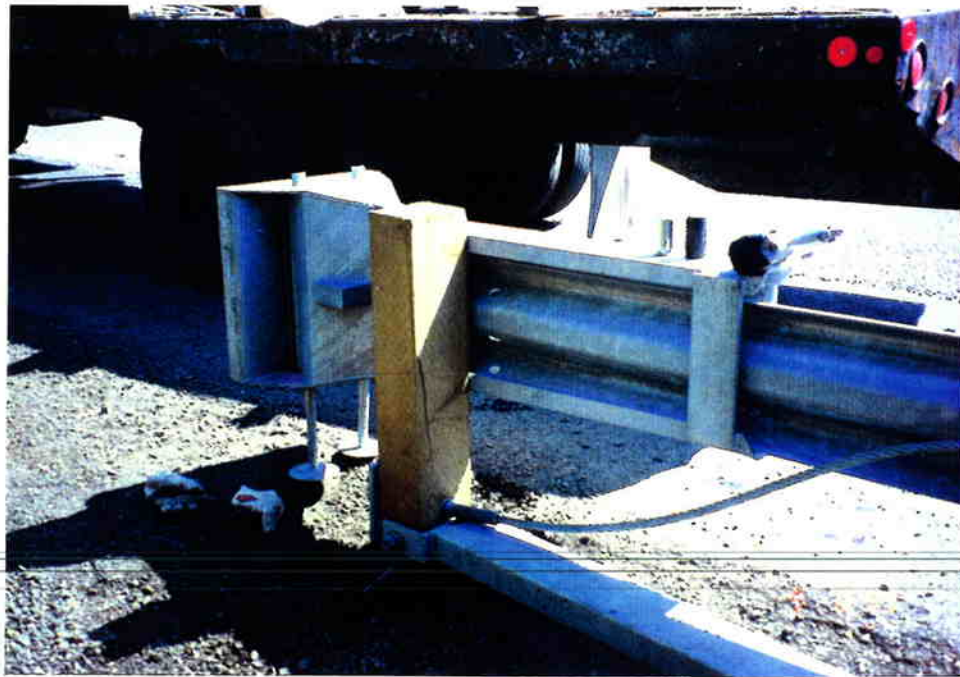
Figure A.3: ET-2000 Guardrail Extruder Head, Offset Strut, and Cable Assembly Installation.

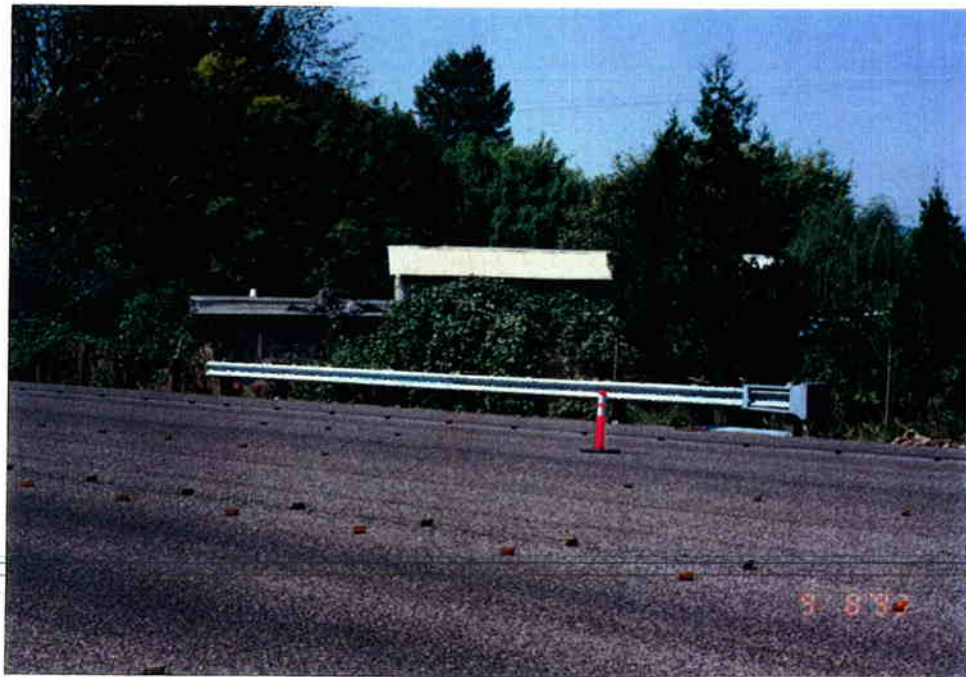
Figure A.5: ET-2000 Extruder Guardrail End-Terminal; unit installation completed.
