**EVALUATION OF 3M™ SCOTCHLITE™
LINEAR DELINEATION SYSTEM**

Final Report

SPR 306-291

September 2004

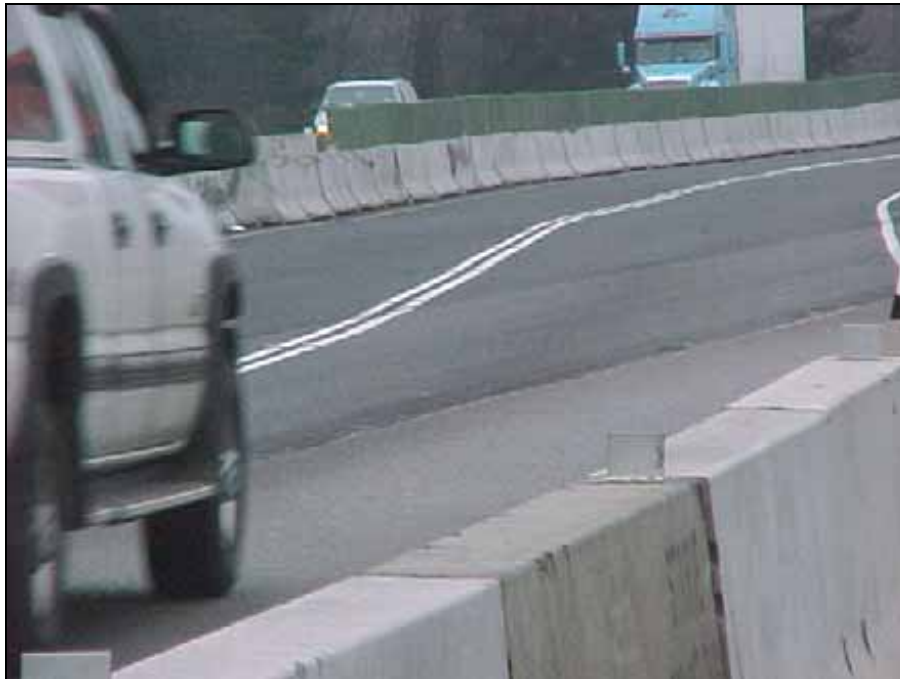
Figure 1.1: Typical concrete barrier used for a lane shift in an Oregon work zone

Safe and efficient traffic movements through work zones are a key concern for every construction project, particularly when space limitations require lane shifts or detours. As seen in Figure 1.1, concrete barriers are often used to guide traffic through the construction area, and warning signs are used to alert drivers of the changing traffic patterns.

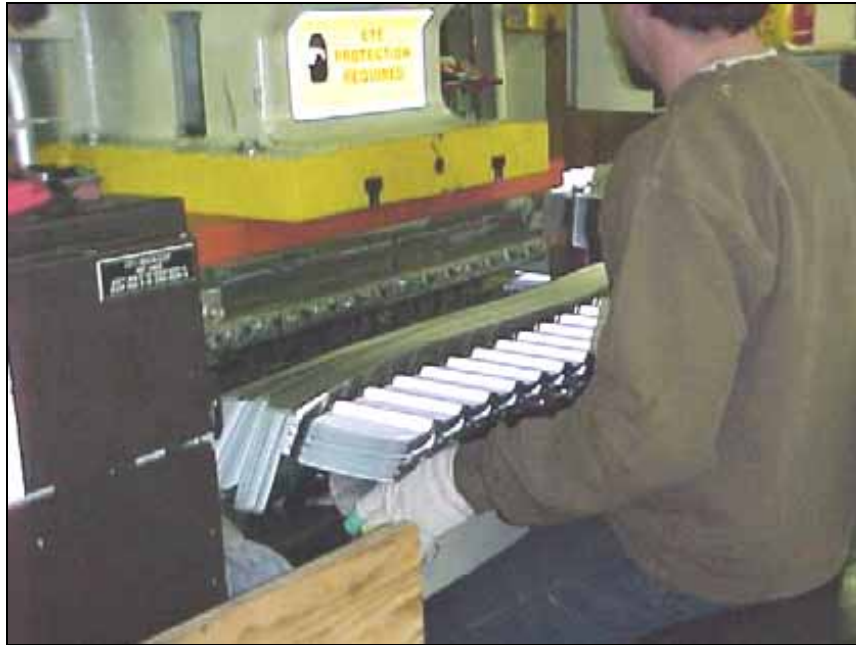
Figure 1.3: 3M™ LDS panels being manufactured at Irwin-Hodson

various license plates for ODOT's Driver and Motor Vehicle Services Division. Figure 1.3 shows part of the LDS manufacturing process.

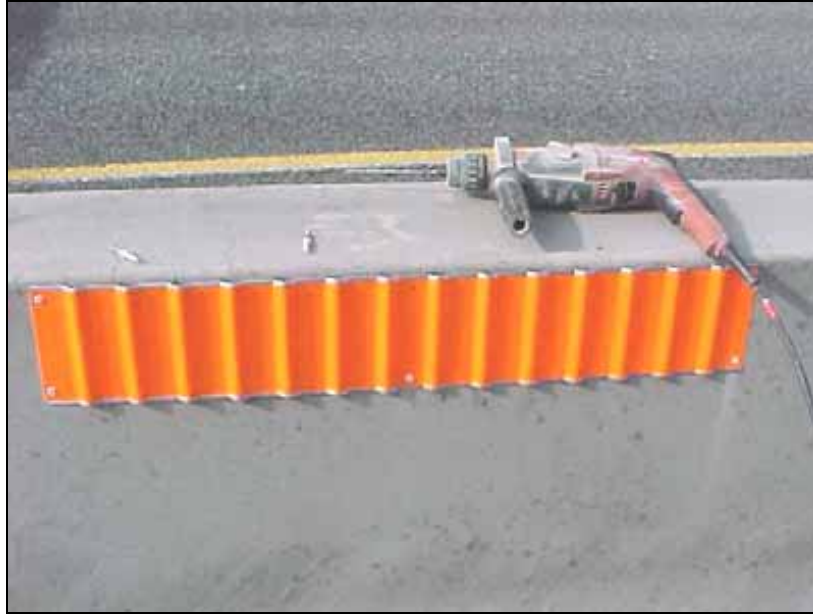
Figure 1.4: Drill and anchor bolts used to attach 3M™ LDS panels to the concrete barrier

For concrete barriers, the LDS panels are installed near the top of the barrier to avoid dirt, snow, sand or road grime. A chalk line is snapped on the barrier to ensure a level installation. The panels are laid out and the barrier is marked where they will be attached using the six pre-punched holes in each panel as a template. Once the barriers have been marked for location, a rotary hammer drill with a concrete drill bit is used to drill holes in the barrier. 3M™ recommends using an adhesive caulking system to attach the panels to the barrier prior to drilling, however this makes removal of the panels difficult at the end of a temporary project, such as in a work zone. After drilling the holes, stainless steel anchors, ¼ inch x 1 inch (6.3 mm x 25.4 mm), with a 5/16 inch (7.9 mm) nylon washer are used to secure the panels to the barrier, as seen in Figure 1.4.

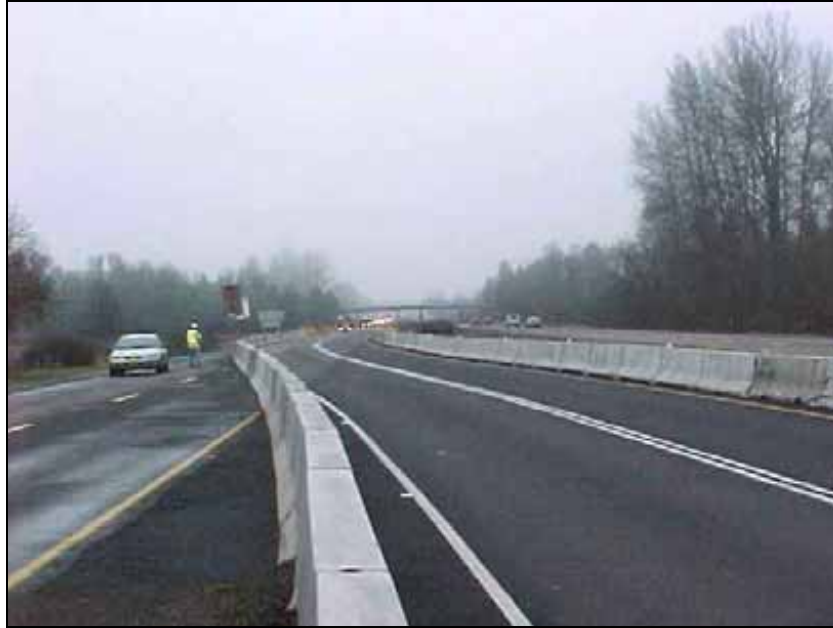
Figure 3.2: Approaching lane shift at the Coast Fork Willamette River Bridge

At the detour, I-5 southbound consists of two lanes with no shoulders. Both lanes are protected by concrete barriers running almost the entire length of the detour as seen in Figure 3.2. The detour is approximately 1500 feet (450 m) in length and the posted speed through the work zone is 55 mph (88 km/h).

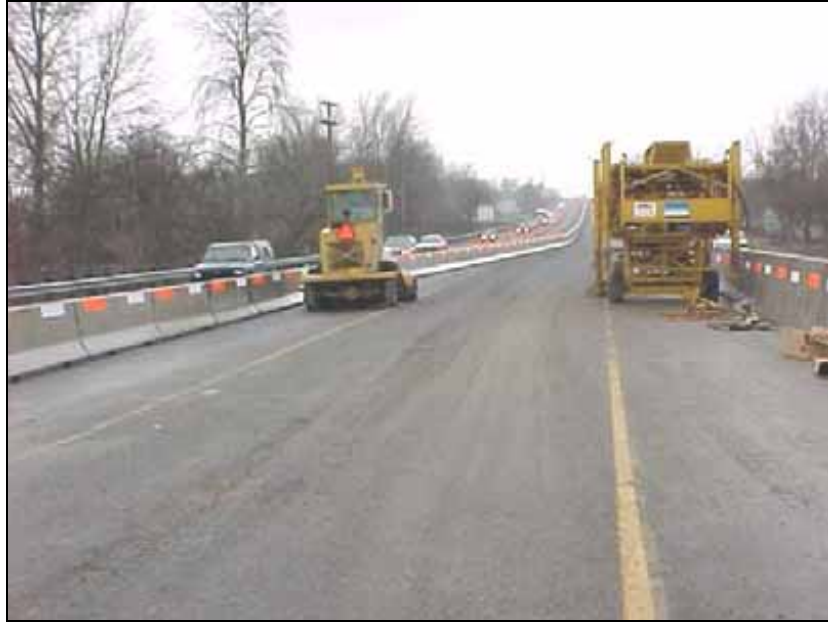
Figure 3.4: Approaching lane shift at Medford Viaduct

Construction at the site was divided into four stages. The first stage reduced traffic to single lanes on either side of the viaduct, while construction took place in the center of the structure. During this stage, both the northbound and southbound lanes were 16.7 feet (5.1 m) wide, with concrete barriers running the entire length of the viaduct on the inside of the travel lanes, see Figure 3.4. As can be seen in Figure 3.5, traffic was moved during Stages 2-4 from the outside to the inside of the structure where lane widths varied from 17 to 20.7 feet (5.2 to 6.2 m). The viaduct is approximately 3300 feet (1000 m) in length and the posted speed through the work zone was 45 mph (72 km/h).

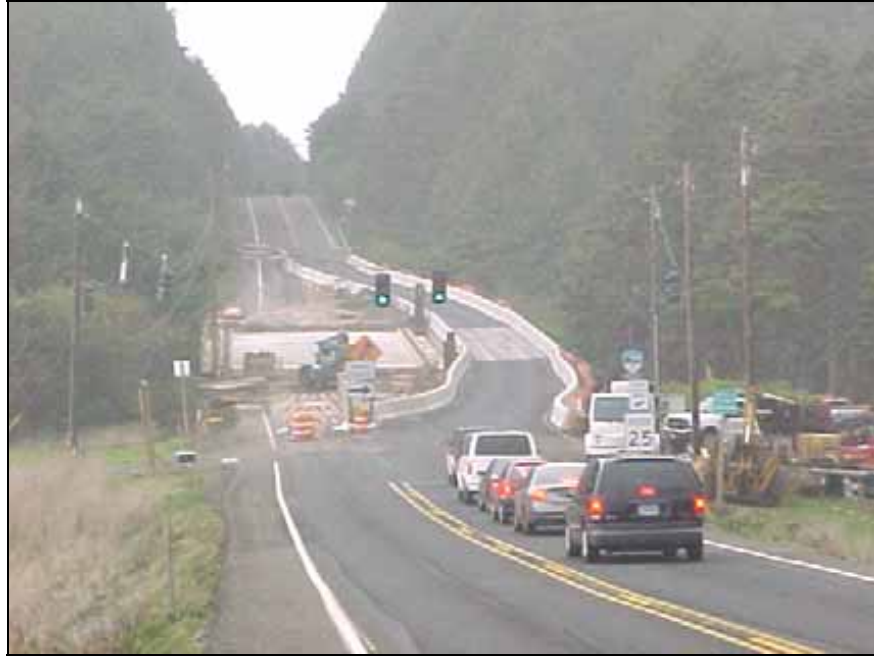
Figure 3.7: Approaching lane shift onto the temporary structure at the Bob Creek Bridge

To accommodate the construction of a new bridge over Bob Creek, the alignment of the highway was shifted to the east onto a temporary structure. At 14 feet (4.3 m) wide, the temporary structure consisted of a single lane with no shoulders. The shared northbound and southbound lane was protected on both sides by a concrete barrier running almost the entire length of the detour as seen in Figure 3.7. The detour was approximately 600 feet (180 m) long, and traffic was controlled by a temporary signal with alternating phasing between northbound and southbound traffic. The posted speed approaching the work zone was 35 mph (56.3 km/h) and 25 mph (40.2 km/h) across the detour bridge.

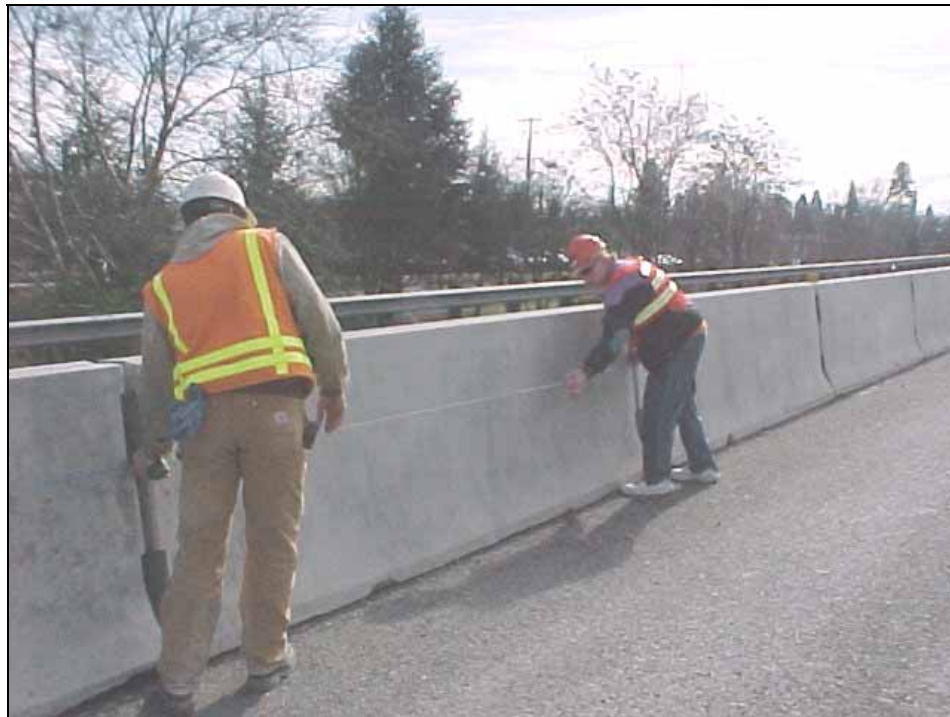
Figure 4.1: Snapping a chalk line on the concrete barrier at the Medford Viaduct project

All of the LDS panels were installed near the top of the barrier as per 3M™ recommendations to avoid dirt, snow, sand or road grime. Installation of the panels is a 4-step process. First, a chalk line is snapped on the barrier to ensure level installation as seen in Figure 4.1.

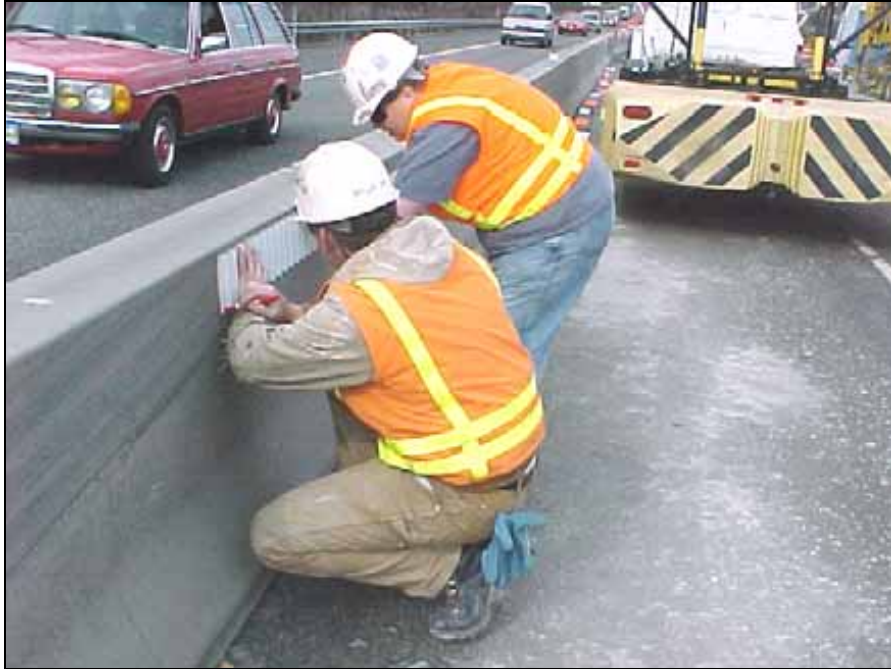
Figure 4.2: Marking holes for drilling

Second, the LDS panels are laid out and the barrier is marked where holes will be drilled to accommodate the anchor bolts that attach the panels to the barrier, as seen in Figure 4.2. Crews found that laying out the panels in advance and using each panel for a template was preferable to using a single panel for this function. This is due to the fact that the layout of the pre-punched holes differs slightly on each panel due to the manufacturing process.

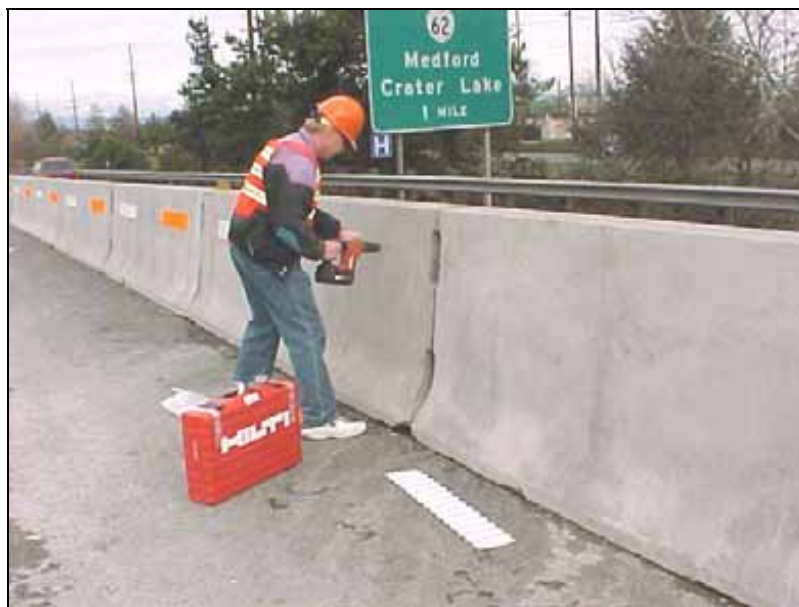
Figure 4.3: Drilling holes into the concrete barrier

Once the barriers have been marked, the third step is to drill the holes in preparation for attaching the panels to the barrier, as seen in Figure 4.3. 3M™ recommends using a rotary hammer drill with a concrete drill bit to drill the holes in the barrier. 3M™ also recommends using an adhesive caulking system to attach the panels to the barrier prior to drilling. ODOT did not use the adhesive because it makes removal of the panels difficult at the end of a temporary project.

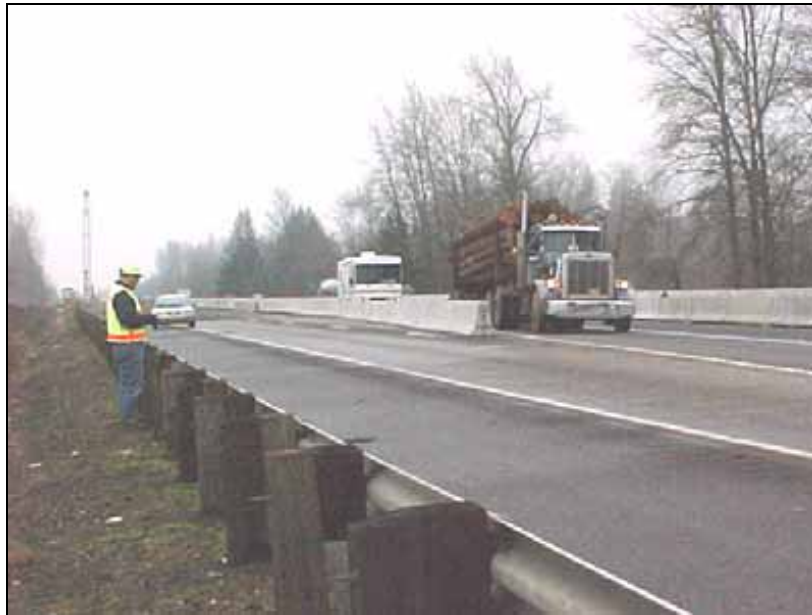
Figure 5.1: Spot speed study being conducted on I-5 at the Coast Fork Willamette River Bridge

Prior to the installation of the LDS panels, spot speed studies were conducted at both the Coast Fork Willamette River Bridge and the Medford Viaduct sites in the southbound travel lane, as seen in Figure 5.1. Data was collected using a Jamar Technologies TDC-8 Traffic Data Collector. The TDC-8 includes a spot speed module that allows spot speed studies to be conducted over fixed distances of up to 250 feet (76 m). A typical observation period included measuring the speeds of 100 total cars and semi-trucks to ensure a good statistical sample.

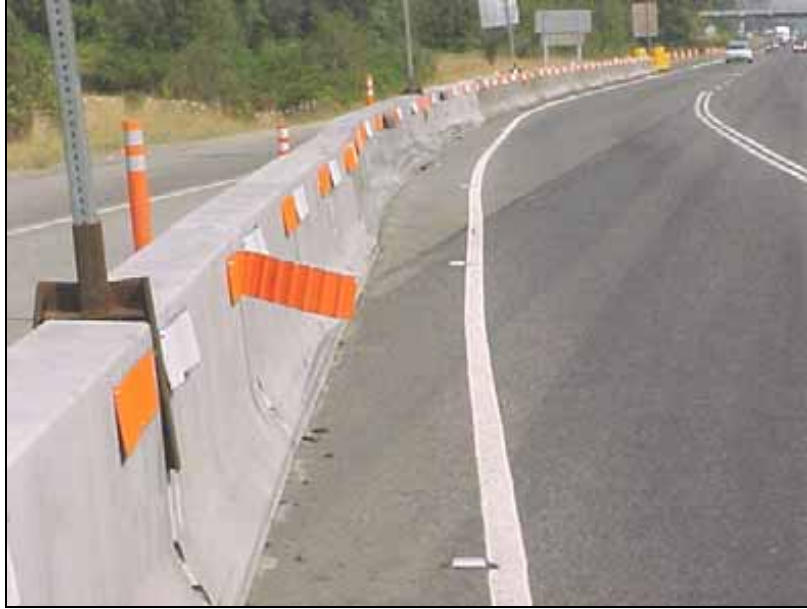
Figure 5.2: Panel detachment from the barrier at the Coast Fork Willamette River Bridge project

One of the keys to successful implementation of the LDS panels is proper installation and maintenance. The tendency for temporary installations, such as work zones, is to use minimal time and effort in attaching the panels to the concrete barrier. This can lead to problems in the weeks and months that follow initial installation as panels are prone to detaching from the face of the concrete barrier due to debris and wind stirred up by passing vehicles. At the Coast Fork Willamette River Bridge project, some of the panels were installed with as few as two anchors. Figure 5.2 shows what happened when the panels began to detach from the face of the concrete barrier several weeks after initial installation.

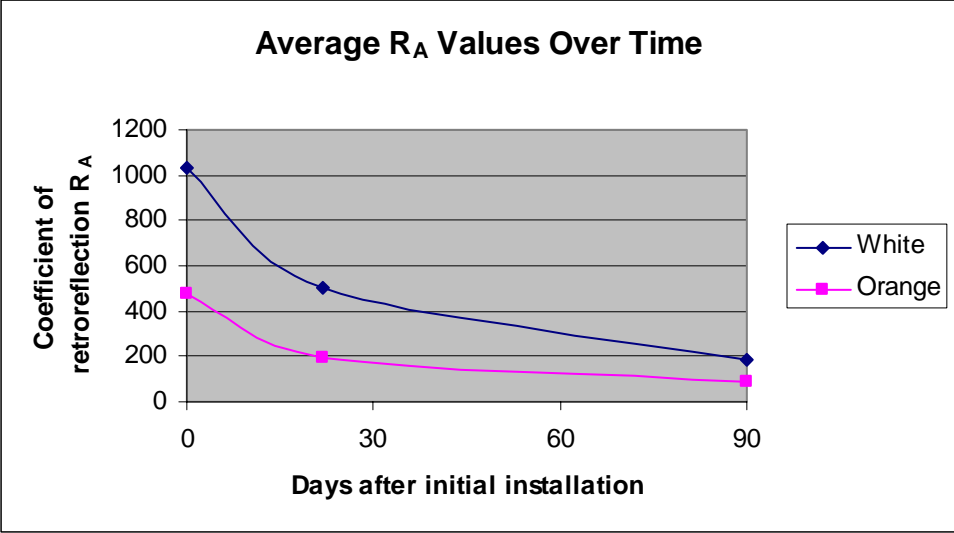
Figure 5.3: Average Coefficient of Retroreflection (R_A)

Retroreflectivity data was collected on a random sampling of both orange and white LDS panels at both sites. Figure 5.3 illustrates how the coefficient of retroreflection (R_A) decreases over time when the LDS panels are not routinely cleaned. At the Medford Viaduct project, routinely cleaning the LDS panels, which had been in service for several months, with a pressure washer restored R_A values to roughly half of their original values.

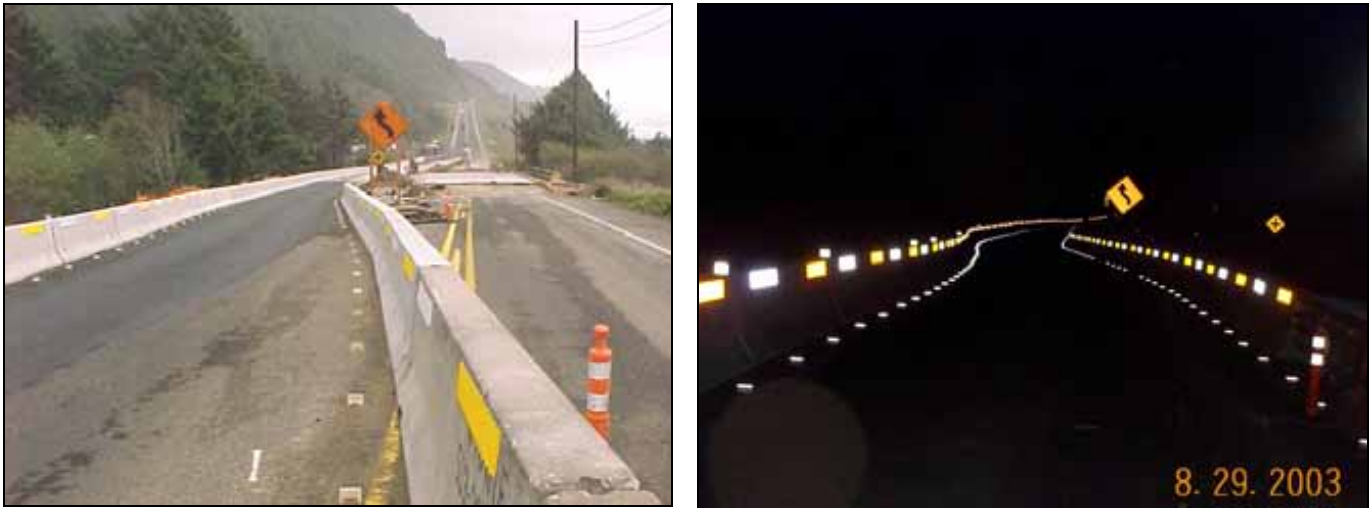
Figure 6.1: Day and night comparison of Bob Creek Bridge site looking southbound

In the twelve months that the LDS panels were monitored, they proved to be effective in guiding motorists through difficult detours and lane shifts on the Coast Fork Willamette River Bridge, Medford Viaduct, and Bob Creek Bridge projects. During their time in-service, the LDS panels were evaluated for their effects on vehicle speeds, crashes, and driver perceptions. Figures 6.1 and 6.2 show how the LDS panels performed during the day and at night while installed at the Bob Creek Bridge project.
