**EXPLORATORY STUDY OF
HOT IN-PLACE RECYCLING
OF ASPHALT PAVEMENTS
VOLUME I**

1. Report No. FHWA-OR-RD-95-07A		2. Government Accession No.		3. Recipient's Catalog No.	
4. Title and Subtitle Exploratory Study of Hot In-Place Recycling of Asphalt Pavements Volume I			5. Report Date November 1994

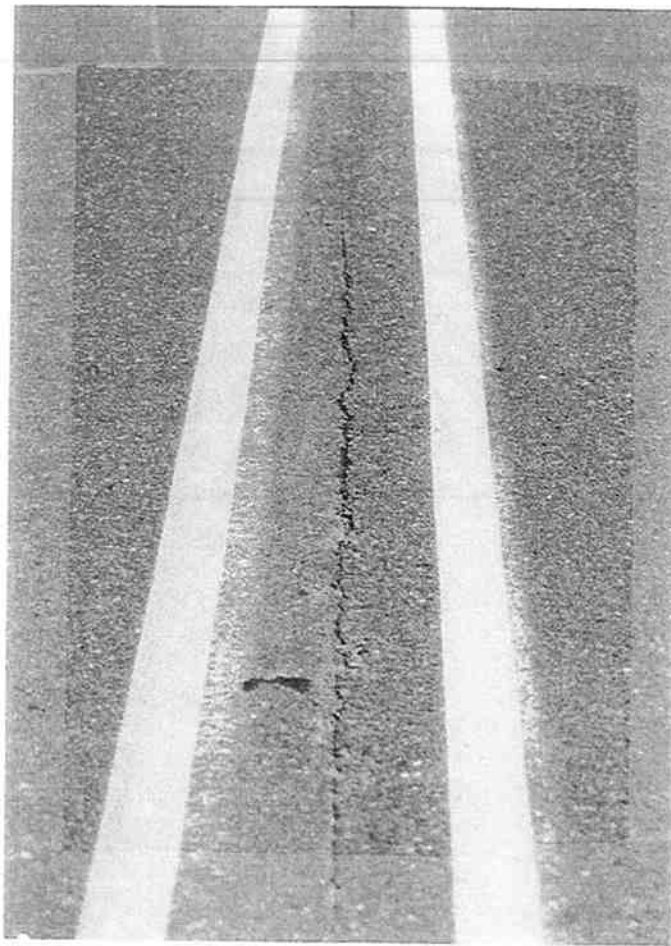
Figure 3.8 Section where centerline "seam" pulled apart near mile point 12.8.

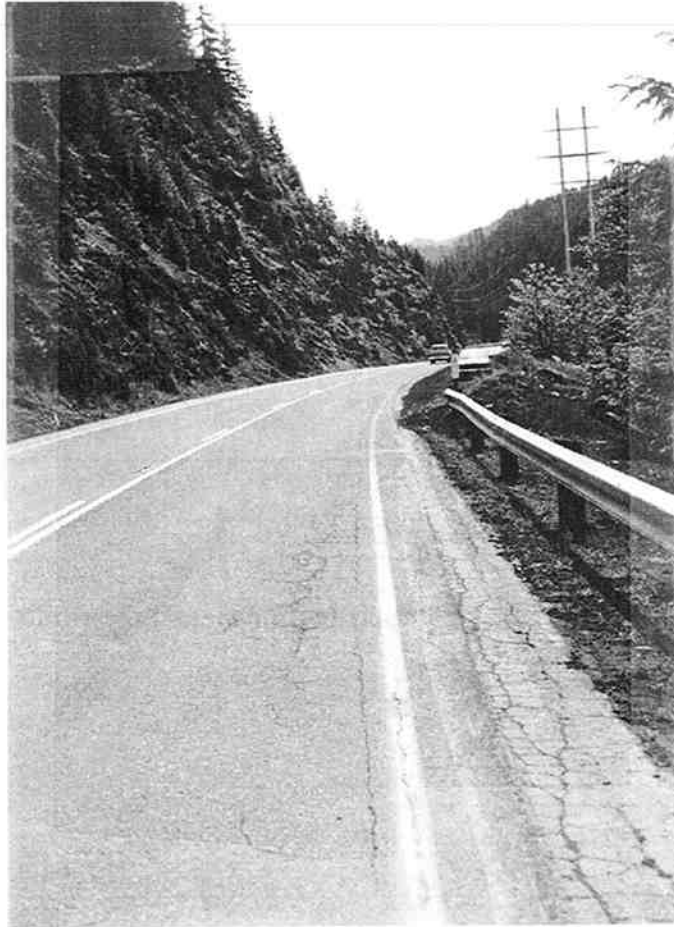
Figure 3.11 Section with reflective cracking breaking through the HIR pavement near mile point 11.1.

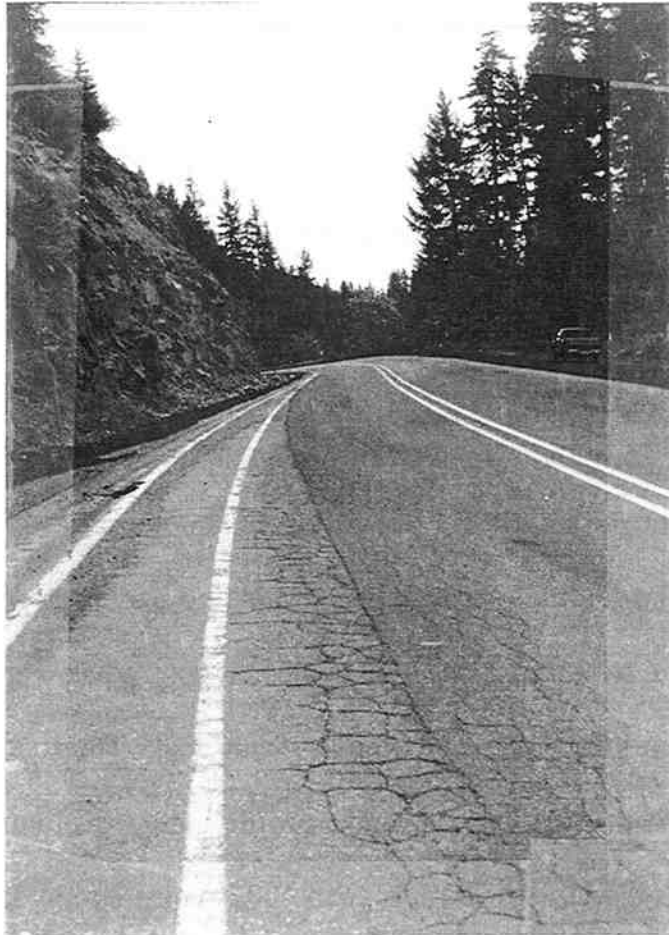
Figure 3.18 Section where cracking in pre-HIR pavement has reflected through near mile point 5.1.

reflective cracking has broken through the HIR pavement, also near mile point 5.1. Figure 3.19 shows a section where the patching is delaminating. Figure 3.20 shows a section where the HIR pavement has a very irregular edge seam near mile point 5.4. Figure 3.21 shows a section where the HIR recycling train missed part of the lane near mile point 5.4. Figure 3.22 shows a section approximately 100 feet long where it appears a chunk of asphalt was dragged by the paver. Figure 3.23 shows a patched section near the entrance to Coldwater Cove near mile point 4.5 at the northern end of the HIR project.

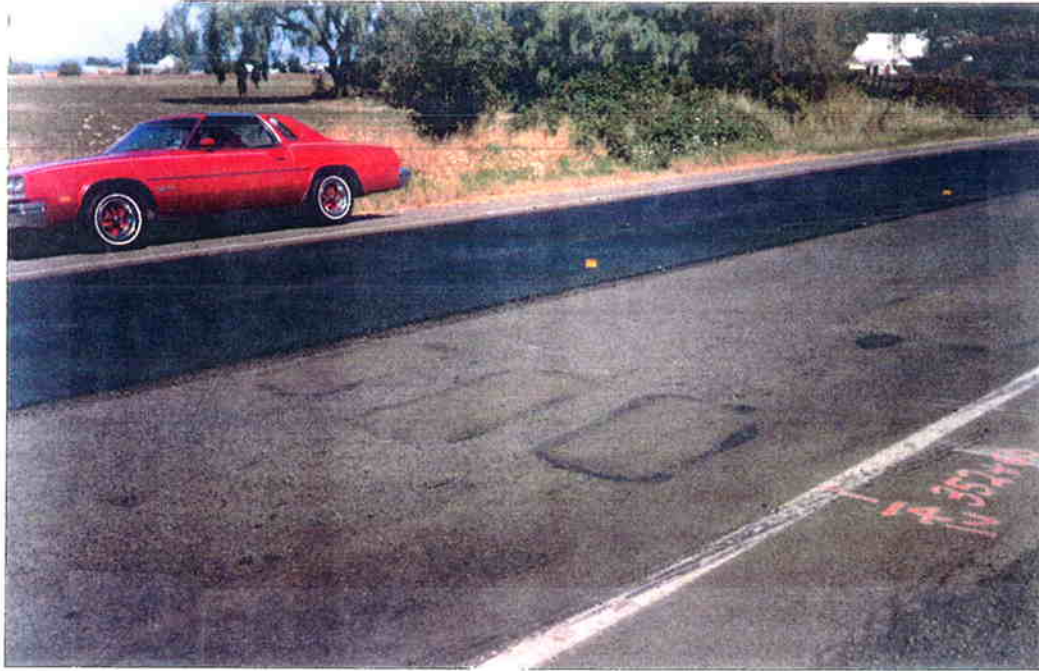
Figure 3.24 Section contrasting pre- and post-HIR pavement. The patched areas mark where the pre-construction pavement was milled.

Some of the problems encountered during the Tangent-Halsey HIR project are shown in Figures 3.24-3.29. Figures 3.24-3.25 contrast the pre- and post-HIR pavement, showing the poor condition of the existing pavement. In Figure 3.24, the three small patches mark where the pre-construction pavement was milled. This pre-construction milling "uncovered" the problem with the thinness of the widened section of the highway as the unbound base material was milled up along with the pavement. Figure 3.25 shows cracking and what appears to be flushing at another section of the road. Figure 3.26 shows the raised edge seam produced by the added virgin mix. The raveling produced by the delaminations is shown in Figures 3.27-3.28. After the project was completed the raveled areas were patched, then covered with a sand seal as shown in Figure 3.29. Figures 3.25 and 3.27 shows how far the recycling equipment extended over the center line which resulted in the HIR seam being in the wheel track in places.

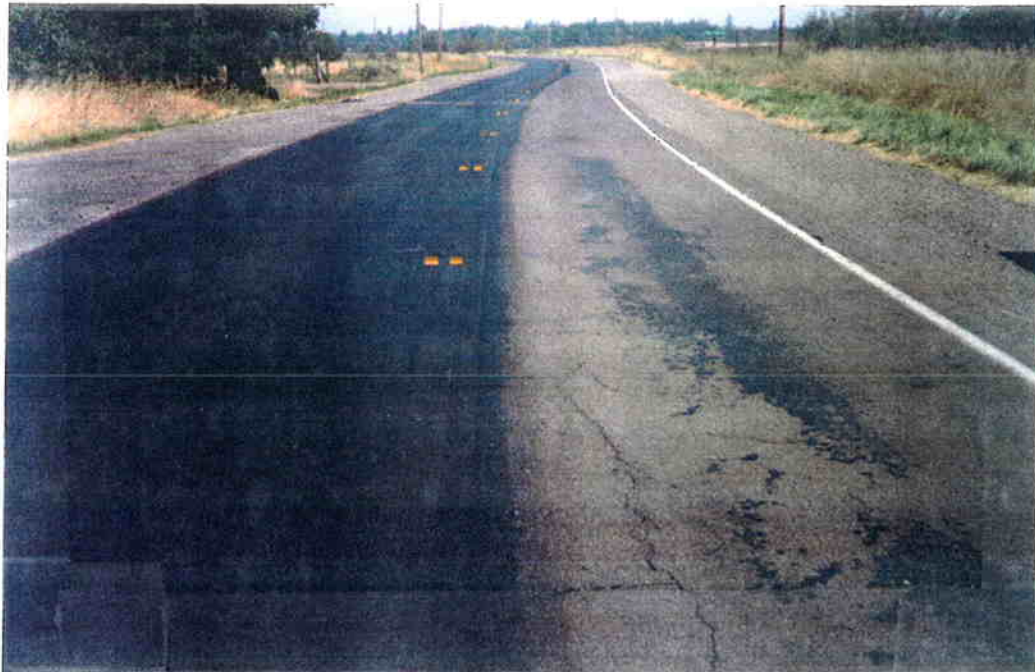
Figure 3.25 Section showing cracking and apparent flushing.

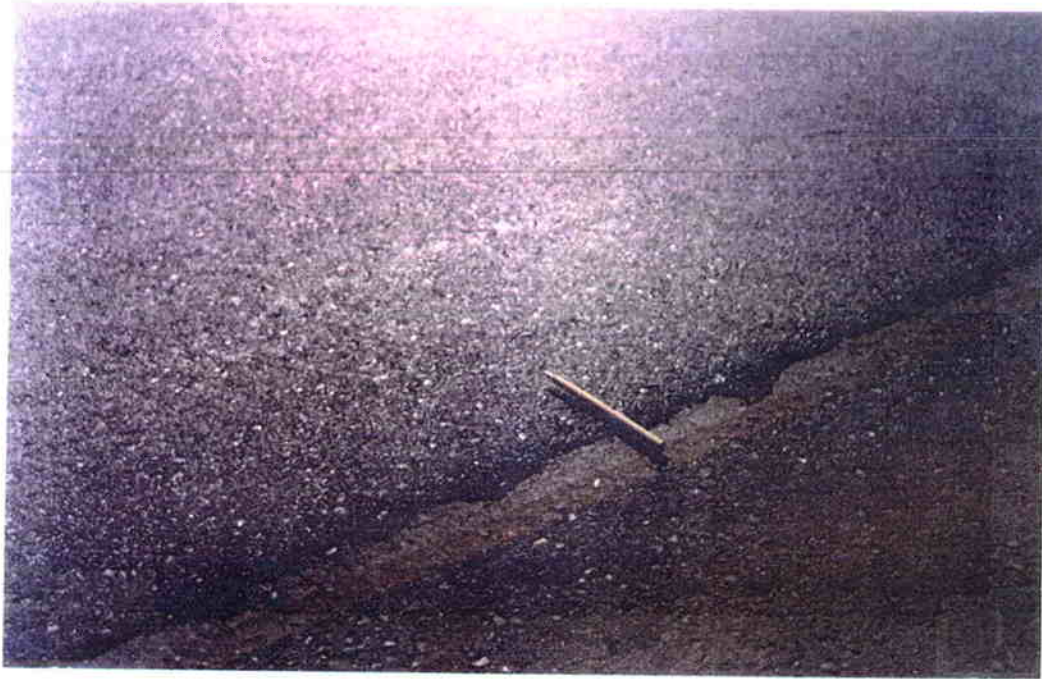
Figure 3.26 Section showing the raised edge seam produced by the added virgin mix.

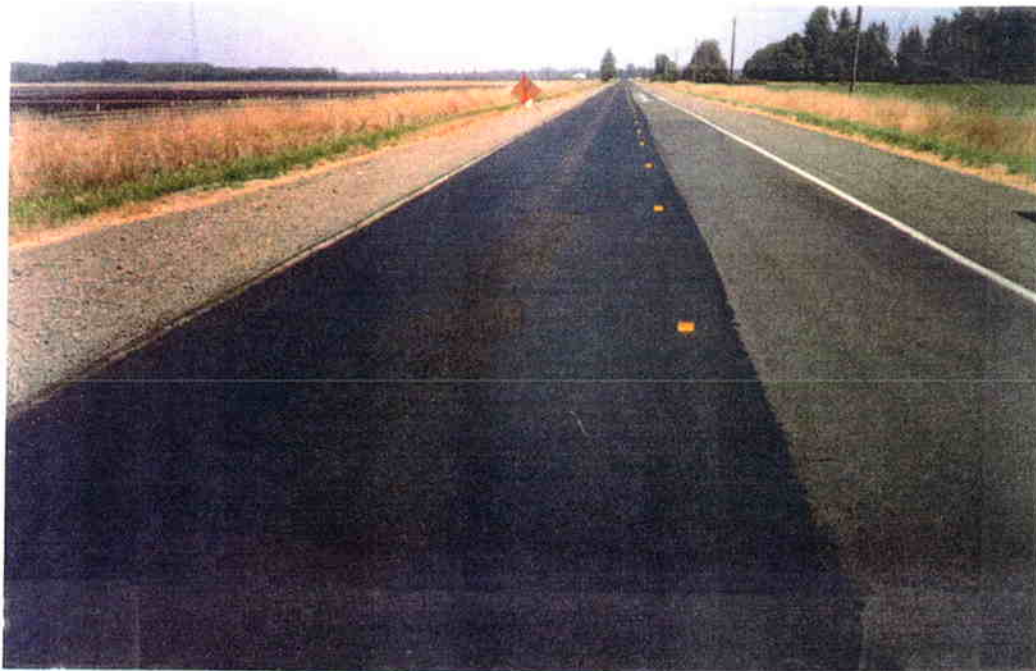
Figure 3.27 Raveled section after HIR.

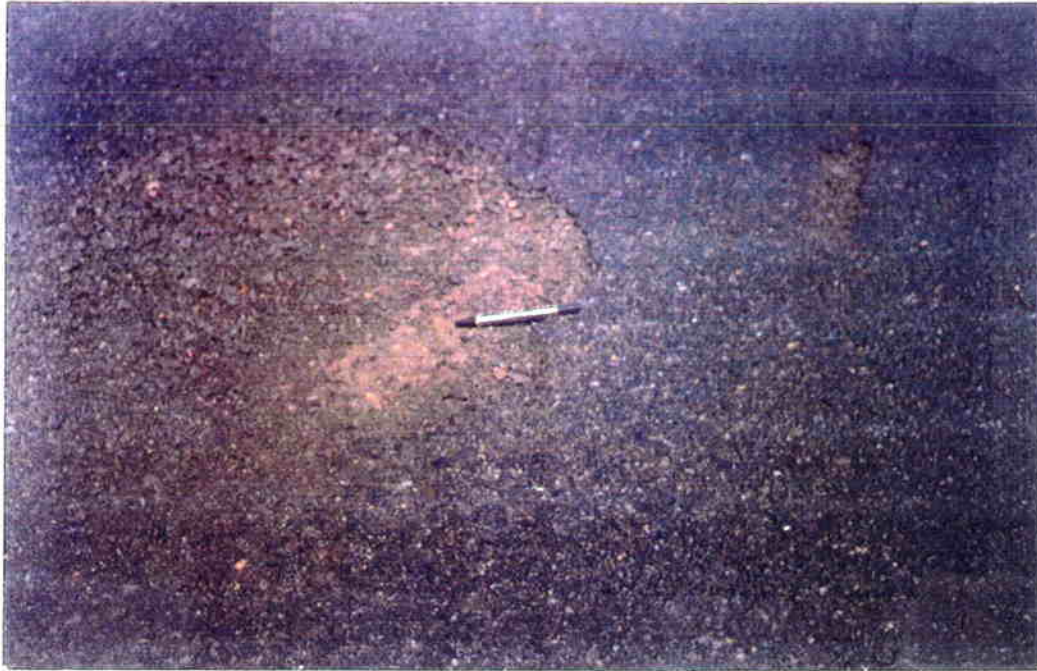
Figure 3.28 Close-up of raveled section.

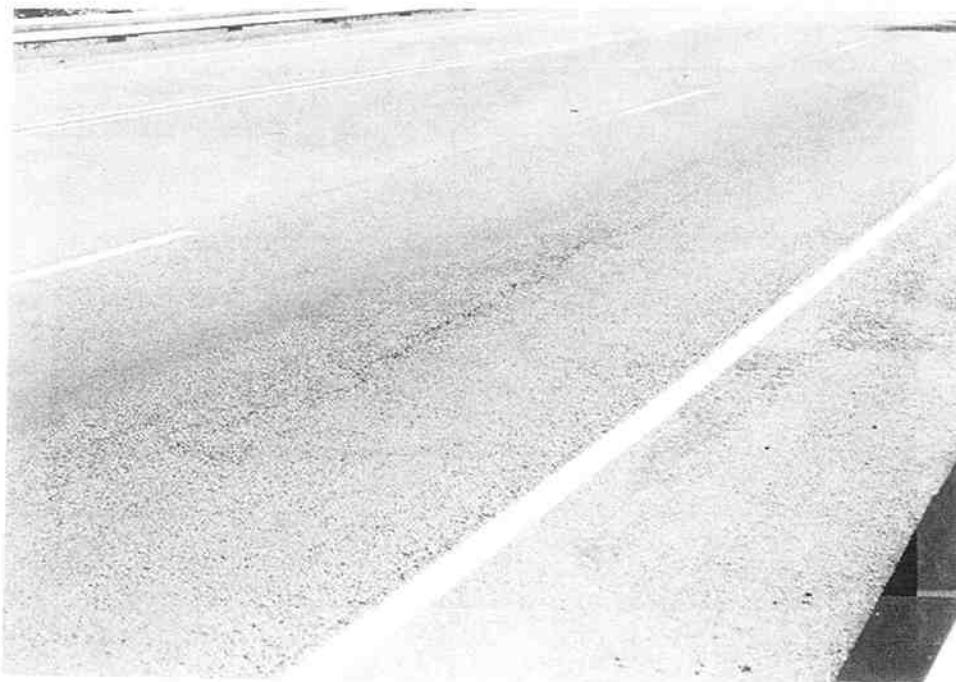
Figure 3.37 Close-up cracking near mile point 30.6.

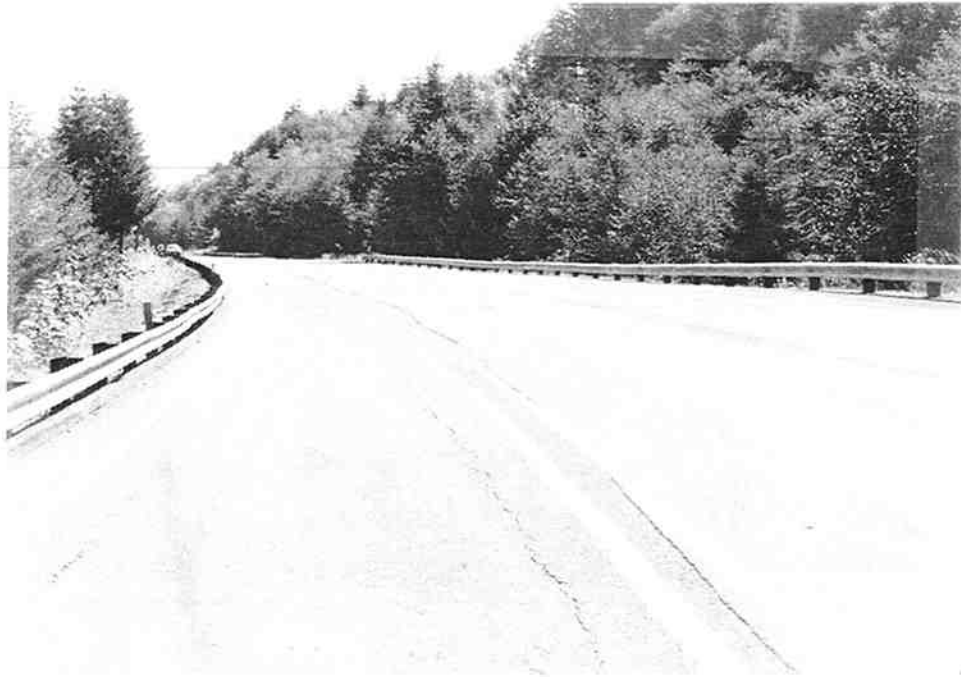
Figure 3.38 Section with "wandering" edge seam between HIR and non-HIR lanes near mile point 30.4. This photograph also shows raveling and cracking in this section.

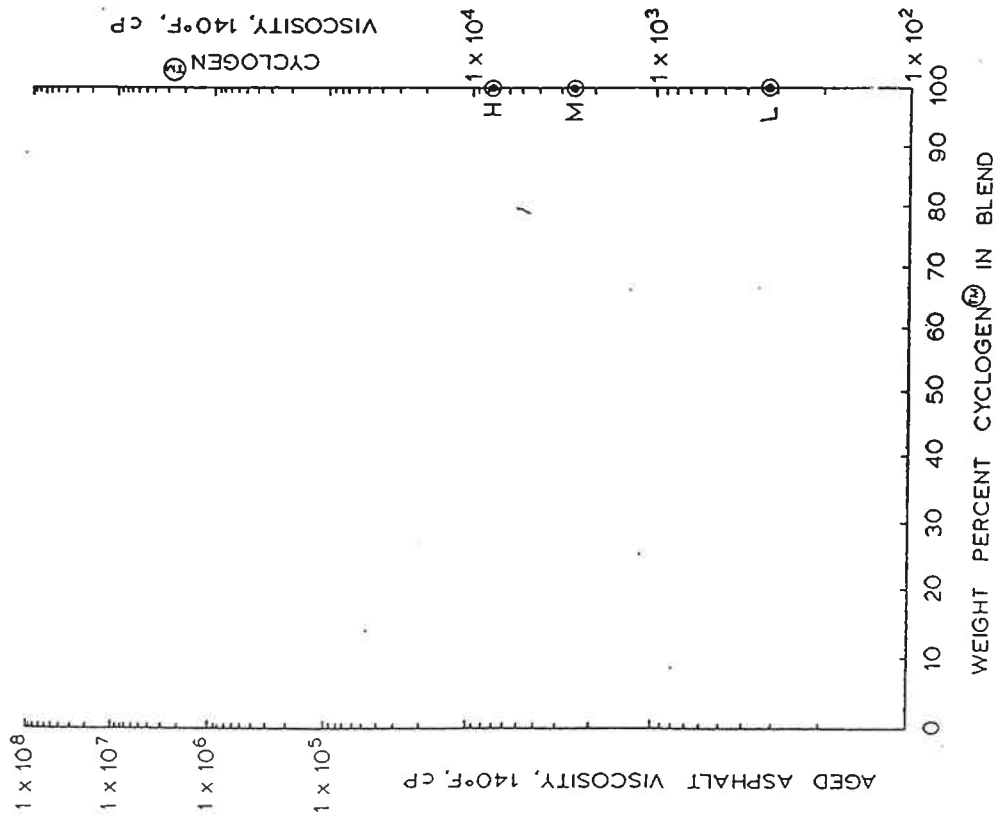
Figure 5.2 Witco viscosity nomograph (courtesy of Witco Corporation).

TO USE: Draw a straight line connecting viscosity of aged asphalt with viscosity of CYCLOGEN[®]. Draw a vertical line up from the percent CYCLOGEN[®] in blend. The two lines intersect at predicted approximate viscosity of the recycled asphalt.
