IDENTIFICATION AND QUANTIFICATION OF
THE EXTENT OF ASPHALT STRIPPING IN
FLEXIBLE PAVEMENTS IN OREGON - PHASE II

June 1985

1. Report No. FHWA-OR-85-3	2. Government Accession No.	3. Recipient's Catalog No.	
4. Title and Subtitle Identification and Quantification of the Extent of Asphalt Stripping in Asphalt Pavements in Oregon - Phase II		5. Report Date June 1985

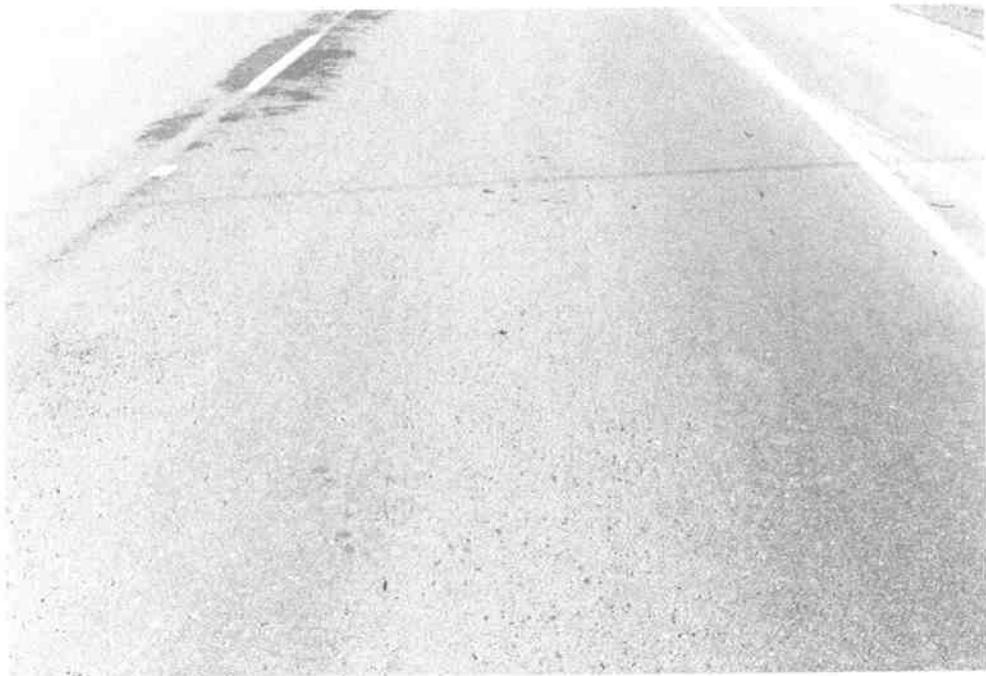
(a) Milepost 285.88, Southbound

This project is a two-lane highway on US Highway 97 with an ADT of 3300. The cores for this project were taken in both the Northbound and Southbound lanes, at Mileposts 285.9 (Southbound) and 291.0 (Northbound). The following types of distress were noted

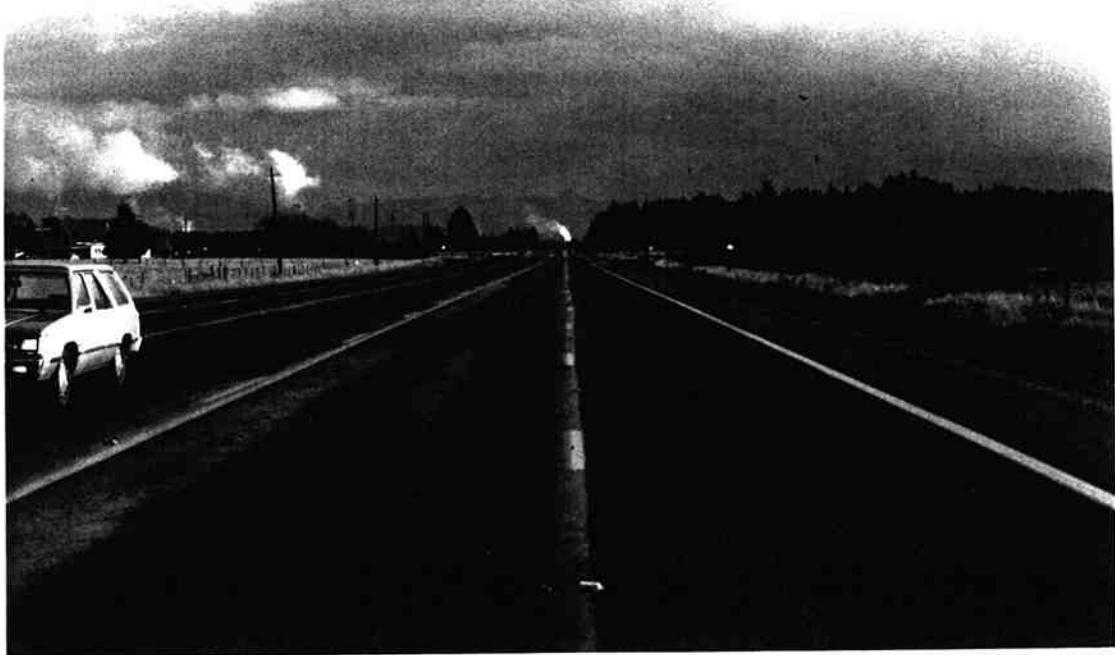
(a) Station 1194+23.5, Eastbound passing and travel lane

- 1) Station 1193+53.5 in the Eastbound passing lane. The surface condition was rated good.
- 2) Station 1194+23.5 in the Eastbound passing lane. The surface condition was rated bad.
- 3) Station 1194+23.5 in the Eastbound travel lane. The surface condition was rated good.
- 4) Station 1206+31.5 in the Eastbound travel lane. The surface condition was rated good.

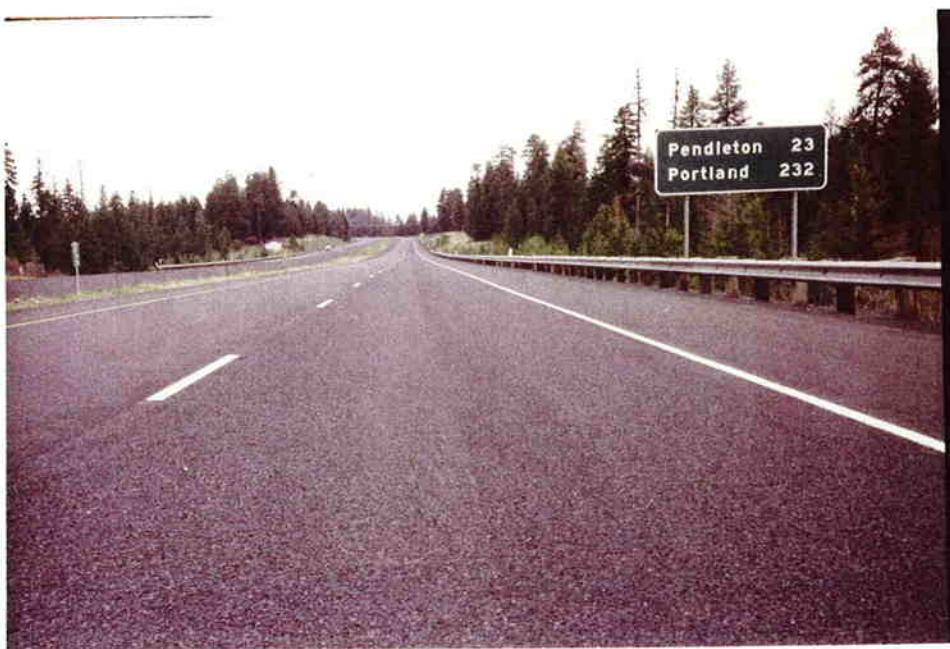
(a) Westbound, MP 233 (looking West)

- 1) Milepost 233 in the Westbound travel lane. There were minor wheel-track ruts (1/8 inch) and the surface condition was good.
- 2) Milepost 223.6 in the Eastbound travel lane. There was little or no rutting and the cores were taken adjacent to a patch (raveling problem). Some flushing was noted.
- 3) Milepost 223.64 in the Eastbound travel lane. The surface condition was rated good with no wheel-track rutting. Some flushing was noted.

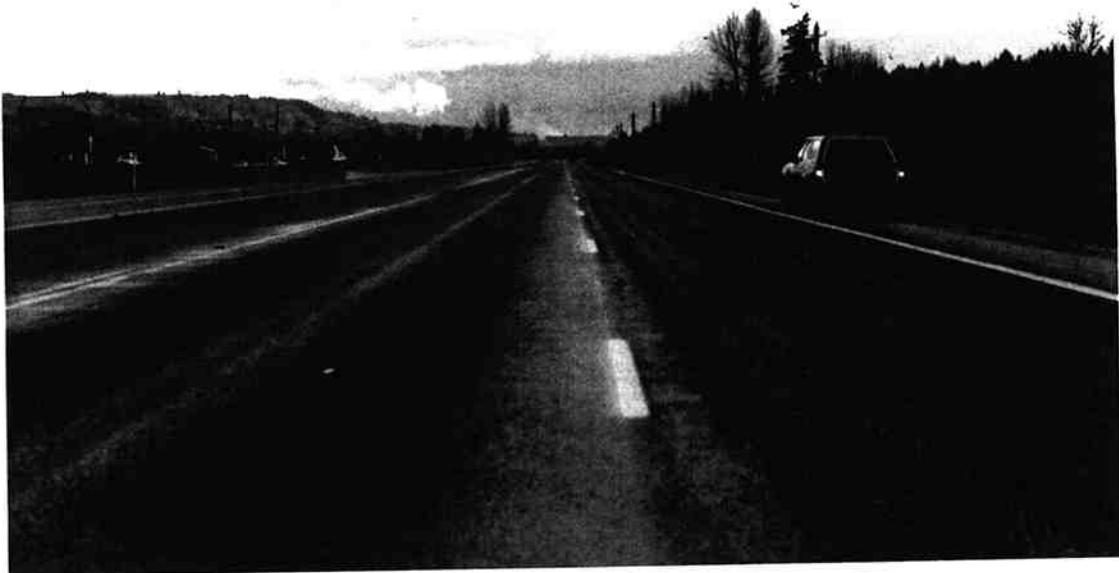
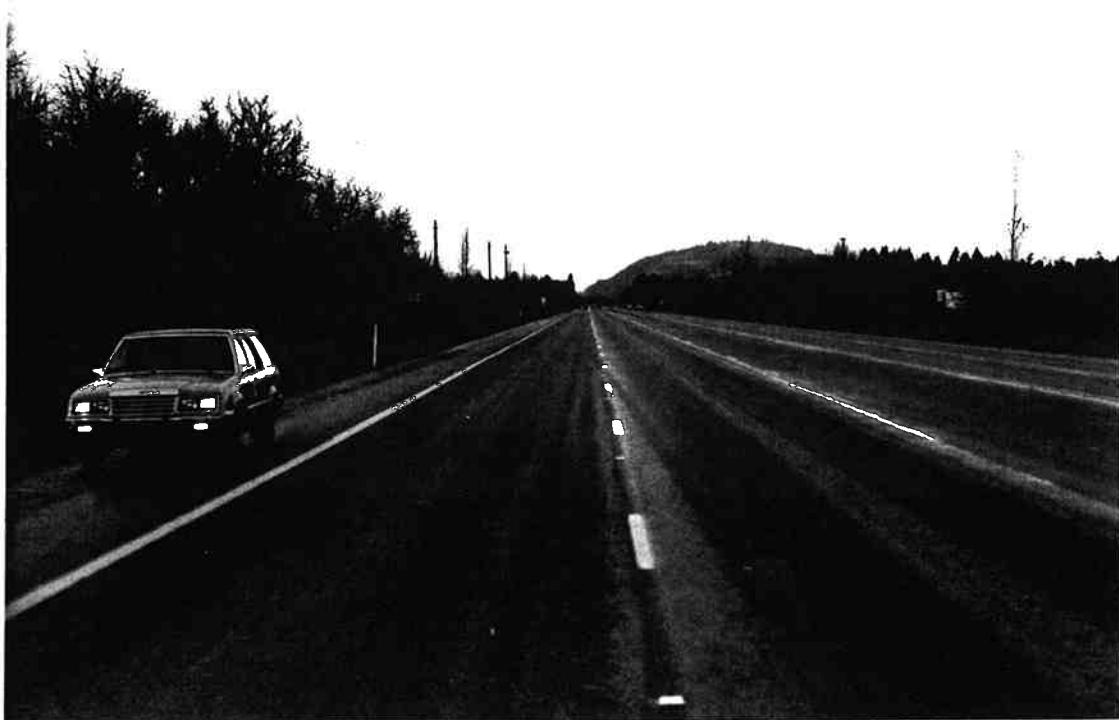
Figure A.4. Photos of Vail Creek-Nylund Road.

- 1) Station 1125+03.5 in the Eastbound travel lane. The condition of the pavement is rated as good.
- 2) Station 1131+68.5 in the Eastbound travel lane. The condition of the pavement is rated as raveled.
- 3) Station 1131+69 in the Eastbound passing lane. The condition of the pavement is rated good.
- 3) Station 1137+52 in the Eastbound passing lane. The pavement was rated as bad.

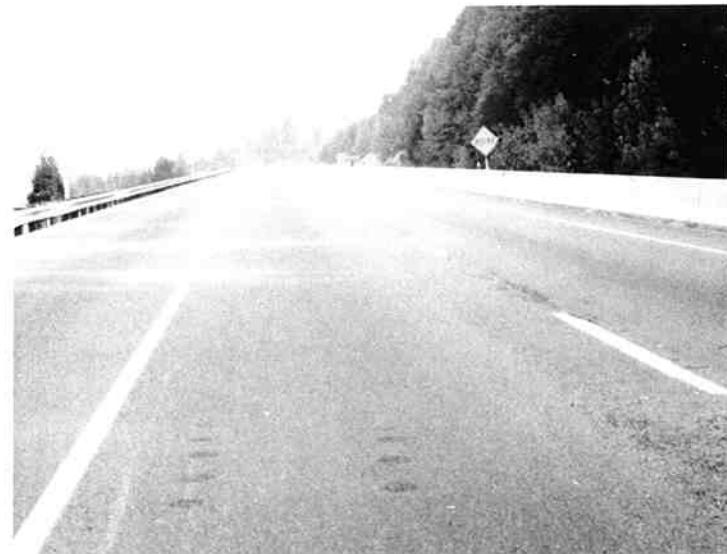
(a) Milepost 69.5, Southbound Lanes

- 1) Milepost 69.5 in the Southbound travel and passing lanes. The pavement condition was rated as good.
- 2) Milepost 68.5 in the Northbound lanes. The surface condition was rated as bad.

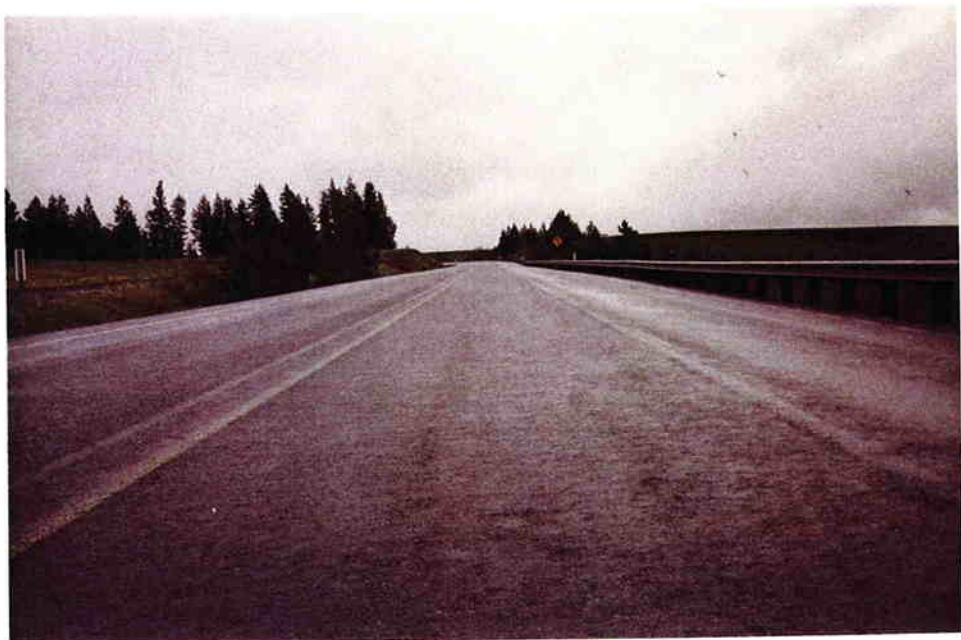
(a) Milepost 5.30 (looking East)

- 1) Milepost 5.3 in the Eastbound travel and passing lanes. The condition of the pavement is rated good with only slight flushing and wheel-track ruts.
- 2) Milepost 4.25 in the Southbound travel and passing lanes. The overall condition of the pavement is very good.

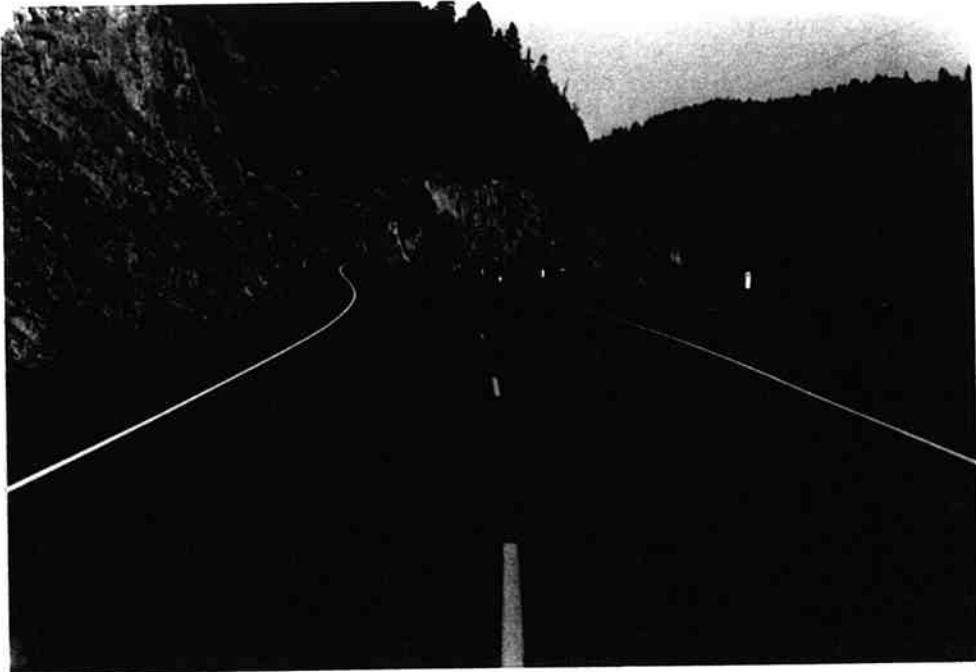
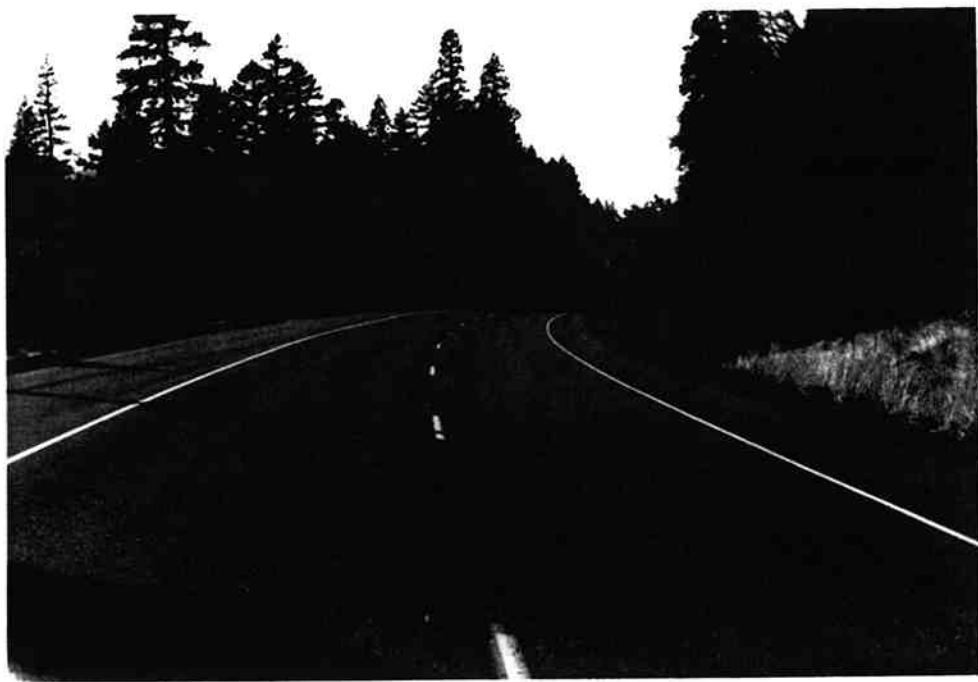
Figure A.7. Photos of Hanley Ranch-Fish Lake Project near MP 21.7.

This project is a two-lane section of highway on State Highway 140 with an ADT of 1745. The cores for this project were taken in the Westbound lanes (Milepost 21.5) just at the start of a taper section from a three-lane to a two-lane road. There were the following types of distress noted:

- 1) wheel-track rutting of 1/16 to 1/4 inch,

- 2) minor loss of fines in the wheel-track and at the construction joint 2 feet left of centerline,
- 3) no flushing,
- 4) no cracking, and
- 5) overall condition of the pavement is good.

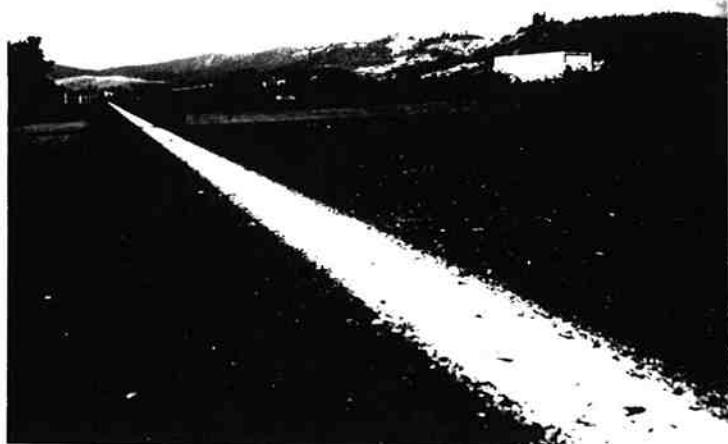
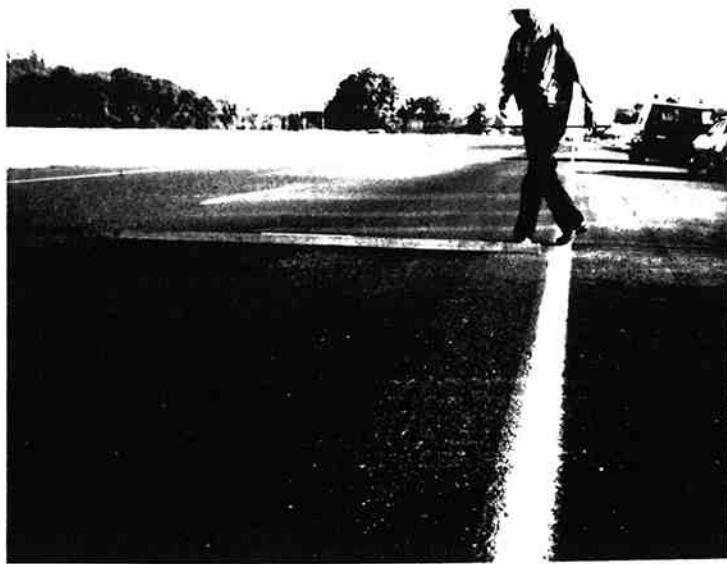
Figure A.8. Photos of Elkhead Road-Rice Hill.

- 1) Milepost 151.70 in the Northbound travel and passing lanes.
The pavement has visible distress in less than 10% of its area with wheel-track ruts of 1/8 to 1/4 inch.
- 2) Milepost 149 in the Northbound lanes. This section also exhibited wheel-track rutting.
