1. Report No. <b>FHWA/LA.11/477</b>		2. Government Accession No.	3. Recipient's Catalog No.
4. Title and Subtitle <b>Evaluation of Continuity Detail for Precast Prestressed Girders</b>		5. Report Date <b>August 2011</b>

# **Evaluation of Continuity Detail for Precast Prestressed Girders**

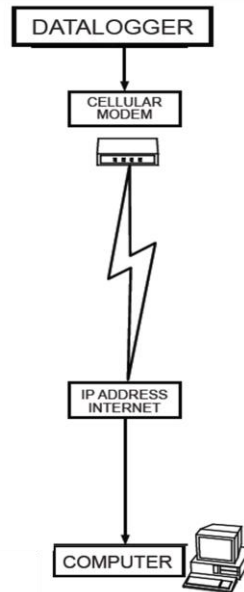
**Figure 11**  
**Communication between the datalogger (station) and the server**

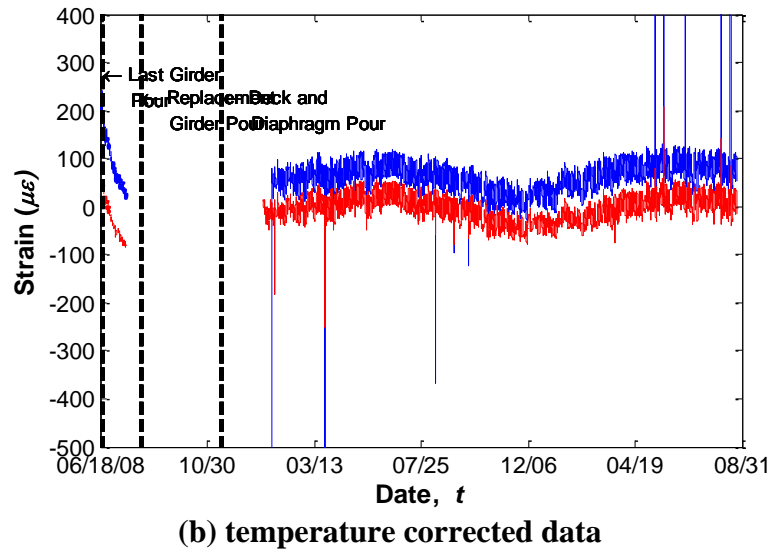
**Figure 13**  
**Temperature correction**  
**Sensors #88(ES) and #92(EC) in G3 (bottom) at Midspan 24**

**Temperature Correction.** The manufacturer of the vibrating wire gages used in this study recommends correcting the recorded raw data to account for temperature variations that affect the length of the vibrating wire inside the gages, and hence, affecting its readings. Temperature corrections were applied to all the sensors used in this study except for tiltmeters, for which temperature correction is not highly recommended. Figure 13 shows a plot of raw and temperature corrected data for a sisterbar and a strandmeter at the same

location (bottom of Girder 3 in the middle of Span 24). It can be seen in Figure 13(a) that the recorded raw data are quite different. This is mainly due to the different characteristics of both sensors such as different gage lengths. Figure 13(b) shows that once the temperature correction is applied, the trend and range of variations from both sensors match very well. The shift between the reading may be due to the condition at the initial stages when the girder concrete was poured. If another datum is chosen, the shift between the relative strain recorded by both sensor types would drop substantially.

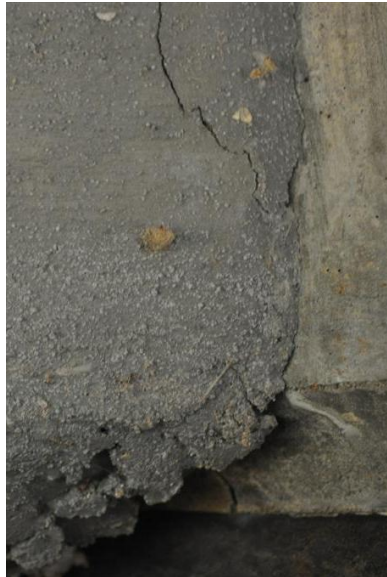
**(c) November 5, 2010 (at Bent 25)**

**Figure 32  
Observed crack at bottom flange of Girder G3 – Span 24**

The strains at the girder's bottom flanges were also investigated to understand the dissipation of these high strains in the hairpin bars 18 in. away from the continuity diaphragm's face, which is where the vibrating wire gages were installed (top, middle, and bottom). Figure 33 shows the strain records from the surface mounted gages on the bottom flanges on Girders G1, G3, and G5 on both sides of the continuity diaphragm, i.e., Span 23 and Span 24. It can be seen that the daily strain changes are about 30-40  $\mu\epsilon$  for all locations except for Girder G3 (both sides) and Girder G1 (Span 24) where the daily strain changes are about 70-80  $\mu\epsilon$ . By comparison with the readings from the strandmeters on the hairpin bars, the changes are much less in all cases. The drop in daily strain changes at the surface-mounted VW gages can be attributed to the fact the tensile force in the hairpin bars has been distributed into a larger area of the girder 18 in. from the diaphragm face. At girder ends, the hairpin bars are the sole resistance of tensile forces. Because Girder G3 is cracked at the face of the diaphragm, the tensile force is still mainly resisted by the hairpin bars. However, because no further cracks took place in the girder beyond the observed crack inward, the tensile force is effectively distributed into the girder. The high strain changes from the surface-mounted VW gage on Girder G1 (Span 24) is also higher than G5 and G1 (Span 23), which may indicate that a crack has taken place at this location. Visual inspection has not revealed any cracks at this location.

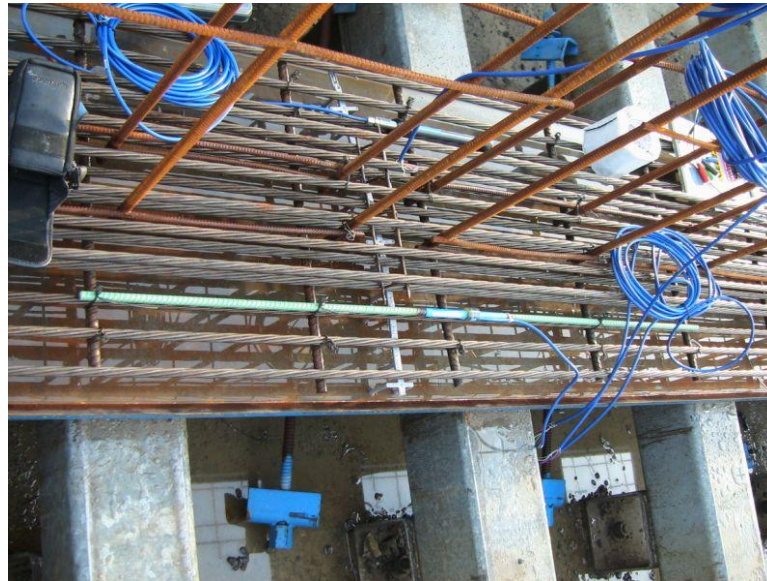
**Figure 44**  
**Sisterbar installed next to a prestressing strand at midspan**

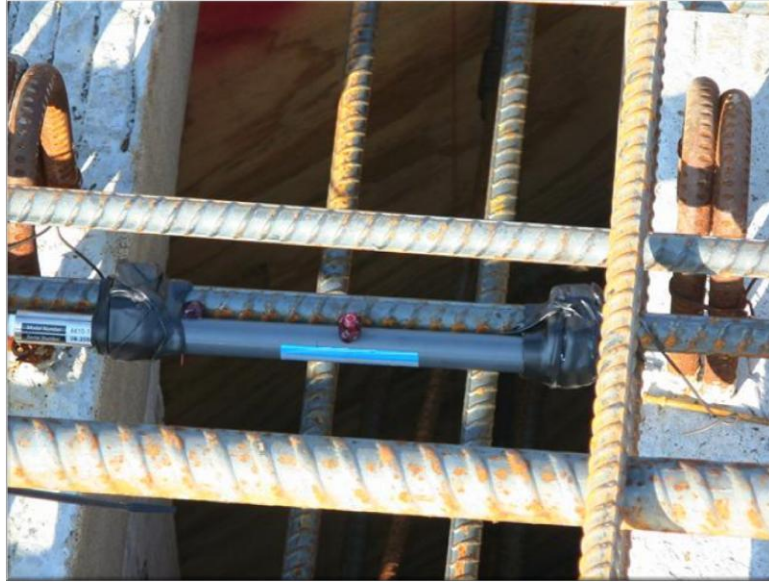
**Figure 45**  
**Strandmeters installed on reinforcing bars in deck over continuity diaphragm**

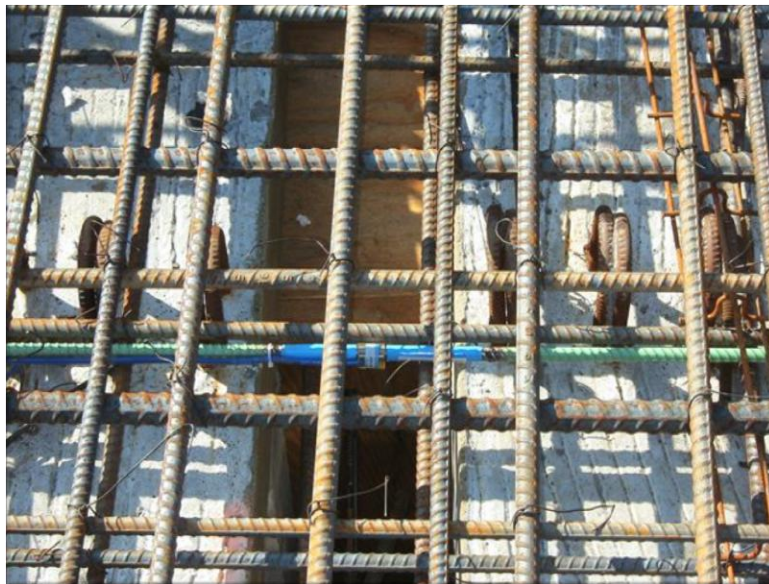
**Figure 46**  
**Sisterbars installed next to reinforcing bars in deck over continuity diaphragm**

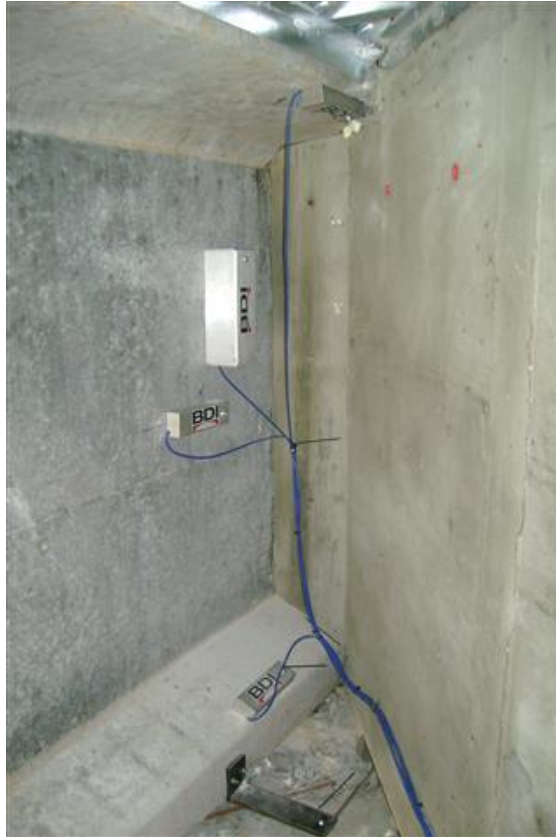
**Figure 47**  
**Surface-mounted sensors (vibrating wire gages and tiltmeters) at girder ends**

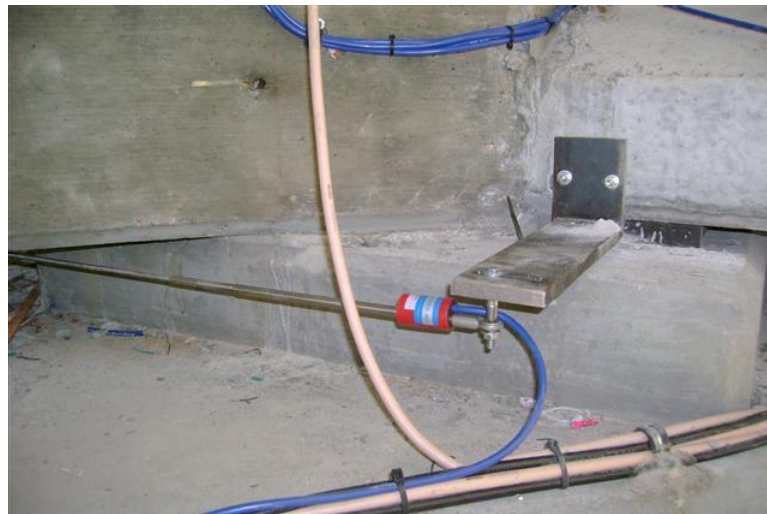
**Figure 48**  
**Gap meter installed on brackets connected to girder ends at continuity diaphragm**

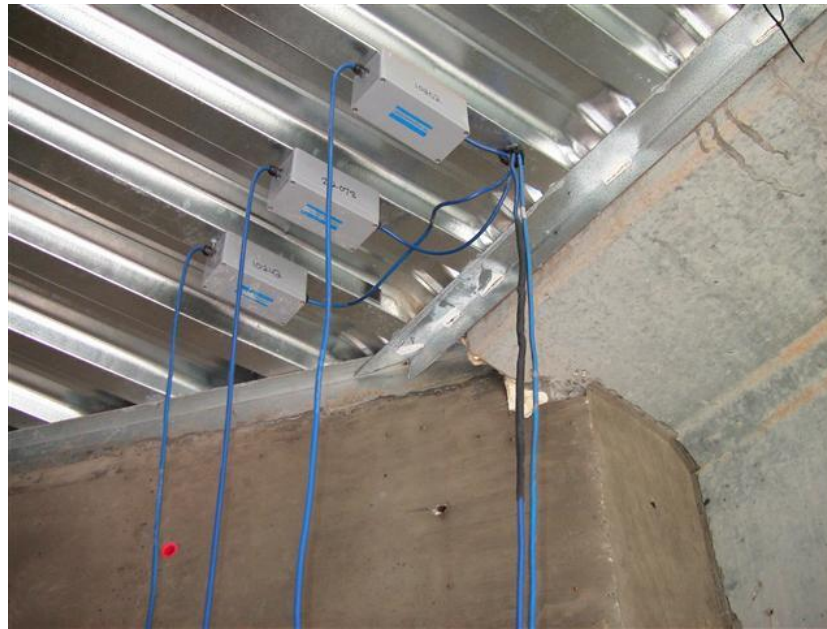
**Figure 50**  
**Surge protectors installed on one of every two embedded sensors at the same location**

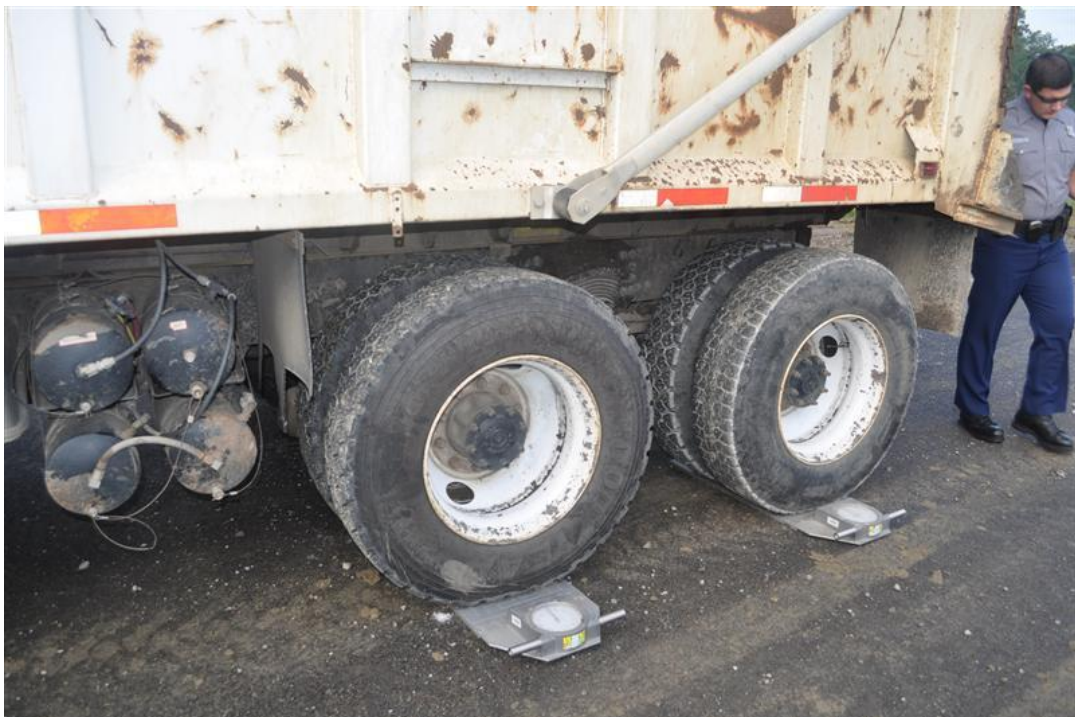
**Figure 131**  
**Portable scales used in weighing individual truck axles**
