# MID-AMERICA TRANSPORTATION CENTER

Report # MATC-UI-UNL: 471/424

## Monitoring the Effects of Knickpoint Erosion on Bridge Pier and Abutment Structural Damage Due to Scour

April 2012

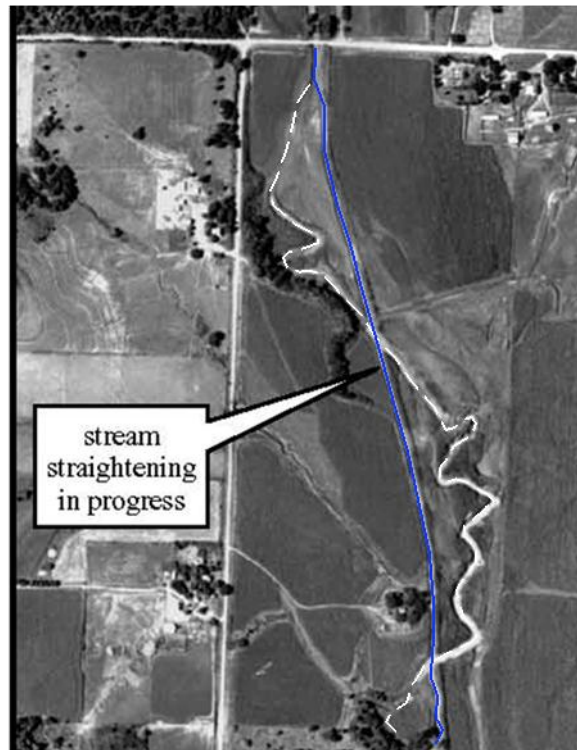
**Figure 1.1 (a)** Channel straightening of Mud Creek, IA in the 1950s. The white line is the original channel. The blue line is the creek after straightening.

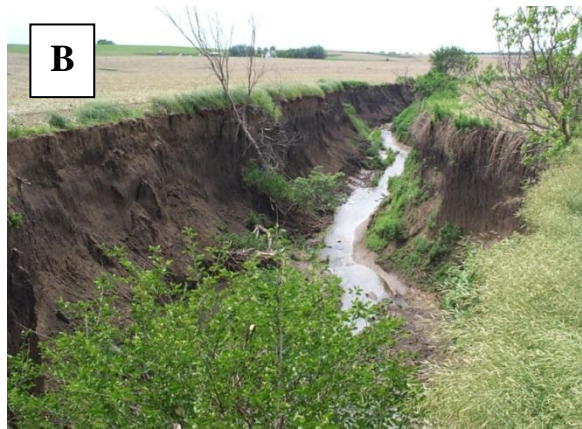
**Figure 1.1 (b)** Channel incision at Mud Creek

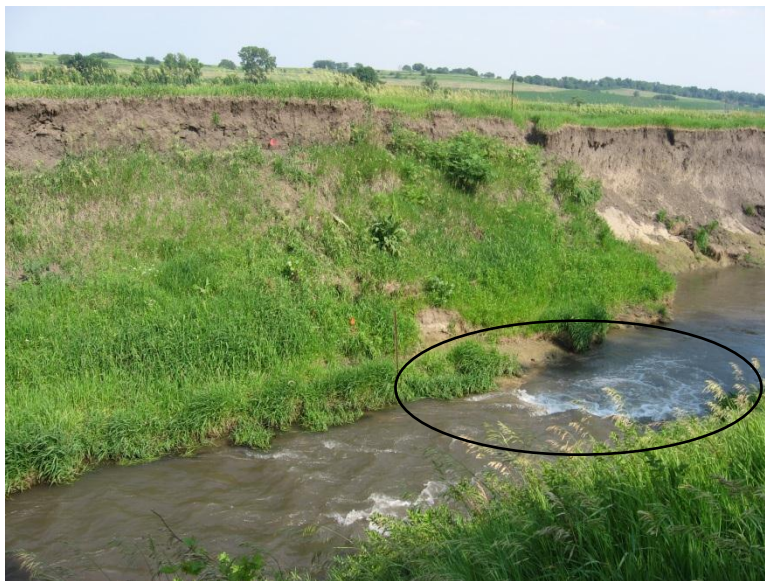
**Figure 1.2** Knickpoint formation. The circled area is a knickpoint in Mud Creek, IA.

Streambed degradation occurs in the loess soils of western Iowa and eastern Nebraska by the formation and headward migration of knickpoints (fig. 1.2). Ongoing research suggests that knickpoints can account for more than 60% of the erosion in the streams where they form (Alonso et al. 2002). In addition, preliminary observations suggest that knickpoints greatly influence the flow thalweg (i.e., line of deepest flow) in small rivers, which is a primary factor contributing to bank erosion and scour.

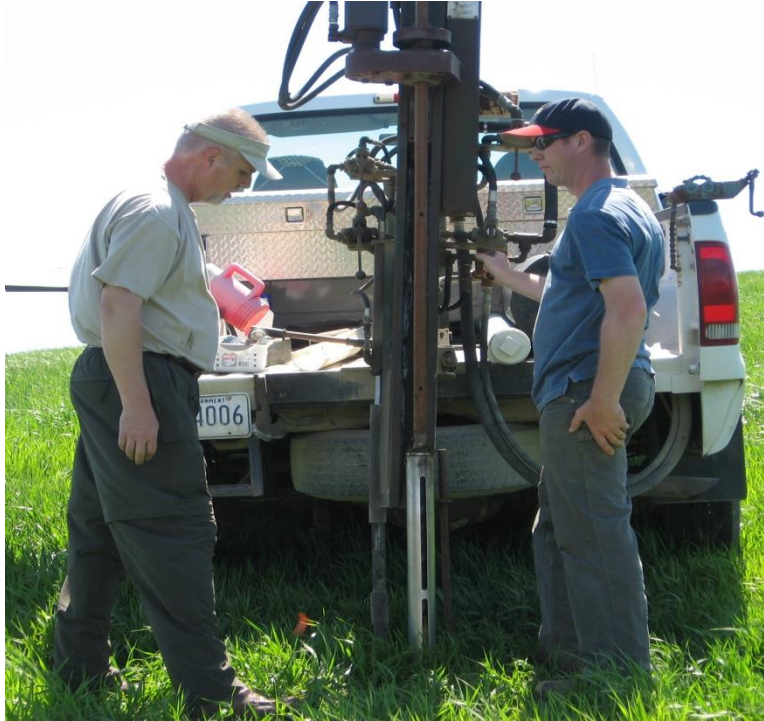
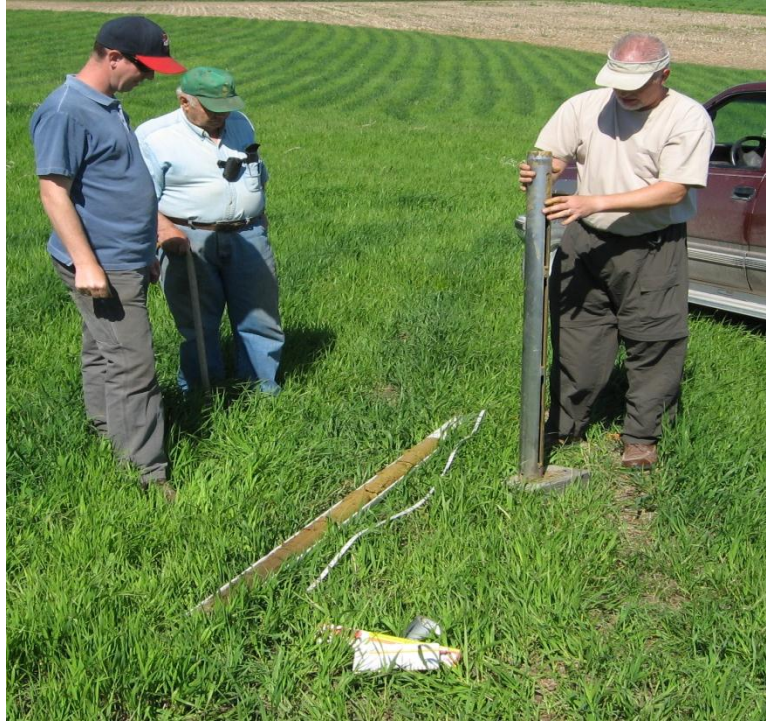
**Figure 3.2** Core collection. Cores from the stream banks near the knickpoint face were collected using a Giddings probe and Shelby tube system (cont'd. next page).

**Figure 3.2 (cont'd.)** Core collection. Cores from the stream banks near the knickpoint face were collected using a Giddings probe and Shelby tube system

Two cores were collected having a 7.6 cm diameter and being approximately 10 m in length from the stream banks along Mud Creek, near the location of the knickpoint face. One core was collected from the east bank, and the other was collected from the west bank. These cores were collected using a Shelby-tube system (fig. 3.2), in conjunction with the U.S. Department of Agriculture – Natural Resources Conservation Service. In addition, eight 2.5 cm diameter cores, approximately 3 m in length each, were collected from the stream bed of the reach containing the knickpoint.

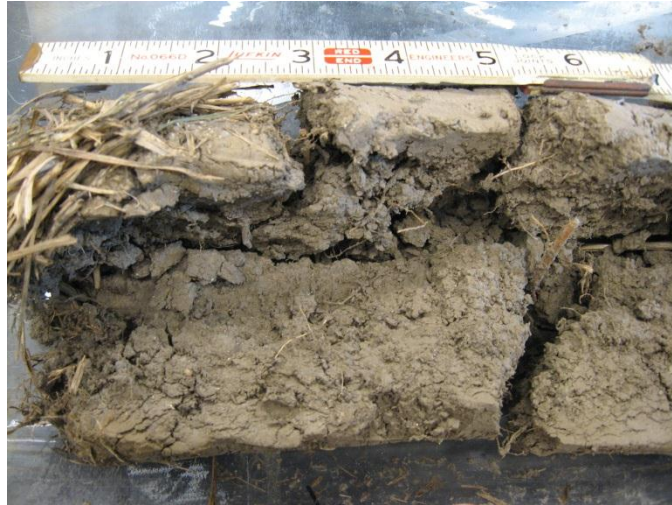
**Figure 3.3** Stratigraphic interpretation. A close-up of the surface section for the stream bank core used in the stratigraphy analysis. The ruler in the image is in inches.

One of the 10 m stream bank cores was classified using a standard stratigraphic interpretation of the Natural Resources Conservation Service (NRCS). The examined soil characteristics during this stratigraphic interpretation included matrix color, soil texture, soil structure, and organic matter (fig. 3.3).

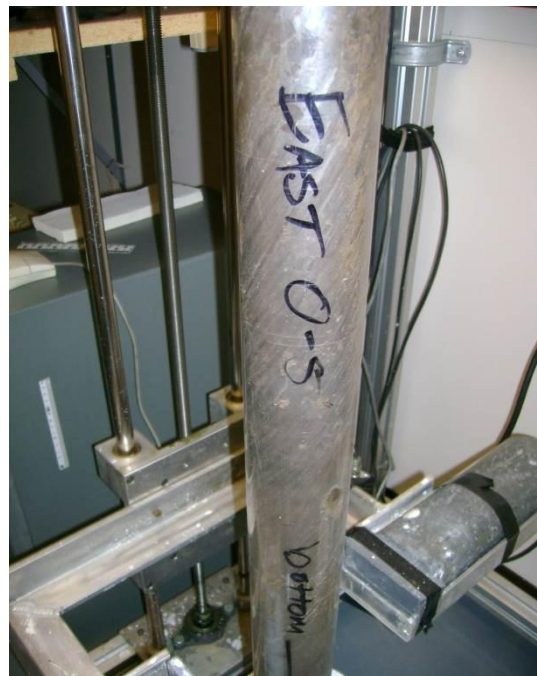
**Figure 3.5** Measuring core bulk density. A section of the stream bank core was placed in a vertical frame. A  $^{241}\text{Am}$  sealed source was moved up and down the core length in conjunction with a gamma energy detector on the other side of the core. The attenuation of the received radioactivity was indication of the core density.

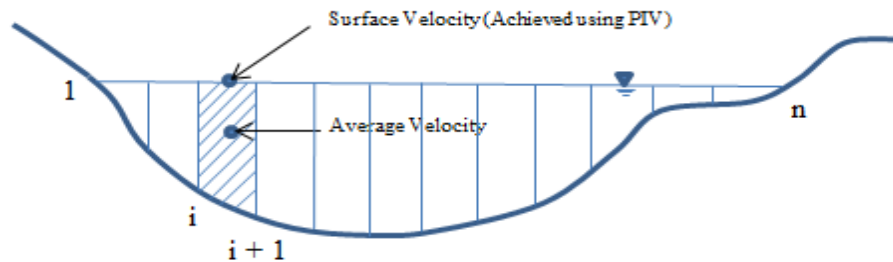
**Figure 3.9** Depiction of subareas associated with interrogation points used for discharge calculations

Using the surface velocity distributions, discharges at the site were also determined for each cross section. To accomplish this, it was assumed that the velocity distribution obeyed the power law. While this assumption was not rigorous, it was likely sufficient in locations where the channel was shallow and wide. Assuming the power law was valid, the mean velocity for each interrogation point would be approximately  $7/8^{\text{th}}$  of the surface velocity. The mean velocity for each interrogation point was then calculated, multiplied by the flow area of the point to obtain the discharge flux associated with the point (see fig. 3.9), and then summed with the fluxes from all of the subareas in the cross section to obtain the discharge in the channel.

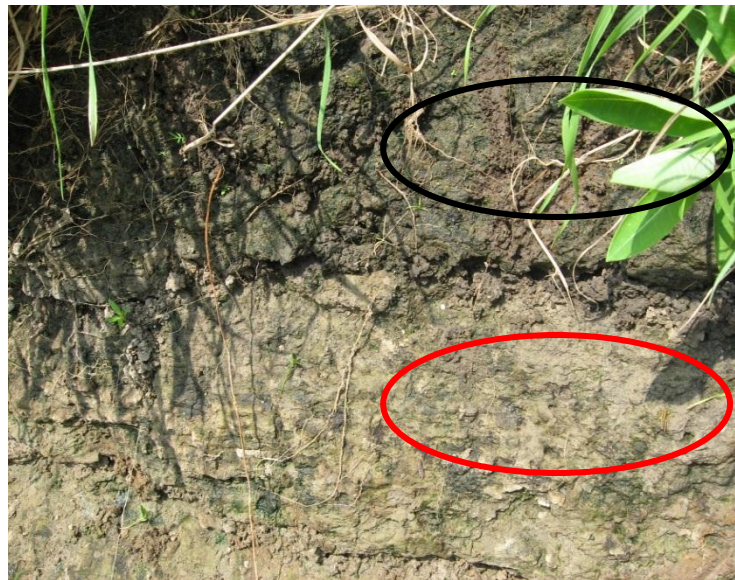
**Figure 4.1** Stratigraphic discontinuity. There appears to be a stratigraphic discontinuity close to the knickpoint with a darker sediment (in the black circle) overlaying a lighter-colored sediment (in the red circle).

A visual analysis of the stratigraphy of the bank soil profile at the knickpoint site in Mud Creek identified a discontinuity that can be seen in figure 4.1. The image distinctly shows two different layers, as well as what appears to be a “fault” between the two layers. This stratigraphic discontinuity is at the same level (i.e., elevation) as the top of the knickpoint face.

Thus, the particle size distribution and soil texture data support the division between the two stratigraphic layers at the study site. The Roberts Creek Member was found in the bank soils, while the Gunder Member was found in the bed sediments. The higher clay content of the Roberts Creek Member caused (at least partially) the darker soil color relative to the Gunder Member of the bed sediment (fig. 4.1). The Gunder Member also trended from loam to sandy

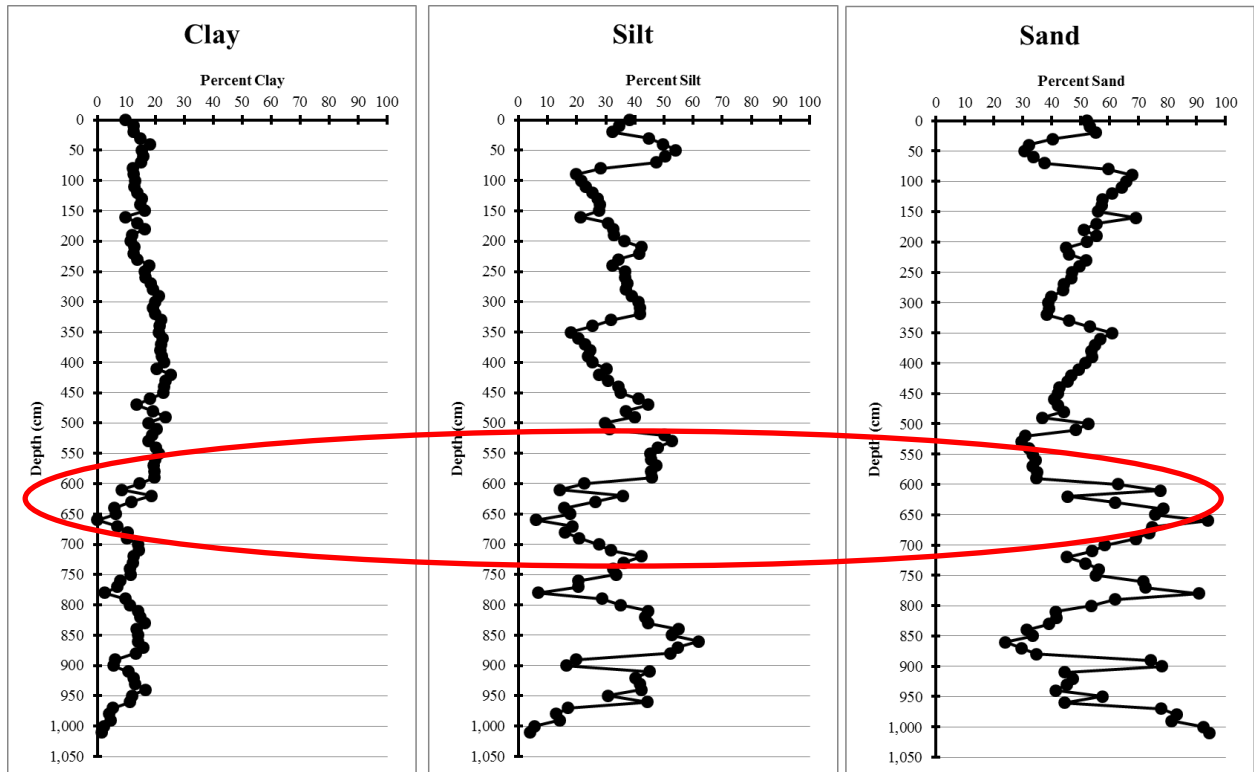
**Figure 4.3** Soil texture. The percentages of clay, silt, and sand for each depth interval of a stream bank core from the study site. The red circle highlighting the 600-650 cm depth interval corresponds to a discontinuity in bank stratigraphy. This discontinuity corresponds to the top elevation of the knickpoint face.

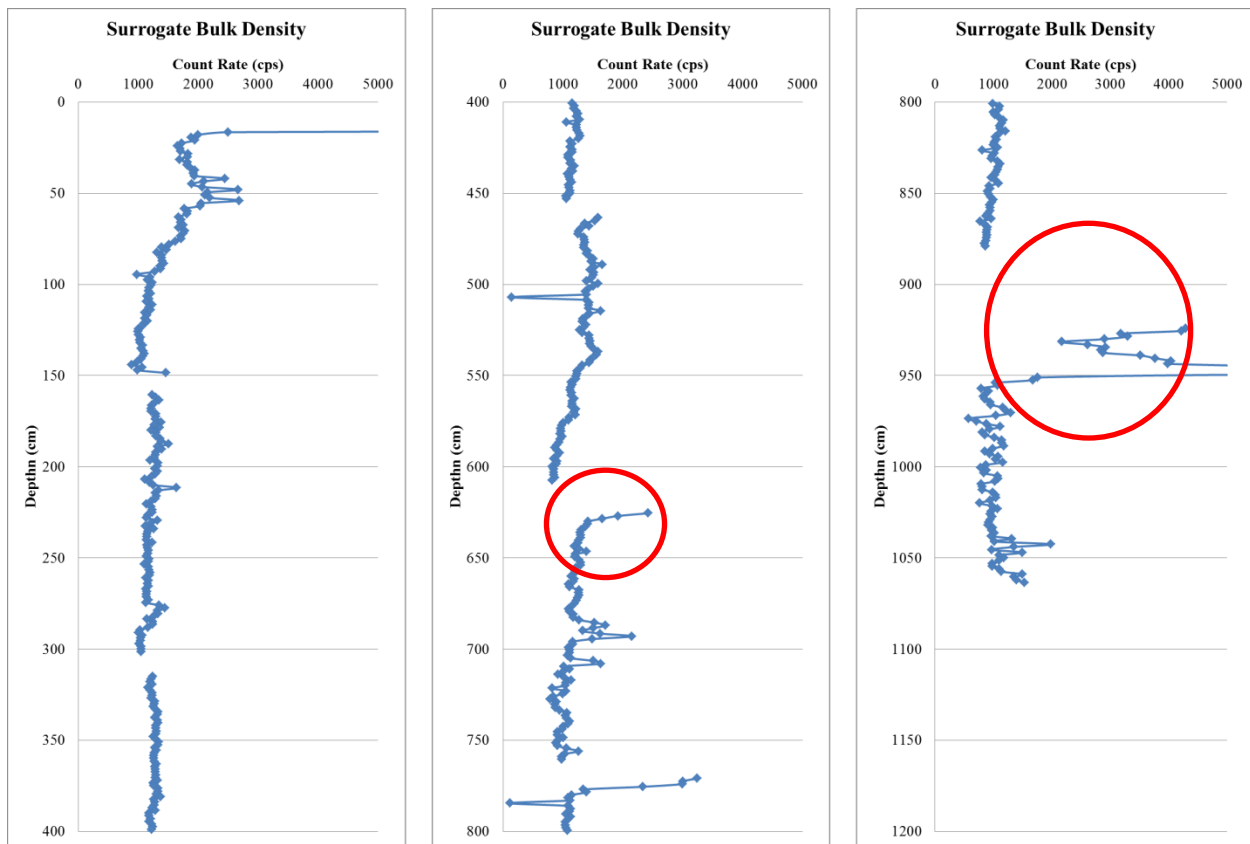
**Figure 4.6** Surrogate bulk density. The density of a stream bank core was measured using the attenuation of a gamma radiation source. These graphs show the depth profile of attenuation count rates for a stream bank core. A high count rate translates to high transmission of the gamma source through the core, so that depth interval will have a lower bulk density. The red circles highlight shifts in the depth profile.

The second, intact, 10 m core from the stream bank was used in the next set of analyses. A radioactive  $^{241}\text{Am}$  sealed source and NaI detector were used to determine the porosity/density of this second core. Figure 4.6 shows the depth profile of the attenuation count rates determined as a result of this analysis.

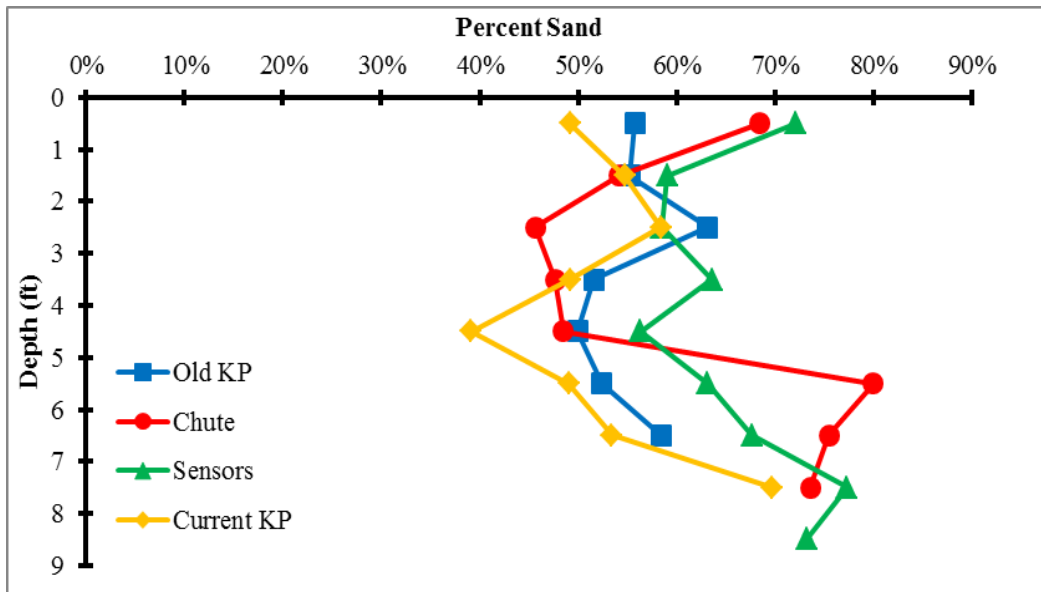
**Figure 4.7** Stream bed cores. The depth profile of the percent sand of cores collected along a transect of the stream bed reach near the knickpoint. The zero level represents the top of the knickpoint face. Old KP represents the core furthest downstream where the knickpoint was in 2009. The transect moves upstream as follows: Chute -> Sensors -> Current KP. There appears to be no difference in the depth profiles; however, there is a coarsening four feet below the surface.

Finally, additional cores were collected from a longitudinal transect in the stream channel from the current location of the knickpoint and moving downstream. A quick analysis of the percentage of sand-sized particles in these cores was conducted to identify any change as the knickpoint migrated upstream. Figure 4.7 shows four cores collected in the transect. There was no significant change (either fining or coarsening) in the cores moving upstream from the location of the knickpoint in 2009 (Old KP) to the Chute, then Sensors, then current knickpoint locations. However, there was a coarsening at depth, approximately 4-5 ft (122-152 cm) below the top of the knickpoint. This was the approximate location of the scour hole floor immediately downstream of the knickpoint face, based on visual observations and prior geodetic surveys.

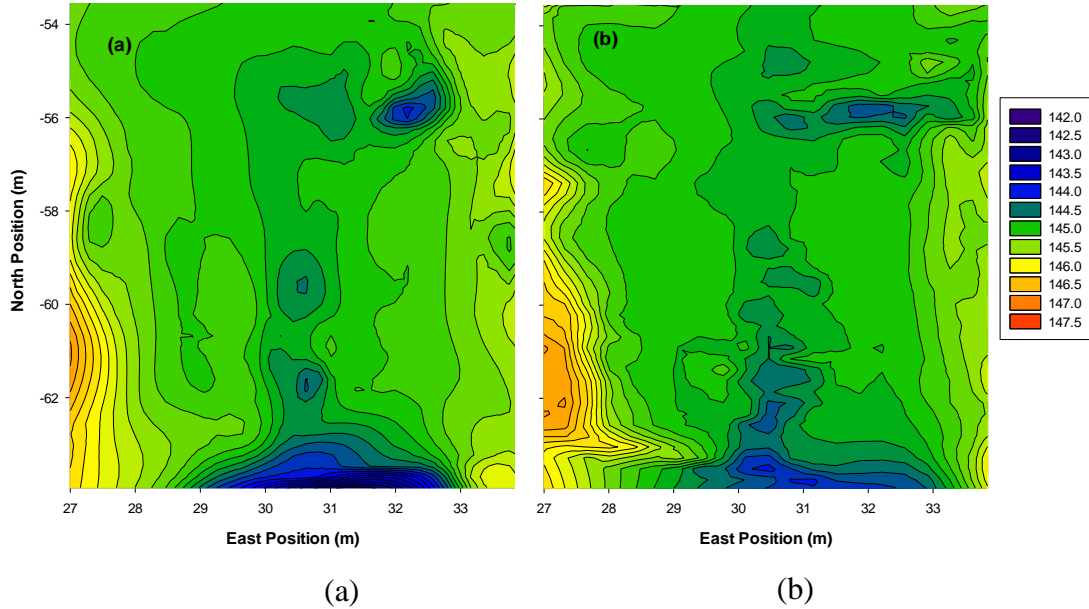
**Figure 4.9** 50 cm contours for surveyed data for (a) September 27, 2011, and (b) March 21, 2012

Extensive survey data sets collected on September 27, 2011 and March 21, 2012 were transformed into the contour plots shown in figure 4.9. The east and north positions given on the x and y axes of figure 4.9 are relative to an arbitrary benchmark located on the southwest corner of the upstream bridge. The elevations given in the contour plot are also relative to an arbitrary benchmark elevation of 500 ft. Although the position and elevation of the benchmark are arbitrary, the same benchmark was used for both datasets so that elevations in the two plots could be directly compared. The second dataset had a higher resolution of surveyed measurements, particularly along the banks and downstream of the knickpoint, so the detail of the banks and downstream of the knickpoint is more accurate in figure 4.9(b). However, the channel bed and knickpoint locations are well-defined for both datasets.

As noted in figure 4.8, figure 4.9 confirms that between September and March there was not much movement of the knickpoint face. However, the contour plots do show that, though the non-vegetated bed of the channel is about 4 m wide, there is also a deeper, narrow region in the center of the channel that is only about 1 m wide. Though the water surface covers most of the non-vegetated surface of the channel for much of the year, the bulk of the flow travels through the narrow region in the middle of the stream during non-storm events. It is only during large events that the flow is more evenly distributed over the entire face of the knickpoint, and these events have been rare and of short duration during the study period.
