Degradation in Rush, Wildhorse, and Salt Creeks of Washita River in Oklahoma for Transportation Planning

FINAL REPORT - FHWA-OK-09-01

ODOT SPR ITEM NUMBER 2194

Oklahoma Infrastructure Consortium
School of Civil and Environmental Engineering
Oklahoma State University
Stillwater, OK 74078

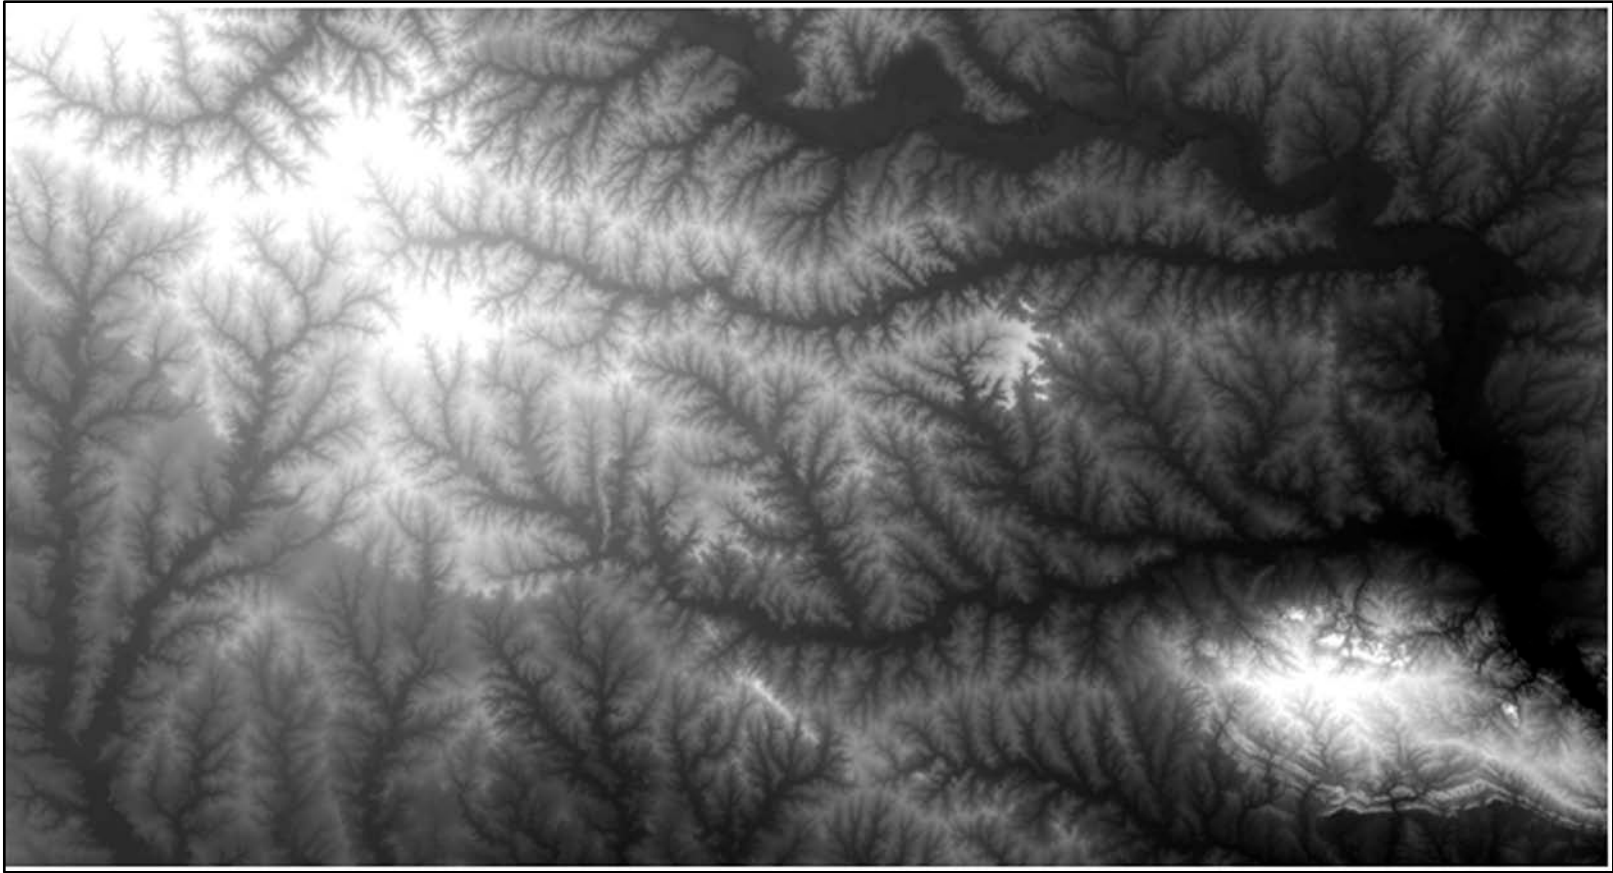
Figure 1. USGS National Elevation dataset for the study area.

The website also provides other GIS data layers besides the NED with excellent graphic interface tools to select data only for the region of interest. From Figure 1, it can be seen that the topography of the area can be clearly identified based on the shaded relief

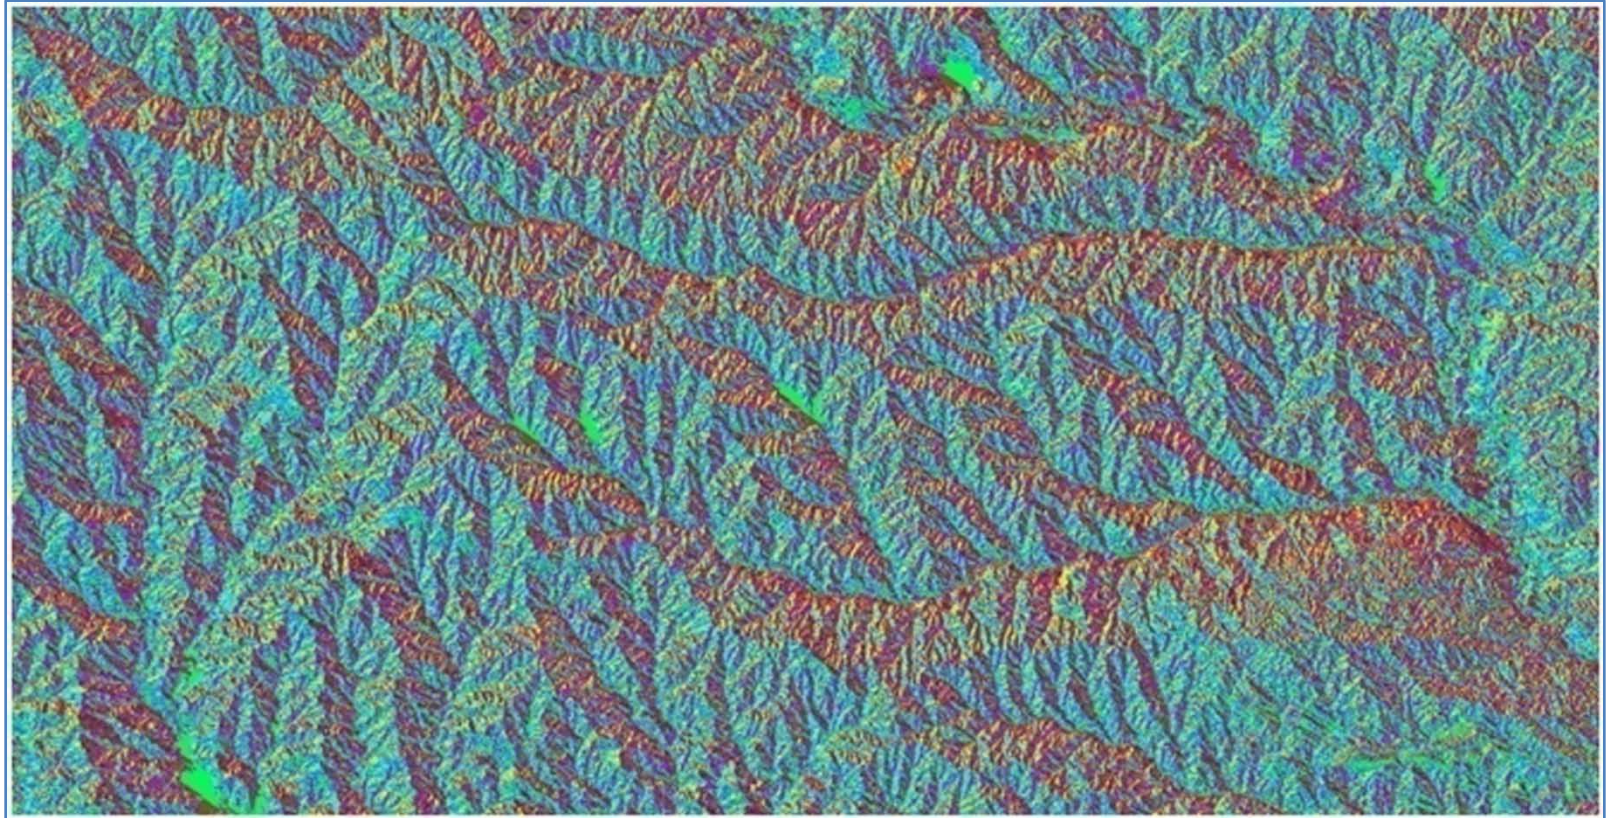
Figure 2. Flow direction Raster Layer.

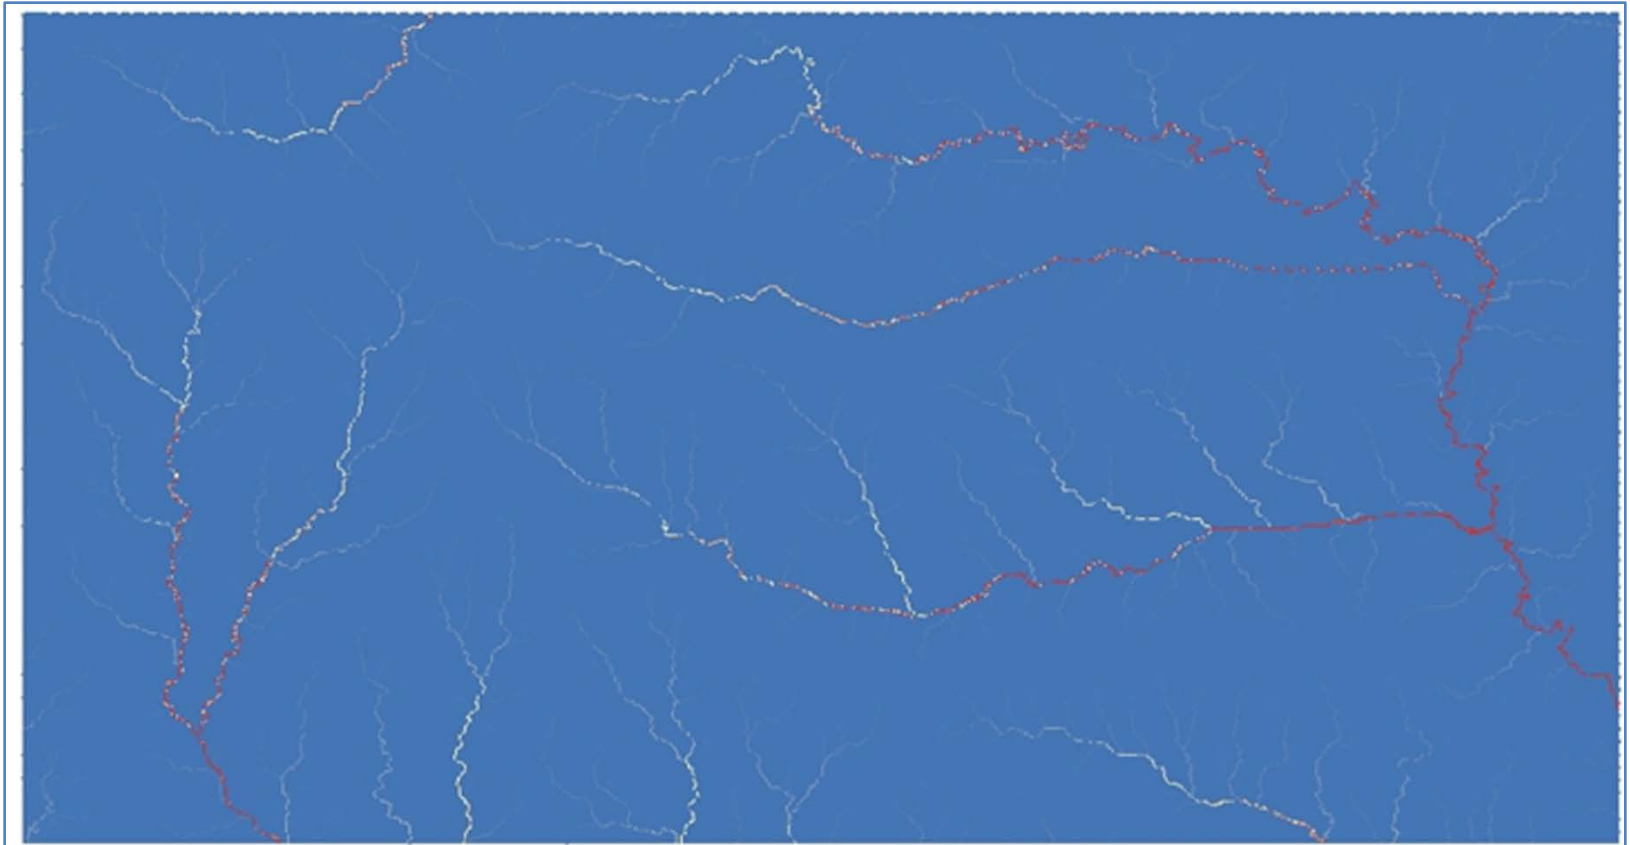
Figure 3. Flow Accumulation Raster Layer.

The Flow Accumulation layer does not participate in the watershed delineation process but is rather used to identify the points of confluence for each of the streams. This identification can be achieved by manipulating the symbology to make the high flow pathways visible. The display of the raster layer is changed from a gray scale image to a classified image with two classes consisting of a break value at “5000”. Now the point that has the highest potential on the stream is clearly highlighted from which a vector layer depicting the pour points or the points of confluence can be created.

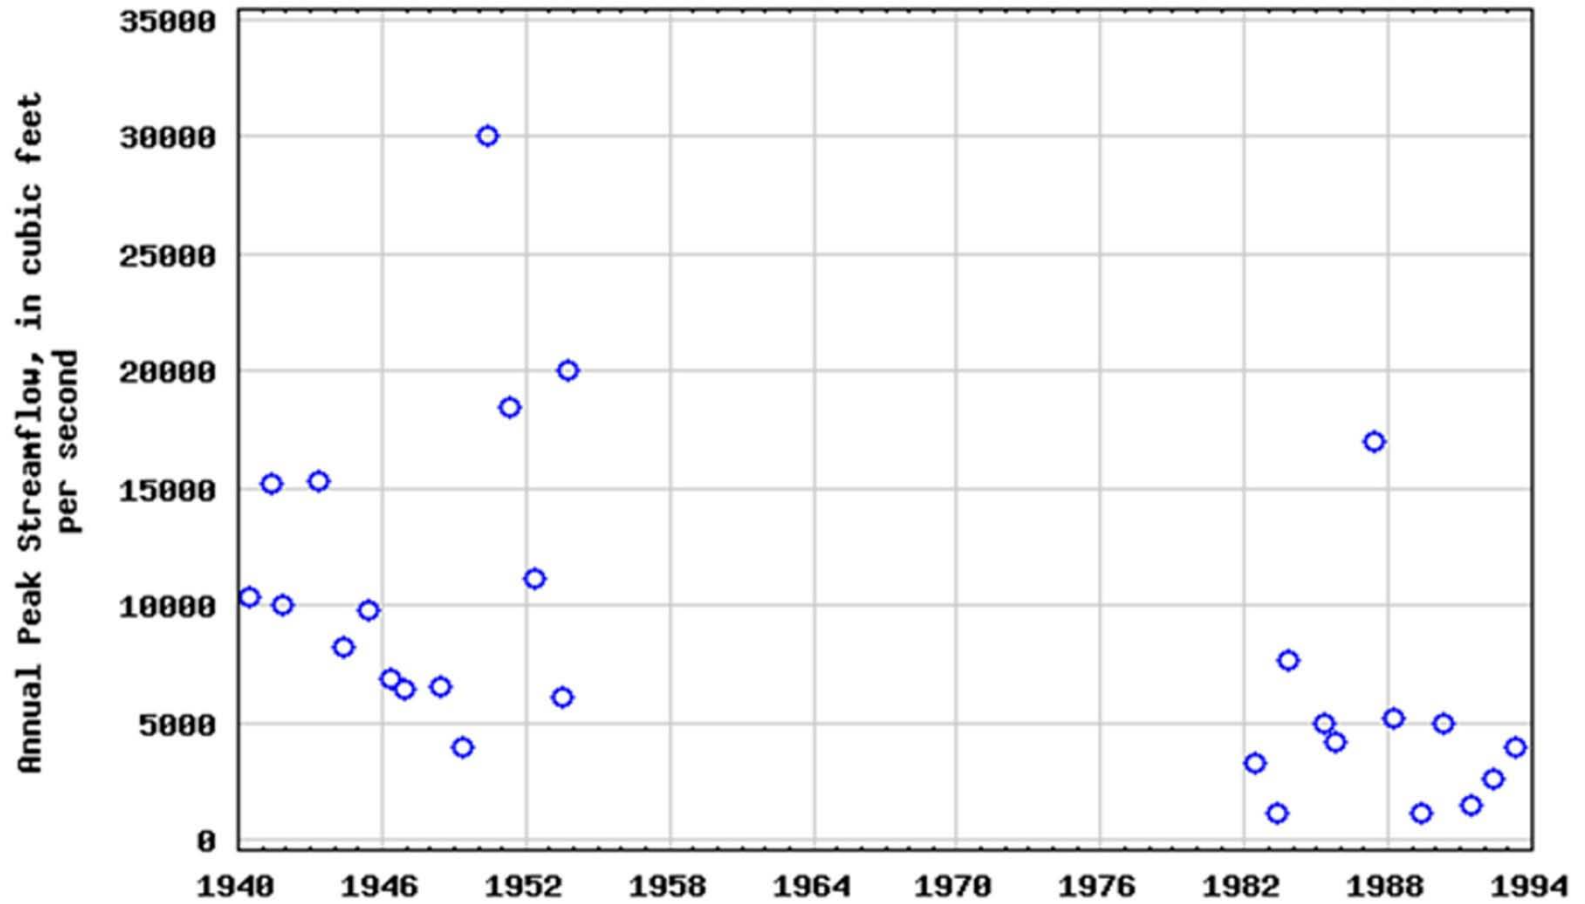
Figure 6. USGS 07329000 Rush Creek at Purdy, OK.

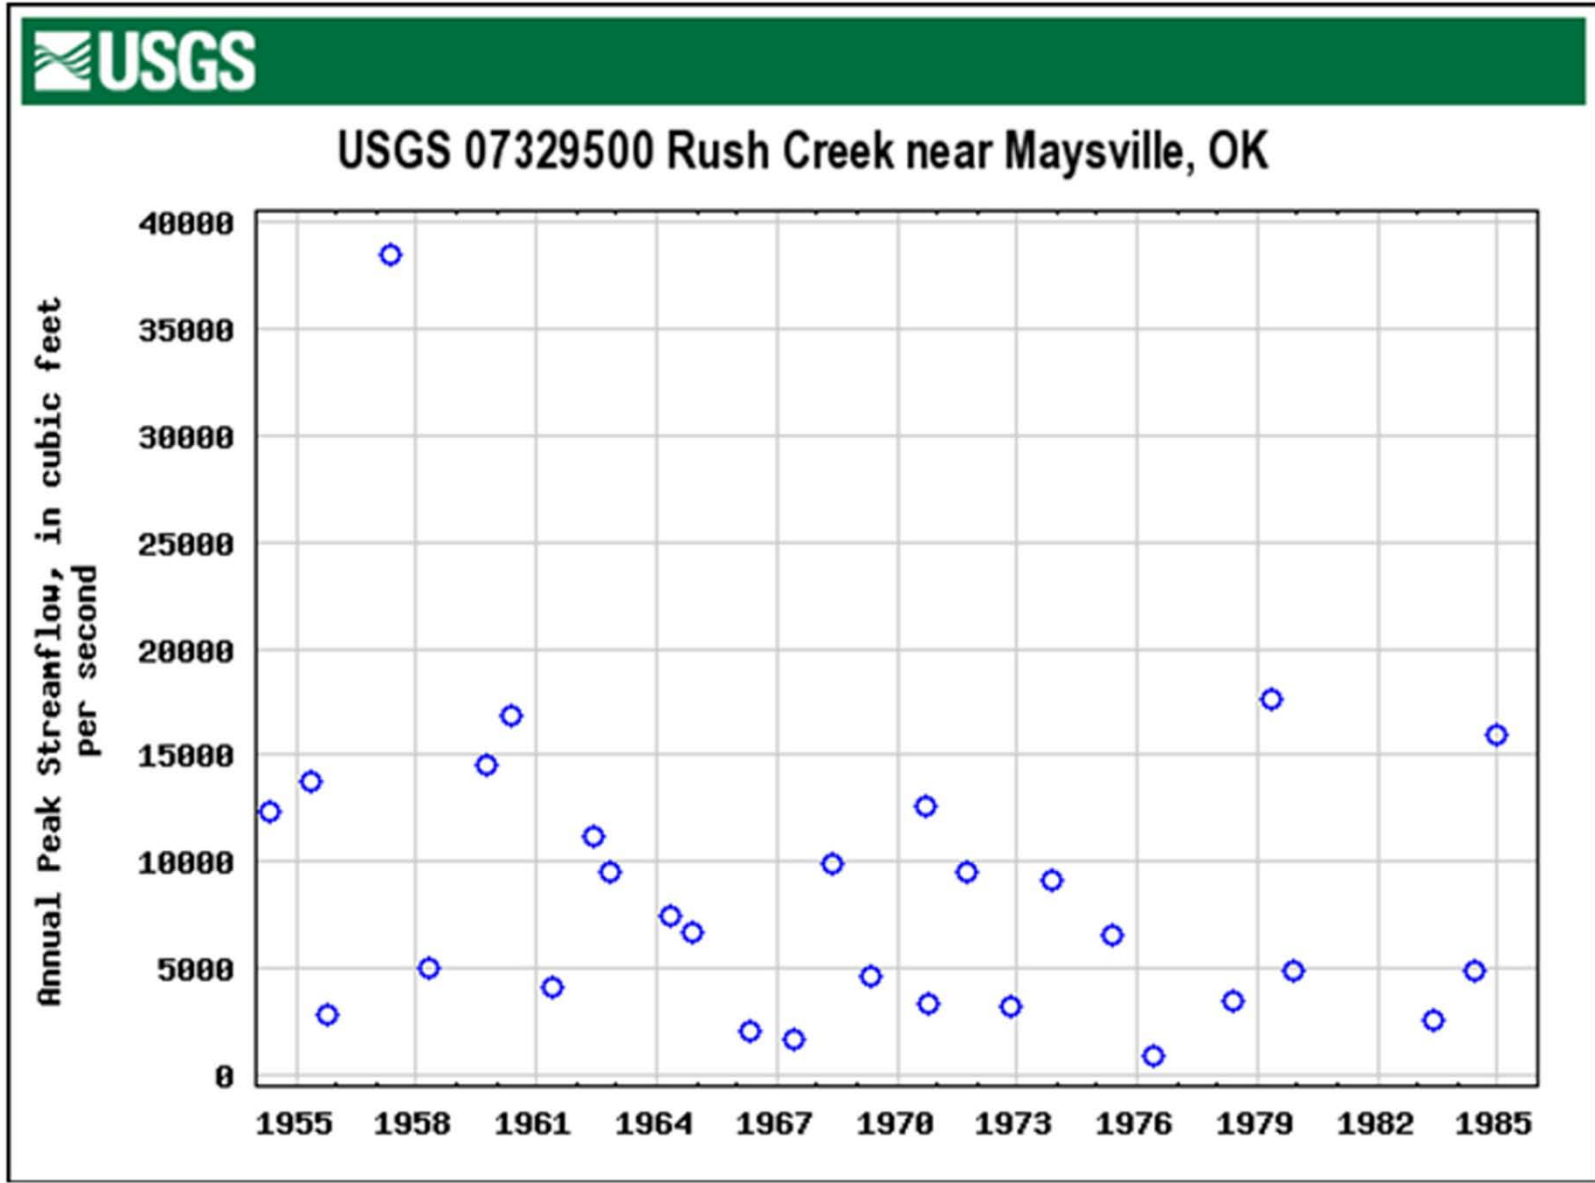
Figure 7. USGS 07329500 Rush Creek near Maysville, OK.

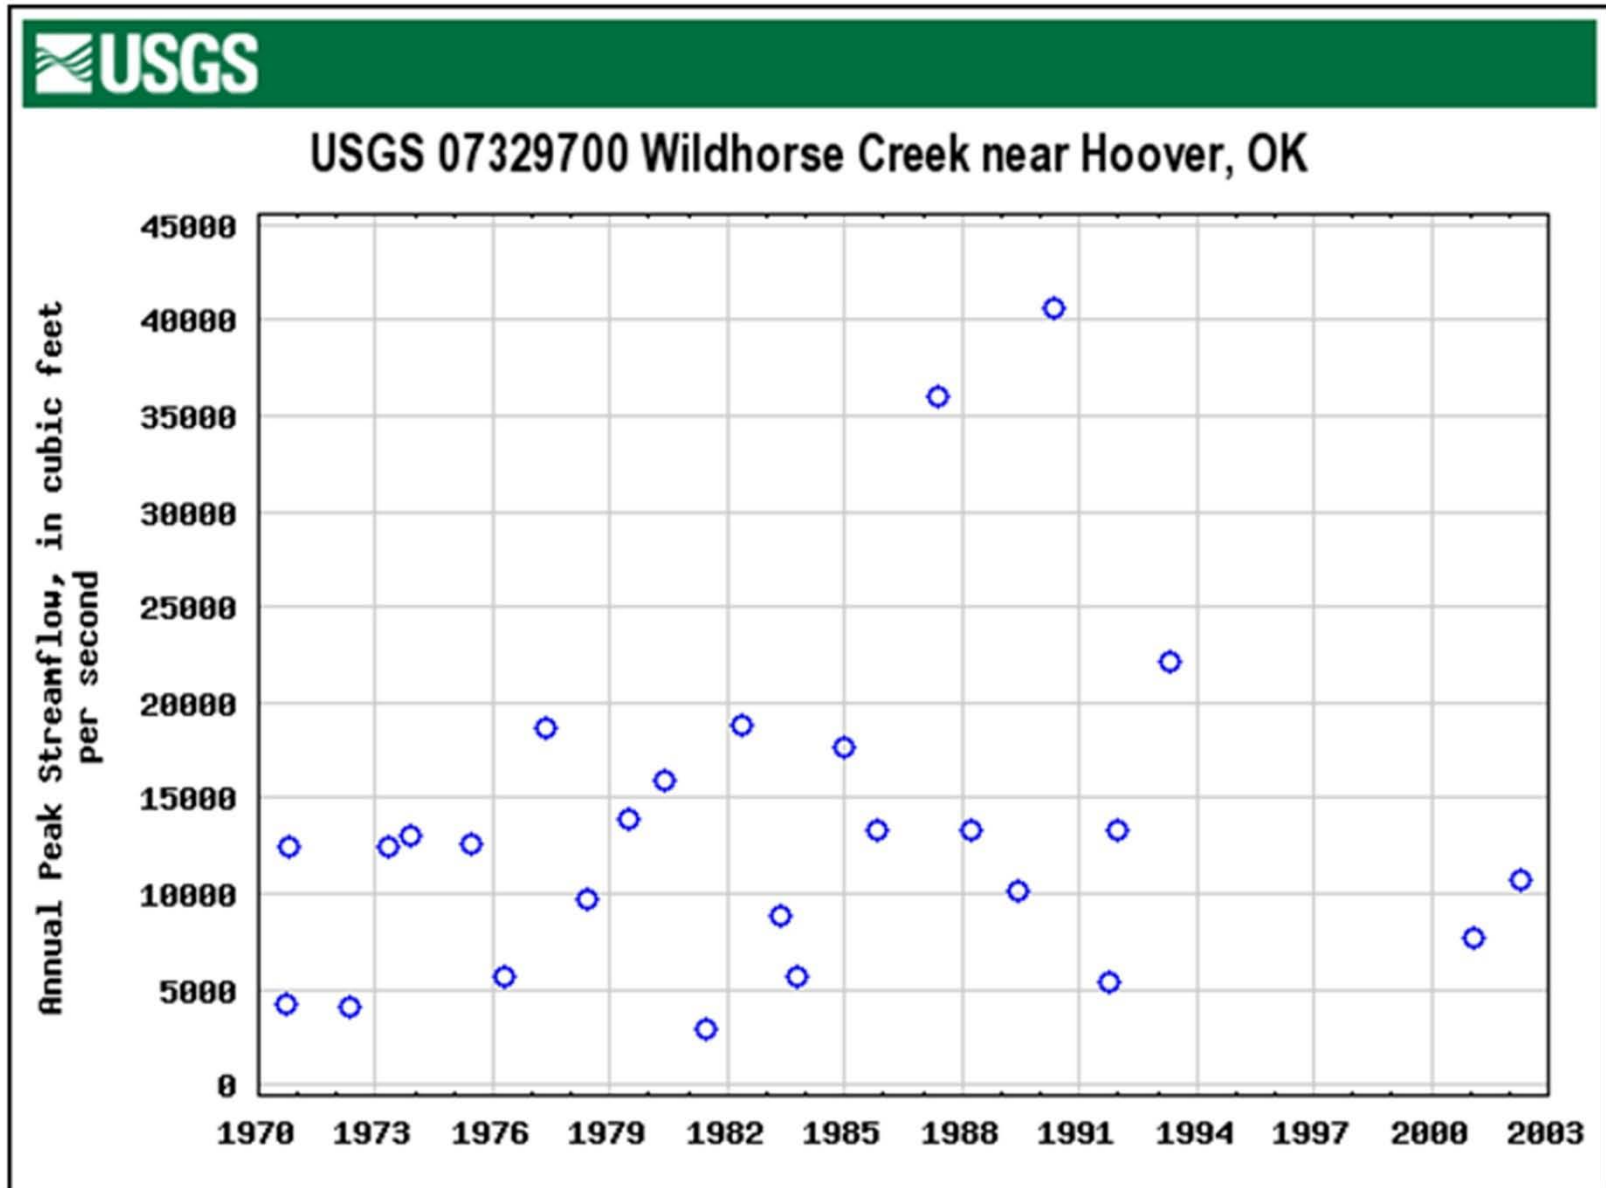
Figure 8. USGS 07329700 Wildhorse Creek near Hoover, OK.

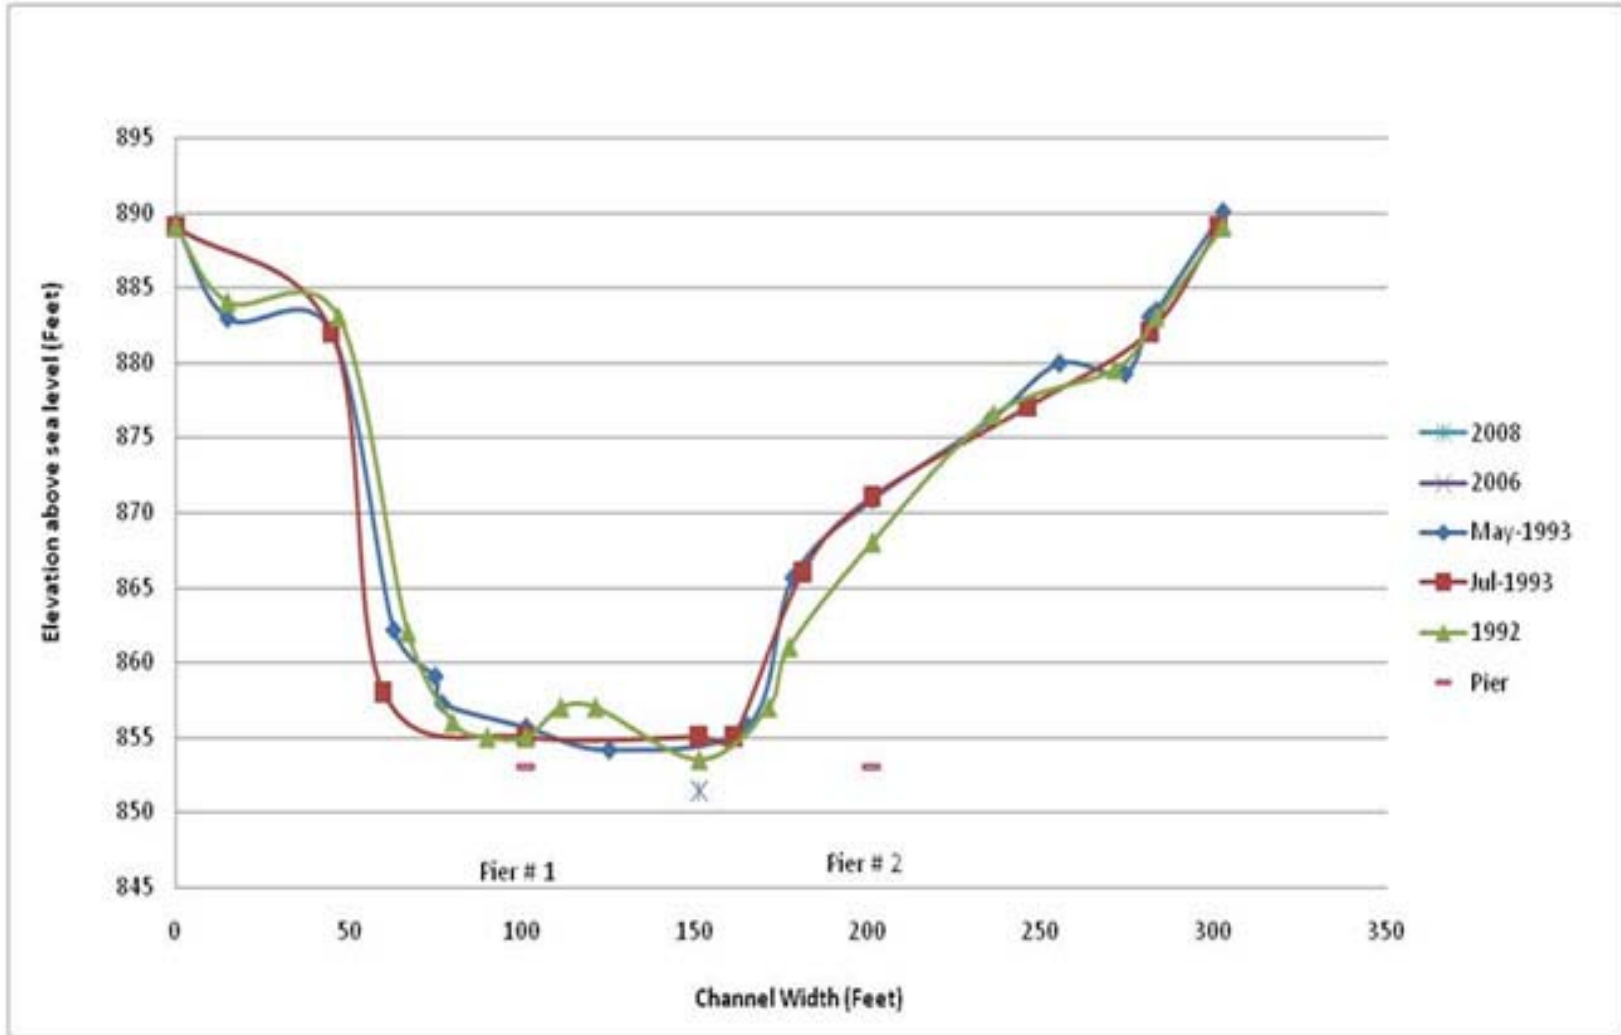
Figure 14. Cross-sectional profile at bridge 17568 on I-35 NB over Rush Creek.

Bridge 17568 on Interstate Highway 35 northbound was built in the year 1969. The location of the bridge is about 6 miles north of the junction of SH 29 and I-35 with the latitude and longitude of $34^{\circ} 43' 55''$ N and $97^{\circ} 15' 26''$ W respectively. Figure 14 demonstrates the extent of river bed degradation at the bridge. Figure 15 shows the typical damage to piers on this bridge.

- 1) Foundation of piers 1 and 2 is too close to the flow line at bridge 17568 on Rush Creek. This area has experienced severe channel-bed degradation.

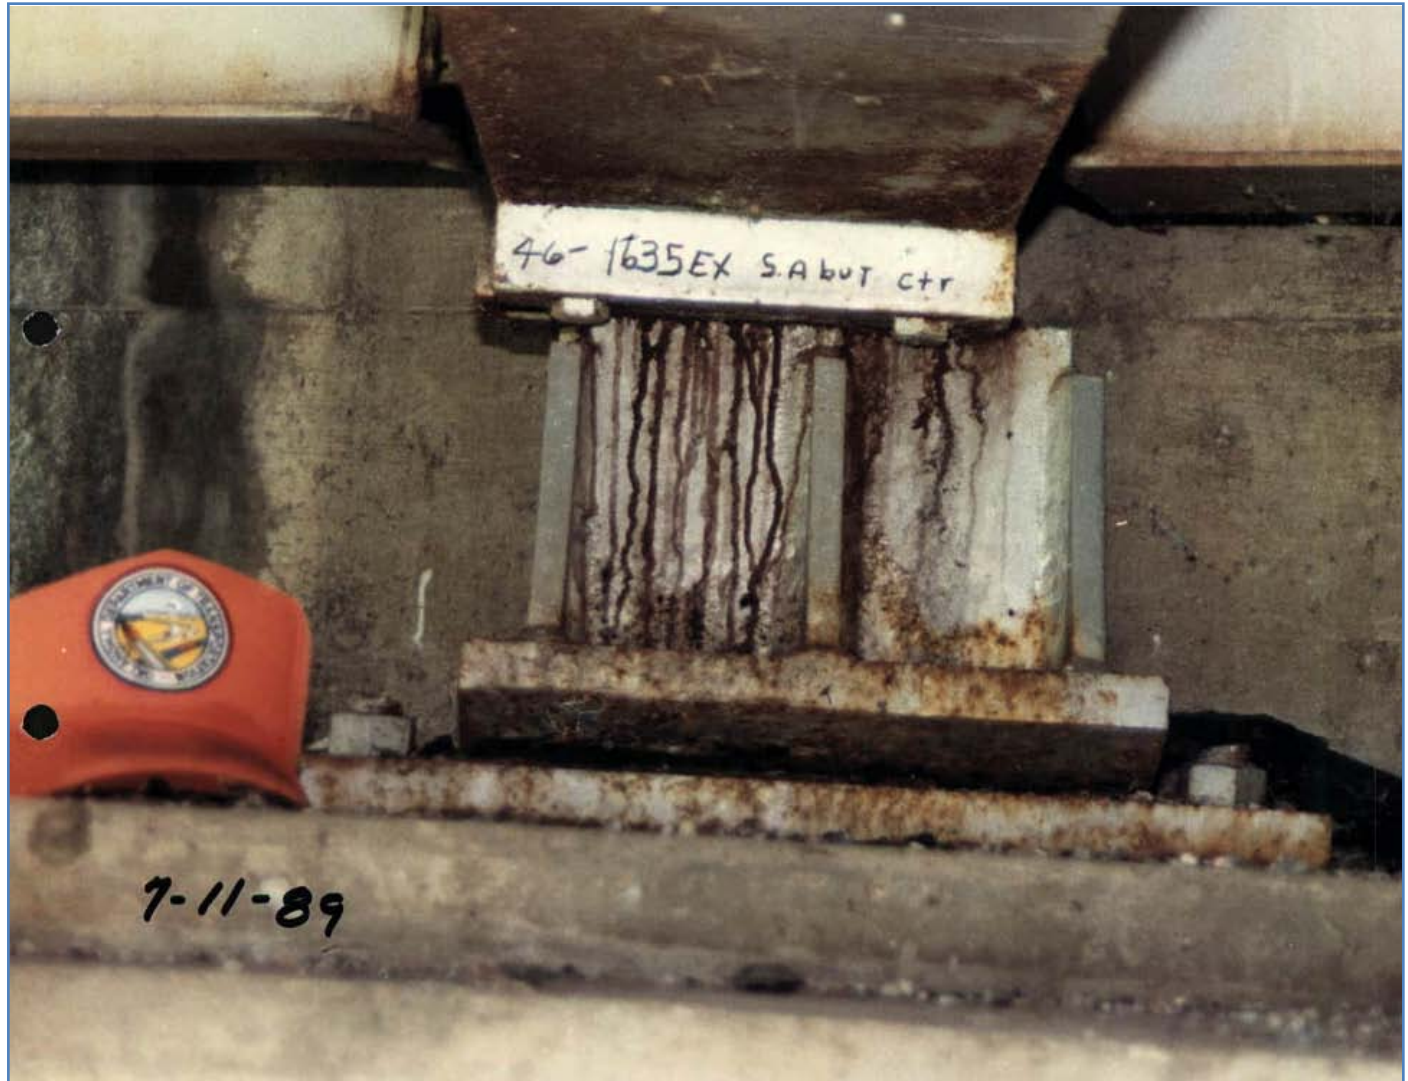
Figure 15. Picture demonstrating extent of damage to pier at bridge 17568 on I-35 NB over Rush Creek.

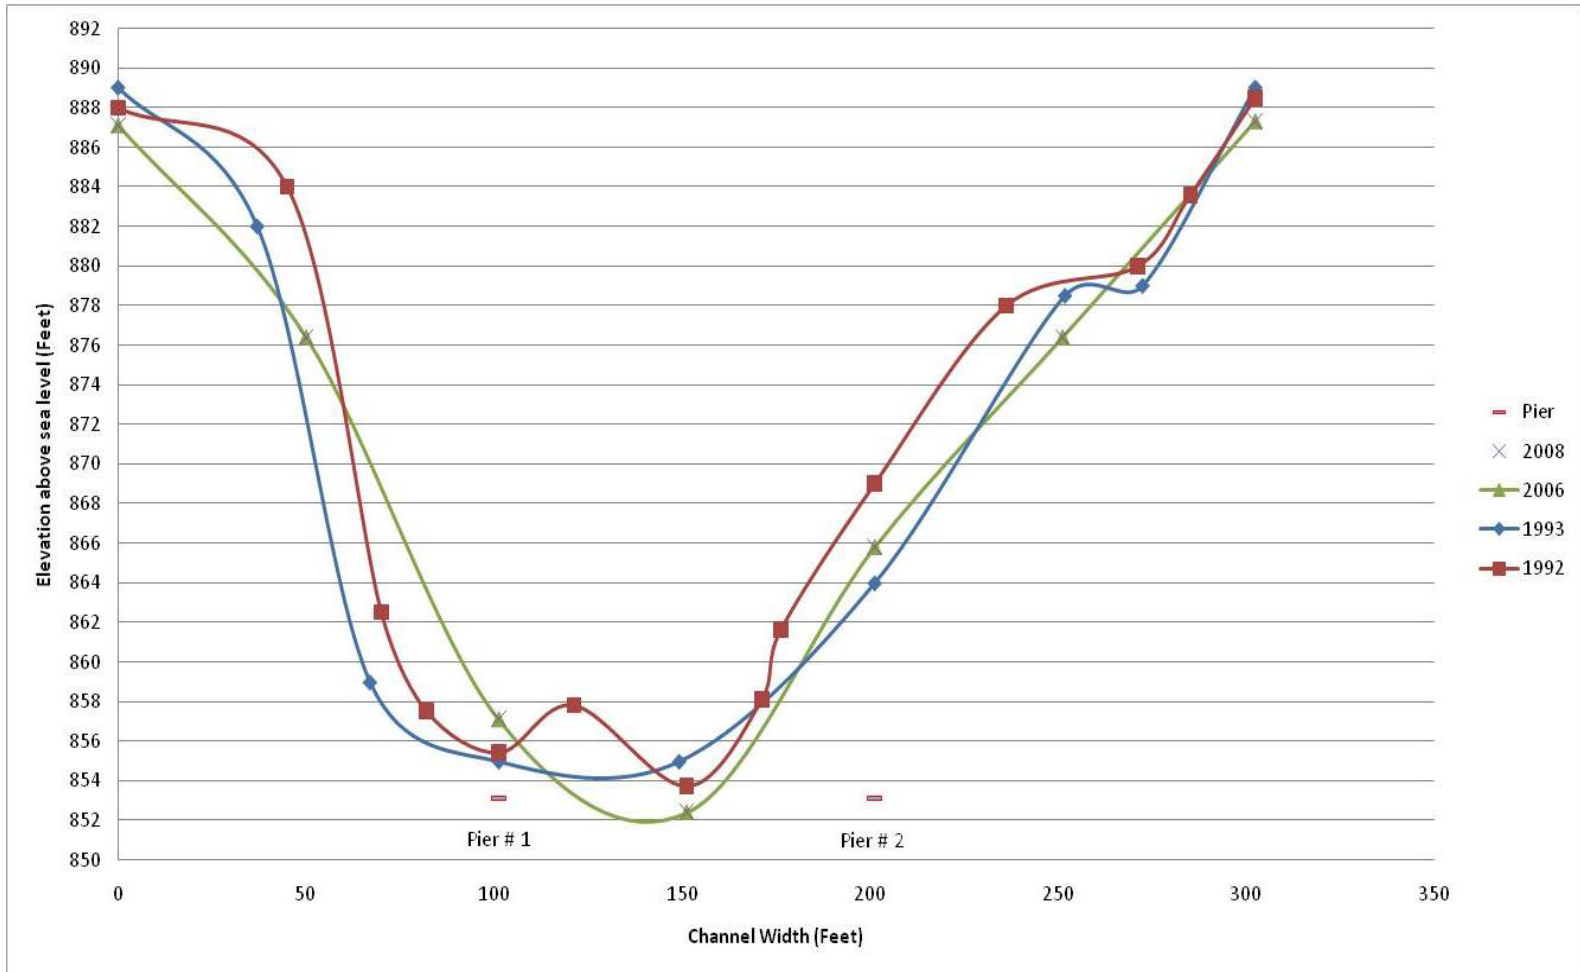
Figure 16. Cross-sectional profiles at bridge 17569 on I-35 SB over Rush Creek.

Bridge 17569 on Interstate Highway 35 southbound was built in the year 1969. The location of the bridge is about 6 miles north of the junction of SH 29 and I-35 with the latitude and longitude of $34^{\circ} 43' 54''$ N and $97^{\circ} 15' 28''$ W respectively. Figure 16 demonstrates the extent of river bed degradation at the bridge. Figure 17 shows a roadway profile of this bridge.

- 2) Foundation of piers 1 and 2 is close to the flow line at bridge 17569 on Rush Creek.
- 3) Foundation of piers 1 and 2 of bridge 17590 is too close to the flow line of Wildhorse Creek.

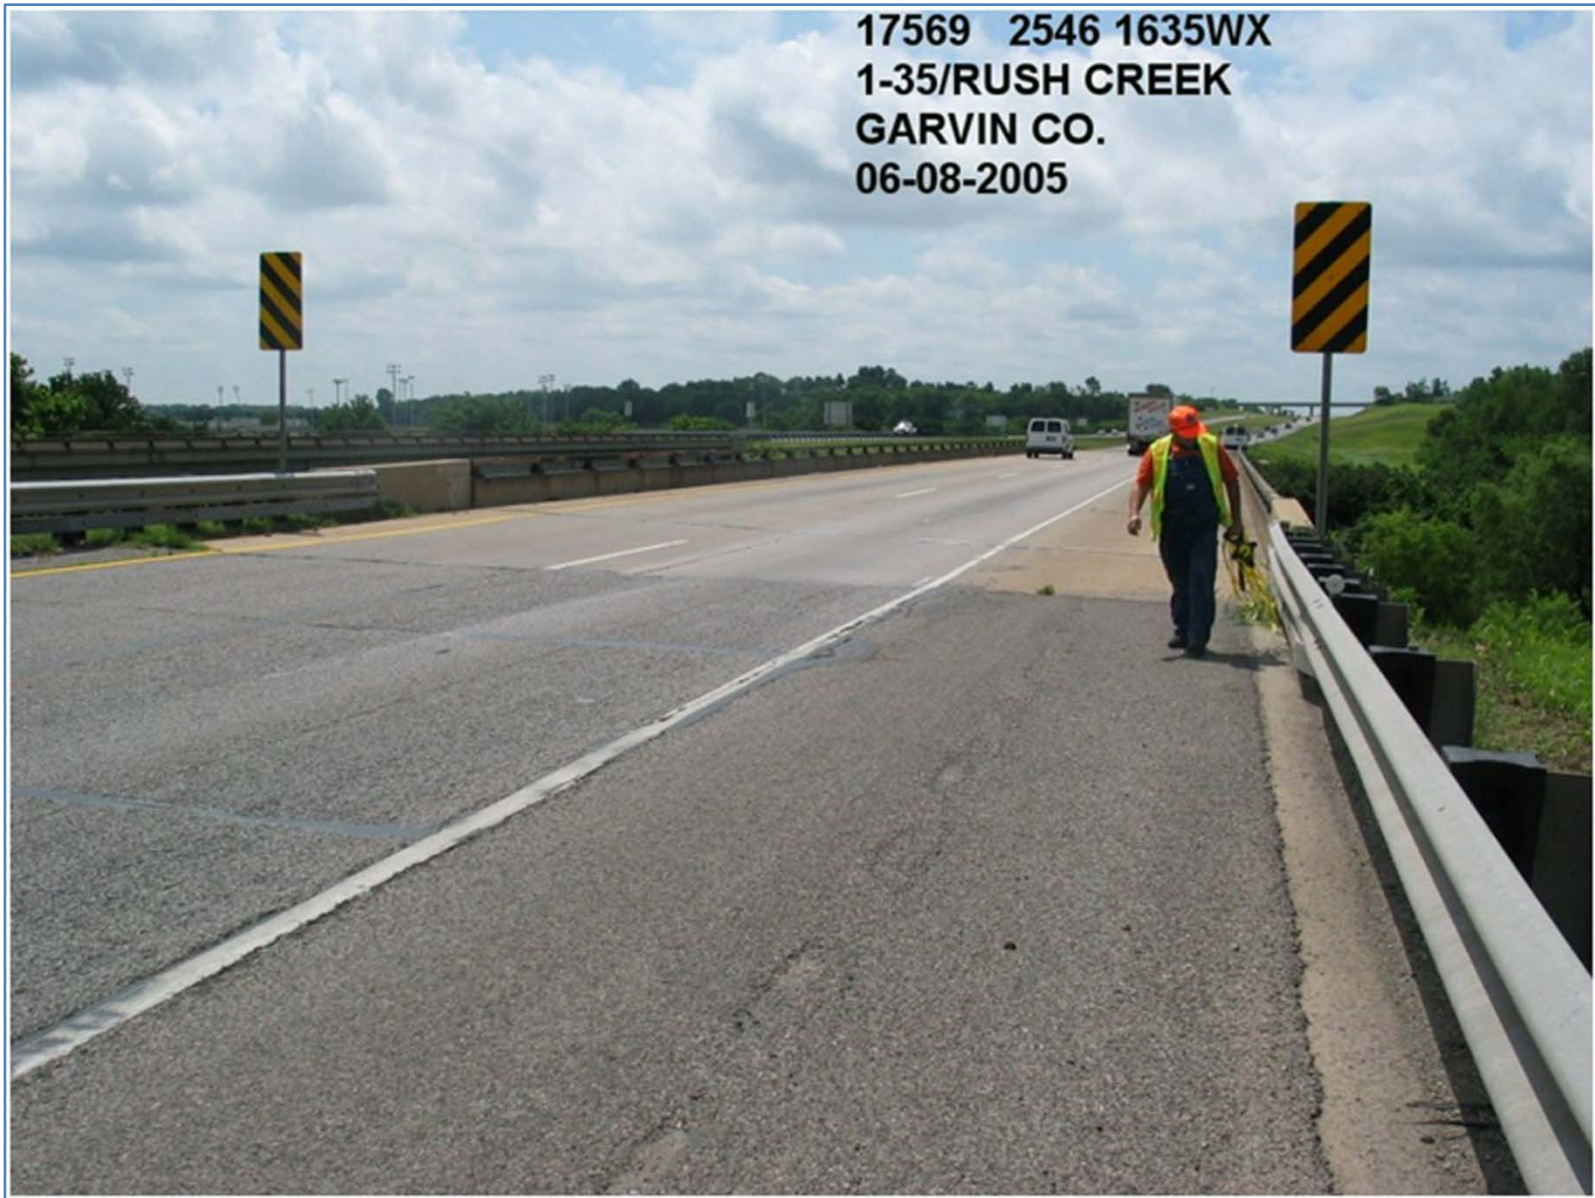
Figure 17. Profile picture of bridge 17569 on I-35 SB over Rush Creek.

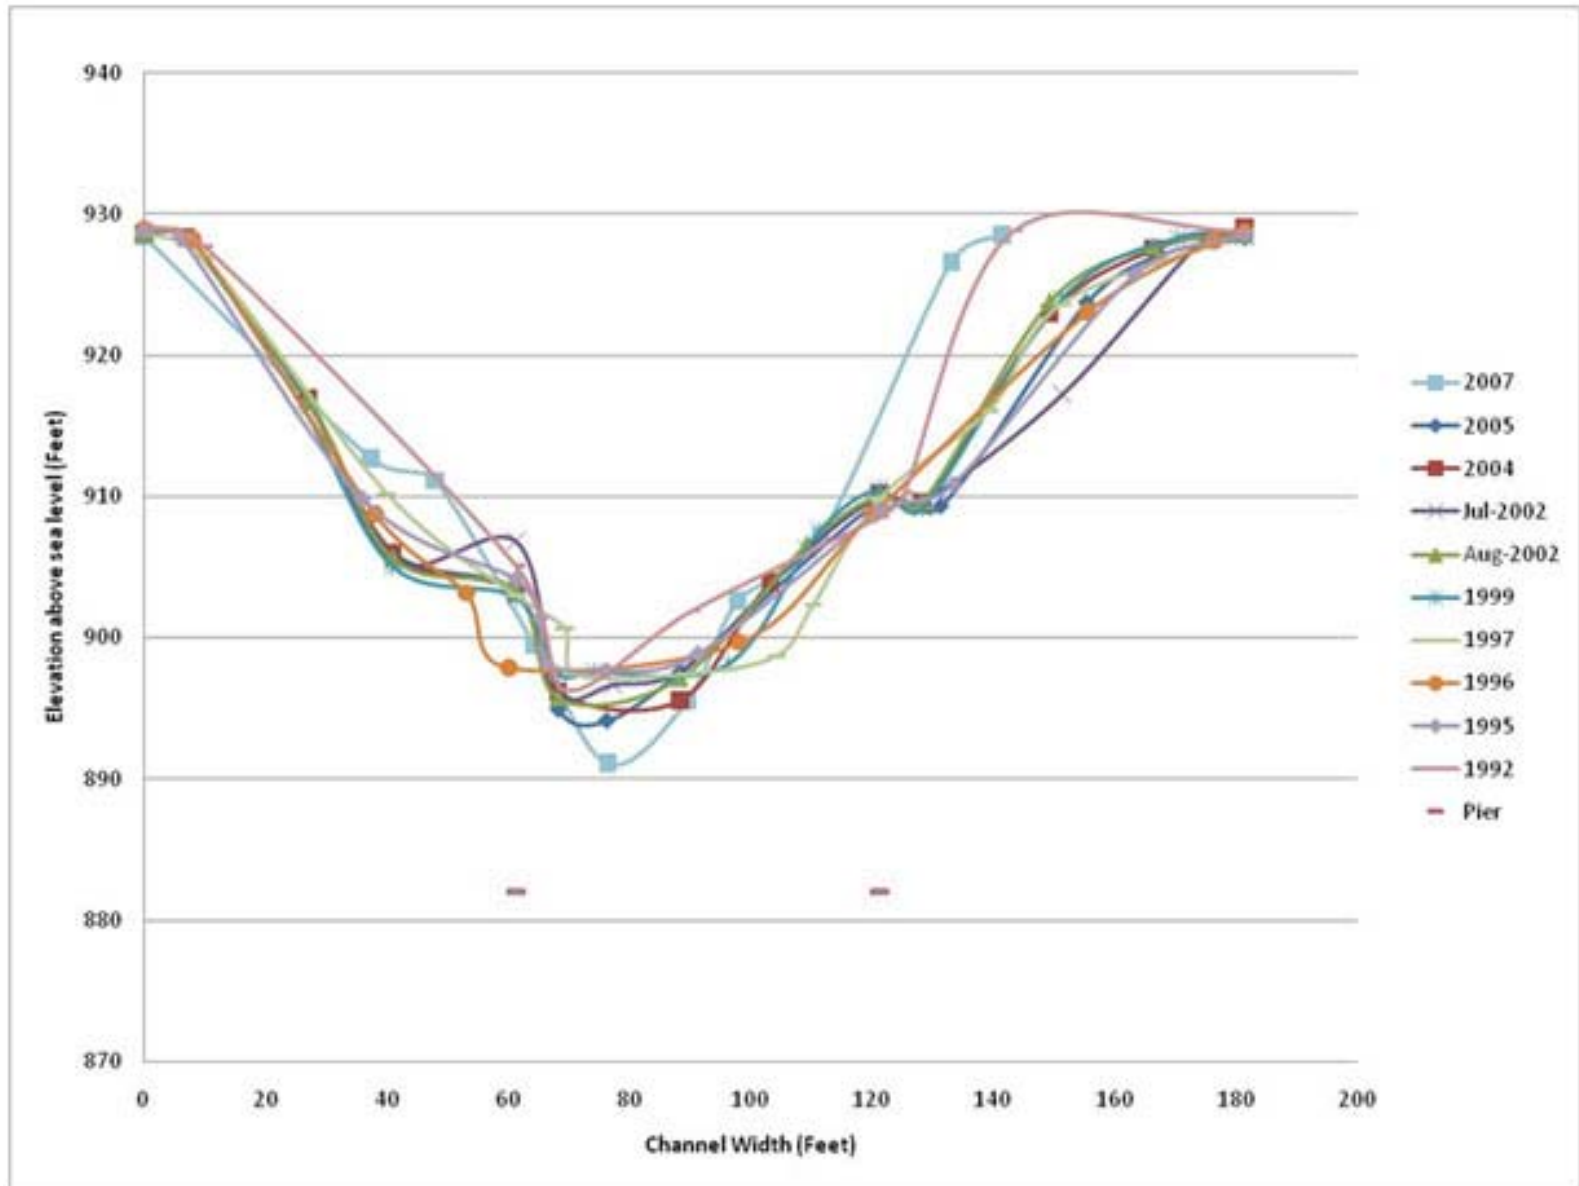
Figure 18. Cross-sectional profiles at bridge 10738 on SH 74 over Rush Creek.

Bridge 10738 on State Highway 74 was built in the year 1947 and is the oldest bridge on Rush Creek. The location of the bridge is about 16.4 miles north of Murray County line with the latitude and longitude of 34° 44' 36" N and 97° 24' 20" W respectively. Figure 18 demonstrates the extent of river bed degradation at the bridge. Figure 19 shows a photo of the existing profile of the roadway for this bridge. Figure 20 demonstrates the damage on the south pier of the bridge.

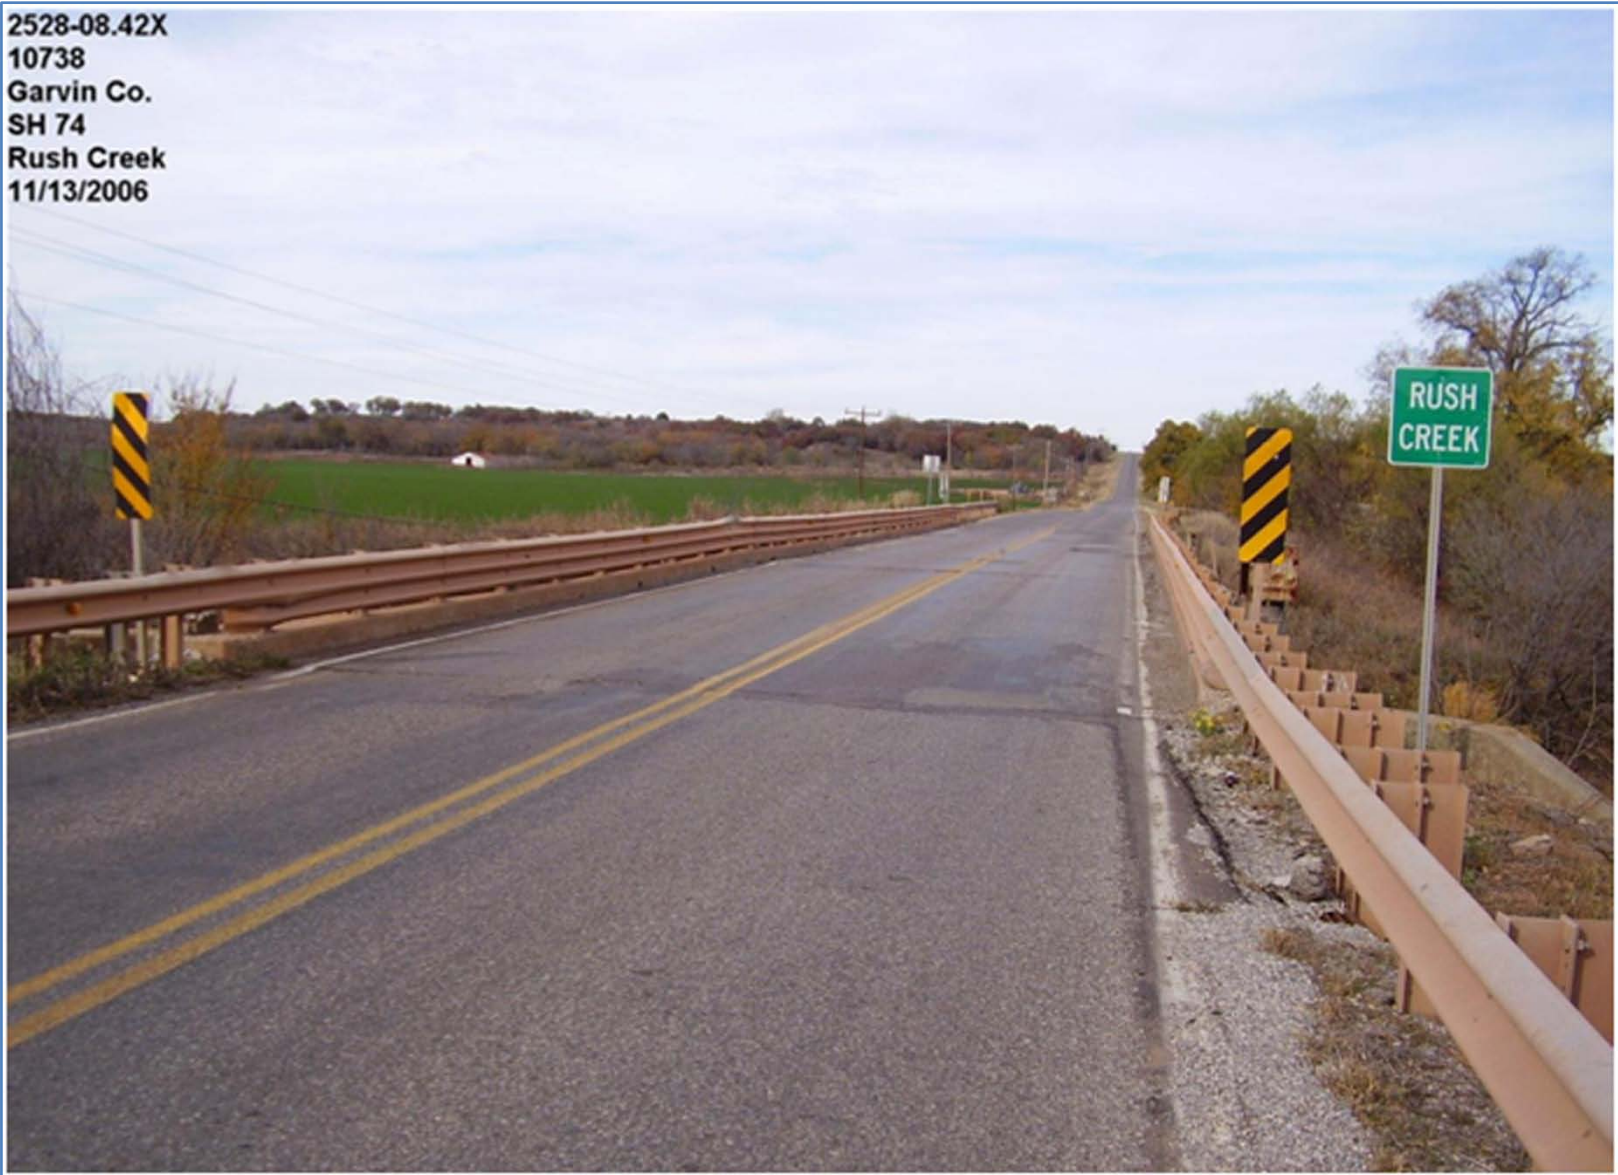
Figure 19. Profile picture of bridge 10738 on SH 74 over Rush Creek.

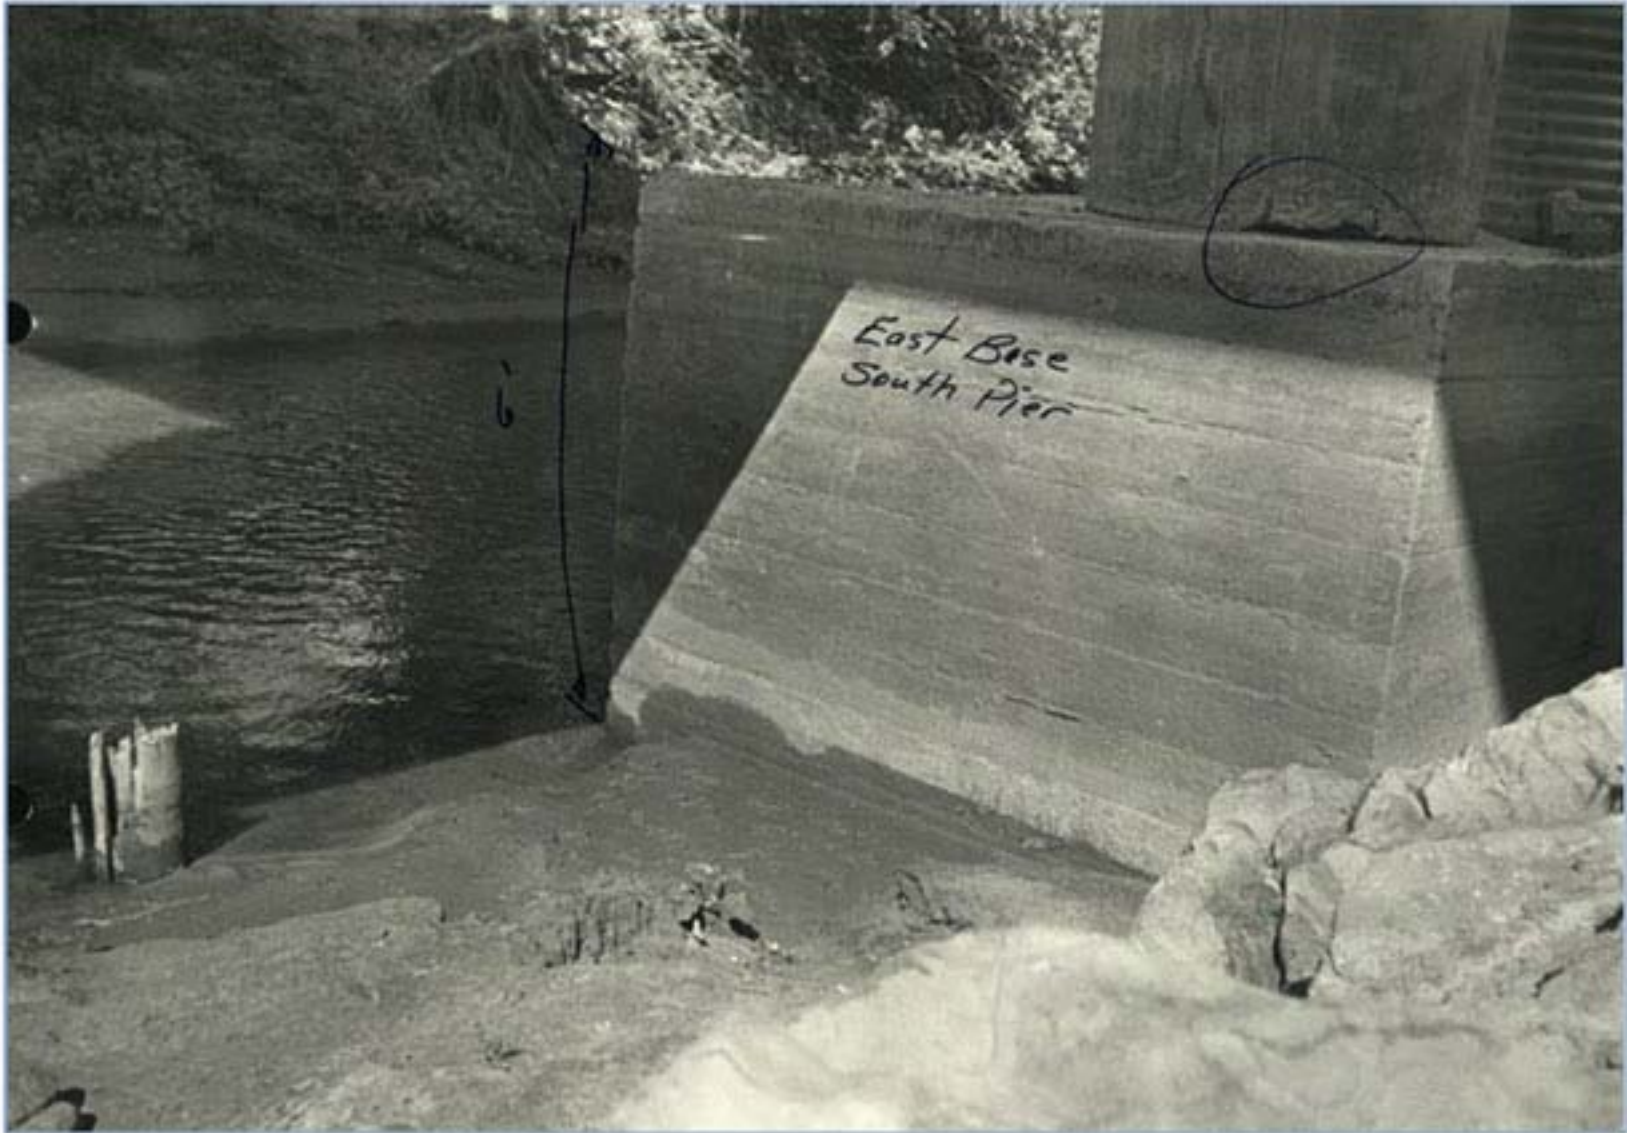
Figure 20. Picture demonstrating extent of damage to south pier at bridge 10738 on SH 74 over Rush Creek.
