Degradation in Rush, Wildhorse, and Salt Creeks of Washita River in Oklahoma for Transportation Planning

FINAL REPORT - FHWA-OK-09-01

ODOT SPR ITEM NUMBER 2194

Oklahoma Infrastructure Consortium
School of Civil and Environmental Engineering
Oklahoma State University
Stillwater, OK 74078

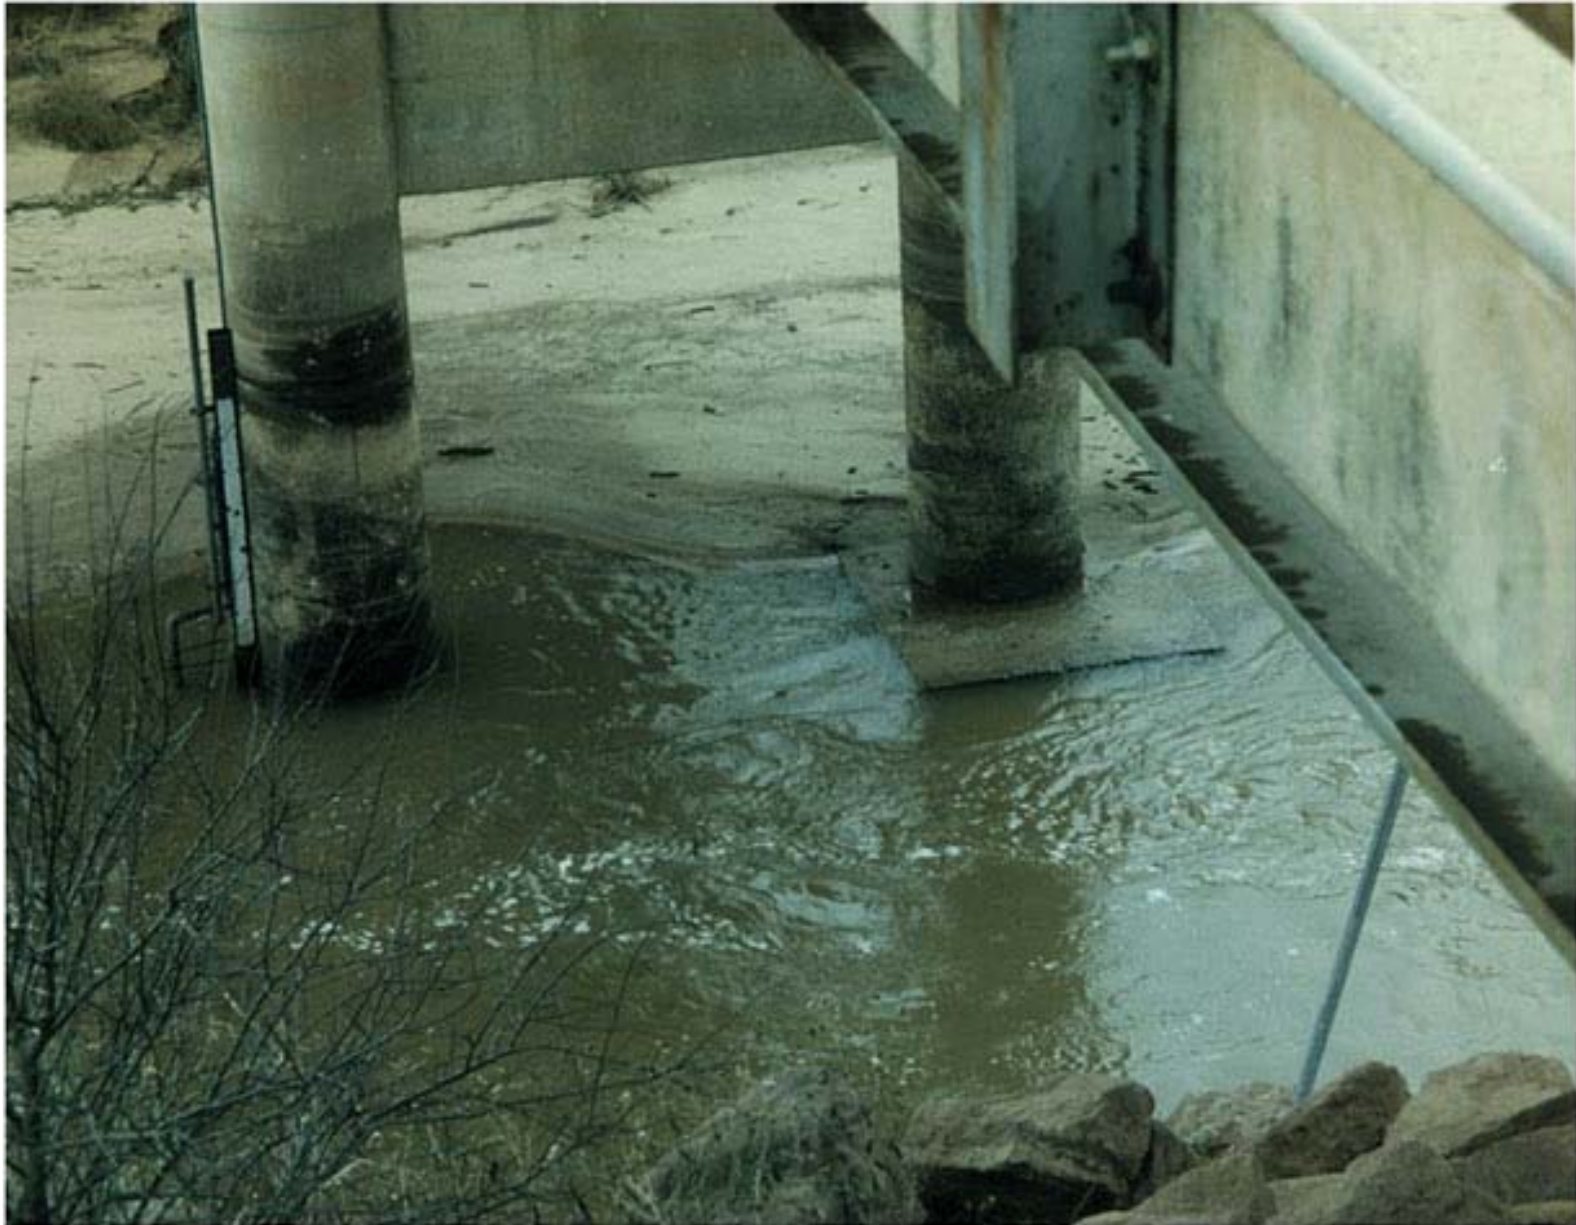
Figure 21. Picture demonstrating extent of damage to pier.

Finally, bridge 12643 on State Highway 76 was built in the year 1951. The location of the bridge in terms of the latitude and longitude of 34° 41' 46" N and 97° 35' 57" W respectively. Figure 21 demonstrates the extent of river bed degradation at the bridge. Figure 22 demonstrates the damage on the pier of the bridge. Since cross-sectional profile values were not available for this structure, a profile chart could not be generated.

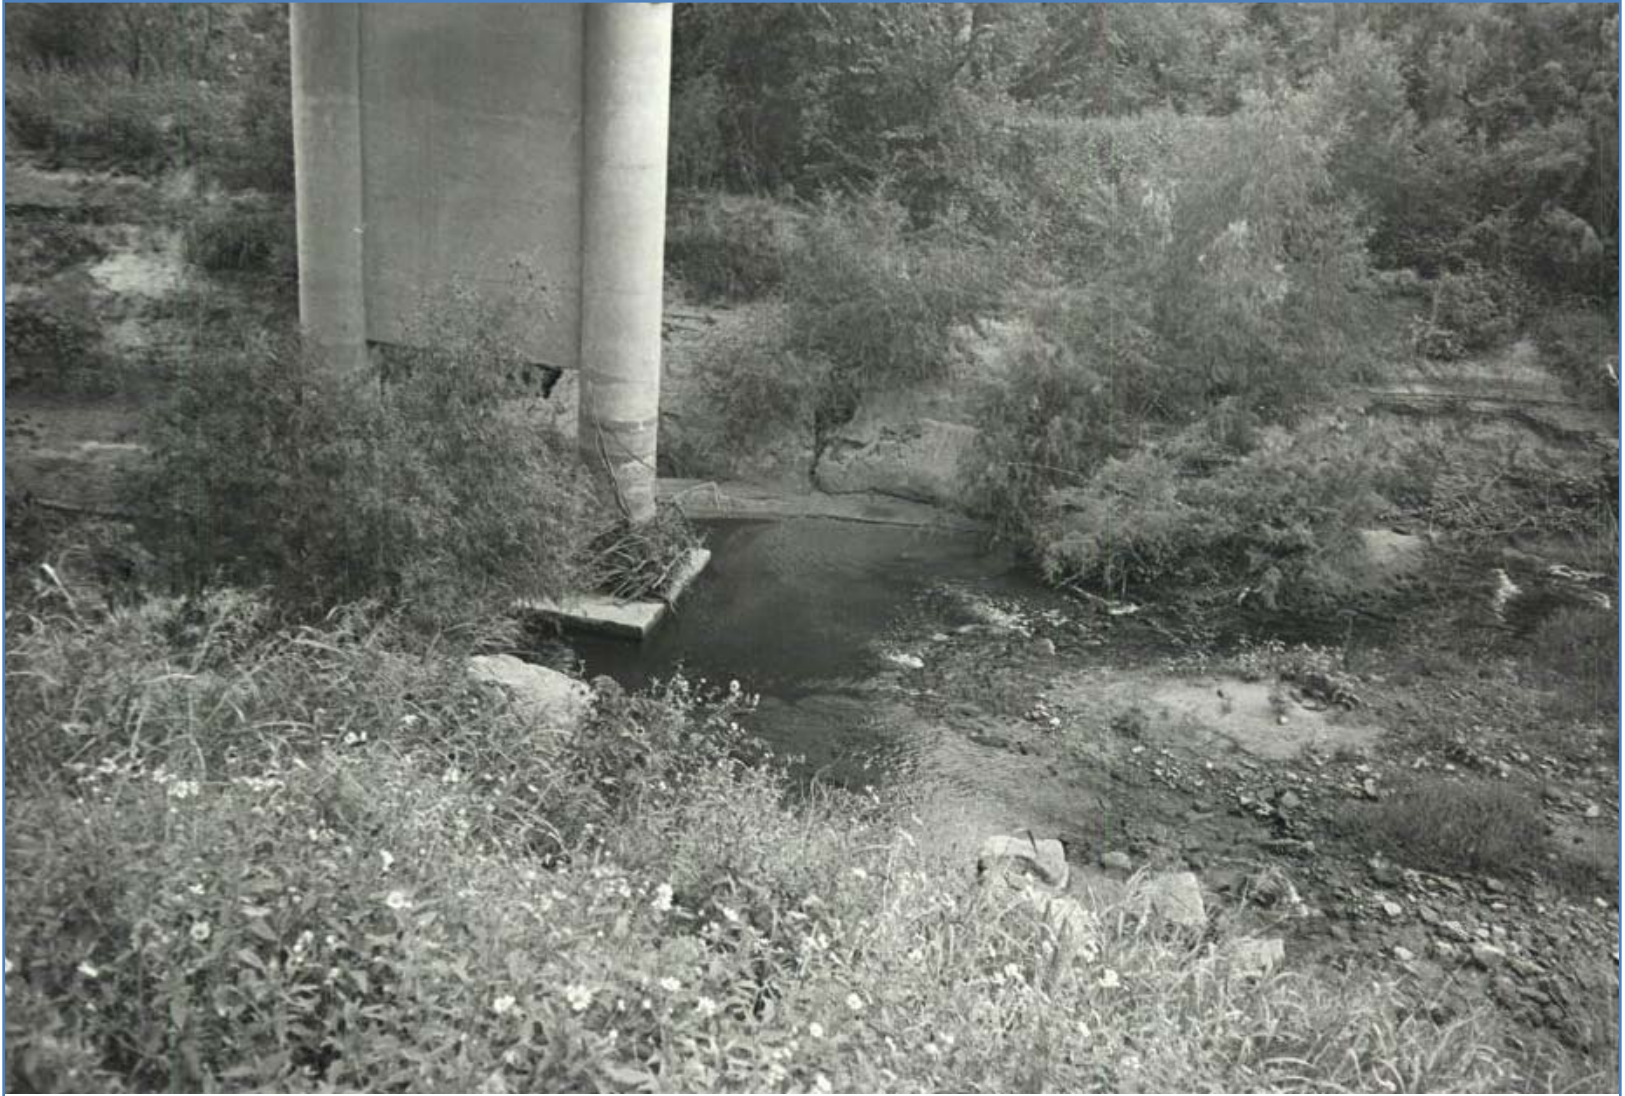
Figure 22. Picture demonstrating extent of damage to pier ar bridge 12643 on SH 76 over Rush Creek.

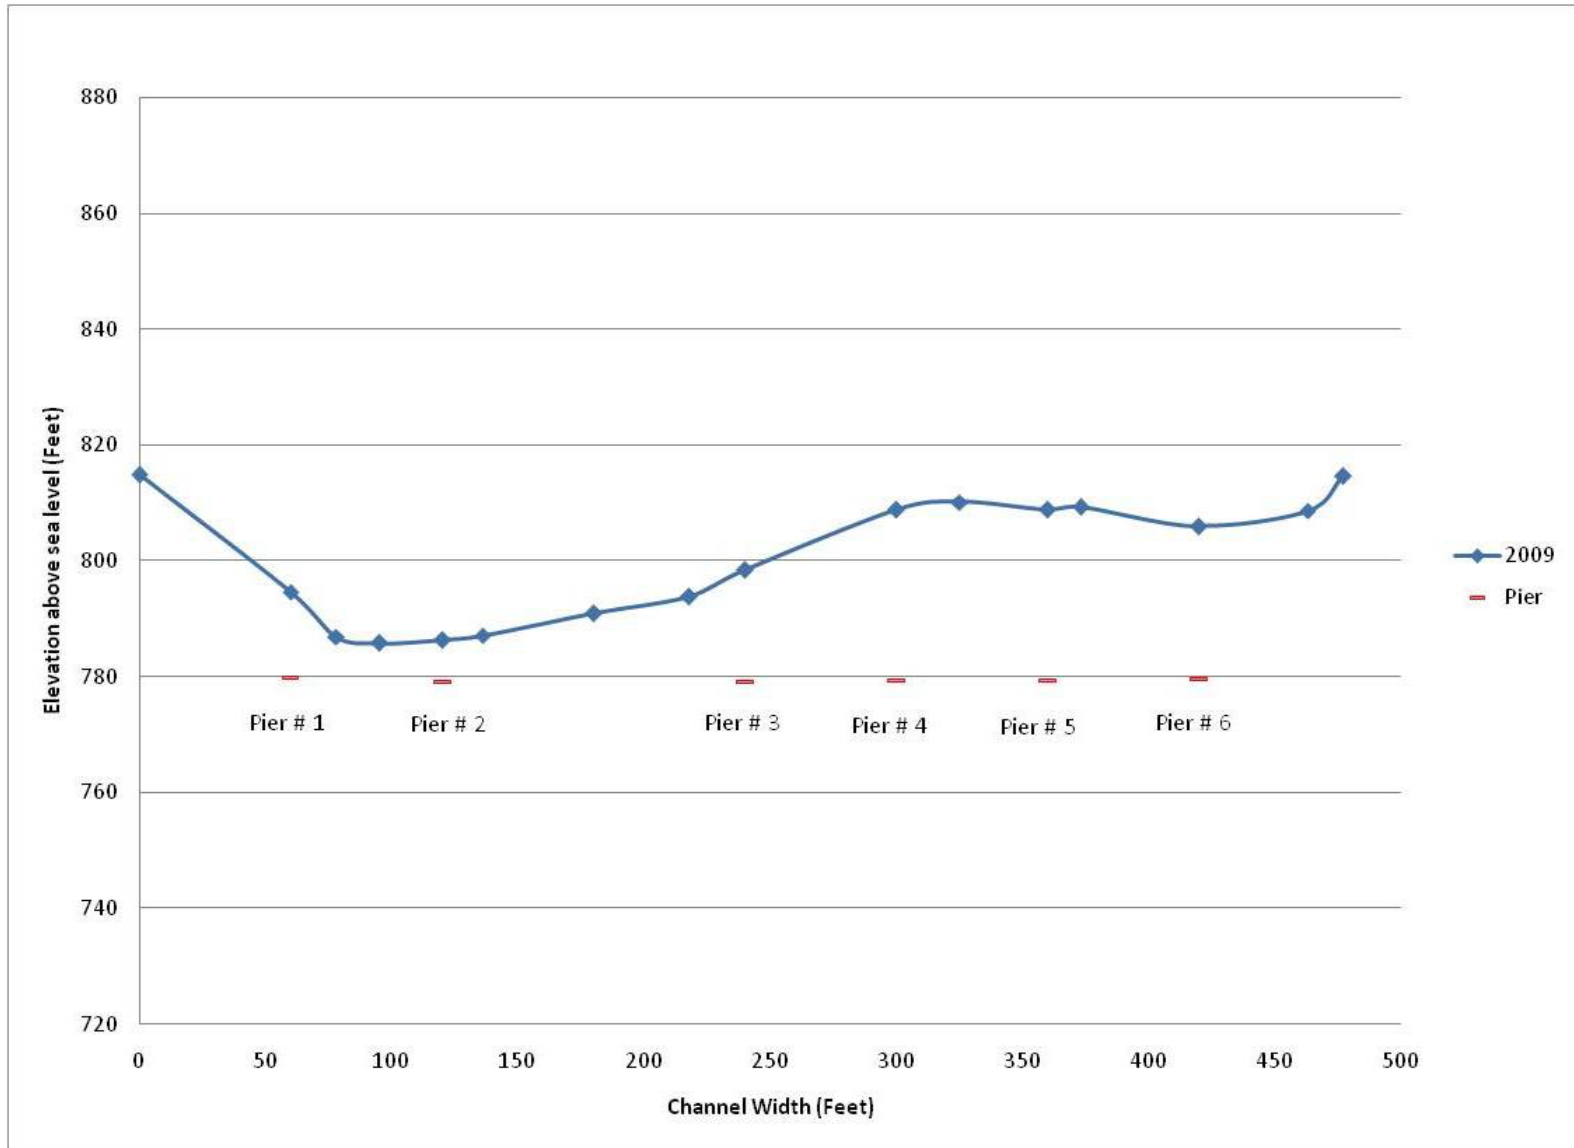
Figure 23. Cross-sectional profile at bridge 17590 on I-35 NB over Wildhorse Creek.

Bridge 17590 on Interstate Highway 35 northbound was built in the year 1969. The location of the bridge is about 2.0 miles north junction State Highway 7 with the latitude and longitude of 34° 31' 59" N and 97° 11' 13" W respectively. Figure 23 demonstrates the extent of river bed degradation at the bridge. Figure 24 demonstrates the flood water level at the pier of this bridge.

- 2) Foundation of piers 1 and 2 is close to the flow line at bridge 17569 on Rush Creek.
- 3) Foundation of piers 1 and 2 of bridge 17590 is too close to the flow line of Wildhorse Creek.

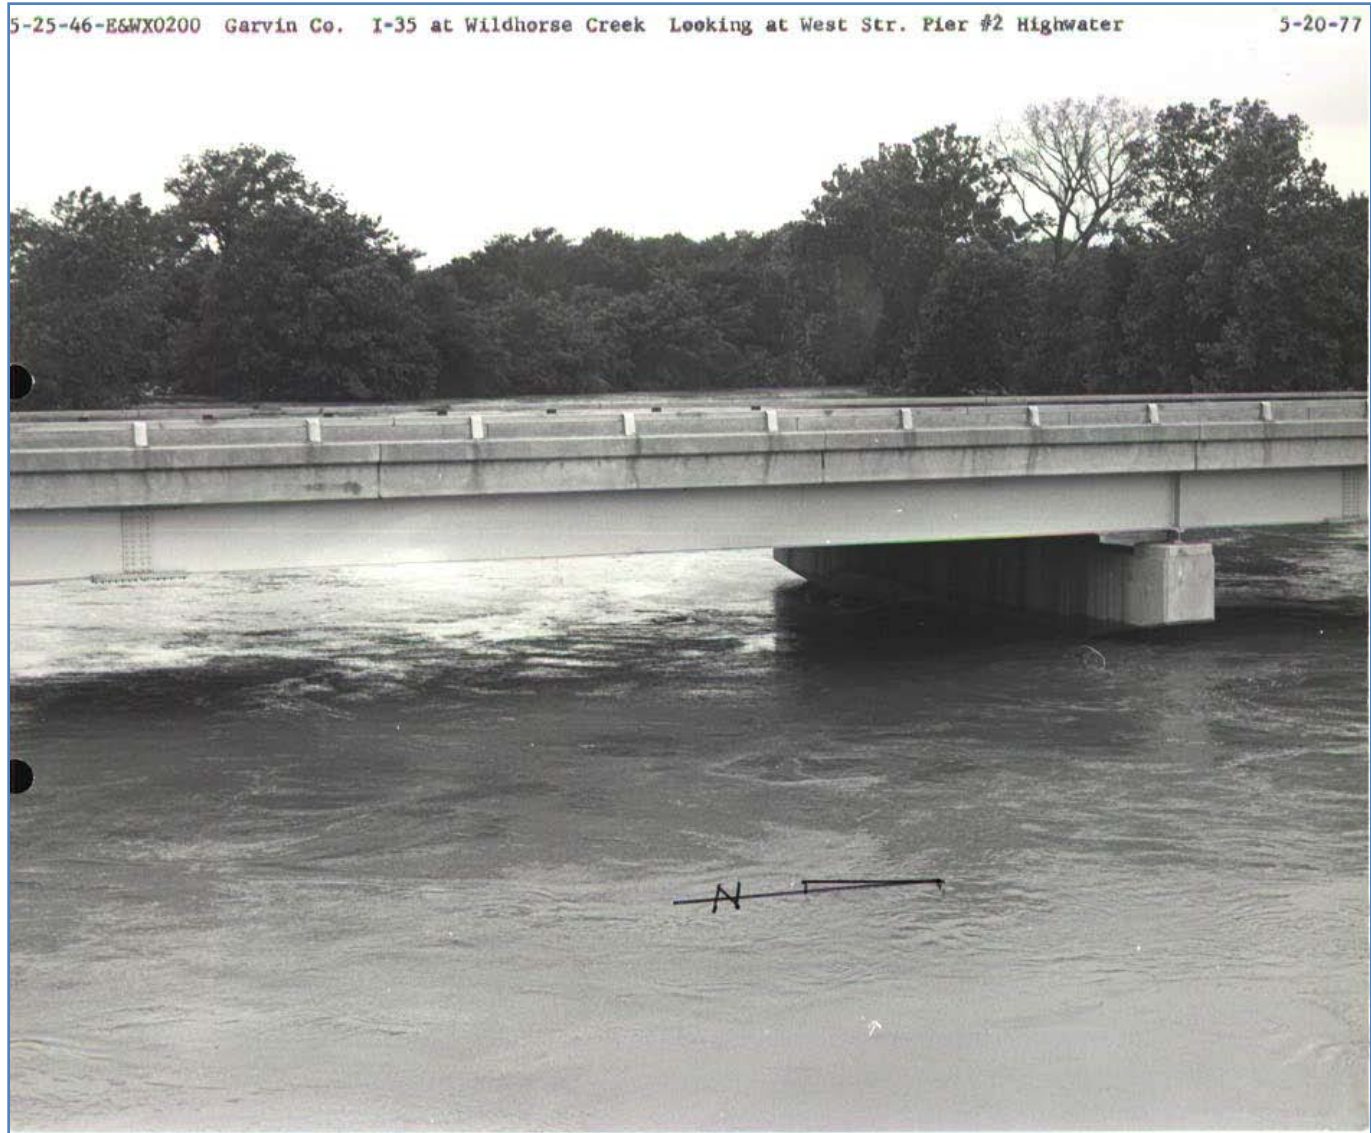
Figure 24. Picture demonstrating flood water level at pier at bridge 17590 on I-35 NB over Wildhorse Creek.

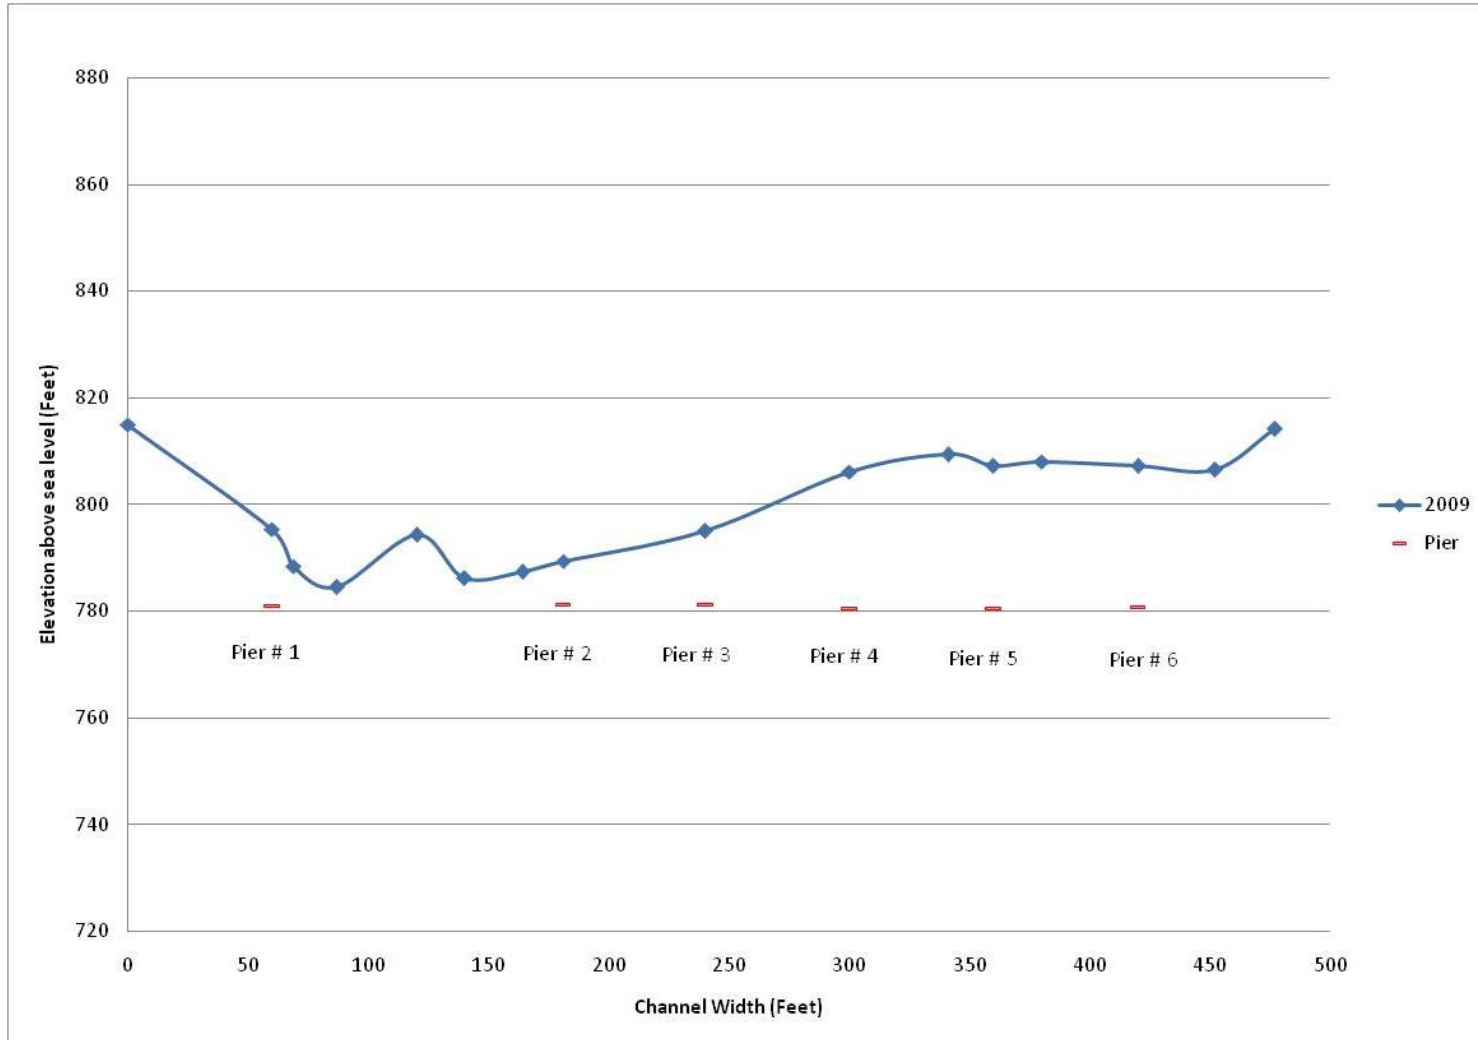
Figure 25. Cross-sectional profile at bridge 17591 on I-35 SB over Wildhorse Creek.

Bridge 17591 on Interstate Highway 35 southbound was built in the year 1969. The location of the bridge is about 2.0 miles north junction State Highway 7 with the latitude and longitude of 34° 31' 59" N and 97° 11' 15" W respectively. Figure 25 demonstrates the extent of river bed degradation at the bridge. At the time of publication there was no photo available for this structure.

- 4) Foundation of piers 1, 2, and 3 of bridge 17591 is too close to the flow line of Wildhorse Creek.
- 5) Washita River degradation rates ranged from 0.1 to 0.3 foot per year as determined in a previous study, while the degradation rates of Rush, Wildhorse, and Salt Creeks ranged from 0.22 to 0.46, 0.072 to 0.43 and 0.02 to 0.63 foot per year, respectively in a small reach of the Washita River.

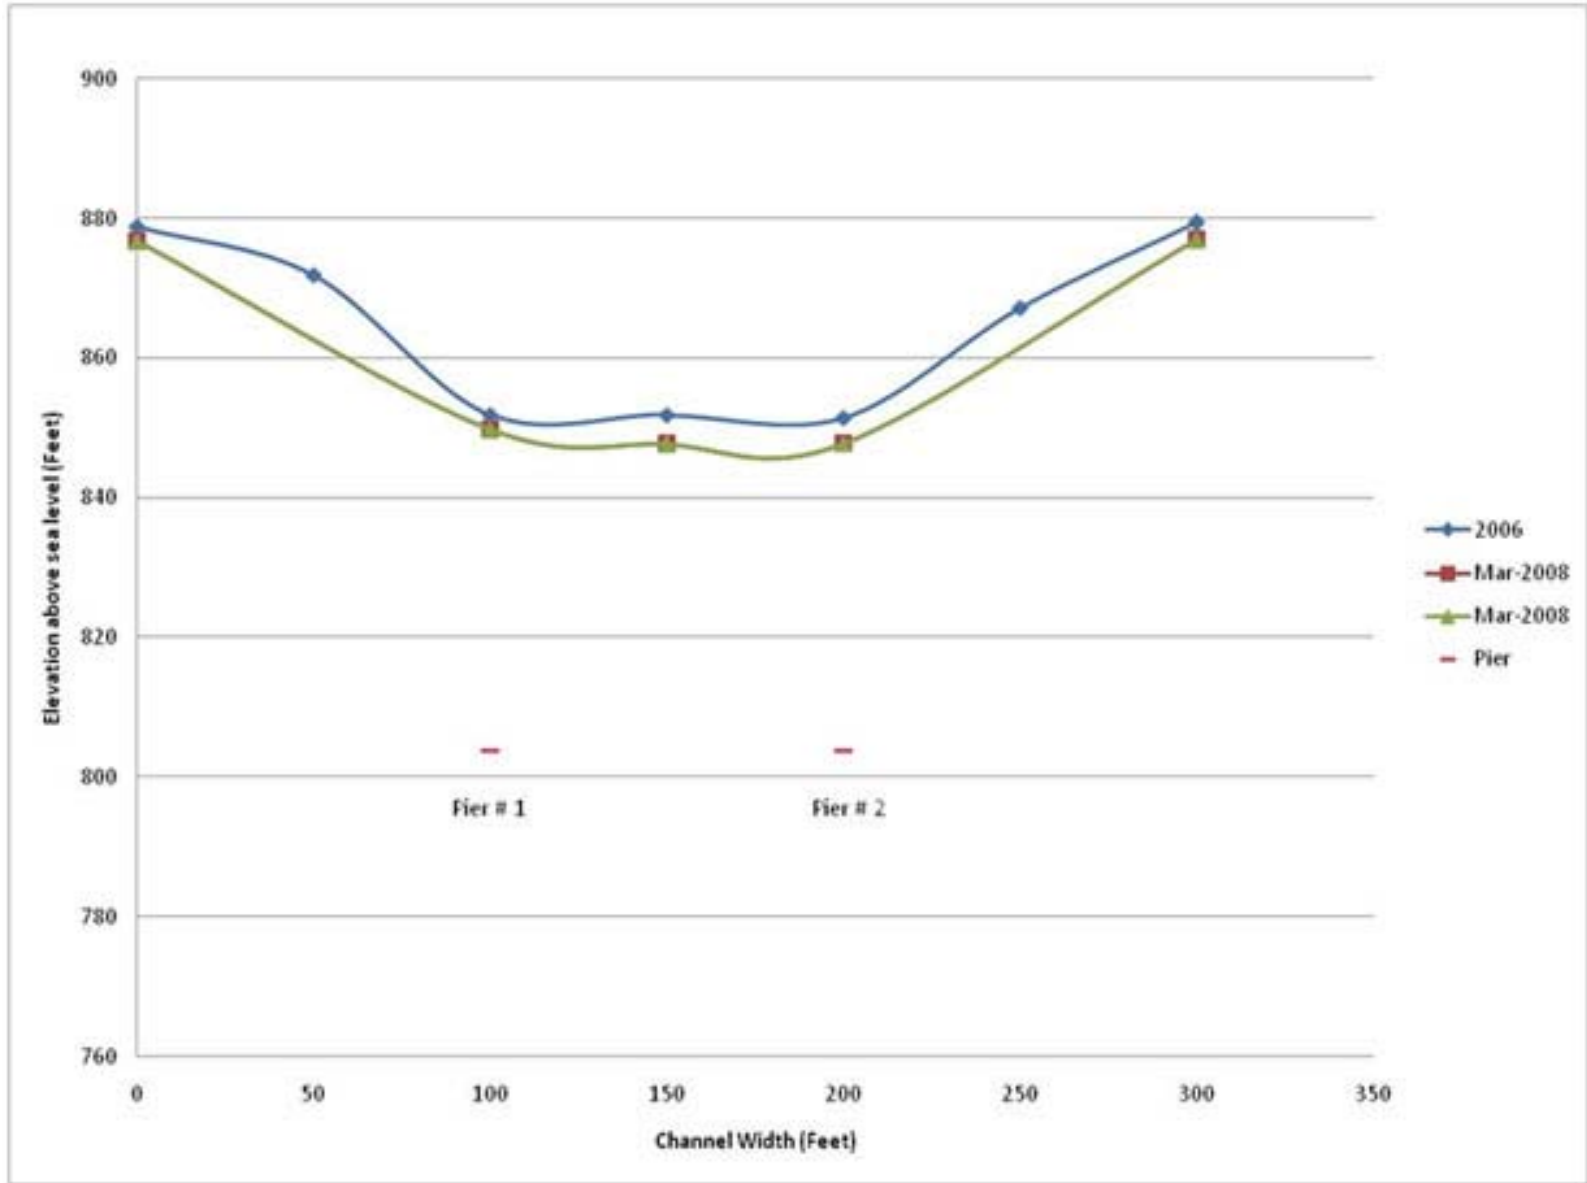
Figure 26. Cross-sectional profiles at bridge 21120 on SH 74 over Wildhorse Creek.

Bridge 21120 on State Highway 74 was built in the year 1985. The location of the bridge is about 0.5 miles north of the Carter Country line at latitude and longitude of 34° 30' 55" N and 97° 24' 19" W respectively. Figure 26 demonstrates the extent of river bed degradation at the bridge. Figures 27 and 28 demonstrate the extent of damage to the piers of this bridge.

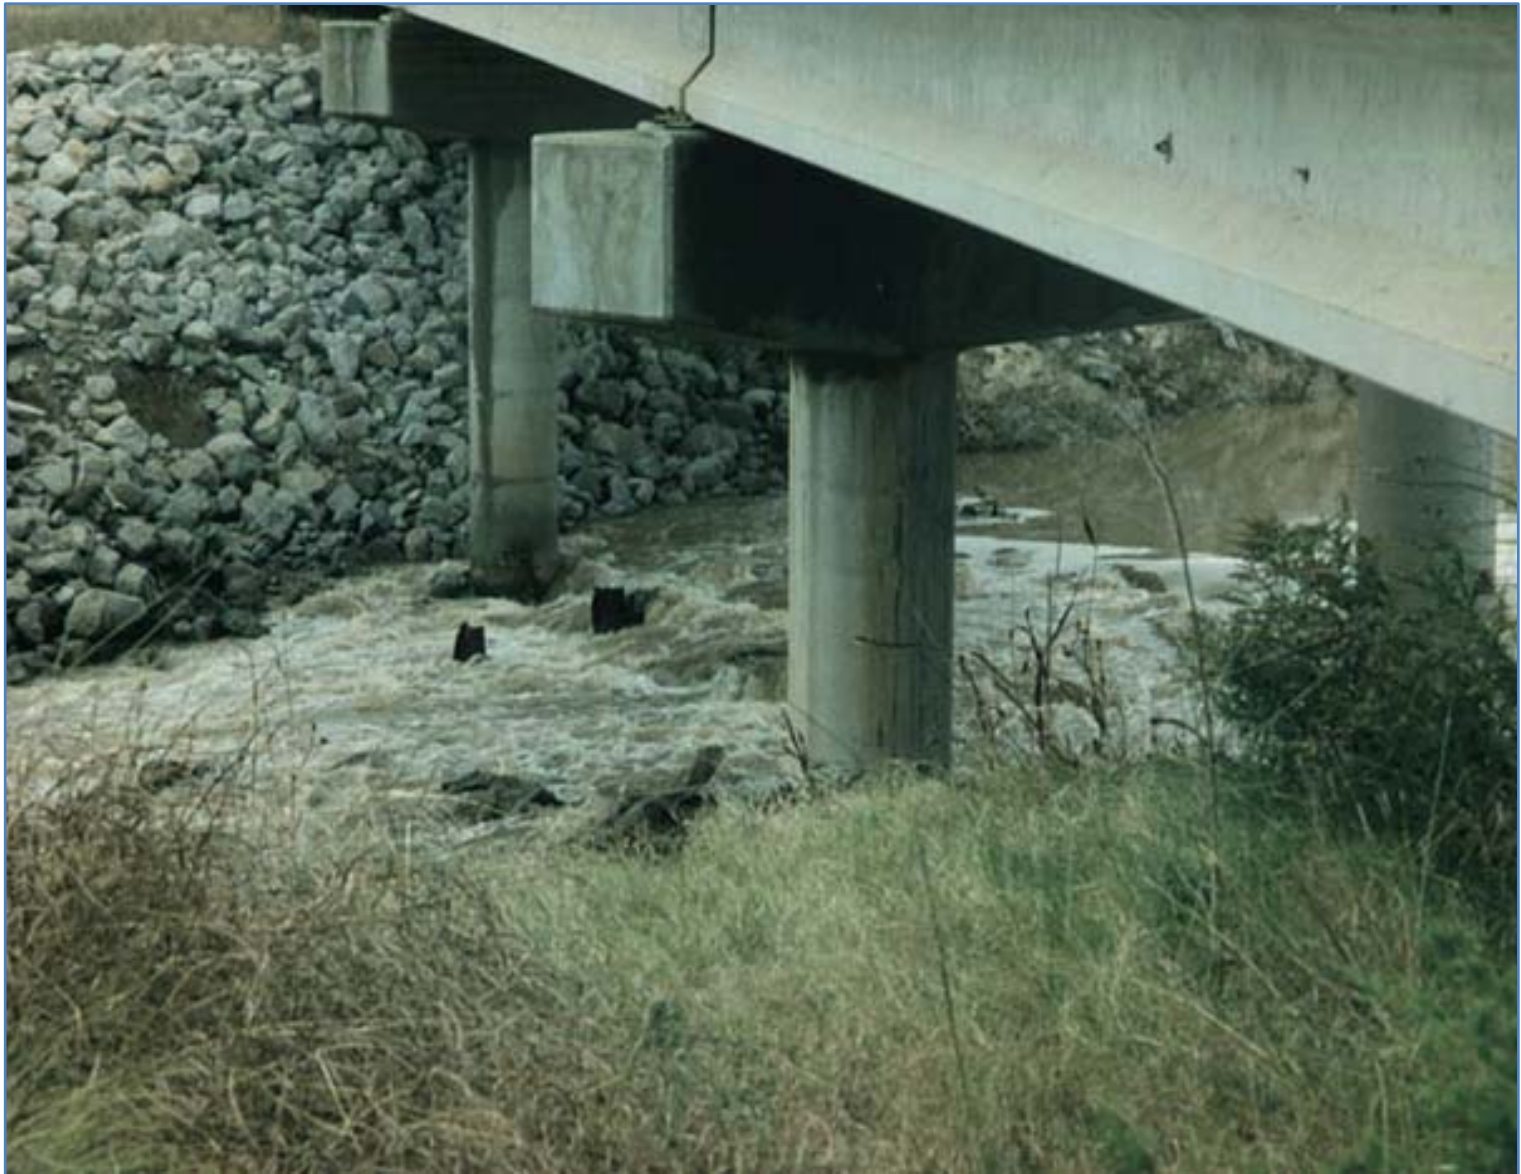
Figure 27. Picture demonstrating extent of damage to piers at bridge 21120 on SH 74 over Wildhorse Creek.

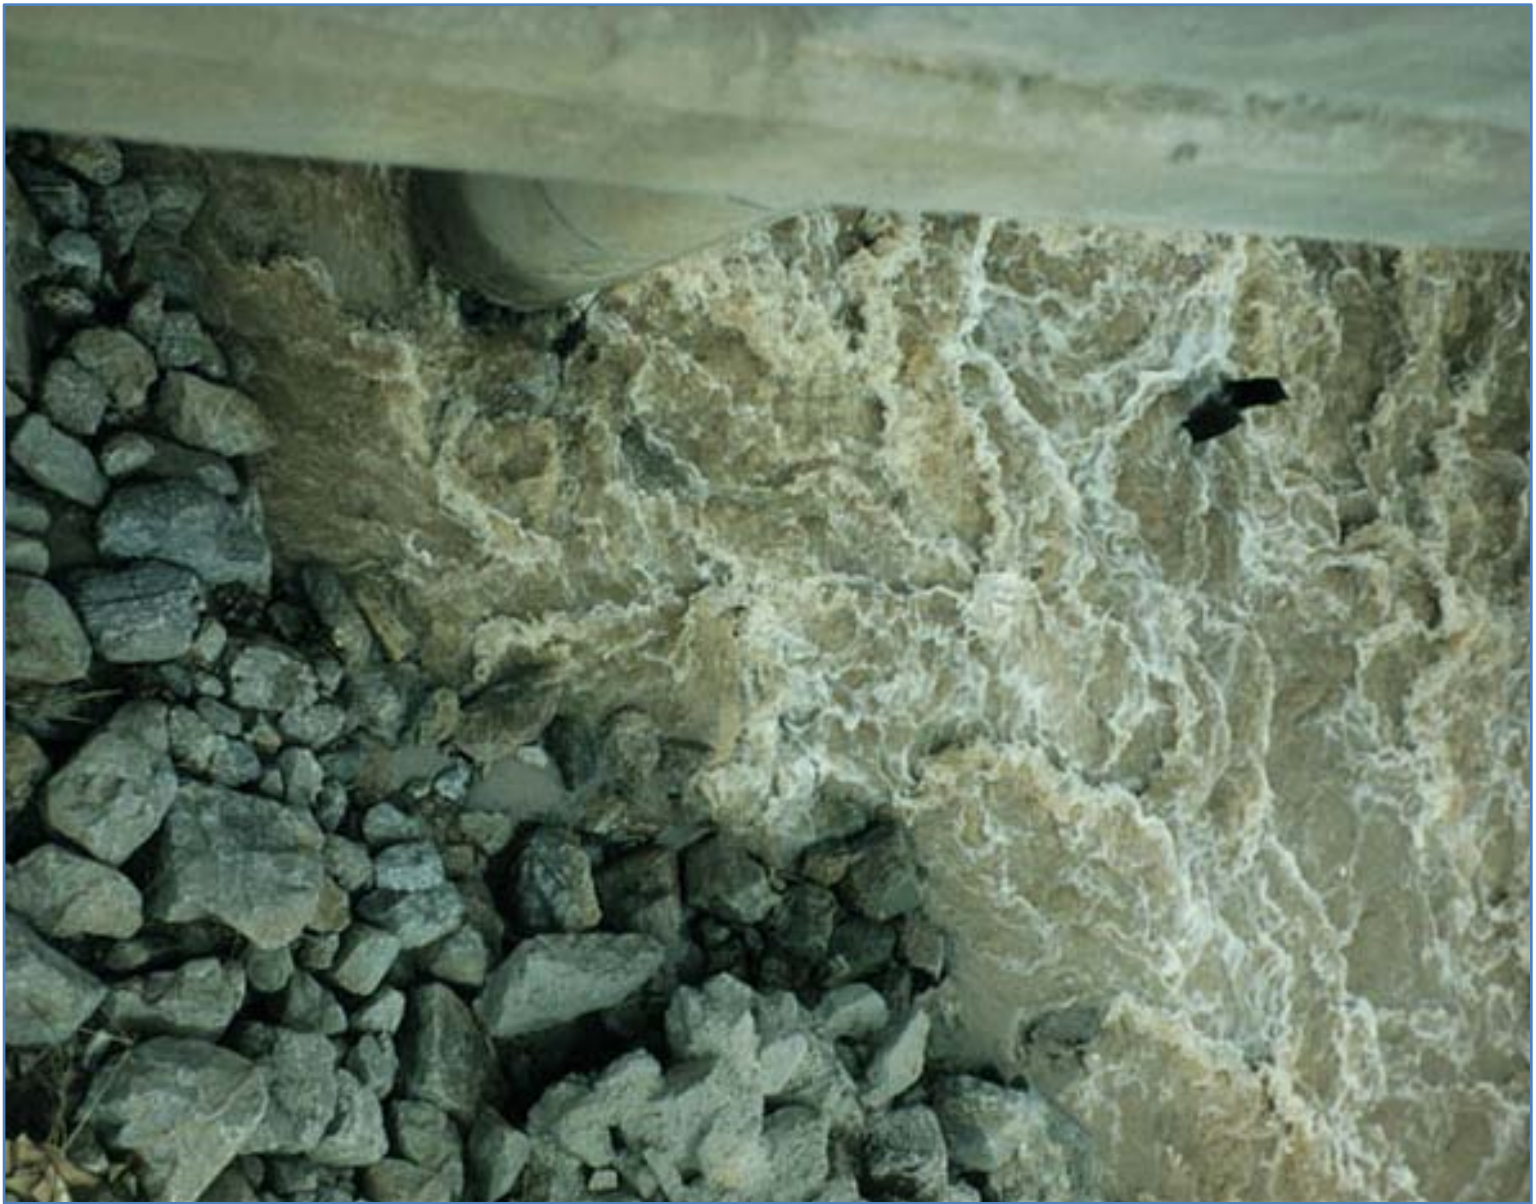
Figure 28. Picture demonstrating extent of damage to piers (b21120).

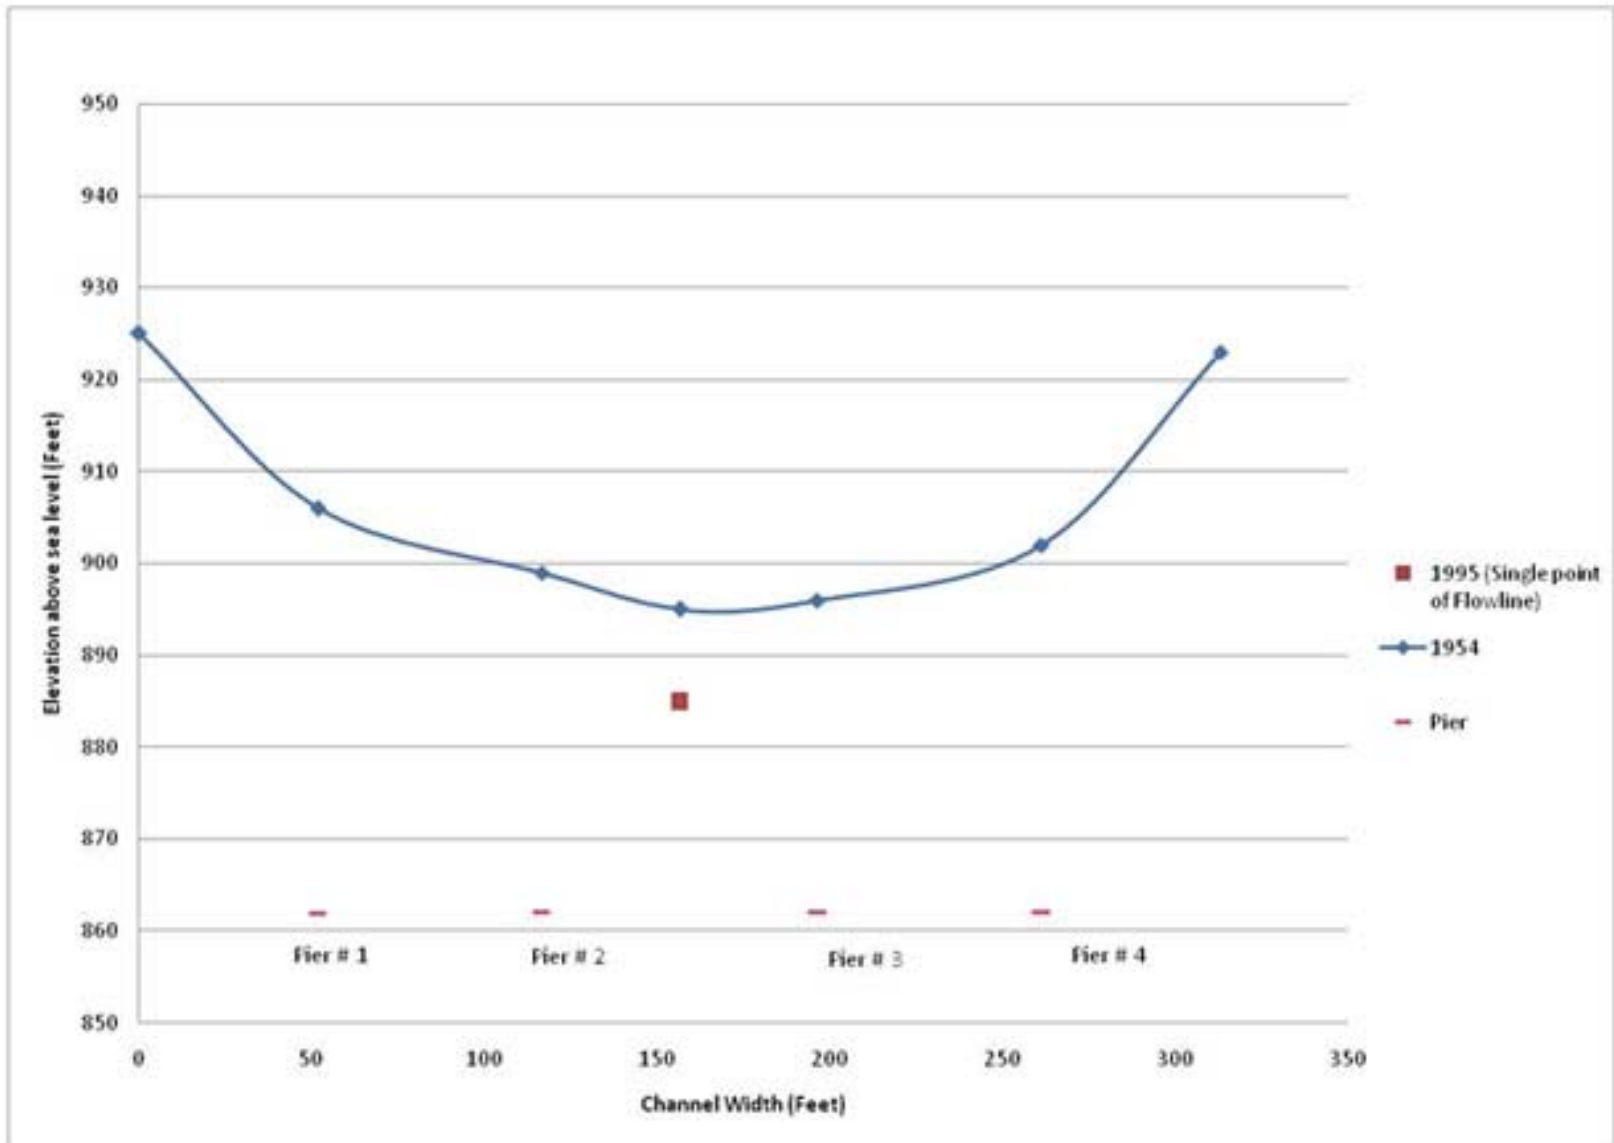
Figure 29. Cross-sectional profile at bridge 13235 on SH 76 over Wildhorse Creek.

Bridge 13235 on State Highway 76 was built in the year 1954 and is the oldest bridge on Wildhorse Creek. The location of the bridge is about 2.8 miles north of the junction with State Highway 7 and the latitude and longitude of 34° 29' 23" N and 97° 30' 35" W respectively. Figure 29 demonstrates the extent of river bed degradation at the bridge. Figure 30 demonstrates the extent of damage to the piers for this structure.

- 6) None of the bridges in Rush, Salt, or Wildhorse Creeks have experienced channel bed degradation above 16 feet. However, a maximum degradation of 15.1 feet in 35 years was observed at bridge 13235 on S.H. 76, Wildhorse Creek.

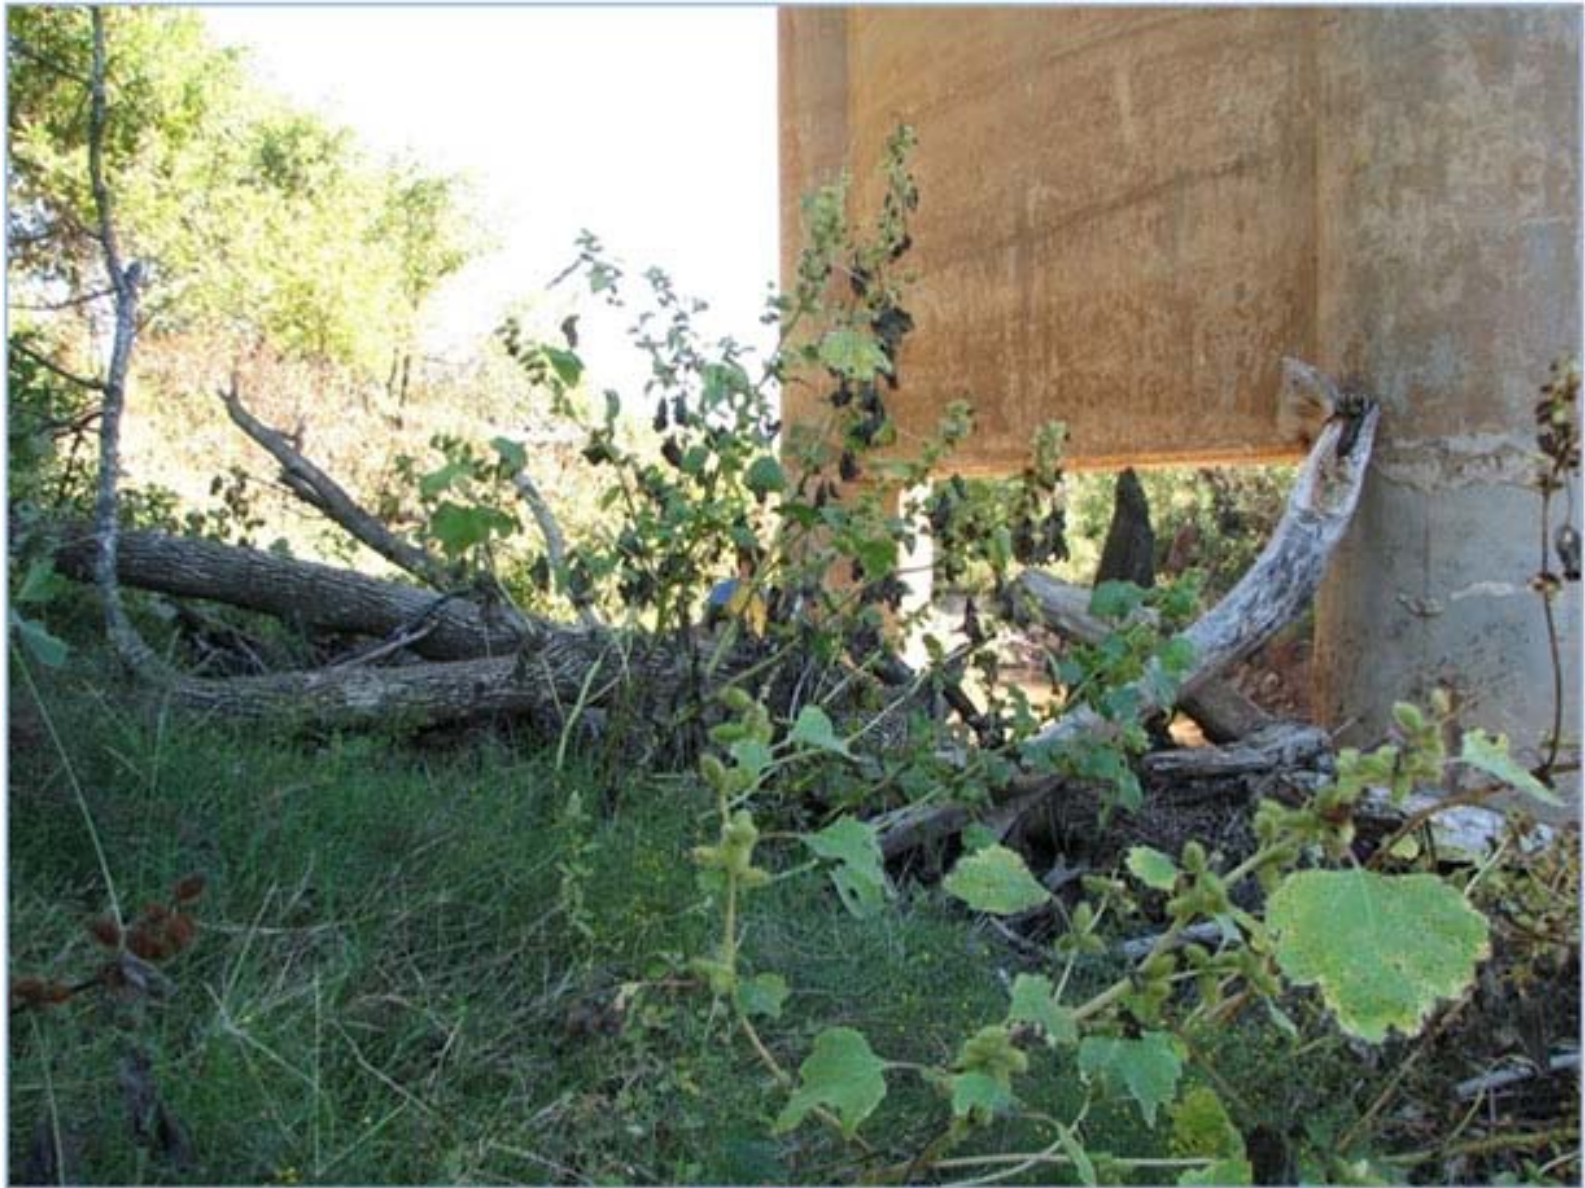
Figure 30. Picture demonstrating extent of damage to piers at bridge 13235 on SH 76 over Wildhorse Creek.

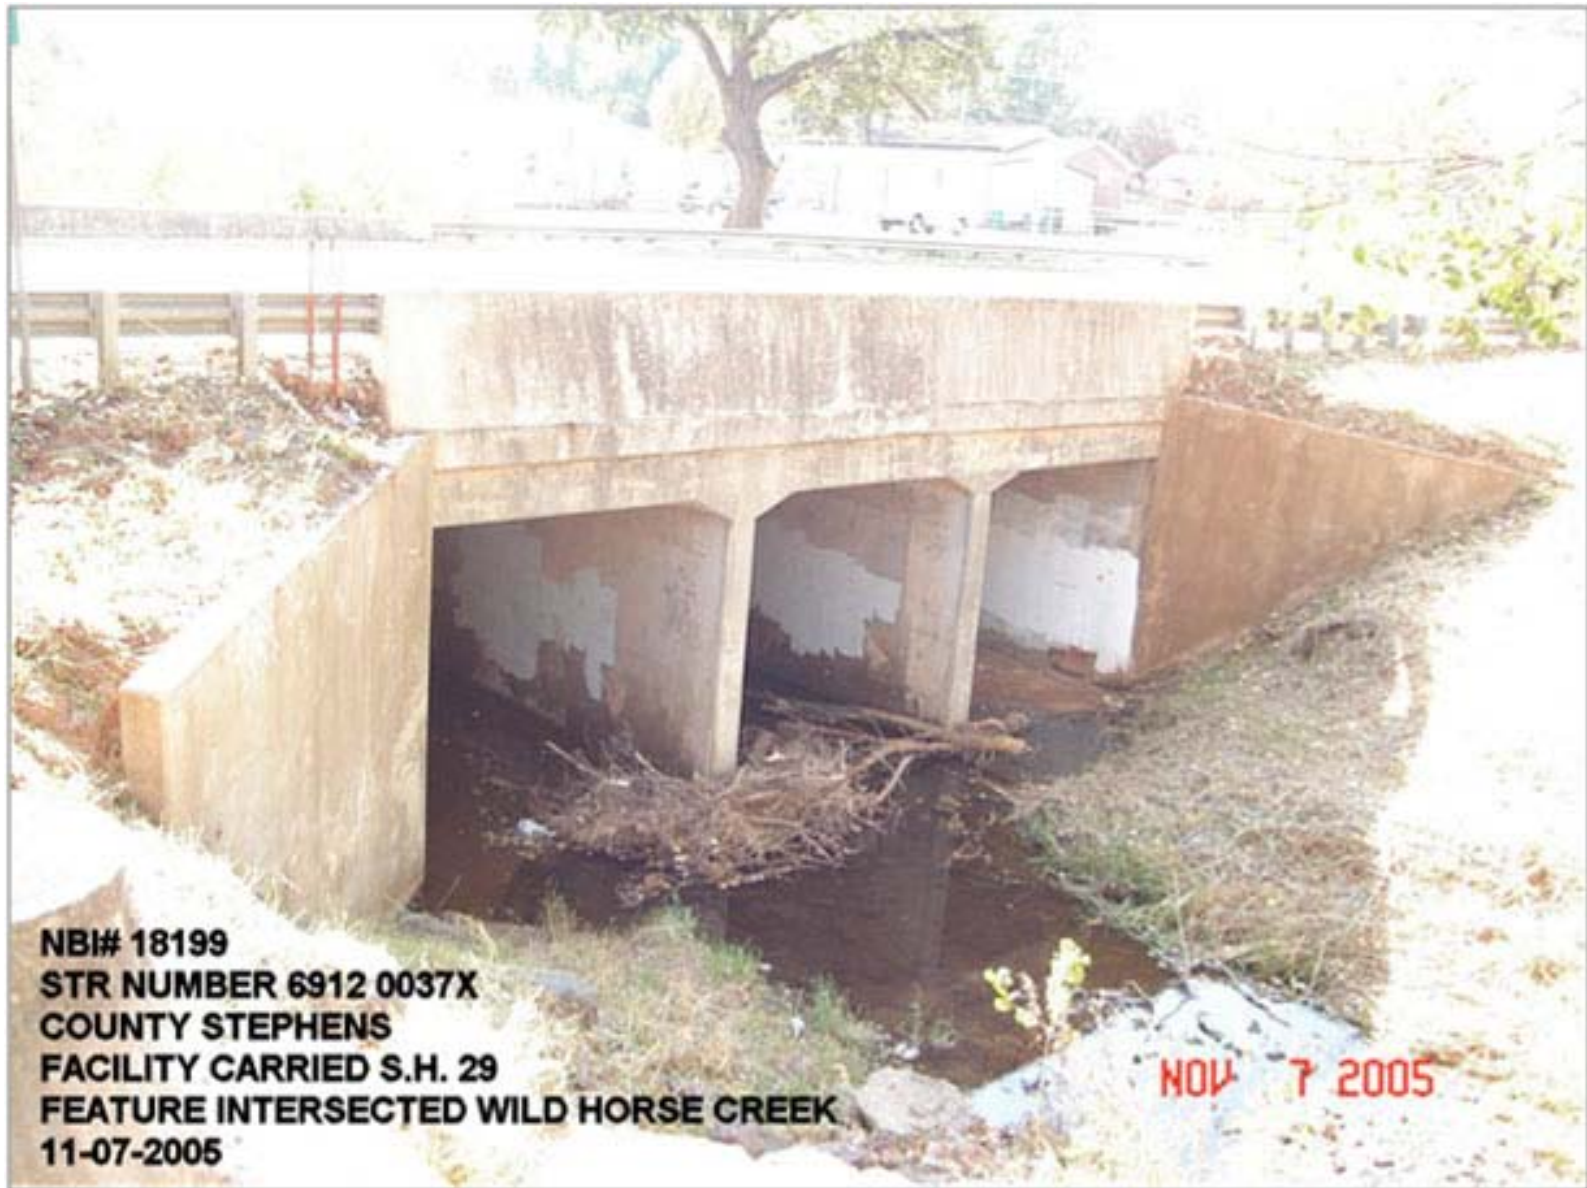
Figure 31. Picture demonstrating extent of damage at culvert 18199 on SH 29 over Wildhorse Creek.

Finally, culvert 18199 on State Highway 29 was built in the year 1972. The location of the culvert is about 0.4 miles east of the junction with State Highway 81 and the latitude and longitude of 34° 38' 51" N and 97° 57' 07" W respectively. Since cross sectional profile values for this culvert were not available, a profile chart could not be created for this bridge. Figure 31 demonstrates the extent of damage to this structure.

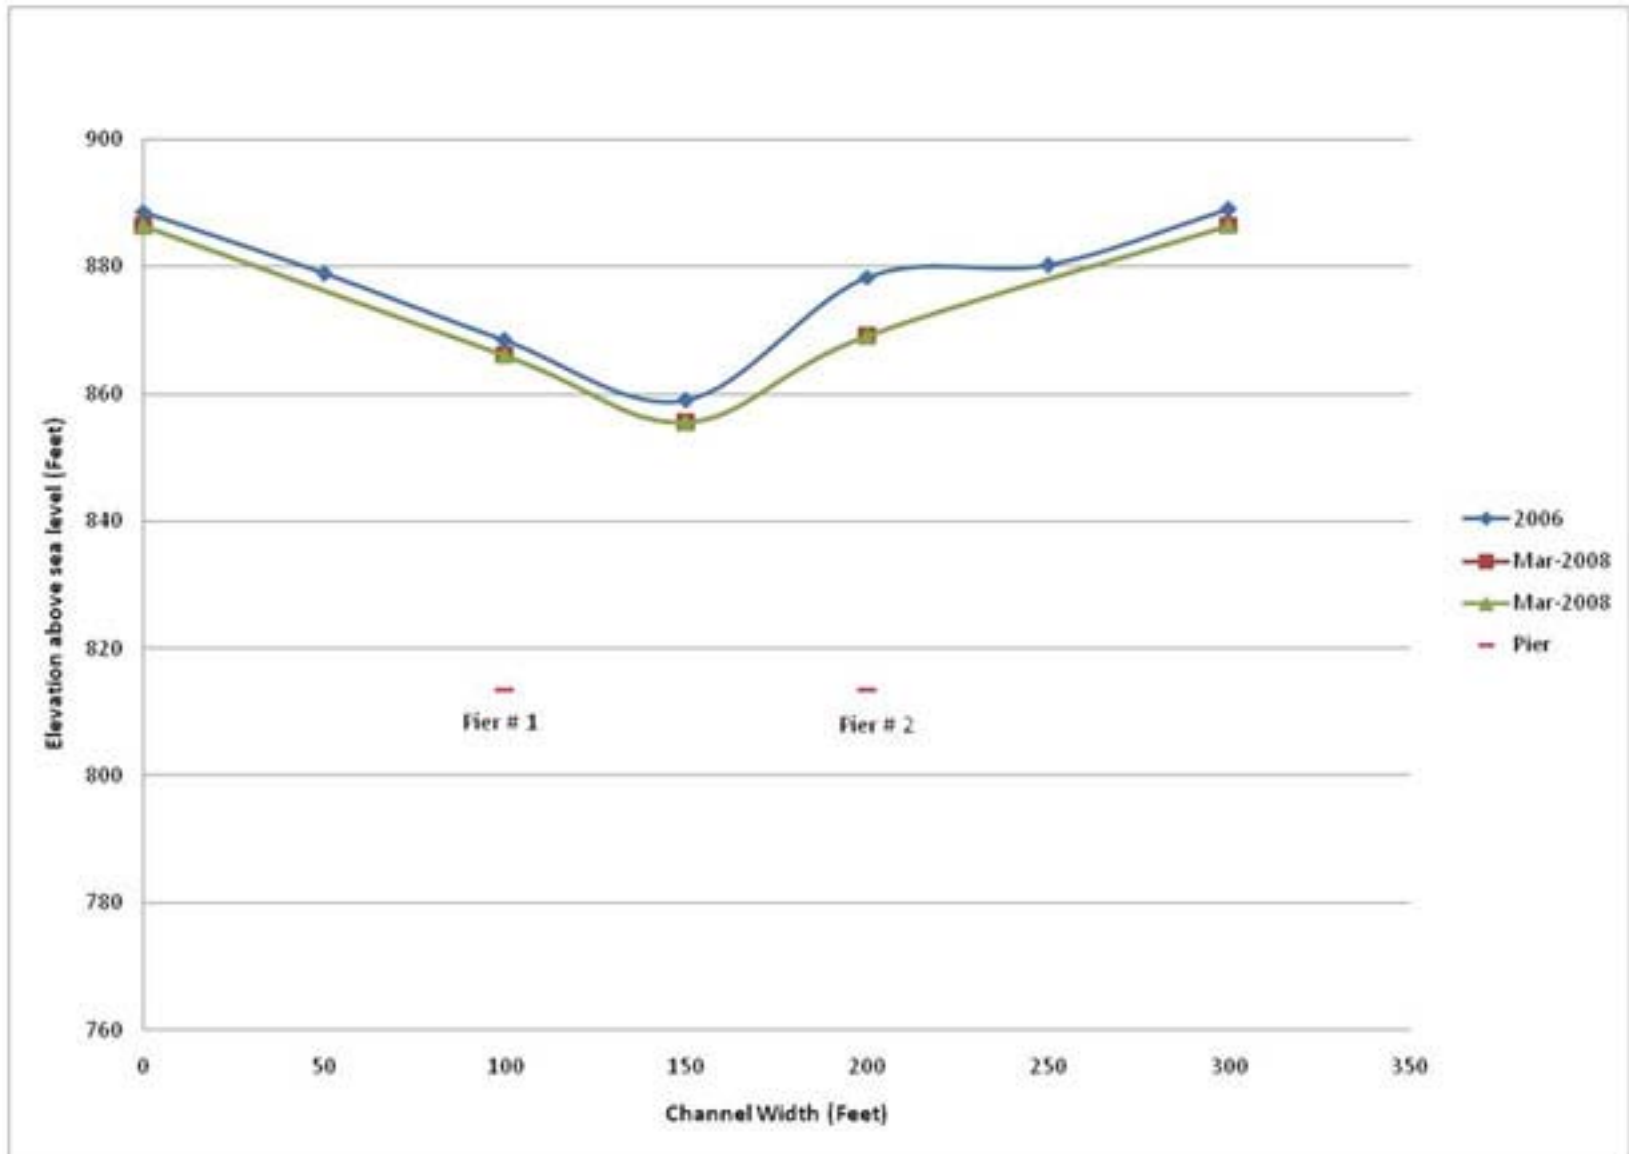
Figure 32. Cross-sectional profiles at bridge 19629 on SH 74 over Salt Creek.

Bridge 19629 on State Highway 74 was built in the year 1979. The location of the bridge is about 2.5 miles north of the Carter County line at latitude and longitude of $34^{\circ} 41' 46''$ N and $97^{\circ} 35' 57''$ W respectively. Figure 32 demonstrates the extent of river bed degradation at the bridge. Figure 33 demonstrates the extent of damage to the piers for this structure.
