Degradation in Rush, Wildhorse, and Salt Creeks of Washita River in Oklahoma for Transportation Planning

FINAL REPORT - FHWA-OK-09-01

ODOT SPR ITEM NUMBER 2194

Oklahoma Infrastructure Consortium
School of Civil and Environmental Engineering
Oklahoma State University
Stillwater, OK 74078

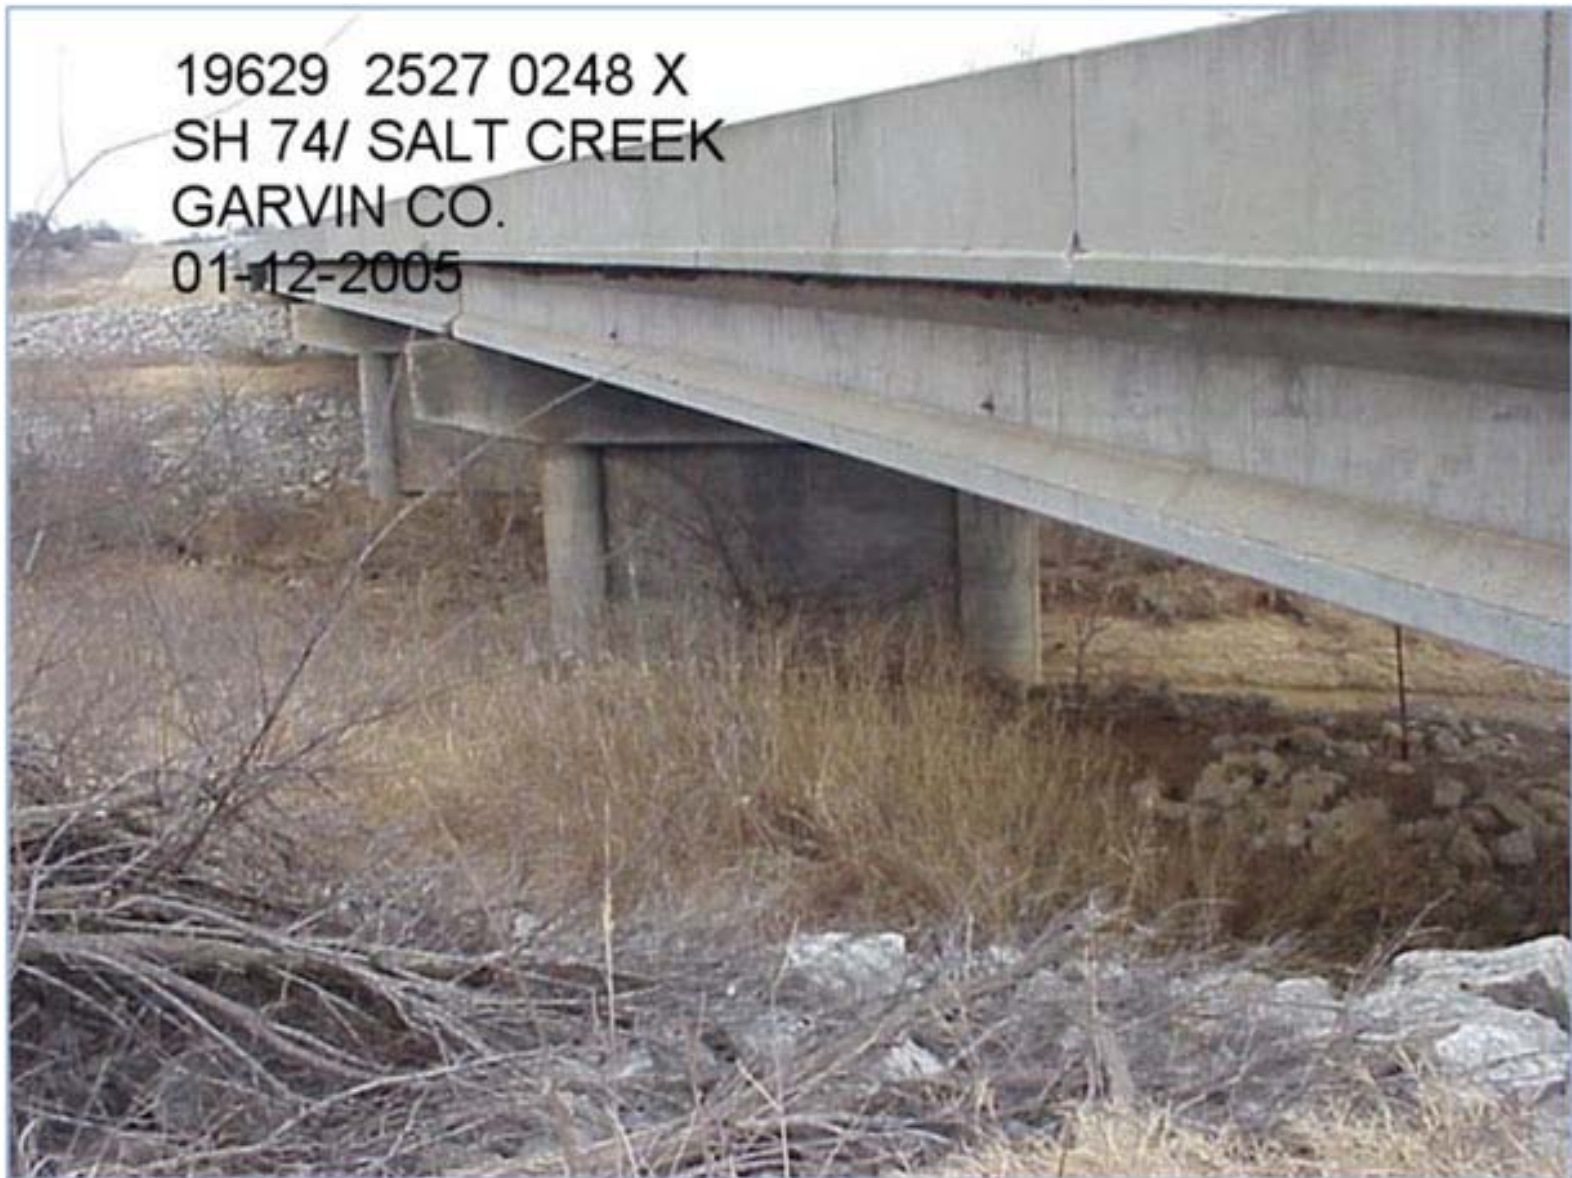
Figure 33. Picture demonstrating extent of damage to piers at bridge 19629 on SH 74 over Salt Creek.

Bridge 19629 on State Highway 74 was built in the year 1979. The location of the bridge is about 2.5 miles north of the Carter County line at latitude and longitude of $34^{\circ} 41' 46''$ N and $97^{\circ} 35' 57''$ W respectively. Figure 32 demonstrates the extent of river bed degradation at the bridge. Figure 33 demonstrates the extent of damage to the piers for this structure.

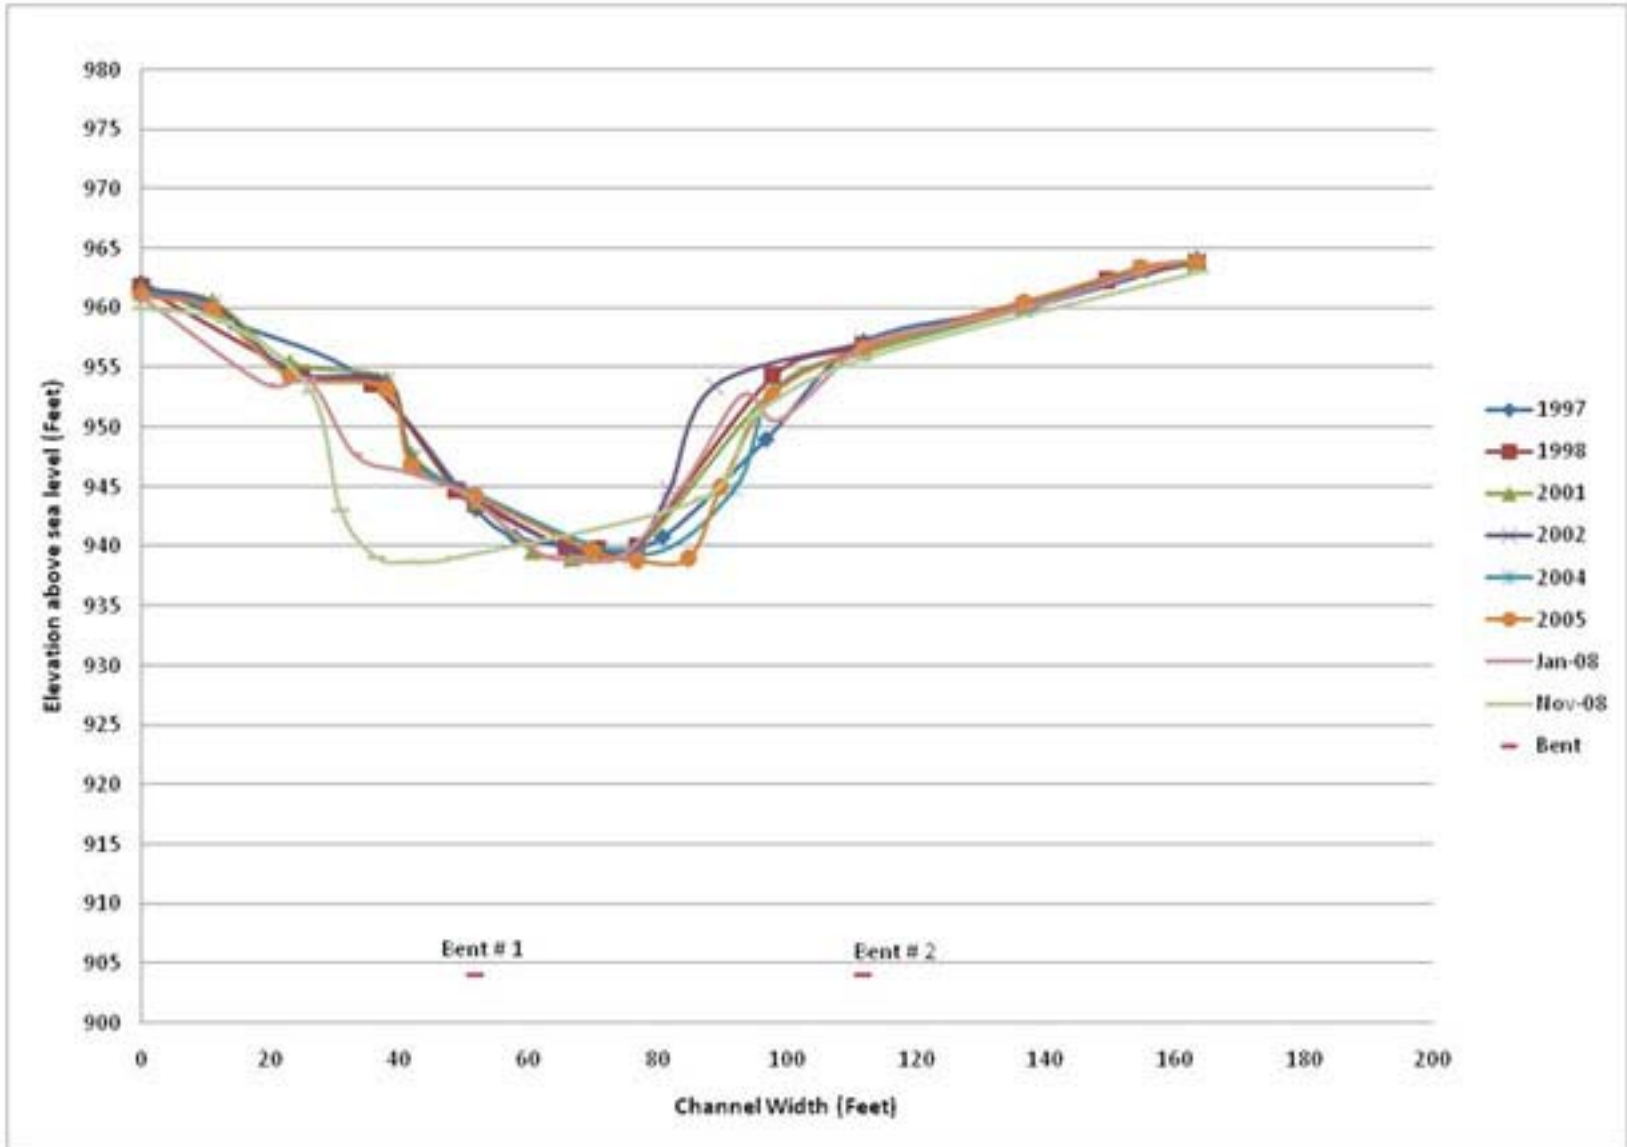
Figure 34. Cross-sectional profiles at bridge 13515 on SH 76 over Salt Creek.

Bridge 13515 on State Highway 76 was built in the year 1955. The location of the bridge is about 6.1 miles north of the Carter County line at latitude and longitude of $34^{\circ} 35' 43''$ N and $97^{\circ} 30' 37''$ W respectively. Figure 34 demonstrates the extent of river bed degradation at the bridge. Figure 35 demonstrates the extent of damage to the piers for this structure.

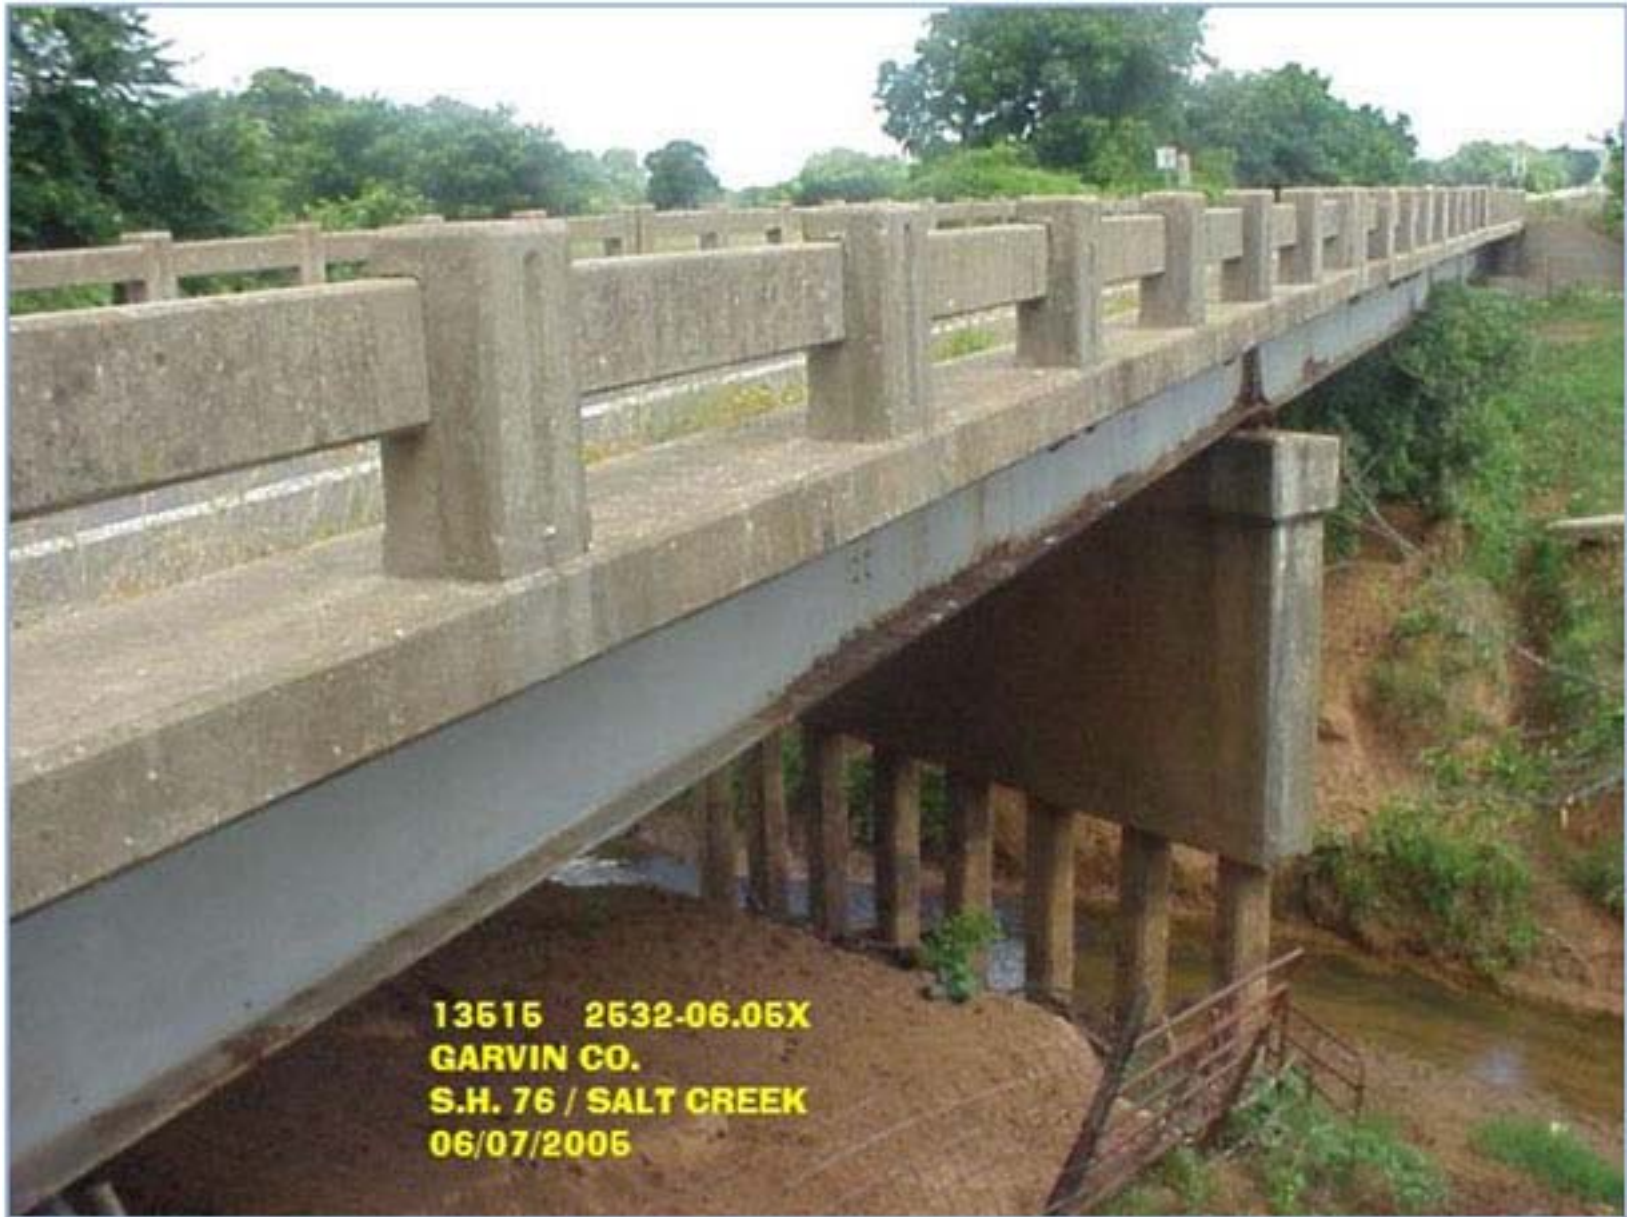
Figure 35. Picture demonstrating extent of damage to piers at bridge 13515 on SH 76 over Salt Creek.

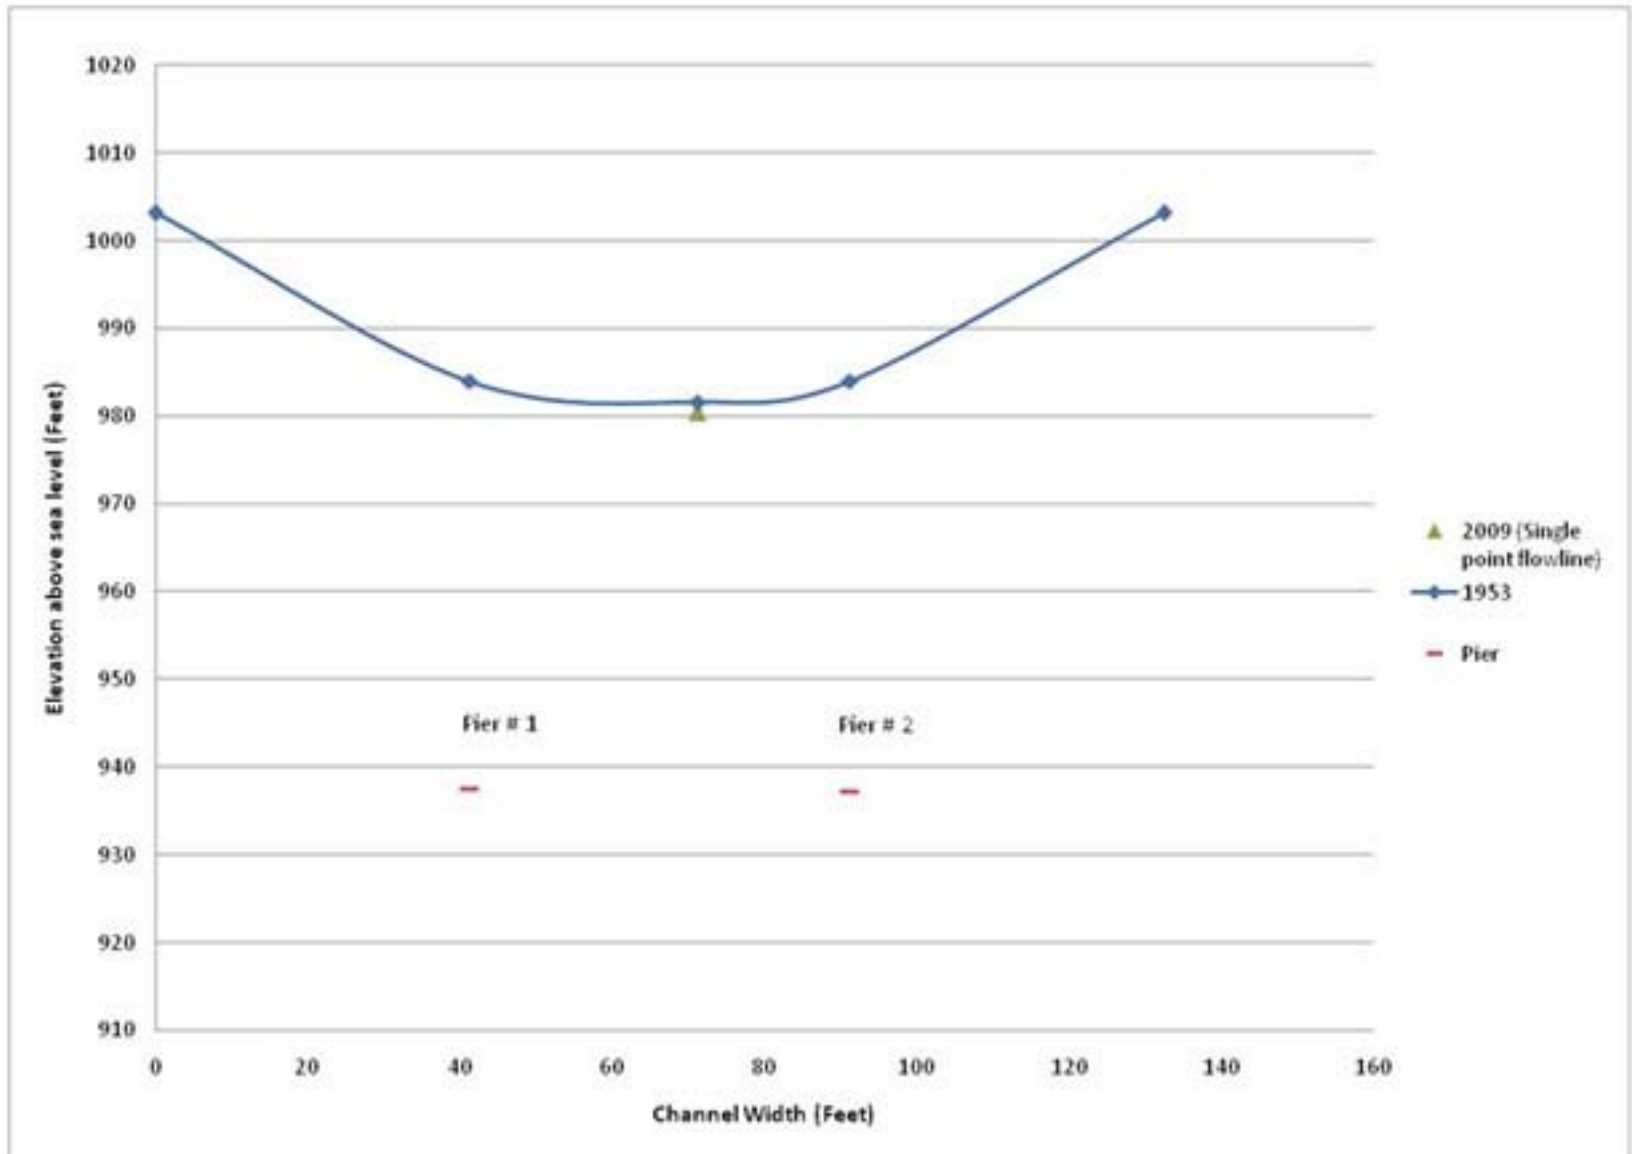
Figure 36. Cross-sectional profile at bridge 13060 on SH 29 over Salt Creek.

Finally, bridge 13060 on State Highway 29 was built in the year 1953 and is the oldest bridge on Salt Creek. The location of the bridge is about 1.5 miles east of the Stephens County line at latitude and longitude of $34^{\circ} 37' 49''$ N and $97^{\circ} 32' 09''$ W respectively. Figure 36 demonstrates the extent of river bed degradation at the bridge. Figure 37 demonstrates the extent of damage to the piers for this structure.

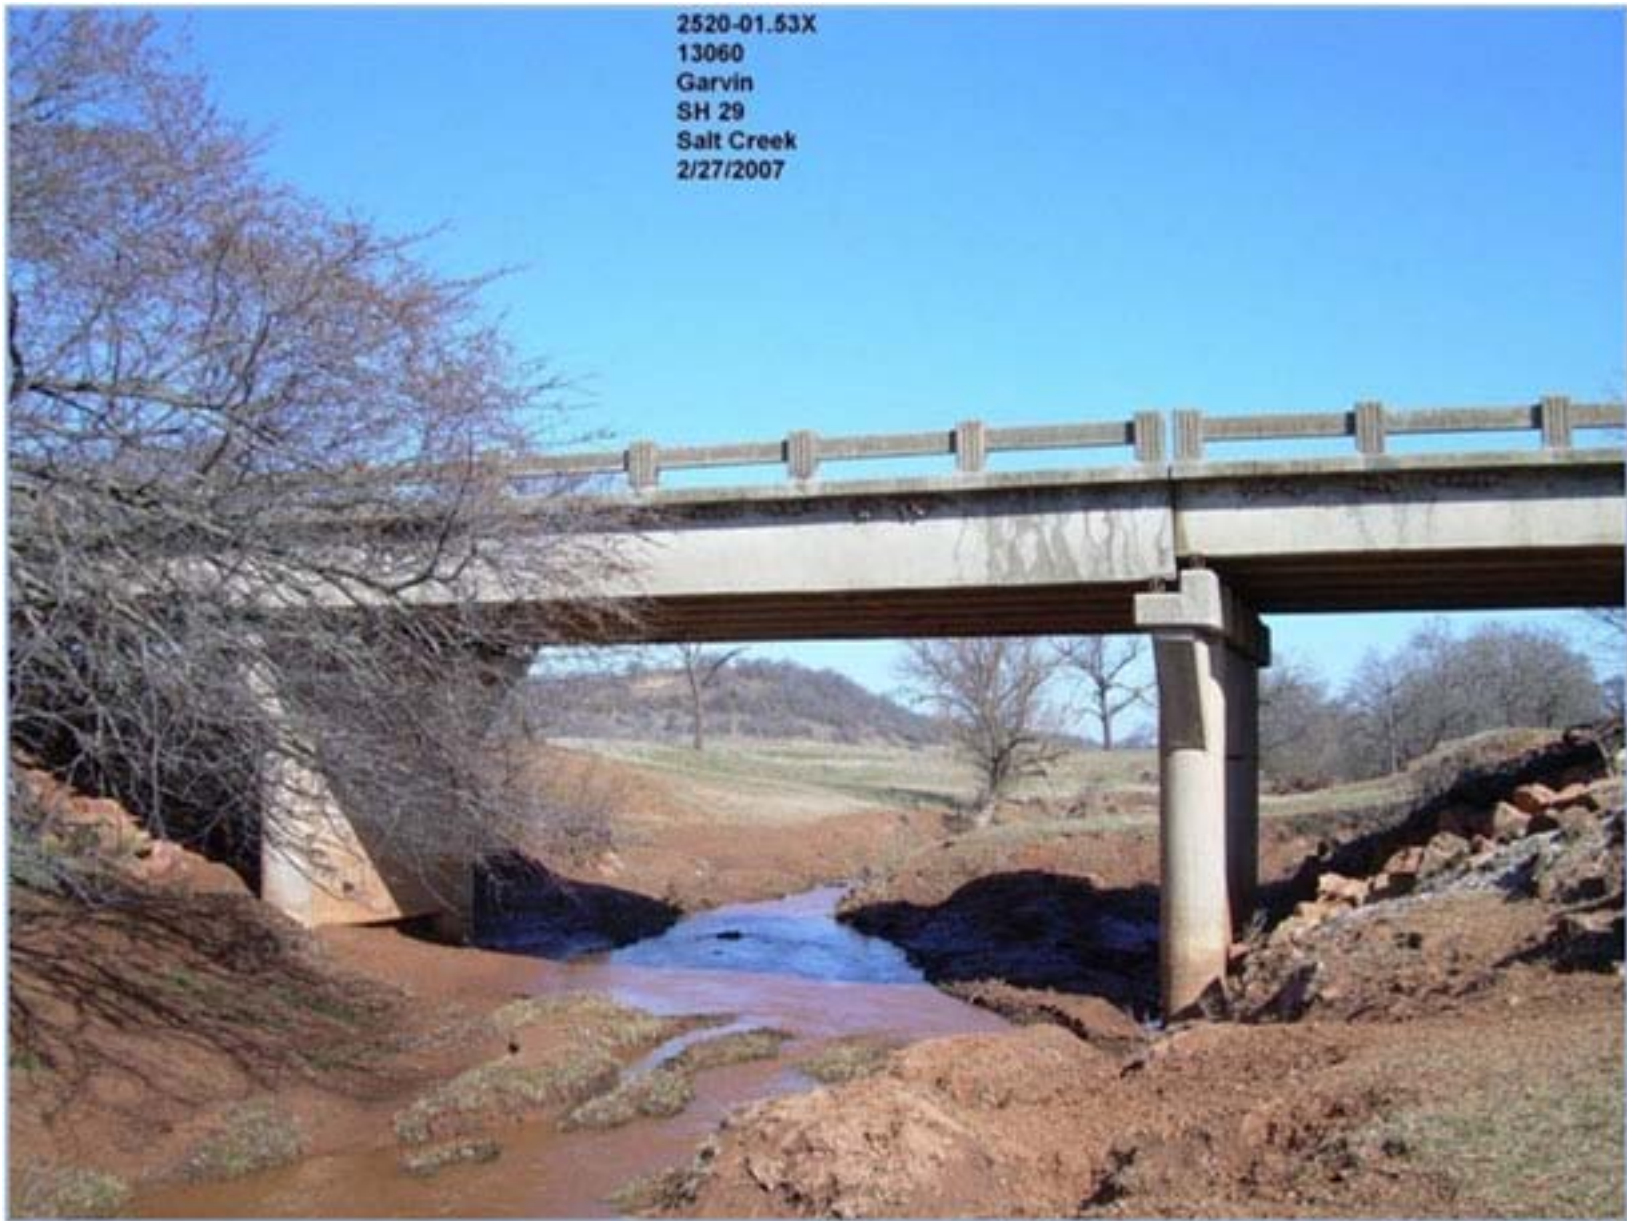
Figure 37. Picture demonstrating extent of damage to piers at bridge 13060 on SH 29 over Salt Creek.

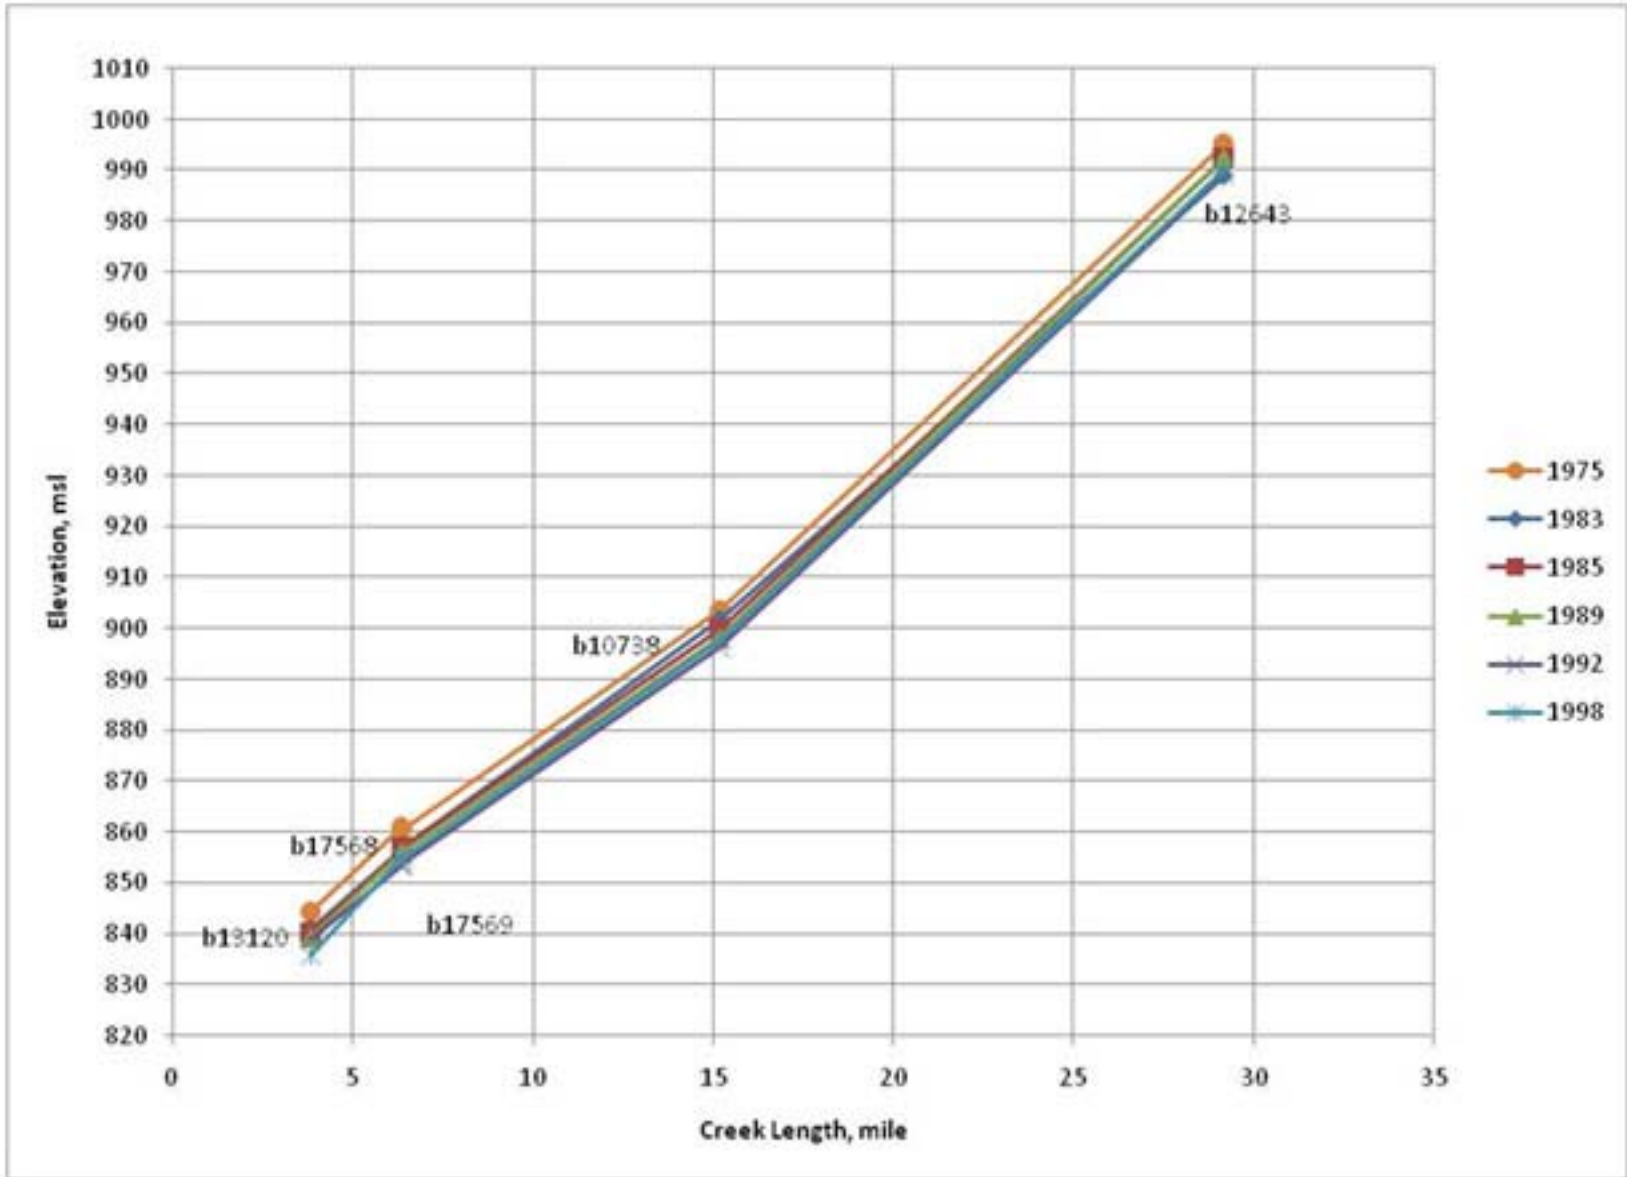
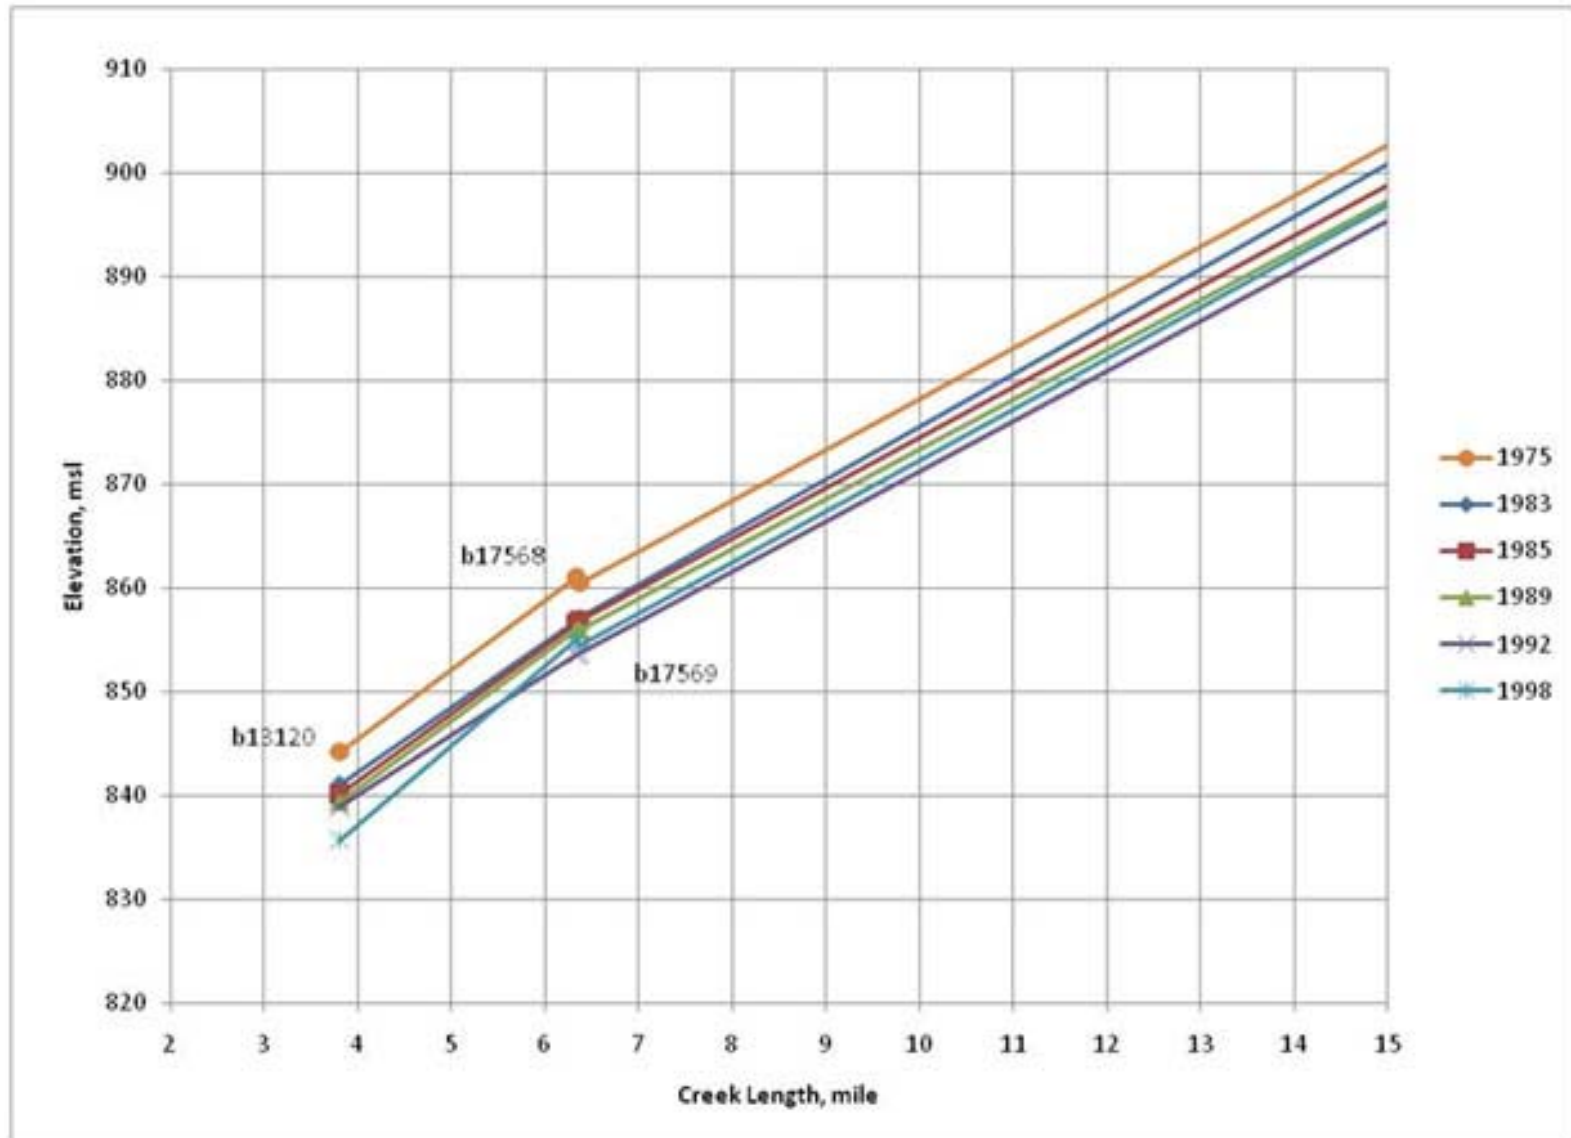
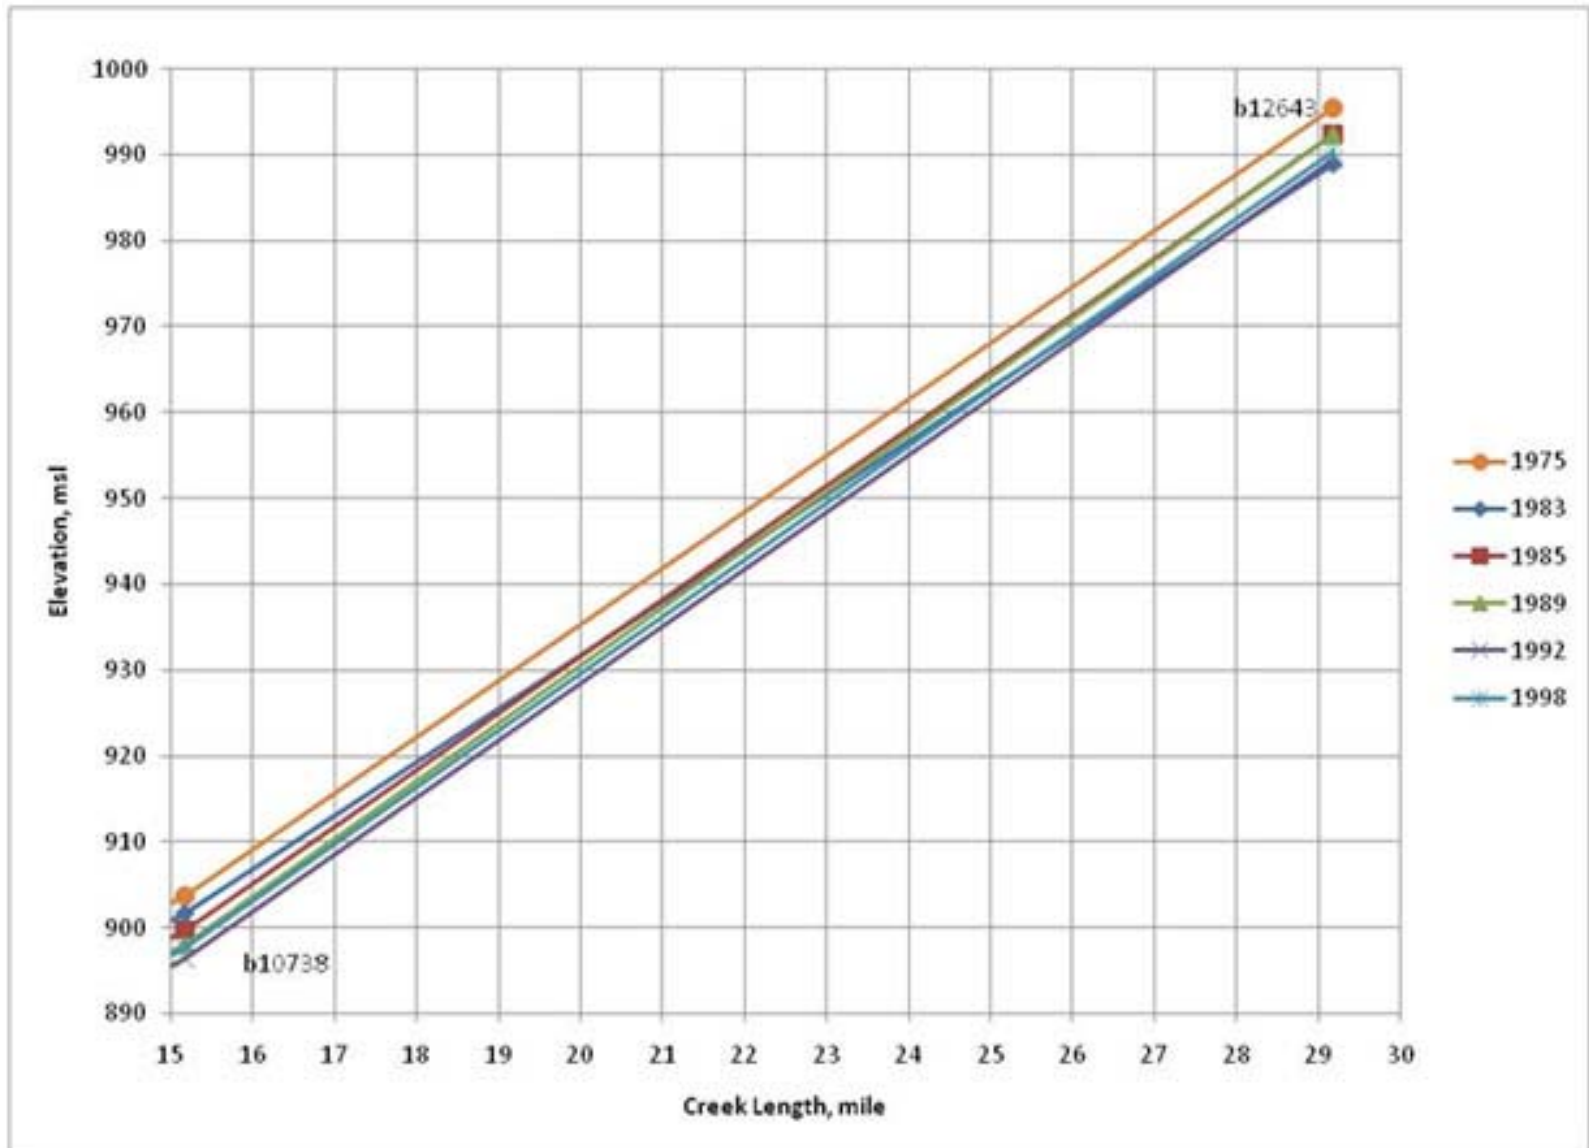
Figure 38. Longitudinal profile for Rush Creek.

Figure 38a. Longitudinal profile for Rush Creek.

Figure 38b. Longitudinal profile for Rush Creek.

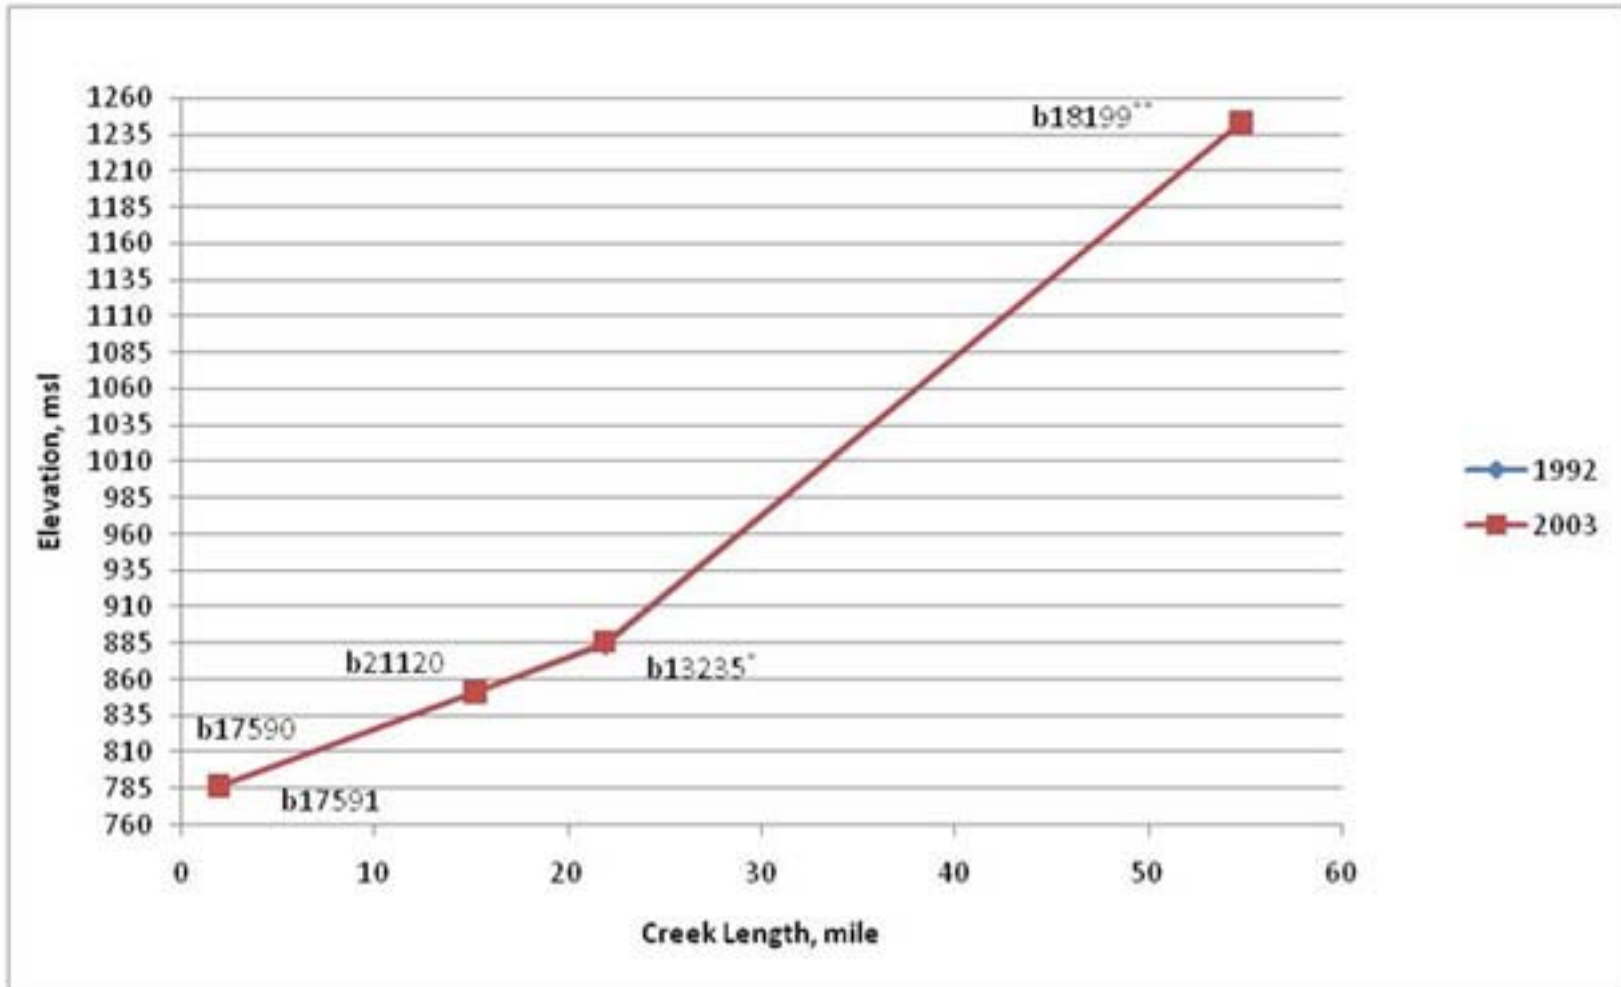
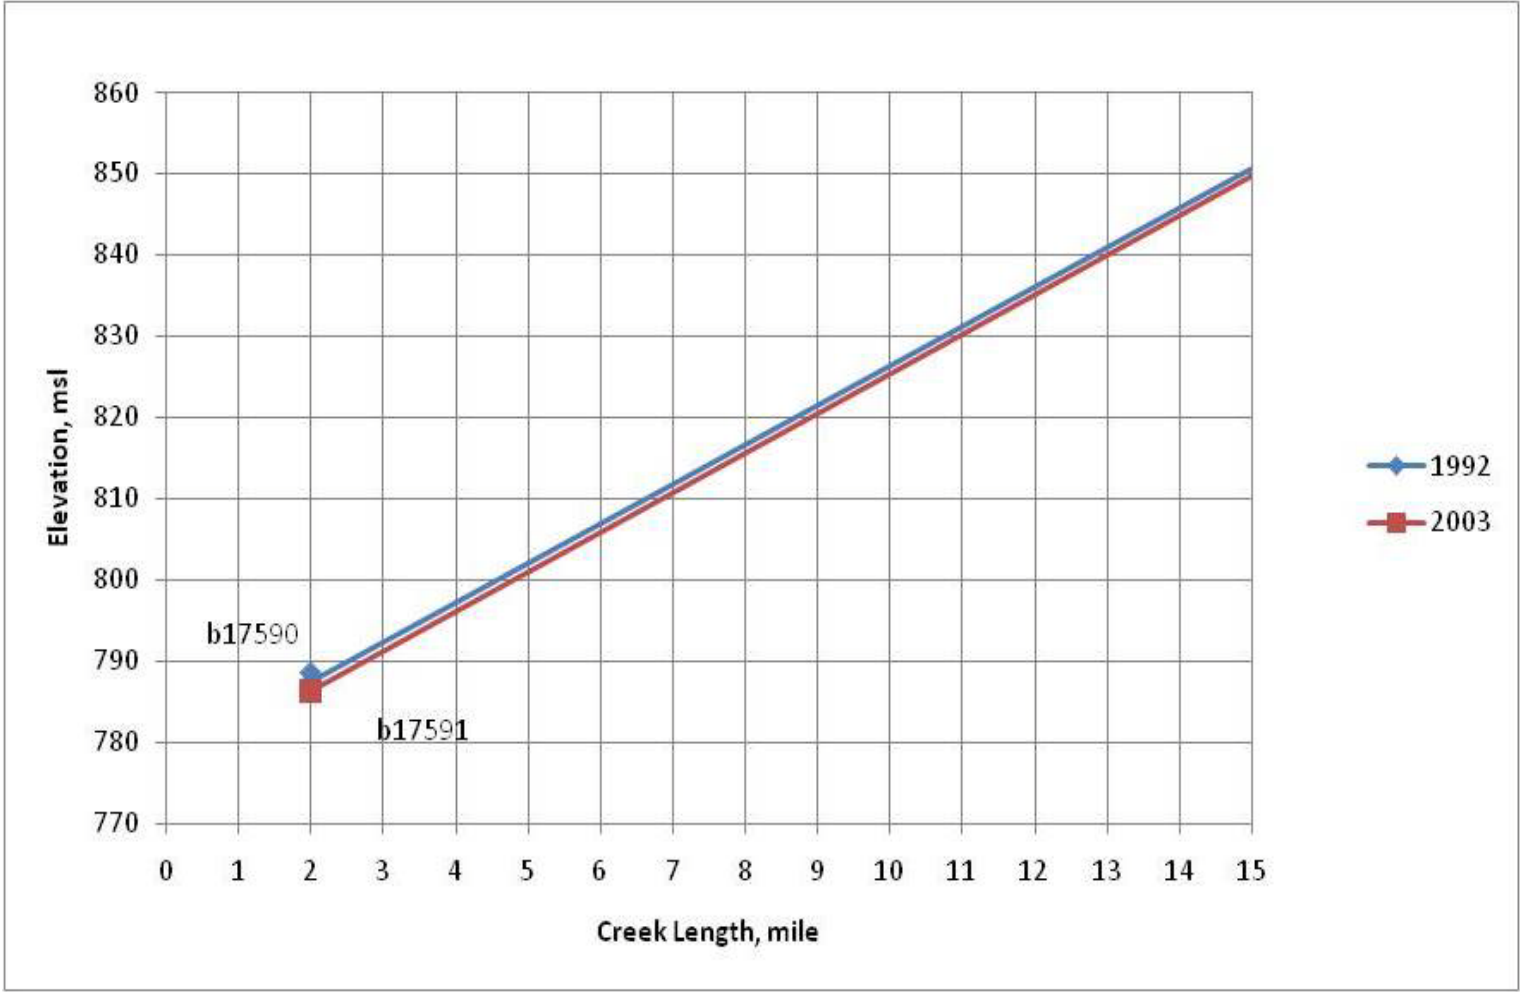
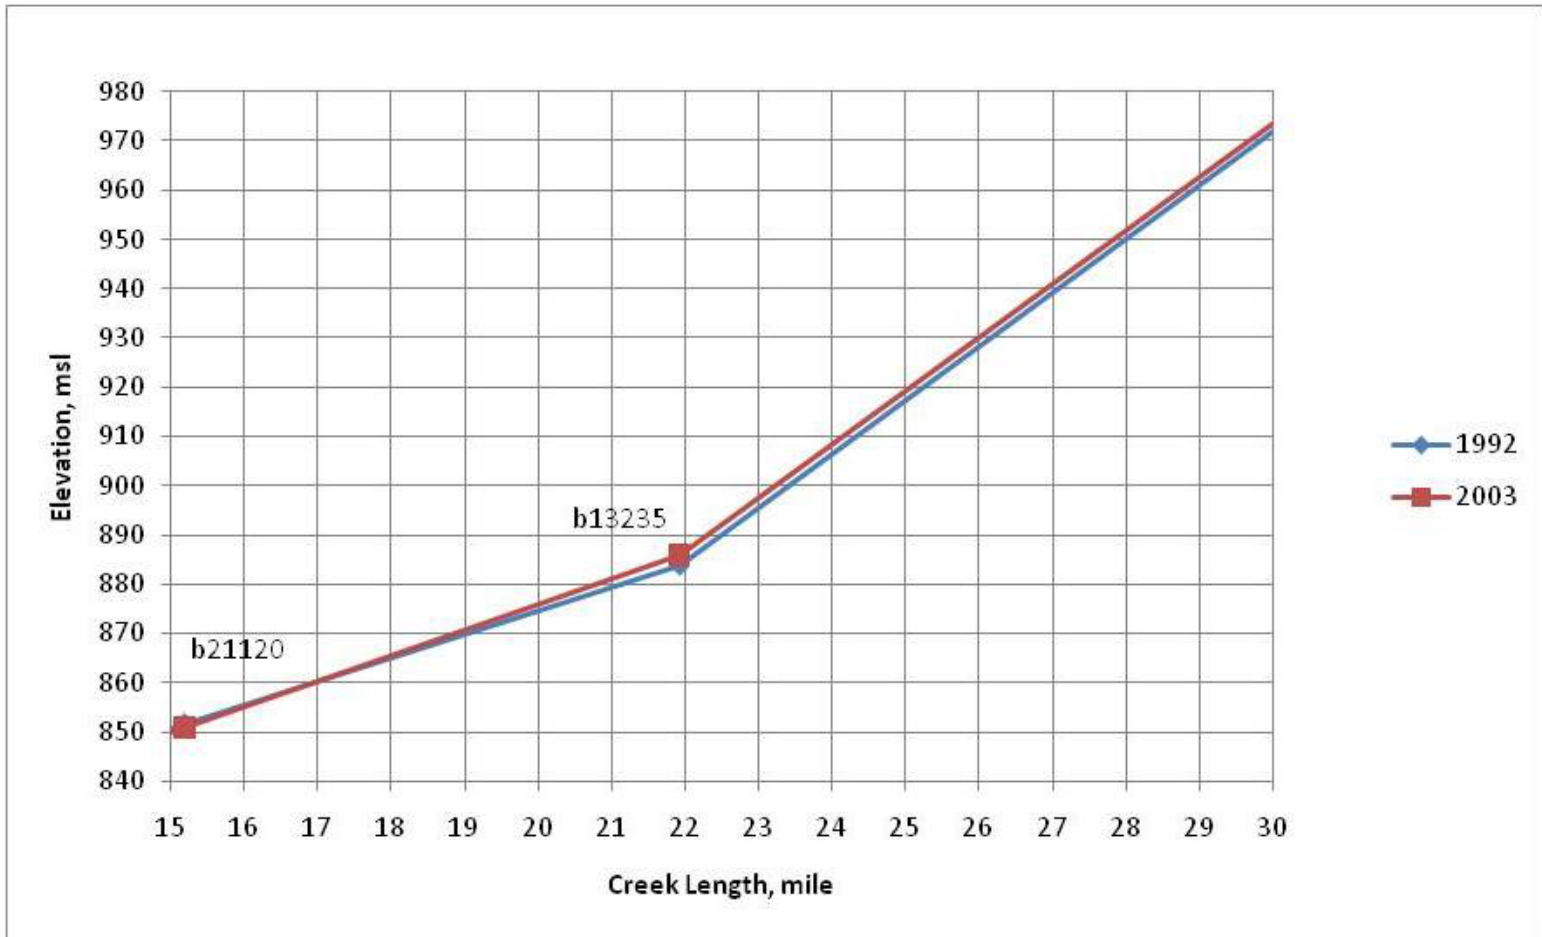
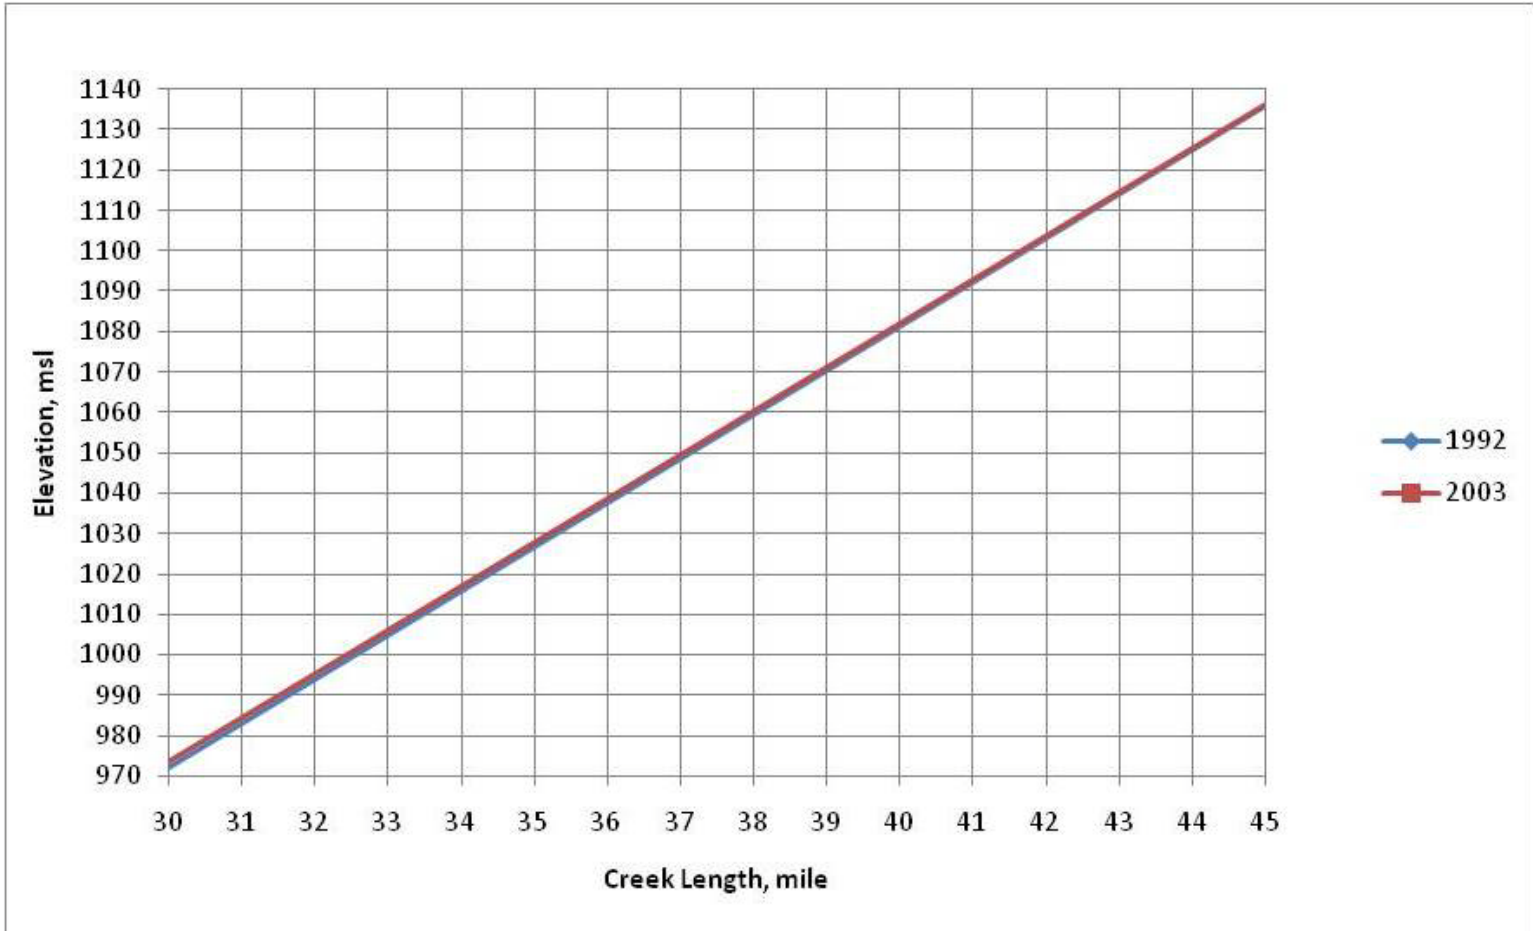
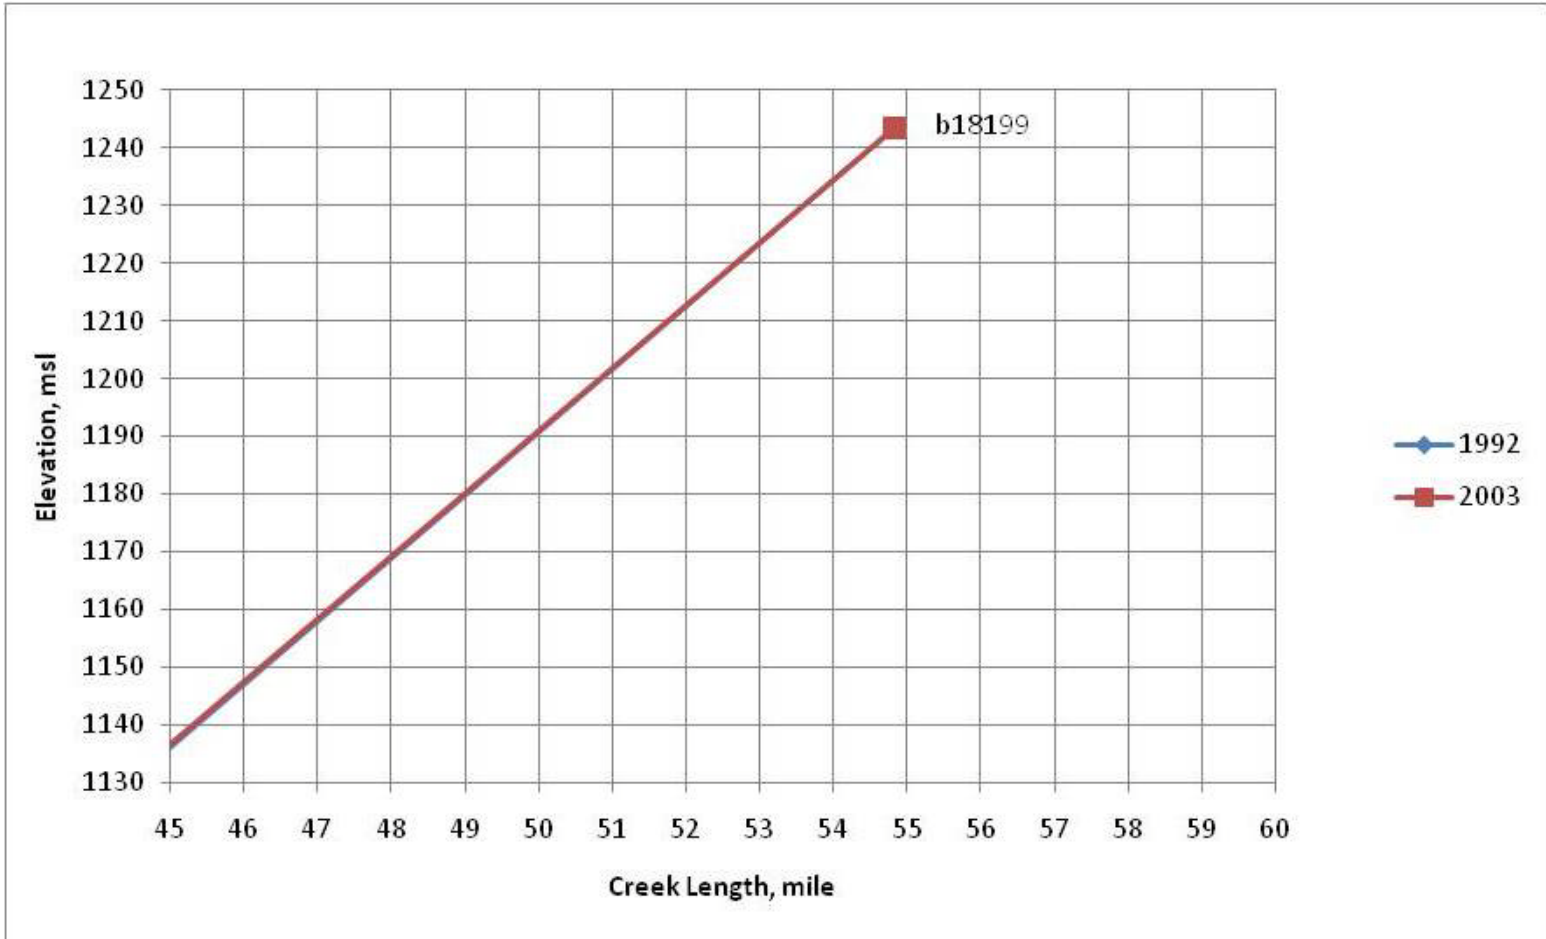
*interpolated value at b13235 for the year 2003

**interpolated value at b18199 for the year 1992

Figure 39. Longitudinal profile of Wildhorse Creek.

Figure 39a. Longitudinal profile of Wildhorse Creek.

Figure 39b. Longitudinal profile of Wildhorse Creek.

Figure 39c. Longitudinal profile of Wildhorse Creek.

Figure 39d. Longitudinal profile of Wildhorse Creek.

The trend line of bed-elevation changes was plotted for Study Reach of Wildhorse Creek in Oklahoma and can be seen in Figures 39, 39a, 39c, and 39d. The flow elevation data was available for bridges 17590, 17591, 21120, 13235, and 18199. Since the flow line changes in the more recent years are considered more important, the flow line change chart was drafted using the elevation values from the years ranging from the 1990's to the 2000's.
