Degradation in Rush, Wildhorse, and Salt Creeks of Washita River in Oklahoma for Transportation Planning

FINAL REPORT - FHWA-OK-09-01

ODOT SPR ITEM NUMBER 2194

Oklahoma Infrastructure Consortium
School of Civil and Environmental Engineering
Oklahoma State University
Stillwater, OK 74078

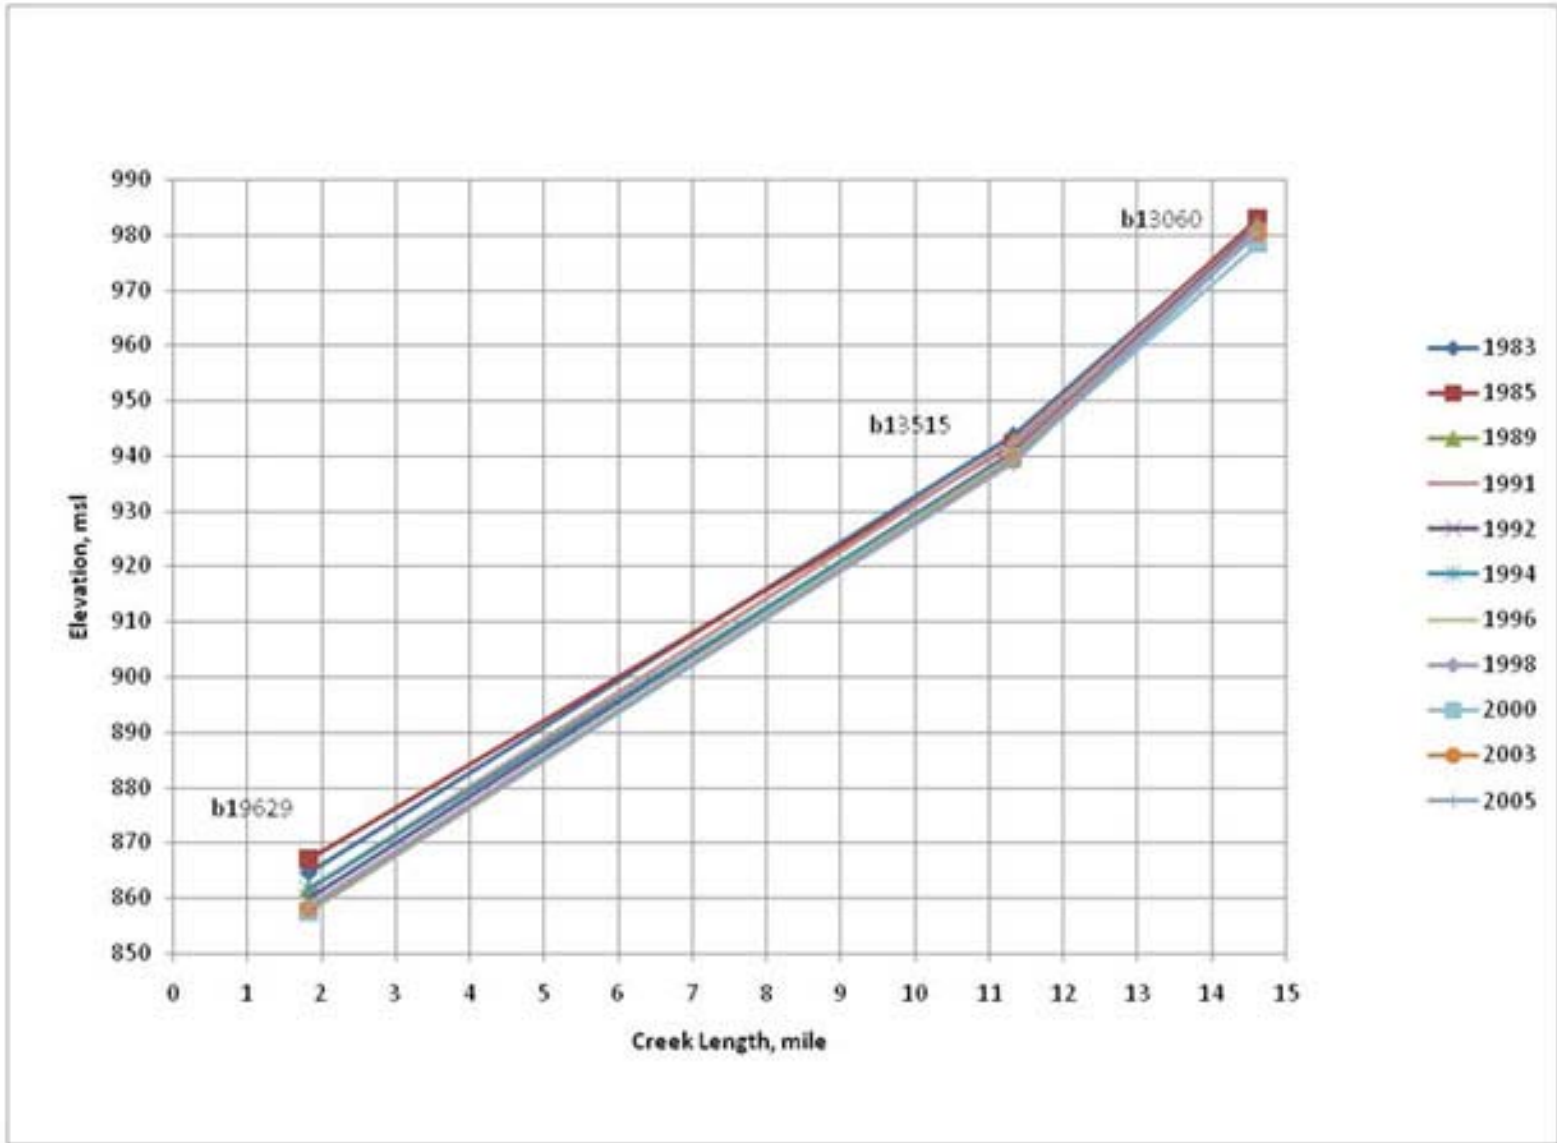
Figure 40. Longitudinal profile of Salt Creek.

The trend line of bed-elevation changes was plotted for Study Reach of Salt Creek in Oklahoma and can be seen in Figure 40. The flow elevation data was available for the bridges 19629, 13515, and 13060. The flow elevation data available for bridges 13515 and 13060 started in the early 1960's. The remaining bridge 19629 was constructed in 1979 and thus the available data starts in the 1980's for this bridge. Figure 40 contains complete flow line data for all three bridges, from the 1980's to the 2000's.

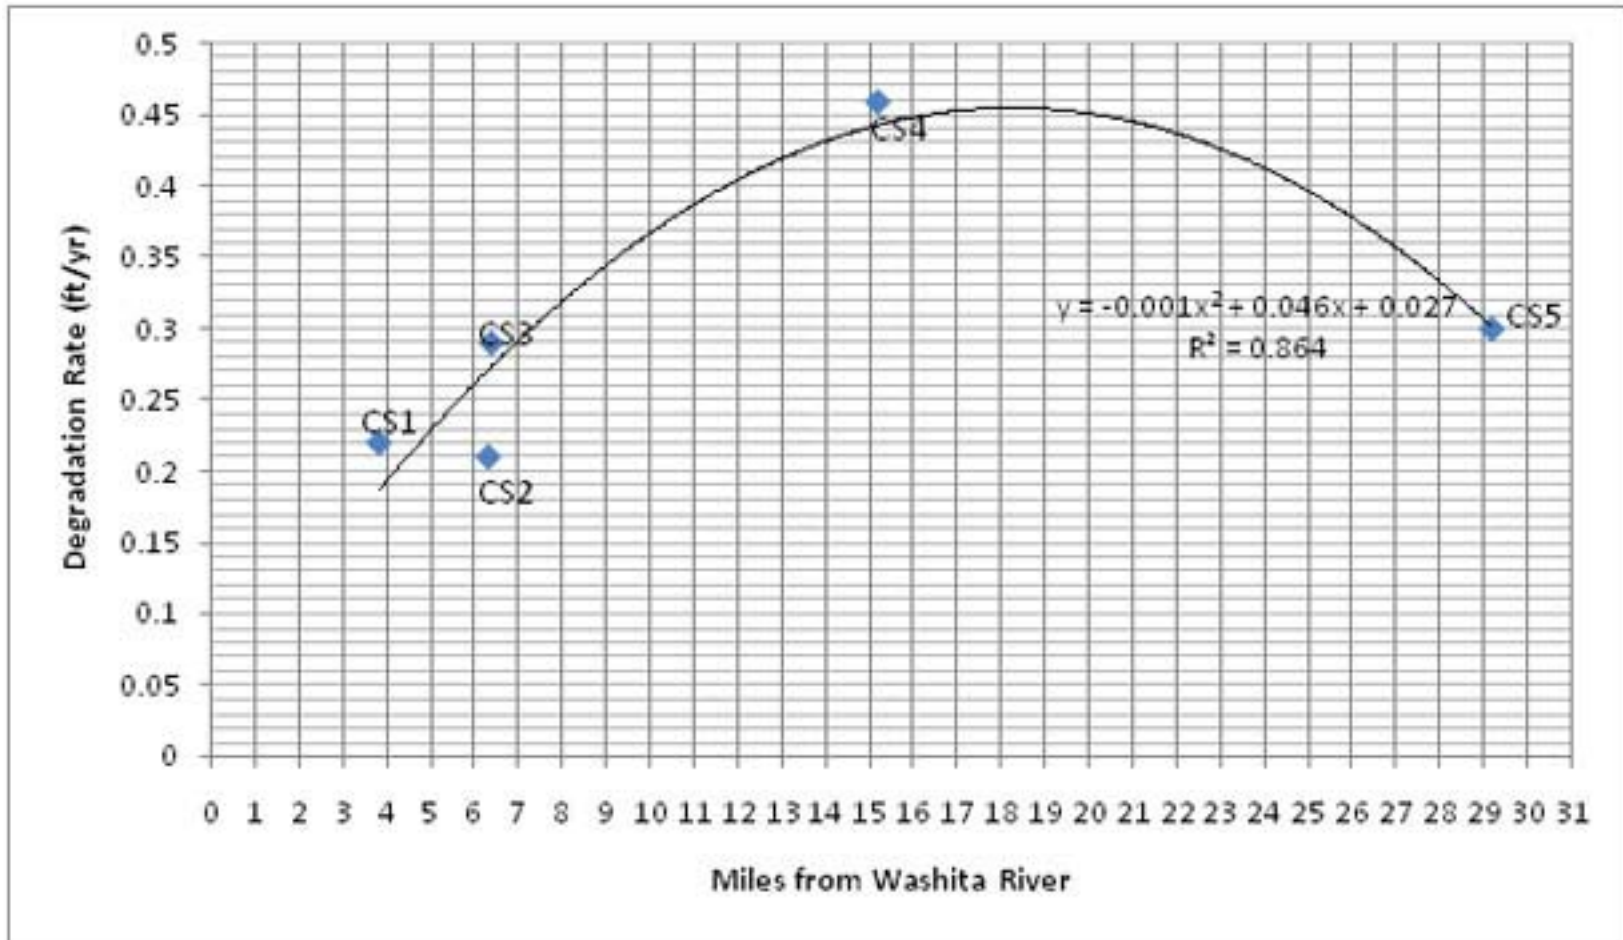
Figure 41. River degradation rate with trend line of Rush Creek, OK.

In order to illustrate the phenomena of increased degradation rates along the length of the three creeks, a regression analysis was performed as shown in Figures 41

through 43. During the regression analysis it became necessary to eliminate a few extreme data point outliers in order to represent an accurate trend line for degradation. The extreme outliers that were eliminated from the regression analysis are c18199 on Wildhorse Creek and b13060 on Salt Creek.

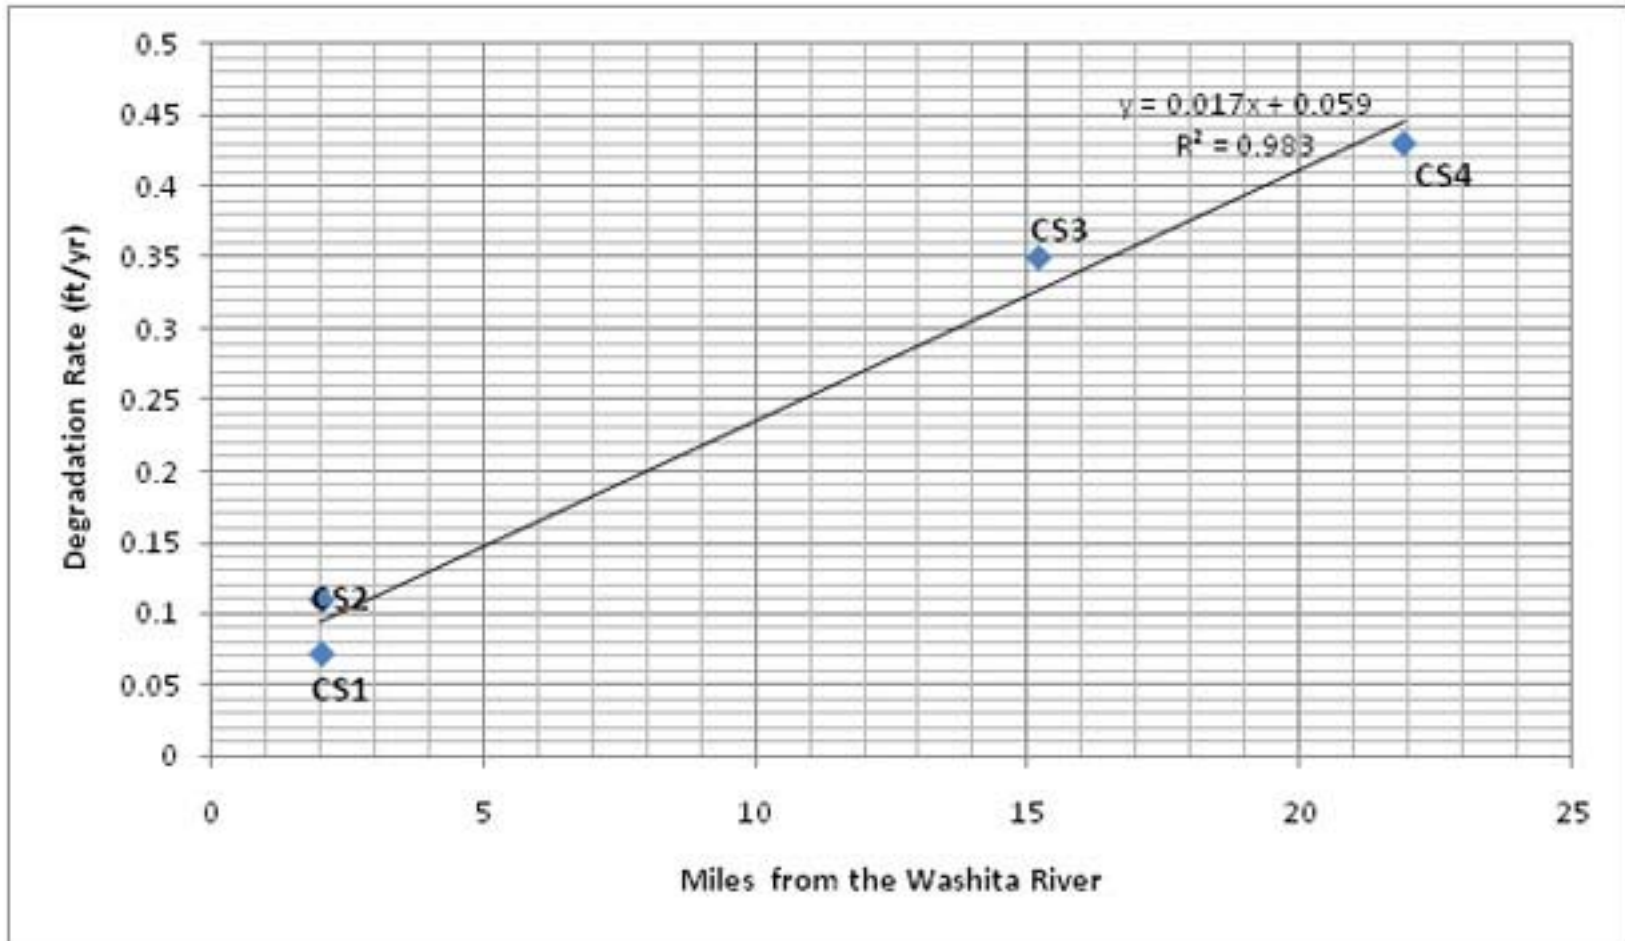
Figure 42. River degradation rate with trend line of Wildhorse Creek, OK.

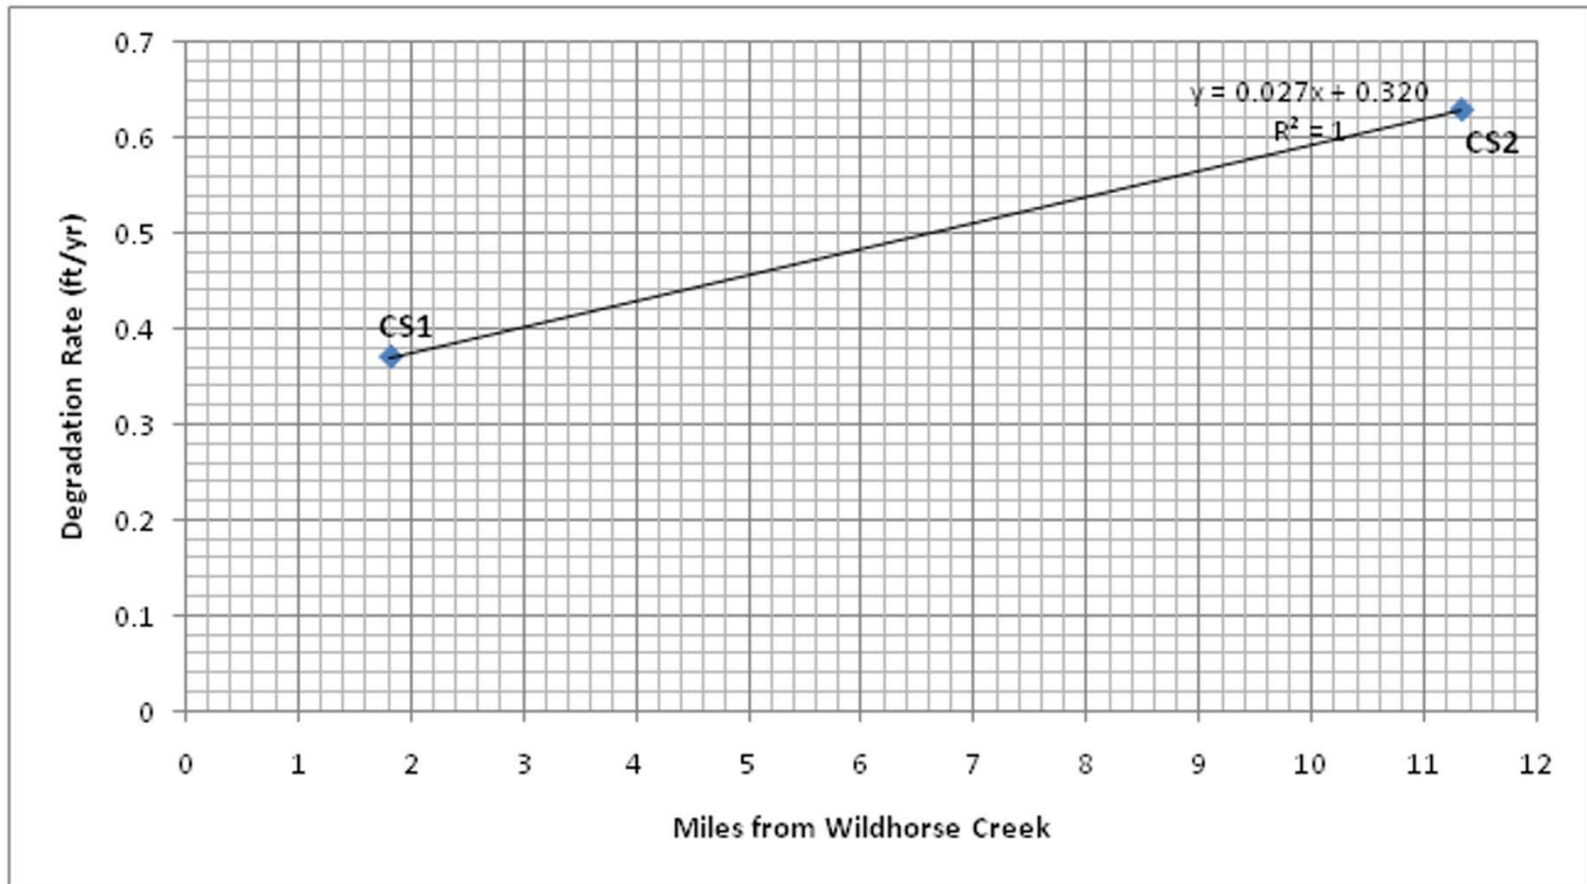
Figure 43. River degradation rate with trend line of Salt Creek, OK.
