RED LIGHT RUNNING CAMERA ASSESSMENT

Final Report

SPR 304-521

Oregon Department of Transportation

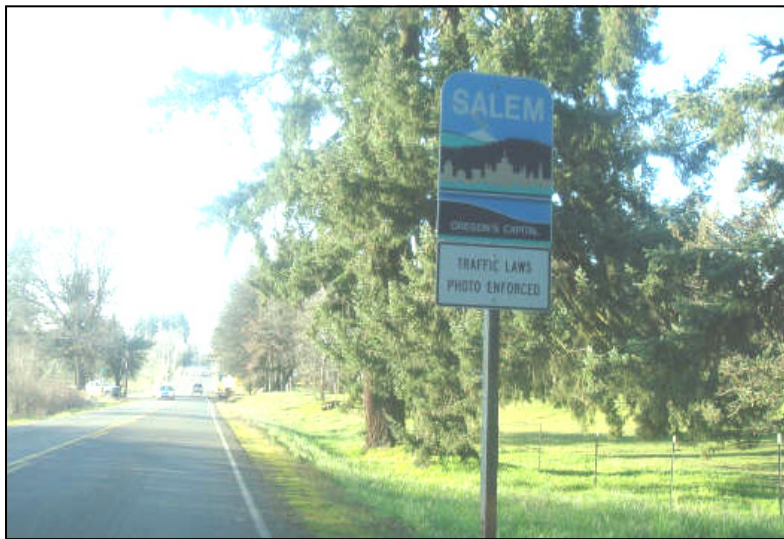
Figure 1.1: Photograph of photo enforcement sign installed at Salem city limits

Signs were installed at the city limits, alerting drivers that photo enforcement was being used in the city. A sign was installed on each approach where a camera would operate, alerting drivers that photo enforcement was in place. Figure 1.1 is an example of a sign installed at the city limits. Figure 1.2 is a photograph of the sign installed at the Mission and 25th intersection in the westbound direction.

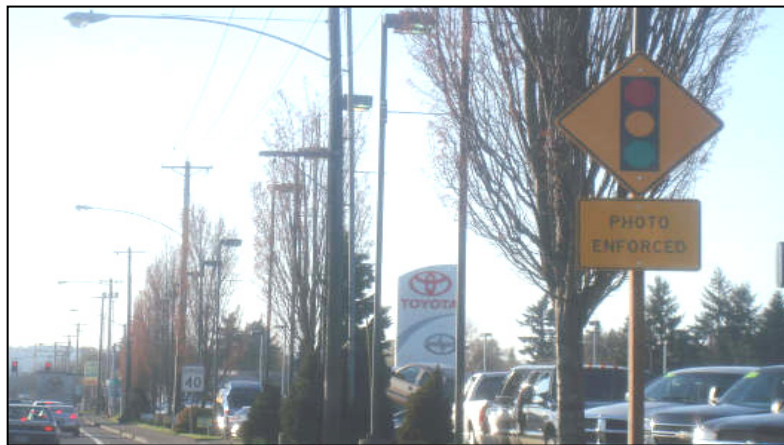
Figure 1.2: Photograph of photo enforcement sign installed on westbound approach of Mission Street SE and 25th Street SE intersection in Salem

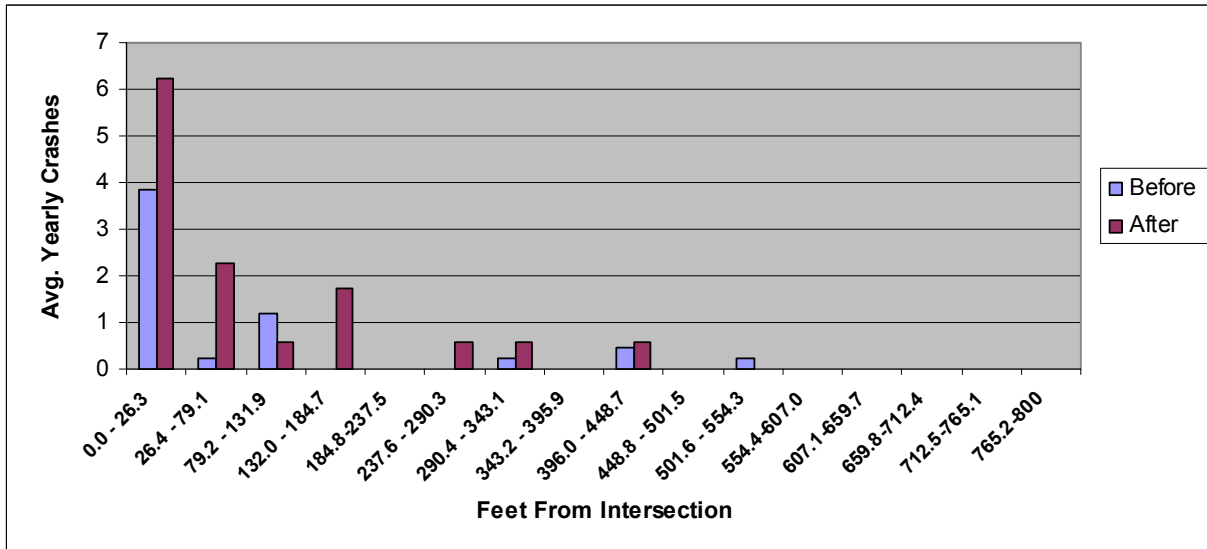
Figure 4.1: Distribution of crashes on Mission Street SE within the area of intersection influence for the pre- and post-camera installation periods

While the area of influence of the intersection on Mission Street SE was determined to be 800 ft west to 50 ft east for drivers traveling westbound, the crash that was the farthest from the intersection occurred at 528 ft. Locations of crashes occurring before and after the cameras were installed were compared, and it was found that the increase in crash rate in the post-camera installation period tended to be greater at distances closer to the intersection. Figure 4.1 presents

a visual representation of this data with the milepoint being converted to feet and the crash rates converted into average yearly crashes.

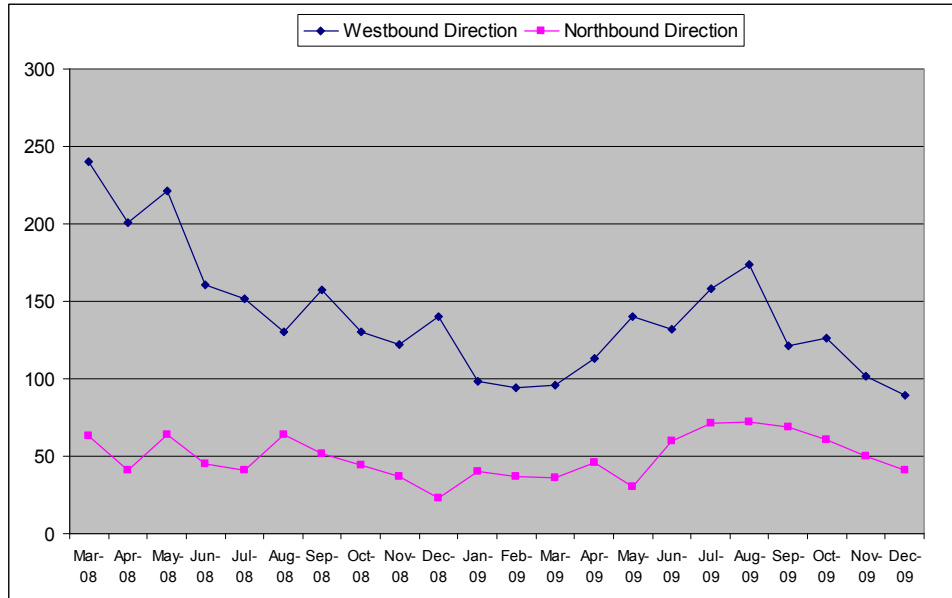
Figure 4.3: Red light running violations, Mission Street SE and 25th Street SE intersection

Violation data from Redflex, Inc. for the Mission and 25th intersection are shown in Table 4.6. Violations recorded by RLR cameras do not always lead to the issuance of a citation. Citations are determined by taking the total number of violations and subtracting controlled (rejects) and uncontrolled factors. Rejects are factors that are within the control of the police or vendor, e.g., camera out of focus, or red lights not visible. Uncontrolled factors are those that are beyond the control of the police or Redflex, e.g., license plate or face blocked by traffic, inaccurate DMV information, or gender mismatch. To make the data easier to view, Figure 4.3 presents the same violation data graphically, showing changes in violations issued over the 21-month study period.

- The data in Table 4.6 show that violations in the westbound direction declined from 240 in March 2008 to 96 in March 2009. This is a 60 percent reduction by the end of one year of camera operation. The average monthly reduction over the entire 21 months of the study period was 43 percent.
- The data in Table 4.6 show that the violations in the northbound direction declined from 63 in March 2008 to 36 in March 2009. This is a 43 percent reduction. The average monthly reduction over the entire 21 months of the study period was 23%.
