Final Report

Pervious Pavements - Installation, Operations and Strength Part 3: Permeable Paver Systems

Work Performed for the Florida Department of Transportation

**Stormwater Management Academy
University of Central Florida
Orlando, FL 32816**

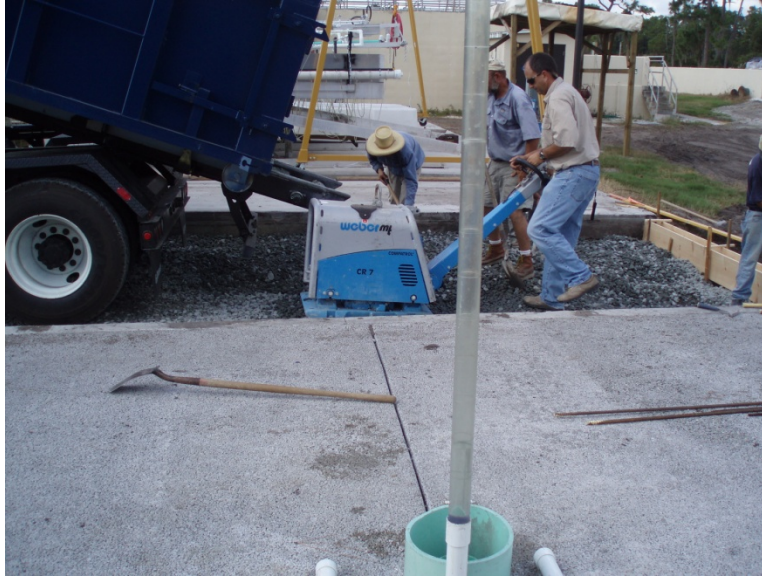
Figure 6: Aggregates placed, leveled, then compacted

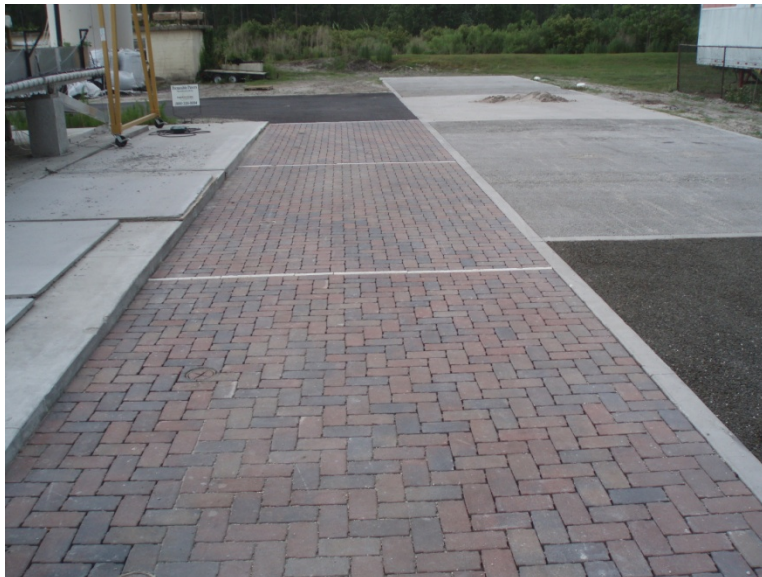
Figure 7: Final Layout of Pervious Pavement Sections with ERIKS

These steps were all done according to the manufacturer's specifications. Figure 7 depicts the final pavement system with the three sections delineated by the curbing.

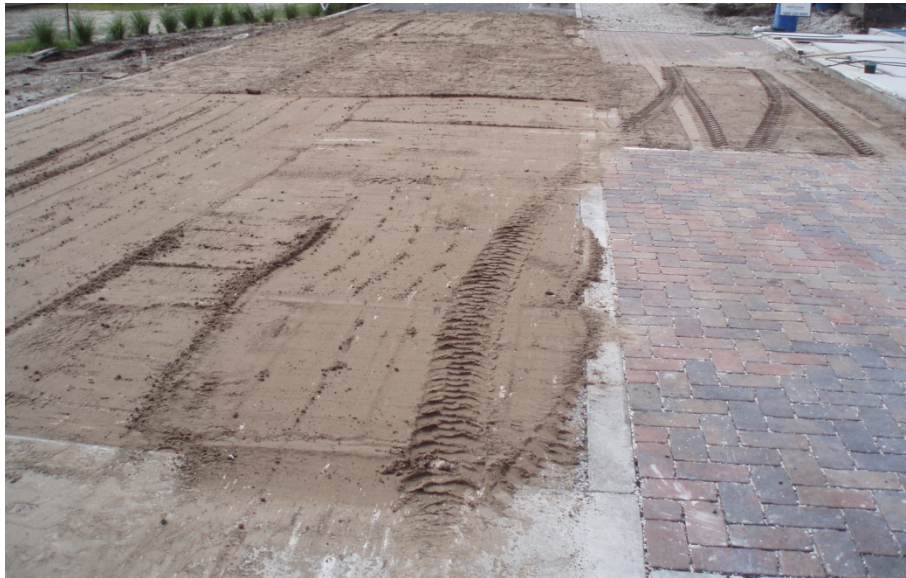
Figure 8: Spreading of A-3 sediments evenly over entire Rejuvenation section

Infiltration and rejuvenation studies began by measuring initial infiltration rates soon after installation and curing was completed. After about a month and a half of measurements, the sections were then intentionally loaded with a layer of A-3 soils, approximately 2 inches thick, spread evenly across the surface with the skid steer loader to simulate long term sediment accumulation conditions (see Figure 8 below). The sediments were then washed into the pores using a garden hose (see Figure 9 below) to simulate accelerated rain events that would eventually wash this sediment into the surface pores by transport processes. The skid steer loader then was driven over the sediments back and forth until the sediments were sufficiently compacted into the pores simulating traffic loading.

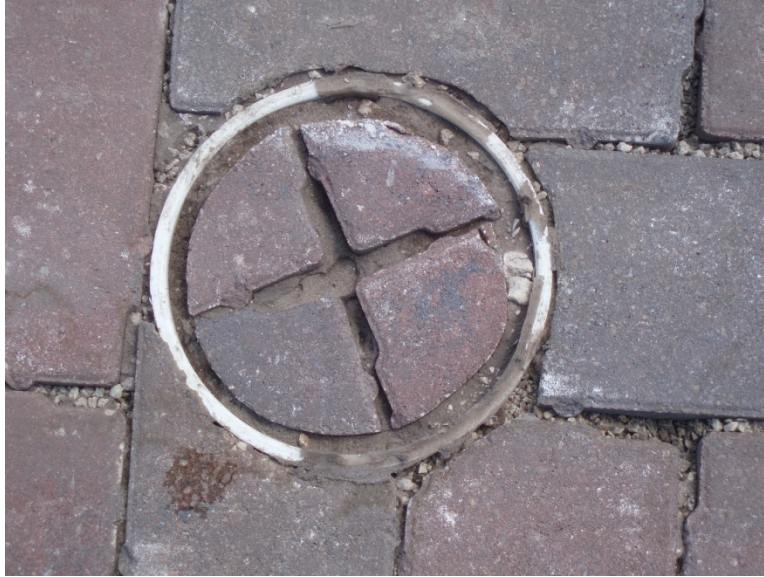
Figure 10: Unsuccessful vacuuming of A-3 soils when dry and hardened

It was noticed that the vacuum force was unsatisfactory at detaching and removing the soils in a dry and hardened state (see Figure 10). At this time, water was added to saturate the pavements surface. This was done by spraying a garden hose onto the pavement surface until water ponded on the pavement surface and the sediment was sufficiently soft. Once water was introduced, the fine grained sediments reached their liquid limit, became plastic and mobile, and the vacuum force was able to remove the sediment from the surface. The vacuum force was enough to remove even the filler stones in the joints of the bricks shown in Figure 11. Once the surfaces were vacuumed, post-rejuvenation ERIK measurements were continued on the paver systems.

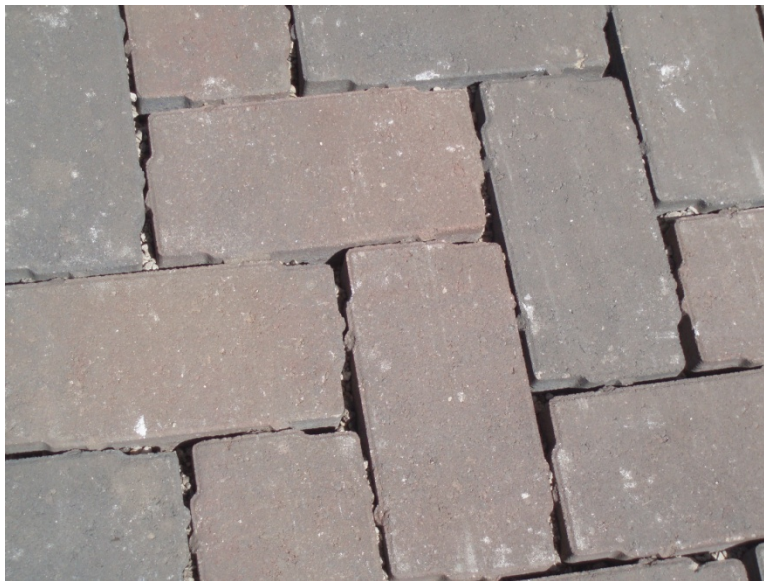
Figure 11: Successful vacuuming of A-3 soil when surface was saturated with water

These observations lead to the recommendation of coordinating the maintenance using a vacuum truck either during or immediately after large rain events or if ponding is noticed on the pavement surfaces. The draft statewide stormwater rule recommends nuisance flooding as an additional indicator of a clogged pavement from the ERIK device, and this study verifies that

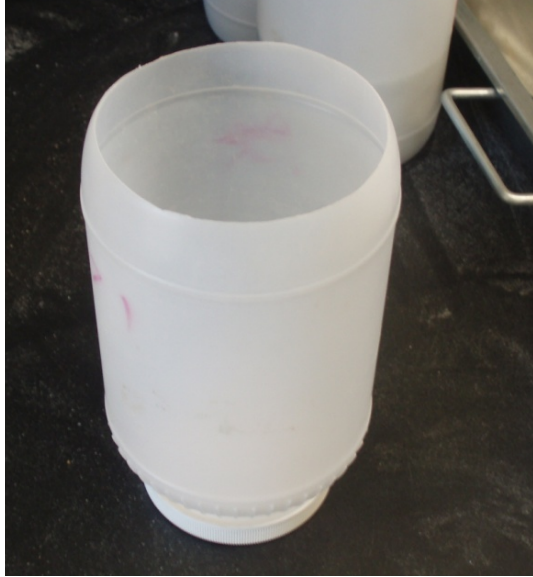
Figure 12: Half Gallon Jar picture for component testing

Due to the nature of the testing, a setup that allowed for repeatability of tests was required to measure the reduction of sustainable storage after clogging, and the rejuvenation of that storage after performing vacuuming on the sample surfaces. To achieve this, small half gallon plastic containers with screw on lids were chosen for the bench scale testing shown in Figures 12 and 13.

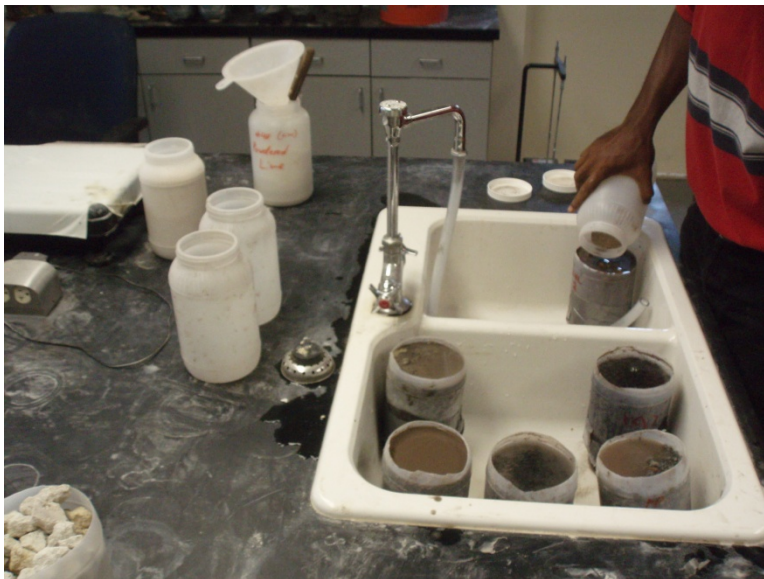
Figure 13: Half Gallon containers being loaded with sediments

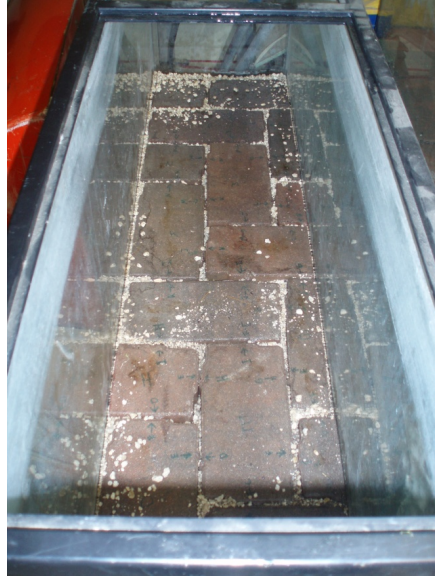
Figure 14: Brick paver (surface layer component) tested in large glass aquarium (12" x 19" x 47")

A larger (12"x19"x47") glass aquarium container (see Figure 14 below) was needed to test the storage within the bricks with joints filled.

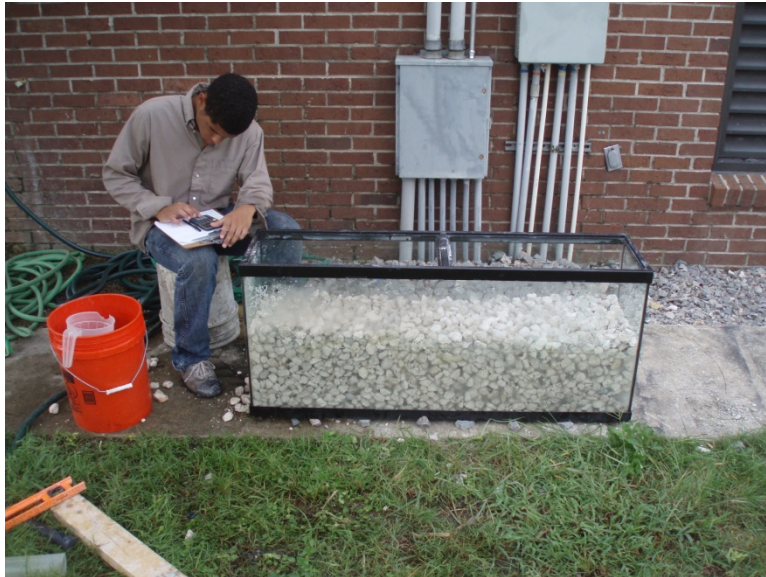
Figure 15: Number 4 Aggregates tested in large glass aquarium (12" x 19" x 47")

Since some of the larger aggregates had noticeably larger gaps near the side walls of the $\frac{1}{2}$ gallon containers, the porosities of the #4 sized aggregates were also tested in the large aquarium see Figure 15 below.

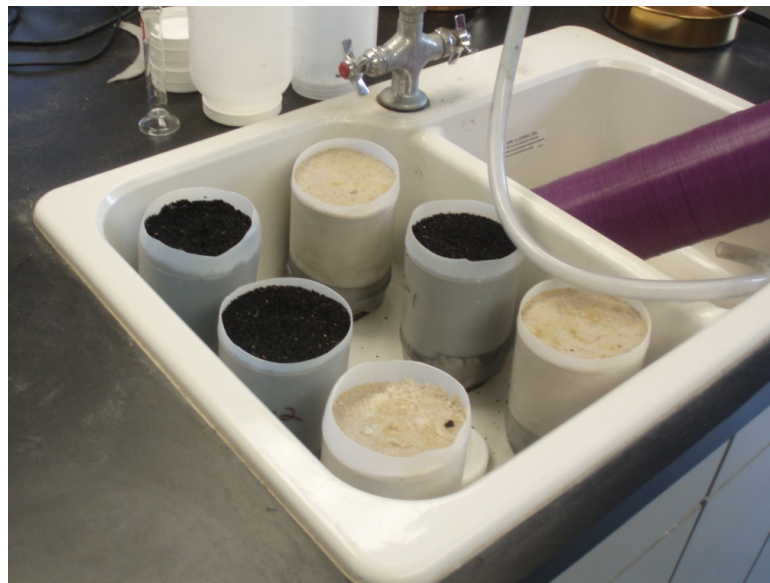
Figure 17: Half Gallon Jars draining by gravity

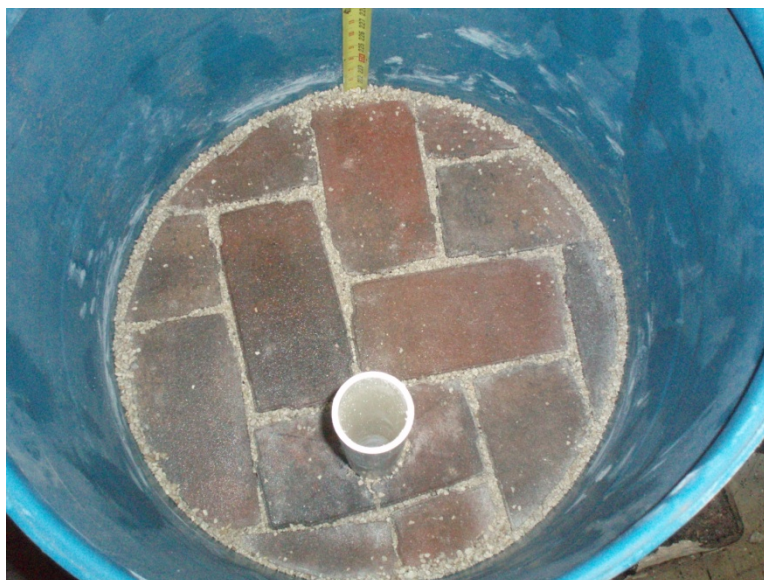
Figure 19: System testing in 55 gallon barrel

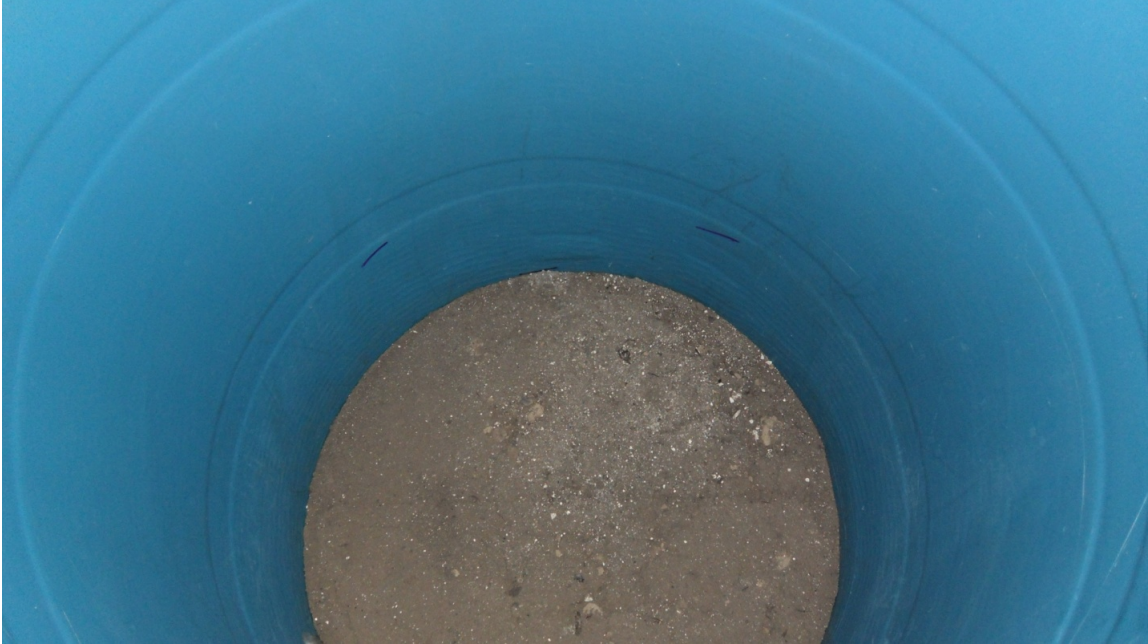
Figure 20: 4 Inches of Compacted AASHTO Type A-3 Soil Installed

Once all of the barrels were labeled, AASHTO type A-3 soil was poured into each barrel and compacted to a height of 4 inches (Figure 20). Next, a non-woven filter fabric was laid over the soil in all of the barrels (Figure 21).

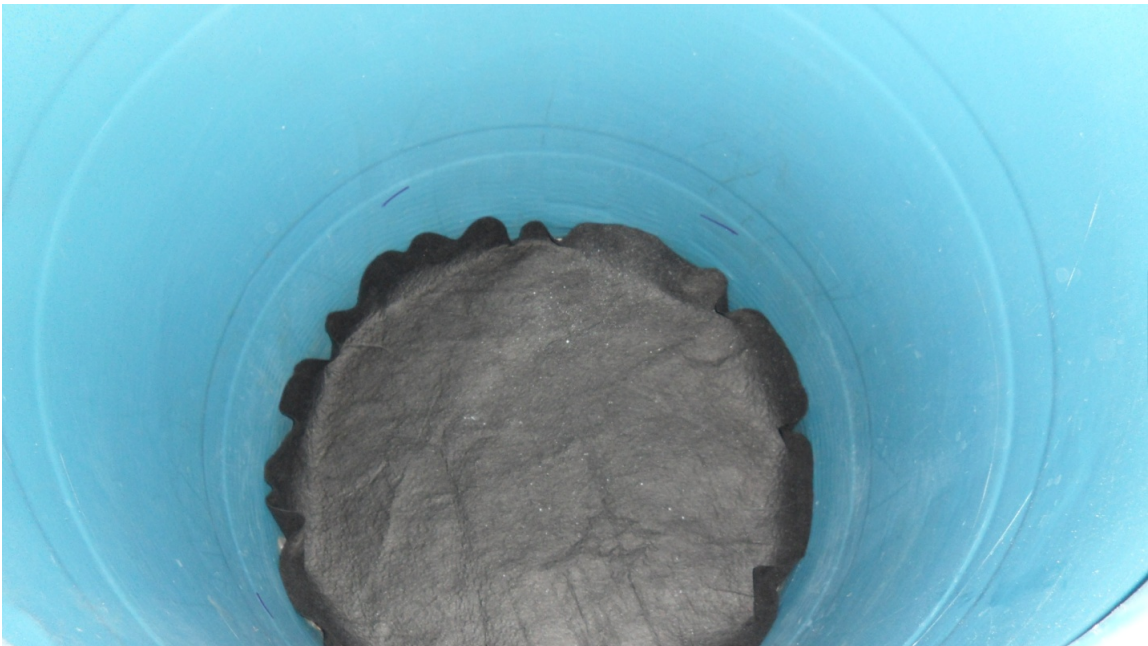
Figure 21: Non-woven Geotextile Separation Fabric Installed

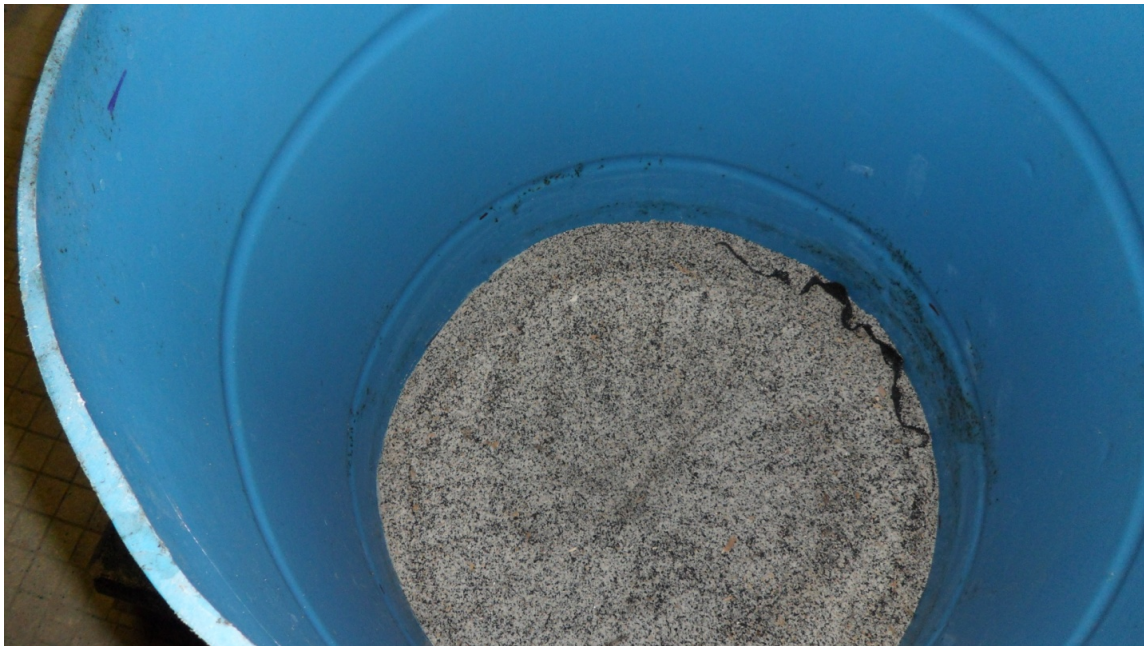
Figure 22: 4 Inches of Bold&Gold™ Pollution Control Media Installed

Bold&Gold™ pollution control media was then poured into the four B&G system barrels and compacted to a depth of 4 inches (Figure 22). Next, #4 Stone was placed into all 8 barrels at a depth of 5 inches, then leveled and compacted (Figure 23). #57 Stone was then placed into all 8 barrels at a depth of 4 inches, then leveled and compacted (Figure 24).

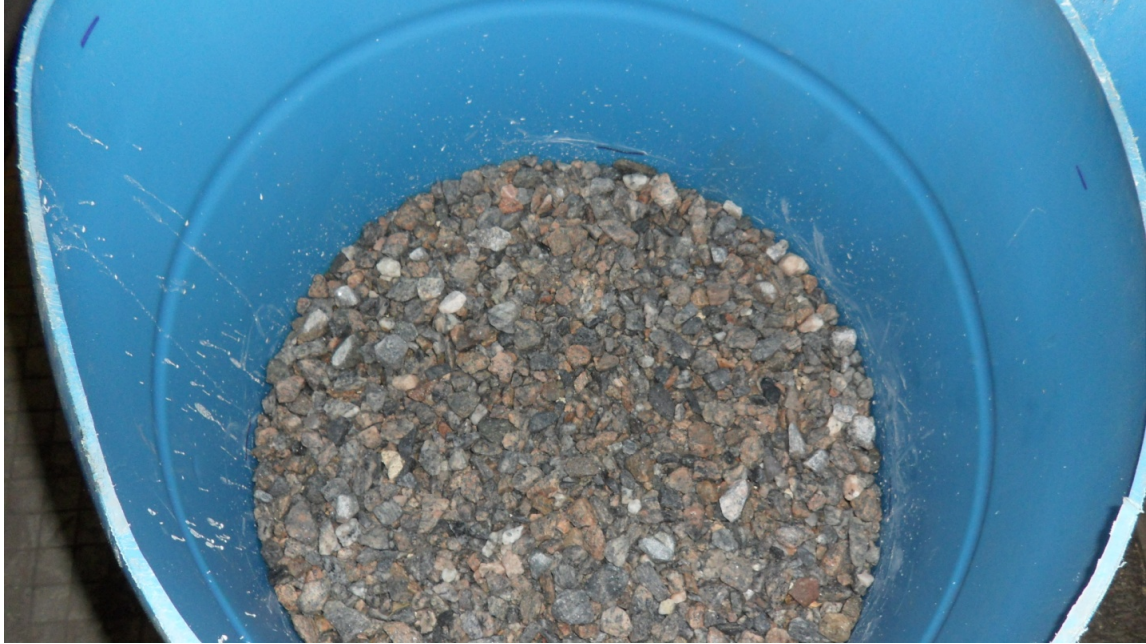
Figure 23: 5 Inches of #4 Stone Compacted

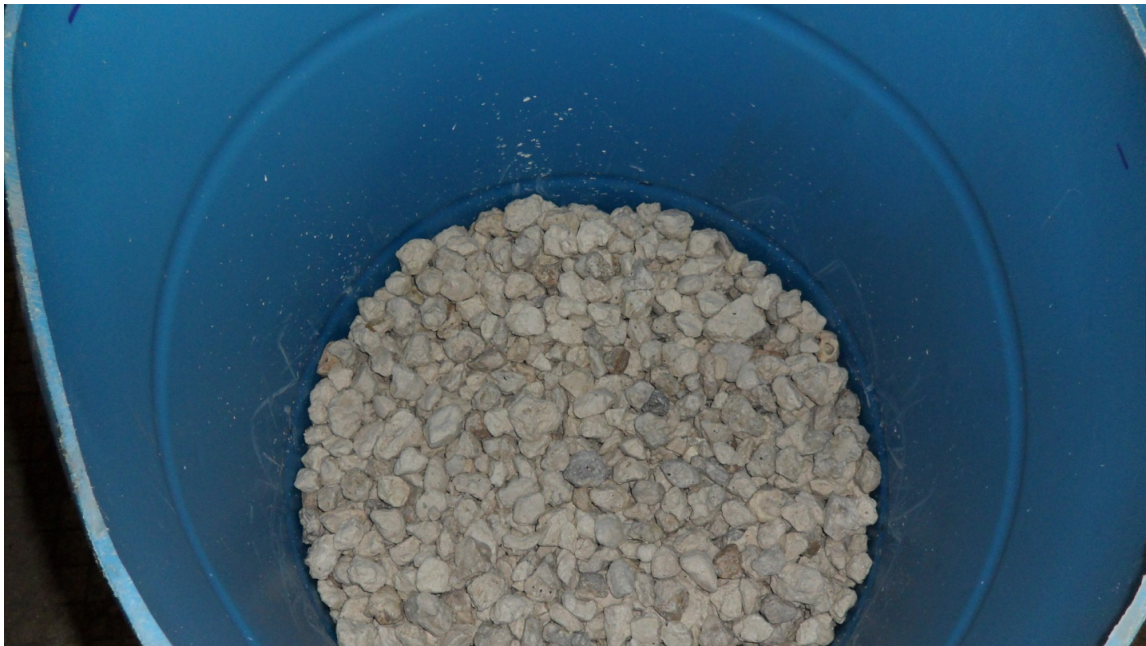
Figure 24: 4 Inches of #57 Stone Compacted

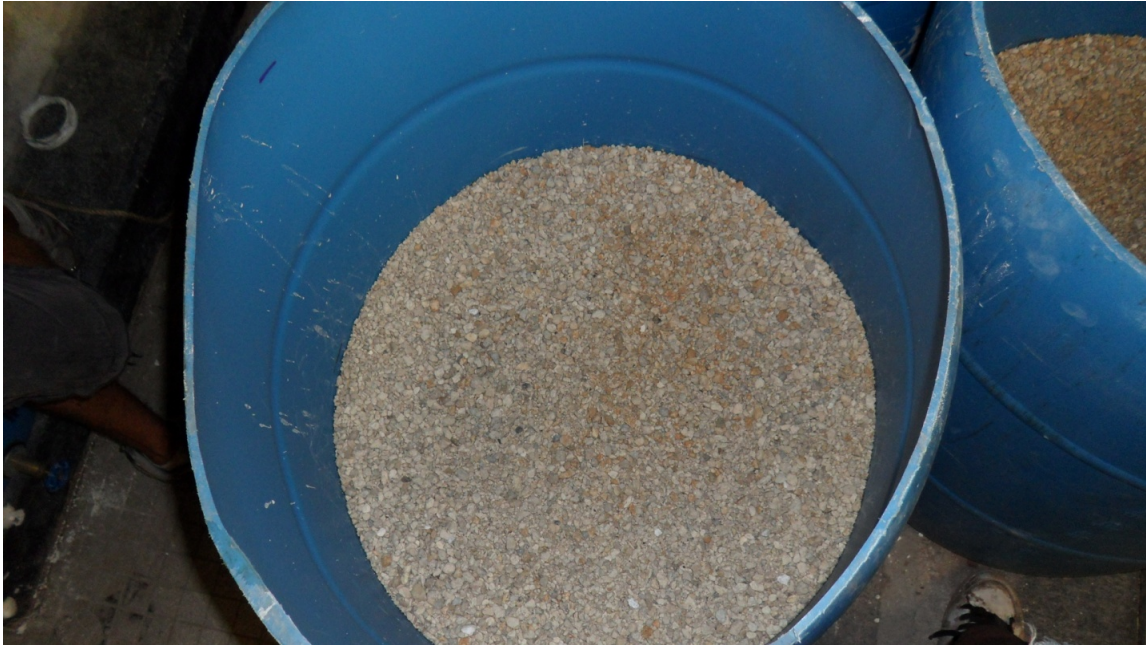
Figure 25: 2 inches of #89 Limerock

The next layer was a bedding layer consisting of #89 limestone compacted to a depth of 2 inches (Figure 25). Lastly, the brick pavers were placed into all the B&G and Fill system barrels except the two control barrels (Figure 26).

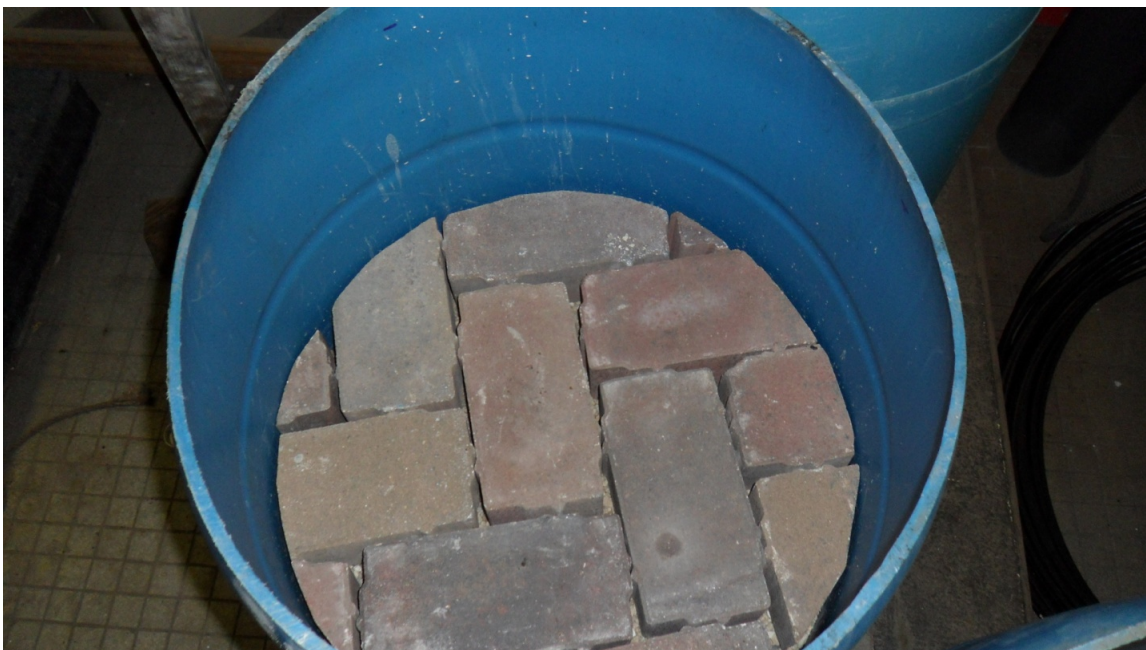
Figure 26: Oldcastle Brick Pavers Installed

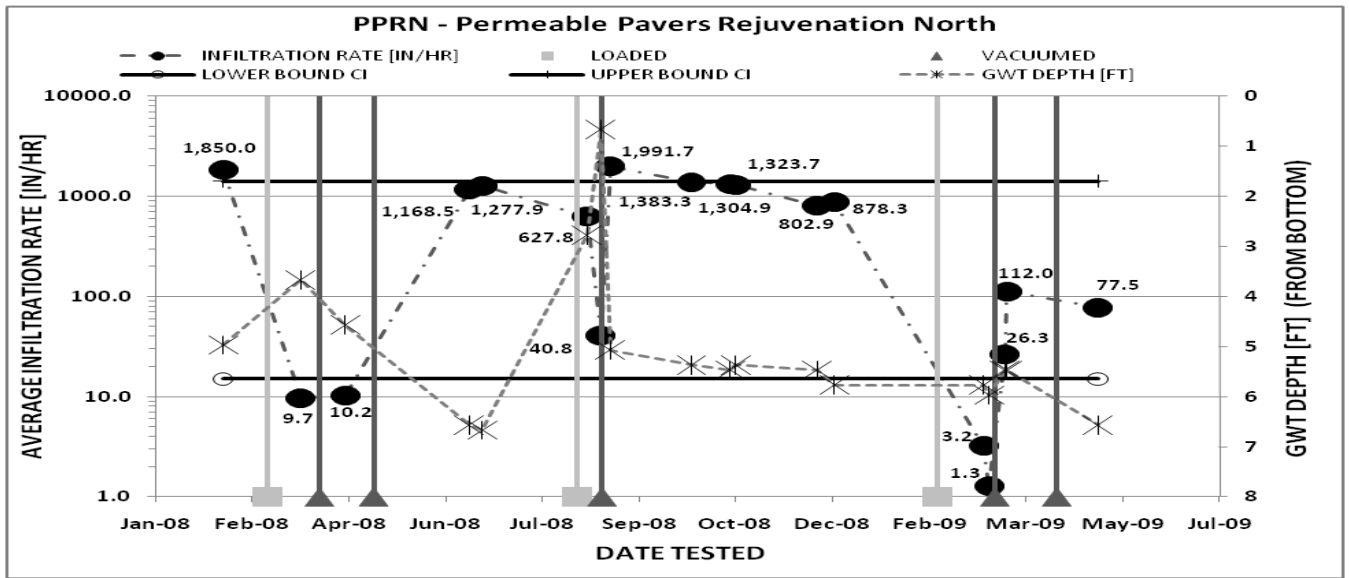
Figure 28: Infiltration Rate (ERIK) Results for the Permeable Pavers Rejuvenation North Section Infiltrmeter

The north infiltrmeter measured an initial rate of 1850 in/hr at the beginning of the study period. After sand was used to clog the system the rate was reduced to 9.7 in/hr. The first vacuum attempt only restored the rate to 10.2 in/hr but when re-vacuumed, the rate was rejuvenated back up to 1169 and 1278 in/hr. The crushed limerock fines were washed in and

compacted into the surface pores next, which caused the rate to fall to 627.8 and 40.8 in/hr during the second set of post-loaded ERIK tests. The vacuum truck performed maintenance, and increased the infiltration of the pavers to 1992 in/hr followed by three tests measuring 1383, 1305, and 1324 in/hr. After about a month the rate had dropped to measured rates of 802.9 and 878.3 in/hr. Towards the end of the study period, the pavement was loaded again with the sandy soils and resulted in decreased infiltration rates measured at 3.2 and 1.3 in/hr. The restoration of the infiltrating capacity of the system was effective by increasing the measured rates to 26.3 and 112.0 in/hr during the next two tests. The pad was vacuumed once more and the post-cleaning rate measured in at 77.5 in/hr.

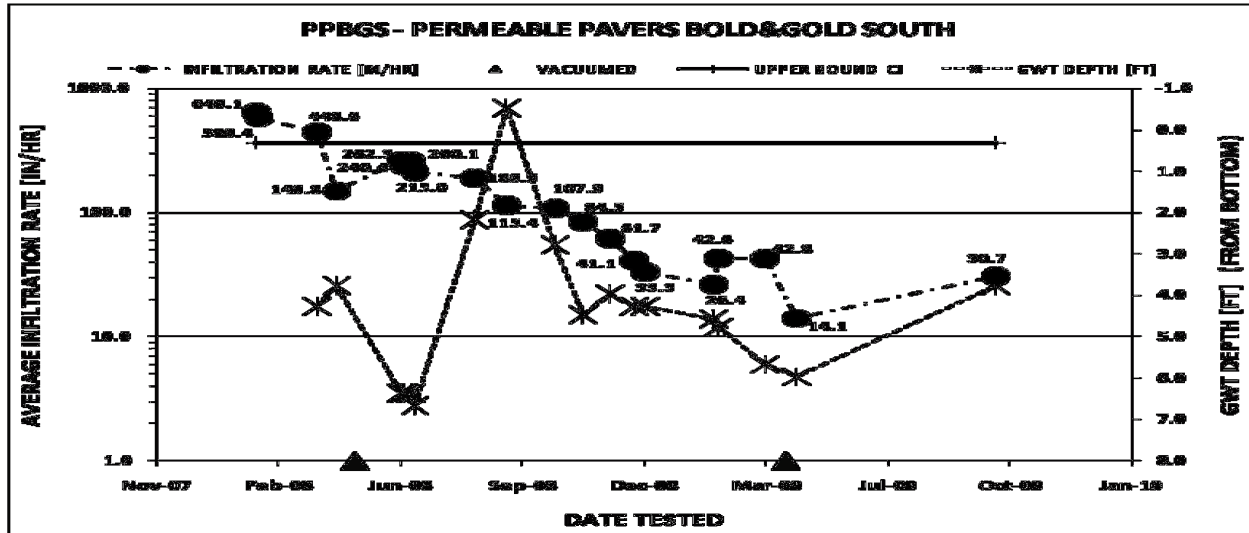
Figure 32: Infiltration Rate (ERIK) Results for the Permeable Pavers Bold&Gold South Section Infiltrometer

for the test that measured 850.2 in/hr while the GWT was about 2.5 feet below the bottom of the system.

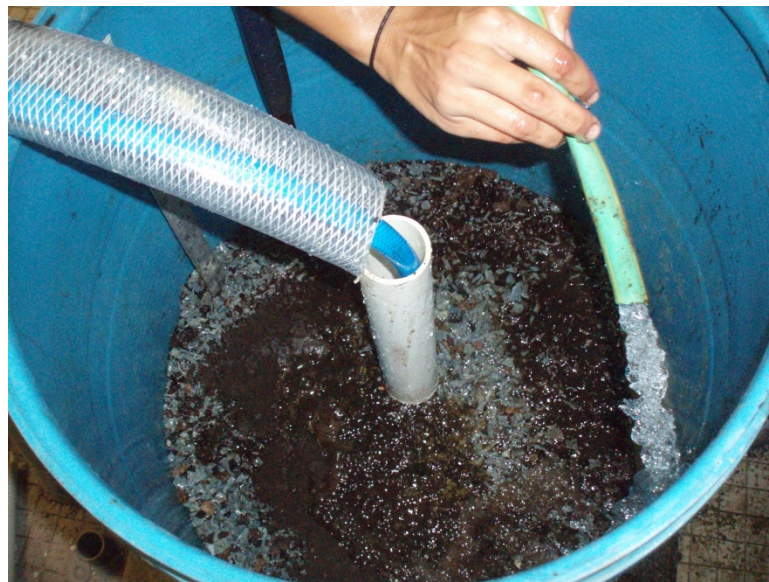
Figure 37: Washing loaded sediments into pores while pumping infiltrated water out through well pipe

micropores in the aggregates and near the contact points, and dead-end pores small enough to prevent gravity from transmitting this water downward due to capillary pressure exceeding the force of gravity in such a small pore size are able to retain some of the water. These next four tests represent the effective porosity (26.6% - 28.8%) of the system in which can be expected of the in-situ pavement that is not oven dried to remove the residual water in the micropores. The sixth test is conducted after loading with 7% of the initial pore volume measured by the initial test using A-3 soil on the surface of the paver bricks and washing into the pores while simultaneously pumping the infiltrated water out of the well pipe from the bottom of the stone reservoir (see Figure 37 below).

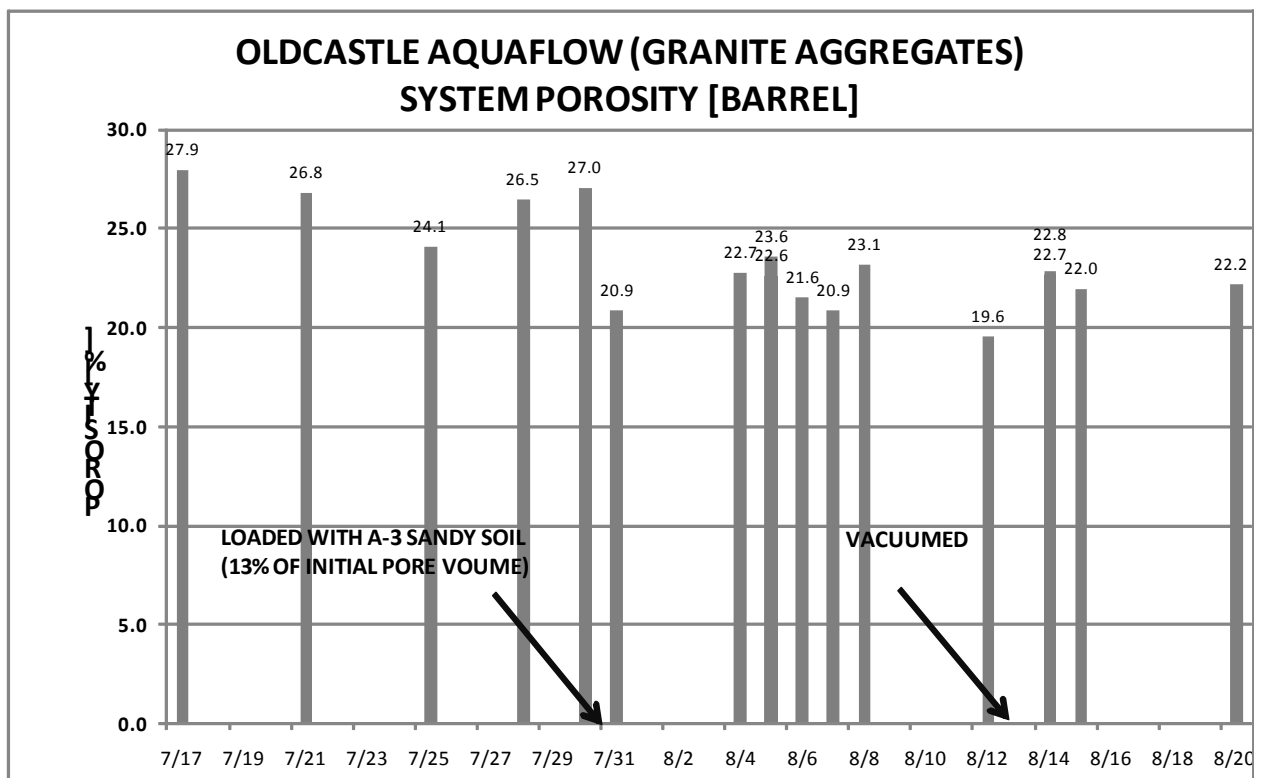
Figure 38: System porosity results using 55 gallon barrels (#4 limerock)

Figure 38 below presents the results of the same cross section but using granite #4 aggregates instead of limerock.
