BRIDGE DECK FOGGING SYSTEM: EVALUATION OF FIELD IMPLEMENTATION OF FOGGING SYSTEM USED DURING CONCRETE BRIDGE DECK CONSTRUCTION

Prepared by :
New Mexico State University
Department of Civil Engineering
Box 30001, MSC 3CE
Las Cruces, NM 88003-8001

Prepared for:
New Mexico Department of Transportation
Research Bureau
7500B Pan American Freeway NE
Albuquerque, NM 87109

PROJECT NM04STR-02
JUNE 2008

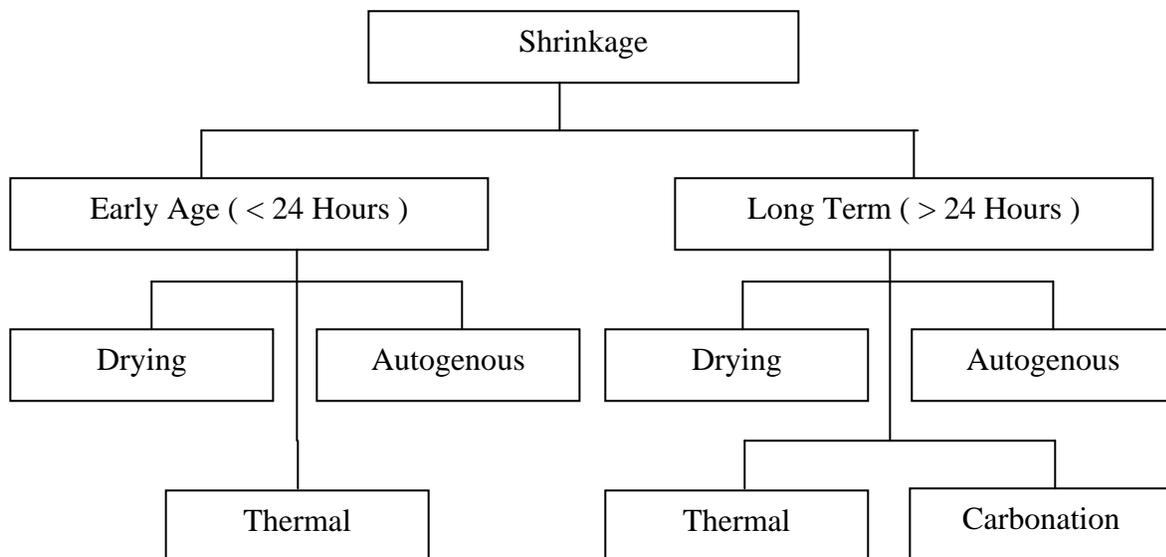
FIGURE 1 Diagram of shrinkage types and stages¹⁰.

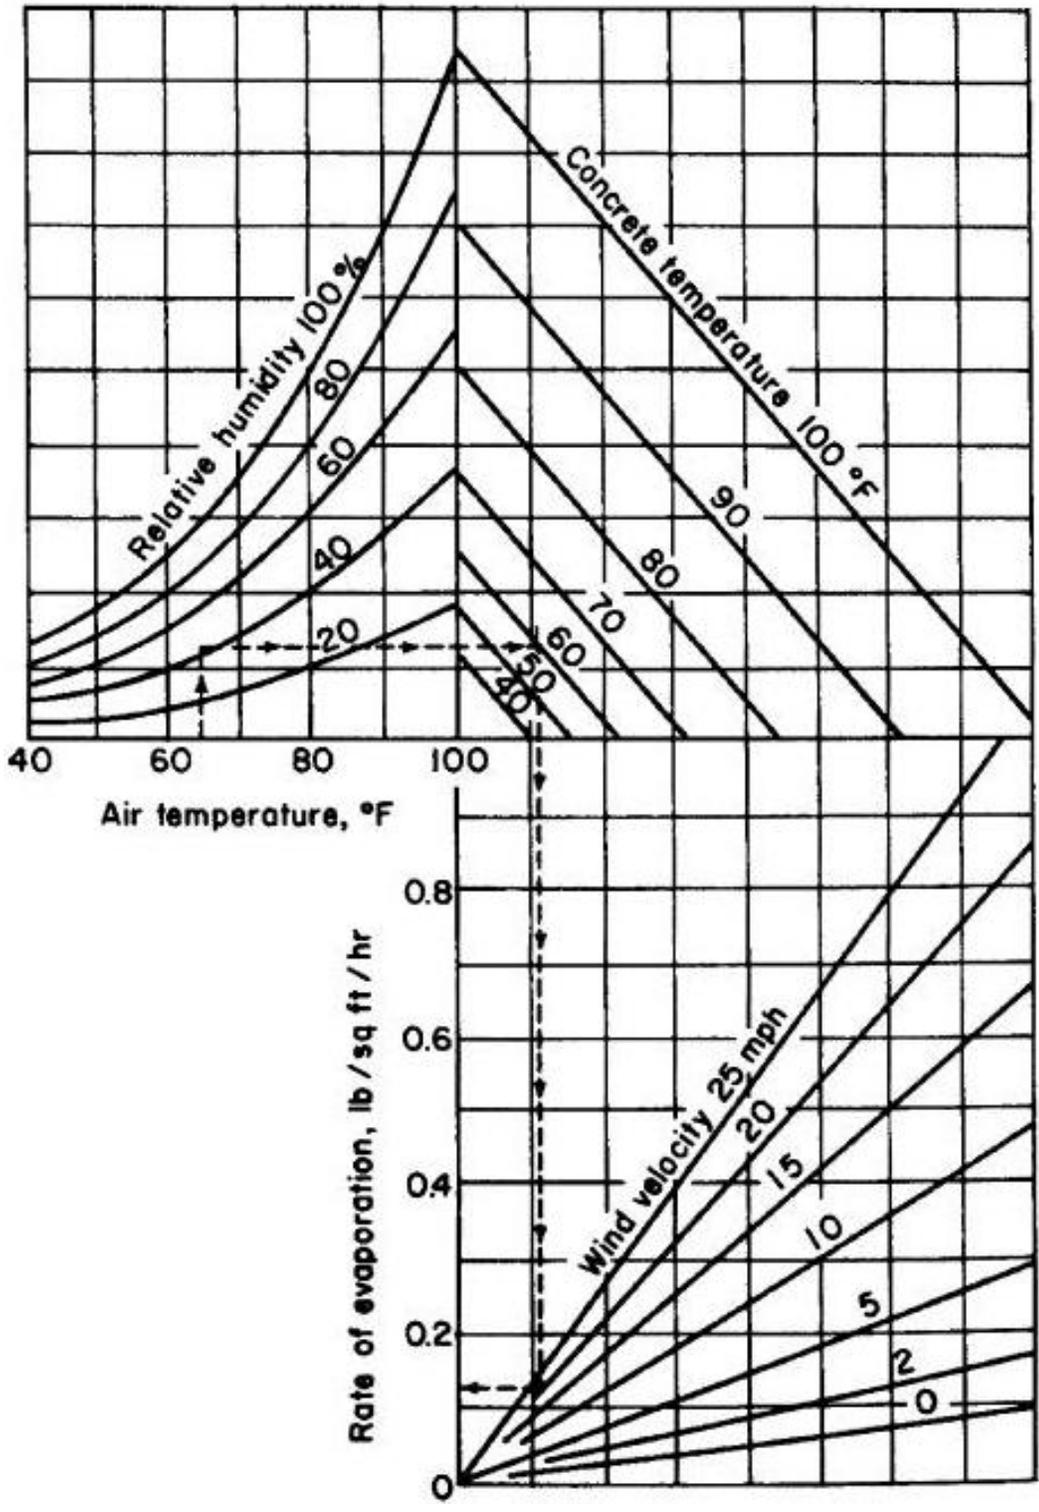
FIGURE 2 Menzel's¹² nomograph².

Weather is also an important factor when considering concrete shrinkage. Weather conditions include wind speed, air temperature, and relative humidity. Weather conditions significantly affect the evaporation rate of water from concrete. Shrinkage cracks often occur when the evaporation rate exceeds the concrete bleeding rate. In normal practice, concrete placing is avoided during windy conditions to reduce the cracking of concrete because wind increases the evaporation rate of water. The evaporation rate can be calculated using Menzel's¹² nomograph presented in Figure 2. The variables used in the nomograph are relative humidity, temperature, air temperature and wind velocity. Evaporation rate is determined in lb/ft²/hr.

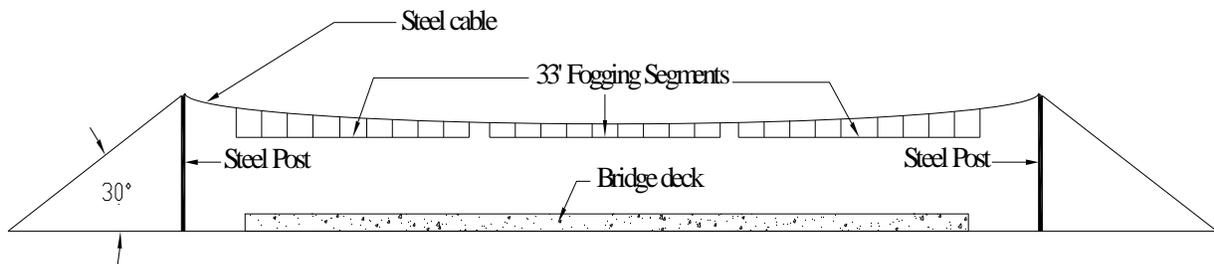
FIGURE 4 Typical cross section of the fogging system.

The nozzles were arranged such that adjacent nozzles sprayed water in opposite directions. The fogging system was fixed 10'-6" above the top of the bridge deck to provide enough head room for workers and still provide appropriate mist distribution. All of the pipes were tied to cables using steel wires. Clamps were used to connect the wires to the cables and to prevent slipping of

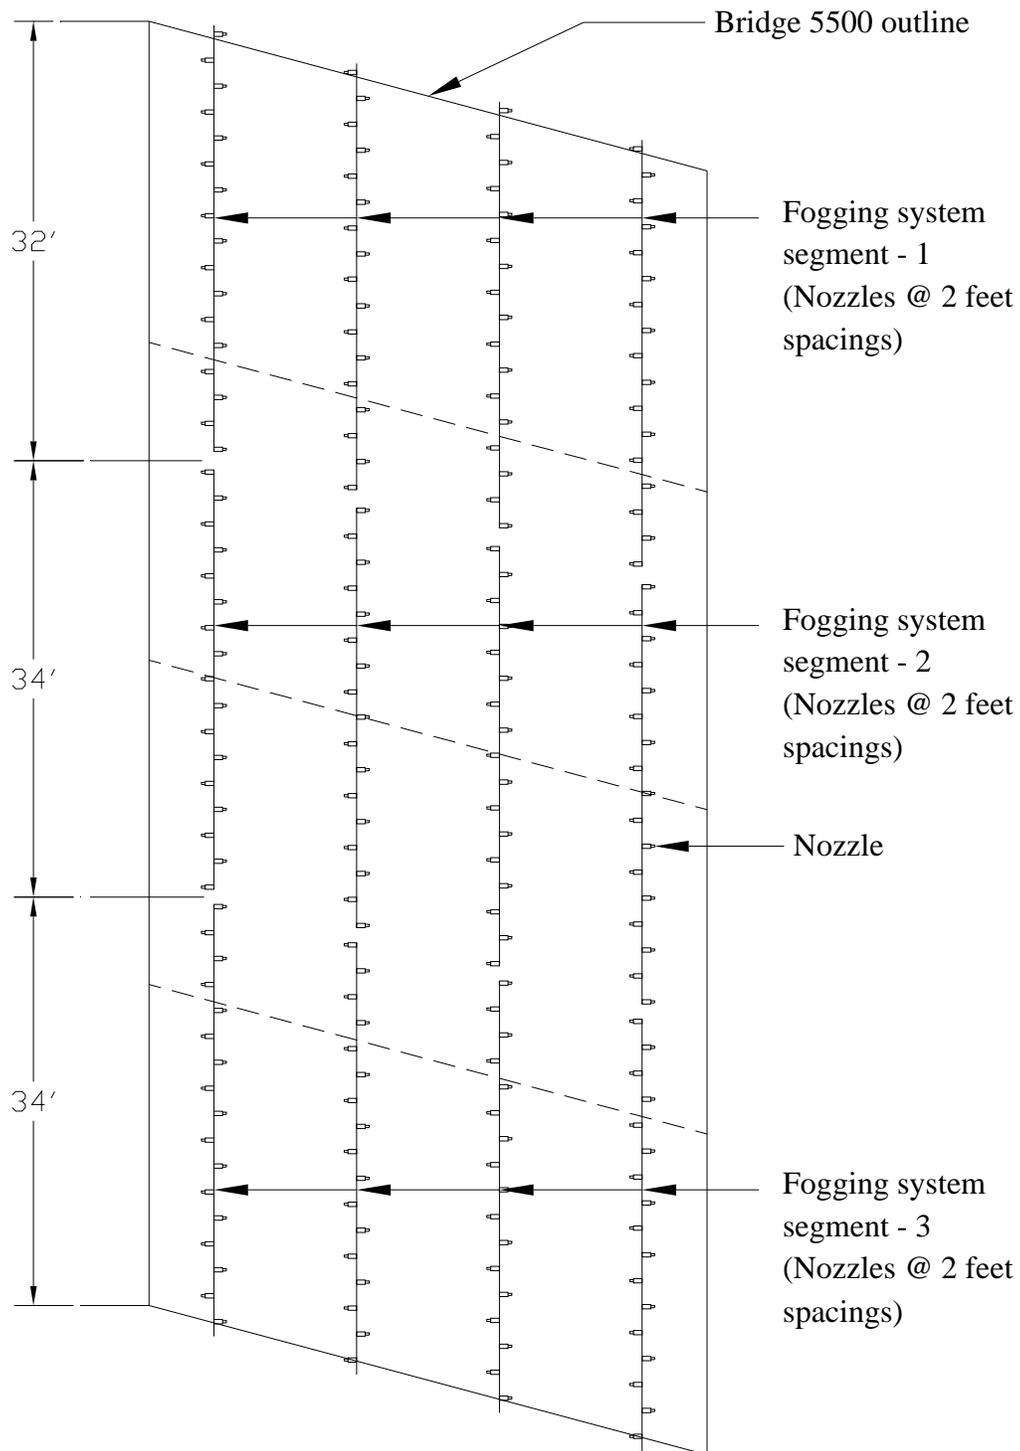
FIGURE 5 Plan view of fogging system.

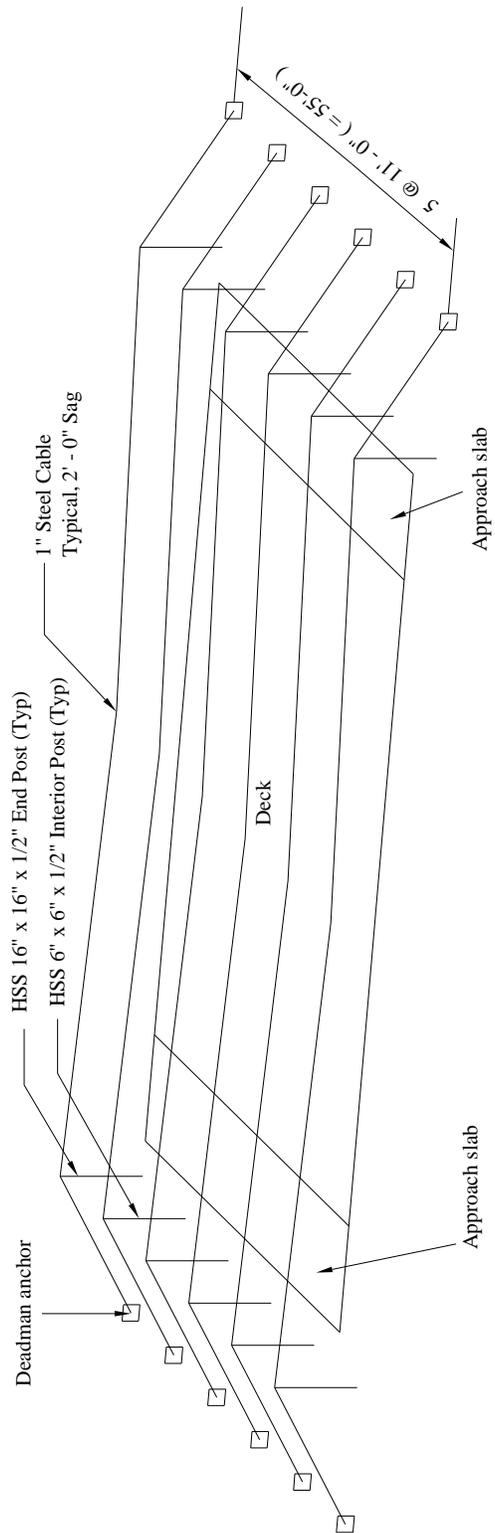
FIGURE 6 Fogging support schematic.

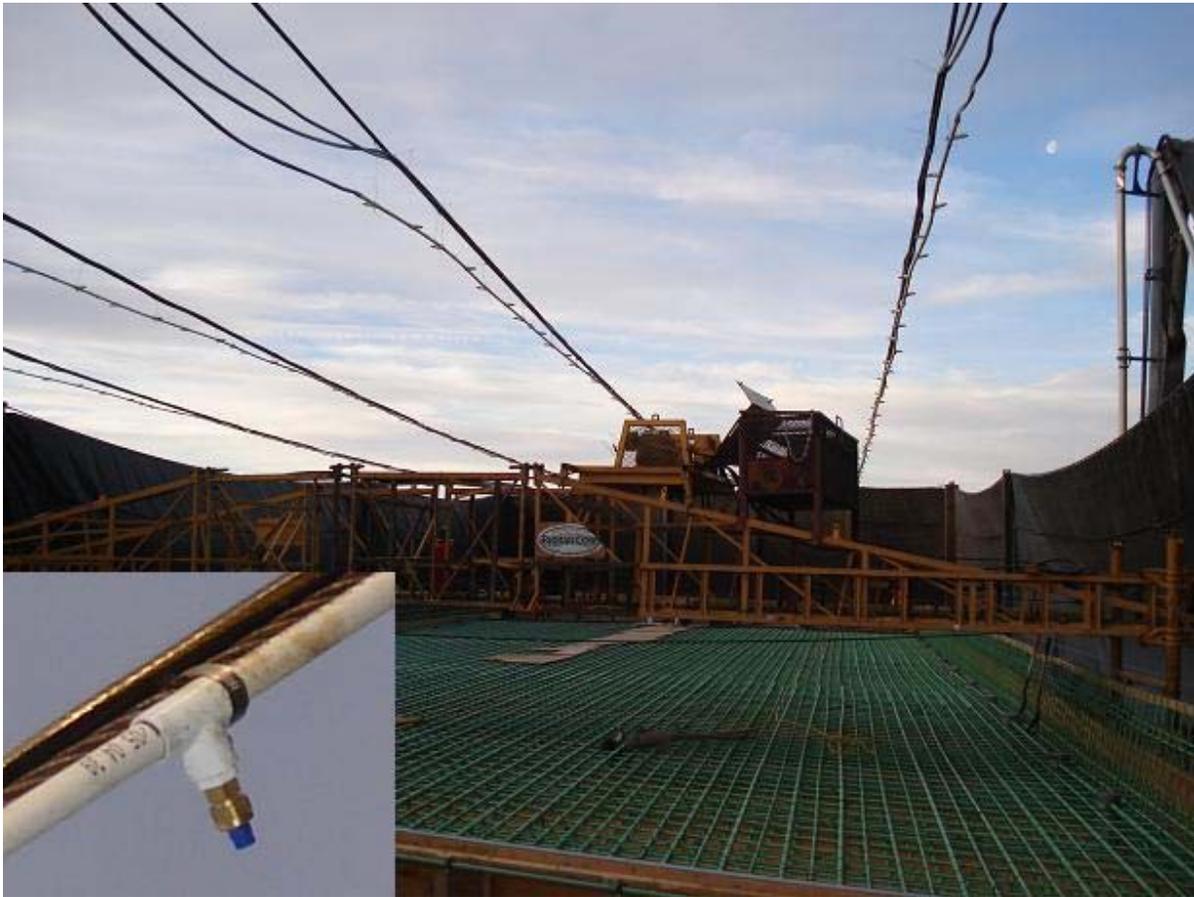
FIGURE 7 The fogging system installed at Bridge 5500.

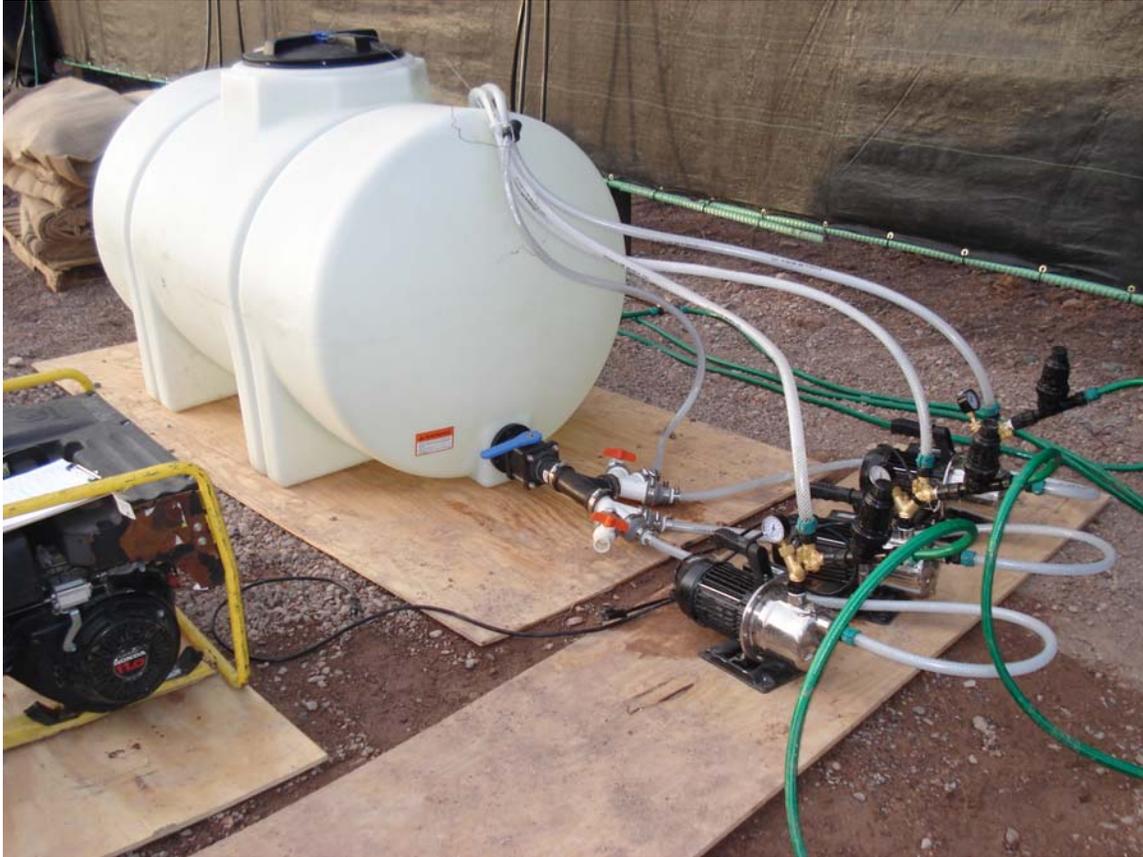
FIGURE 8 Water tank, water pumps and pressure gauges for the fogging system.

Simer MOD.2825ss model water pumps were used to pump water with adequate pressure through the pipes. One pump was used for each 33 ft segment of the fogging system. The pumps and water tanks are shown in Figure 8. The maximum possible pressure supplied by the pump was 80 psi. The fogging rate was selected based on the expected evaporation rate of water from concrete determined using Menzel’s12 nomograph. The fogging rate used in this study was 0.40 lb/ft²/hr. This fogging rate is substantially greater than the maximum expected

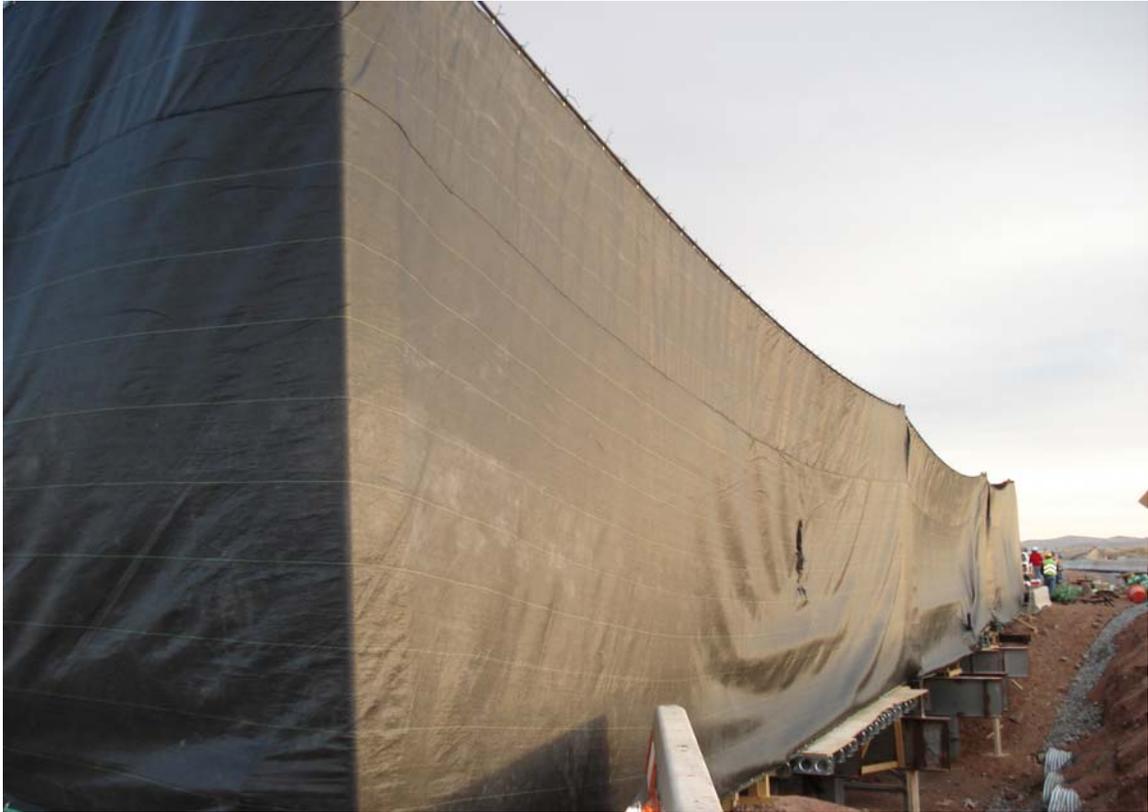
FIGURE 9 Windbreak at Bridge 5500.

The windbreak was installed around the bridge by hanging it from the exterior cables, and its height averaged about $12'-9''$ above the top of the bridge deck. The windbreak was installed at

the bridge site by the contractor. Windbreak fabric by PAK INC. - E.11 GC was used as the windbreak material and holes were made by the contractor for access. Additional openings in the windbreak were caused by the Bid-well machine. Figure 9 shows a photograph of the windbreak installed at Bridge 5500.

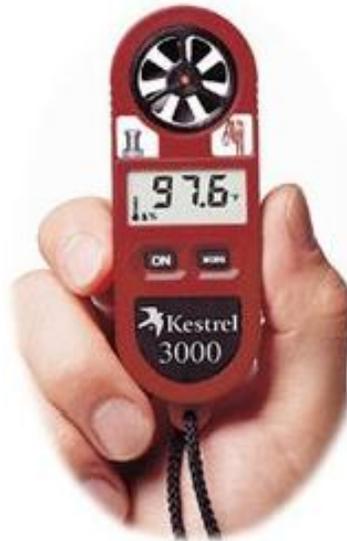
FIGURE 10 Kestrel 3000 pocket weather meter¹⁷.

A Kestrel 3000 pocket weather meter, as shown in Figure 10, was used to measure wind velocity, relative humidity and temperature at 15 minute intervals during the construction of both bridge decks. The Kestrel 3000 can measure current wind speed, maximum wind speed, average wind speed, air temperature, wind chill, relative humidity, heat stress index and dew point ¹⁷.

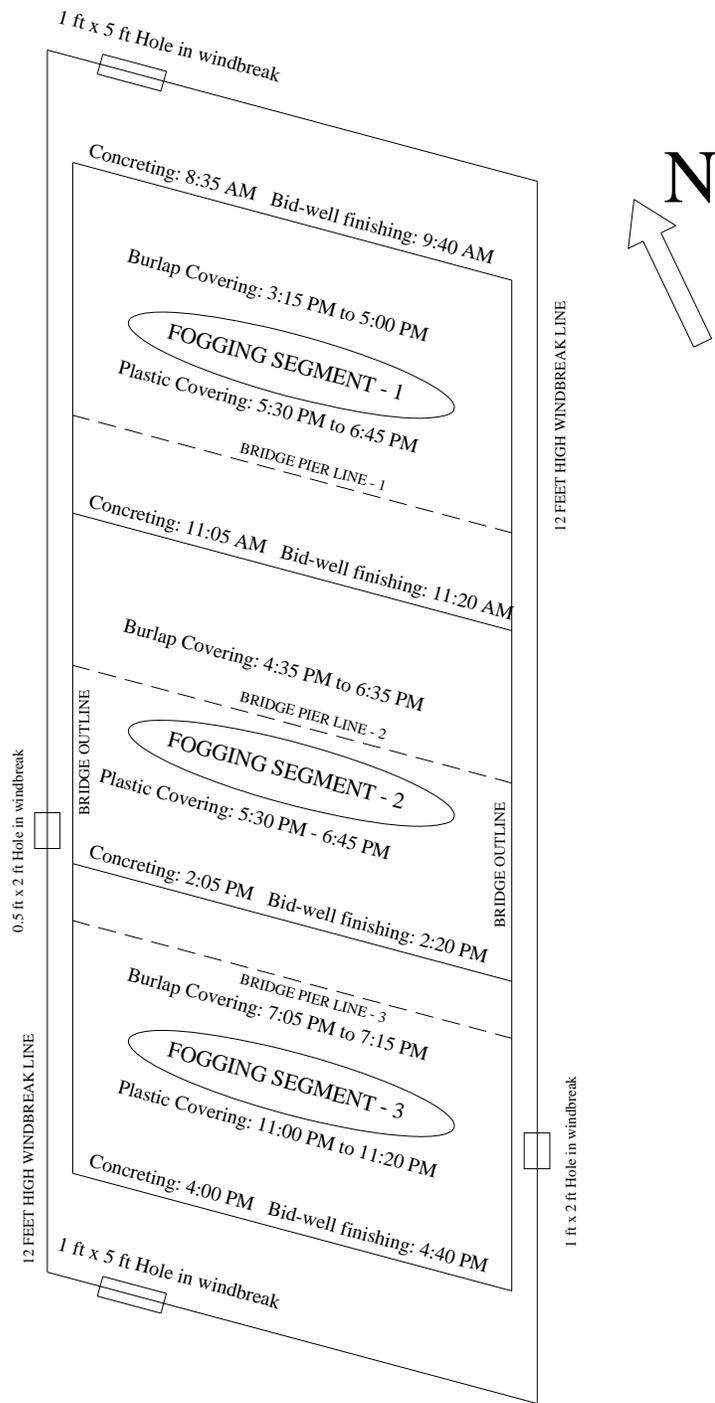
FIGURE 11 Bridge 5500 construction sequence observations and wind break openings.

The observations for the construction and fogging sequences for Bridge 5500 are summarized in Figures 11 and 12. Similar observations for Bridge 5701 are presented in Figure 13. In Figure 12, two stoppages are listed for the fogging system. These stoppages were to allow the contractor to repair footprints left during burlap coverage. NMDOT specifications state that the rate of forward progress of the finishing machine shall be 20ft/hr over the entire width of the slab bridge being placed. Finishing durations for Bridges 5500 and 5701 were 7 hours and 10.5 hours, respectively. The rate of forward progress for Bridges 5500 and 5701 was about 14 ft/hr. The forward progress rate was slower than the rate specified by NMDOT. Other authors have

A windbreak was erected for the Bridge 5500 site to reduce the wind speed at the concrete surface, which reduces the evaporation rate and allows proper fogging operation. There were two openings in the windbreak that were made by the contractor for access to the inside of windbreak, and the Bid-well machine damaged the windbreak in two places. All of those holes in the windbreak are documented in Figure 11.

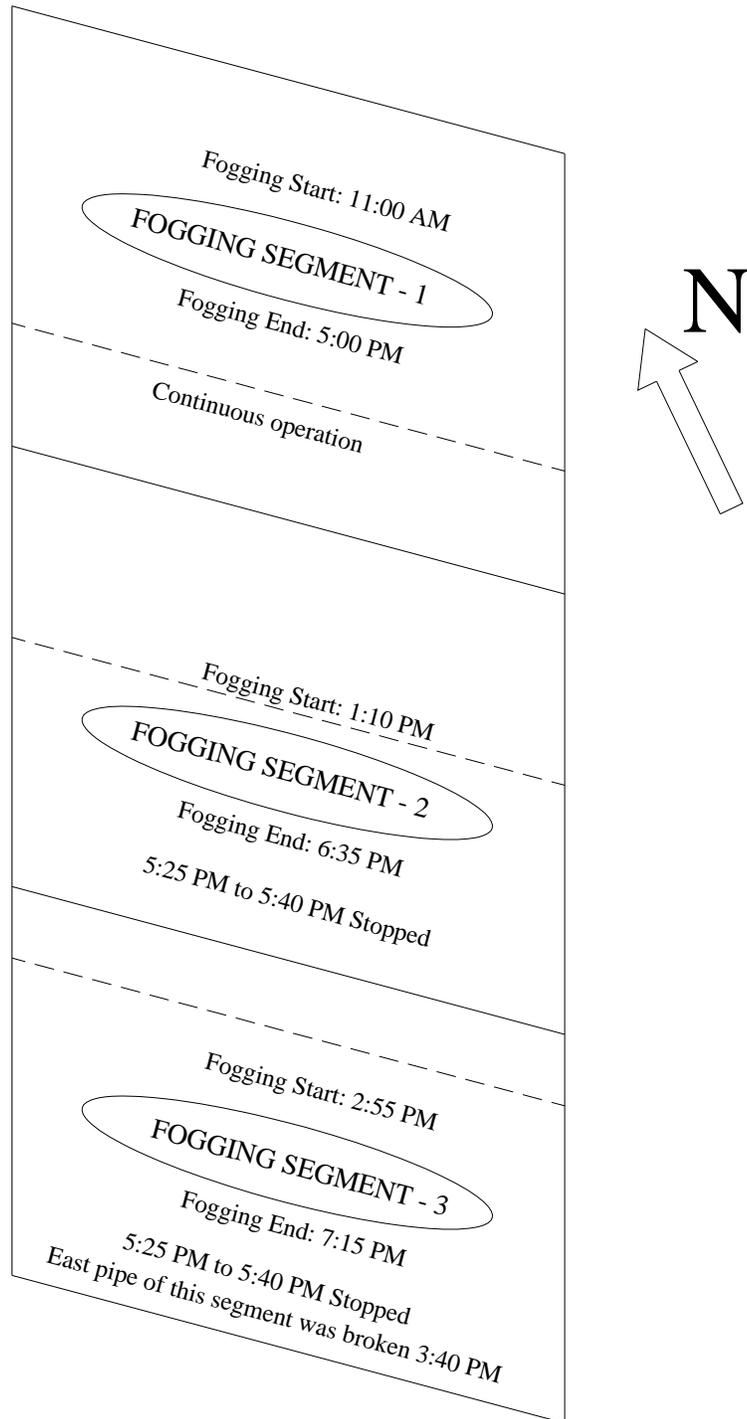
FIGURE 12 Bridge 5500 fogging observations.

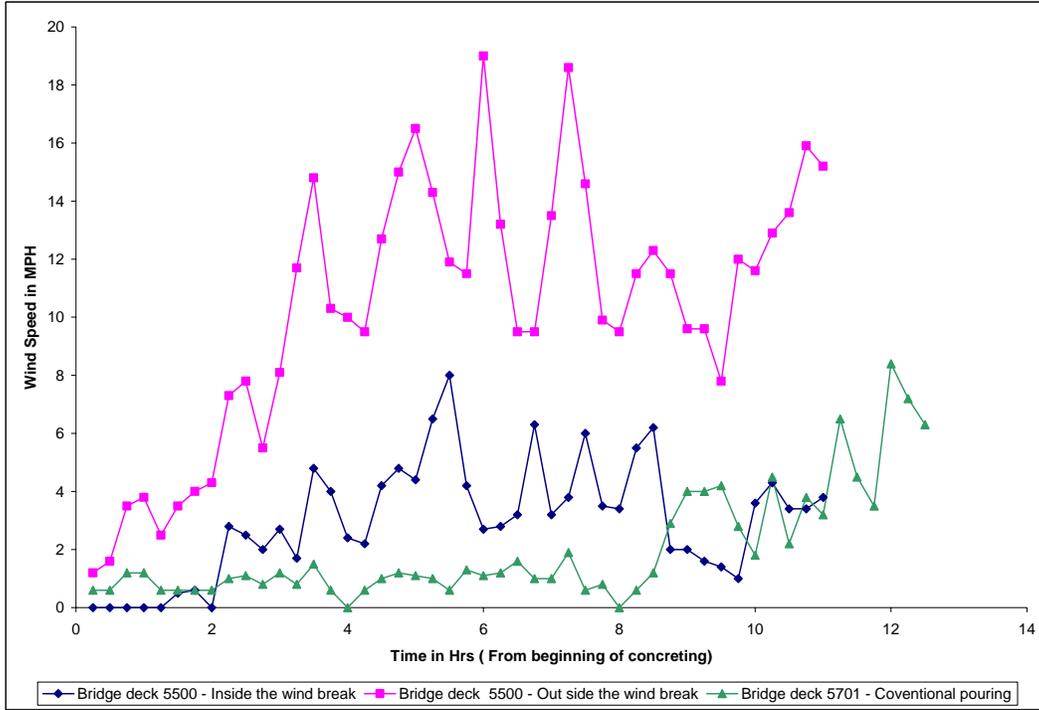
FIGURE 14 Wind speed variation during the concrete placement for both bridges.

Wind speed is the most important factor for evaporation rate which strongly influences early-age cracking. The windbreak for Bridge 5500 reduced the wind speed by 60-65% inside the windbreak compared to the outside wind speed. Even though a windbreak was not erected at Bridge 5701, wind velocity was low on the night and morning of deck placement on Bridge 5701. Wind speeds present during the construction of both bridge decks are plotted in Figure 14. Even though the windbreak was erected for Bridge 5500, Bridge 5701 experienced lower wind speeds than Bridge 5500.

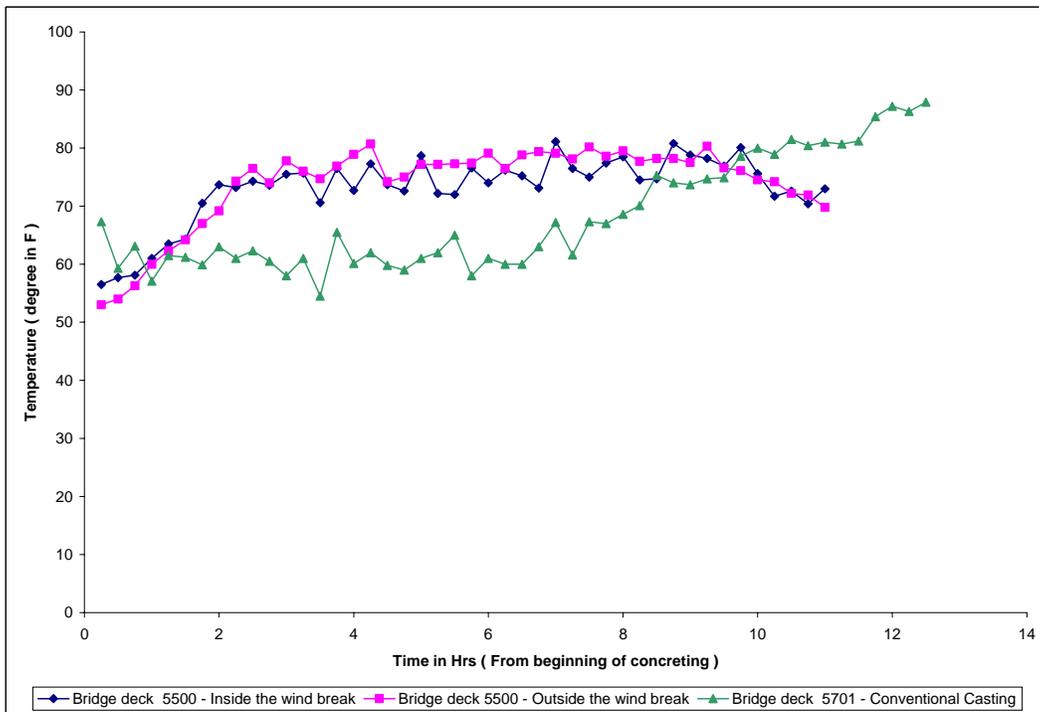
FIGURE 15 Temperature variation during concrete placement for both bridges.

Air temperature during the placement of Bridge deck 5701 was good for the first eight hours. Maximum and minimum recommended temperatures for placing concrete are 80°F and 45°F²⁰. The air temperature was near the upper end of this recommended range during the Bridge 5500 placement, but near the middle of the range for most of the Bridge 5701 deck placement.

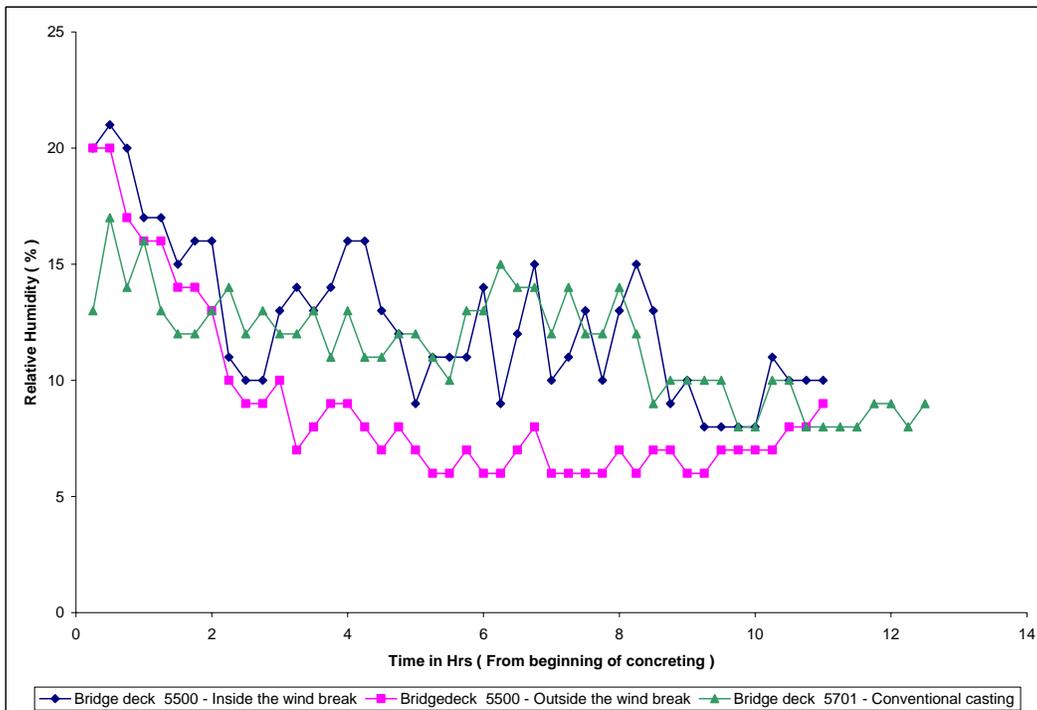
FIGURE 16 Relative humidity variation during concrete placement for both bridges.

Relative humidity is another weather condition that influences evaporation. Fogging increases the relative humidity and reduces the amount of water that evaporates from concrete. The plotted relative humidity values in Figure 16 show that fogging increased the relative humidity by 70-80% over the concrete surface for Bridge 5500. This elevated relative humidity for Bridge deck 5500 was approximately equal to that observed for Bridge deck 5701 without fogging. Bridge deck 5701 experienced higher relative humidity because the concrete was placed at night. It should be noted that fogging provides moisture over the concrete surface, but doesn't

necessarily raise the relative humidity measurement to 100%. Fogging produces water particles in the air, but the relative humidity measurement doesn't capture individual water droplets; however, the droplets provided by fogging provide a source of water that will evaporate before water evaporates from the concrete.

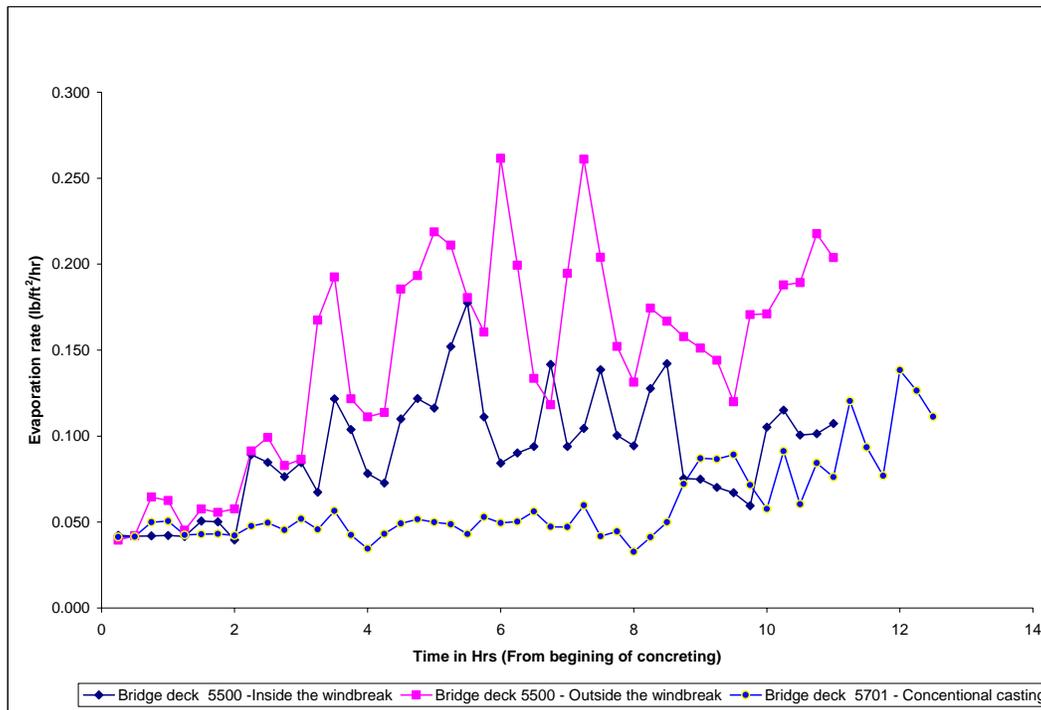
FIGURE 17 Evaporation rate variation during concrete placement for both bridges.

Evaporation rate is a primary source of cracking in concrete. Air temperature, concrete temperature, relative humidity and wind speed all influence the rate of evaporation. Using Menzel's¹² equation, with assumed concrete temperatures of 74°F for Bridge deck 5500 and 68°F for Bridge deck 5701, evaporation rates were computed for the weather conditions presented in Tables 3 and 4. The calculated evaporation rates are plotted in Figure 17. Normally, shrinkage cracks are expected when the evaporation rate exceeds 0.2 lb/ft²/hr.

When the evaporation rate is between 0.2 lb/ft²/hr and 0.1 lb/ft²/hr, plastic shrinkage cracks may still occur²¹. However, if the evaporation rate is less than 0.1 lb/ft²/hr, plastic shrinkage cracks are not expected.

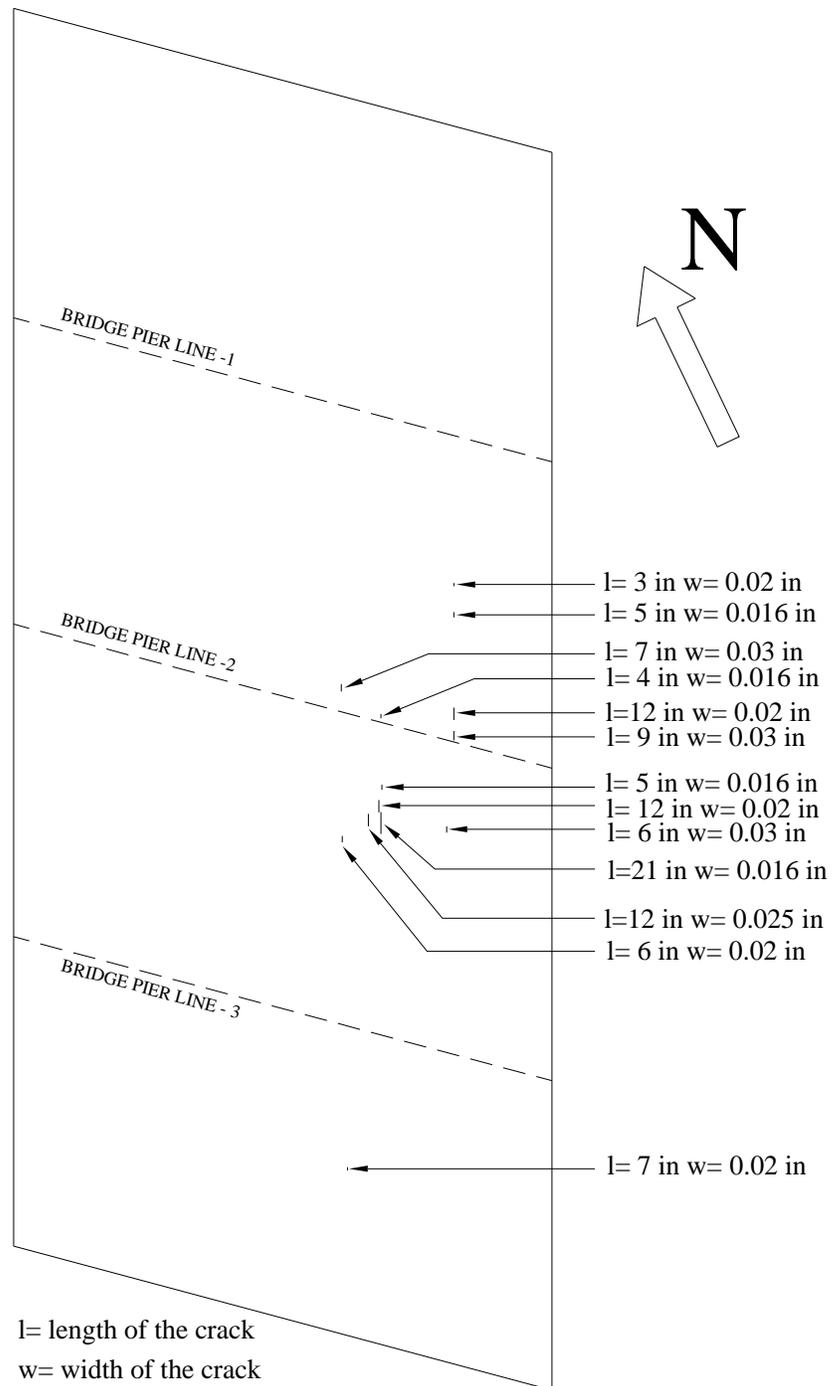
FIGURE 18 Bridge deck 5500 crack map at 7 days.

Both bridges were covered by burlap and plastic sheets for 7 days. The first visual inspection was made on the seventh day. For Bridge deck 5500, thirteen small cracks were observed on the seventh day (Figure 18). Most of the cracks are located near pier line 2 on the east side of the bridge. The first span and last span were observed to be in good condition. For Bridge deck 5701, five small cracks were observed at 7 days (Figure 19). Three cracks were located in the span between the abutment and pier line 5 and the other two cracks were near pier line 5. Spans 1 through 4 were in good condition.

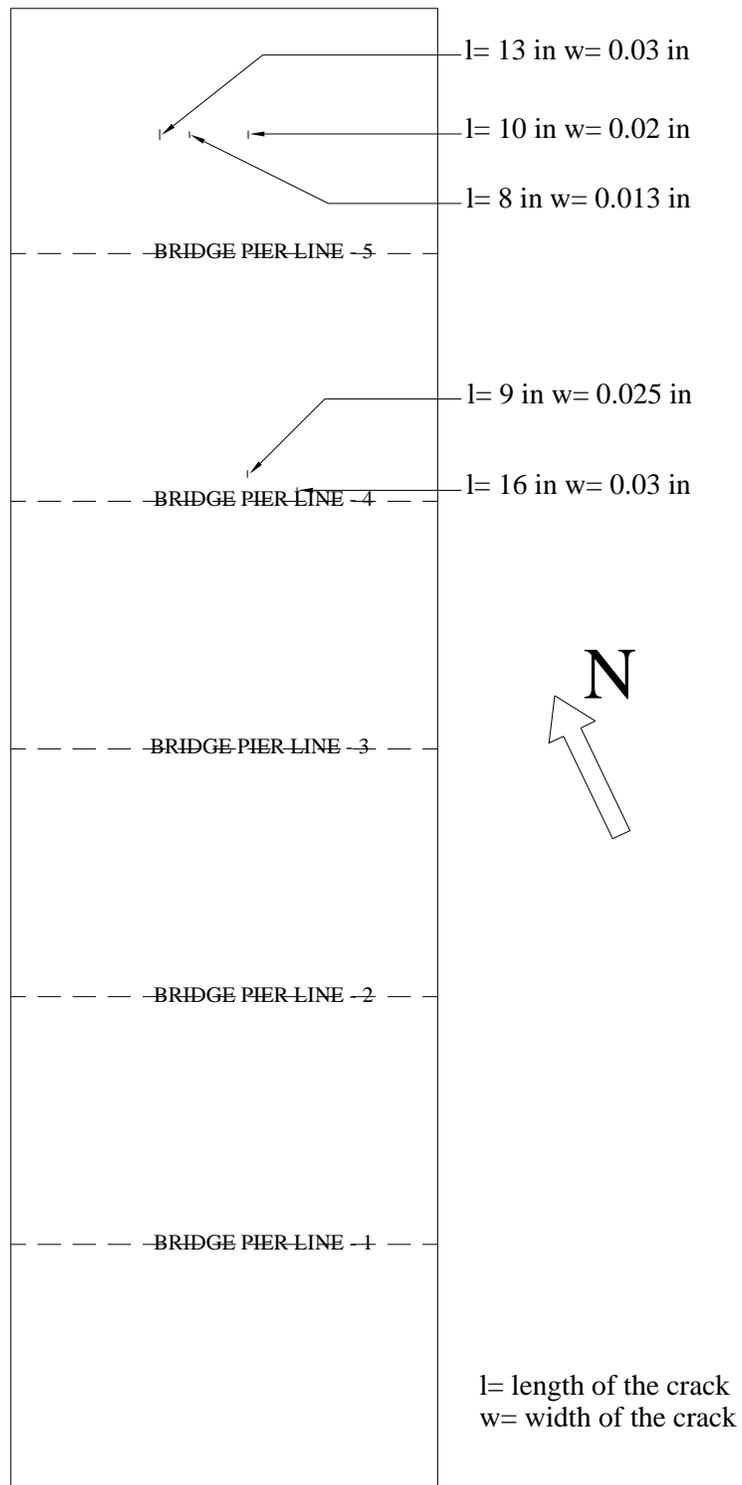
FIGURE 19 Bridge deck 5701 crack map at 7 days.

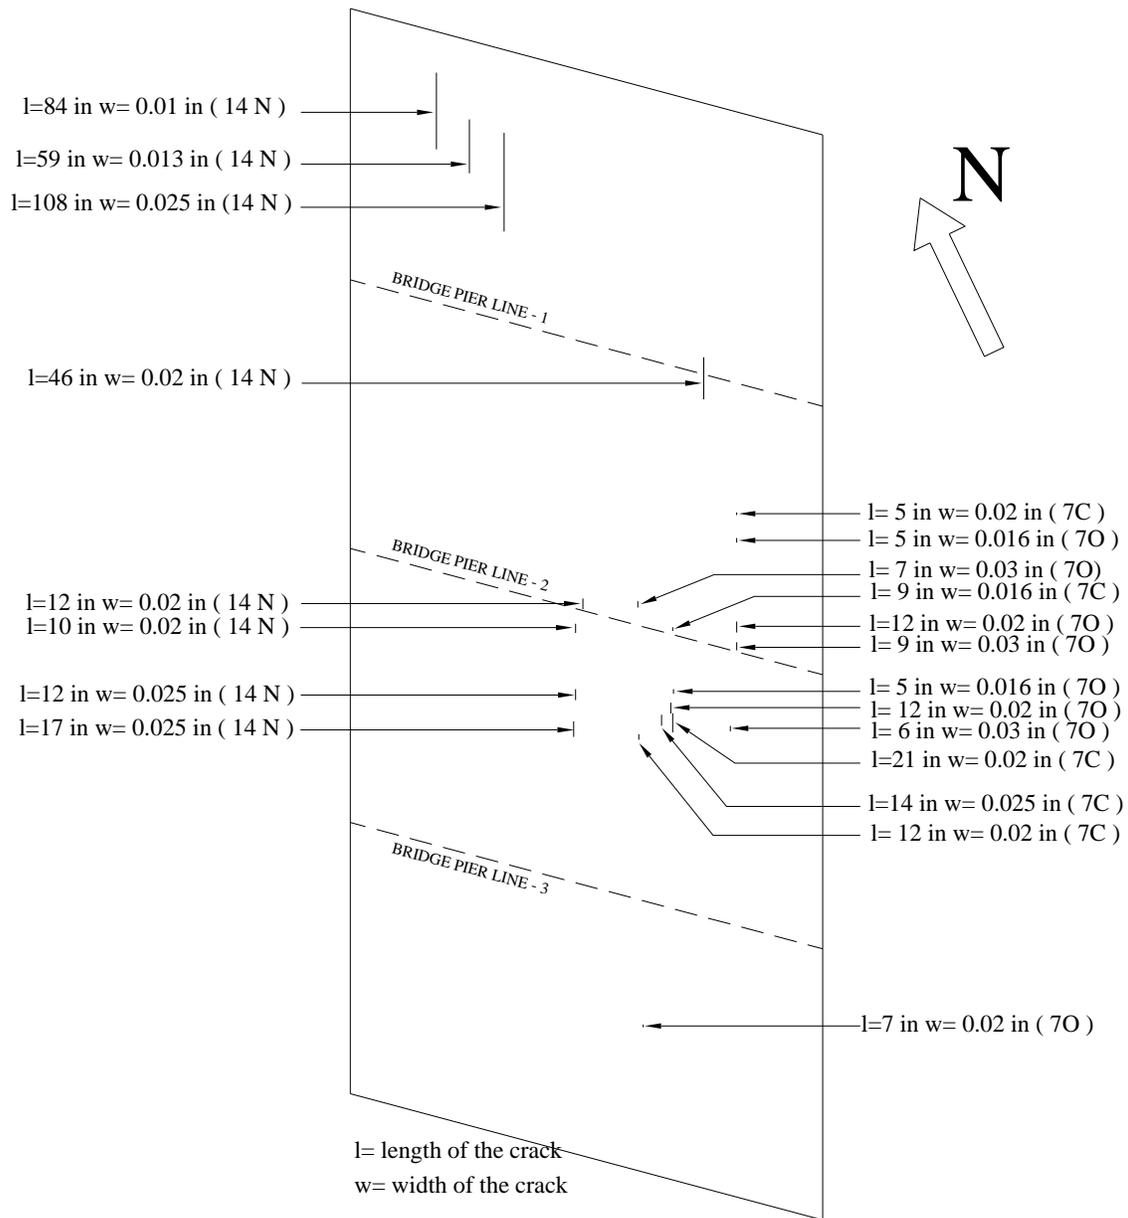
(7C) Indicates changed cracks from 7 days
 (7O) Indicates unchanged cracks from 7 days
 (14N) Indicates new cracks at 14 days

FIGURE 20 Bridge deck 5500 crack map at 14 days.

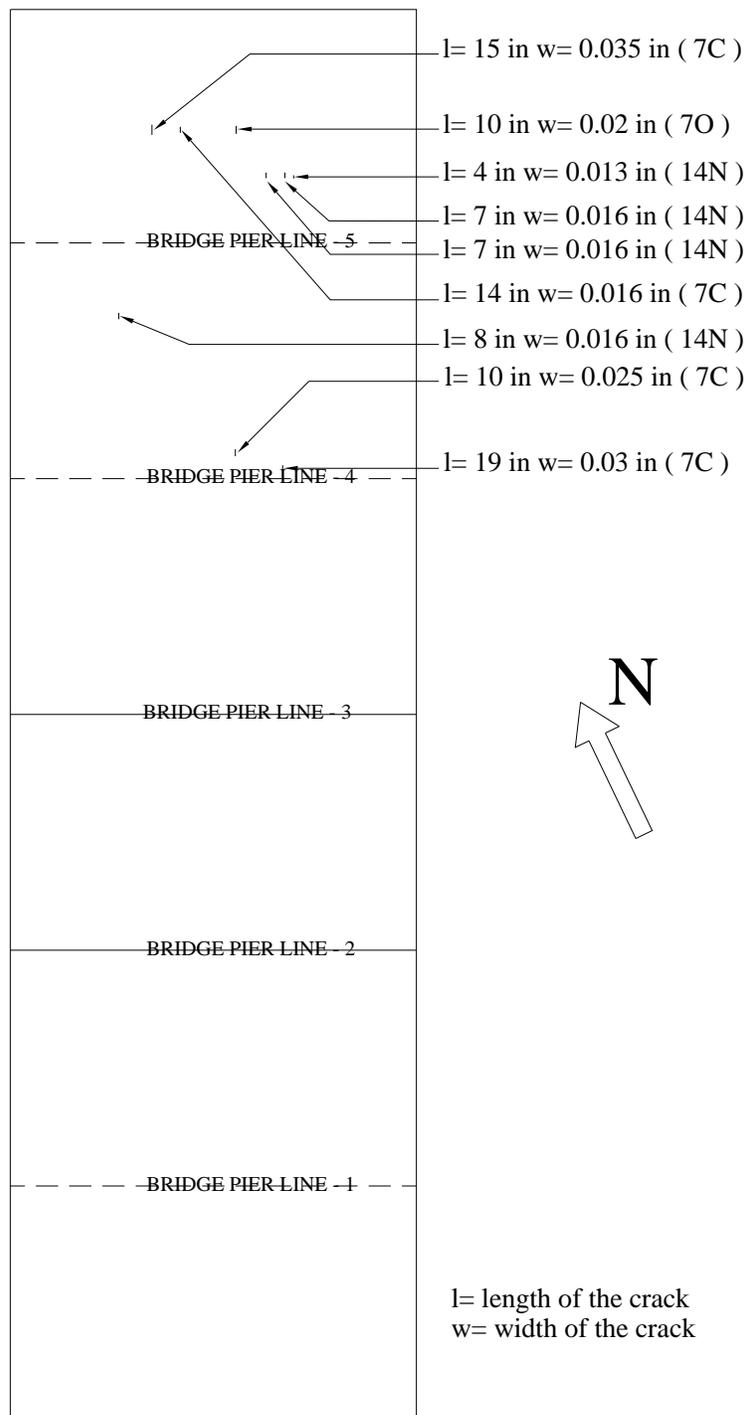
- (7C) Indicates changed cracks from 7 days
- (7O) Indicates unchanged cracks from 7 days
- (14N) Indicates new cracks at 14 days

FIGURE 21 Bridge deck 5701 crack map at 14 days.

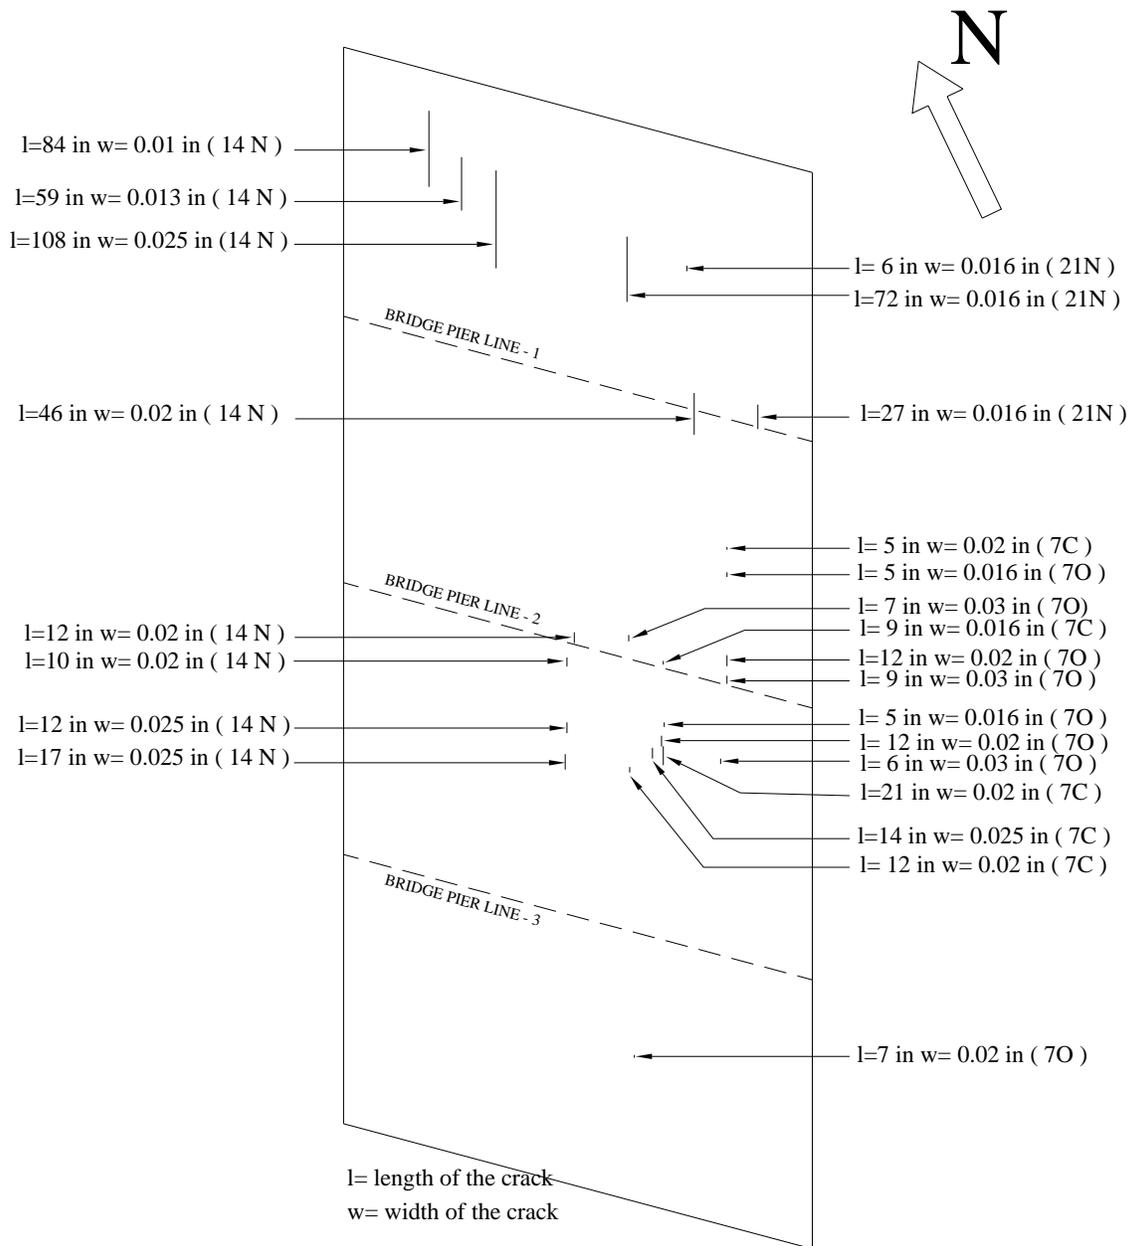
- (7C) Indicates cracks that changed between 7 days and 14 days
- (7O) Indicates unchanged cracks from 7 days
- (14N) Indicates new cracks at 14 days that remain the same at 21 days
- (21N) Indicates new cracks at 21 days

FIGURE 22 Bridge deck 5500 crack map at 21days.

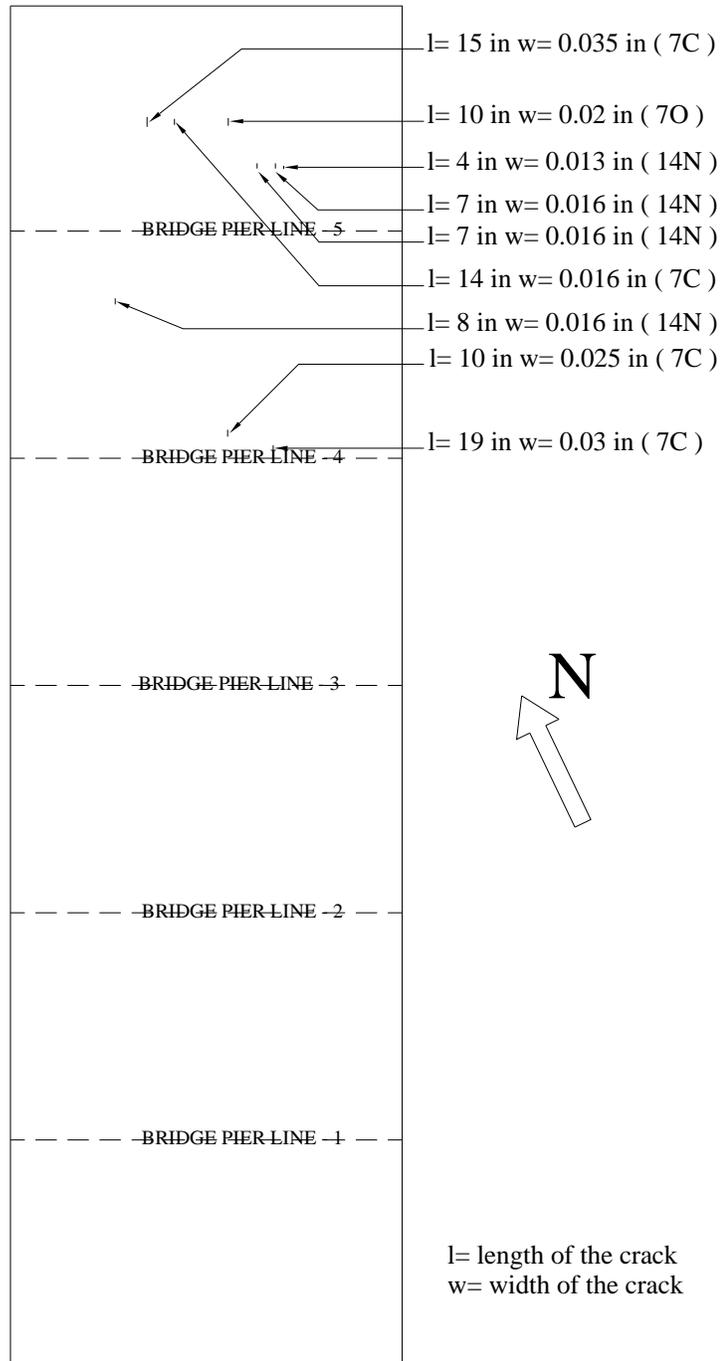
- (7C) Indicates cracks that changed between 7 days and 14 days
- (7O) Indicates unchanged cracks from 7 days
- (14N) Indicates new cracks at 14 days that remain the same at 21 days
- (21N) Indicates new cracks at 21 days

FIGURE 23 Bridge deck 5701 crack map at 21 days.
