BRIDGE DECK FOGGING SYSTEM: EVALUATION OF FIELD IMPLEMENTATION OF FOGGING SYSTEM USED DURING CONCRETE BRIDGE DECK CONSTRUCTION

Prepared by :
New Mexico State University
Department of Civil Engineering
Box 30001, MSC 3CE
Las Cruces, NM 88003-8001

Prepared for:
New Mexico Department of Transportation
Research Bureau
7500B Pan American Freeway NE
Albuquerque, NM 87109

PROJECT NM04STR-02
JUNE 2008

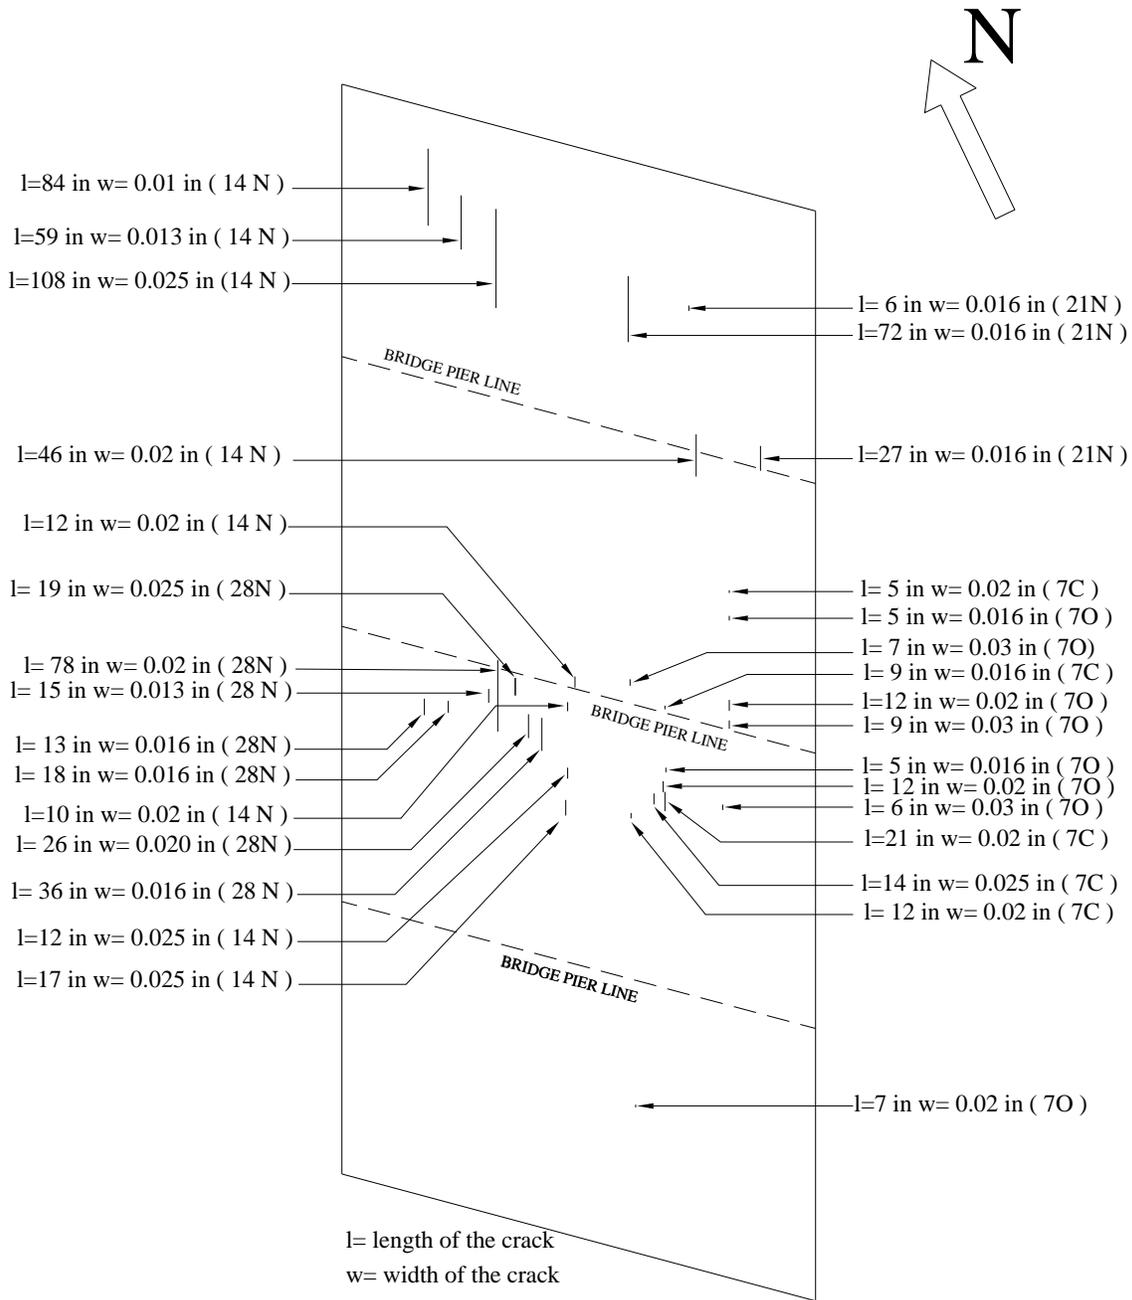
- (7C) Indicates cracks that changed between 7 days and 14 days
- (7O) Indicates unchanged cracks from 7 days that remain at 28 days
- (14N) Indicates new cracks at 14 days that remain the same at 28 days
- (21N) Indicates new cracks at 21 days that remain the same at 28 days
- (28N) Indicates new cracks at 28 days

FIGURE 24 Bridge deck 5500 crack map at 28 days.

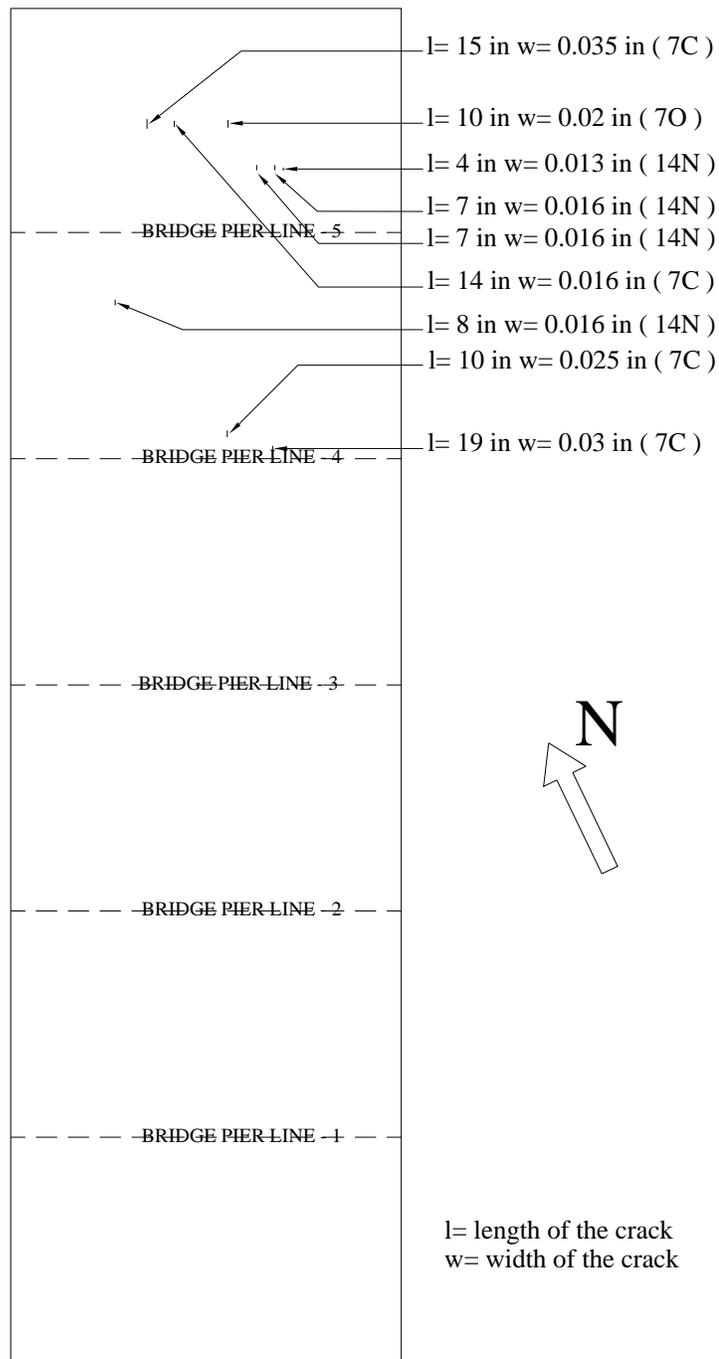
- (7C) Indicates cracks that changed between 7 days and 14 days
- (7O) Indicates unchanged cracks from 7 days that remain at 28 days
- (14N) Indicates new cracks at 14 days that remain the same at 28 days
- (21N) Indicates new cracks at 21 days that remain the same at 28 days
- (28N) Indicates new cracks at 28 days

FIGURE 25 Bridge deck 5701 crack map at 28 days.

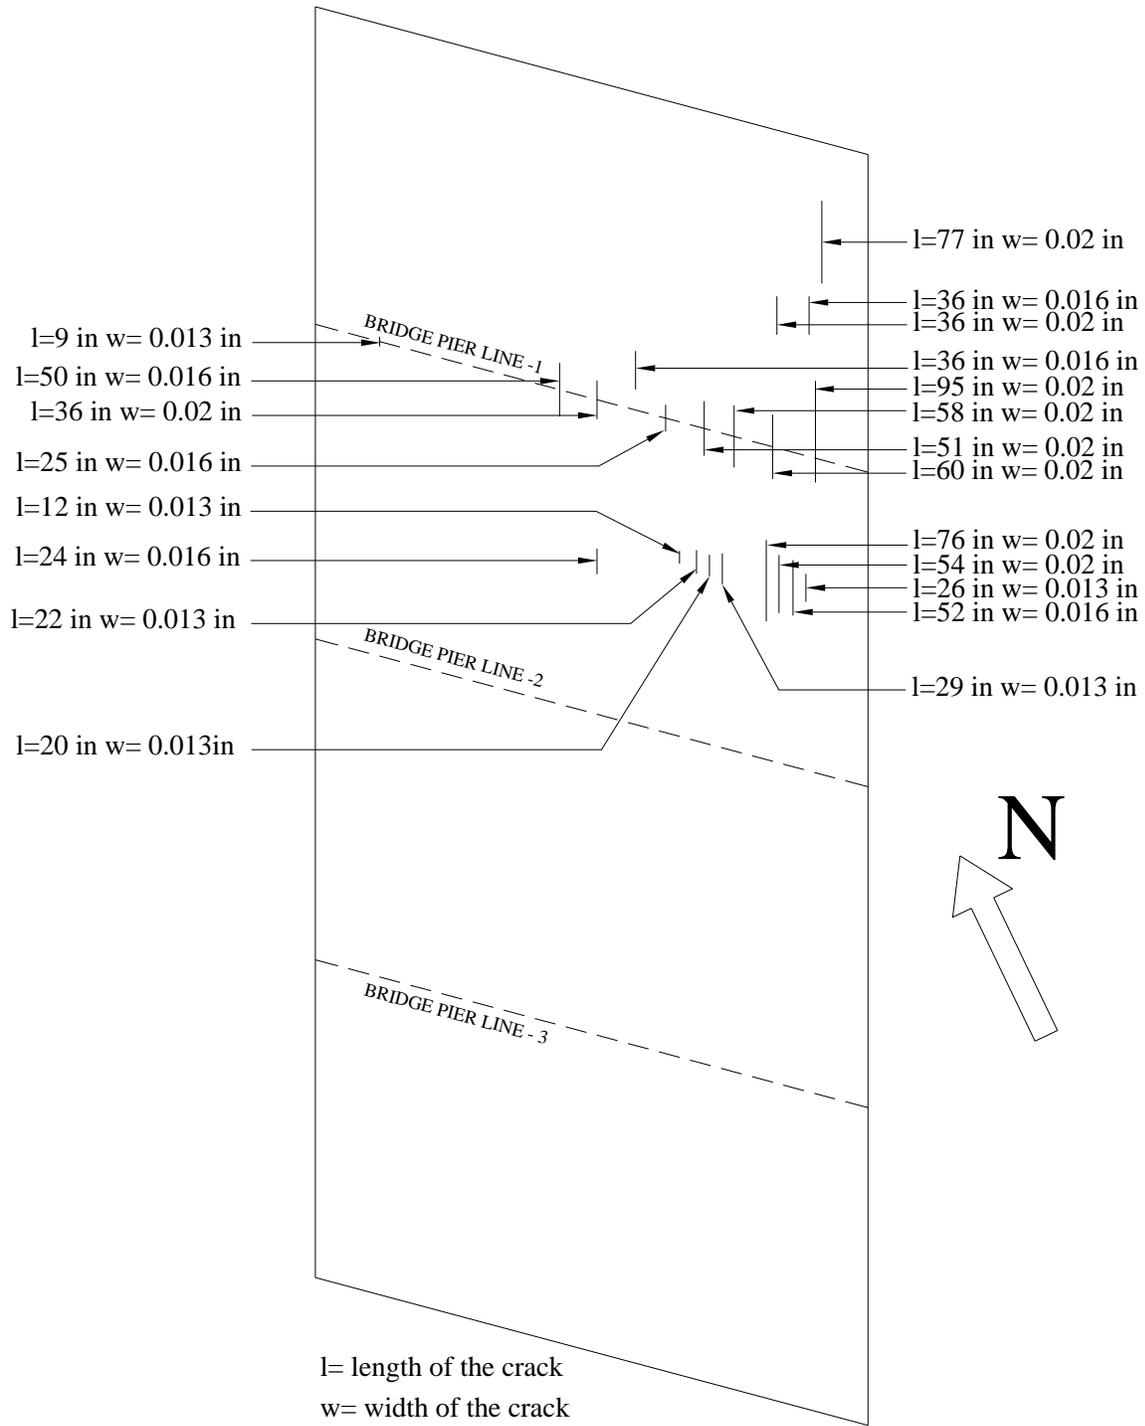
FIGURE 26 Bridge deck 5500 new cracks between 28 and 56 days.

The more extensive cracking on Bridge 5500 appears to be largely due to the greater evaporation rate experienced during placement. It should also be noted that the cracks in Bridge 5500 were in the location of a stoppage in placement. The cracks in Bridge 5701 occurred in concrete that was placed with an elevated evaporation rate.

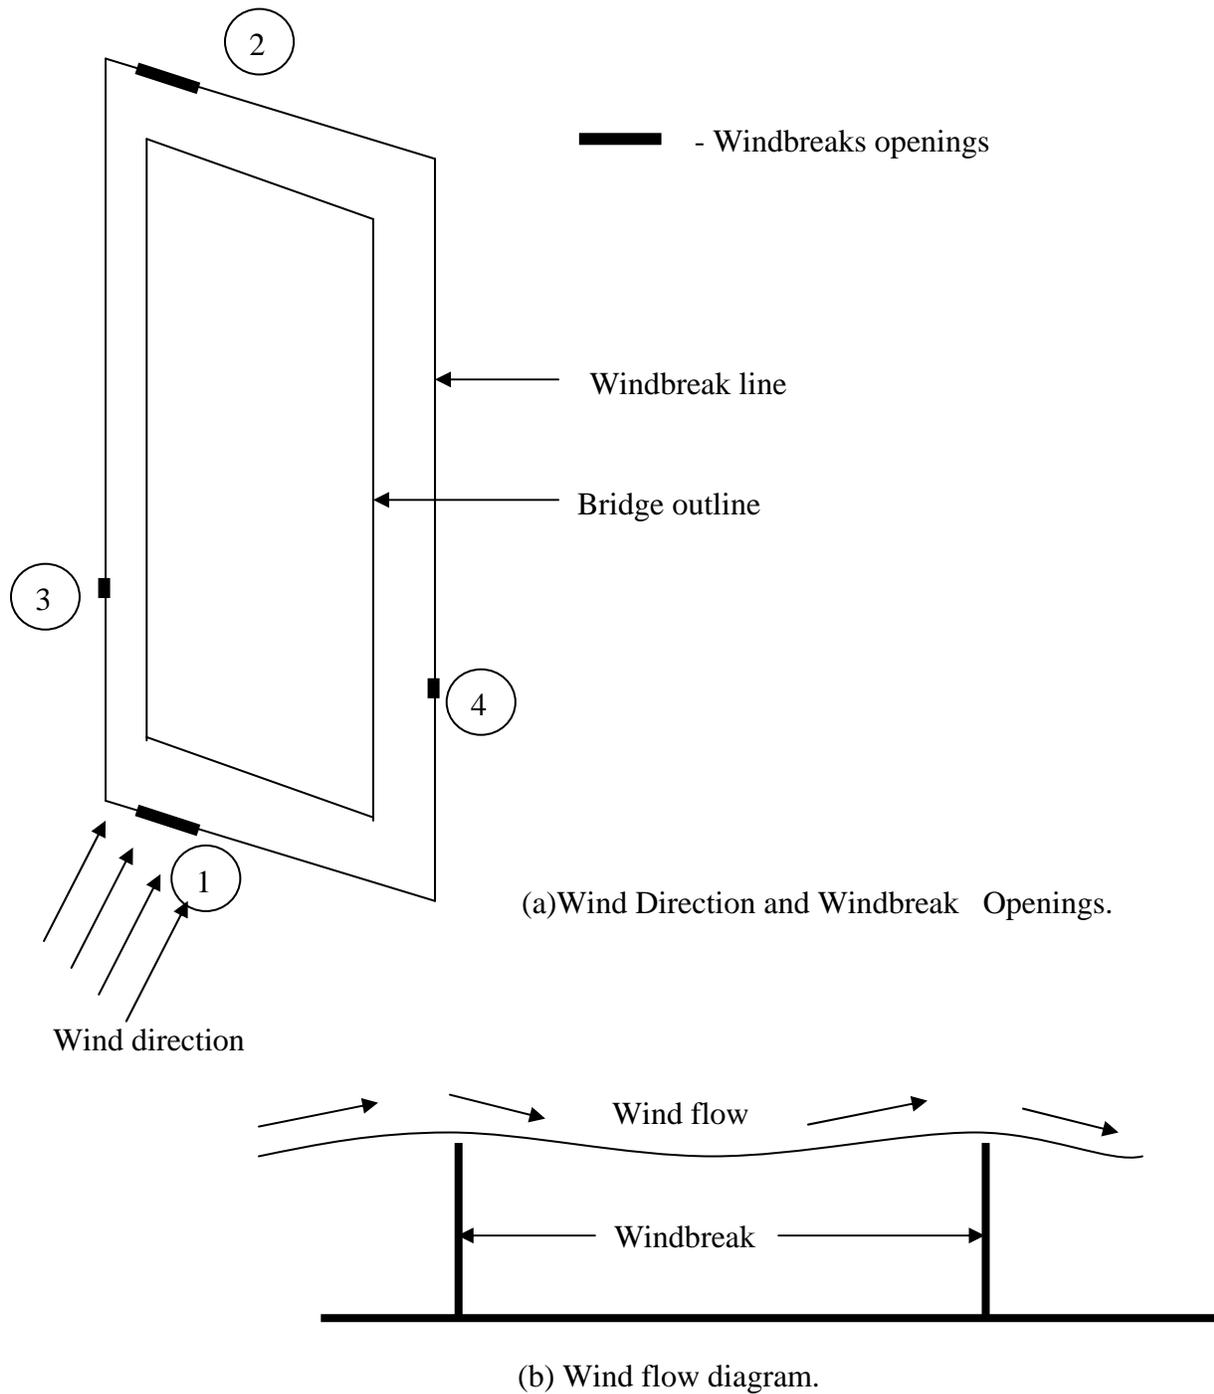
FIGURE 27 Wind direction, windbreak openings and wind flow diagram.

Other than the reasons listed above, there are other possible causes for the observed cracks. For Bridge deck 5500, formwork for span 1 was removed during the 7-14 day period. The removal of formwork may have caused some tensile stresses or movement in the first span of Bridge deck 5500. Three long cracks were observed in the first span of Bridge deck 5500 on the 14th day. In the week following the placement of Bridge deck 5701, weather conditions were overcast in southern New Mexico. This also provided a favorable environment for Bridge deck 5701 placement.

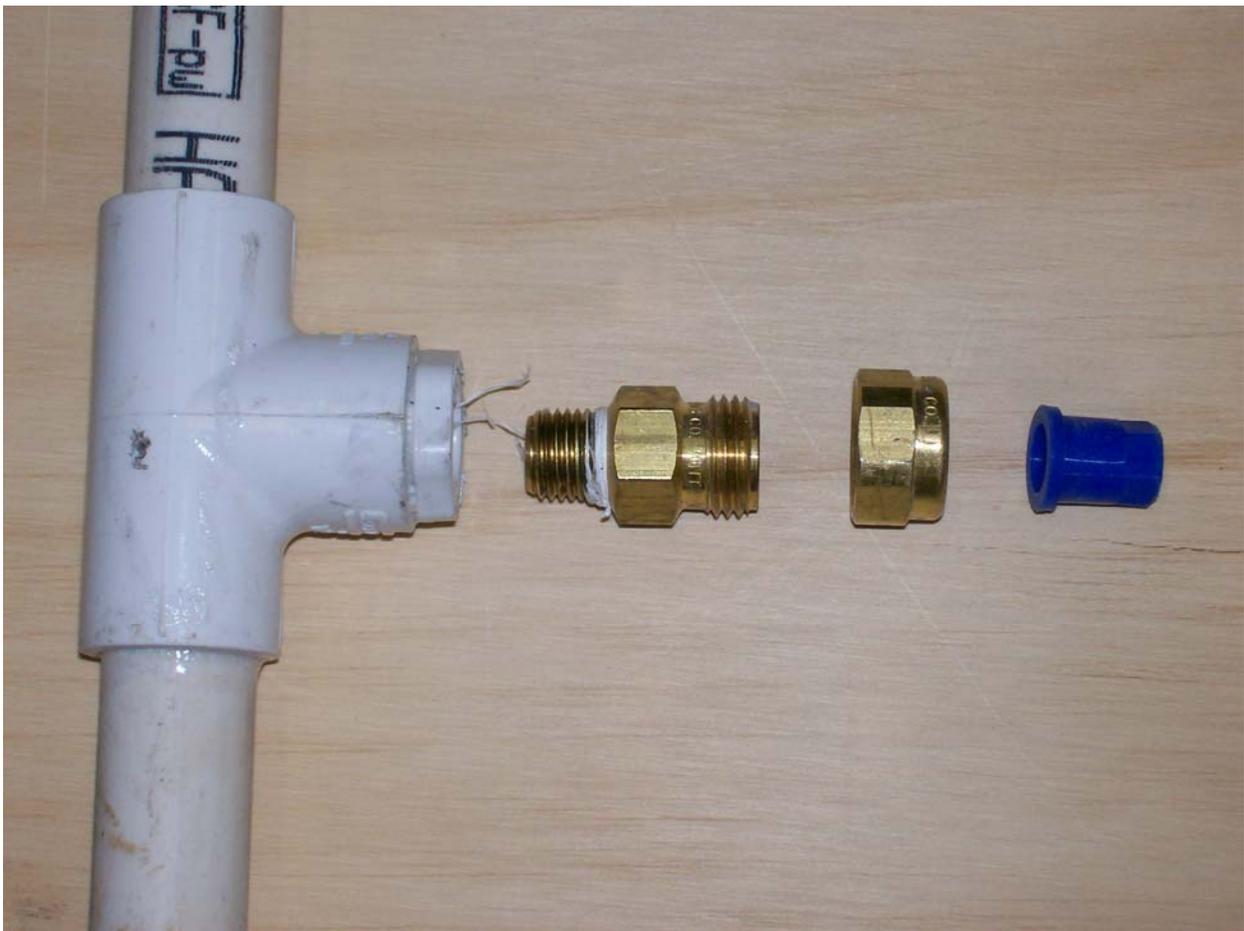
FIGURE A1 Nozzle fitting assembly.

The fogging system has been preassembled in 11 foot sections of 0.5 inch inside diameter PVC pipes fitted with cone jet TXWS-1 nozzles spaced two feet apart. The nozzles are arranged such that adjacent nozzles spray water in opposite directions. Each of the nozzle fittings is assembled as shown in Figure A1, using Teflon tape on all threaded connections.

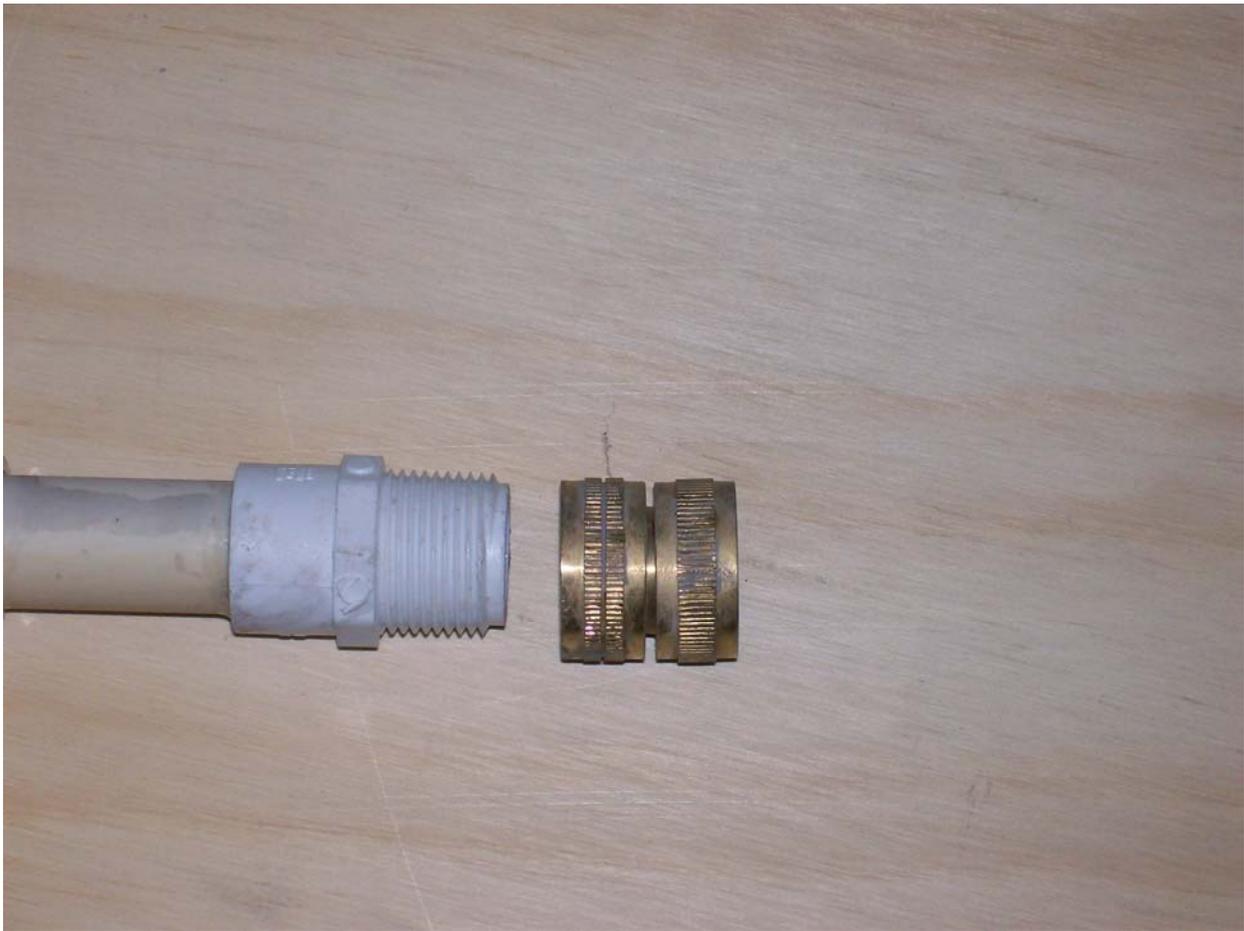
FIGURE A2 Hose fitting at end of fogging segment.

sections. The section nearest the pump has one end with hose fitting, and one end with a compression connection. An end with a hose fitting is shown in Figure A2. A compression connection is shown in Figure A3. Although there is a threaded coupler on the compression connection, no Teflon tape is necessary. The connection is sealed by compressing a rubber gasket. The middle section of each line has compression connections at each end, and the section furthest from the pump has one end capped.

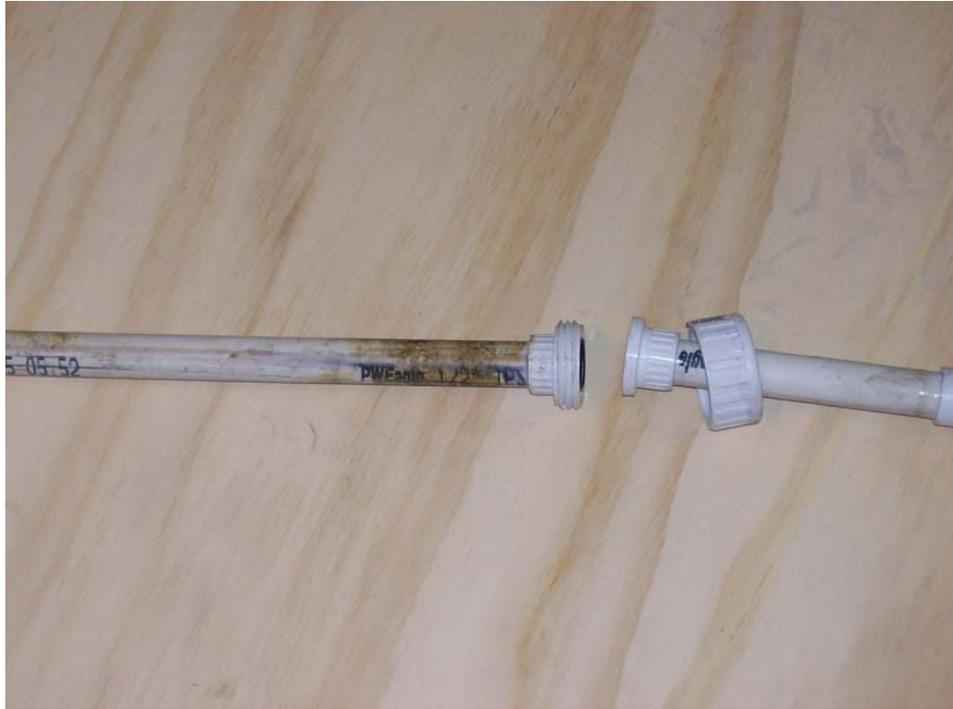
FIGURE A3 Compression connection.

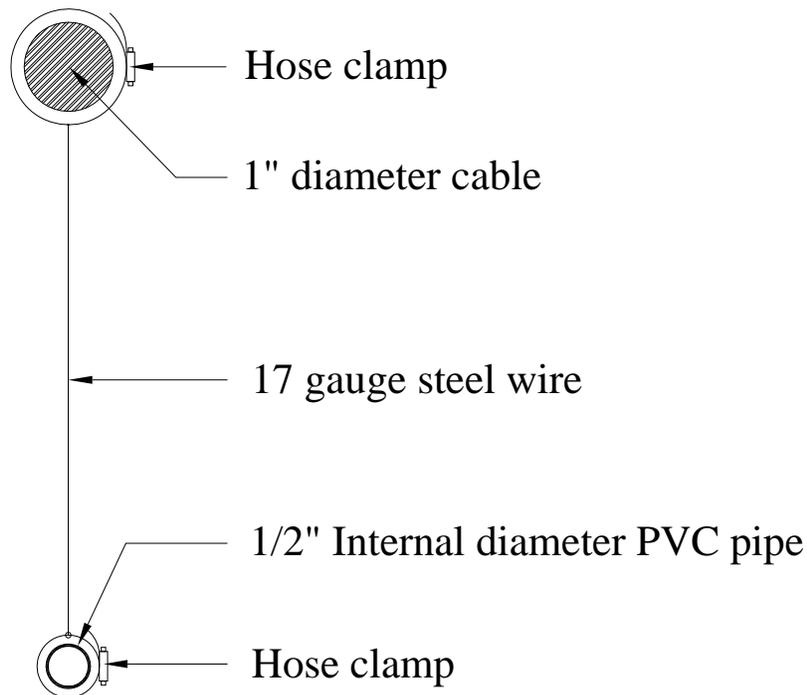
FIGURE A4 Wire connection to cable.

After installing all of the sections in each line for the first segment of the fogging system, the hoses should be connected to this segment. As the proceeding segments are installed, the hoses for the first segment can be tied to the cable using plastic or wire ties. Tying the hoses to the

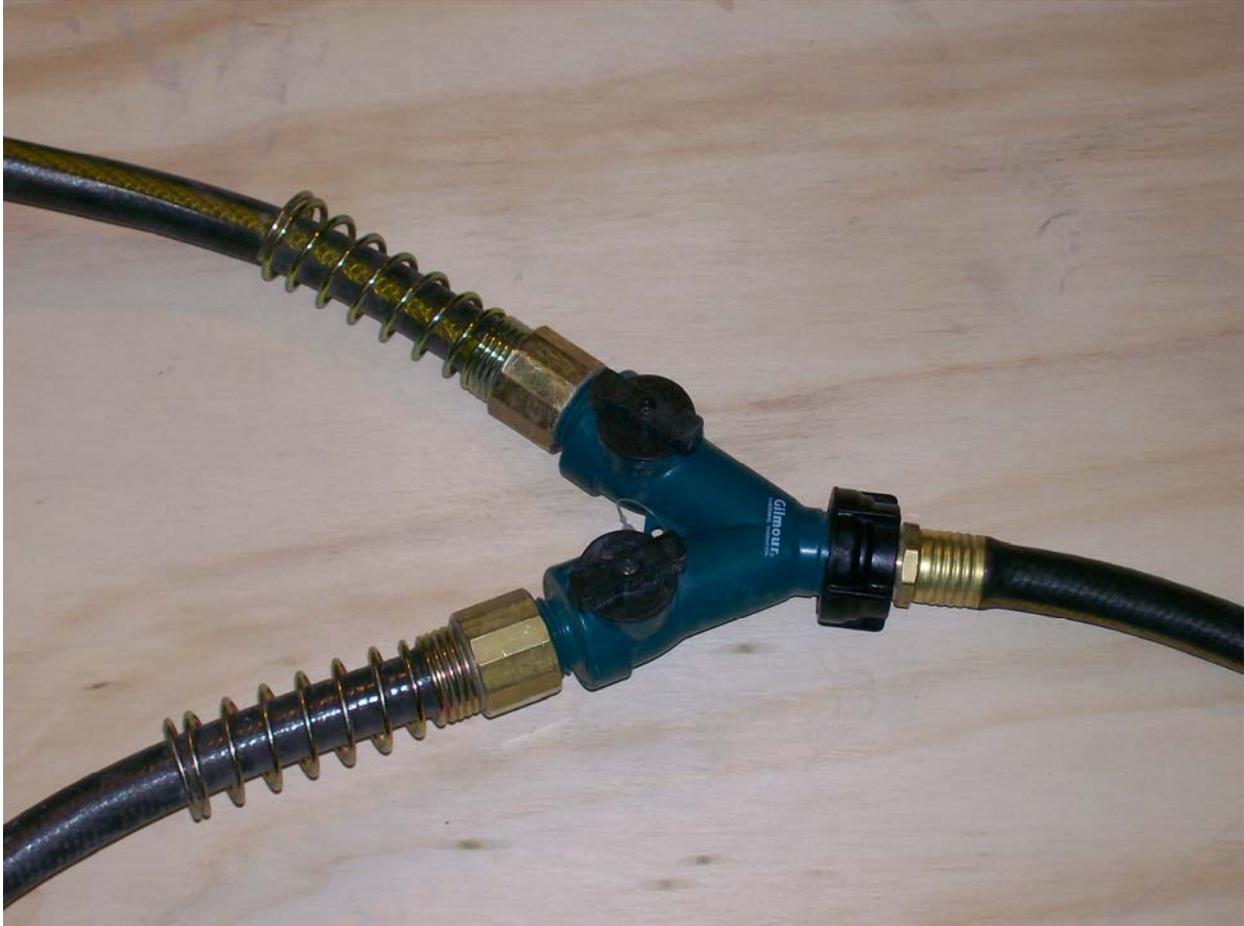
FIGURE A6 Flow tee.

pressure. This is accomplished by increasing or decreasing the backflow to decrease or increase the fogging rate, respectively. Adjustment outside this range of fogging rates requires changing either the size of the nozzles, the spacing of the nozzles, or the spacing of the cables.

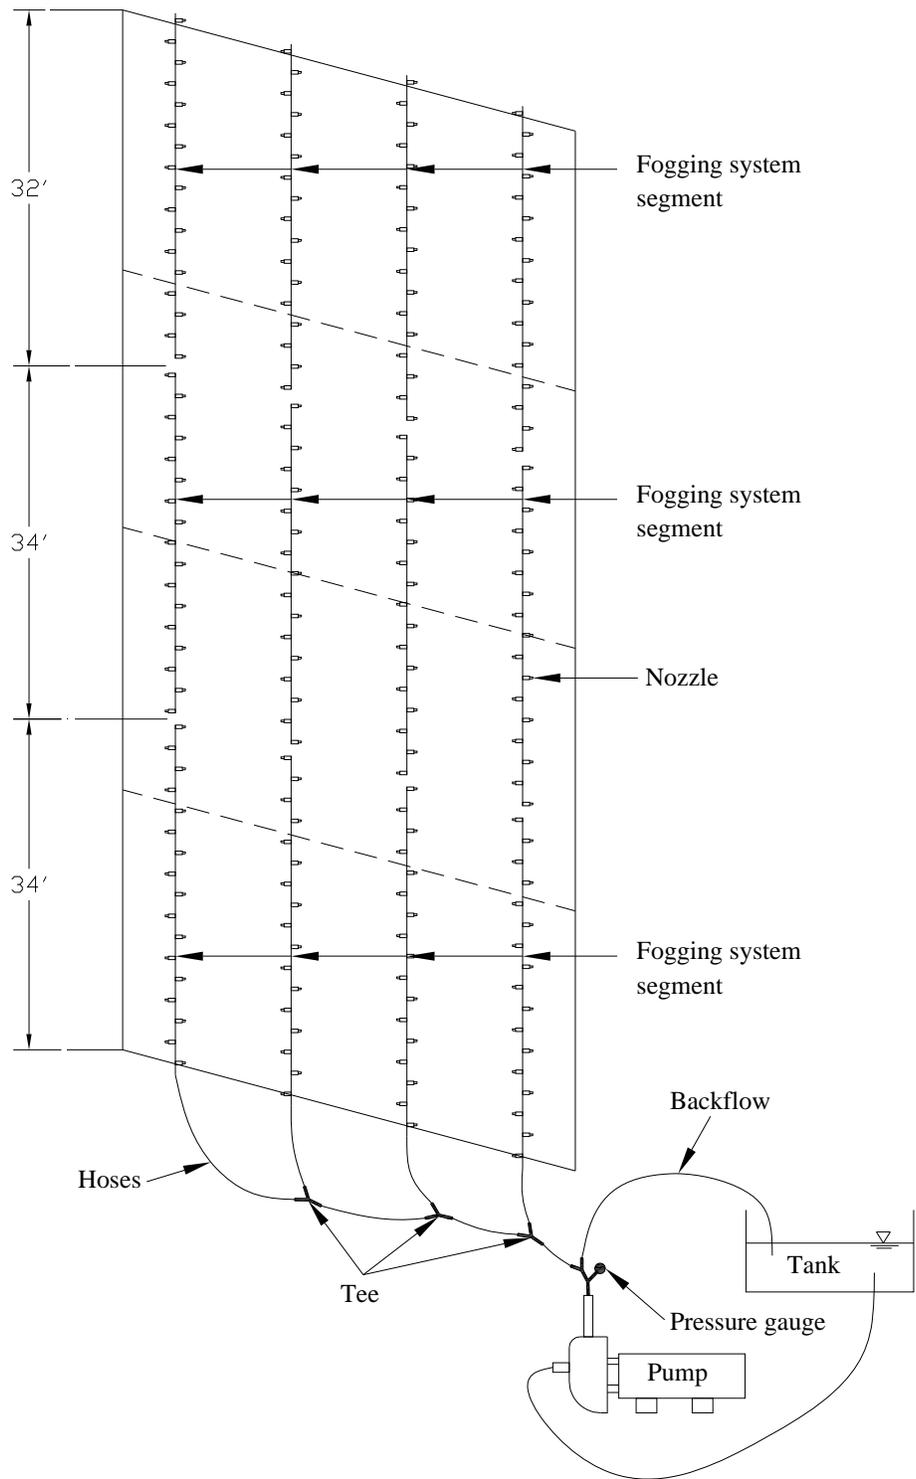
FIGURE A7 Hose, pump and tank arrangement.

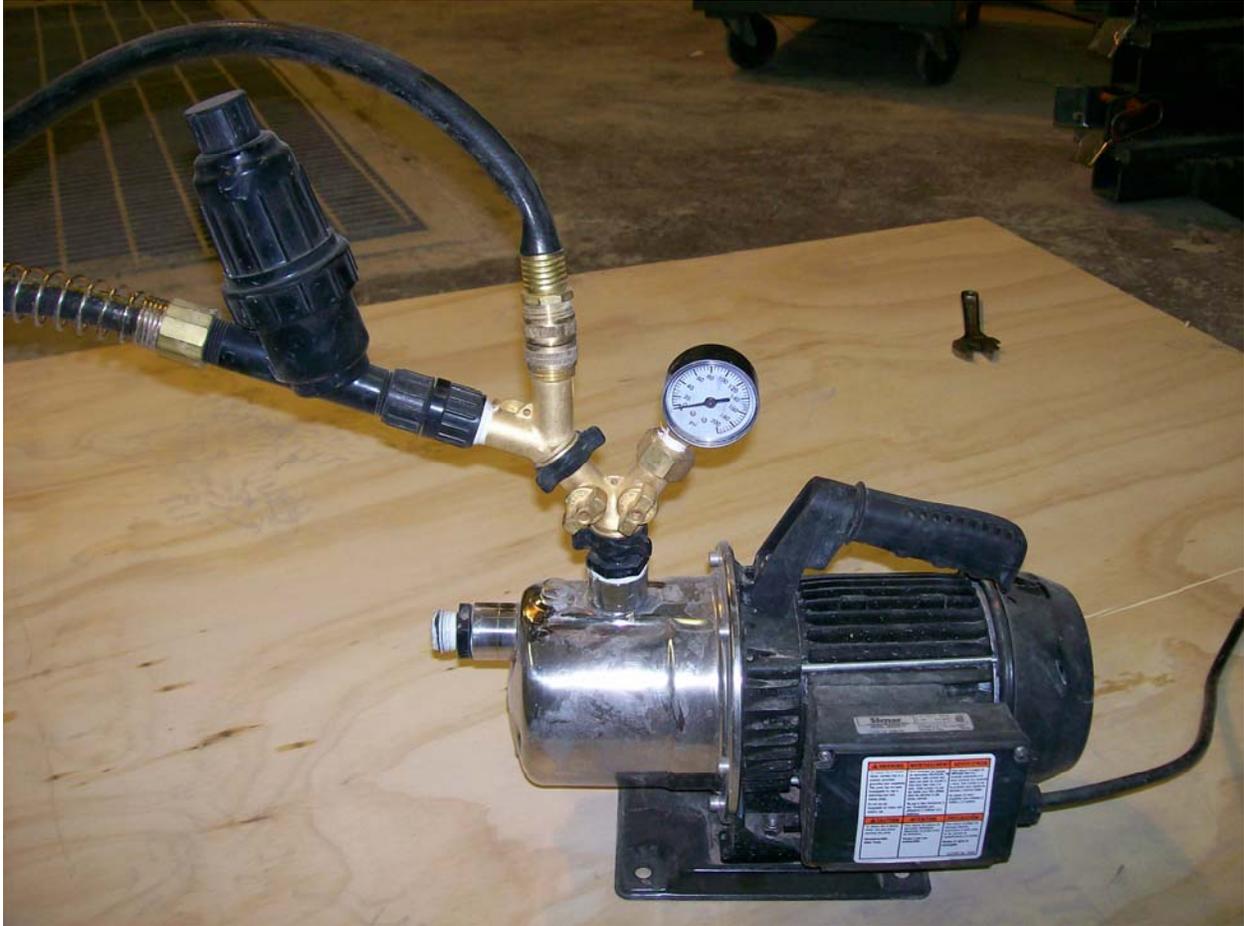
FIGURE A8 Pump with pressure gauge.

Pressure gauges are attached to the pumps to measure the system pressure as shown in Figure A8. The hose line rising vertically from the pump is the backflow line, and the bulbous apparatus attached to the main line is a sediment filter to capture sediment that could plug nozzles. The pumps require electrical power for operation, so generator will be needed at most sites.
