**IMPROVING DMS 9210 REQUIREMENTS FOR LIMESTONE ROCK
ASPHALT – YEAR ONE INTERIM REPORT**

Cindy Estakhri, P.E.
Research Engineer
Texas A&M Transportation Institute

Report 0-6686-1

Project Title: Improving DMS 9210 Requirements for Limestone Rock Asphalt

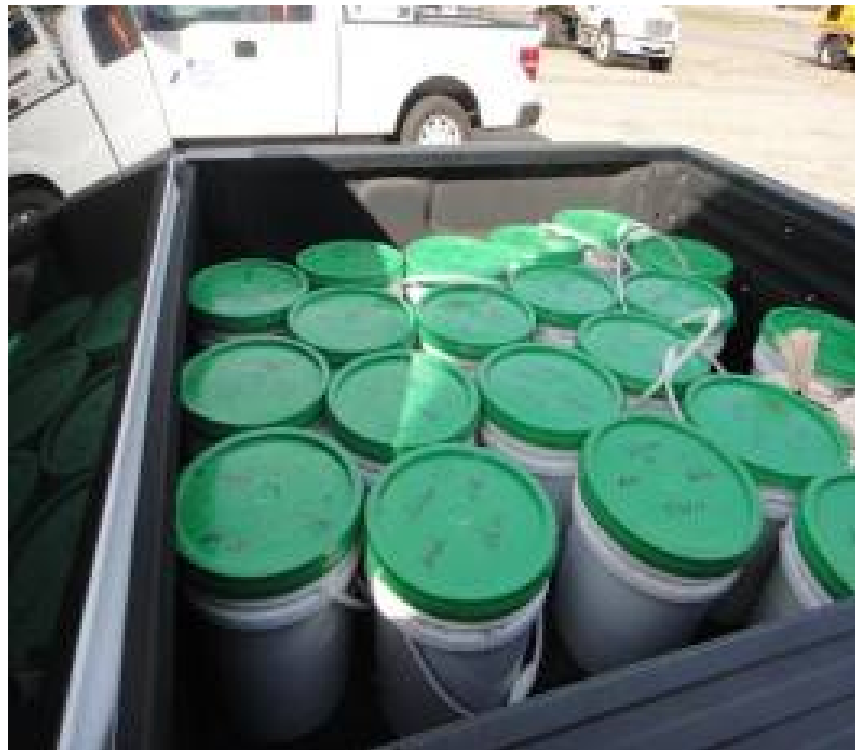
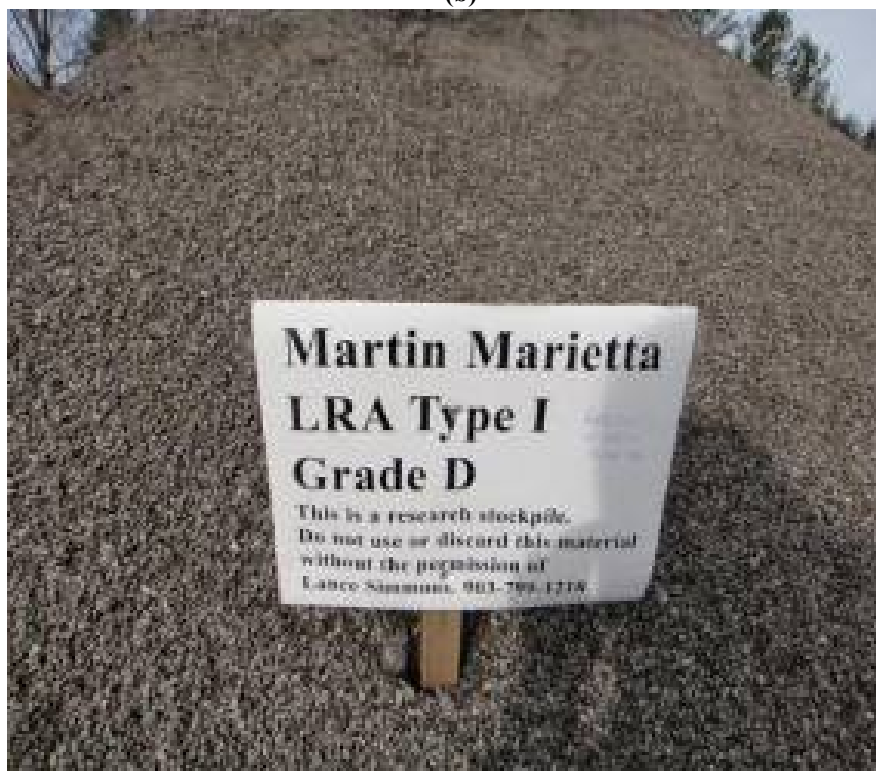
(a) Five Buckets Per Material Were Sampled.
(b)

(c) Signs Provided to Maintenance Yards.

Figure 3.1. Sample Containers and Stockpile Designation Signs.

Researchers provided sampling buckets for TxDOT personnel to sample materials soon after delivery. Signs were provided to the district to designate the four separate stockpiles at each maintenance yard (Figure 3.1). Figure 3.2 shows the typical stockpiles.

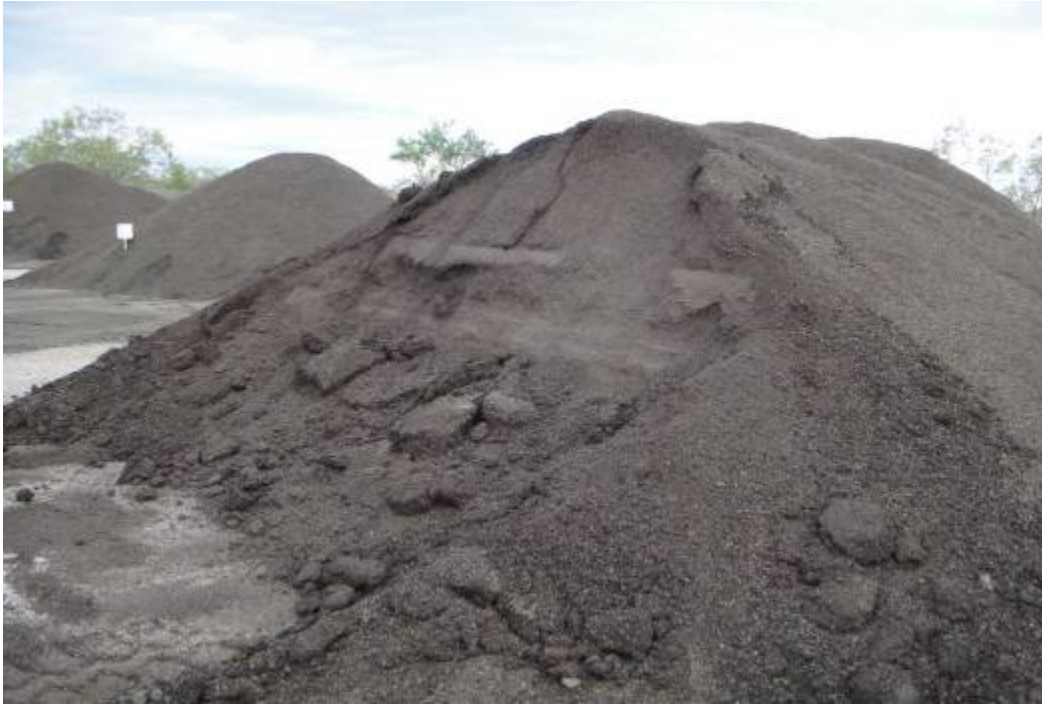
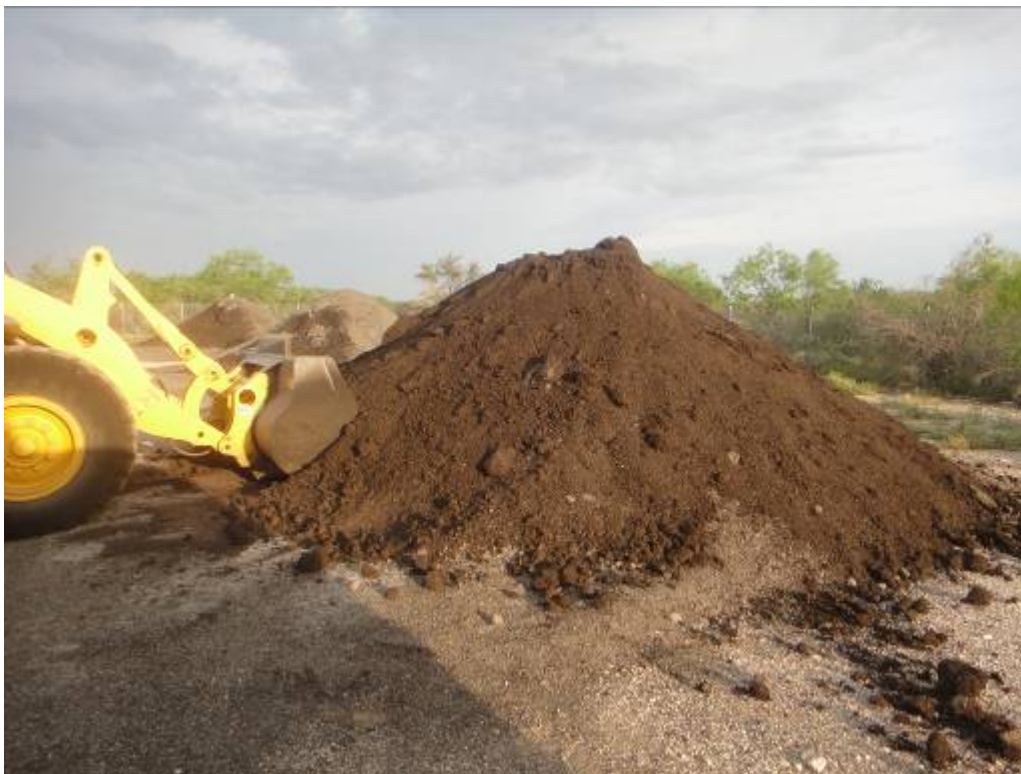
(a) Fresh Stockpiles.

(b) Stockpiles After Four Months Age.

Figure 3.2. Research Stockpiles at Uvalde Maintenance Yard.

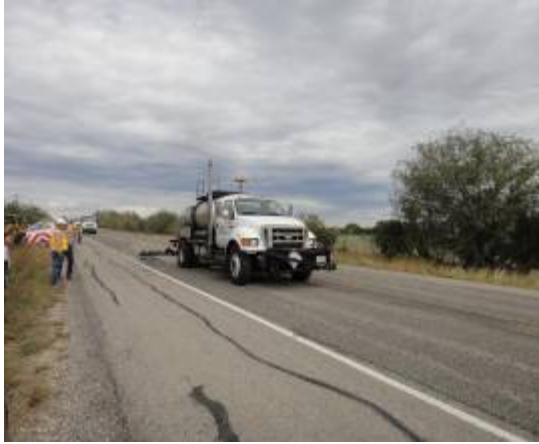
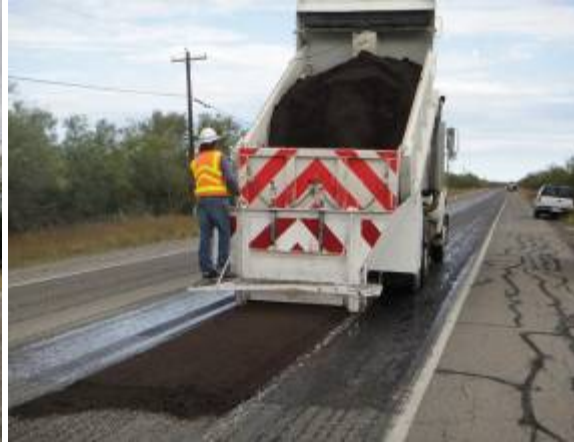
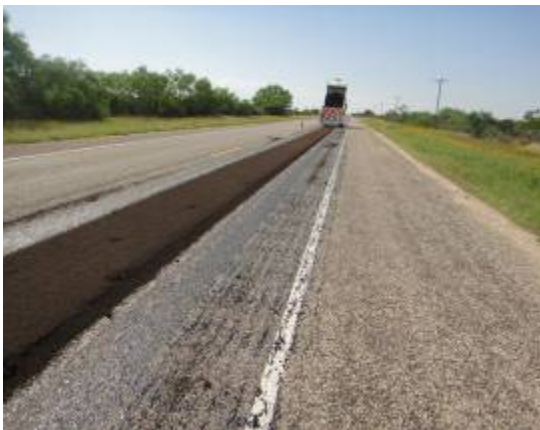
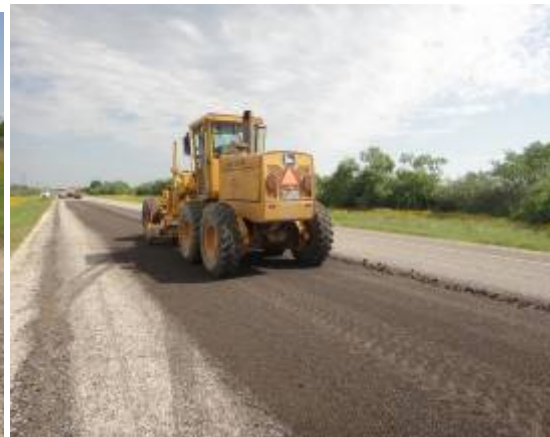
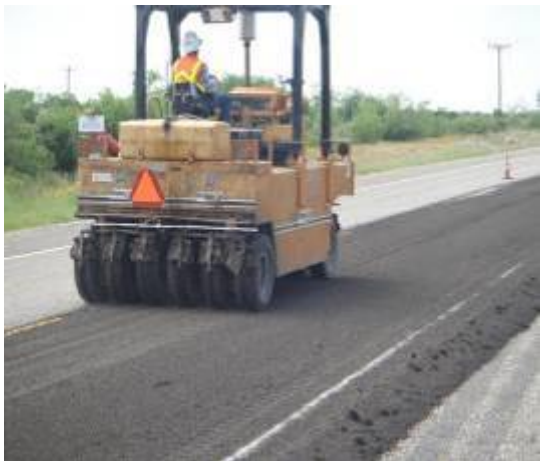
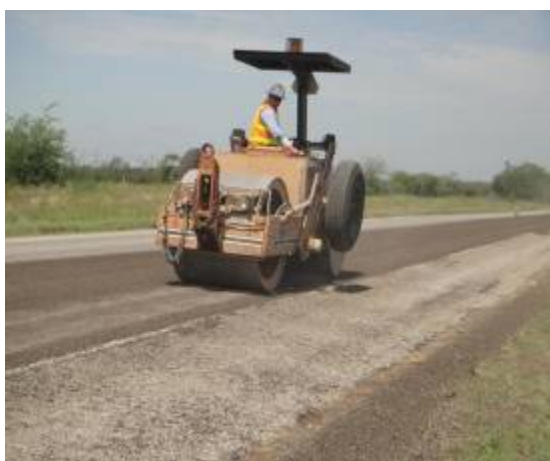
Figure 3.3 Construction Sequence of Uvalde Test Sections.

a) Application of Tack

b) Box Spreader

c) Spreading Material

d) Blading Material

e) Pneumatic Roller

e) Small Steel Wheel Roller

Test section construction in each of the four districts is shown in Figures 3.3 through 3.6.

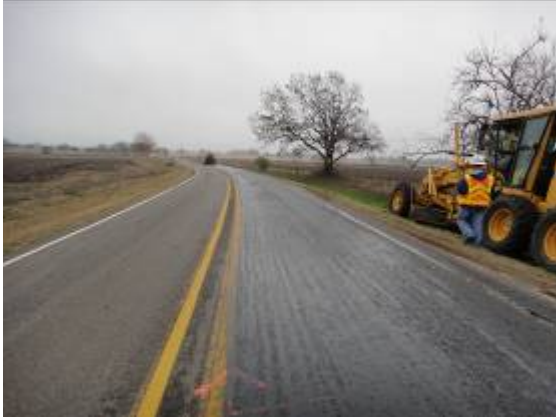
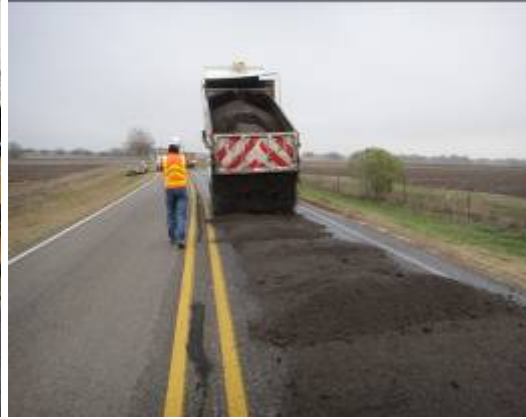
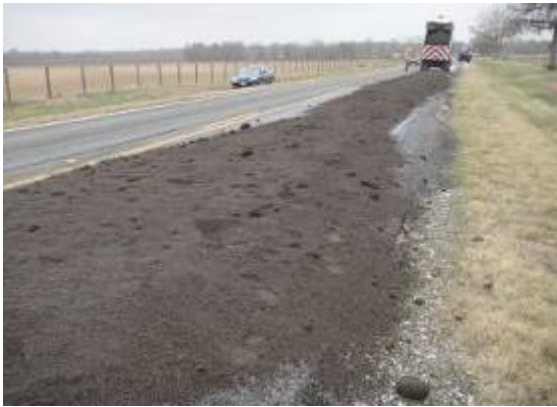
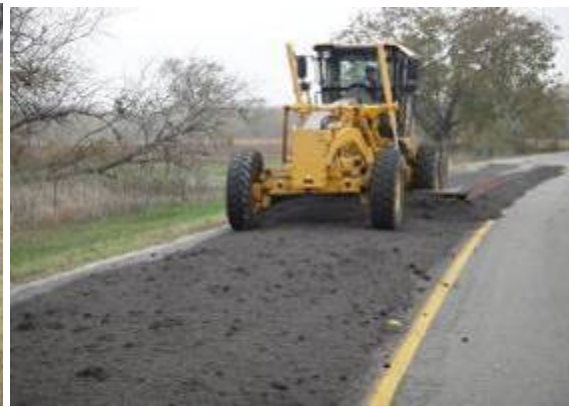
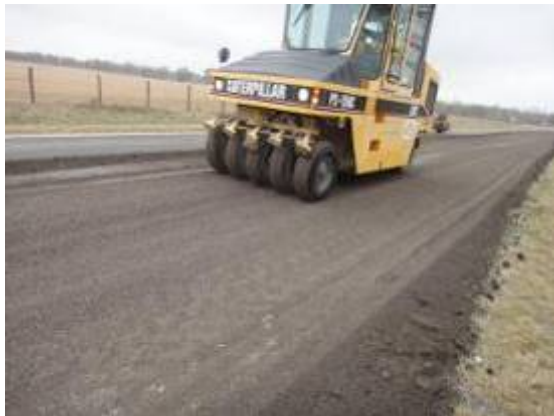
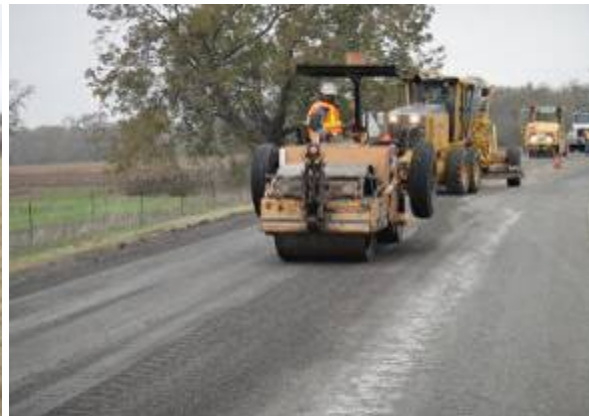
Figure 3.4. Construction Sequence of Navasota Test Sections.

a) Application of Tack

b) Placement of Material

c) Placement of Material

d) Spreading Material

e) Pneumatic Rolling

f) Small Steel Wheel Roller

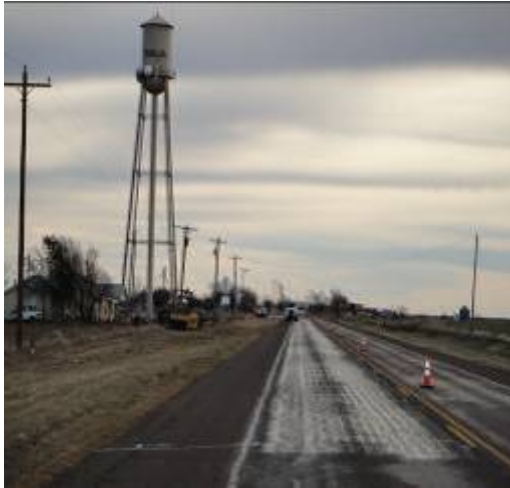
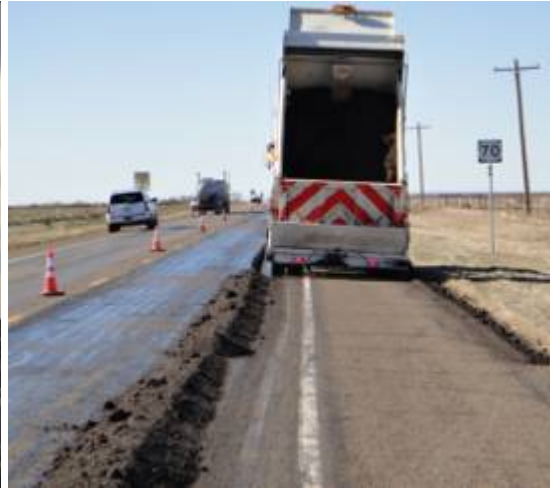
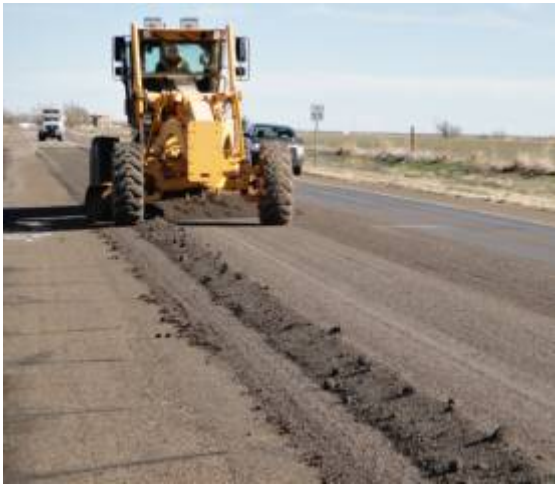
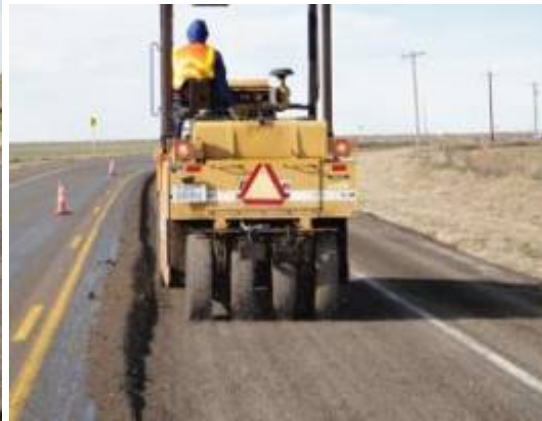
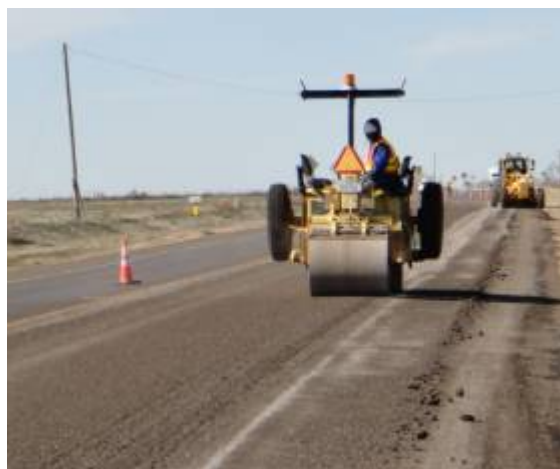
Figure 3.5. Construction Sequence of Childress Test Sections.

a) Application of Tack

b) Placing Material

c) Spreading Material

d) Compacting in Multiple Lifts

e) Steel Wheel Roller

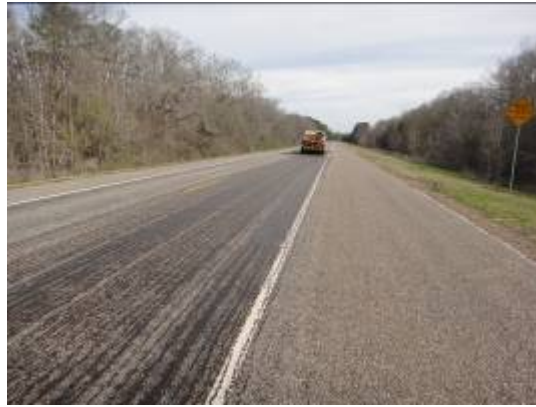
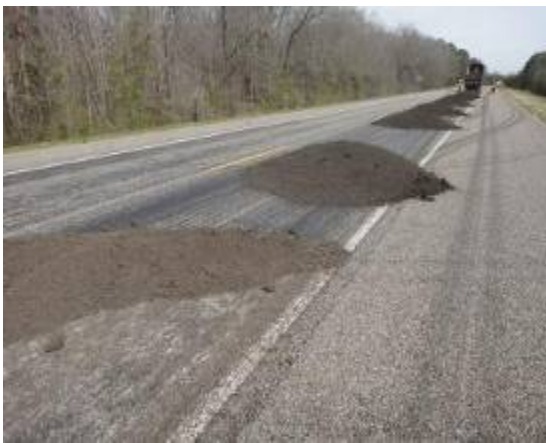
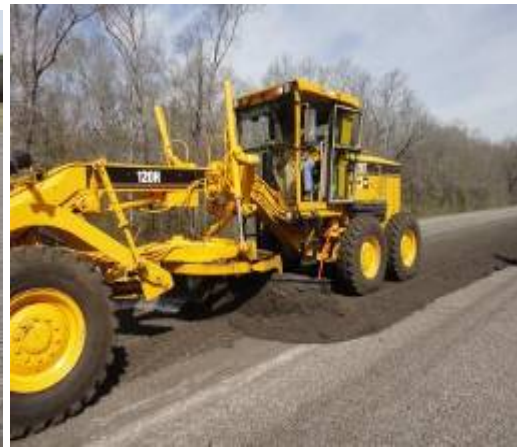
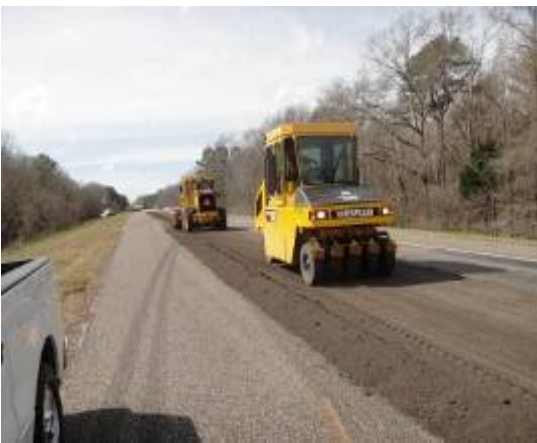
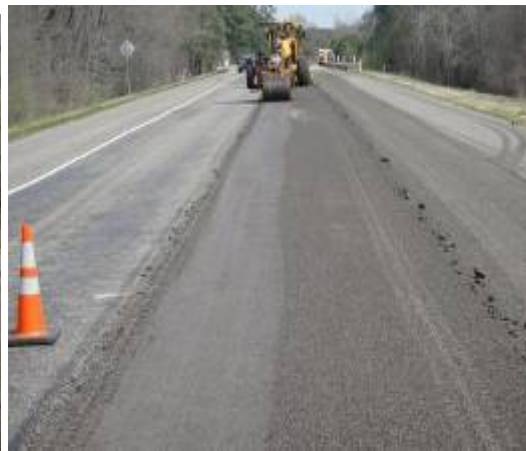
Figure 3.6. Construction Sequence of Jefferson Test Sections.

a) Application of Tack

b) Placing Material

c) Spreading Material

d) Pneumatic Rolling

e) Steel Wheel Roller

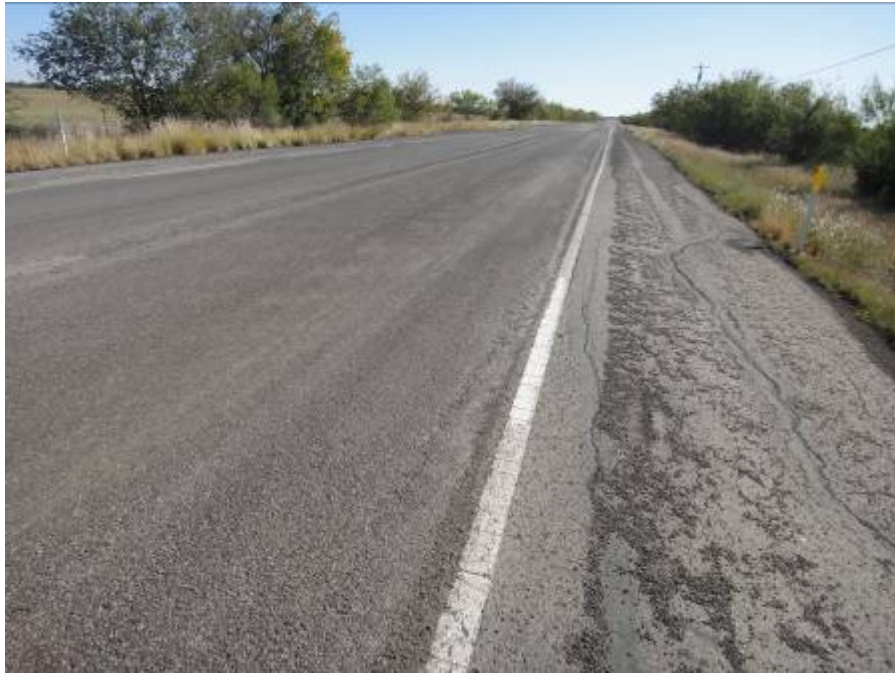
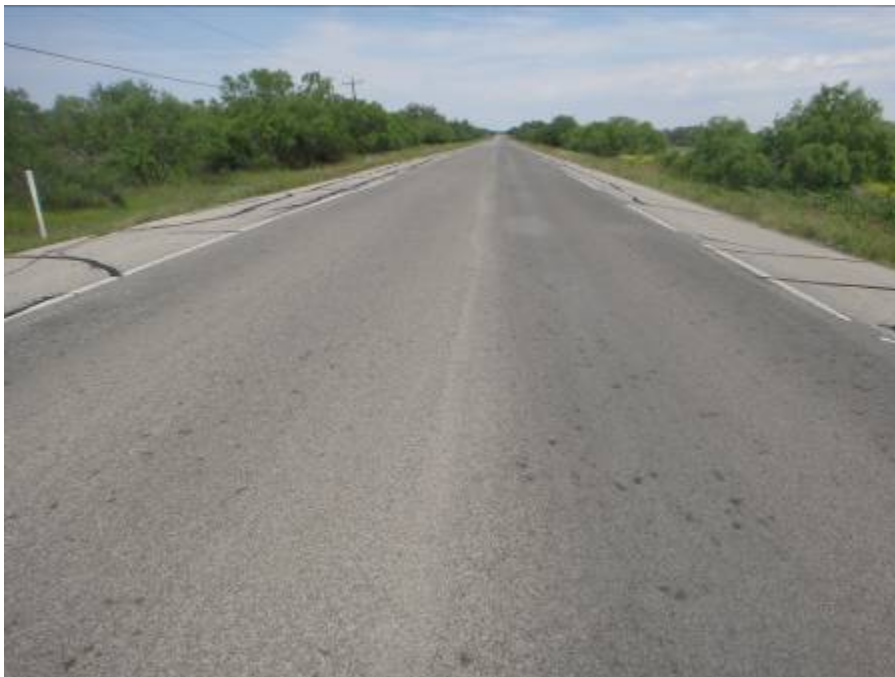
(a) Ravelling Observed 24 Hours After Construction.

(b) No Sign of Ravelling at Four Months of Age.

Figure 3.7. Typical Example of Ravelling Seen on All Test Sections but Only in the First 24 hours of Trafficking (Uvalde, US 83).

- Early raveling in the first 24 hours. TTI researchers noted that in almost all of the test sections around the state, some raveling occurred within the first 24 hours of patch placement as shown in Figure 3.7. In this photo, shoulders were present on the roadway where the loose material collected, and all four materials performed similarly in terms of raveling. In every test section, this type of raveling did not progress any further after the first day or two of trafficking.

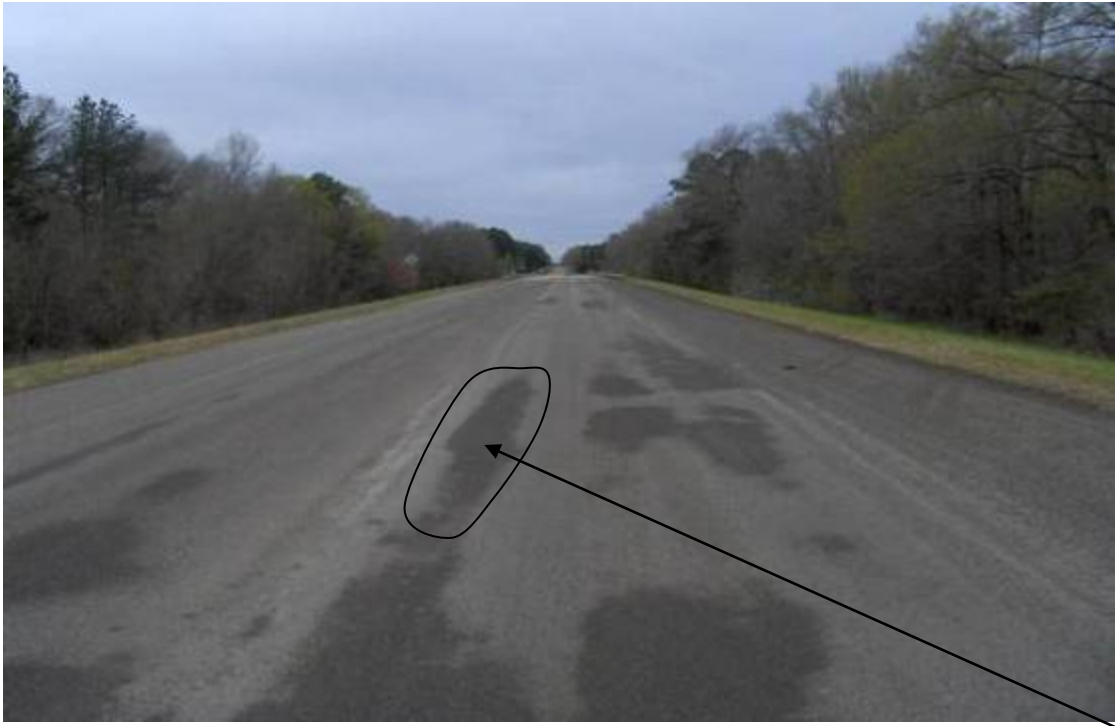
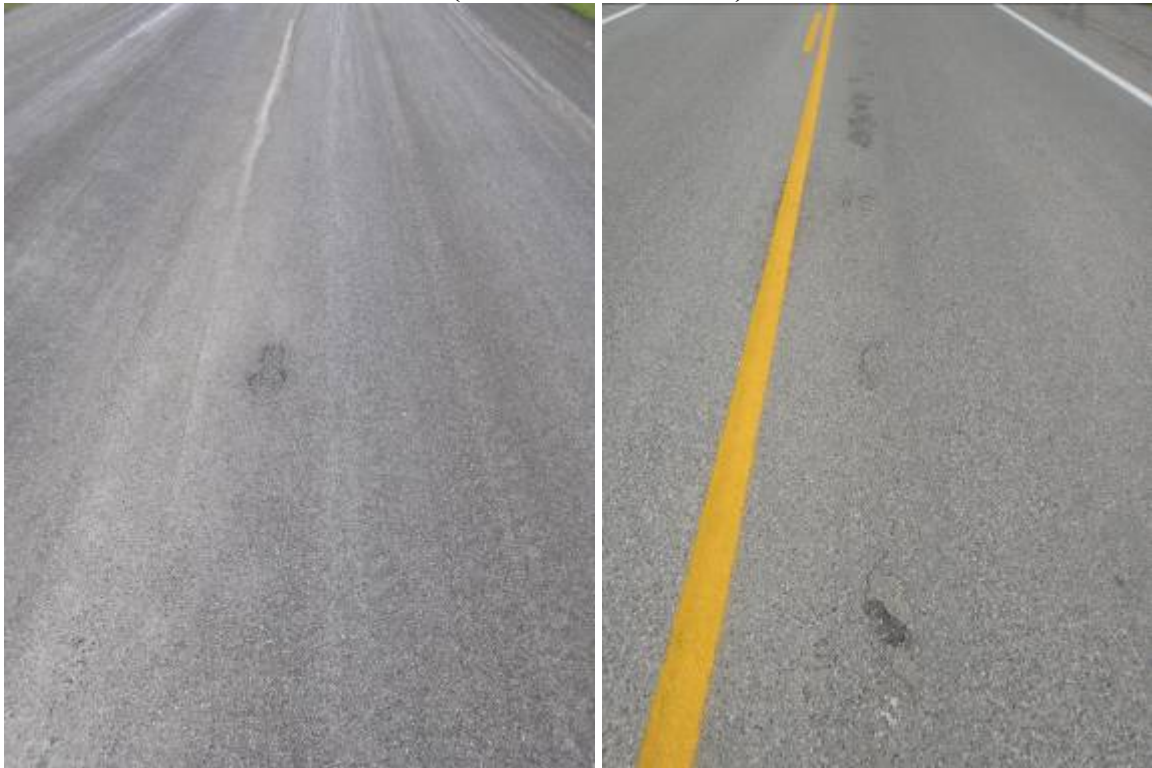
(a) Areas of Low Density Holding Water (Small Potholes Developed in Wheelpath (Martin Marietta DS).

(b) Close up of Pothole (2 days After Rain) (c) Patched Potholes 3 months later.
Figure 3.8. Jefferson Test Section Developed Pothole in Wheelpath in Area Holding Water (After a Rain in First Week).

- Development of a few small potholes after a rain within the first week. This happened on one of the test sections for the Jefferson test patches (Figure 3.8). Note that the photo was taken soon after the rain occurred and the moisture in the pavement indicates areas of low density and in the wheel path which was attributed to the loss of material after the rain. Maintenance patched these few small potholes and no further loss of material was observed as shown in the photo in Figure taken 6 months later.

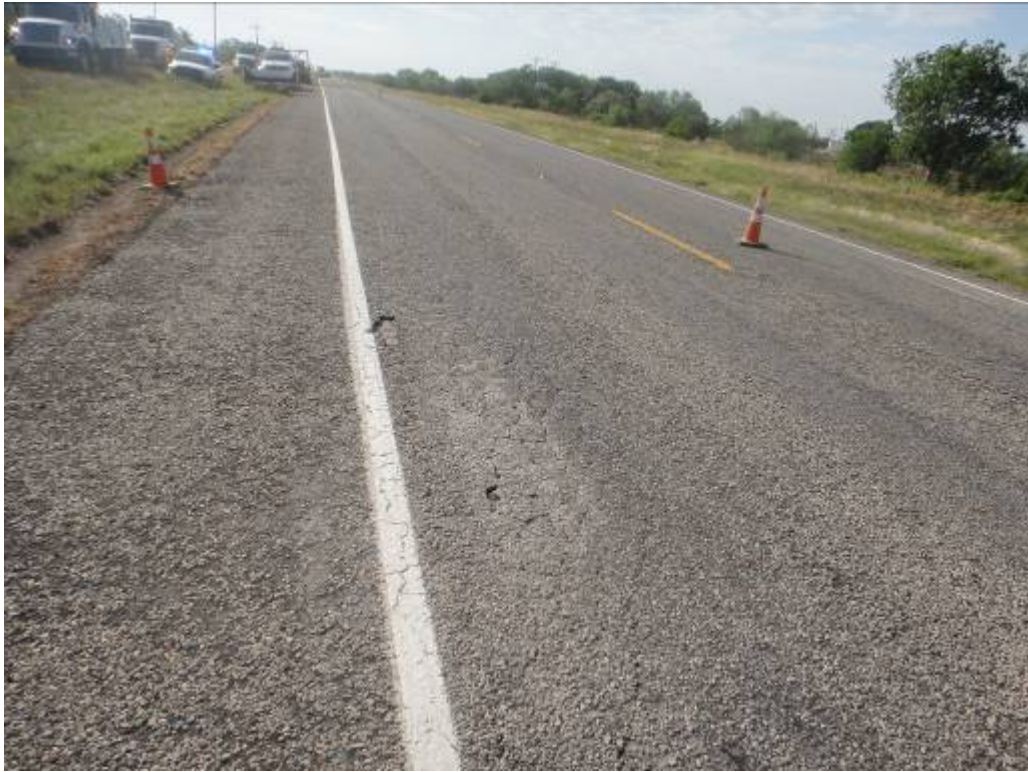
Figure 3.9 FM 55 Uvalde Isolated Location of Alligator Cracking in Surface Prior to LRA Application (of Martin Marietta Type D).

- Fatigue cracking on test patch in Uvalde. This occurred within the first few days of placement in one of the materials; however, it was in an area where alligator cracking was observed in the surface prior to placement (Figure 3.9).

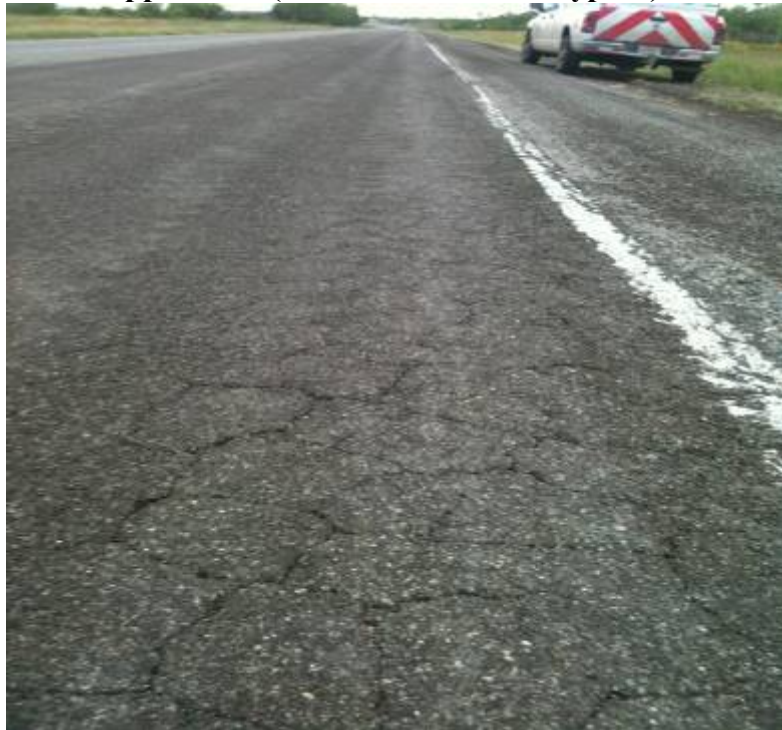
Figure 3.10. Alligator Cracking Reappeared Two Days after Placement of LRA Level-up.

- OVERALL, NO DIFFERENCE IN MATERIAL PERFORMANCE BETWEEN ITEM 330 TYPE (D vs DS) or SUPPLIER. None of the performance problems noted above are attributed to the type or supplier of LRA. Overall performance of the test patches placed around the state indicate no significant difference among any of the materials or between the suppliers and no significant performance problems were noted with any of the materials (Figures 3.10 through 3.13).

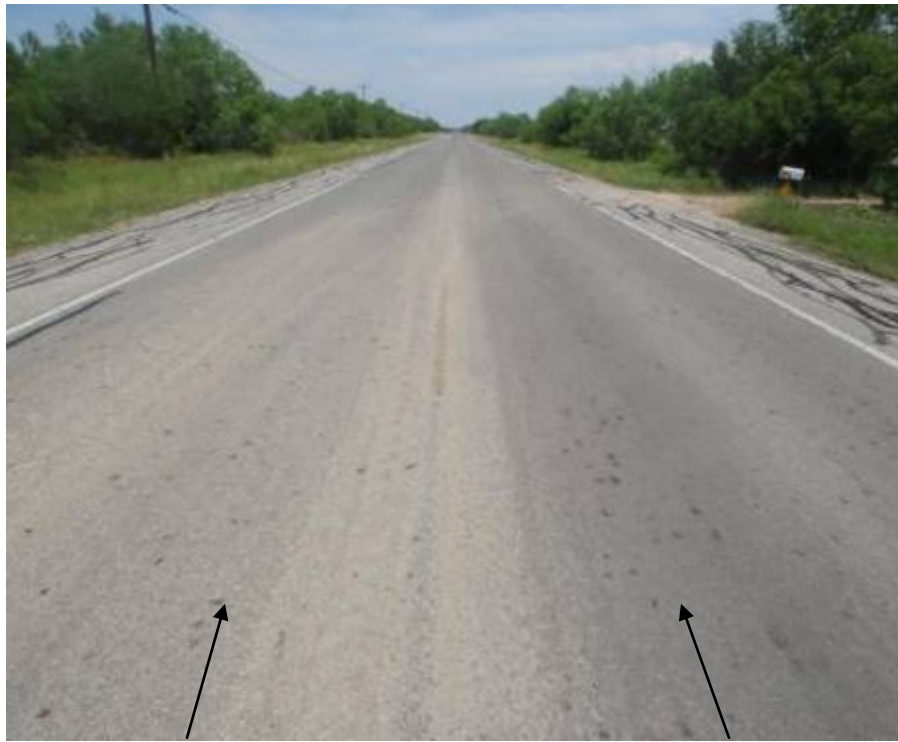
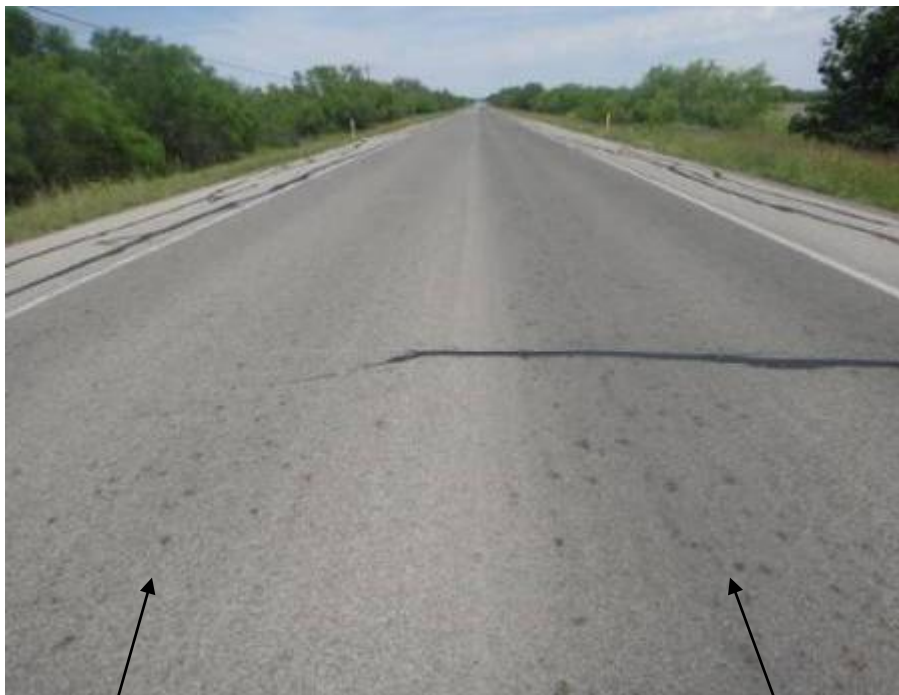
Figure 3.11. Uvalde Test Sections After 6 Months in Service.

(a) Type D Mixes

(b) Type DS Mixes

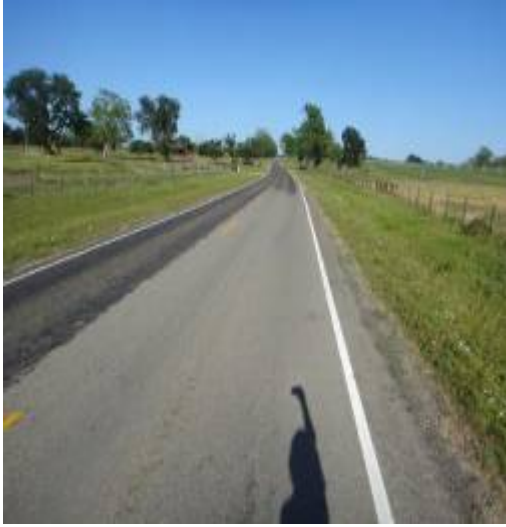
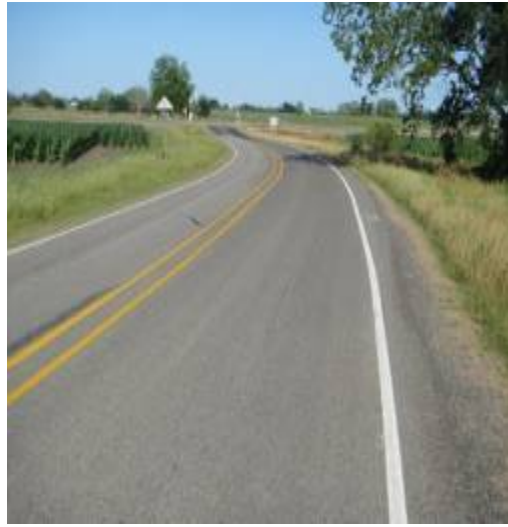
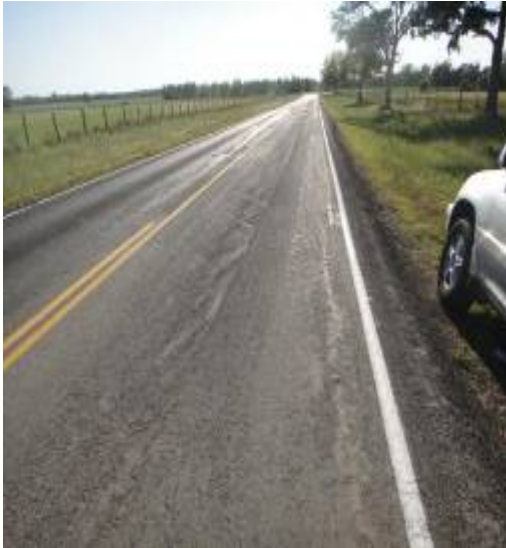
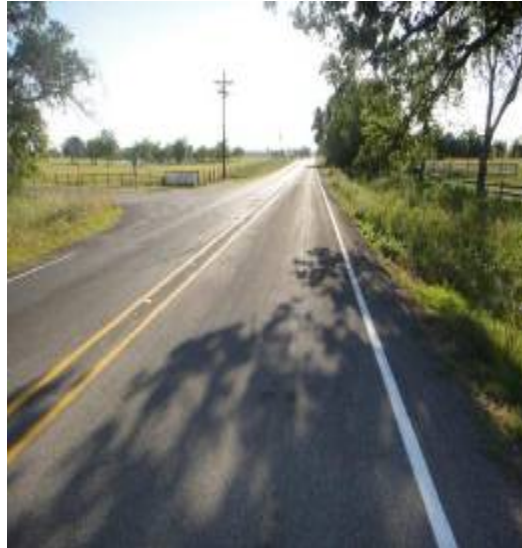
Figure 3.12. Bryan Test Sections After 6 Months in Service.

(a) Martin DS

(b) Vulcan DS

(c) Martin D

(d) Vulcan D

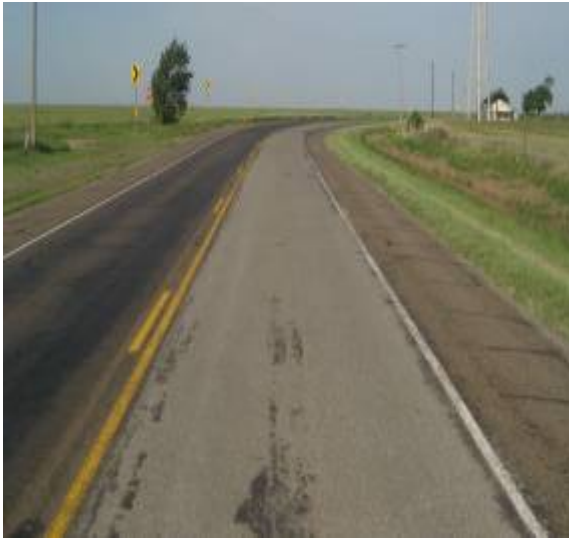
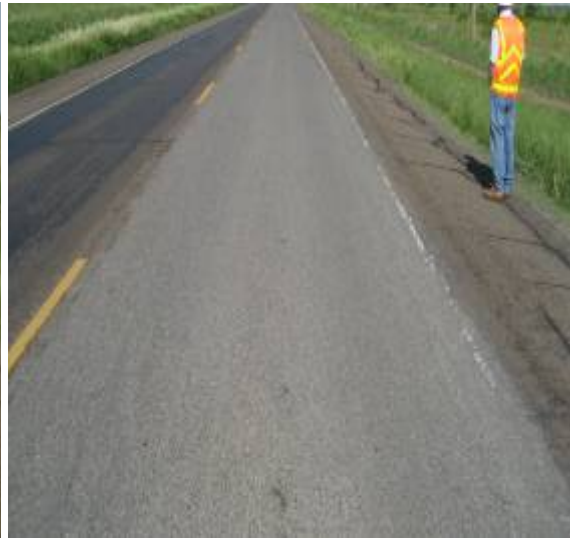
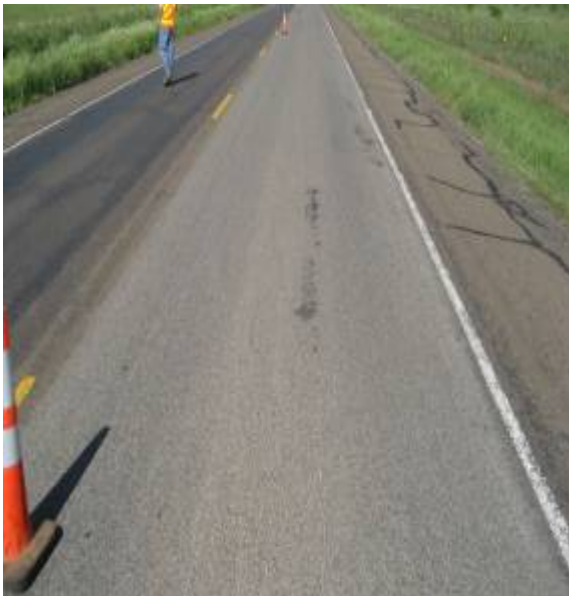
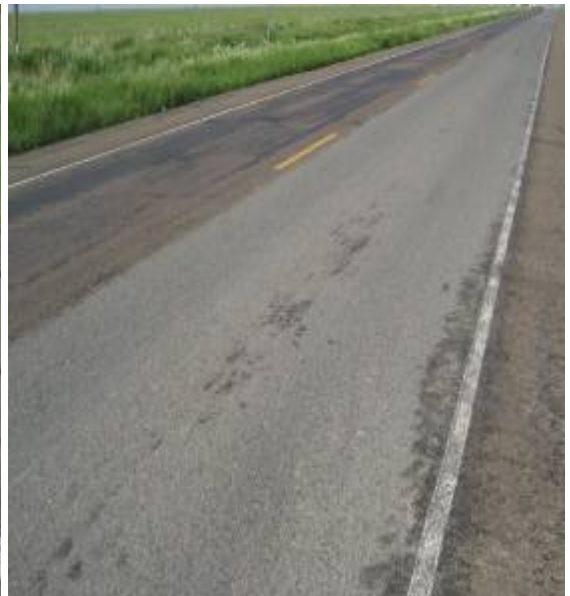
Figure 3.13. Childress Test Sections After 6 Months in Service.

(a) Martin DS

(b) Vulcan D

(c) Martin D

(d) Vulcan DS

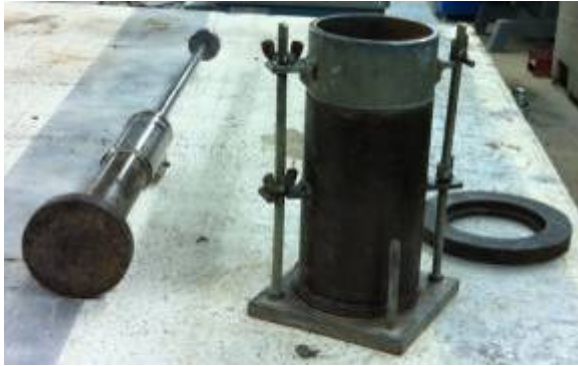
(a) Compaction Mold and Marshall Hammer

TTI modified the test slightly by compacting mixtures in a steel mold (Figure 4.10a) which is easy to fix during the specimen extraction (Figure 4.10b). A standard Marshall Hammer will be used as in the CPST to compact the LRA mixtures. Figure 4.11 illustrates this procedure.

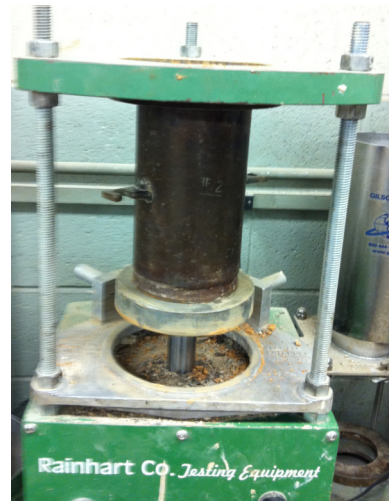
Figure 4.10. TTI-Modified Cold Patch Slump Test

(b) TTI Specimen Extraction Process

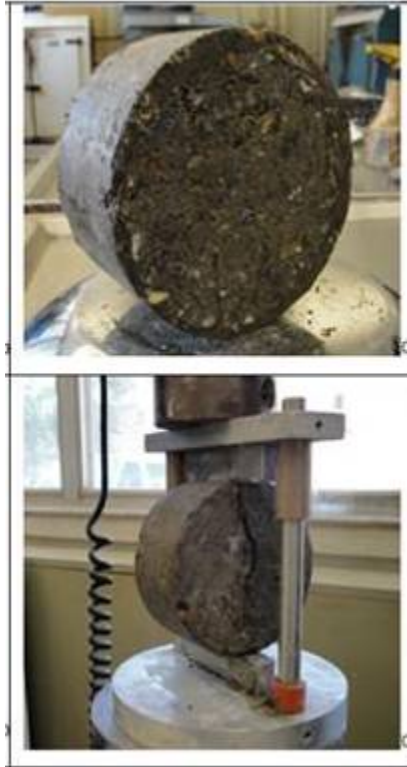
Figure 4.16. Tex-226-F, Indirect Tensile Strength (IDT) Test.

Test equipment and sample configuration (see Figure 4.16) were used to conduct indirect tensile strength tests on LRA mixtures compacting in the Texas Gyrotory Compactor according to Tex-206-F. In addition, IDT strength tests were performed on specimens after soaking in a water bath overnight. Results are presented in Tables 4.3 and Figure 4.17. This test measures indicates a significant susceptibility to moisture of the LRA mixtures as is measured by the loss of strength after water conditioning. This test is being explored in more detail in the second year of this research effort.

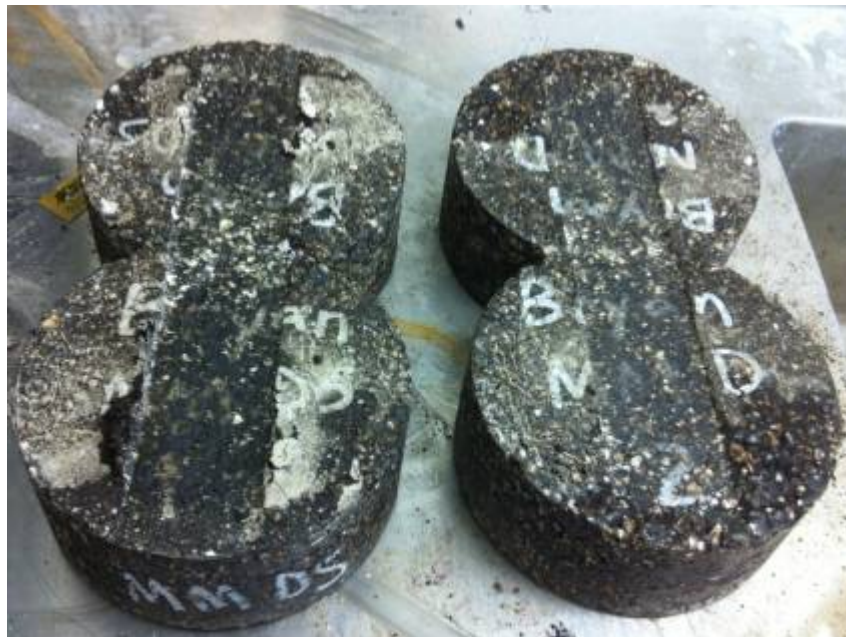
Figure 4.19. LRA Specimens after 20,000 Passes in a Dry Condition in the Hamburg Wheel Tracking Test.

Hamburg Wheel Tracking Tests were performed on limited samples of LRA. Performed under water, this test is too severe for LRA mixtures (see Figures 4.18 to 4.19) and all mixtures failed in less than 2500 cycles (see Table 4.4). Since the test appeared too severe for LRA, the same samples were tested in the Hamburg equipment but without water. Under these conditions, the test is not severe enough. Based on these results, the researchers will not pursue further Hamburg testing on LRA mixtures.
