Federal Railroad
Administration

Full-Scale Locomotive Dynamic Collision Testing and Correlations: Offset Collisions between a Locomotive and a Covered Hopper Car (Test 4)

1. AGENCY USE ONLY (Leave blank)		2. REPORT DATE September 2011	3. REPORT TYPE AND DATES COVERED Technical Report	
4. TITLE AND SUBTITLE Full-Scale Locomotive Dynamic Collision Testing and Correlations: Offset Collisions between a Locomotive and a Covered Hopper Car (Test 4)			5. FUNDING NUMBERS

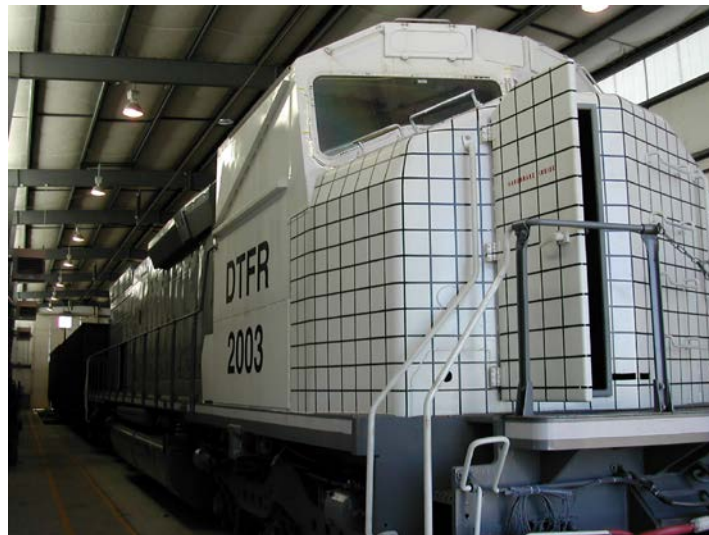
Figure 6. Locomotive and Bullet Consist before Impact Test

The test used a moving consist with a speed of 29.8 mph with the leading SD70-MAC locomotive and three loaded hopper cars as the striking vehicle. The stationary consist, beginning with a covered hopper partially fouling the right-of-way of the oncoming locomotive, had a total of 30 loaded mixed-duty cars, most of which were open-top hopper cars. Figure 5 shows the test setup, and Figure 6 shows the bullet consist before impact. Figure 7 shows the covered hopper car and the target consist.

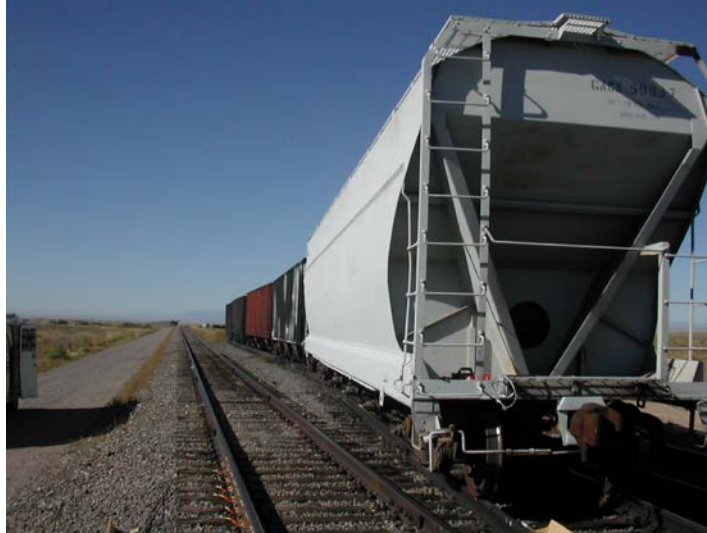
Figure 7. Covered Hopper Car and Target Consist before Impact Test

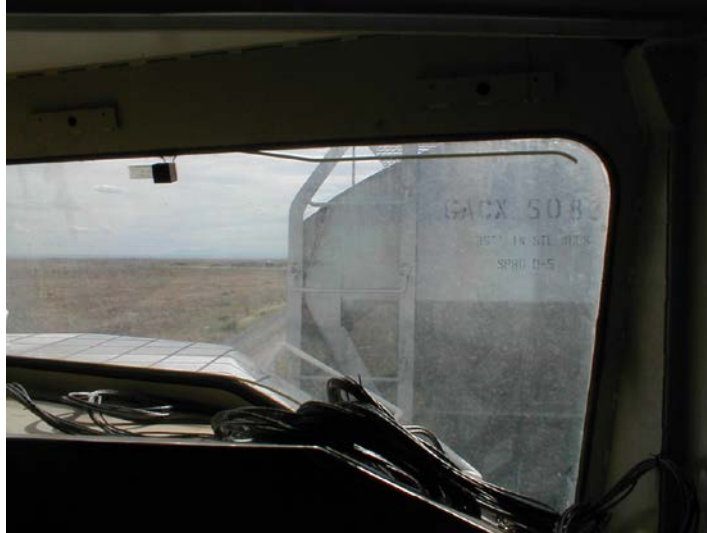
Figure 9. View of Covered Hopper Car from Engineer's Seat in Locomotive

Figure 8 depicts the alignment of the locomotive and covered hopper car at the point of impact. The covered hopper car sits on a turnout connecting the locomotive's rail path to a parallel track, where it fouls the locomotive's right-of-way by approximately 36 inches (in). Figure 9 shows the engineer's view of the covered hopper car while the locomotive was parked during pretest activities.

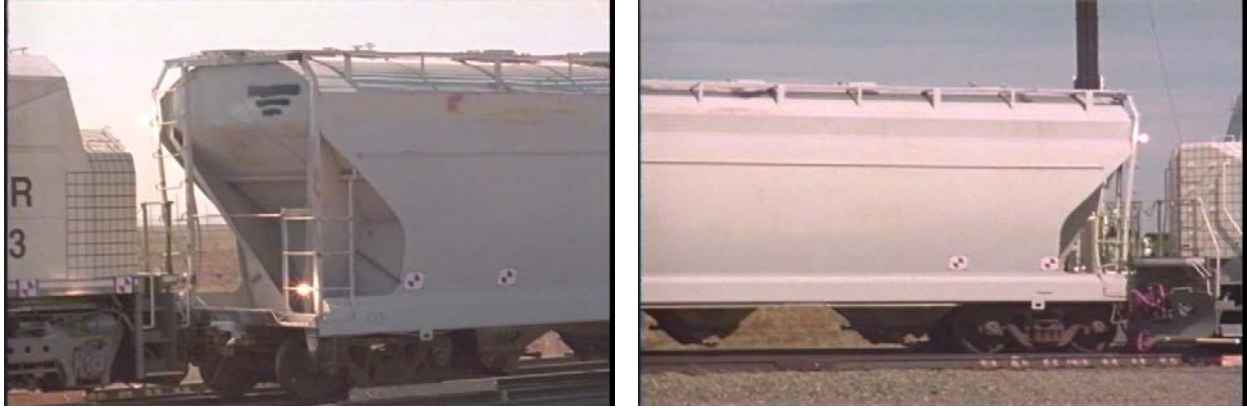
Figure 10. Test at Moment of Impact

- The first contact between the moving locomotive and the stationary covered hopper car occurred when the anticlimber touched and deformed the ladder at the corner of the hopper car (Figure 10). Soon thereafter, the locomotive plow made contact with the hopper side sill and was bent back toward the locomotive end plate. The hopper ladder and locomotive plow, being nonstructural elements, both immediately deformed.

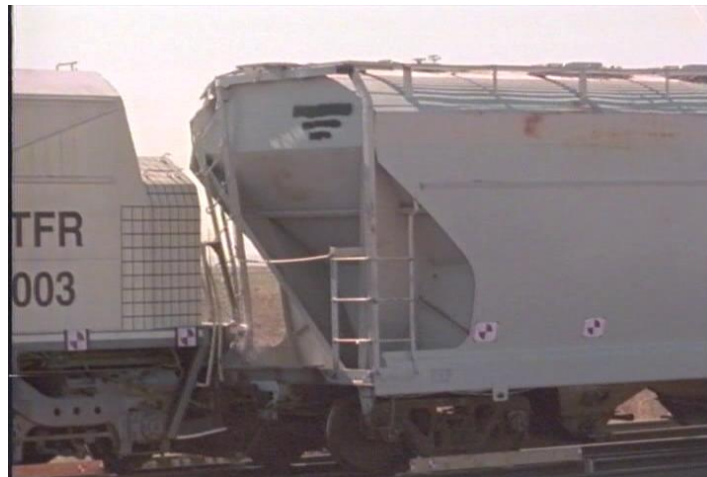
Figure 11. Locomotive Vertical End Plate Contacts Front Truck

- The locomotive vertical end plate made contact with the covered hopper side sill and the horizontal end plate. The side sill was torn away from the horizontal end plate as the left corner of the horizontal end plate was bent downward, making contact with the covered hopper's front truck (Figure 11). The locomotive vertical end-plate sheared off vertically near the draft gear pocket and was bent back underneath the underframe when it came in contact with the front truck. The excessive deformation of the locomotive vertical end-plate caused the plow to completely break free of the end plate.

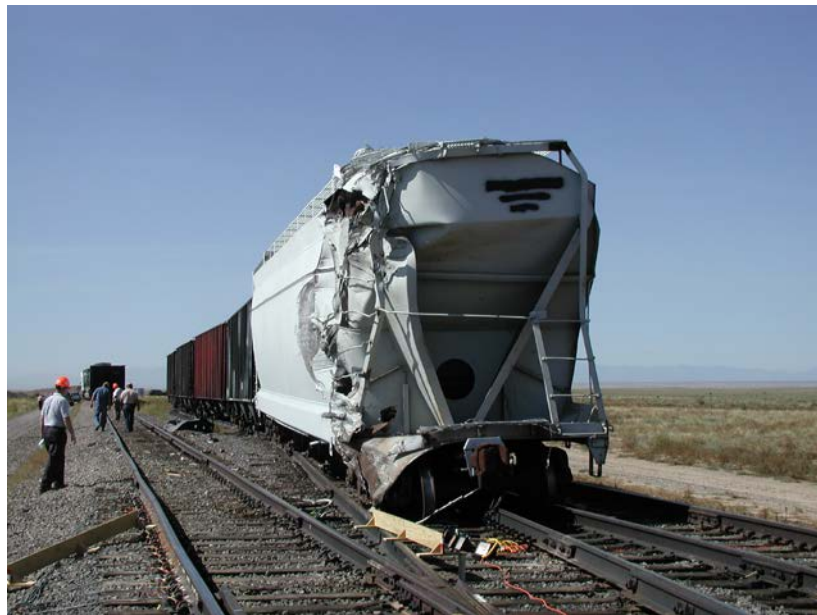
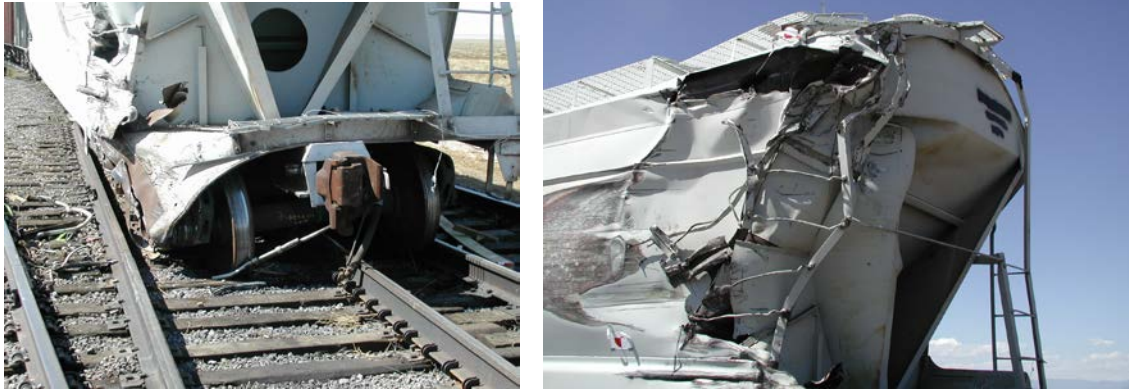
Figure 17. Covered Hopper Car after Collision

Longitudinal translation of the covered hopper car was limited by its being coupled to the remainder of the stationary consist. The collision slightly displaced the second and third stationary cars, which showed damage but did not derail. Figure 17 shows the derailed, damaged covered hopper car after the test. Figure 18 shows the close-up views of the damage of the side sill, horizontal end plate, bolster, and hopper body.

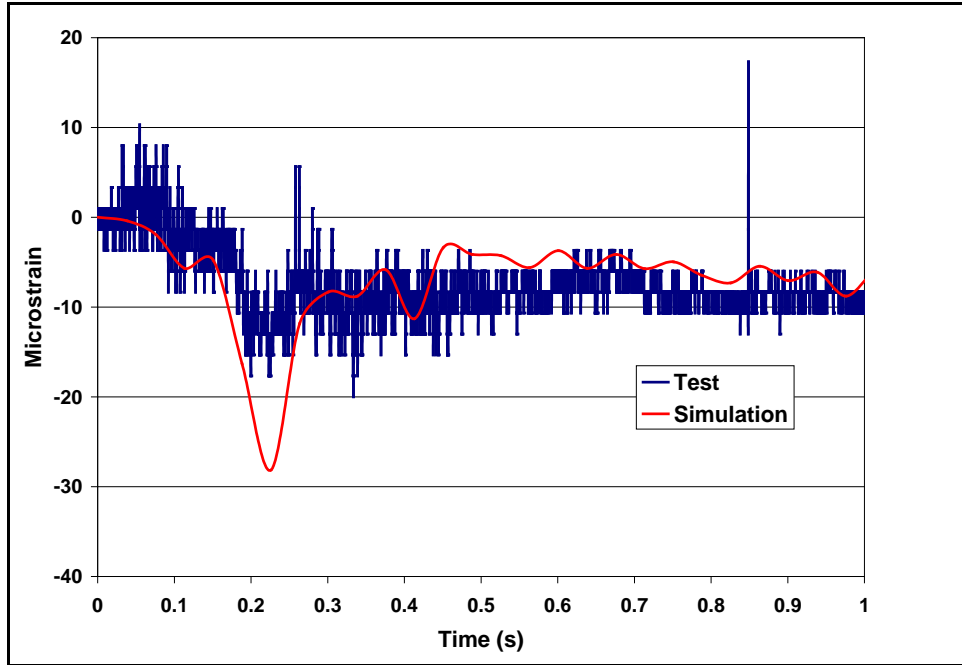
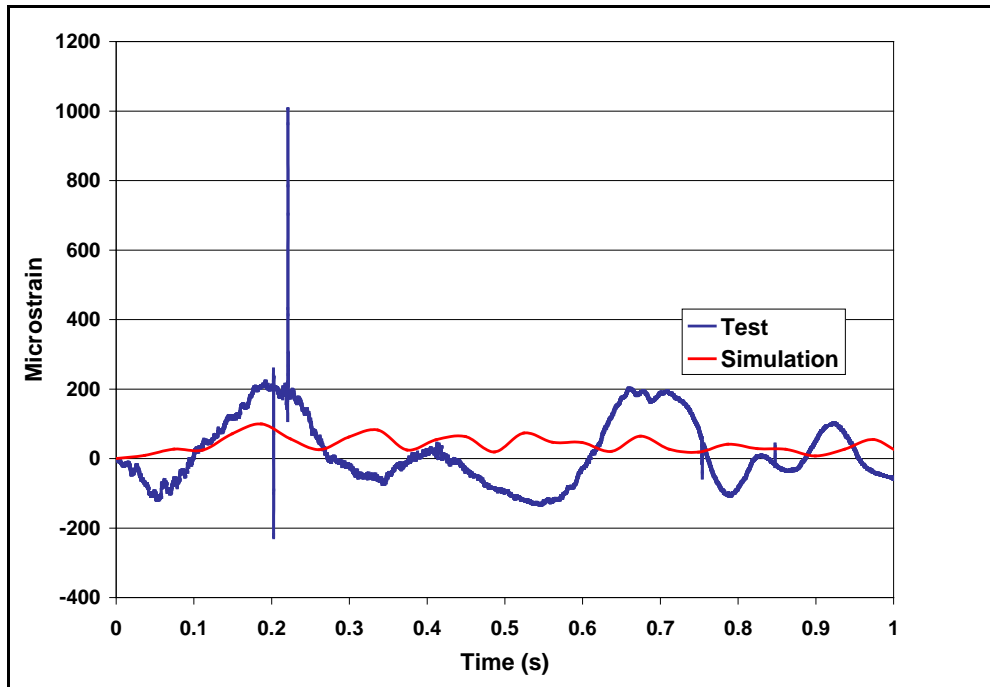
Strain data for collision posts, lead underframe, and the right-hand corner windshield post of the locomotive correlated data between simulation and test. The collision posts and underframe did not suffer any significant damage in the real collision. Simulation results, however, would suggest the occurrence of plastic deformation in the right collision post and surrounding hood structure. The right-hand windshield corner post was torn from the cab in both the test and simulation. Table 4 describes element locations and the identified strains chosen for correlation. Figure 31 through Figure 36 show these strain correlations.

The above figures show that simulation results are in poor, mixed agreement with the test data on the right collision post for gauge location 1 during the first 0.1 s of the collision locations.

The largest strain on the collision post was 1,800 microstrain. TTCI measured this value on the longitudinal leg of the rosette gauge (location 10) located on the bottom front of the right collision post in the test. The simulation found the largest strain at the same location (location 10) on the right collision post with a value of 1,650 microstrain during the same time frame.

The strains at the top front of the collision posts caused permanent deformation at both collision post locations. The locomotive crashing into hopper cars in the simulation caused the plastic deformation.

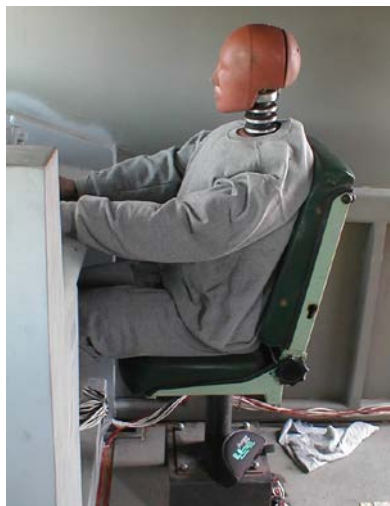
Figure 37. ATD Position in Cab of Locomotive

TTCI used an instrumented ATD with accelerometers in the engineer’s seat of the striking locomotive, as shown in Figure 37, to evaluate the injuries to the crew during the collision.

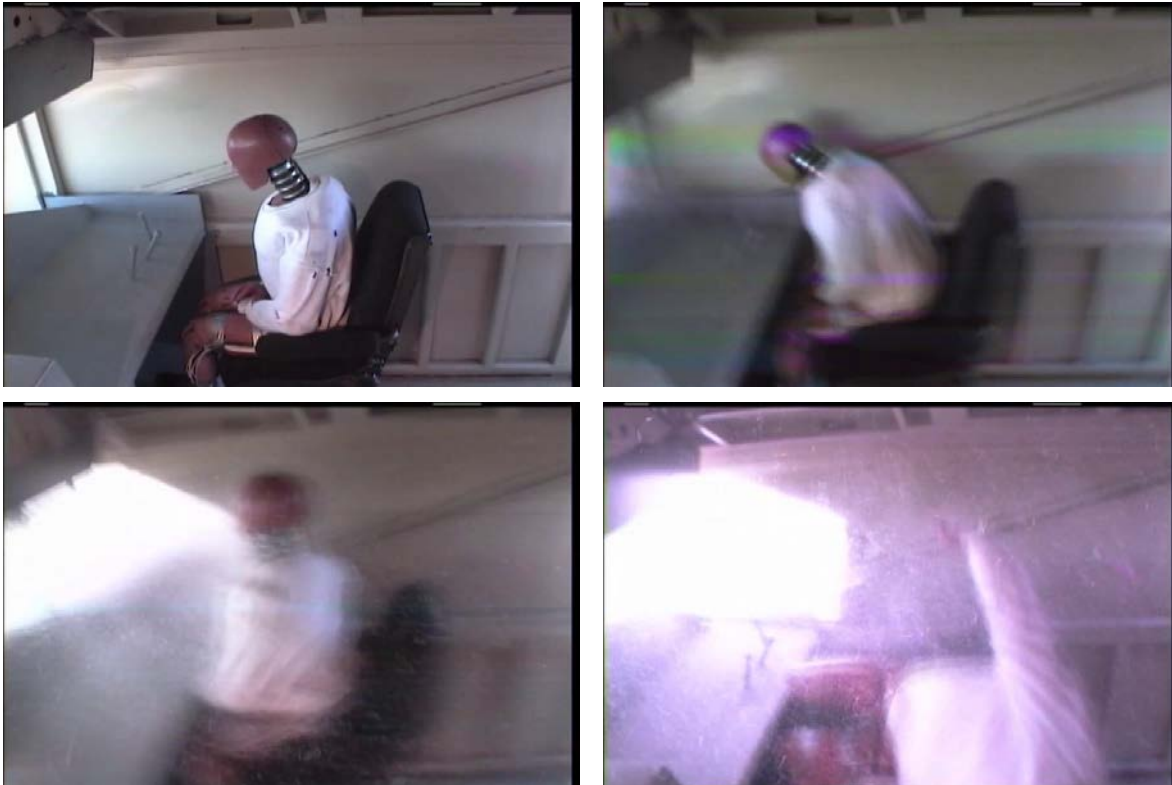
Figure 38. ATD Impact with Corner Post Sequence

upper corner of the covered hopper car impacted and tore away the right corner post. This violent deformation of the cab corner imparted a large force on the ATD, pushing it back towards the center of the cab and out of the engineer's chair. Figure 38 shows this sequence as the ATD as it hits the cab corner post and gets thrown from the seat.
