1. Report No. RC-1551	2. Government Accession No.	3. MDOT Project Manager Adnan Iftikhar	
4. Title and Subtitle Extending the Life of Asphalt Pavements (OR09-086A)		5. Report Date May 2011

6. Performing Organization Code 000510	
7. Author(s) Harold L. Von Quintus, P.E. and Rohan Perera, P.E.		8. Performing Org. Report No. 000510 – R5	
9. Performing Organization Name and Address Applied Research Associates, Inc. 100 Trade Centre Drive, Suite #200 Champaign, Illinois 61820		10. Work Unit No. (TRAIS)

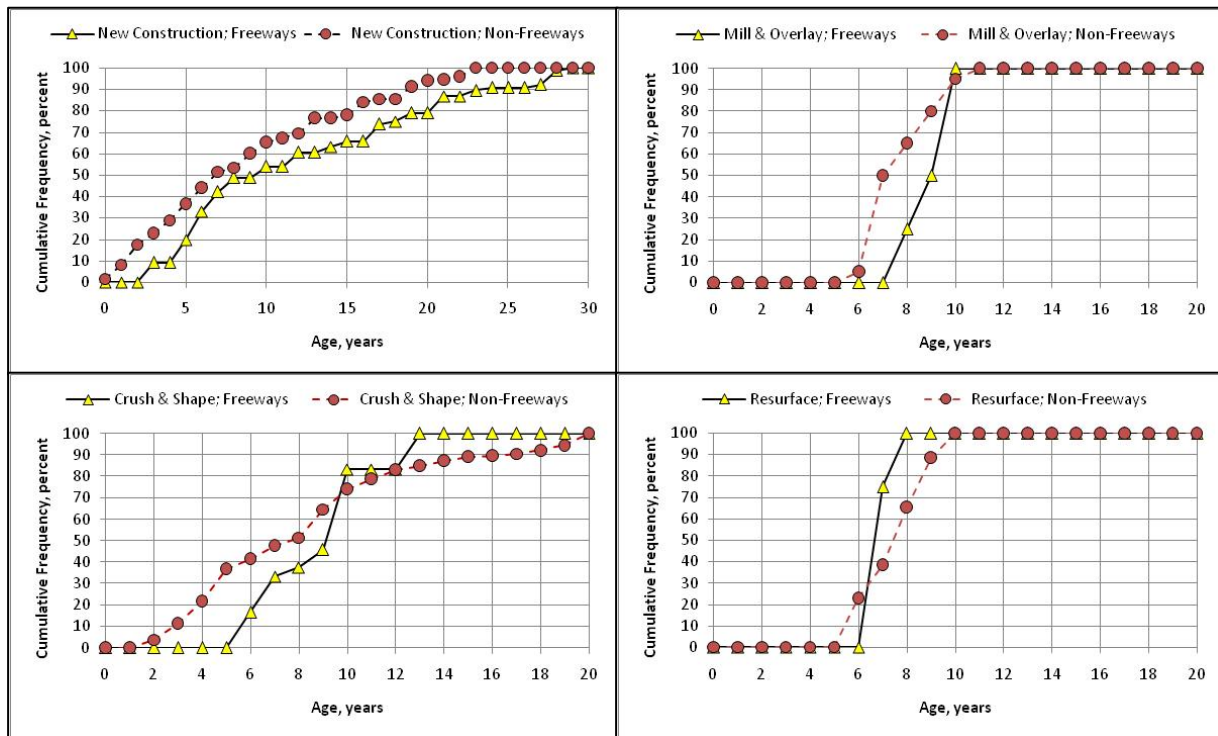
Figure 8. Cumulative Frequency Histogram of Pavement Age

Figure 8 shows the cumulative frequency of pavement age for the segments included in the analysis, while Table 2 lists the number of PM segments for each pavement structural category or data set. Nearly 500 PM segments were used in the service life analysis for each performance indicator. It should be noted that not all of the PM segments were used – many of the newer segments had too few data points or magnitudes to accurately determine the coefficients for an individual PM segment.

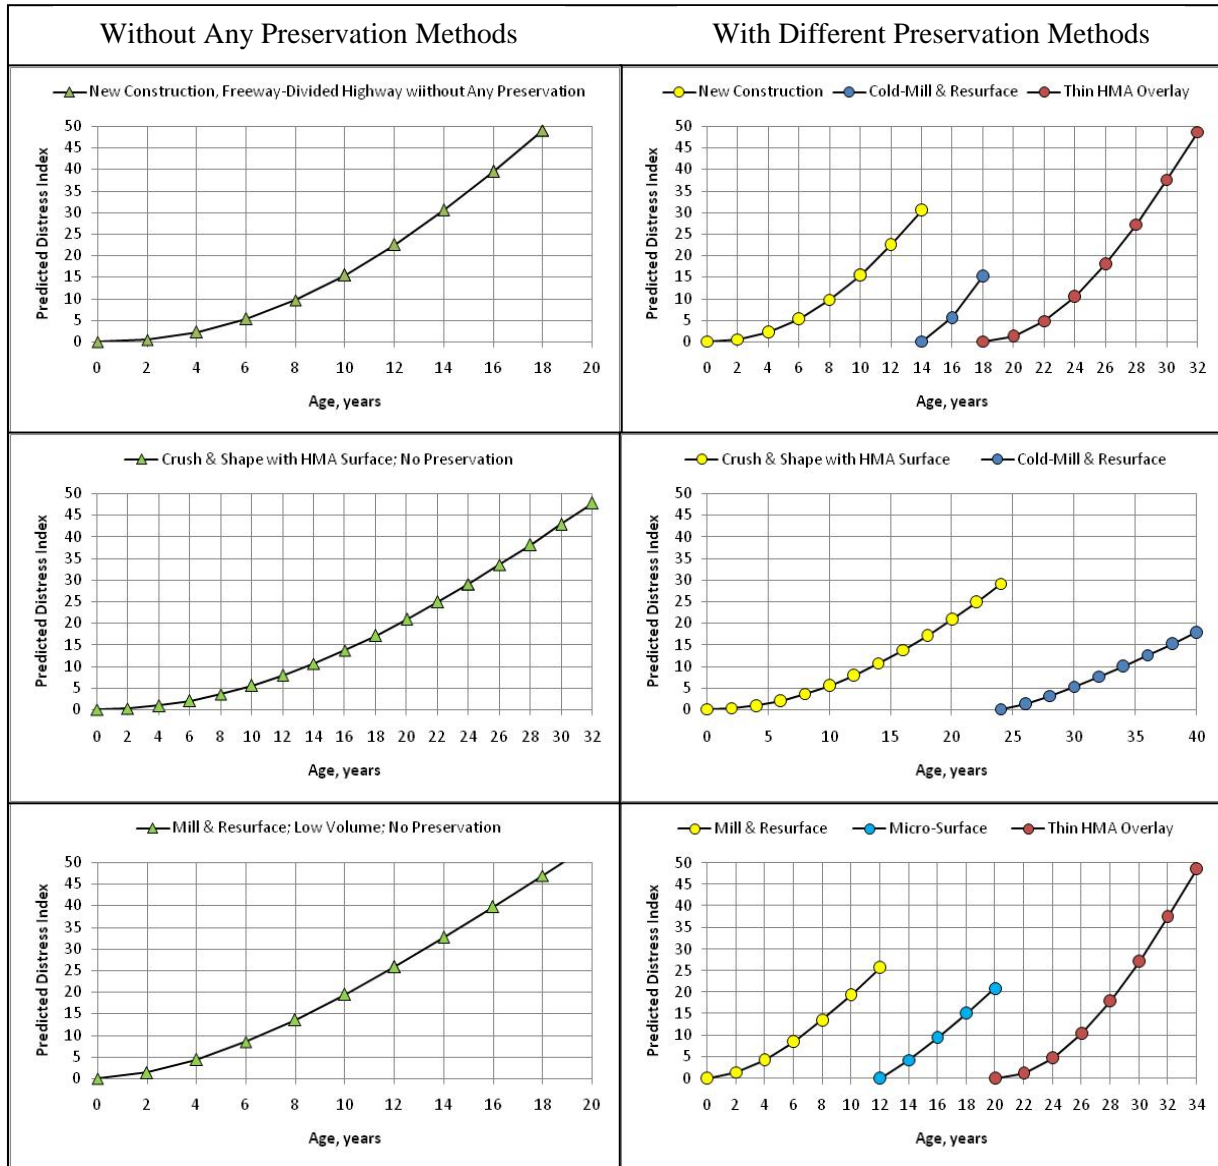
Figure 30. Predicted Service Life Based on DI Values from Equation 1 with and without Using Preservation Methods

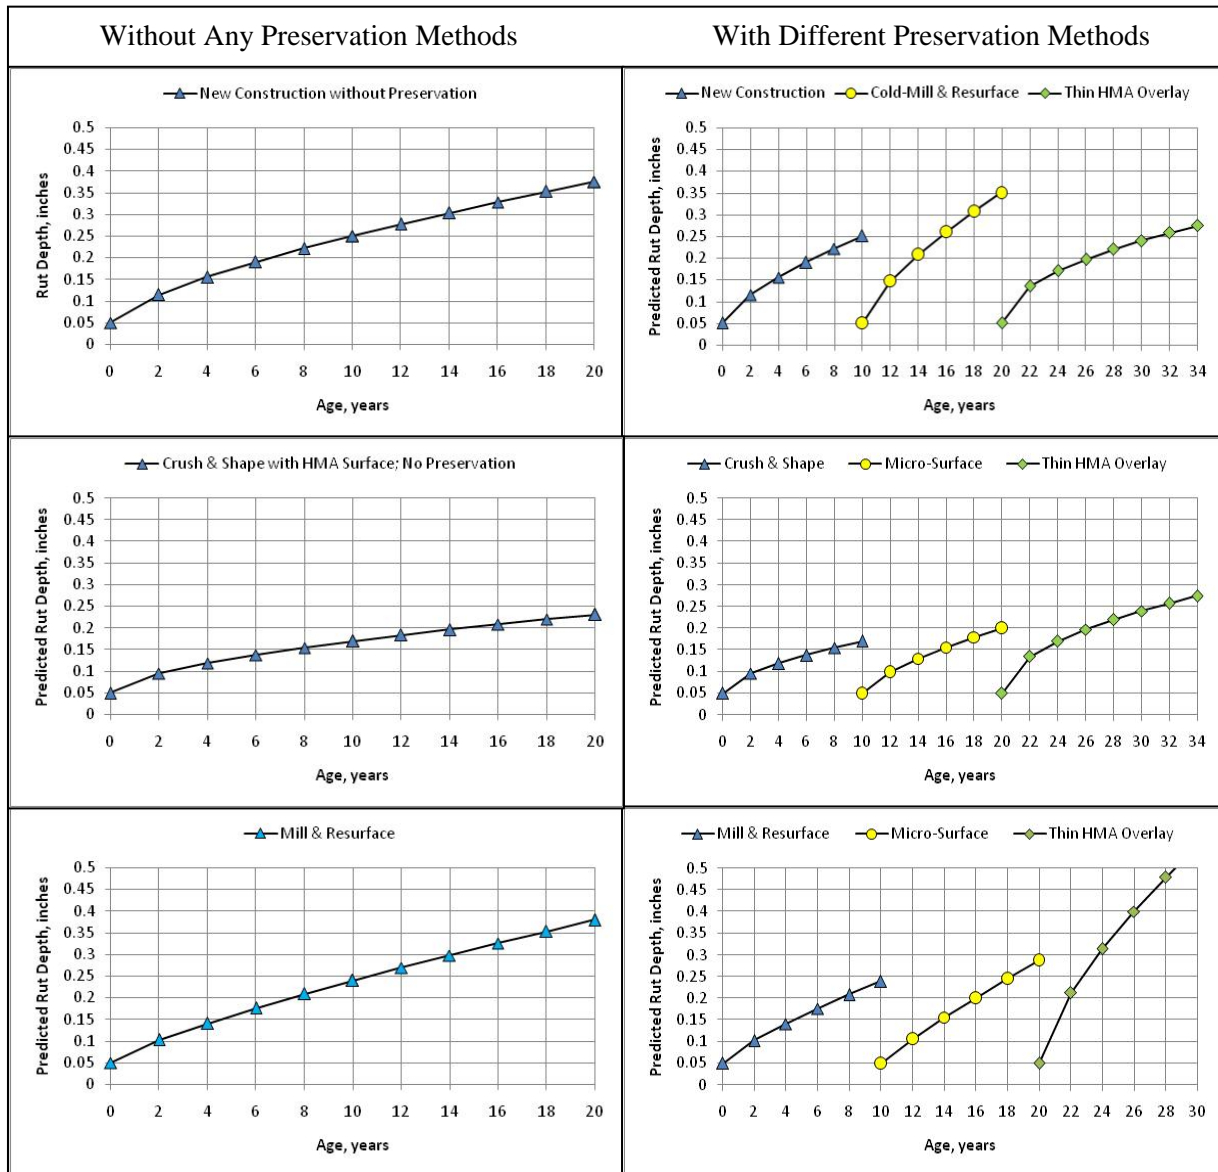
Figure 36. Predicted Service Life Based on Rut Depths from Equation 2 with and without Preservation Methods

Different preventive maintenance methods were used for the examples included in Figure 36 to be consistent with MDOT actual practice recorded in the performance database. Of the different pavement preservation methods, the cold-mill and resurface and thin HMA overlay placed over the mill and resurface category were found to have the poorer rutting performance (refer to Figure 36).

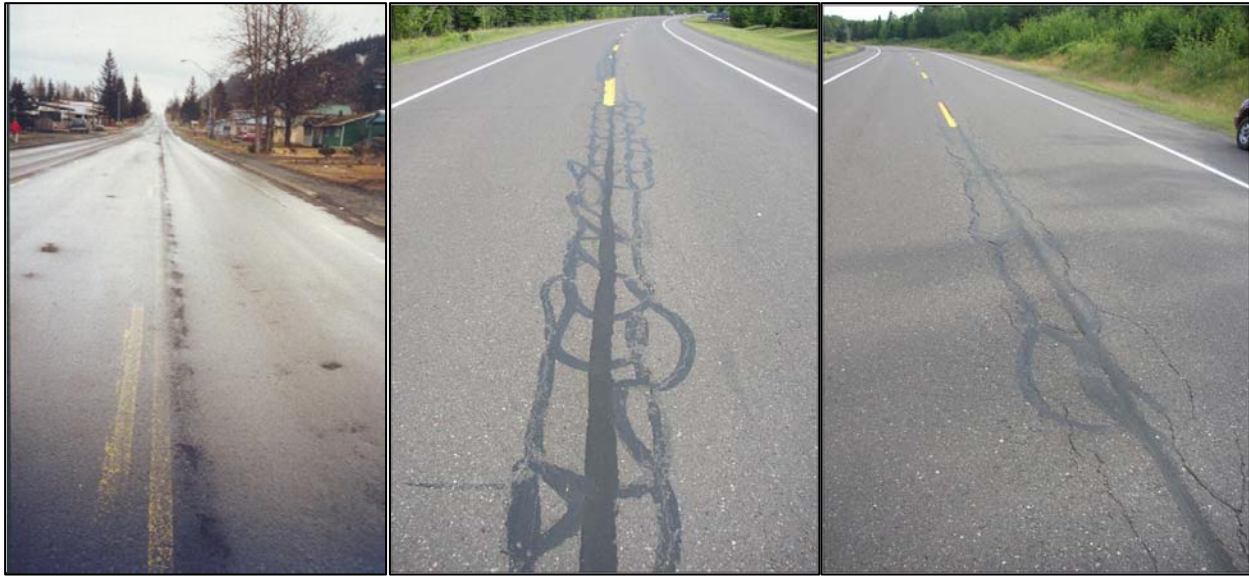
Figure 49. Cracking and Accelerated Deterioration Along Longitudinal Centerline Joints that were Inadequately Constructed

Longitudinal centerline cracking was recorded on 100 percent of the projects exhibiting poor and good performance (refer to Tables 21 and 22). Figure 49 is an example of excessive longitudinal cracking and deterioration along the centerline joint, which is directly related to the construction of the centerline joint. Figure 44 shows the amount of centerline cracking for projects with poor performance, while Figure 47 shows the amount of cracking for projects with good performance. The magnitude and severity of the centerline cracks are lower over an extended period of time for the asphalt pavements and overlays with good to exceptional performance with the exception of the mill and resurface pavement category.

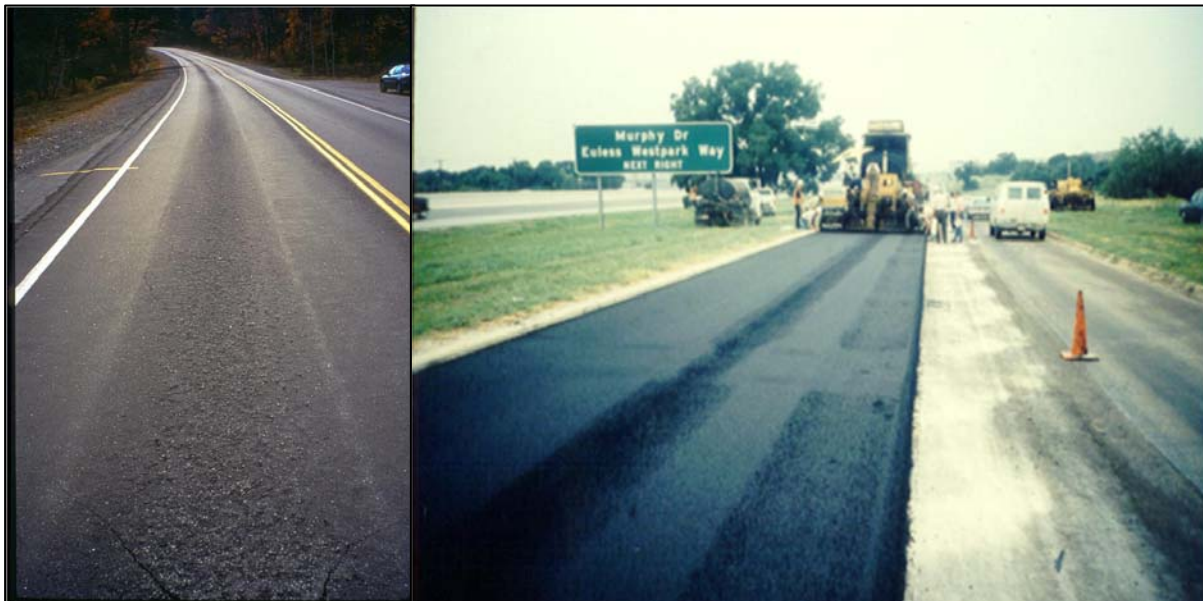
Figure 50. Cracking and Deterioration Along the Center of the Lane where the HMA was Improperly Placed
