**FINITE ELEMENT ANALYSIS  
OF DEEP WIDE-FLANGED  
PRE-STRESSED GIRDERS TO  
UNDERSTAND AND  
CONTROL END CRACKING**

SPR # 0092-10-12

**University of Wisconsin-Madison**  
**Civil and Environmental Engineering**  
**October 2011**

## Technical Report Documentation Page

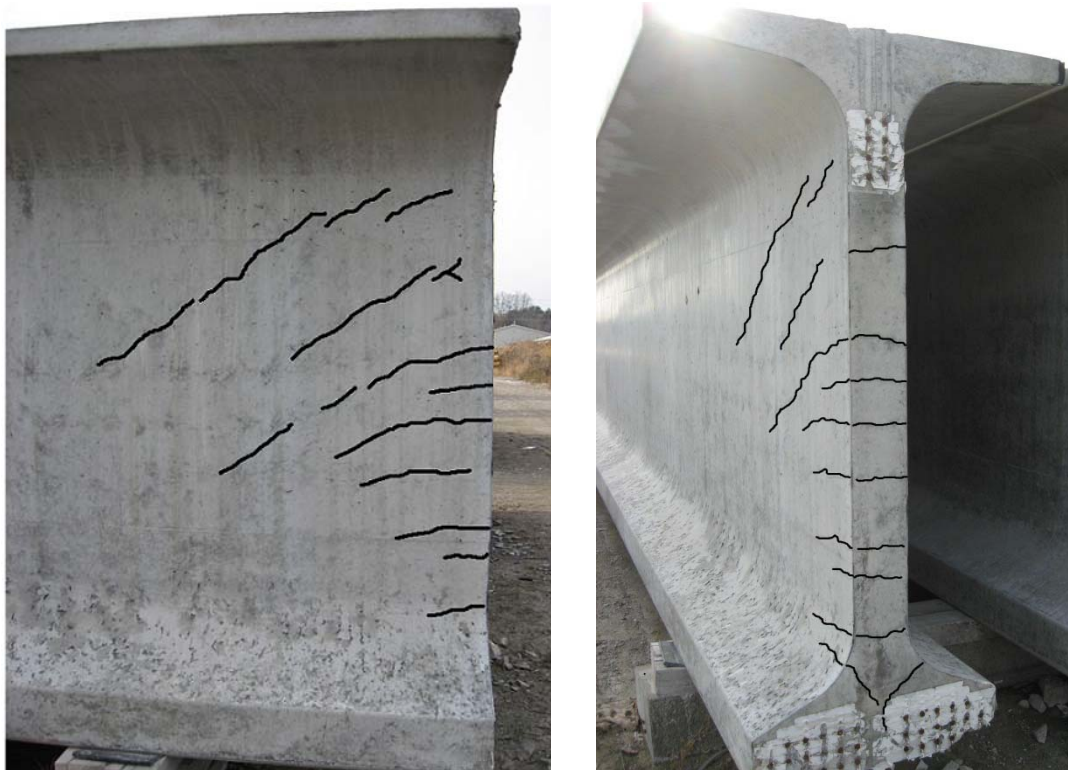
Figure 1 – Typical cracking pattern of the deep wide flanged girders.

Girder end zones, where the prestress transfer takes place, often exhibit characteristic cracking during or right after the prestress is applied to the concrete. The cracking is more severe for deeper girders with higher amounts of prestressing. The deep frequently used wide flanged W sections of Wisconsin are in this category of girders. Their deep slender cross section and large bottom flange designed to accommodate heavy prestressing makes these girders particularly prone to cracking. An 82 in deep Wisconsin wide flange girder with severe end zone cracking is shown in Figure 1.

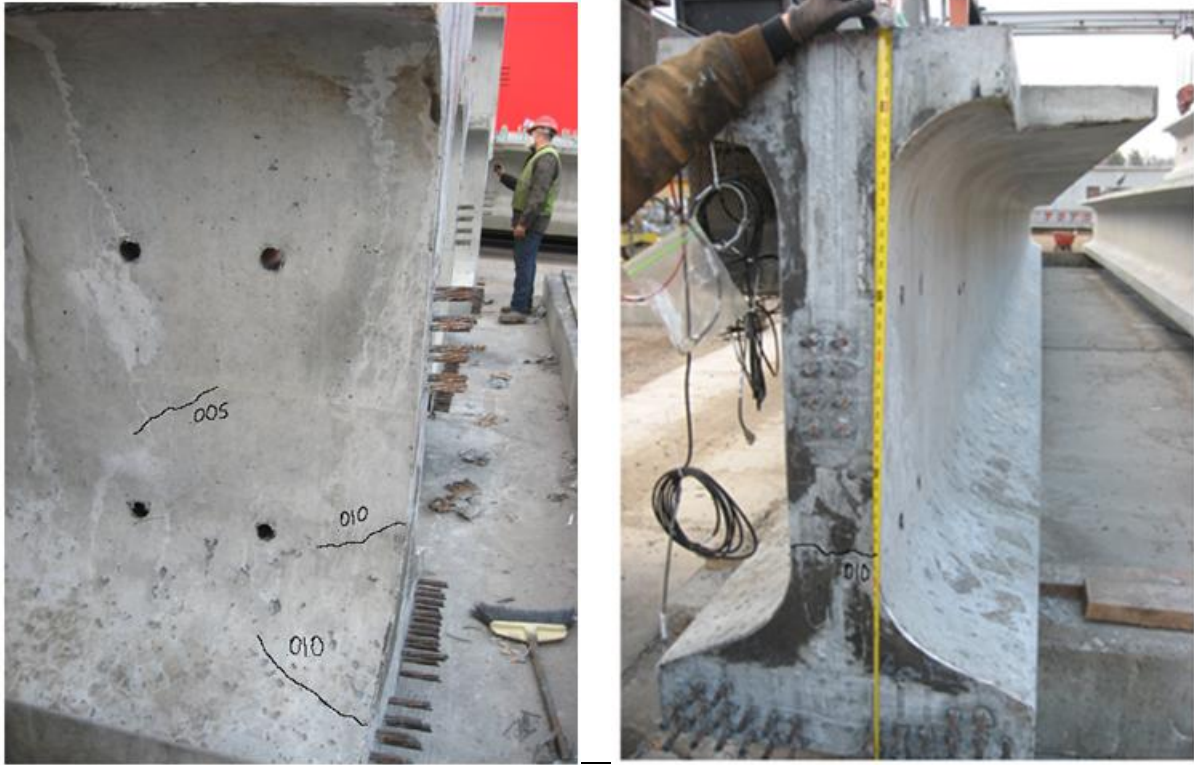
Figure 37 – Initial crack locations and widths in the monitored girder.
