# **FINITE ELEMENT ANALYSIS of WIDE FLANGE PRESTRESSED GIRDERS to UNDERSTAND and CONTROL END CRACKING**

**Research Update  
by  
Michael G. Oliva, Professor  
Pinar Okumus, PhD. Candidate**

*12-16-2010*

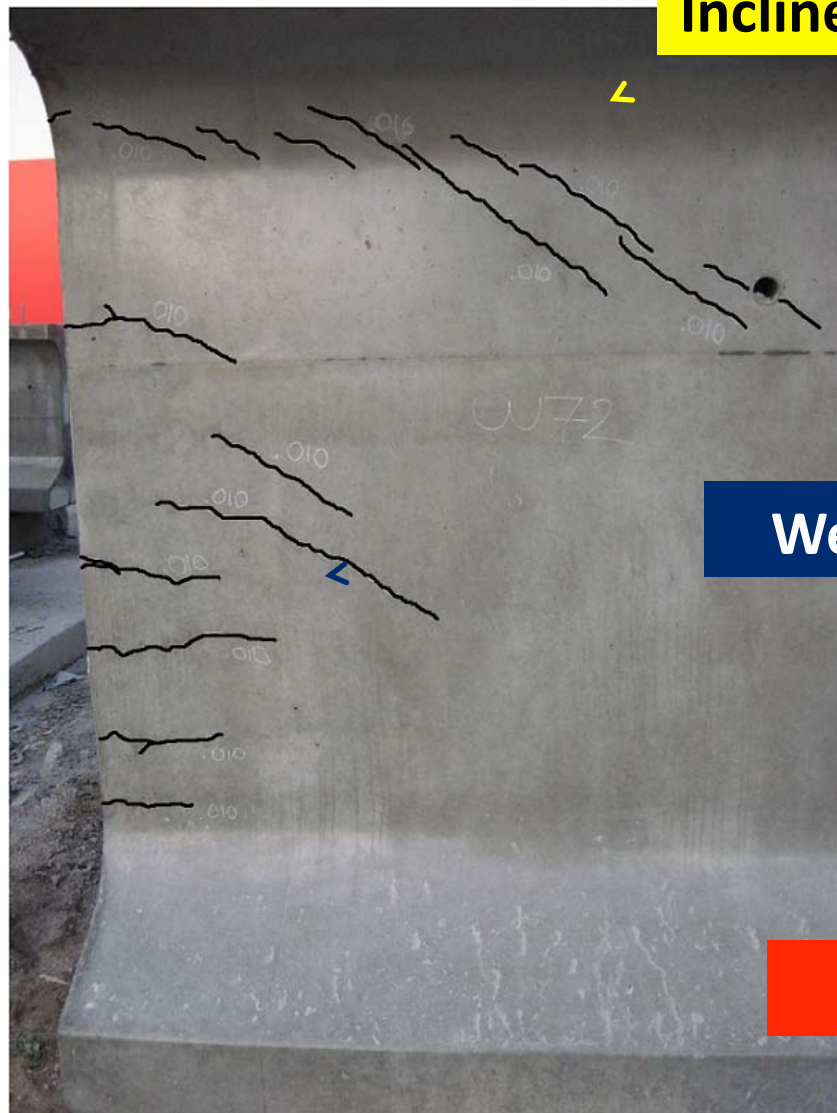
Inclined cracks

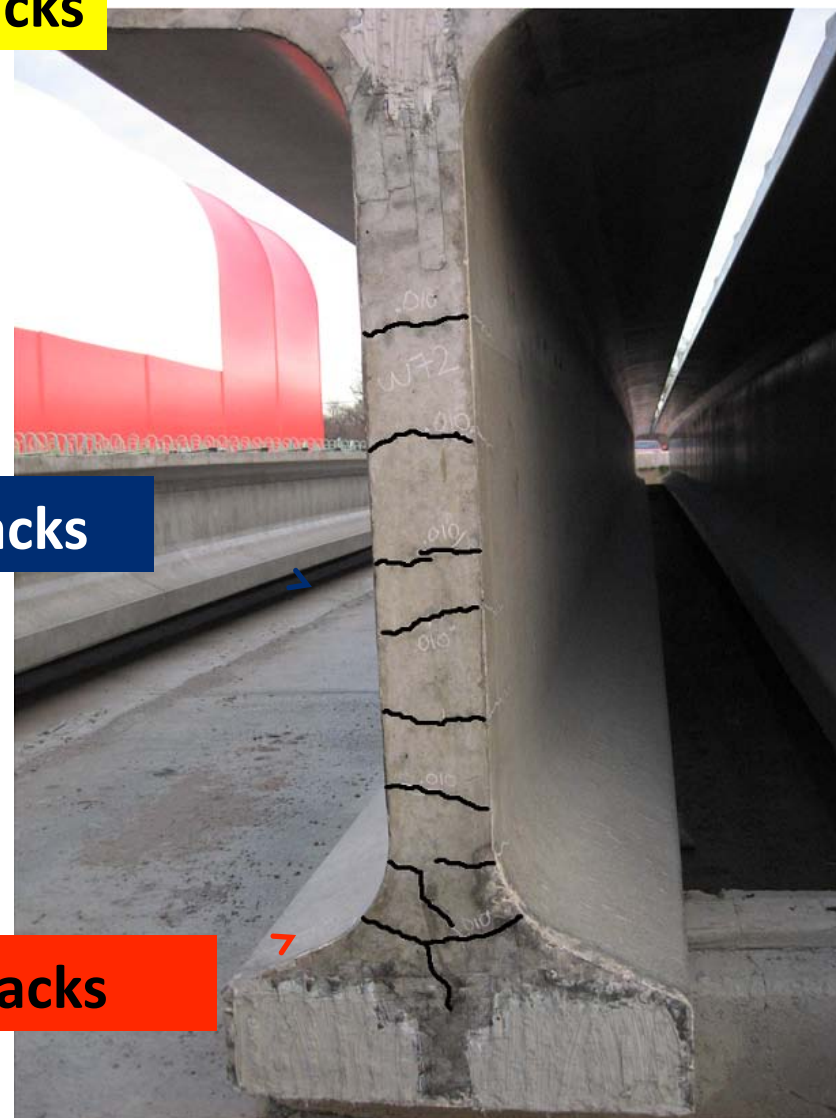
Web cracks
