<b>1 Report No.</b> K-TRAN: KU-10-6	<b>2 Government Accession No.</b>	<b>3 Recipient Catalog No.</b>	
<b>4 Title and Subtitle</b> USE OF FLEXIBLE FACING FOR SOIL NAIL WALLS		<b>5 Report Date</b> November 2011	
		<b>6 Performing Organization Code</b>	
<b>7 Author(s)</b> Sanat Pokharel, Ph.D.; Robert L. Parsons, Ph.D., P.E.; Matthew Pierson, Ph.D.; Jie Han, Ph.D., P.E.; Isaac Willems		<b>8 Performing Organization Report No.</b>	
<b>9 Performing Organization Name and Address</b> University of Kansas Civil, Environmental & Architectural Engineering Department 1530 West 15 <sup>th</sup> Street Lawrence, Kansas 66045-7609		<b>10 Work Unit No. (TRAIS)</b>	
		<b>11 Contract or Grant No.</b> C1835	
<b>12 Sponsoring Agency Name and Address</b> Kansas Department of Transportation Bureau of Materials and Research 700 SW Harrison Street Topeka, Kansas 66603-3745		<b>13 Type of Report and Period Covered</b> Final Report September 2009–February 2011

# **Use of Flexible Facing for Soil Nail Walls**

## **Final Report**

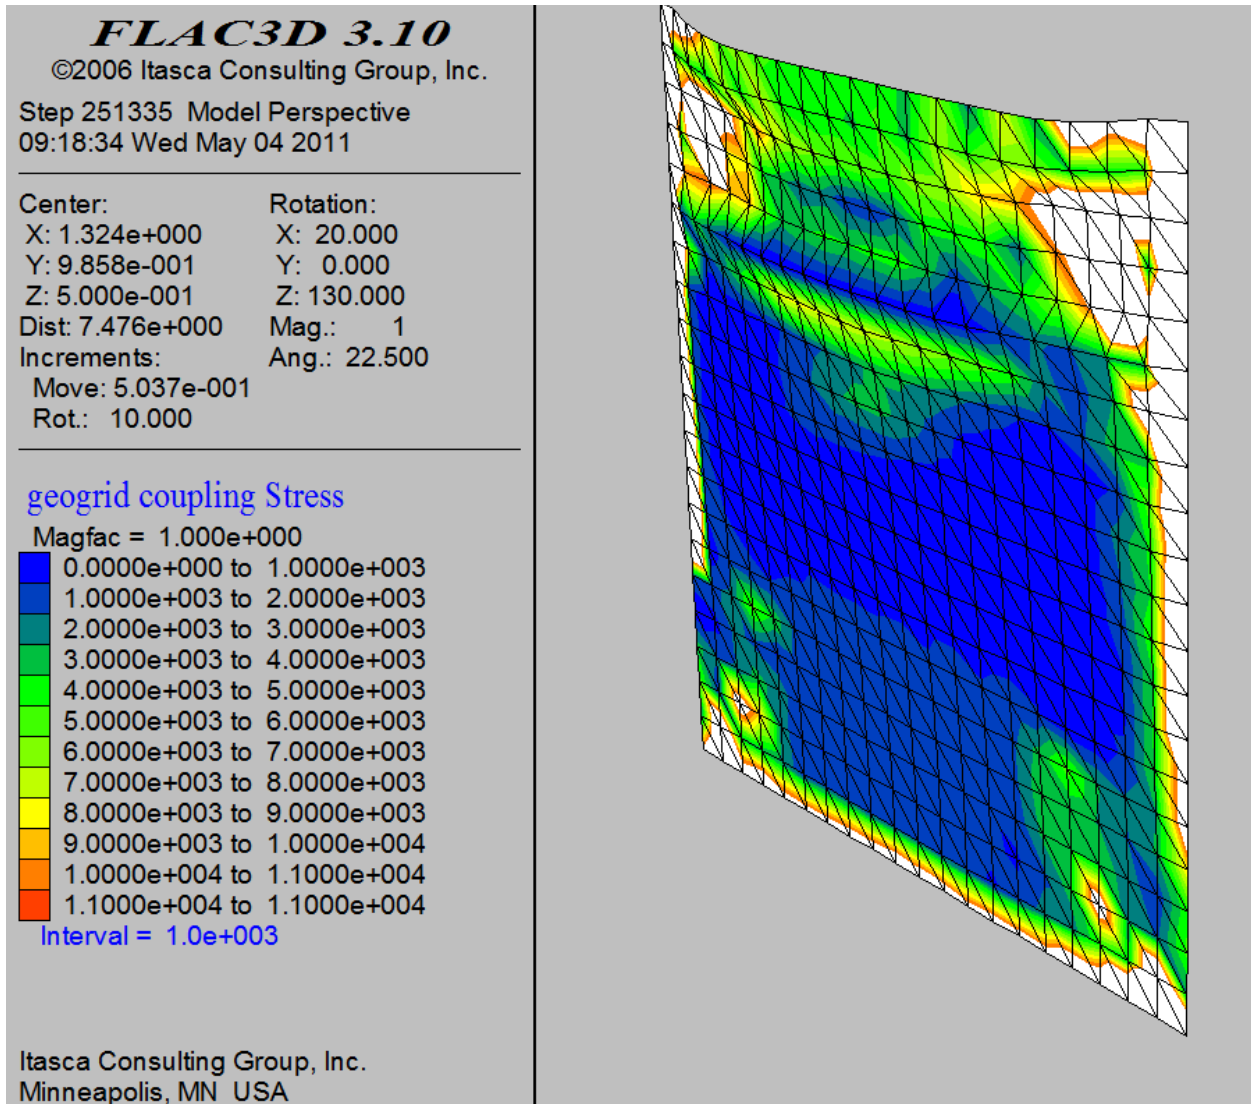
**FIGURE 3.5**  
**Long-term grid stress on the soil nails wall facing for a 5 psi surcharge application for the long-term condition (units in kPa)**

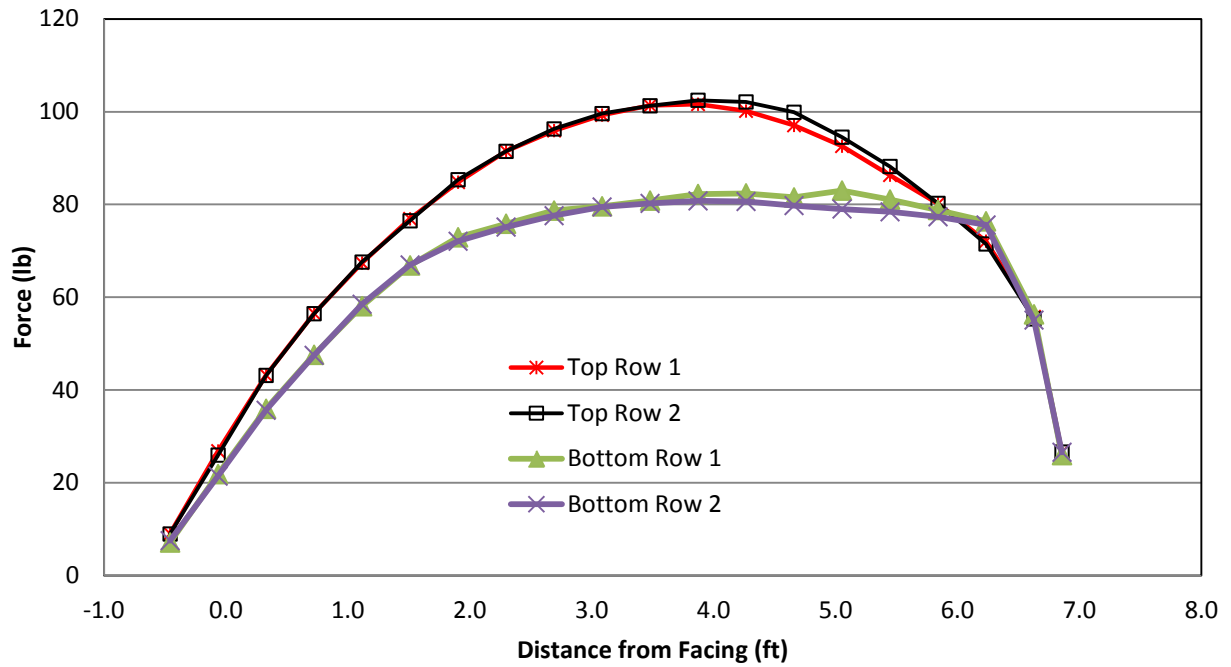
**FIGURE 3.6**  
**Force acting along the length of the soil nails at 4 psi surcharge application for the short-term condition**

The forces acting along the length of the soil nails obtained from the FLAC numerical modeling under short-term and long-term conditions for 4 psi are shown in Figures 3.6 and 3.7 and for 5 psi in Figures 3.8 and 3.9. In all the cases, the soil nails at the upper row were subjected to higher tensile force compared with the lower layer of nails. It was more evident in case of long-term loading. These relative results are consistent with strain measurements observed from the physical model test which will be discussed in Chapter 5 of this report and shown in Figure 5.25.

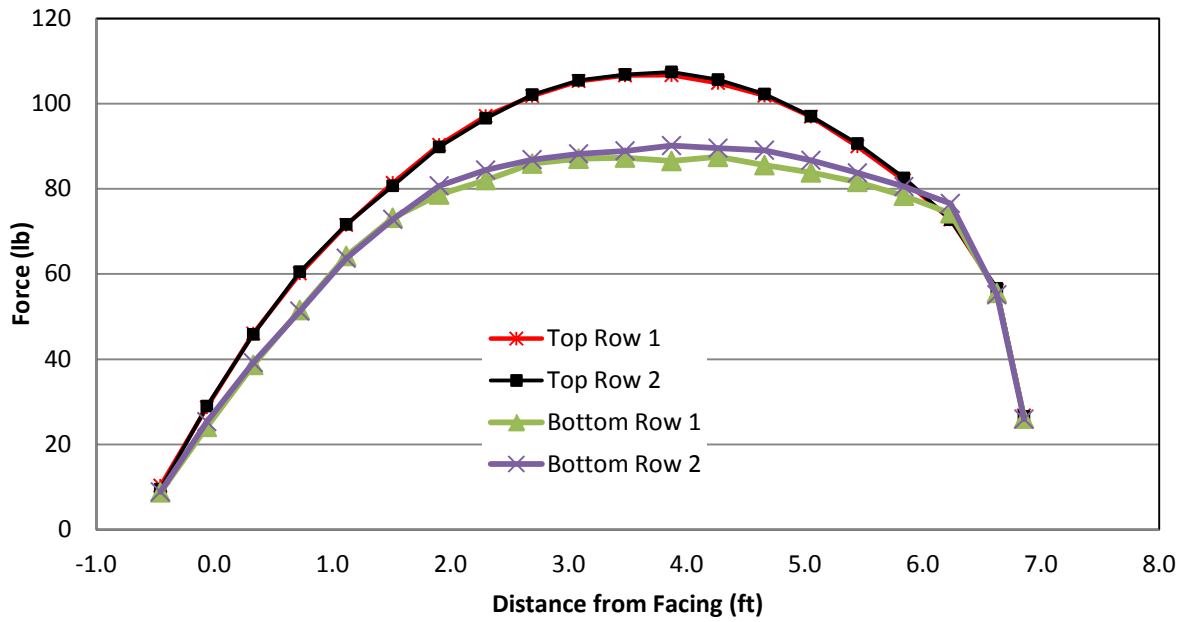
**FIGURE 3.8**  
Force acting along the length of the soil nails at 5 psi surcharge application for the short-term condition

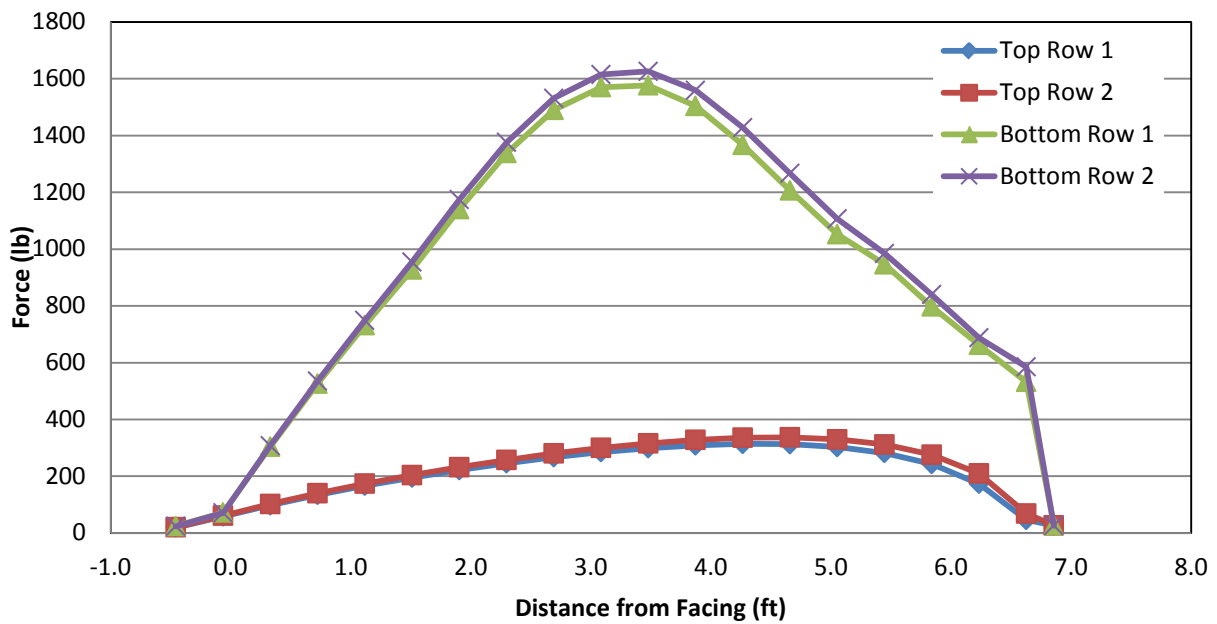
**FIGURE 3.9**  
Force acting along the length of the soil nails at 5 psi surcharge application for the long-term condition

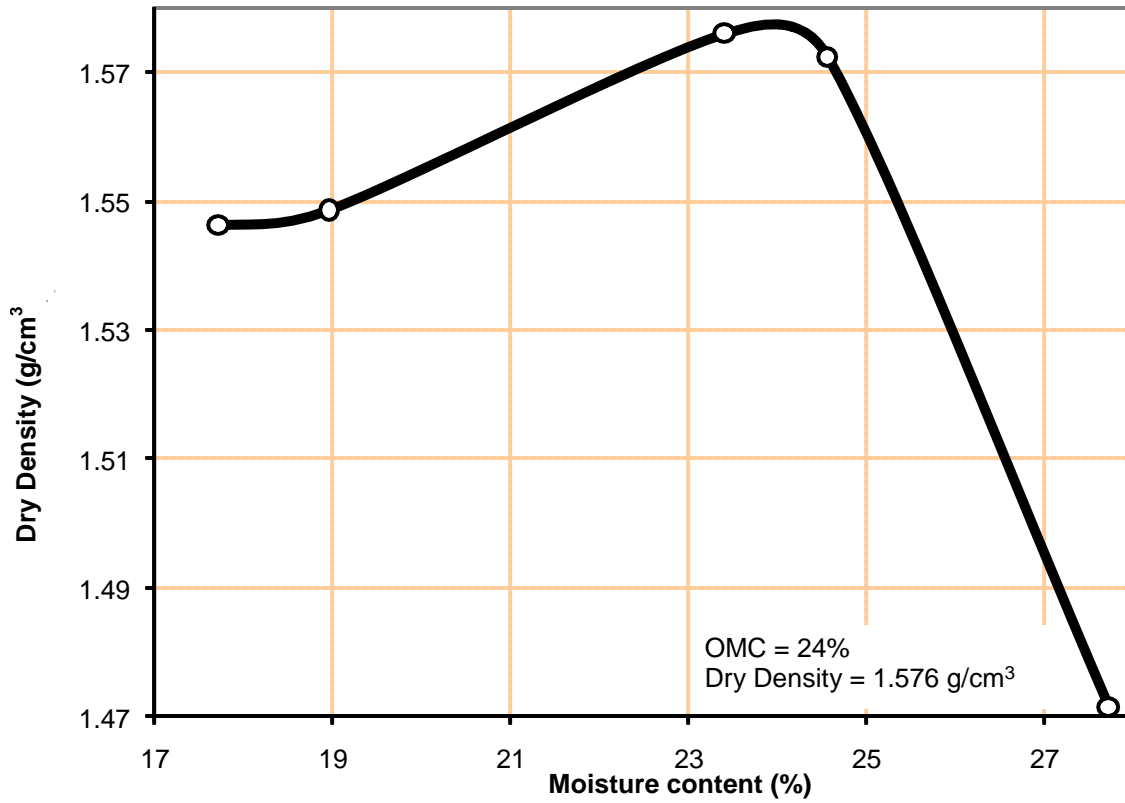
**FIGURE 4.3**  
Compaction curve of soil

Clay from the Lawrence, Kansas, area that had been used as retained fill was used to construct the soil wall. The soil is shown in Figure 4.1. This clay had a liquid limit of 55 and plastic limit of 25, resulting in a plasticity index of 30. The soil was classified as A-7-6 (AASHTO System) and CH (USCS). The specific gravity of the clay material was 2.71, and the grain size distribution is shown in Figure 4.2. Standard Proctor compaction and unconfined compression tests on this soil were carried out in the laboratory. The optimum moisture content and the maximum dry density were 24% and 98.3 lb/ft<sup>3</sup> (1.576 Mg/m<sup>3</sup>), respectively. The Standard Proctor compaction curve and the unconfined compression tests results are shown in Figures 4.3 and 4.4, respectively. Table 4.1 shows the results of three unconfined compression tests. Based on the test results of the Standard Proctor compaction test, the target for the soil compaction was set at a minimum of 90% of standard compaction and a moisture content 2% wet of optimum.

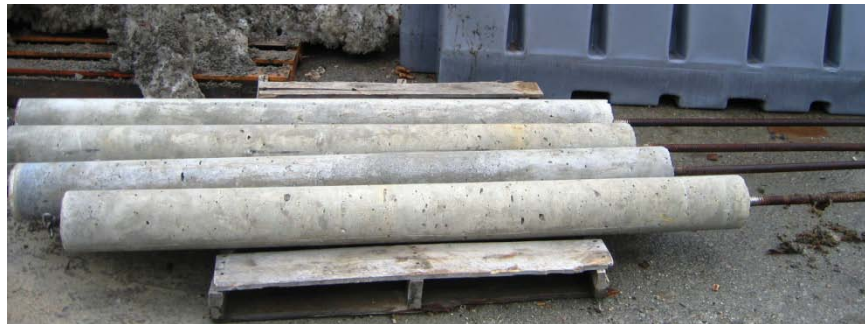
**FIGURE 4.5**  
**Soil nails**

Four soil nails were used in the test. The nails, plates, and wire mesh were supplied by Geobrugg. The soil nails were 0.959 inch diameter threaded steel bars. The elastic modulus of the steel bars used for soil nails was 29,000,000 psi. For an actual wall, the soil nails are grouted with cement, so for the test wall the steel bars were covered with 6 inch diameter cement concrete prior to construction. The soil nails are shown in Figure 4.5. Two steel plates with connecting chain links were fixed at the back of the test box as shown in Figure in 4.6, which served as the anchor for the soil nails. The picture of the chain link connections are shown in Figure 4.7. Figure 4.8 shows the stress–strain curve of the steel rod used as soil nails.

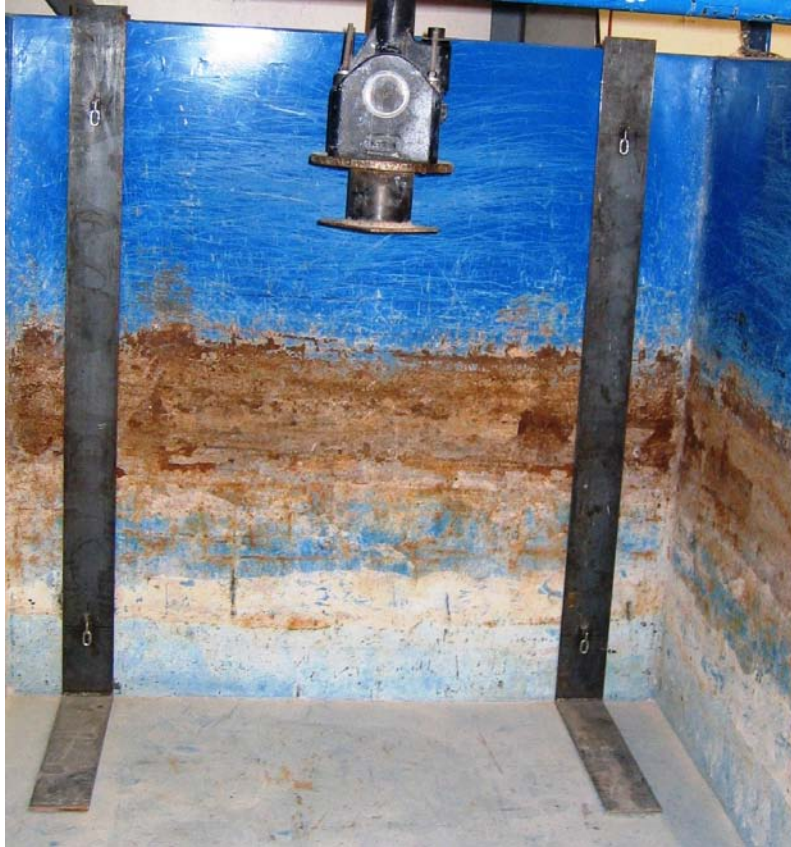
**FIGURE 4.6**  
Anchor steel plates

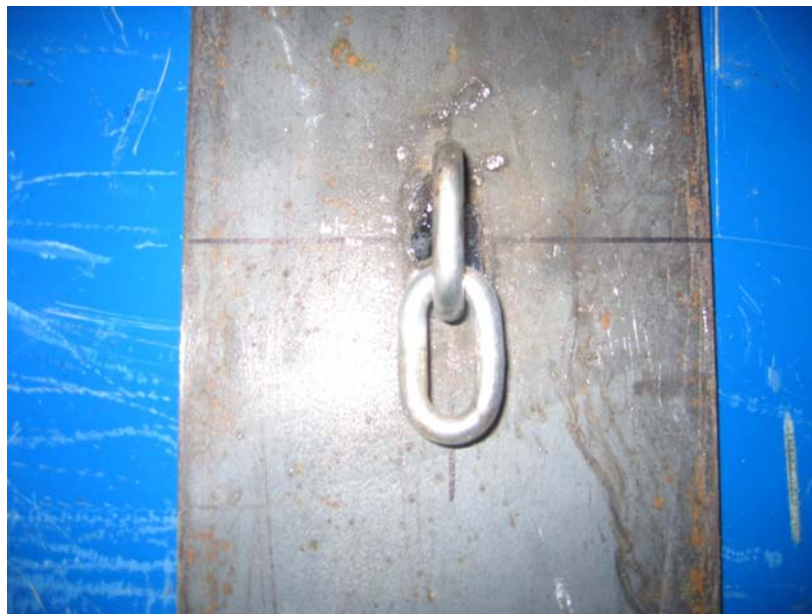
**FIGURE 4.7a**  
Chain link on the anchor plates

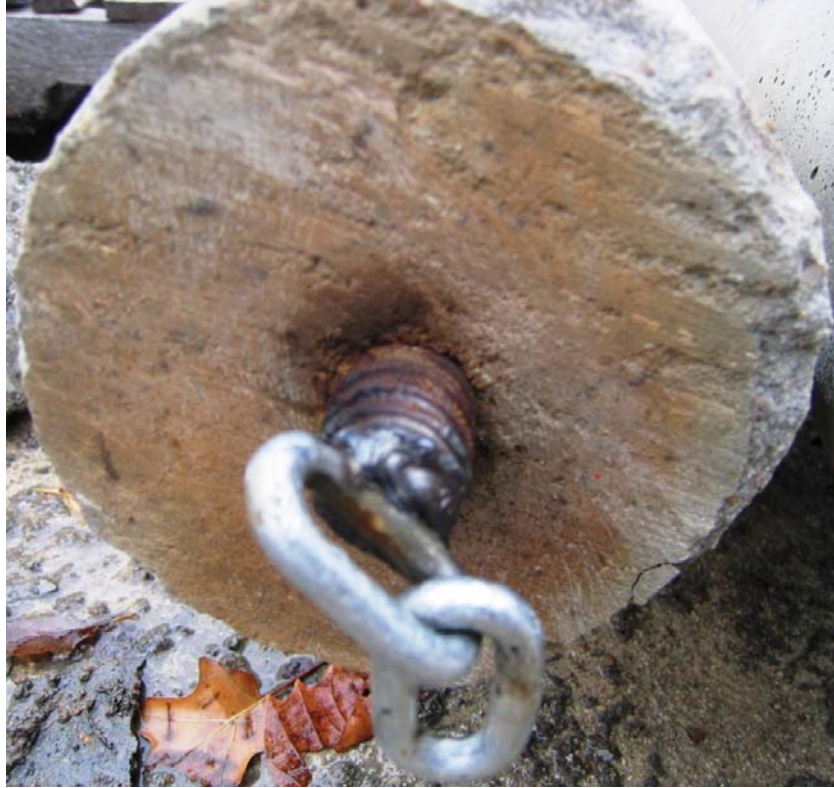
**FIGURE 4.7b**  
**Chain link on the soil nails**

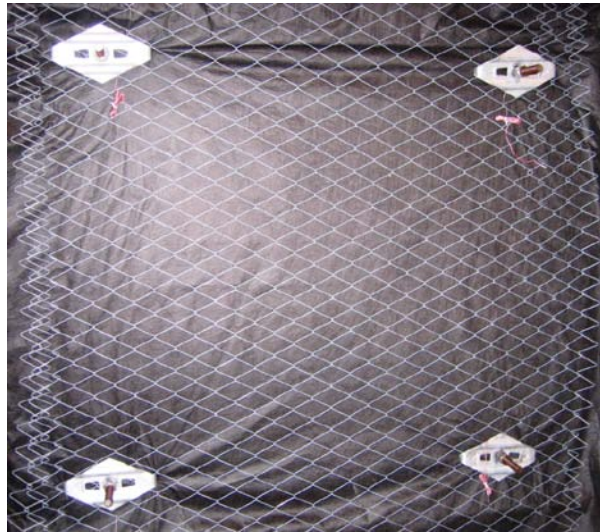
**FIGURE 4.9**  
Galvanized wire mesh and geotextile at the front face of the soil nailed wall

A 3.5 oz (99.65 g) non-woven geotextile was used between soil and the galvanized wire mesh. The picture of the geotextile, wire mesh, and connection to the soil nails are shown in Figures 4.9 and 4.10. The spike plates seen in these figures are made of galvanized iron and have dimensions of 13.0 inch by 7.5 inch by 0.4 inch (330 mm × 190 mm × 10 mm).

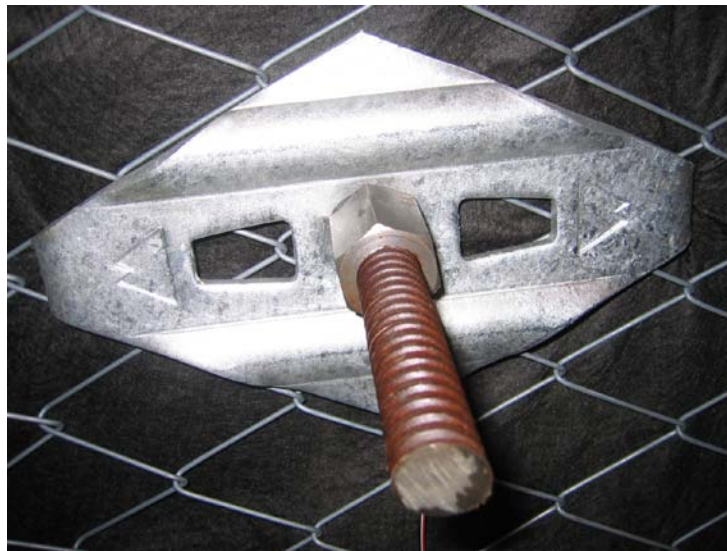
**FIGURE 4.10**  
Spike plate (bearing plate) attached at the end of the soil nails

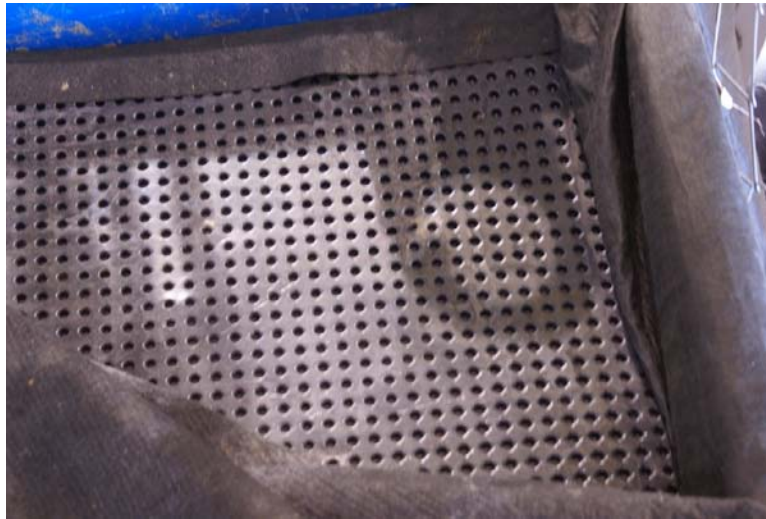
**FIGURE 4.11**  
Drainage layer

After completing the construction of the fill, a geosynthetic drainage layer was placed on top of the soil wall as shown in Figure 4.11 with the permeable side down. A set of tubes attached to a water supply was distributed throughout this layer to introduce simulated rainfall in the event the wall was not failed during the initial loading procedure.

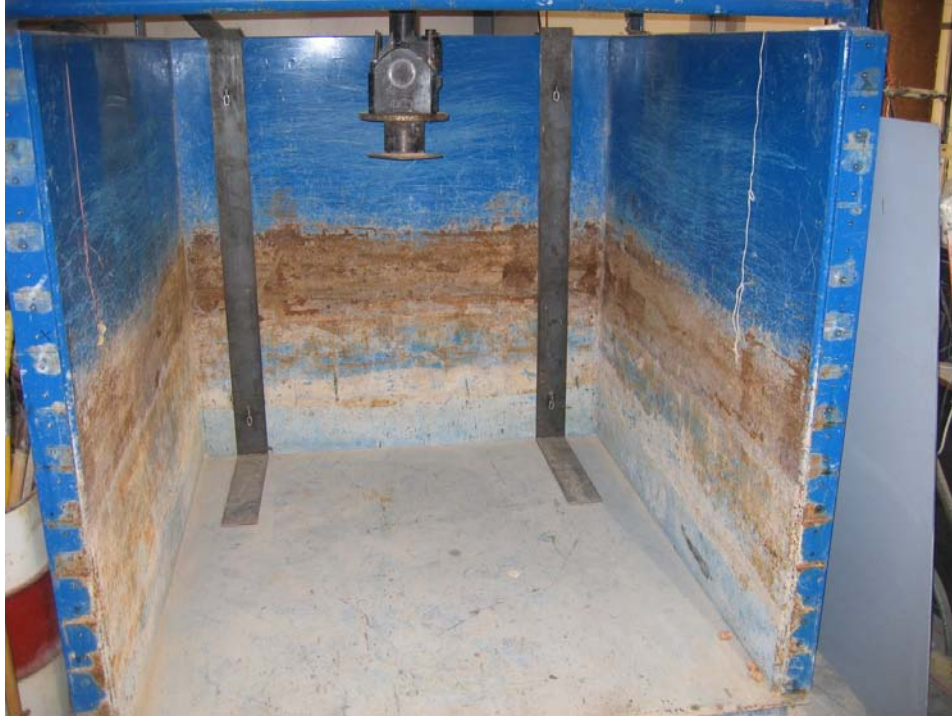
**FIGURE 4.12**  
**Large geotechnical test box**

A servo hydraulic MTS loading system consisting of a loading frame, a hydraulic actuator, and a servo-control unit connected to both a data acquisition system and a hydraulic control valve was used to apply the load on test sections in the large geotechnical testing box. The load actuator has a 55 kip (245 kN) capacity, which is equivalent to a surcharge of approximately 7 psi. The MTS loading actuator is seen on Figure 4.12 hanging from above the center of the geotechnical box.

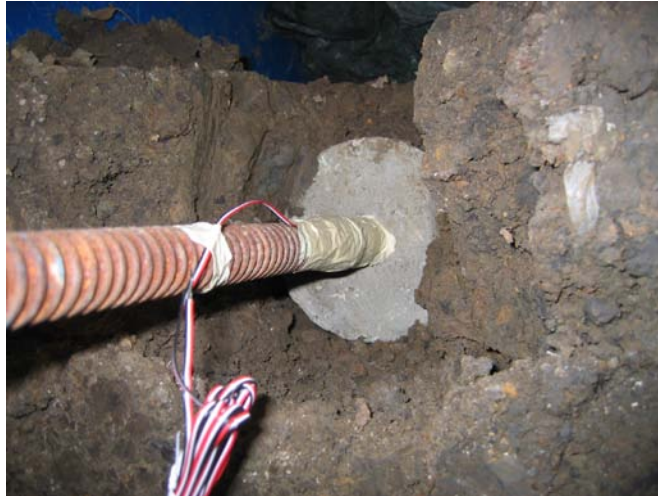
**FIGURE 4.13**  
**Strain gage connected to the soil nail**

Half-square grid general purpose strain gages were used in the tests. The strain gages had grid resistance of  $120.0 \pm 0.6$  ohm, grid length of 6.35 mm, and grid width of 3.18 mm. One strain gage each was affixed on each soil nails. The strain gages were all fixed on the top part of the nail. A smart dynamic strain recorder (DC-204R) was used to record the strain data from all the strain gages. The strain gages were fixed on the steel rods as shown in Figure 4.13.

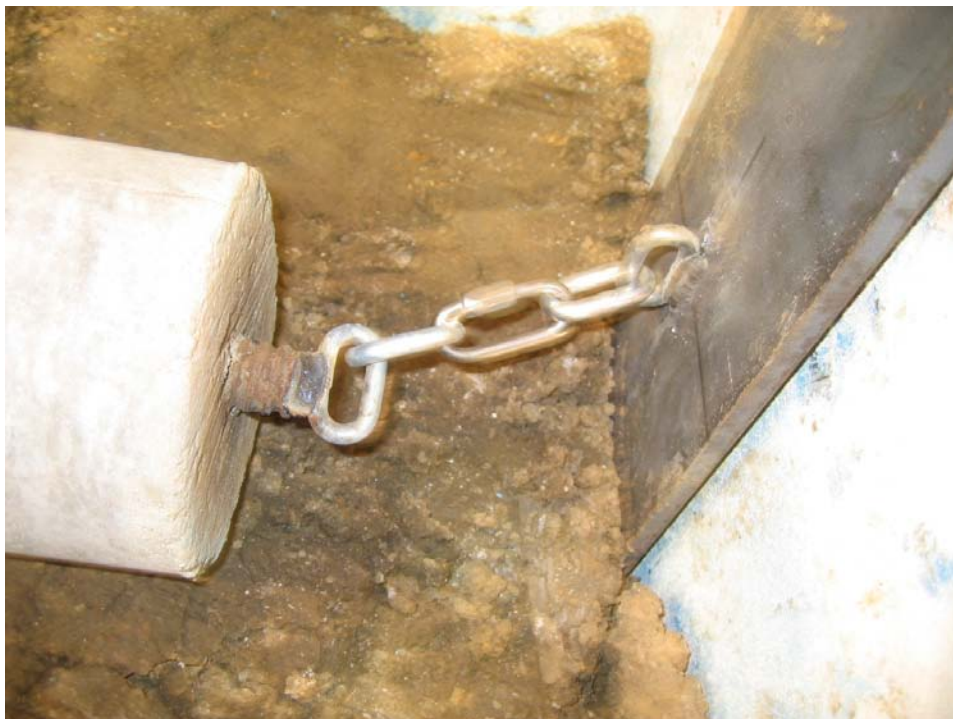
**FIGURE 5.3**  
Soil nail connected to the anchor plate with chain links

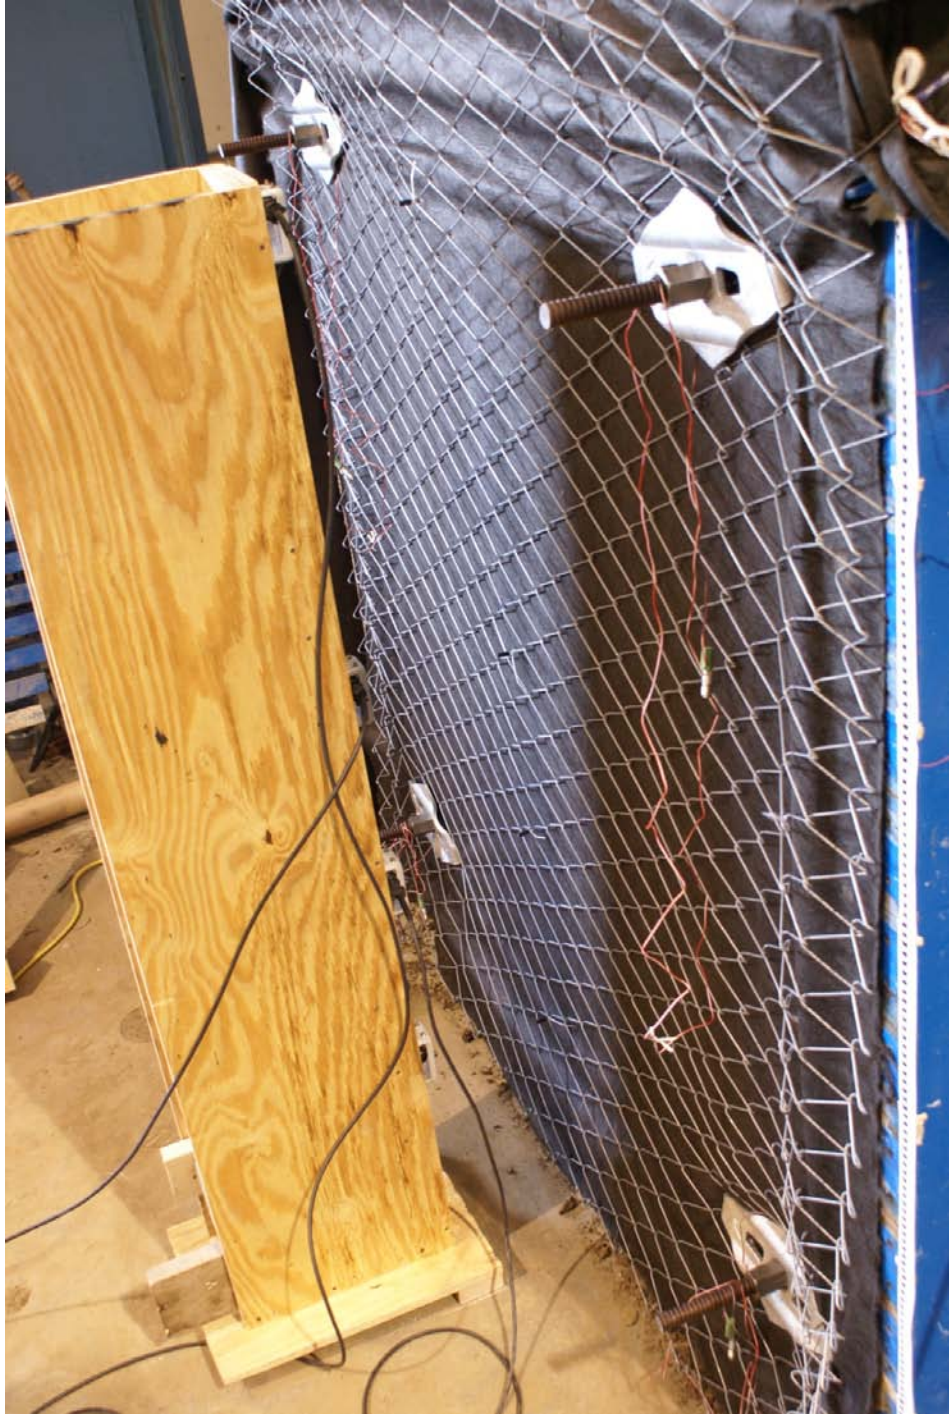
**FIGURE 5.6**  
**String pots on the soil face**

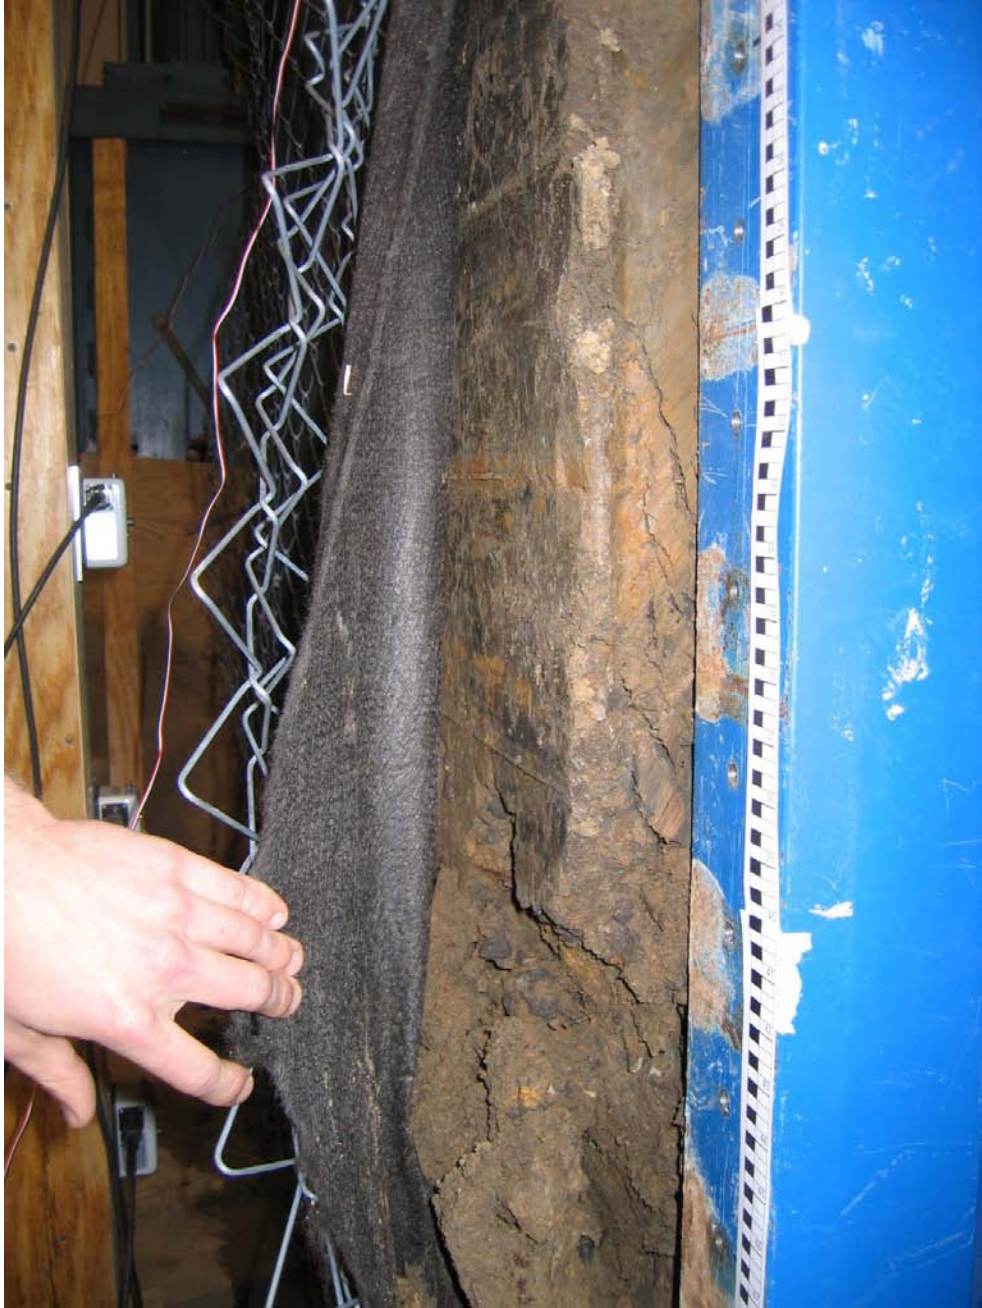
**FIGURE 5.8**  
Right side of soil face after application of 5 psi surcharge

Figure 5.8 through Figure 5.13 show the wall face for different surcharges and the final face shape at the time of failure. Figure 5.14 shows the settlement of the soil wall with the application of load on top. The string pot line shown was connected essentially horizontally to

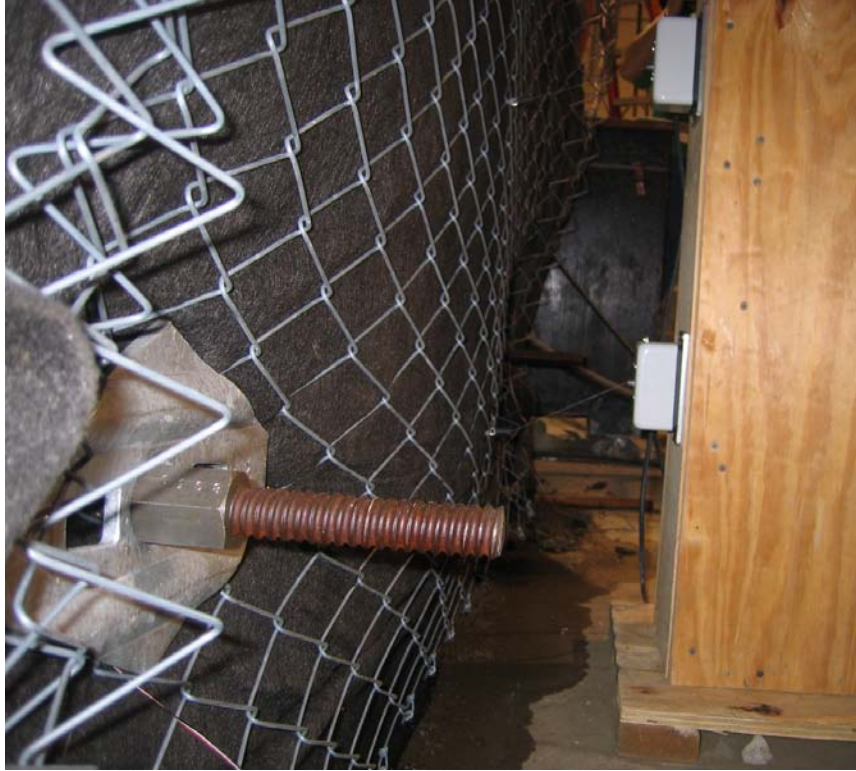
**FIGURE 5.9**  
**Soil face after application of 5 psi surcharge**

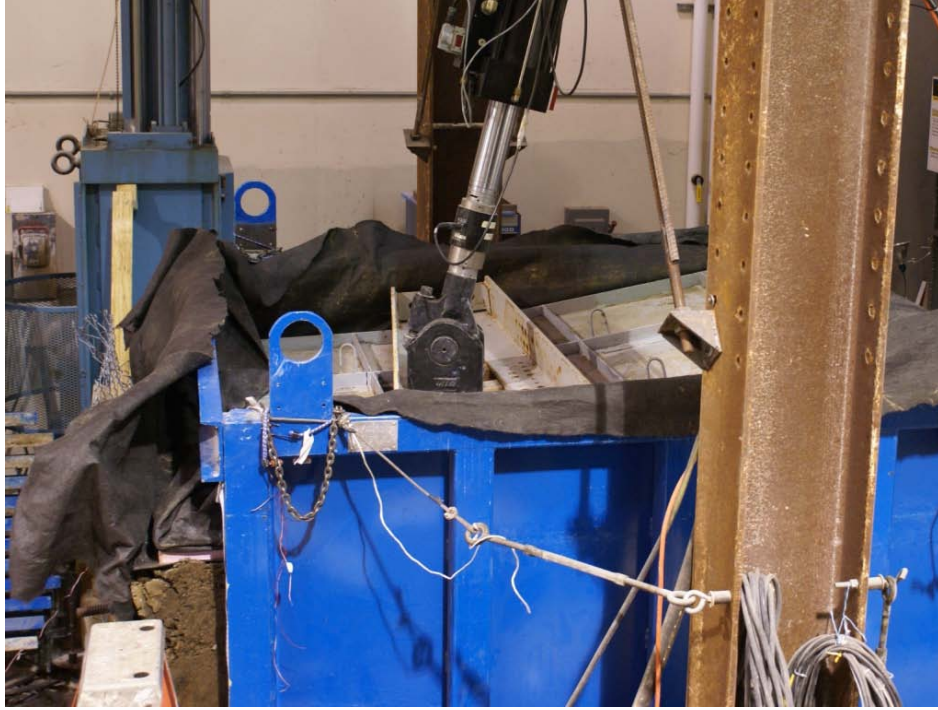
**FIGURE 5.11**  
Side view after failure of nail connections

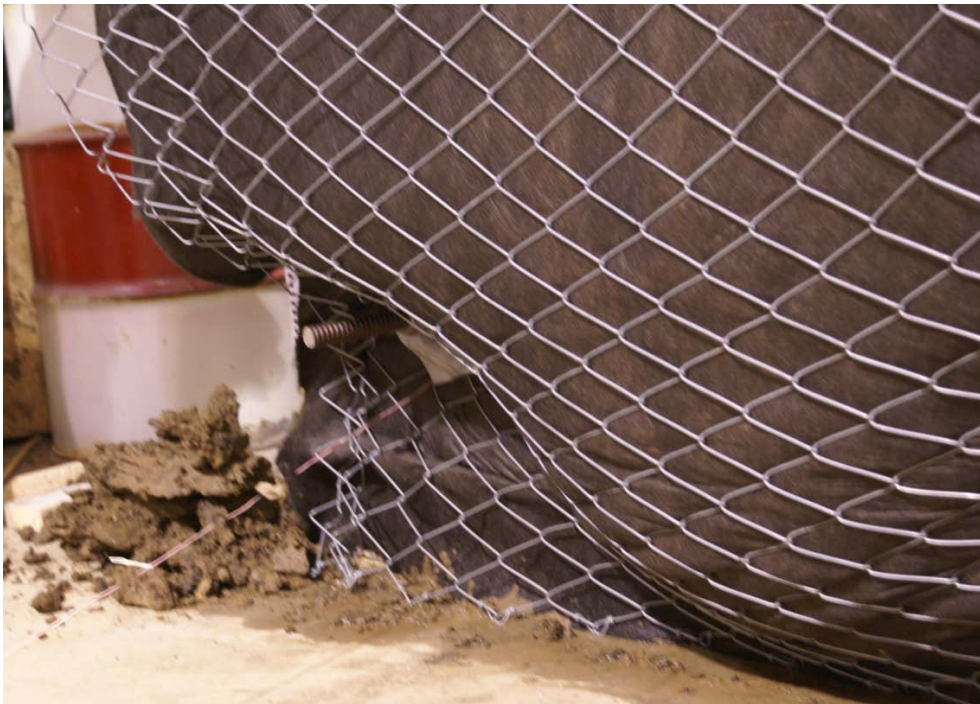
**FIGURE 5.12**  
Lower left nail after failure

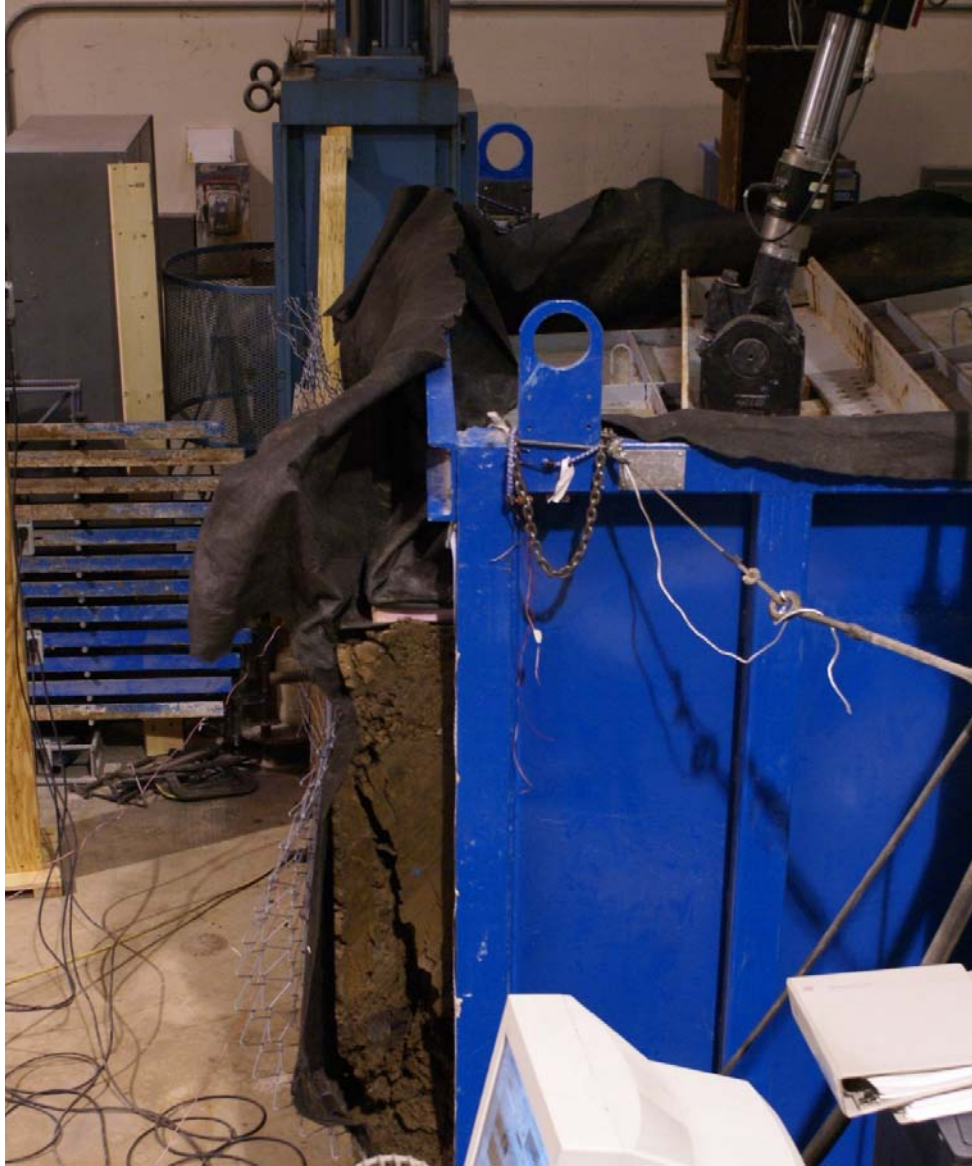
**FIGURE 5.13**  
Side view after failure of nail connections

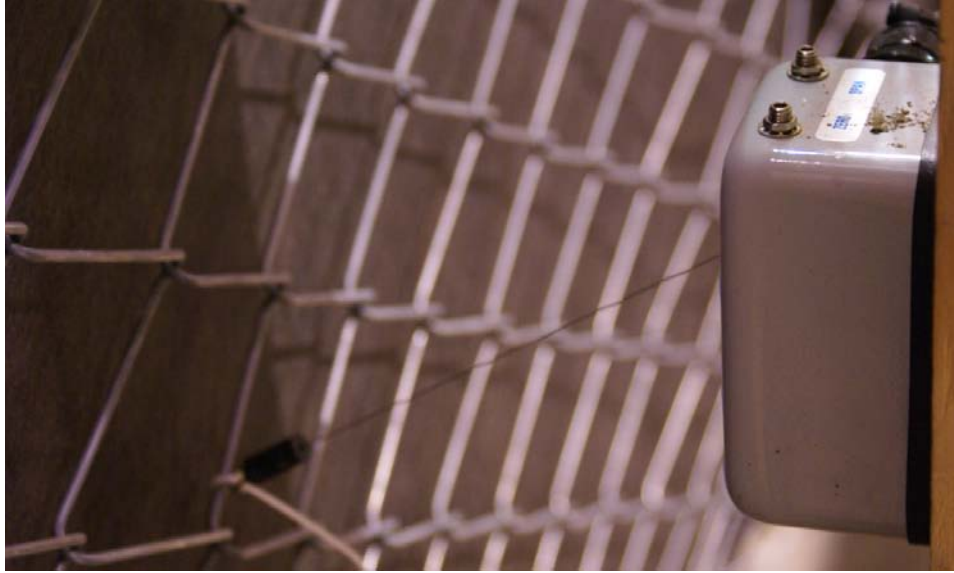
**FIGURE 5.14**  
Downward movement of string pot connection due to settlement

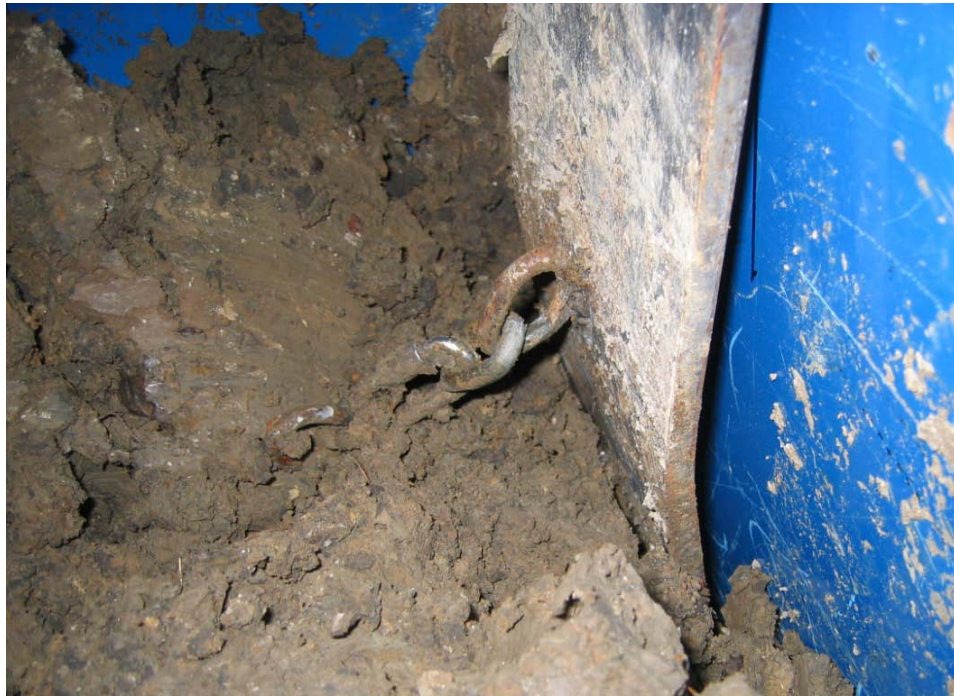
**FIGURE 5.15**  
Anchor plates pulled out from the rear face of the wall

Forensic tests showed that at failure, the weld between the chain link and the anchor plates had broken. The 1 cm thick steel anchor had deformed (Figure 5.15) by about 1 inch from the back side of the geotechnical box. Failure of the connection was apparently more due to the downward movement of the nail, which overstressed the chain weld, than pullout stress. Along the width of the box at 1 ft from the back of the wall a 6 inch wide crack developed at failure as shown in Figure 5.16. As the soil nails were pushed out, the anchor plate deformed as shown in Figure 5.17. Other sets of cracking on the top surface along the width of the geotechnical box were observed close to the front face as shown in Figure 5.18. At the time of failure, the soil nails also slid forward by about 15 cm (6 inches) from their original position as seen in Figure 5.15.

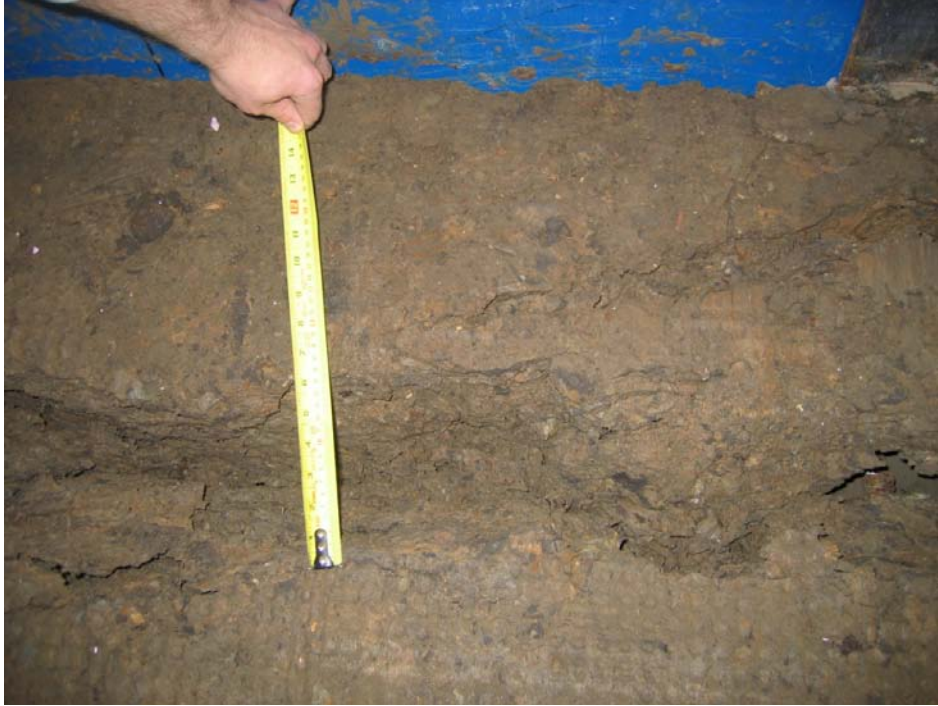
**FIGURE 5.16**  
Crack developed at failure at 1 ft from the rear face of the wall

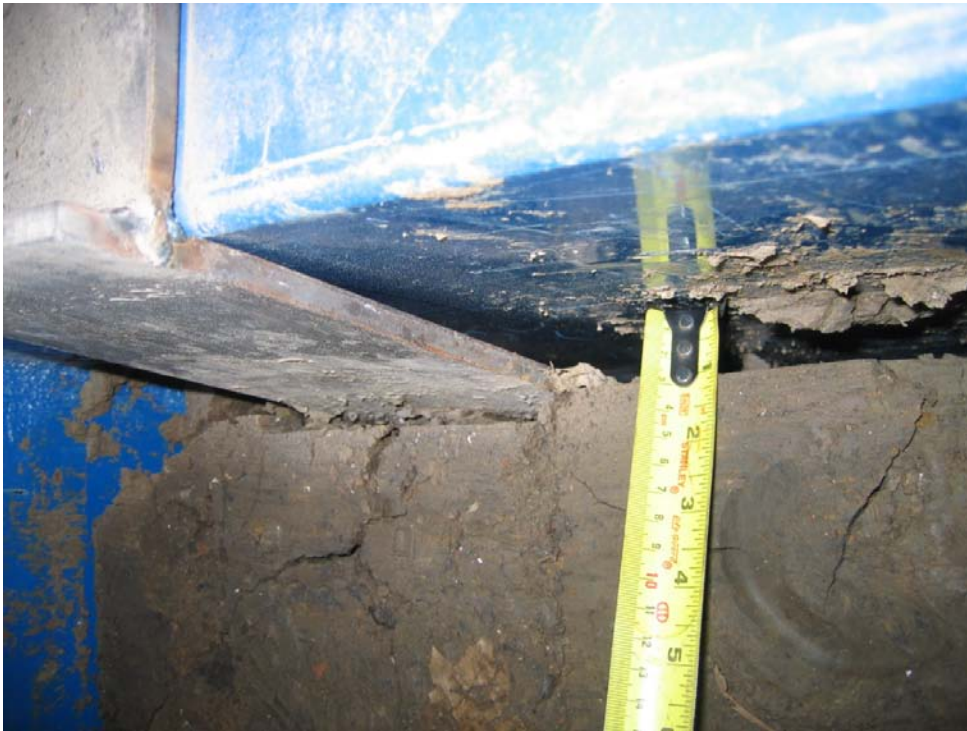
**FIGURE 5.17**  
Movement of soil mass out of the rear face of the wall

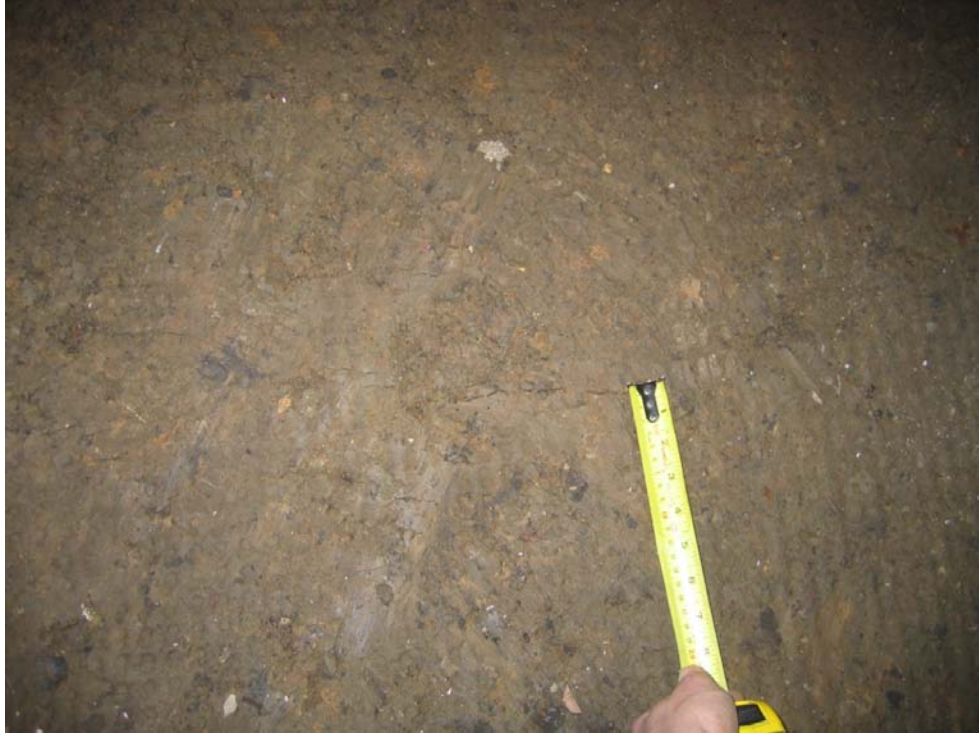
**FIGURE 5.18**  
Crack seen on the top surface close to the front face of the nailed wall

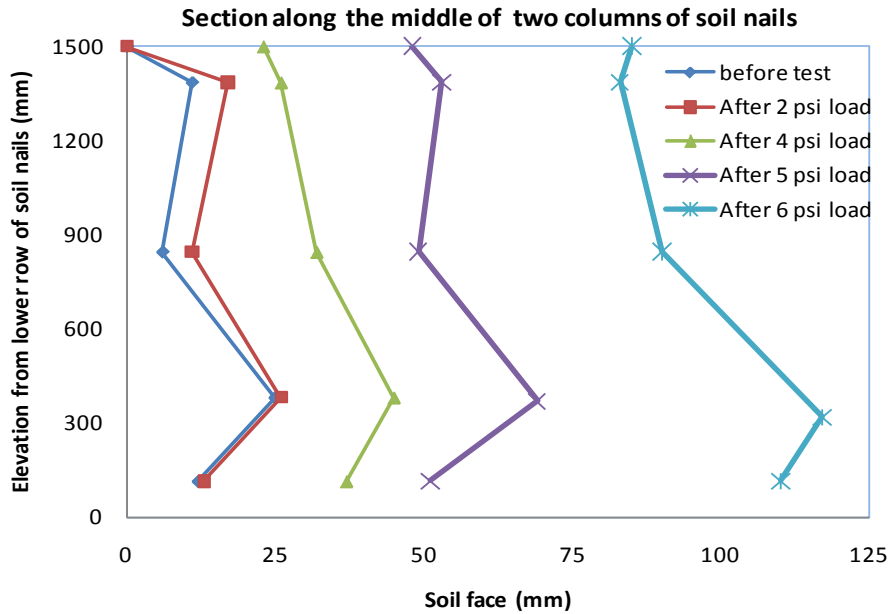
**FIGURE 5.23**  
Position of soil facing midway between the two columns of soil nails with increasing vertical surcharge

Figures 5.22 through 5.24 show how the soil face lead to progressive failure after the application of different load increments at the top.

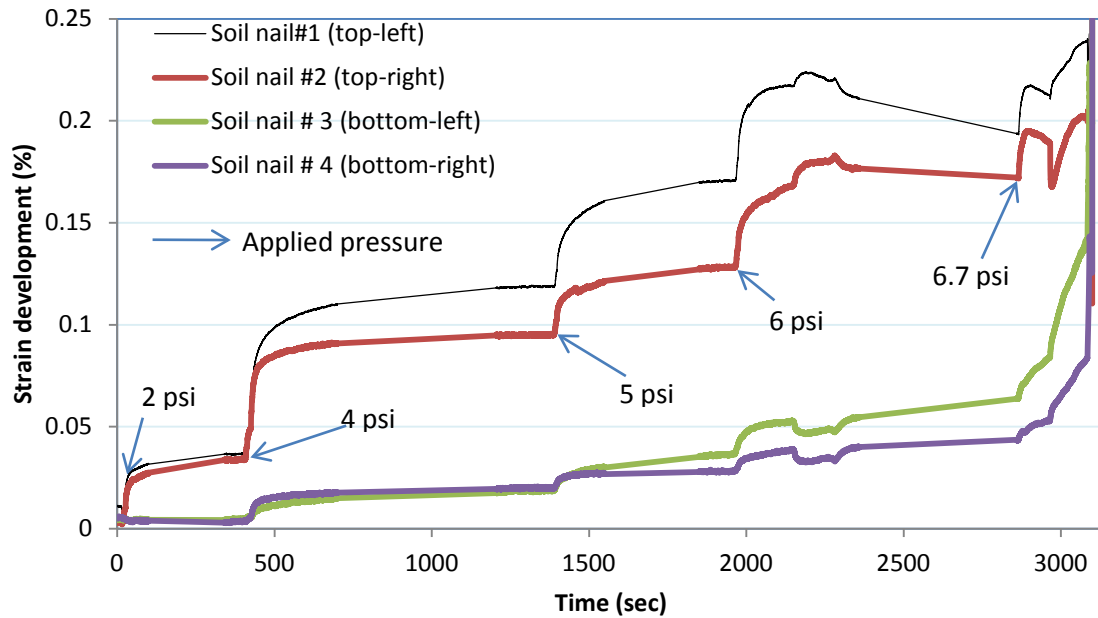
**FIGURE 5.25**  
**Strain development at the soil nails at different pressure application on the top of soil nailed wall**

The strain gages on the tops of the nails showed larger strains when the nails began to yield in bending due to downward movement of the face. The strains shown in Figure 5.25 are more a function of bending stresses than tension in the nails as the load from the slumping face was transferred to the nails. Stresses from bending were much greater in the upper nails where the soil had more freedom to move.

The soil nails held the face firmly throughout the test. Significant horizontal deformations of the soil face were observed near the bottom of the box and midway between the two columns of soil nails. By this time, the upper row of soil nails had moved slightly outward as the chain link connection between the back of the soil nail and the anchor plate stretched tightly and eventually the anchor plate bent outward as shown in Figure 5.15. At failure, the connection with the anchor plate was broken and the soil nails moved at least 15 cm (6 inch) outward. This phenomenon was not observed in the lower row of soil nails. The major cause of failure of top row of soil nails was the excessive settlement of the soil at top. The vertical deformation of the soil mass caused the upper soil nails to move downward, which transferred a substantial vertical force to the connecting chain link (which broke at 6.7 psi surcharge) and bent the soil nails on top row. Therefore, the vertical deformation (settlement) was more responsible than the horizontal force for the nail failure. Once the upper soil nails failed, the lower rows of nails started to take more load, which can be seen in Figure 5.25, with the increase in strain at approximately 2800 seconds.
