<b>1 Report No.</b> K-TRAN: KU-10-6	<b>2 Government Accession No.</b>	<b>3 Recipient Catalog No.</b>	
<b>4 Title and Subtitle</b> USE OF FLEXIBLE FACING FOR SOIL NAIL WALLS		<b>5 Report Date</b> November 2011	
		<b>6 Performing Organization Code</b>	
<b>7 Author(s)</b> Sanat Pokharel, Ph.D.; Robert L. Parsons, Ph.D., P.E.; Matthew Pierson, Ph.D.; Jie Han, Ph.D., P.E.; Isaac Willems		<b>8 Performing Organization Report No.</b>	
<b>9 Performing Organization Name and Address</b> University of Kansas Civil, Environmental & Architectural Engineering Department 1530 West 15 <sup>th</sup> Street Lawrence, Kansas 66045-7609		<b>10 Work Unit No. (TRAIS)</b>	
		<b>11 Contract or Grant No.</b> C1835	
<b>12 Sponsoring Agency Name and Address</b> Kansas Department of Transportation Bureau of Materials and Research 700 SW Harrison Street Topeka, Kansas 66603-3745		<b>13 Type of Report and Period Covered</b> Final Report September 2009–February 2011

# **Use of Flexible Facing for Soil Nail Walls**

## **Final Report**

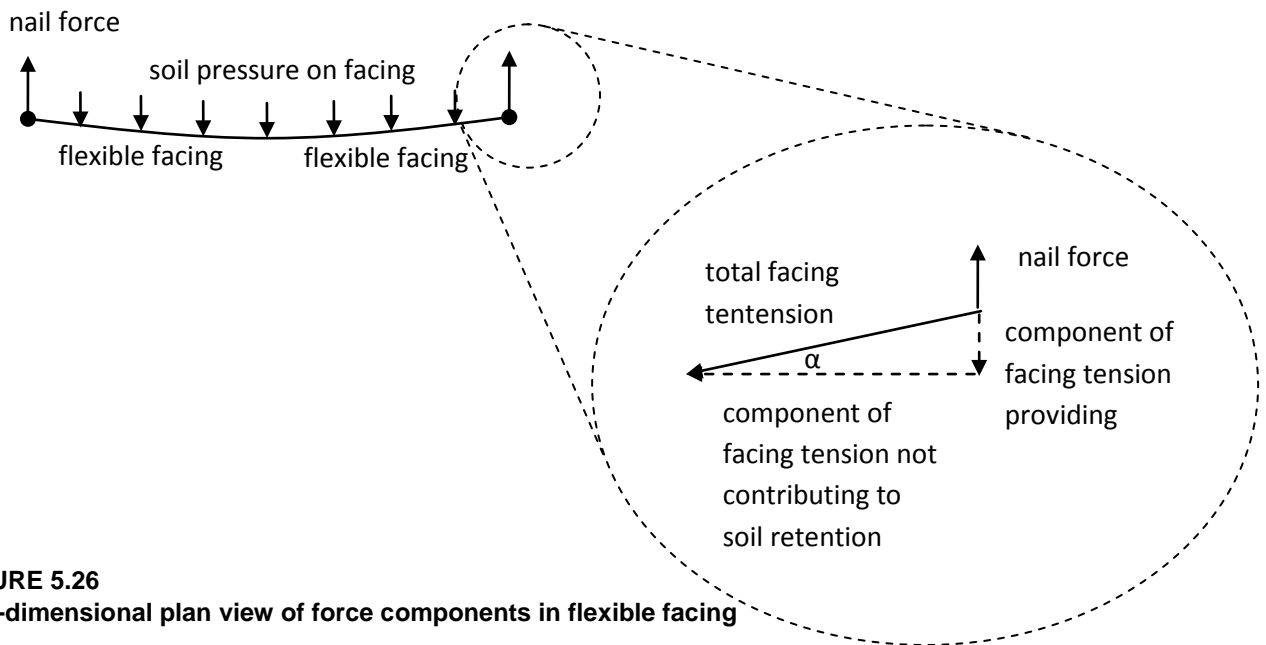
**FIGURE 5.26**  
Two-dimensional plan view of force components in flexible facing

A limitation inherent to the use of the flexible facing method is illustrated in Figure 5.26. In this figure, a 2-dimensional model of a flexible facing shows that the angle  $\alpha$  must be greater than zero for there to be a soil retention force transmitted by the facing. For very small angles, the tension in the facing must be very large to develop a significant retention force. Therefore, to develop a significant retentive force, one or more of the following conditions must occur:

1. The flexible facing is installed against a slope with  $\alpha \approx 0$ . Significant movement of the soil is required to engage the facing.
