U.S. Department of
Transportation
**Federal Railroad
Administration**

Rolling Contact Fatigue: A Comprehensive Review

6. AUTHOR(S) Eric E. Magel				8. PERFORMING ORGANIZATION REPORT NUMBER	
7. PERFORMING ORGANIZATION NAME(S) AND ADDRESS(ES) Centre for Surface Technology 2320 Lester Road, Ottawa, Ontario K1V 1S2, Canada				10. SPONSORING/MONITORING AGENCY REPORT NUMBER DOT/FRA/ORD-11/24

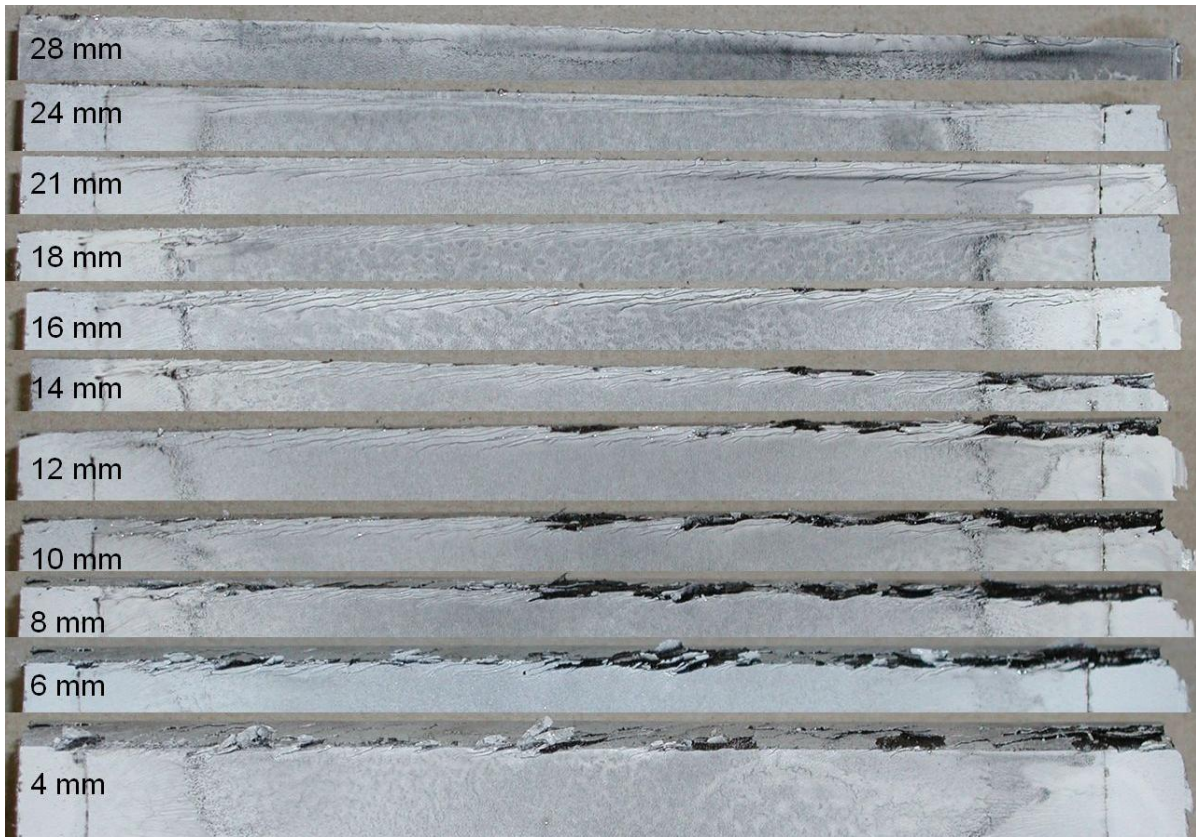
- Surface and/or subsurface cracks linking up with other cracks below the surface such that the material above is no longer connected to the parent rail (Figure 5) or wheel (Figure 6) and drops out; or
- Collapse of the rail gauge corner because of excessive loading and shear failure along a “slip line.” Although shelling from gauge corner collapse occurs preferentially at stringers of alumina inclusions [35], even in the cleanest steel, too many high stress loads at the gauge corner will cause it to yield along a slip line [170]. This defect is often referred to as the “deep seated shell.”

Figure 5. Shelling of a Rail; Shown Are Longitudinal Sections Machined Vertically (parallel to the rail web) at Distances Ranging from 4 to 28 mm from the Gauge Side of the Rail; The Steel Is a 1984 CC CFI Rail Steel

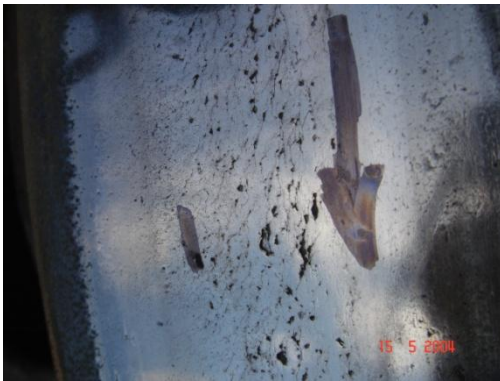
C) Well-defined cracks on the field/rim side of the wheel.

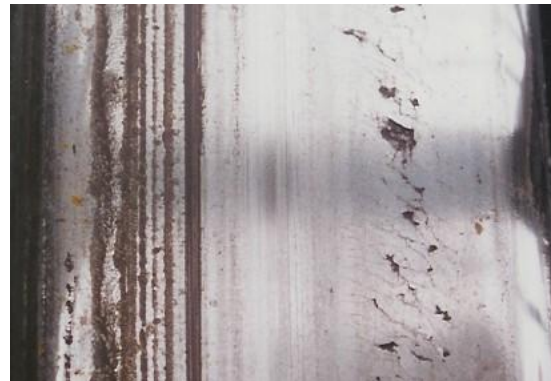
D) Deeper cracks on the field/rim side of the wheel tread with material starting to shell out.

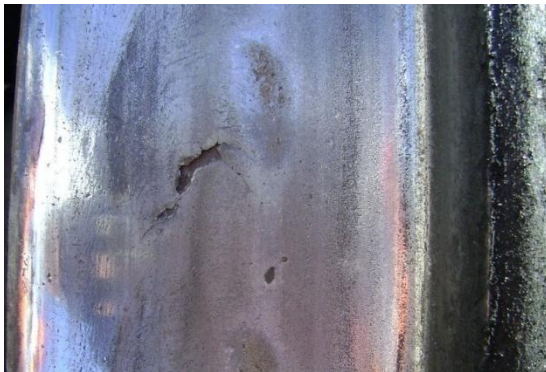
E) Incipient shells initiating at the field/rim side of the wheel.

Figure 6. Progression of Wheel-Tread Surface Fatigue from Microcracks to Fully Shelled [171]

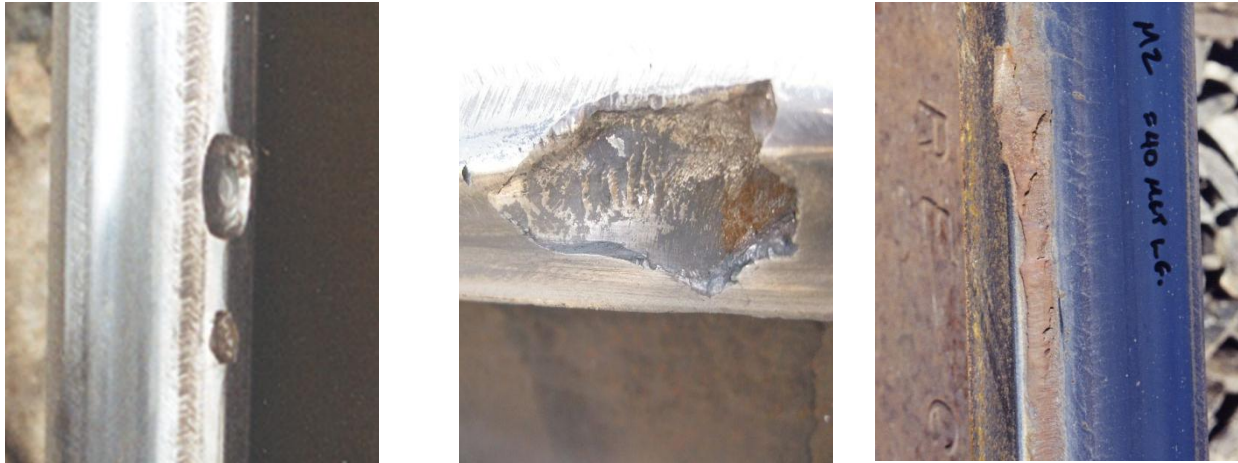
Poorly restrained high rails that rotate outwards under load (Figure 8A), well-lubricated rail with a particularly high-stress gauge corner shape (Figure 8B), and even some dry rails (Figure 8C) see large chunks of metal slough from the gauge corner. The most effective treatment for this is ensuring the implementation and maintenance of proper rail shapes that eliminate the overloading, reducing the stress for each contact and distributing contacts over a wider portion of the railhead. Modeling the system as a quarter space (see Section 2.1.2.1) found that in practice it is necessary to minimize the number of wheels that touch the railhead within three-eighths of 1 inch (9 mm) of the gage face to avoid gauge corner collapse.

A) Loss of rail cant due to rail seat abrasion resulted in overloading of the gauge corner B) Well-lubricated rail with a sharp gauge corner C) Gauge corner collapse in a dry environment

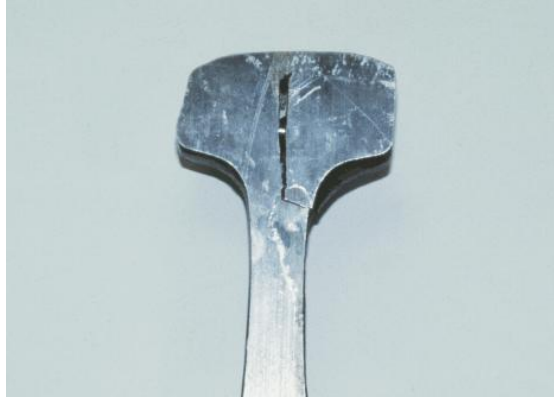
Figure 11. Vertical Split Head Defect

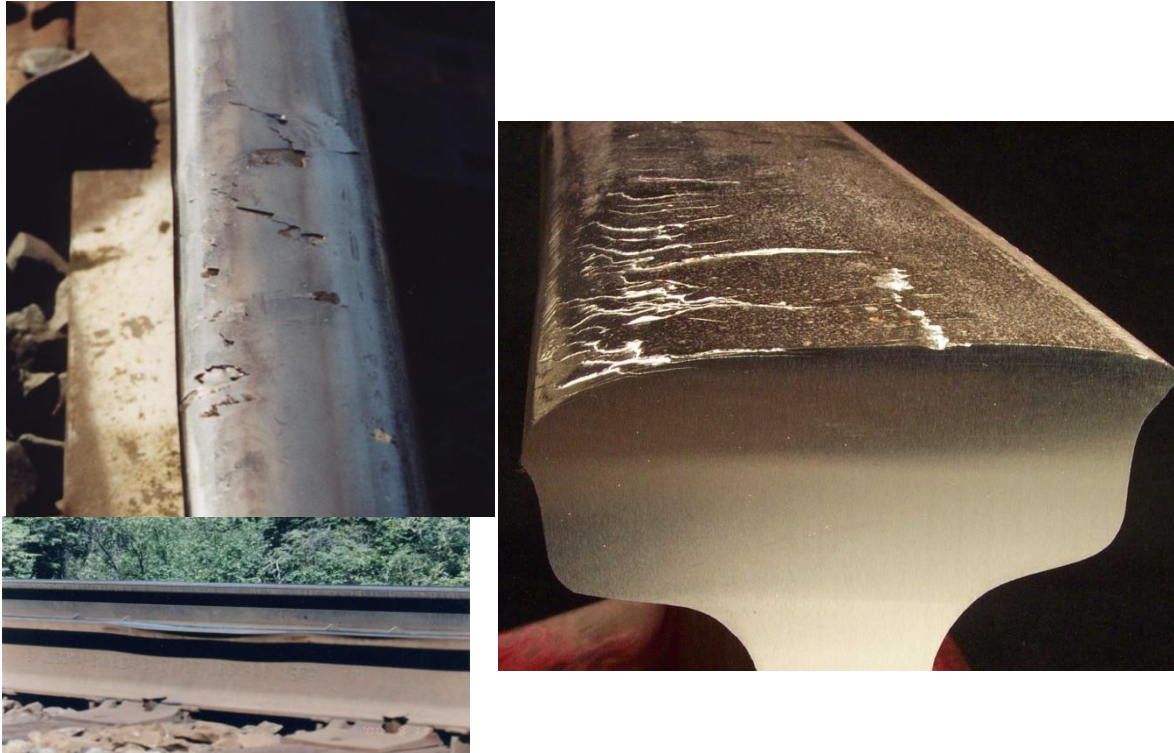
Crushed heads are typically about one-quarter to one-half meter in length. They are characterized by increased frequency and growth of large surface cracks and plastic flow to one or both sides of the running surface. The concentration of cracks is usually caused by a local stress raiser associated with improper rail grinding, lack of rail grinding, track irregularities, dirty steel, or some combination of all of these factors. Grinding can prolong the life of crushed-head-affected rail by either removing damaged material or moving the contact band away from the stress raiser [172]. Crushing is especially problematic on older rail, often having significant vertical wear, where the head may collapse entirely. The crushed head defect and its treatment are discussed in Reference 47.

Figure 13. The Crushed Head Defect Is Associated with Collapse and Deformation of the Underside of the Rail Head as a Result of Cracks That Initiate at the Mid-Gauge and Propagate to the Center of the Rail

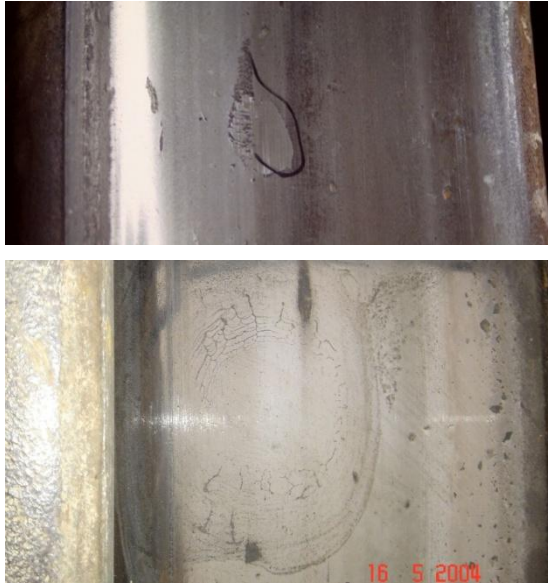
A light martensitic contact patch at a wheel slide location with cracking starting.

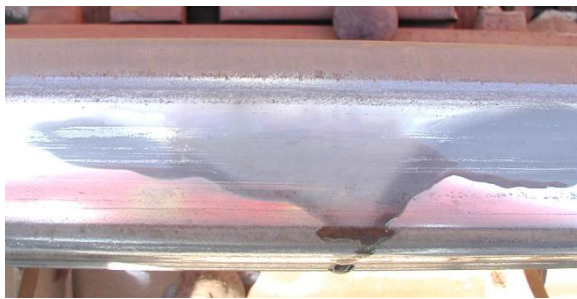
On the rail, a completely analogous effect arises because of the spinning of the wheel on the rail. High tractive effort can leave a more or less continuous thin layer of martensite on the surface of the rail, which has been postulated as the causal mechanism of rail squats (see Section 1.3.5). On a macroscopic scale, a wheel burn is a deep layer of martensite that, upon subsequent wheel passes, develops a whole network of surface cracks, any one of which might be the cause of a broken rail.

A) With a perchlorate etchant

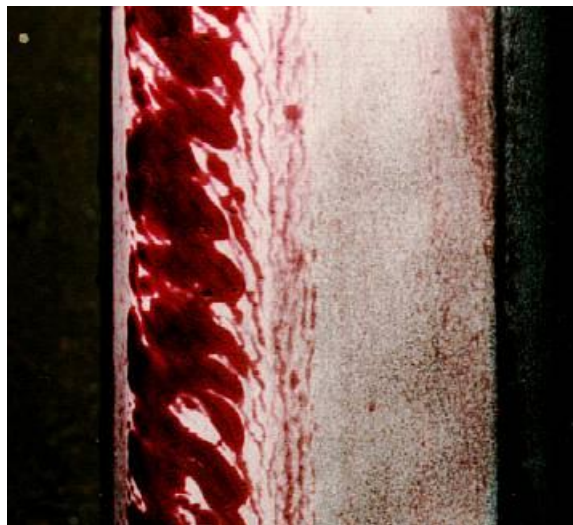
- C. In a dry environment, these cracks will remain relatively dormant at that length. Yet, in moist environments, or in alternating wet and dry environments, the hydraulic propagation mechanism demonstrated by Way [292] in 1935 and quantified analytically and extended by Bower [12] contributes to continued and rapid crack growth to a depth of several millimeters. Once the crack grows large enough that it cannot be fully closed by the contact patch, hydraulic pressurization is no longer effective. The surface length of the cracks will be on the order of 15 mm, with a depth of approximately 4–8 mm (Figure 18).

Figure 18. Hydraulic Mechanism Is No Doubt Contributing to Shelling on This High Rail; Cracking Is Enhanced by Dye Penetrant

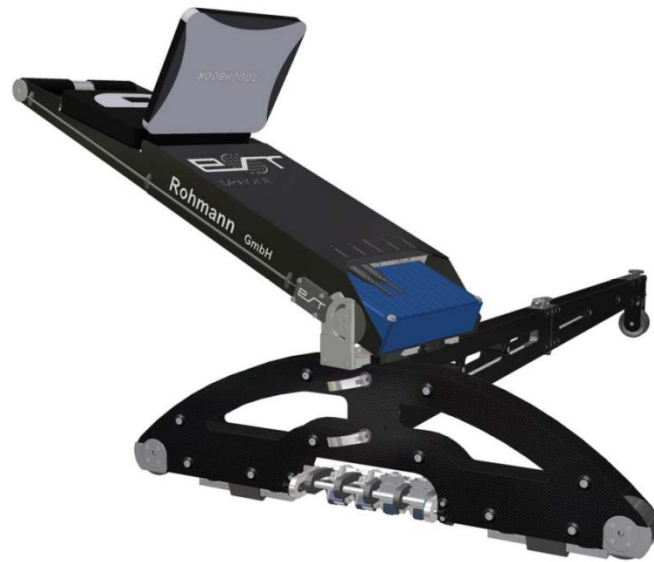
C) Rohmann Drasine trolley

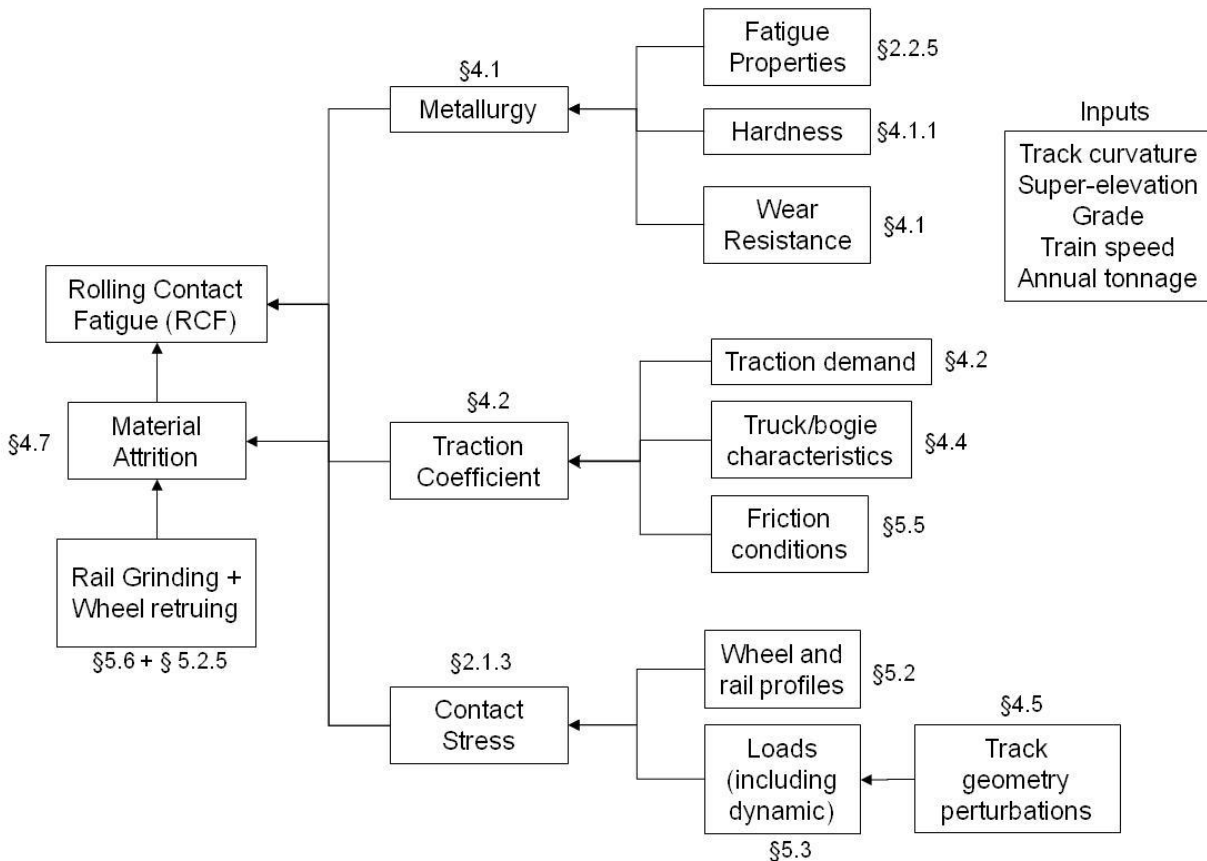
Figure 40. The Key Factors Controlling RCF; The Section Numbers Point to Relevant Portions of the Report

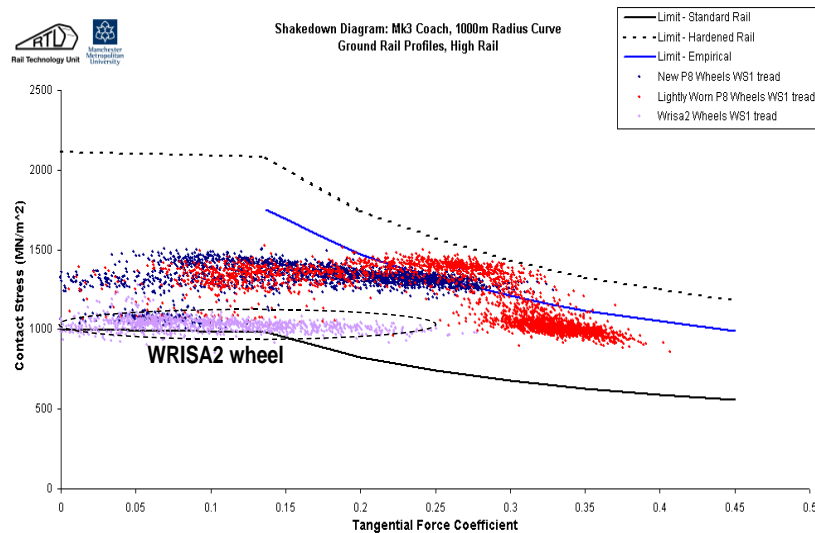
Figure 49. A Dynamic Shakedown Plot Summarizes Contact Conditions for Three Different Wheel Profiles against the Same Rail Shape As-Is Negotiates a 1,500-Meter, High Cant Deficiency Curve

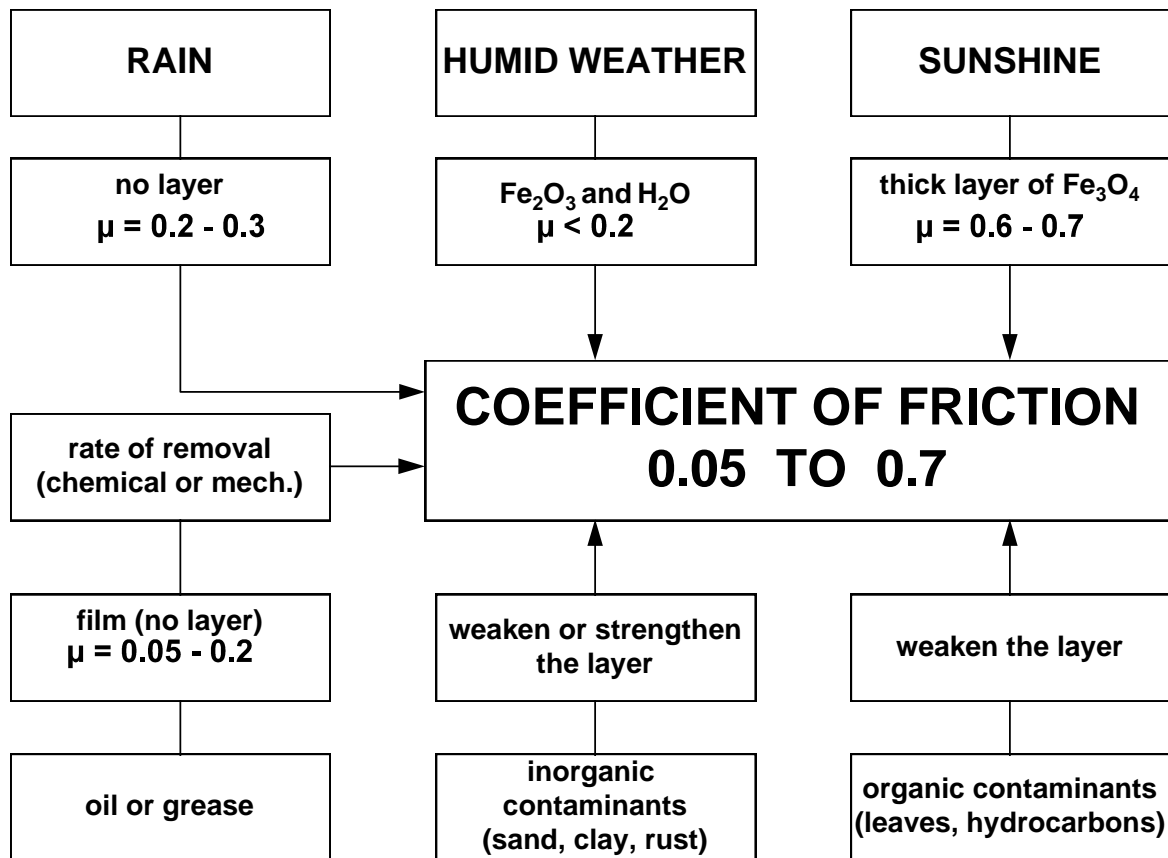
Figure 54. The Coefficient of Friction at the Unmanaged Wheel-Rail Interface Can Vary Widely, from 0.05 to 0.7

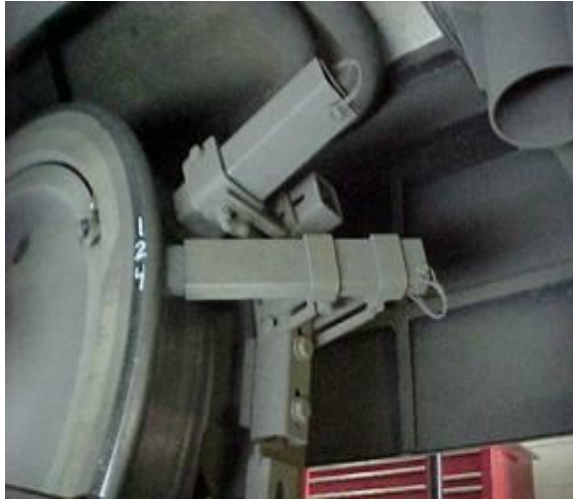
Friction modifier sticks apply products directly to the running surface of the wheel.

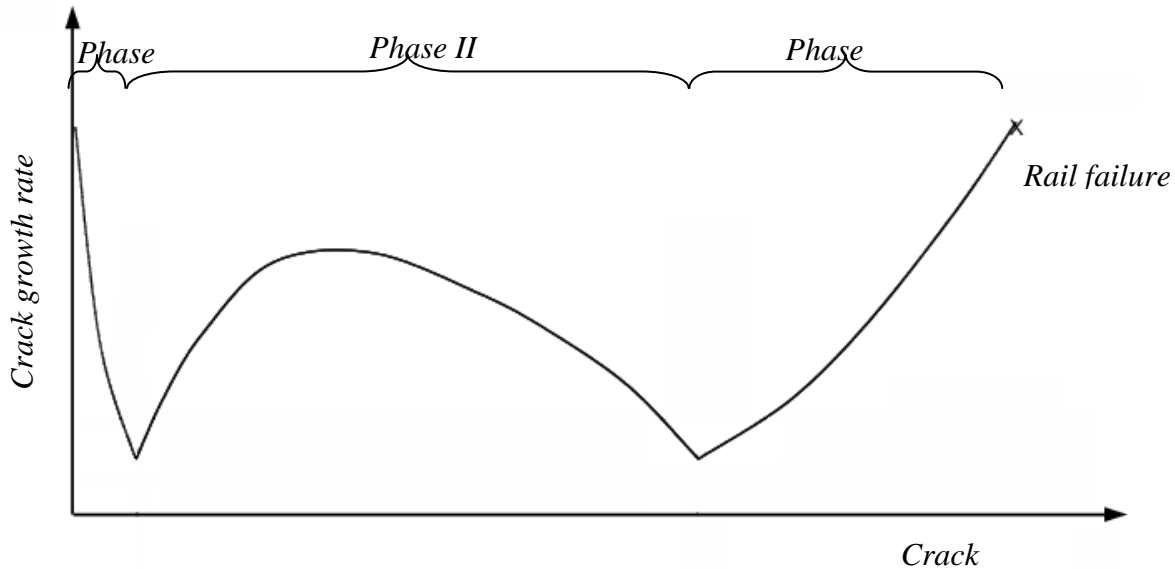
Figure 59. Crack Initiation and Fatigue Model Presented by Kapoor [139]
