Interim Guide for Optimum **JOINT PERFORMANCE** of Concrete Pavements

1. Report No.	2. Government Accession No.	3. Recipient's Catalog No.	
4. Title and Subtitle <i>Interim Guide for Optimum Joint Performance of Concrete Pavements</i>		5. Report Date September 2011

Interim Guide for Optimum JOINT PERFORMANCE of Concrete Pavements

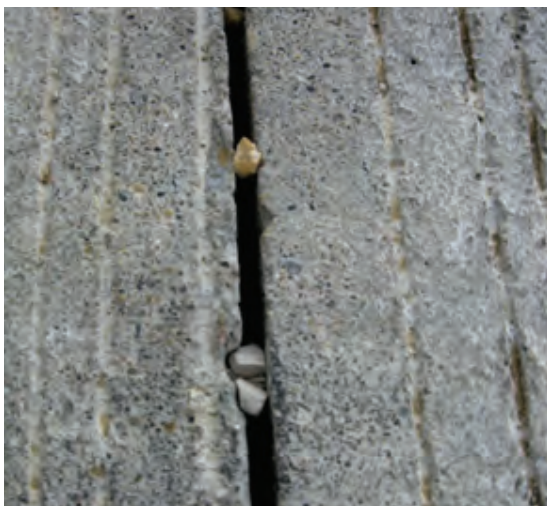
Figure 1. Incompressibles causing mechanical damage, which can lead to further distress

Spalling due to mechanical damage is typically found at the surface and will rarely extend through the depth of the slab. Mechanical-related joint damage can often be attributed to stresses caused by incompressible materials (sand, rocks, other debris) trapped in the joint (see Figure 1).

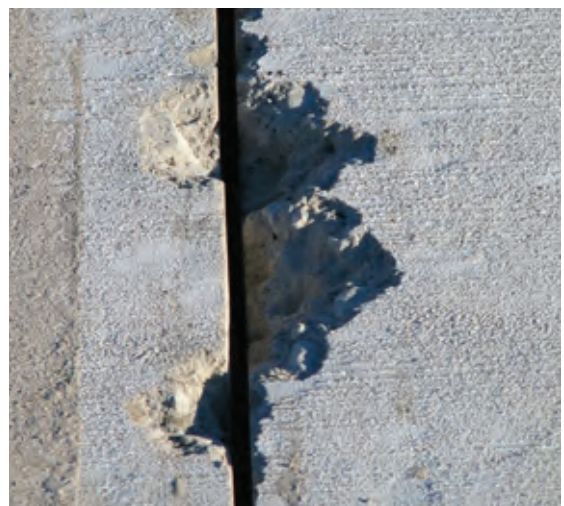
Figure 2. Raveling due to poor sawing practice (Source: Iowa Department of Transportation)

Raveling of a saw cut is caused by aggregate particles being dislodged during sawing, typically because the concrete strength is too low when sawing occurs. This is common when the shoe on an early-entry saw is not functioning properly, or when conventional sawing is started too early (Figure 2).

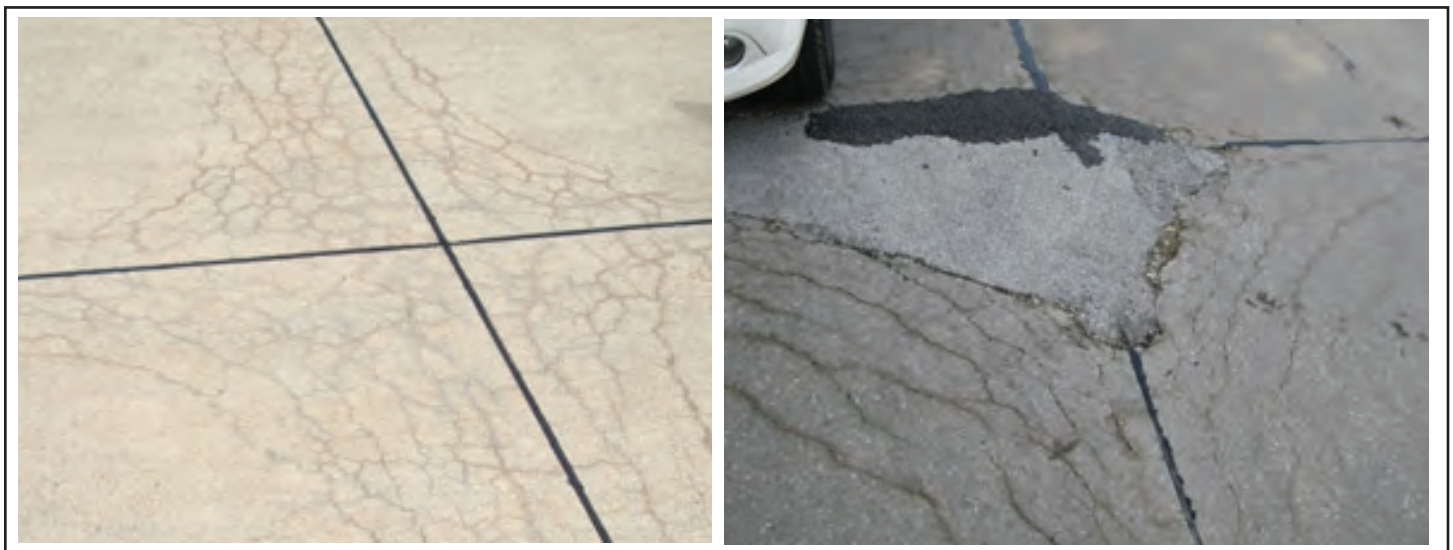
Figure 5. D cracking of low severity (left) and high severity (right) (Source: The Transtec Group)

D cracking is a type of joint deterioration caused by expansive freezing of water trapped inside some types of aggregate particles. The damage normally starts near joints and forms a characteristic crack pattern (Figure 5). The

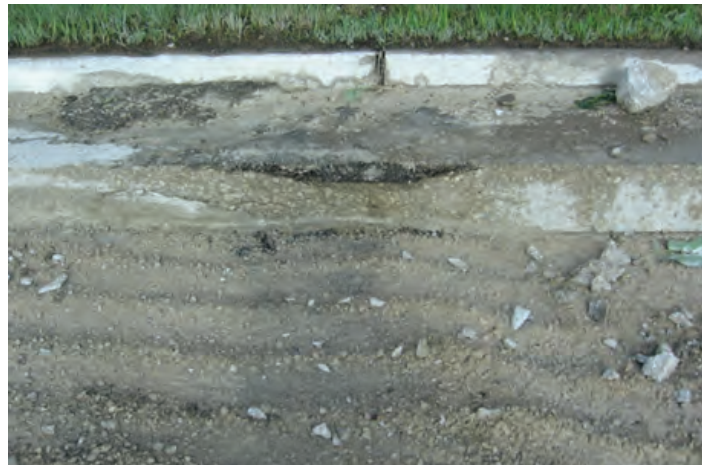
Figure 7. Typical saturated foundations under a shadowed section (Source: Snyder and Associates)

In most cases where shadowing is observed, the system is not well drained (Figure 7). Furthermore, the air-void systems of concrete near afflicted joints are often marginal or deficient. If petrographic examination is conducted on cores, it is common to observe evidence of secondary ettringite deposition in the air voids (Figure 8). This indicates abundant water within the concrete, although the exact mechanisms and effects of this ettringite deposition are still not resolved.

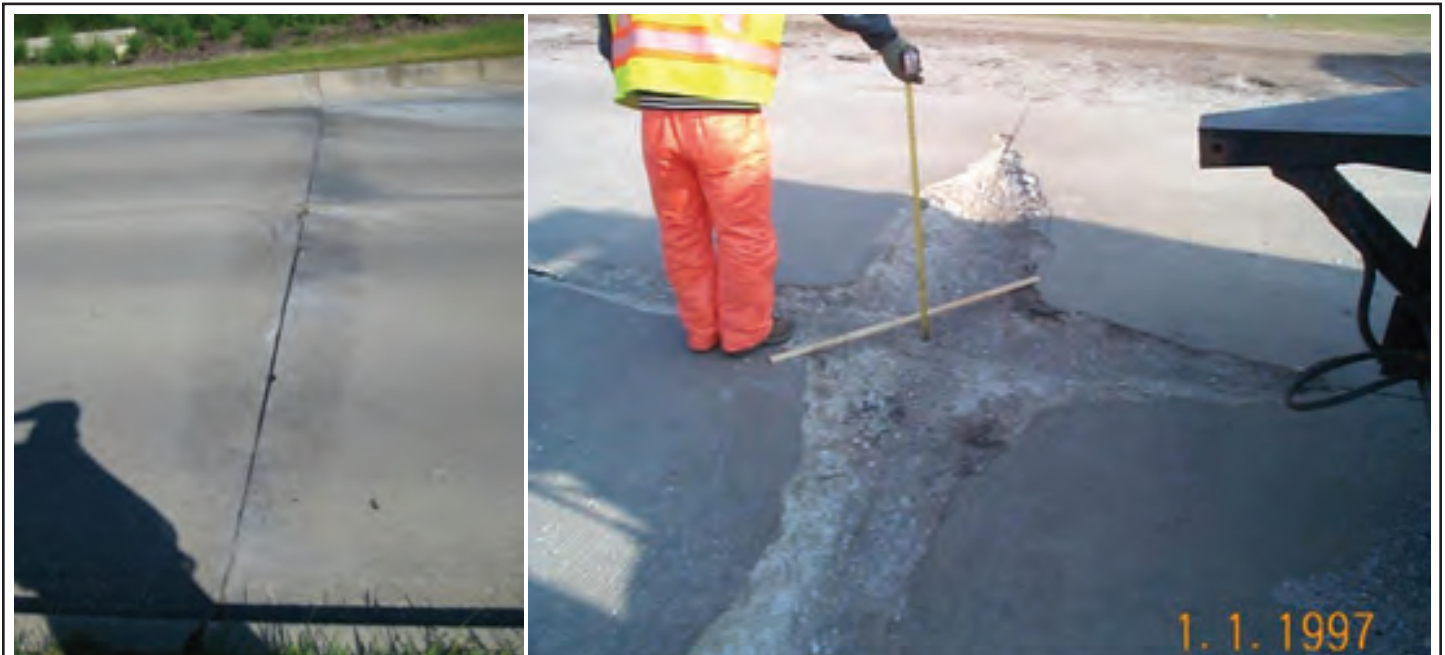
Figure 6. Evolution of joint deterioration from shadowing (left) to high severity (right)

Joint deterioration from frost damage is sometimes first observed as shadowing or darkening of a zone a few inches on either side of a joint. This effect is the result of a fine network of microcracks that develop near and parallel to the joint. The cracks trap water, which lead to the darker color. Over time, the concrete begins to crumble, and significant loss of material may occur. This evolution is shown in Figure 6.

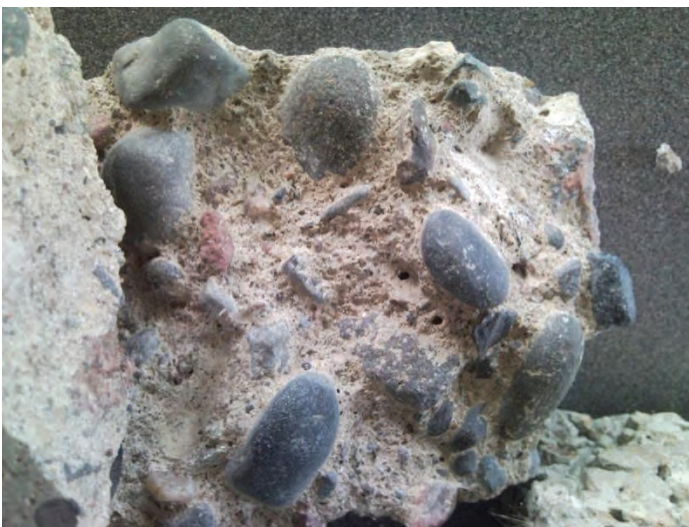
Figure 10. Coarse aggregate exposed by damage to the paste

The coarse aggregate still embedded in the concrete is often free of adhering mortar on the exposed face (Figure 10). This indicates a mechanism that is attacking the paste alone.

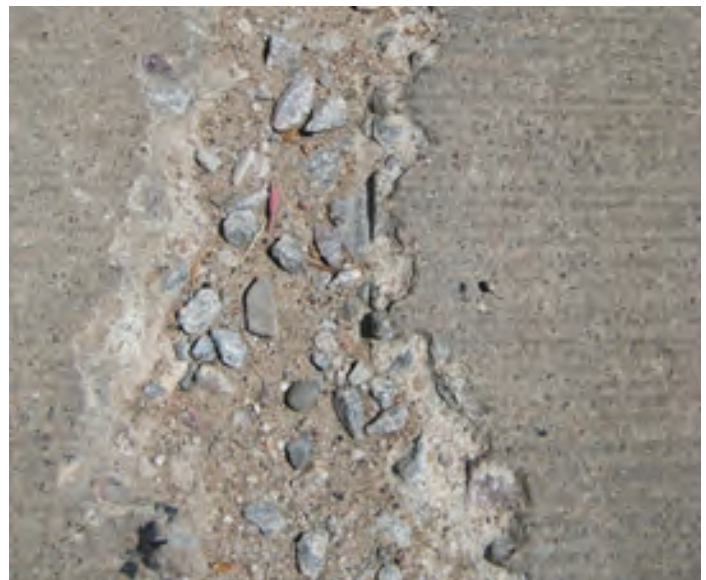
Figure 11. Shallow joint damage

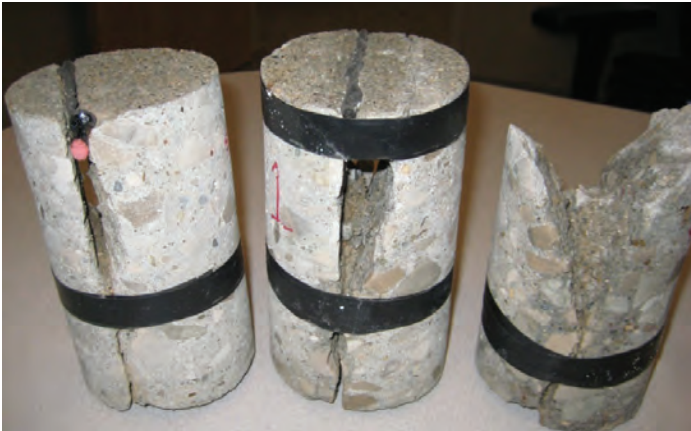
Figure 12. Three cores illustrating progression of distress from bottom-up moisture

Another form of frost damage can occur when the pavement is placed on a non-draining base and/or when the water table is above the bottom of the slab. In this case, the top of the pavement may appear to be in reasonable condition, but coring reveals concrete that has been seriously damaged in the joint. Figure 12 illustrates the progression of this phenomenon. Interestingly, the damage is more pronounced in the saw-cut than in the crack, presumably because a significant amount of water can collect in the saw-cut while cracks tend to be tight. Figure 13 illustrates the site where these cores were extracted, showing the clear signs of abundant water flow.

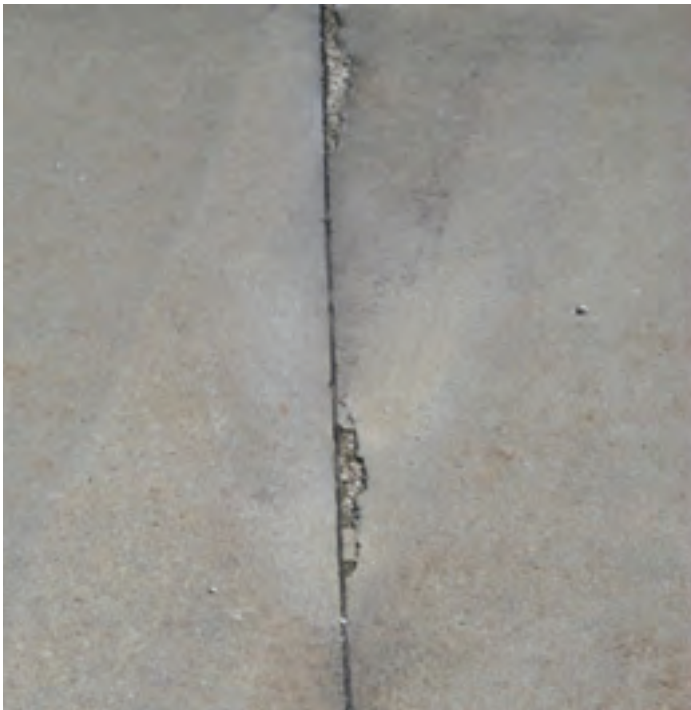
Figure 13. Water flow through joints from a high water table (bottom-up moisture); note staining on surface

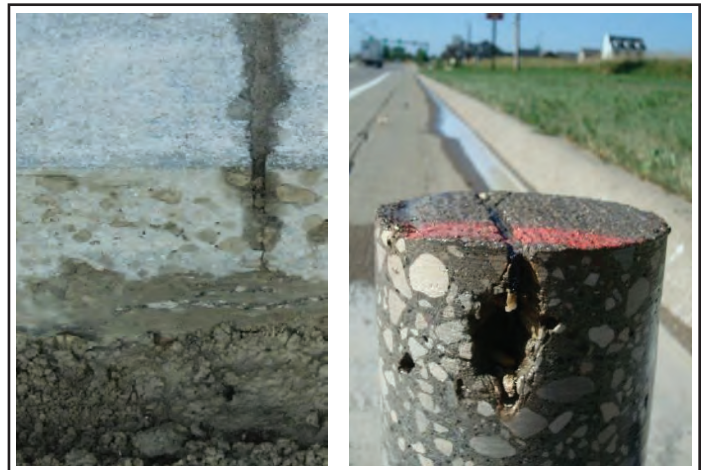
Figure 15. Saturated soils due to inadequate drainage and roadside irrigation (left) leading to joints showing frost damage (right) (Source [left]: Snyder and Associates)

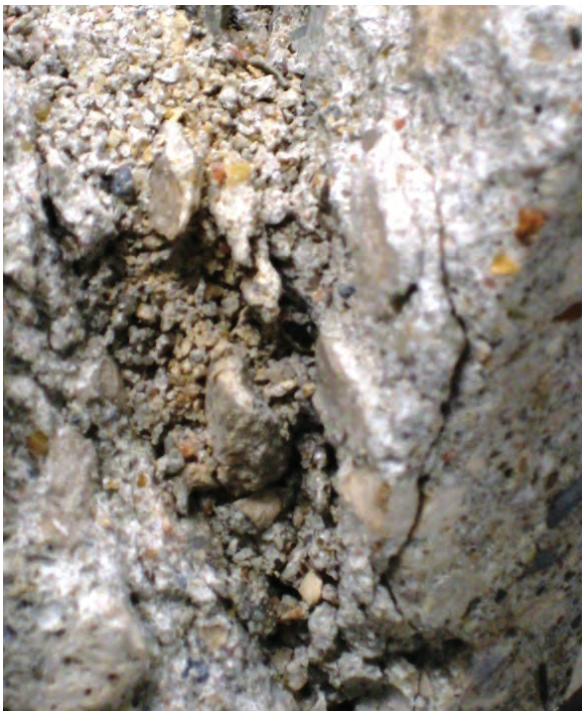
Figure 16. Typical slivers from freezing and thawing cycles

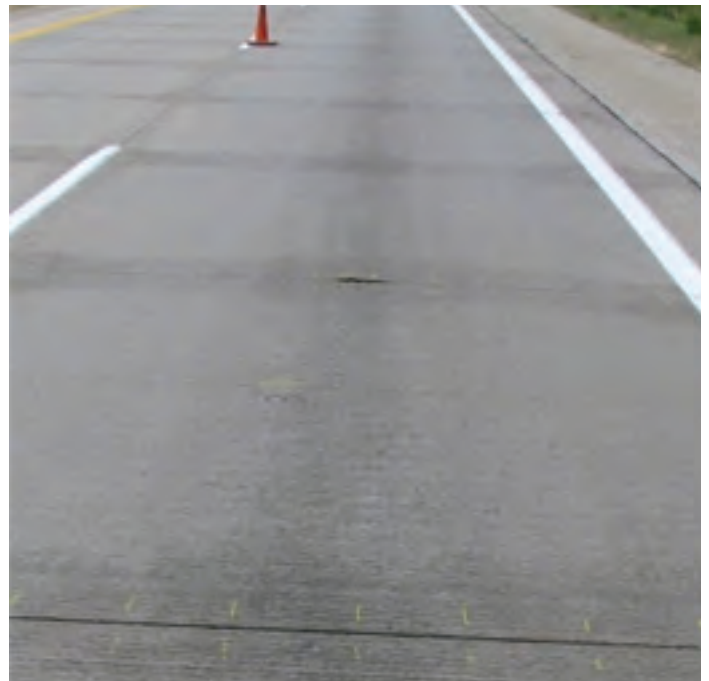
Figure 17. Shadowing at the joints, which is commonly followed by loss of material

Basic forms of joint deterioration are shown in Figure 17 through Figure 22. Following are the critical factors:

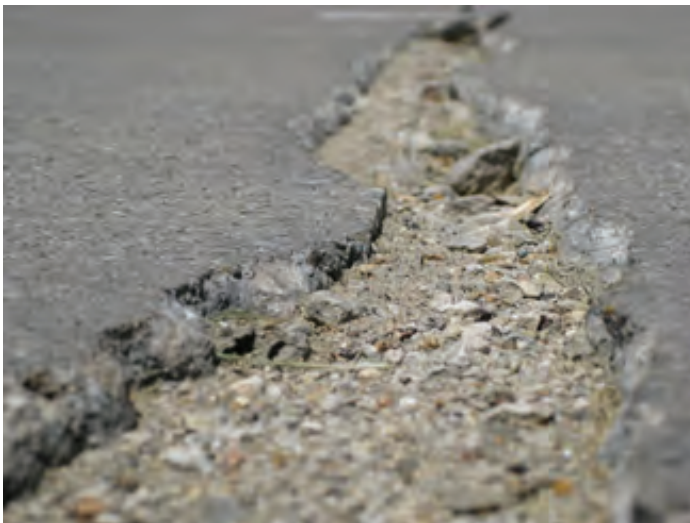
Figure 18. Top-down joint distress, with vertical edges and shallow depth

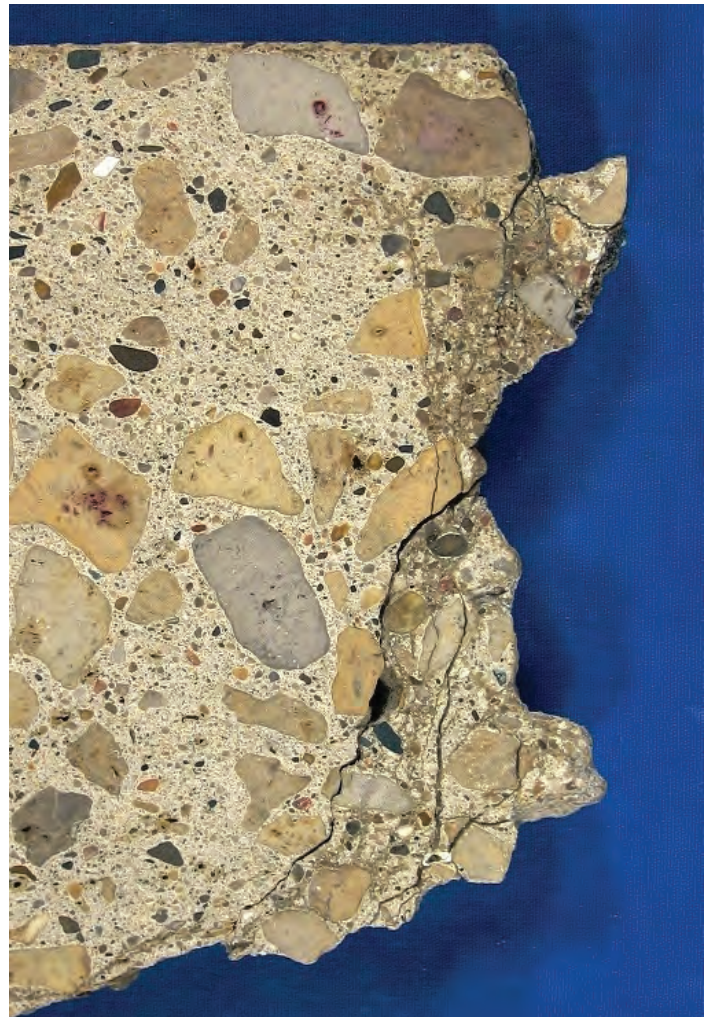
Figure 21. Deterioration due to bottom-up moisture

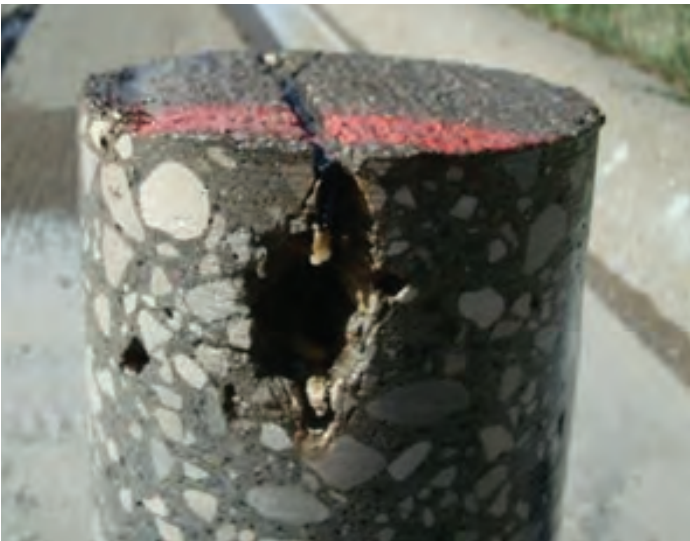
Figure 19 Joint deterioration evident below the joint sealant

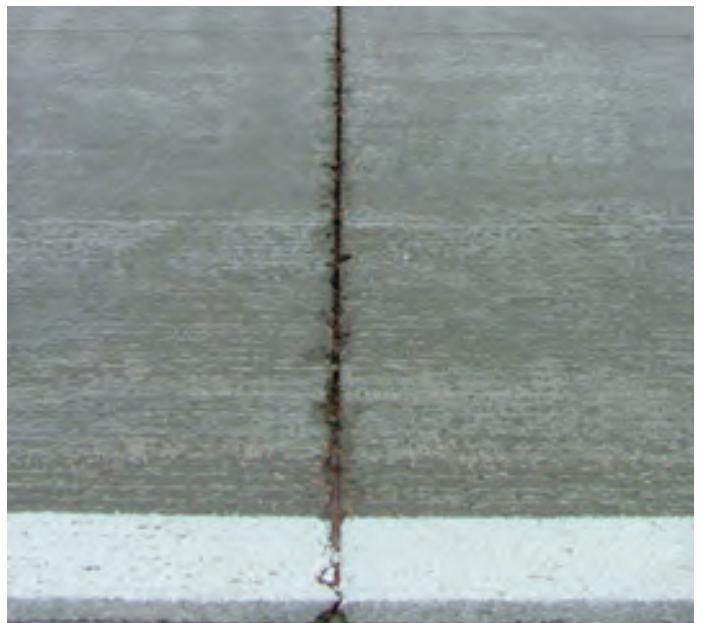
Figure 22. Joint deterioration due to raveling from improper saw-cut procedures

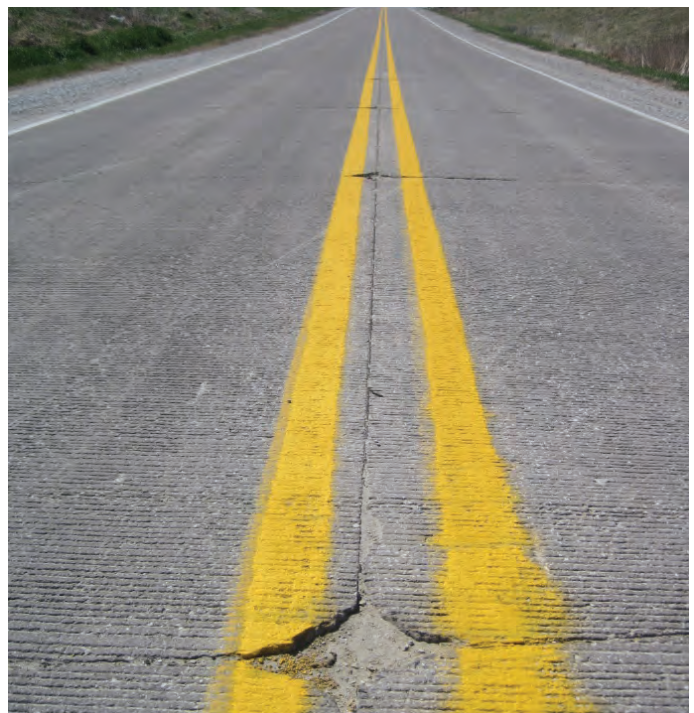
Figure 23. Damage starting at joint intersections

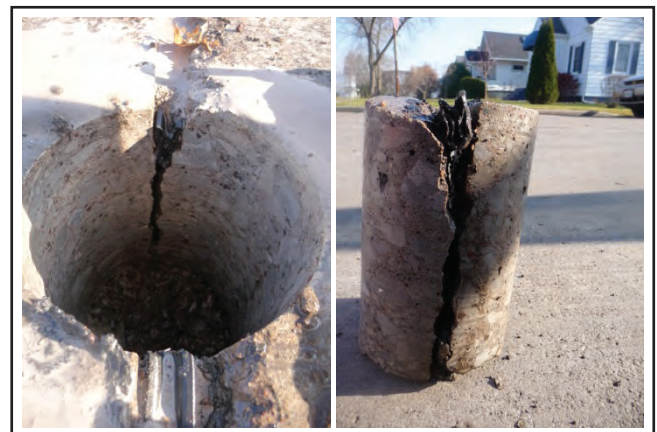
Figure 24. Coring at deteriorated joints to help identify causes of failure

Ideally, cores should be extracted from several locations:

- Over a distressed area of a joint.
- Over the same joint, but at the end of the distressed area in an attempt to identify damage early in its development.
- In the slab, a few inches from the joint, in order to characterize the concrete near the joint.
- At the center of the slab, to assess variability in the mixture and placement.
- From a nearby section that is not exhibiting distress in order to determine why one section is distressed and the other is not.

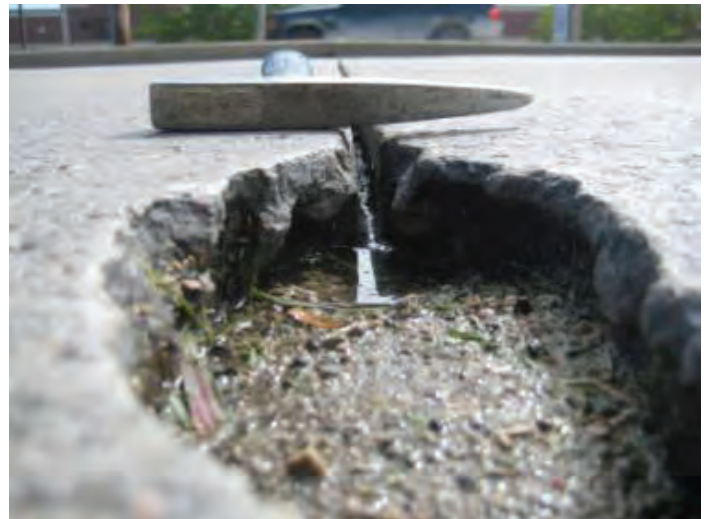
Figure 25. Example of a poorly draining pavement

- Provide stable and drainable base layers (evidence of the lack of this is shown in Figure 25). It should be noted that because the amount of water that penetrates

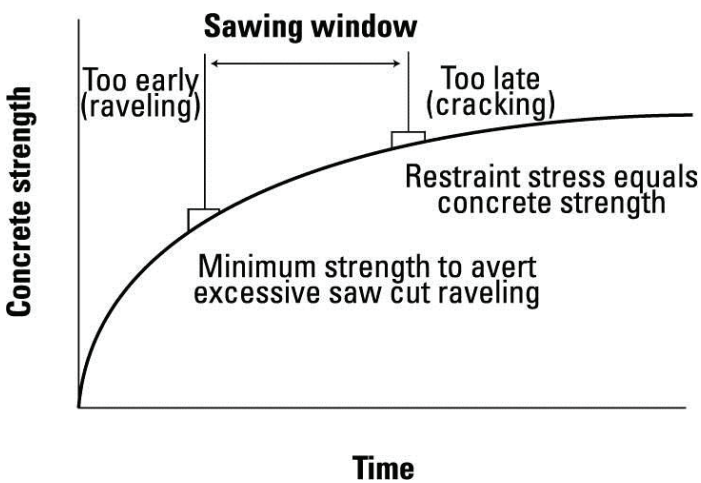
Figure 26. Definition of the sawing window (9)

There is window to saw contraction joints in new concrete pavements (Figure 26) (2,9,11). The window begins when concrete strength is sufficient for sawing without excessive raveling along the cut. The window ends when random cracking starts to occur. The risk of random cracking increases as joint sawing is delayed.

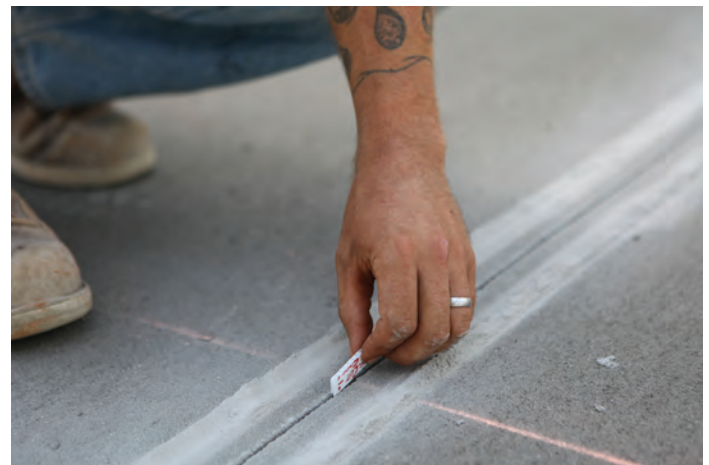
Figure 28. Using temporary joint spacers to protect and minimize damage due to early entry sawing (Source: Husqvarna)

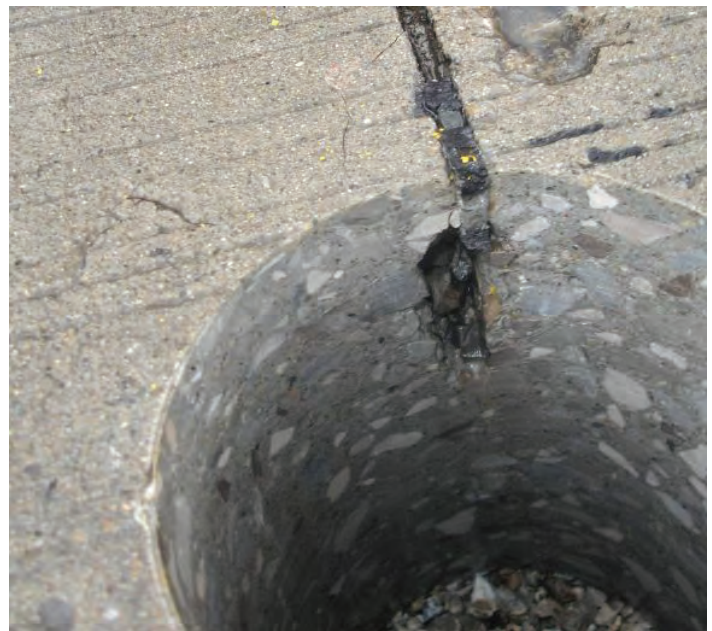
Figure 29. Evidence of saturation within joint beneath seal (Source: Purdue)

However, there have been numerous examples of pavements exhibiting premature joint deterioration where water has been trapped in the joint, particularly below a seal in a tight or uncracked joint, as illustrated in Figure 29.

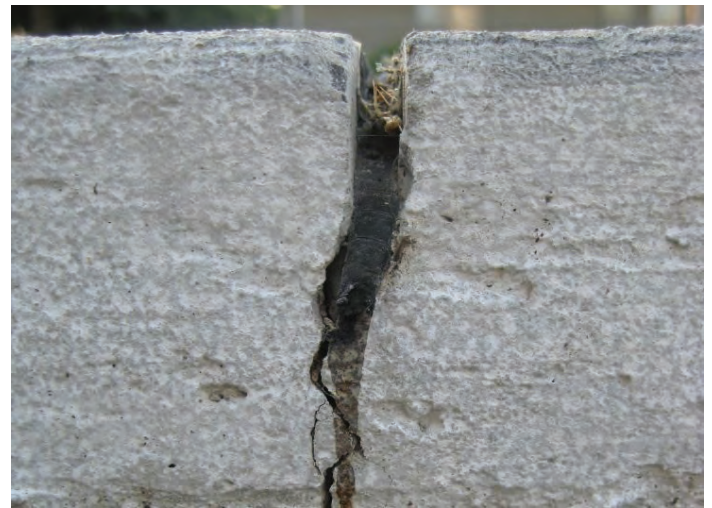
Figure 30. Joint filled with hot pour sealant (Source: The Transtec Group)

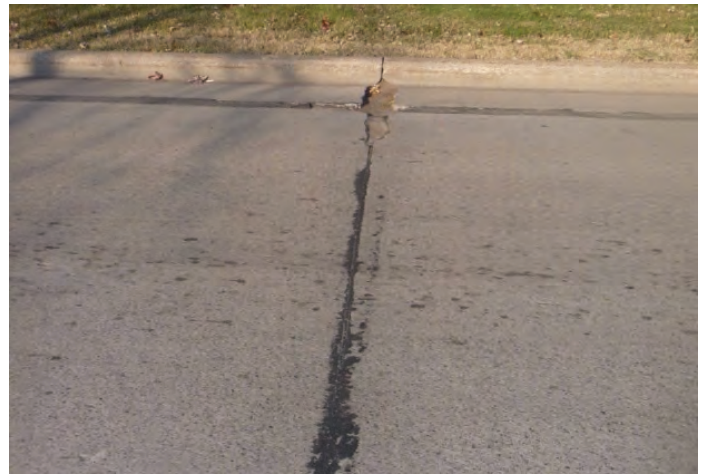
Figure 31. Failing transverse joint associated with poor drainage at gutter

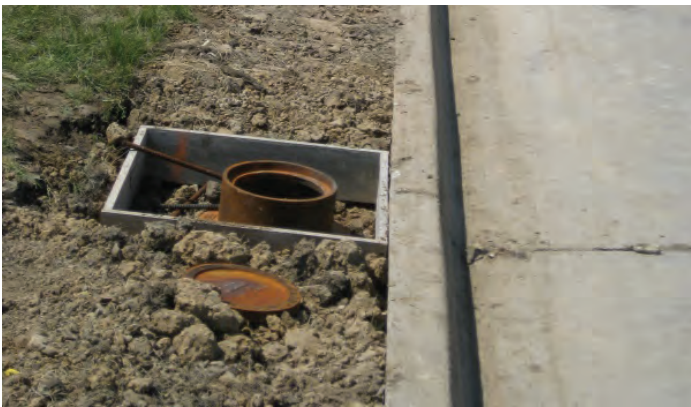
Figure 33. Subdrain retrofit operation including clean out (The Transtec Group)

groundwater tables. If a source of excess water is identified and cannot otherwise be mitigated, edge drain retrofit can be considered. A retrofit is shown in Figure 33. It should be noted that this process requires careful project evaluation, design, installation, and maintenance. The presence of existing utilities can be particularly problematic during the retrofit process. Retrofitting edge drains is not recommended for sections exhibiting severe joint deterioration. More guidance on this topic can be found in the *Concrete Pavement Preservation Workshop Reference Manual* (14).

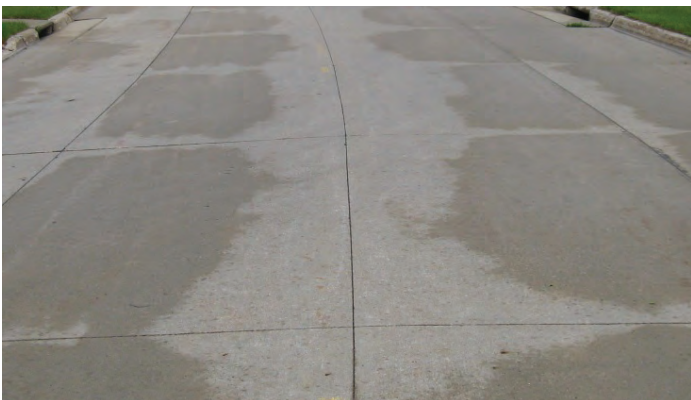
Figure 34. Example of effective drainage of unsealed joints

One technique to determine if there are drainage issues is to observe the pavement surface immediately after a rain event, noting whether the joints or the rest of the slab dries first. Figure 34 shows a pavement with unsealed joints after measurable rain. It can be observed that the water is effectively exiting the system and the joints are drying before the rest of the slab. This pavement is in good condition after 10 years in service.

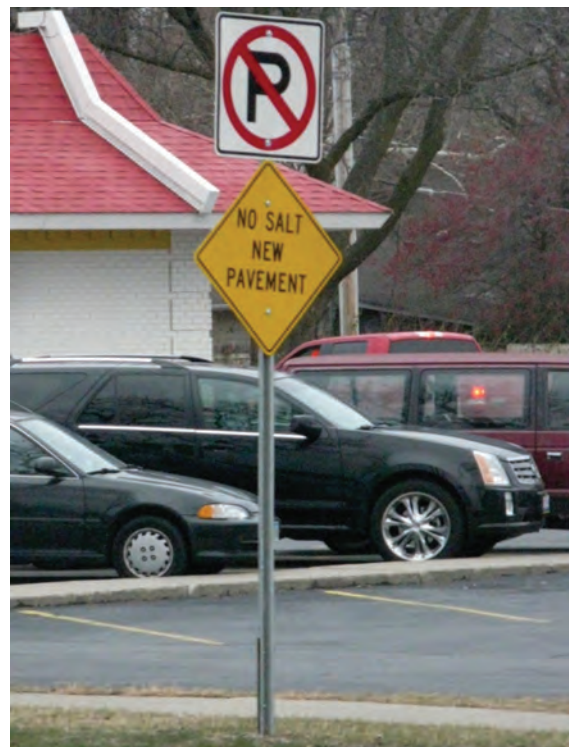
Figure 35. Signage to help avoid salting of new pavement

An additional recommendation from Transportation Pooled Fund TPF 5(042) (5) is to employ a minimum 30-day or one-winter “drying period” before applying deicing chemicals to new concrete (Figure 35).

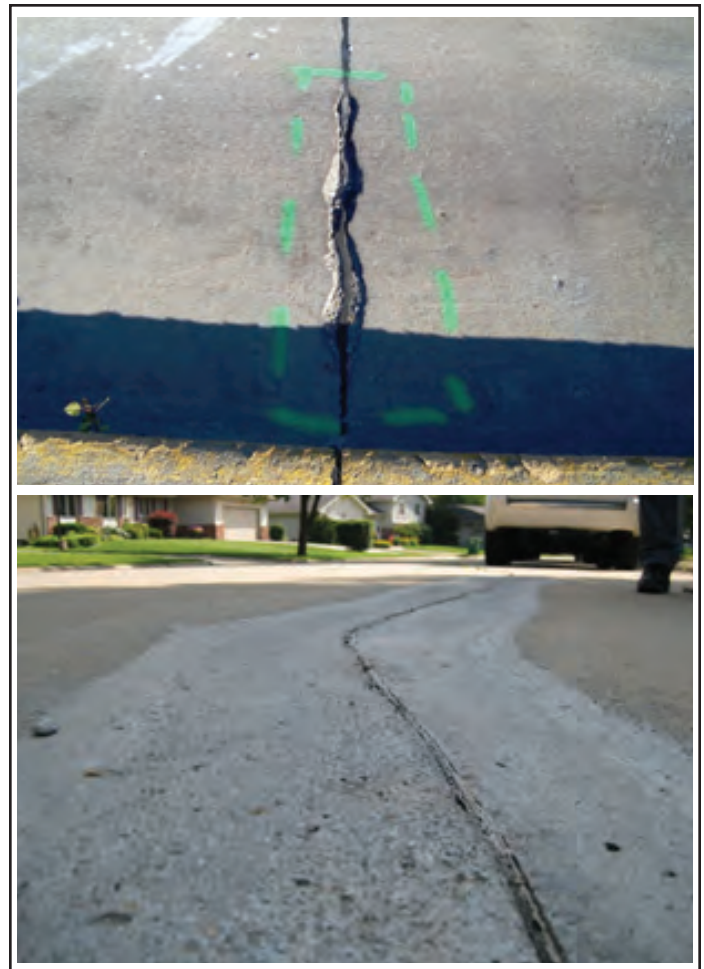
Figure 37. Delineation of spalled area for partial-depth repair (top) and a completed patch (bottom) (Source [bottom]: The Transtec Group)

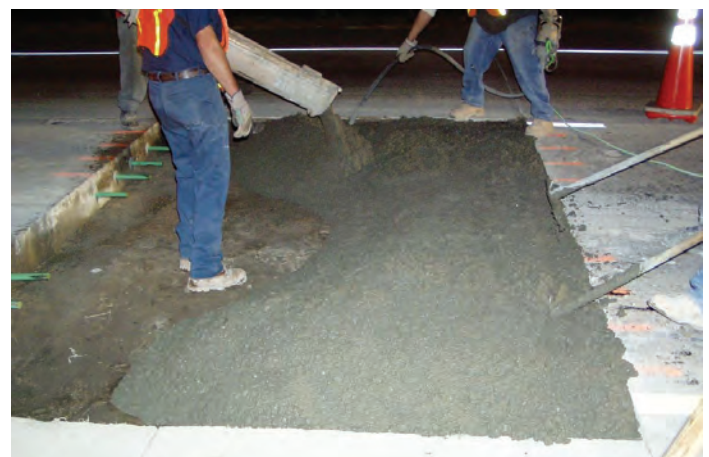
Figure 40. Full-depth patching

- Full-depth repairs are effective if deterioration is limited to the joints or cracks.
- Full-depth repairs are effective if the deterioration is not widespread over the entire project length; otherwise, a structural overlay or reconstruction is more suited.
- Long-lasting full-depth repairs are dependent upon many items, including appropriate project selection, effective load transfer design, and effective construction procedures.
- Diamond grinding should be considered after the repairs are made to produce a smooth-riding surface.
