Performance of Strip Seals in Iowa Bridges, Pilot Study

FINAL REPORT

Iowa Highway Research Board
Project TR-437

Iowa State University

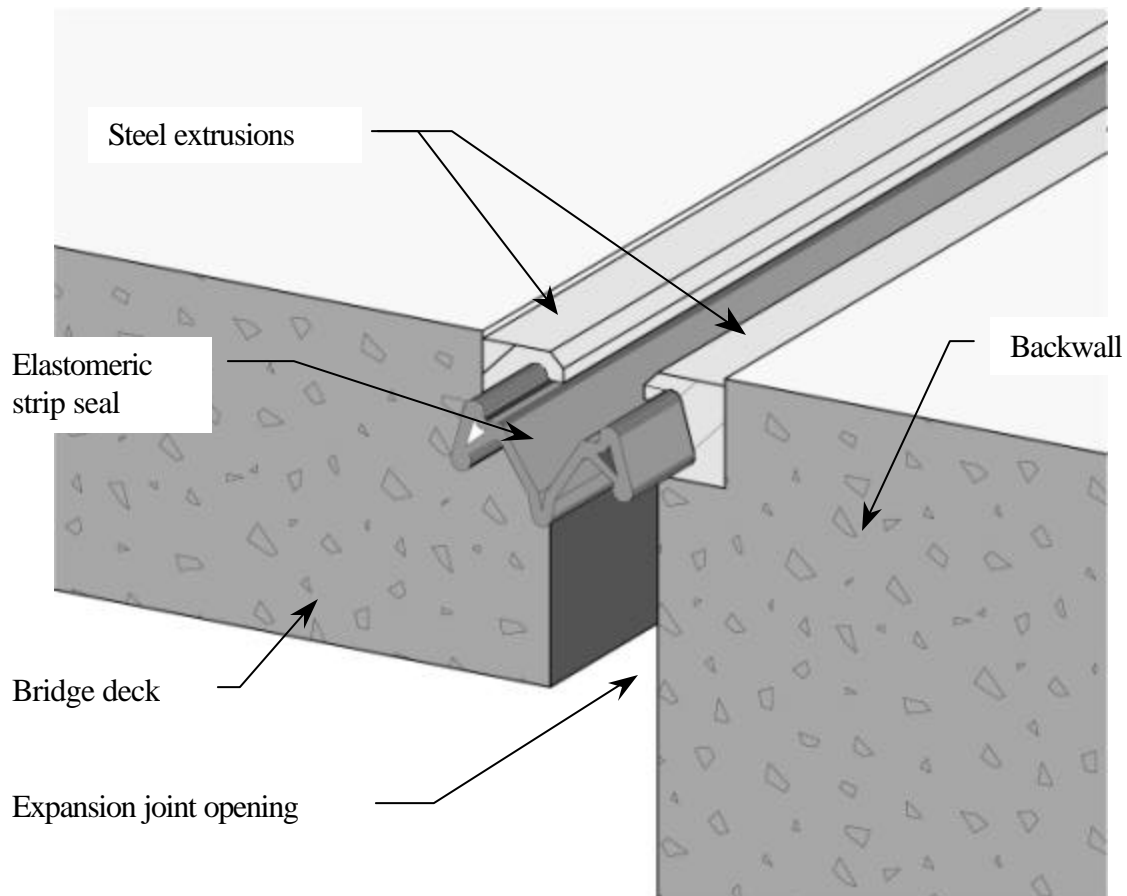
Figure 1.1 Typical strip-seal expansion joint device

Expansion joints are used in bridges to allow expansion and contraction of the bridge superstructure due to temperature changes. In order to prevent salt, water and debris from passing through the expansion joint opening and reaching the bridge substructure, a seal or trough is required in the expansion joint opening. A strip-seal expansion joint device is one alternative for this function. It consists of a pair of steel retainer rails (steel extrusions), a polychloroprene (neoprene) gland and lubricant/adhesive material to facilitate the installation of the gland and to seal the gland in the extrusions.

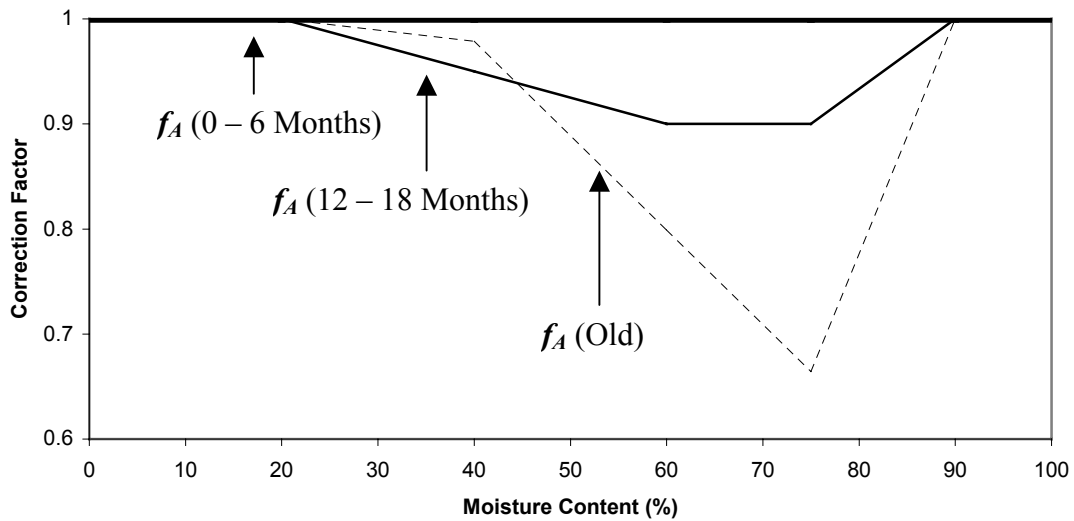
Figure 2.2 Correction Factor for f_A (adapted from [3])

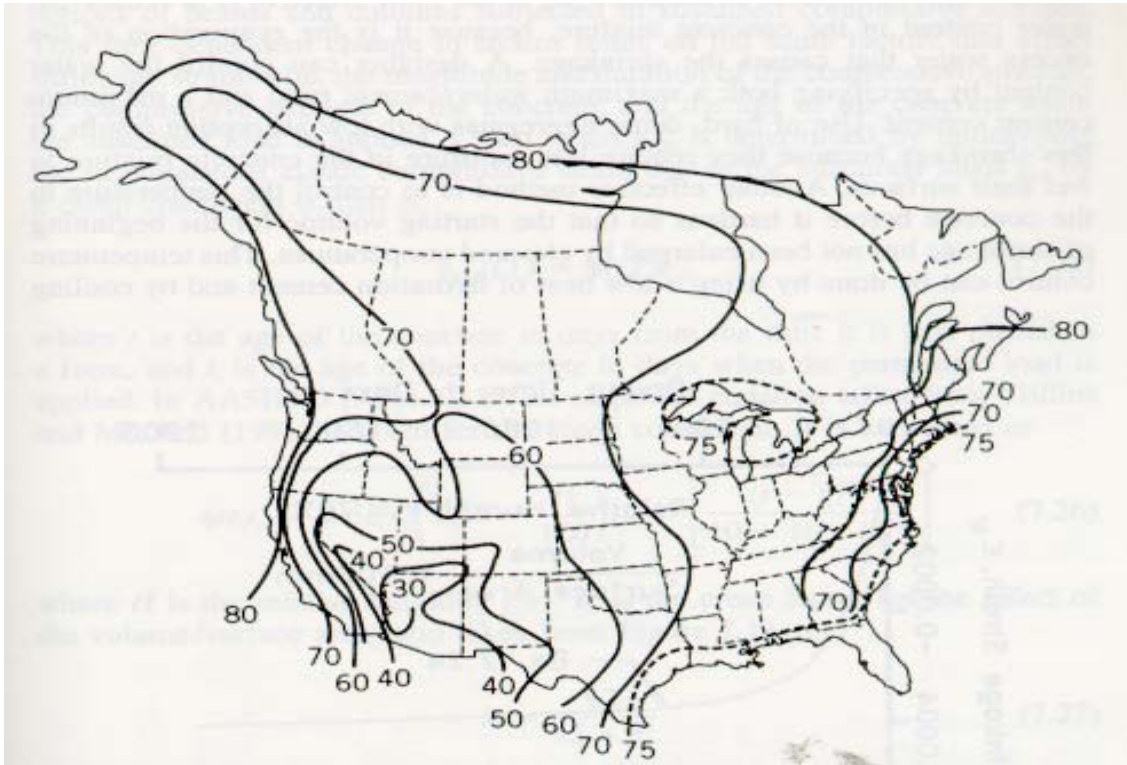
Figure 2.3 Annual average ambient relative humidity in % (Adapted from [7])

k_h = humidity factor specified in Table 2.9 and Figure 2.3,

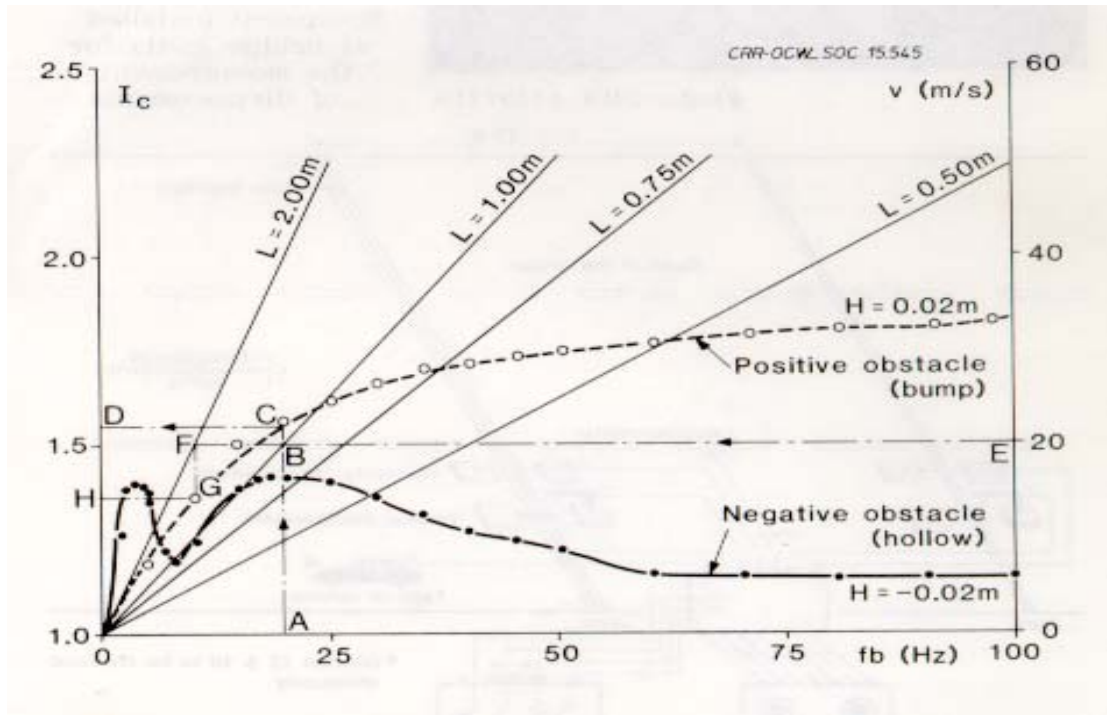
Figure 2.4 Determination of dynamic amplification factor (adapted from [22])

I_c = dynamic amplification factor (Figure 2.4).

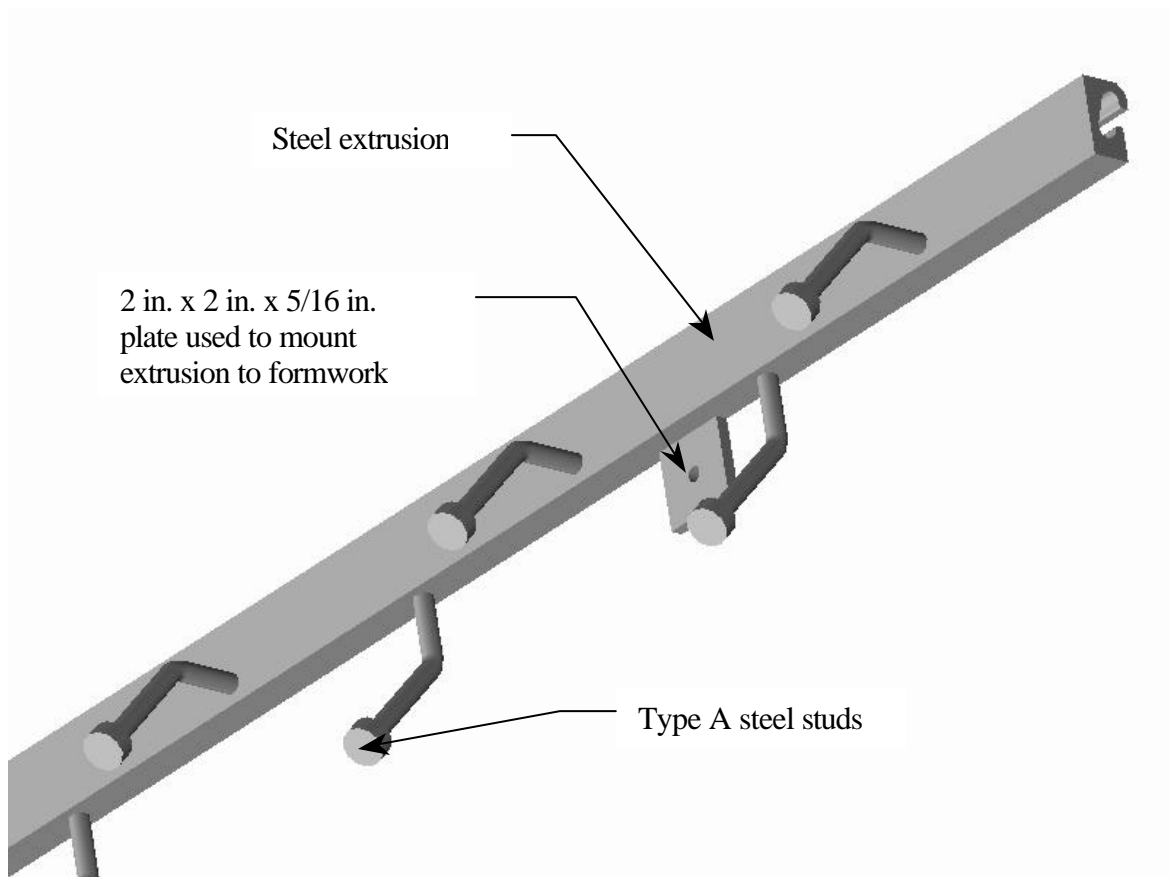
Figure 3.2 Typical configuration of steel extrusions as used in South Dakota.

The South Dakota DOT permits the use of A36, A242, or A588 steel for the rails. The small steel plates welded to the bottoms of the rails for purposes of mounting the rails to the formwork, however, are to be of A36 steel and the concrete anchors are to be Type A Steel Studs (Figure 3.2). South Dakota requires that, before installation, the shop plans of the proposed strip seal showing the fixed dimensions, thickness of the seal, and dimensions pertinent to the fit of the seal in the extrusion be submitted to and approved by the engineer.

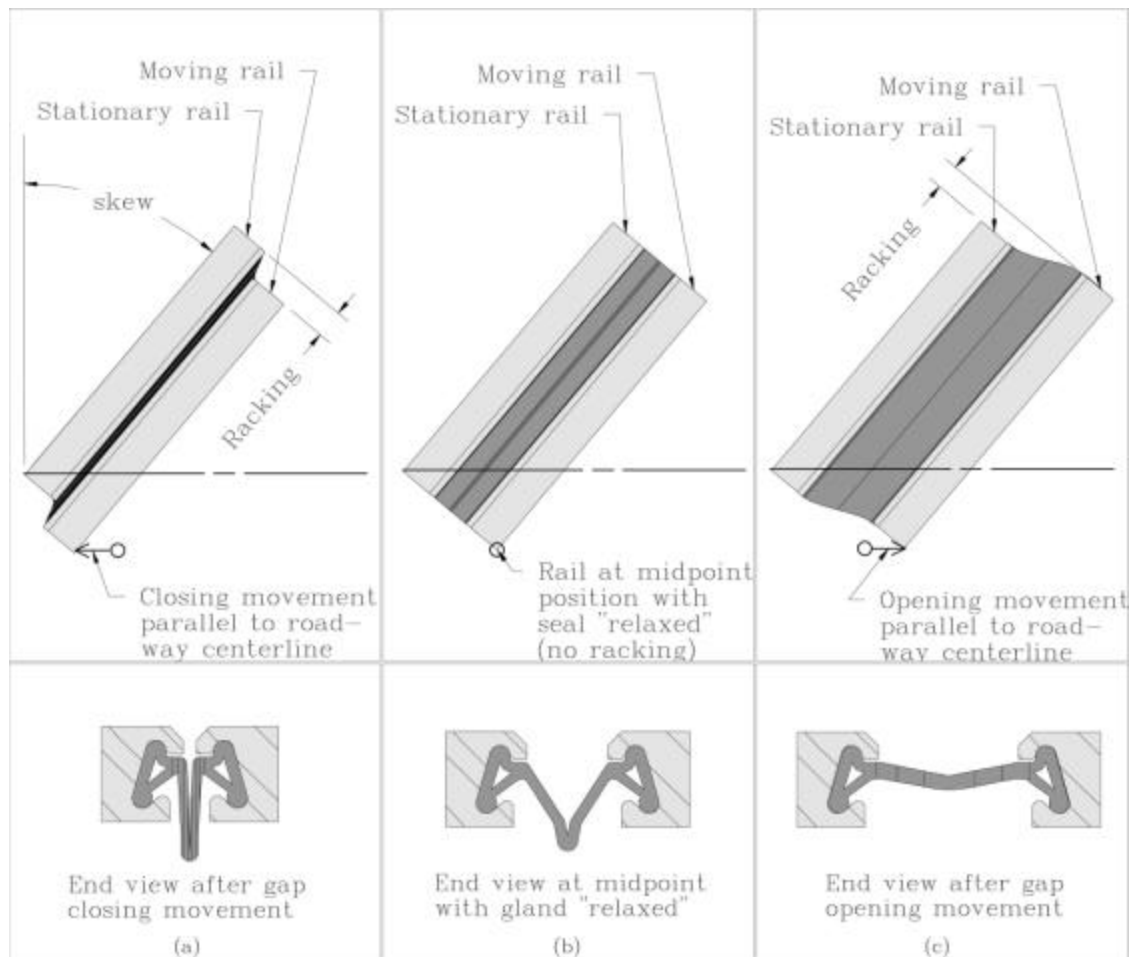
FIGURE 3.4 For large skew angles, movement includes a significant racking component which decreases the effective movement range of the neoprene gland.

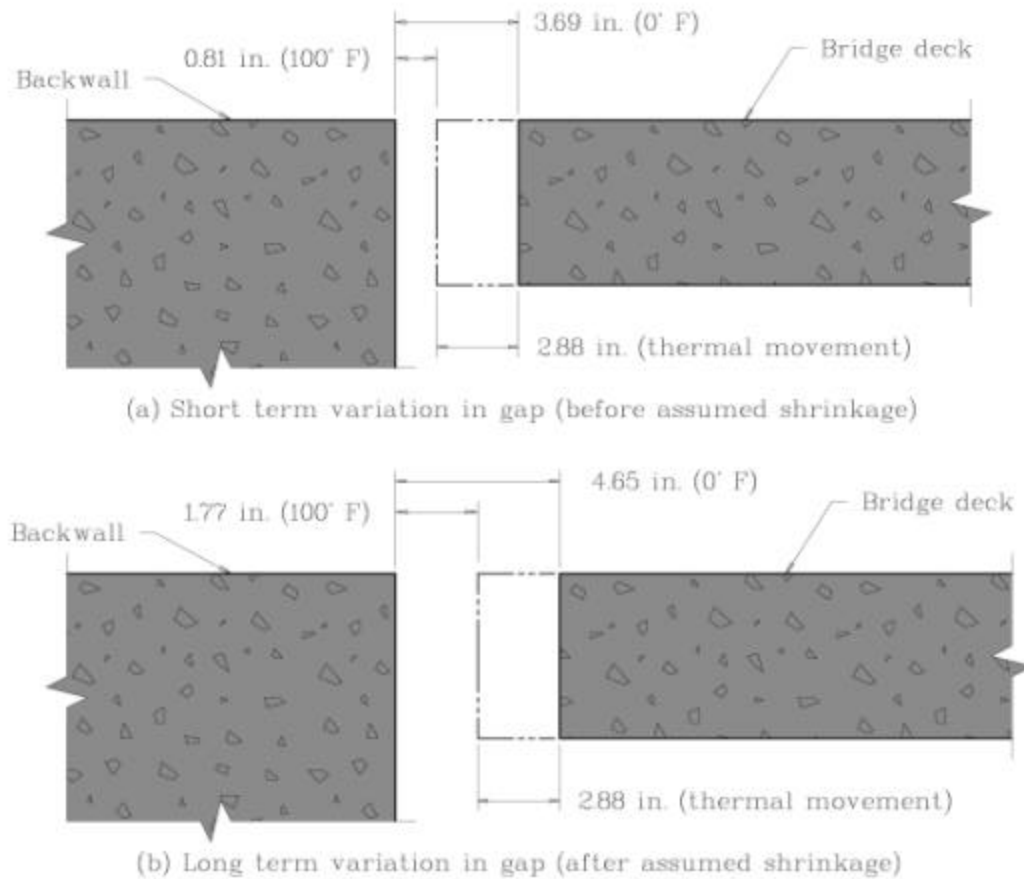
Figure 3.5 Predicted gap variation with and without the effects of shrinkage

These long-term minimum and maximum gaps are illustrated in Figure 3.5(b). The gap variation due to thermal effects is still 2.88 in. However, because of shrinkage effects, the maximum gap (i.e., the gap at 0° F) is now 4.65 in., which is considerably larger than the 4 in. maximum opening rating for the SE400 gland.

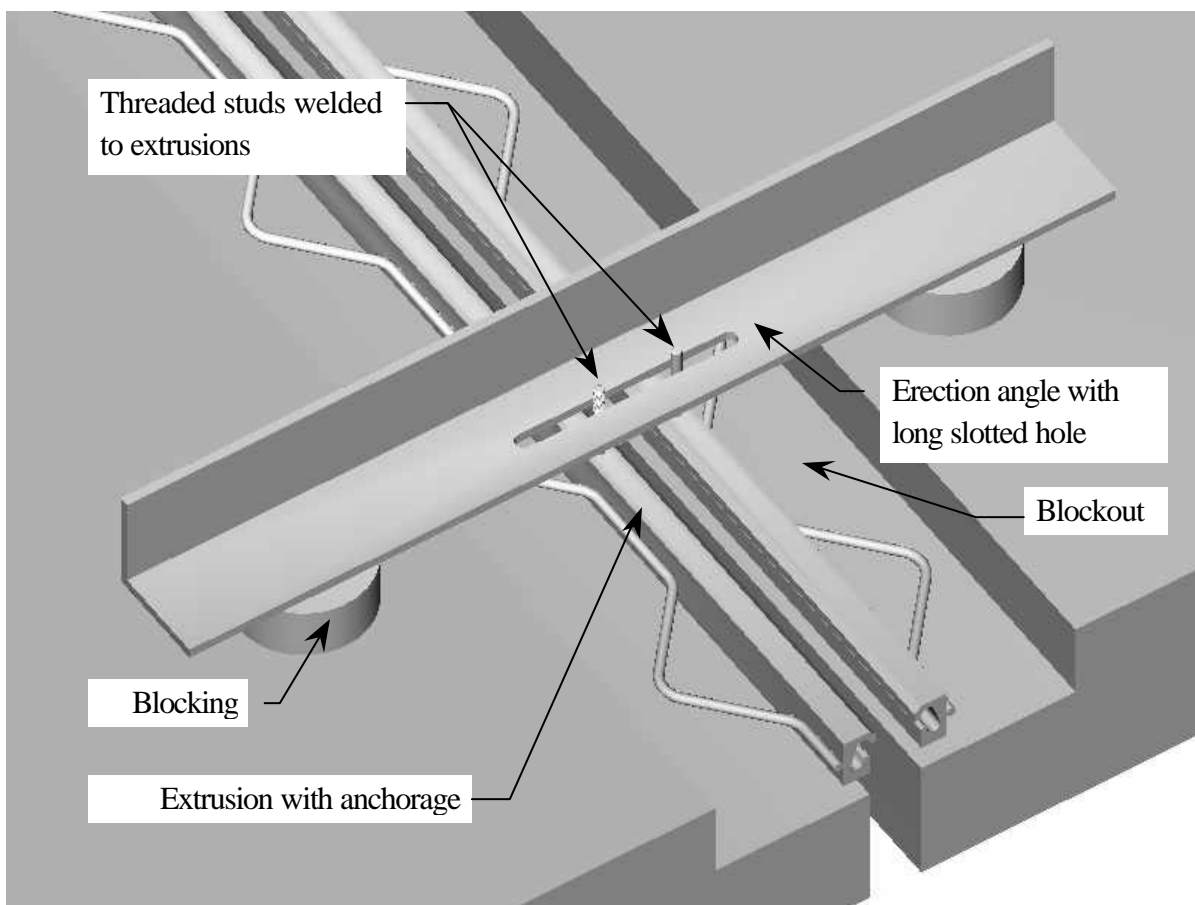
Figure 4.1 Computer model of extrusions positioned in blockouts using an erection angle

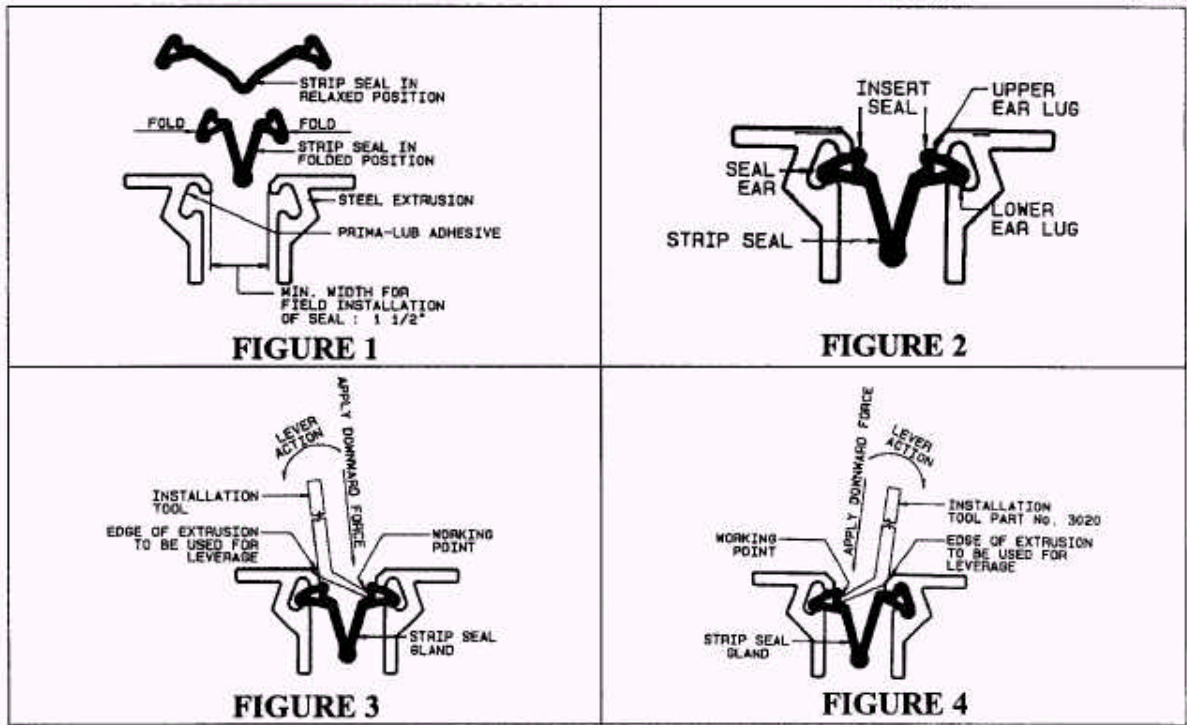
Figure 4. 2 Figures from Watson Bowman Acme to illustrate the seal installation steps

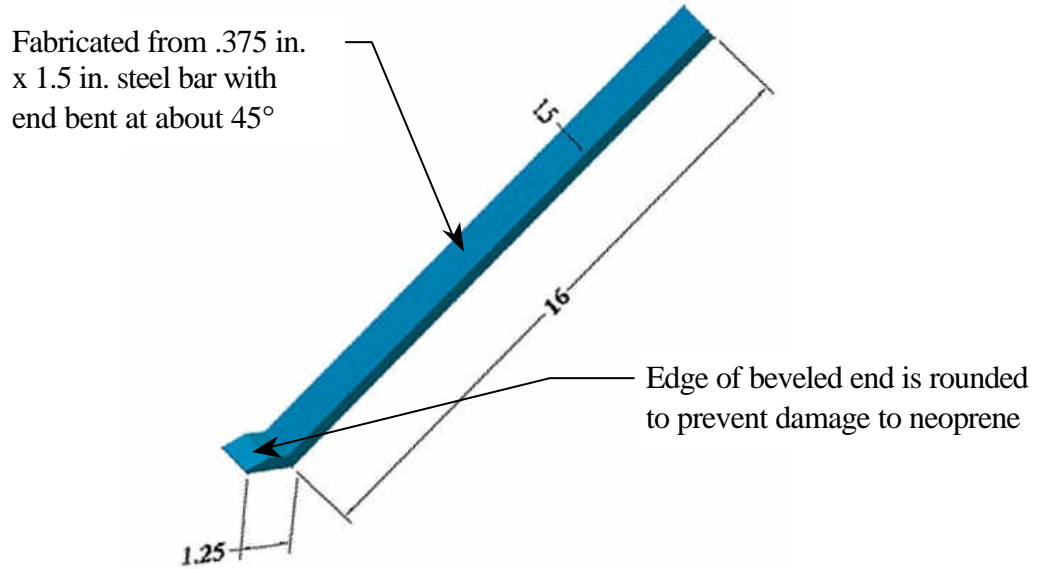
Figure 4.3 Installation tool similar to that available from Watson Bowman Acme

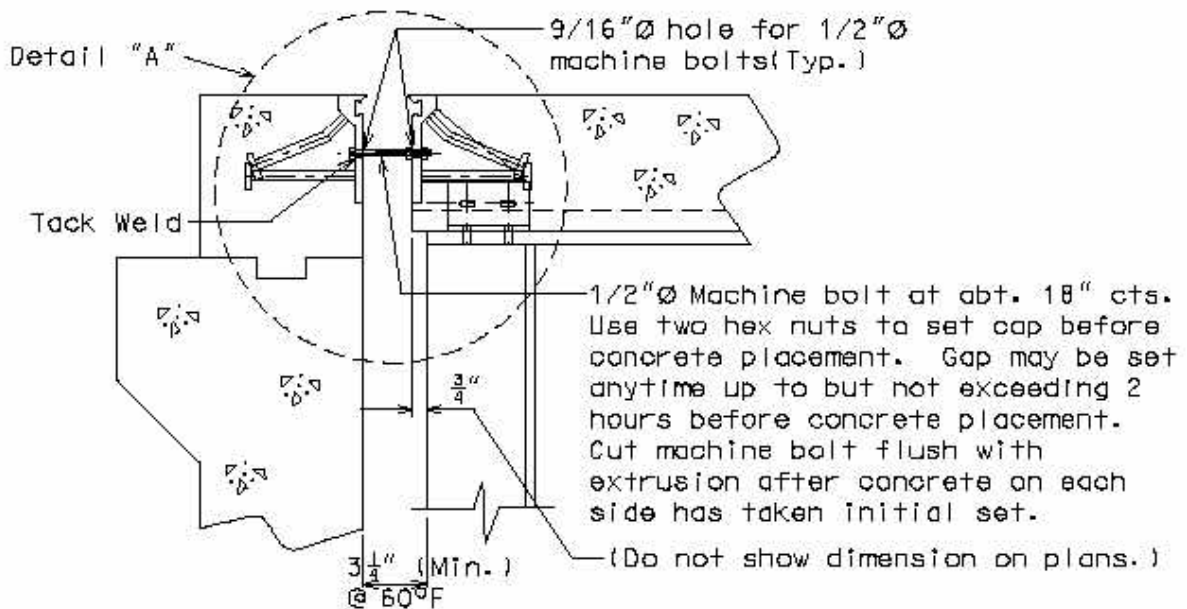
Figure 4.4 Mechanism used in Missouri for setting the gap with P-type extrusions

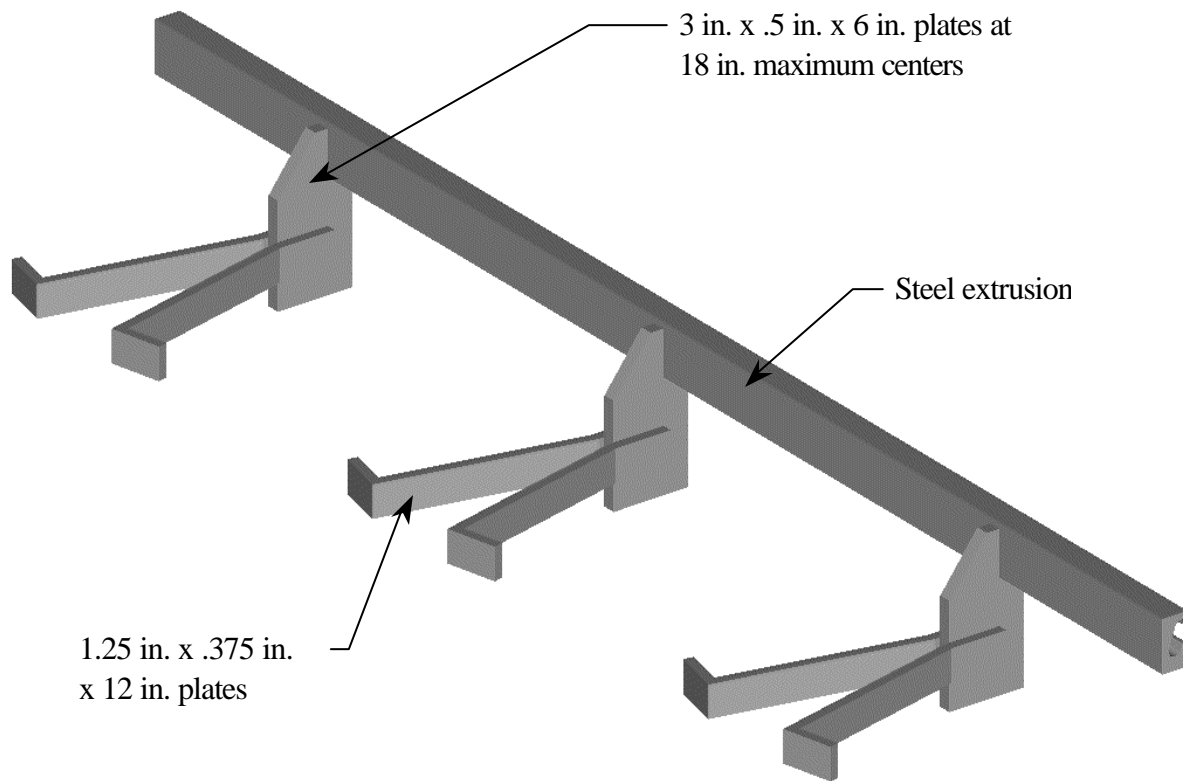
Figure 4.5 Model of the extrusion with anchorages of the type used in Iowa

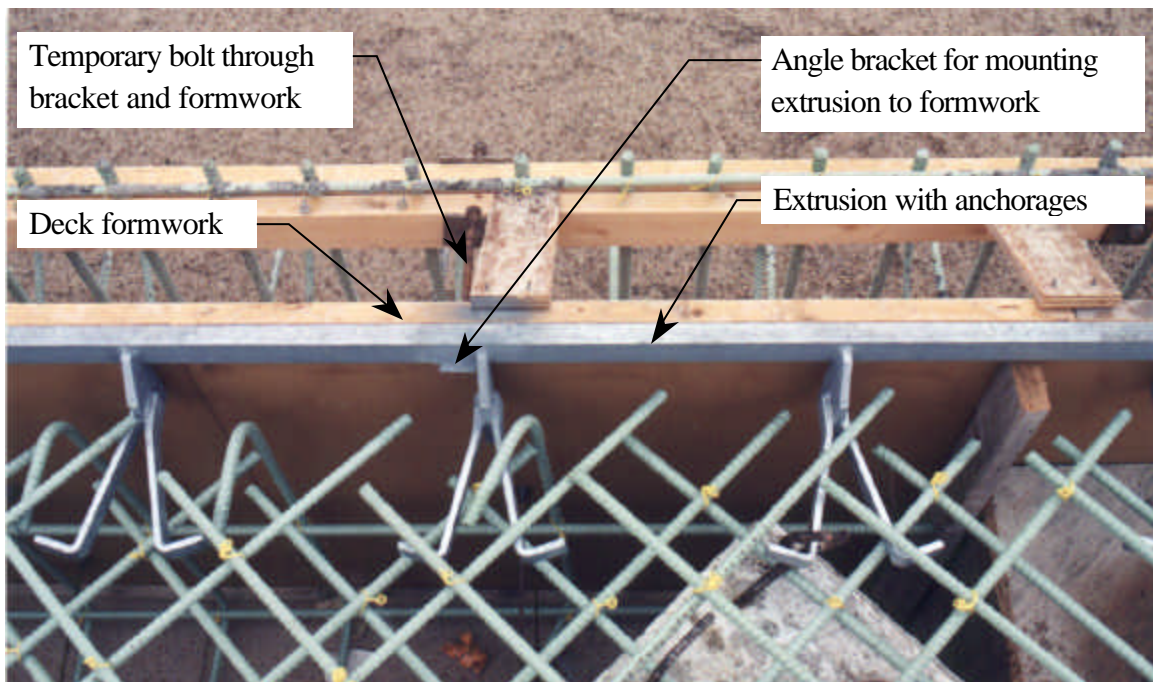
Figure 4.7 Rail section with anchorages positioned and bolted to deck formwork

Sometime after the deck rails are installed, the deck is poured and the anchorages and bottom and deck-side of the rail are encased in concrete (Figure 4.13). After adequate curing time for the deck concrete (usually about a week), the deck formwork is stripped and forming of the backwalls begins. Once the formwork for the backwalls is complete, the rail sections on the backwall sides are positioned, attached to the backwall formwork, and welded together in a manner like that used for the rails on the deck side of the expansion joint. There is very limited space available between the deck and backwall formwork for connecting the rails to the formwork. On the Highway 5 bridge, small angle brackets with short bolts were welded to the bottom of the rail sections for this purpose (Figures 4.7 and 4.10).

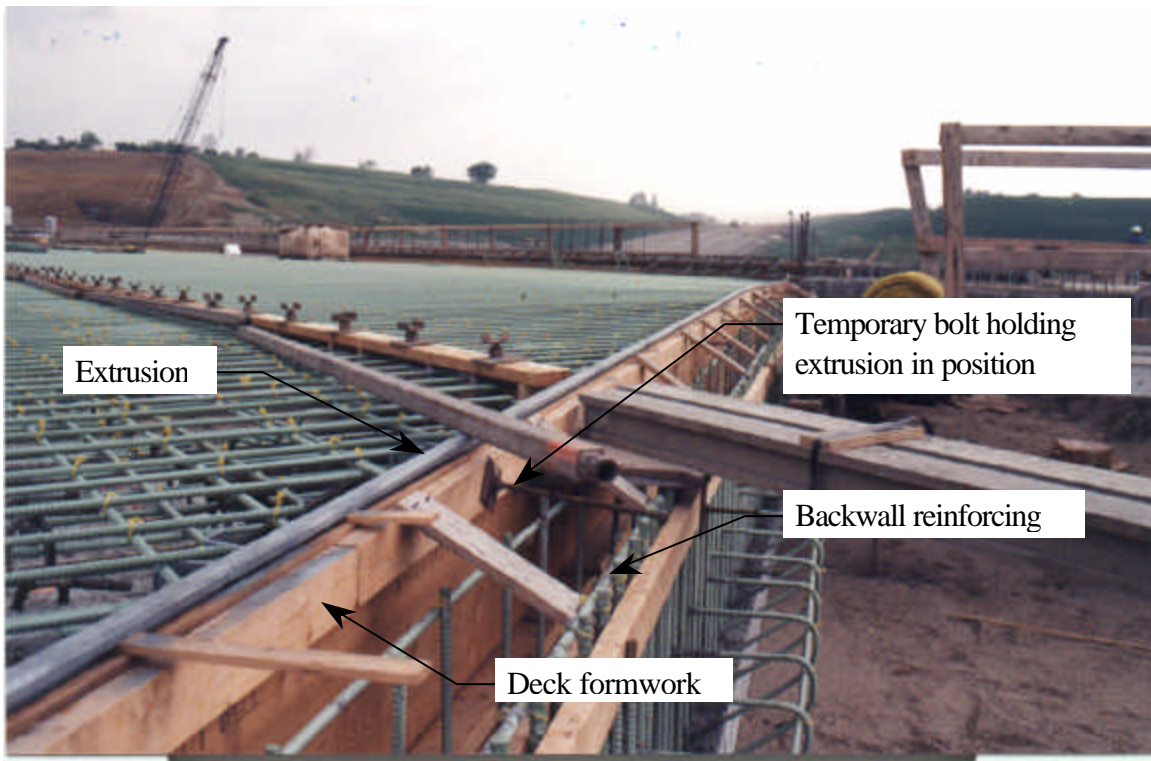
Figure 4.8 Extrusion at one end of deck installed from gutter to gutter

The rail sections are then welded together as necessary on site. For example, on the IA Highway 5 bridge, the rails at either end of the deck were installed first (there were no intermediate joints in this bridge). Starting at one side of the bridge, a gutter section (rail section with upturn – see Figure 3.3) was positioned and attached to the deck formwork with temporary bolts (Figure 4.7). A second section was then positioned adjacent to the first, bolted to the formwork, and welded to the first across the top, back (deck side), and bottom of the rail. Additional rail sections were positioned and welded in a similar fashion to complete the rails at either end of the deck (Figure 4.8).

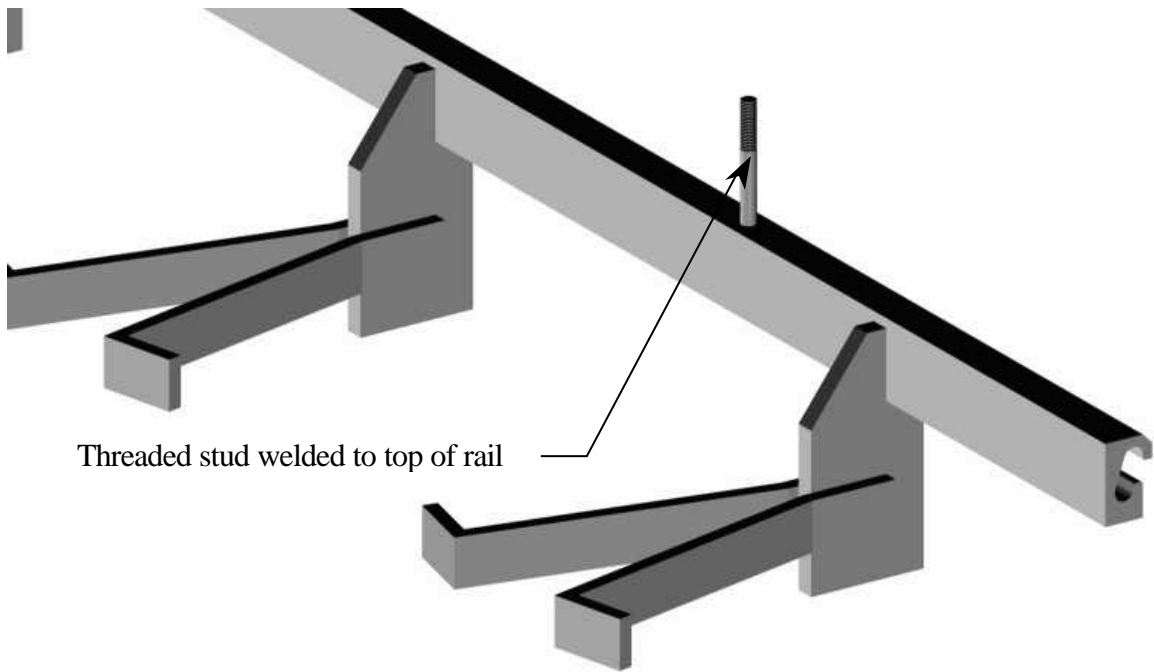
Figure 4.9 Threaded studs are one mechanism used to hold rails in position (see Figure 4.1)

On this particular bridge, the total length of rail supplied did not quite match the length of the formwork – the ridge had a large skew – so a short piece of rail (3 to 4 in. long) had to be obtained and used as a filler for each of the two rails of the two joint systems. Also, the fabricator had welded threaded studs to the top of the rails for use in positioning devices typically used for rehabilitation work rather than new construction (Figure 4.9). The contractor therefore cut these studs off and welded small angle brackets to the bottom surface of the rail (Figures 4.7 and 4.10). Once the sections are all positioned and the welding is completed, the welds are ground flush and a spray-on galvanizing is applied to the welded areas. For the IA Highway 5 bridge, galvanizing paint was also applied to the angle brackets and short filler pieces of rail.

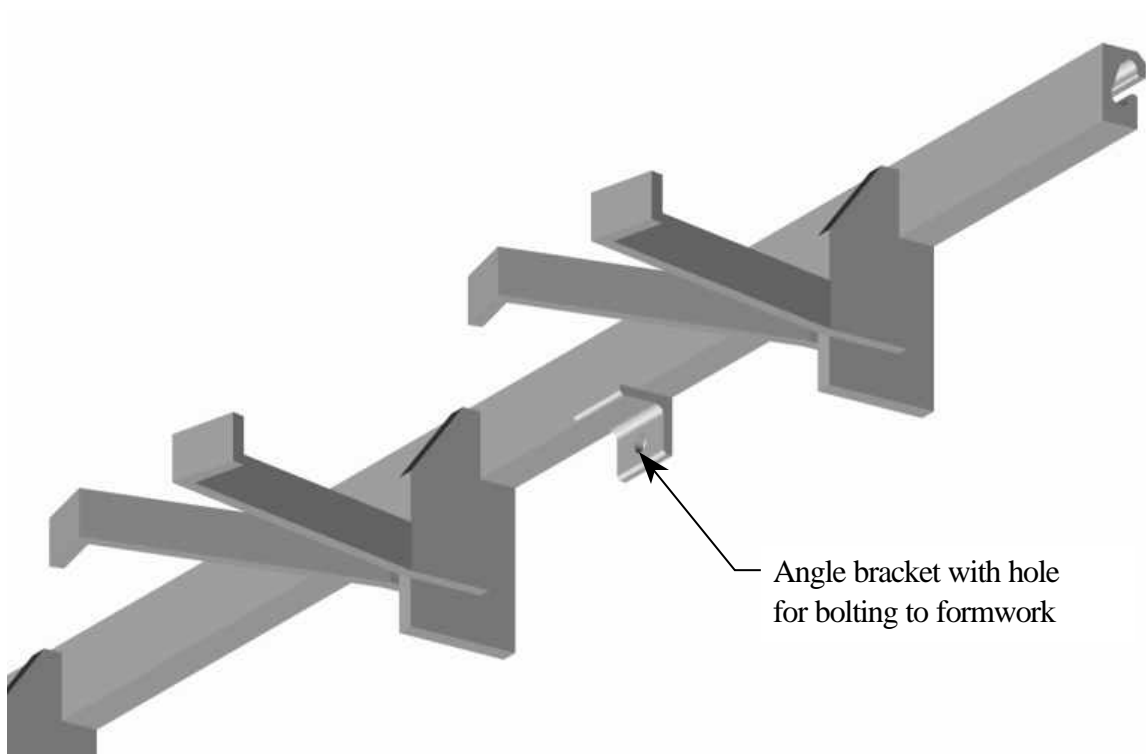
Figure 4.10 Model of extrusion with angle bracket for mounting welded to bottom surface

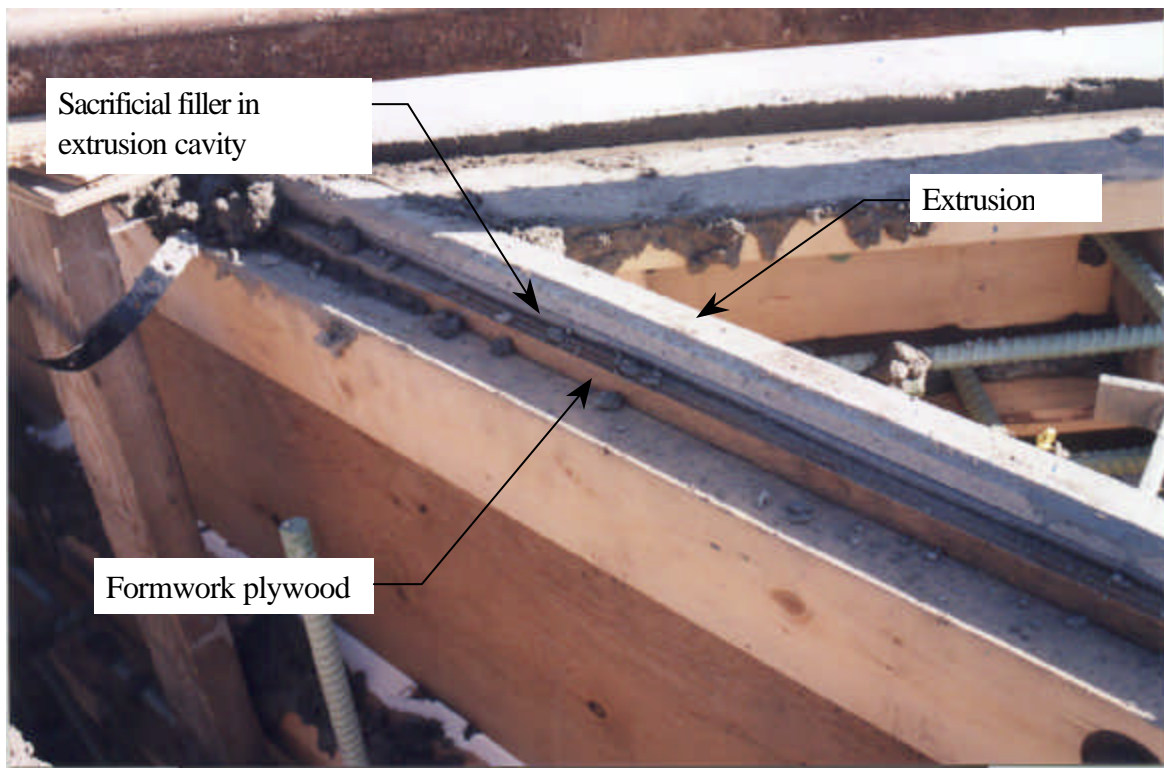
Figure 4.11 Foam backer rod was used to protect the cavity of the west side deck extrusion

On the Highway 5 bridge on the day the deck was cast, the cavity of the west rail was filled with a sacrificial filler (cylindrical pieces of foam or backer rod wedged into the cavity) to keep out concrete and debris during concrete placement and other construction operations (Figure 4.11). The cavity of the east rail was open on the day the north half of the deck was placed (Figure 4.12). Tape is also sometimes used to seal the cavity against concrete and debris. A clean, smooth rail cavity is essential for the efficient installation and ultimate effectiveness of the neoprene seal. Protecting the cavity with a sacrificial filler, tape, or other means can save considerable labor later required to clean out a contaminated cavity. And a contaminated cavity that is not cleaned out can make the efficient and effective installation of the neoprene seal impossible.

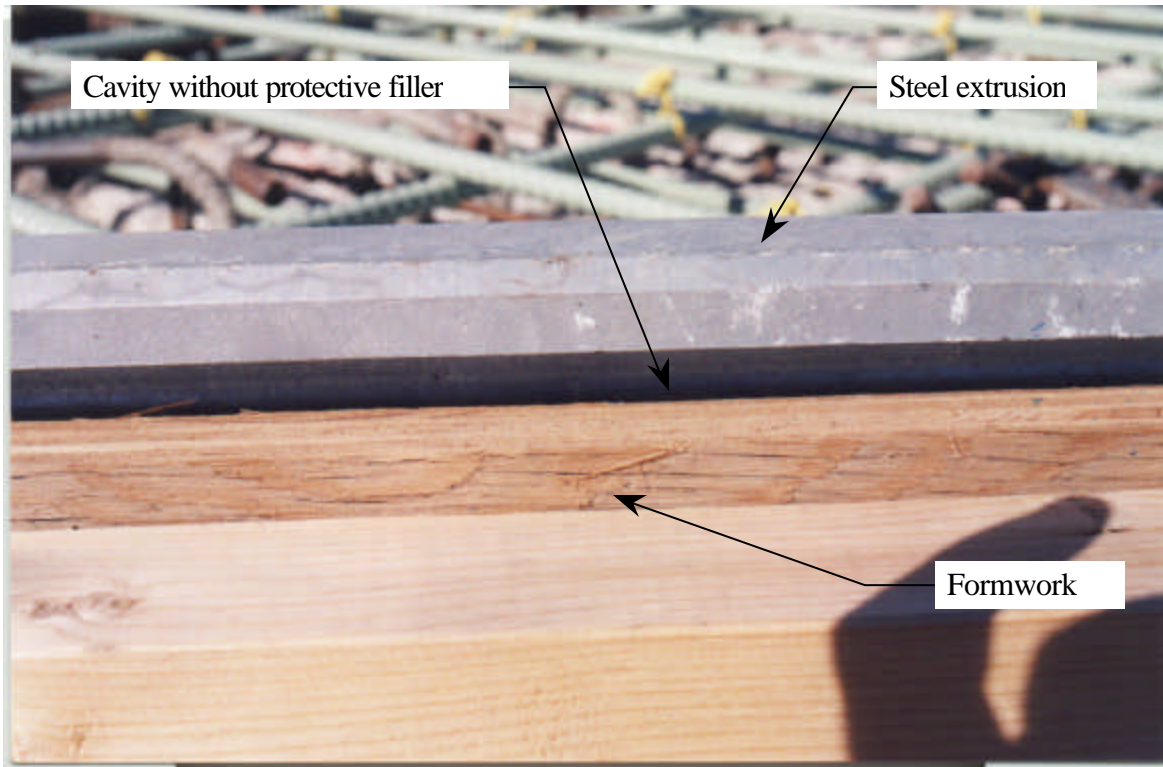
Figure 4.12 No sacrificial filler was present in the cavity on the east end of the deck

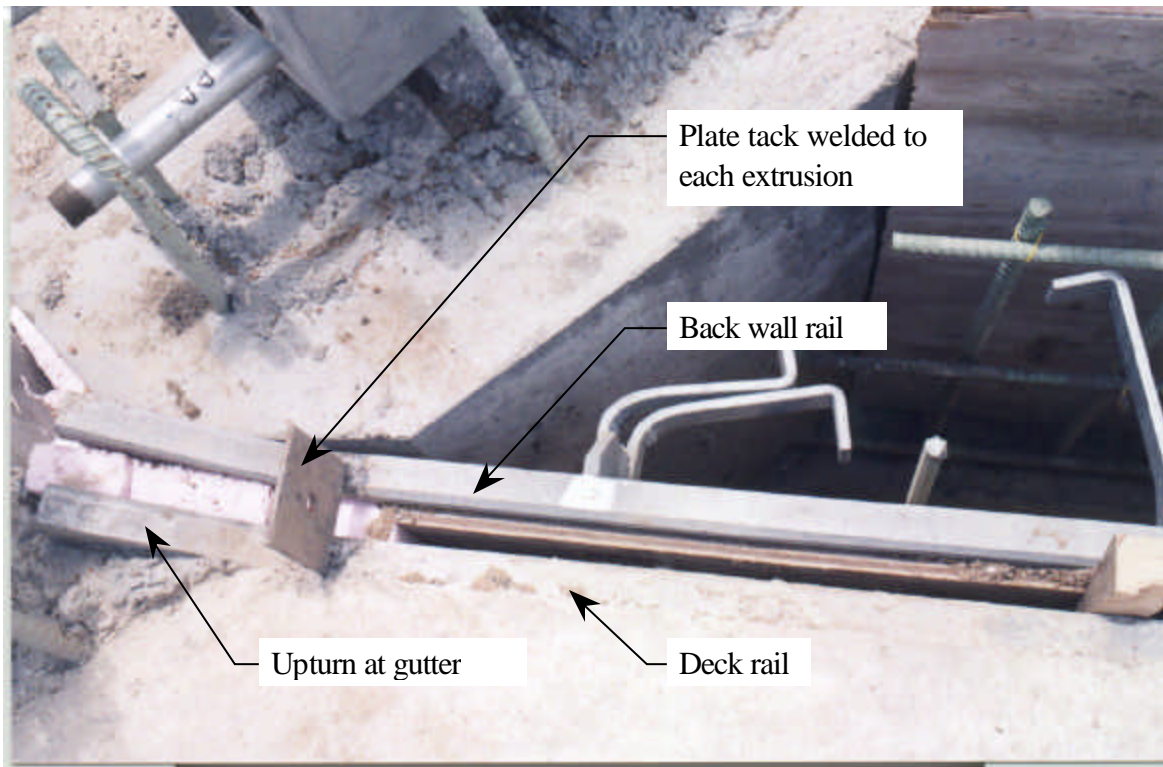
Figure 4.14 Small plates are tack welded to either extrusion to maintain gap

To create a uniform gap between the rails during the casting of the backwalls, a gap size is first selected (the top edge of the backwall formwork has enough play to allow adequate adjustment for this purpose). To maintain the selected gap, small steel plates are placed across the gap and tack welded to both rails (Figures 4.14 and 4.15). The gap is selected based on the gap-versus-temperature values given in the design specifications. For

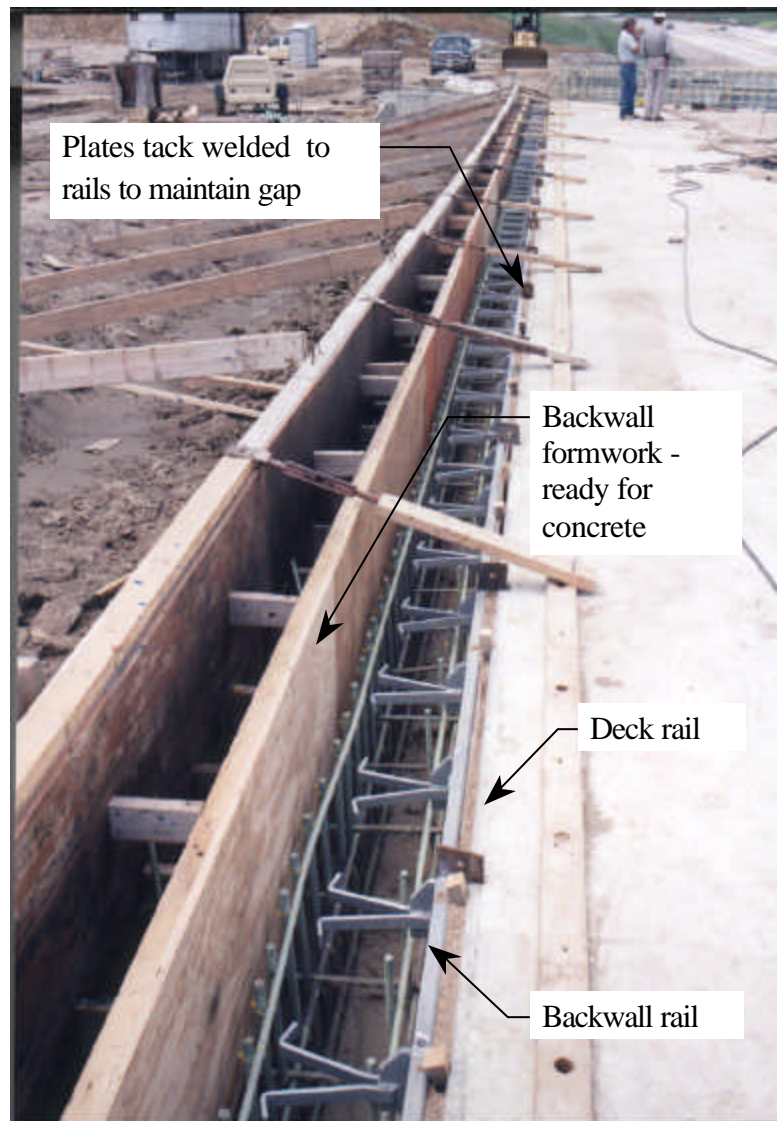
Figure 4.15 West backwall formed and ready for concrete

Sometime after the backwall rails are in place, the backwalls are cast and the anchorages and bottom and backwall faces of the rails are encased in concrete. Using the technique of plates across the gap that are tack welded to each rail (Figure 4.14), the gap setting cannot easily be changed. On the day the west backwall was poured on the IA Highway 5 bridge, the sky remained overcast longer than the weather service predicted. The air temperature at the time of concrete placement was therefore not quite as warm (by 5 to 10 degrees) as had been assumed in setting the gap opening.

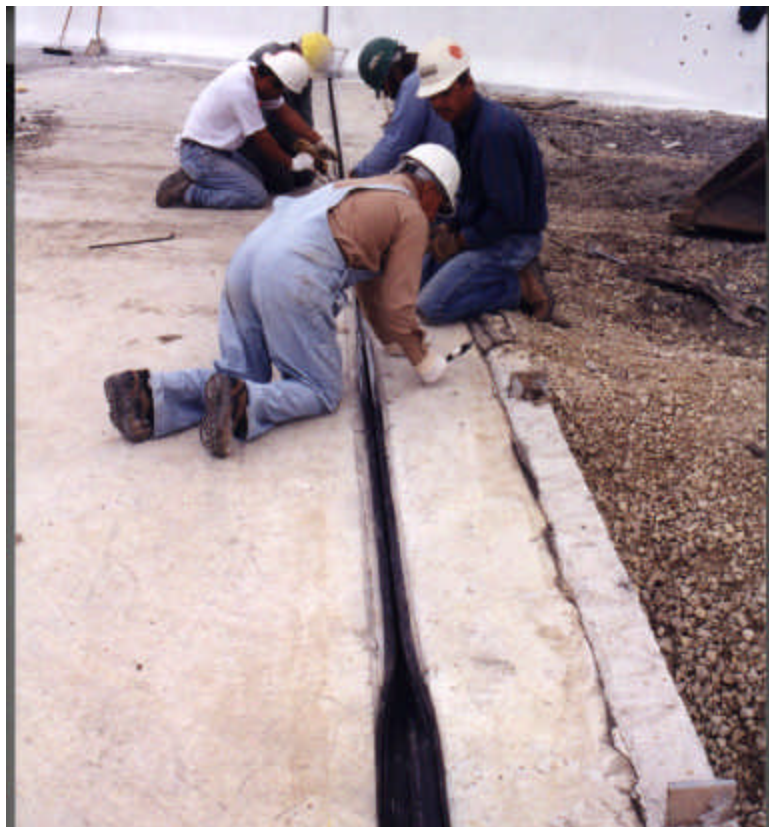
Figure 4.16 Seal is installed in one piece from end to end

After the deck and backwall or deck sections are cast, embedding the two rail anchorages, and the forms have been stripped, the neoprene seal is installed in one piece from gutter to gutter (Figure 4.15). Before the actual installation of the neoprene seal, the cavities in the metal extrusions are cleaned as necessary to ensure that the strip seal will fit into the recesses properly. Cleaning the cavity can be difficult, especially if concrete has run over the rail and entered the cavity. That is the primary reason some contractors use a sacrificial filler in the recess or tape over the cavity to prevent dirt, concrete, and debris from fouling the cavities.

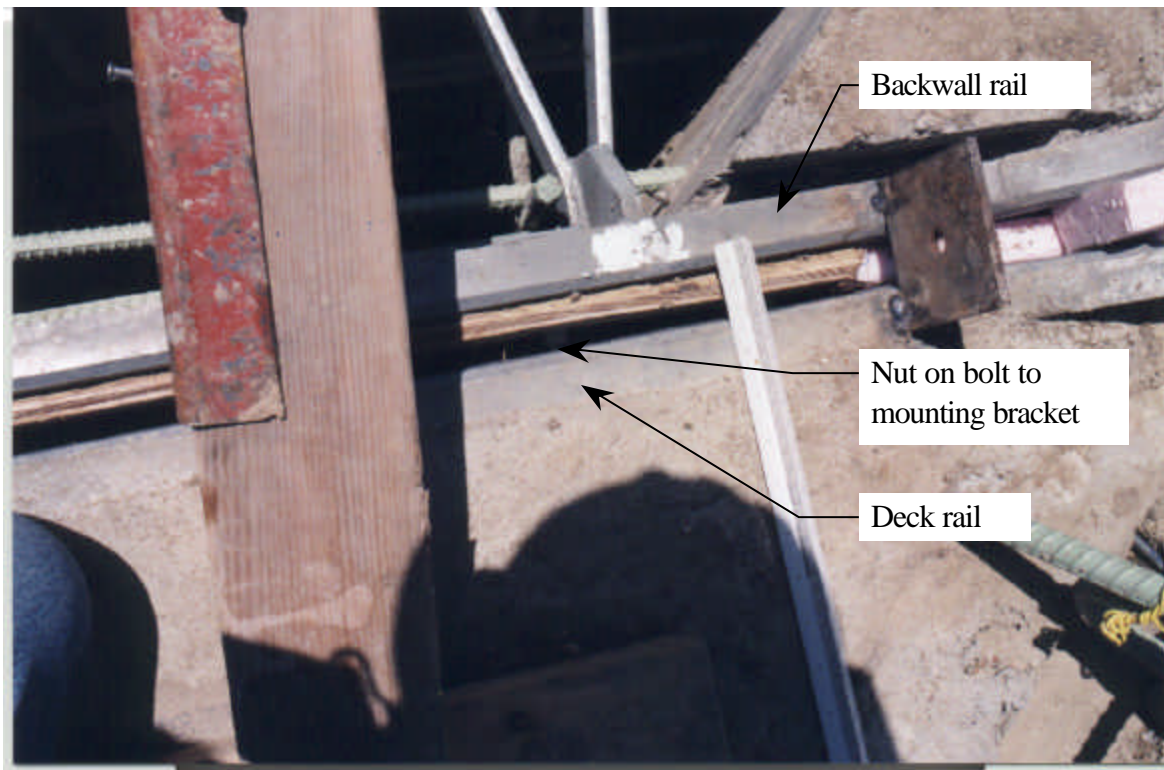
Figure 4.17 There is typically little room to work between the pair of extrusions

Tools for efficiently cleaning the cavity do not seem to be readily available. Since the temperature is typically warm during construction, the gap between the pair of rails is typically small (2 in. or less) and provides little room to work (Figure 4.17). Even when the gap is larger, it is practically impossible to see into the upper portion of the cavity without mirrors or other special optical equipment. Cleaning of much of the cavity must therefore be

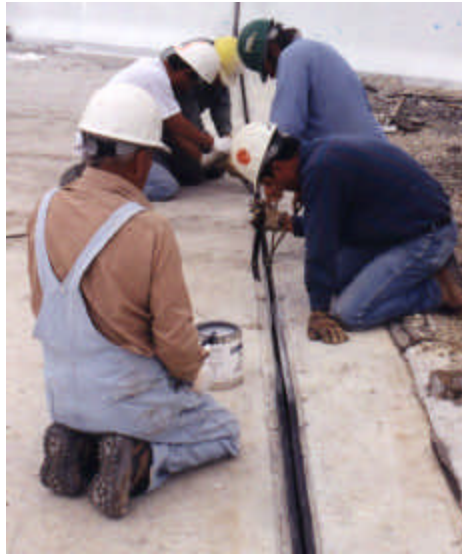
Figure 4.18 Installation requires working in small increments

To install the neoprene seals on the IA Highway 5 bridge the seal was first cut to length and then folded in the middle with the lugs up. Then the bottom “V” was pushed into the expansion joint opening with a metal bar (e.g., a pry bar or seal installation tool) such that the lugs were resting flat on top of the extrusions (Figures 4.16 and 4.18). Next, lubricant/adhesive was applied to the seal lugs with a paint brush. The seal was then pushed further down into the expansion joint opening until the two outer ears of the lugs caught on the opposing rail cavities (Figure 4.2). Then two installers, one working on each side of the joint and each with a pair of prying tools, forced the upper ears of the lugs into each rail cavity. The prying action to push the upper ears into the cavity was done in alternating fashion with the pair of tools and in increments of 2 to 3 in. The installers said the best test of whether or not the upper ear was completely seated was the appearance of the seal. They said there was generally no particular sound or feel when the upper ear became fully engaged. The lubricant/adhesive was applied 3 to 5 ft ahead of the installers (Figure 4.18).

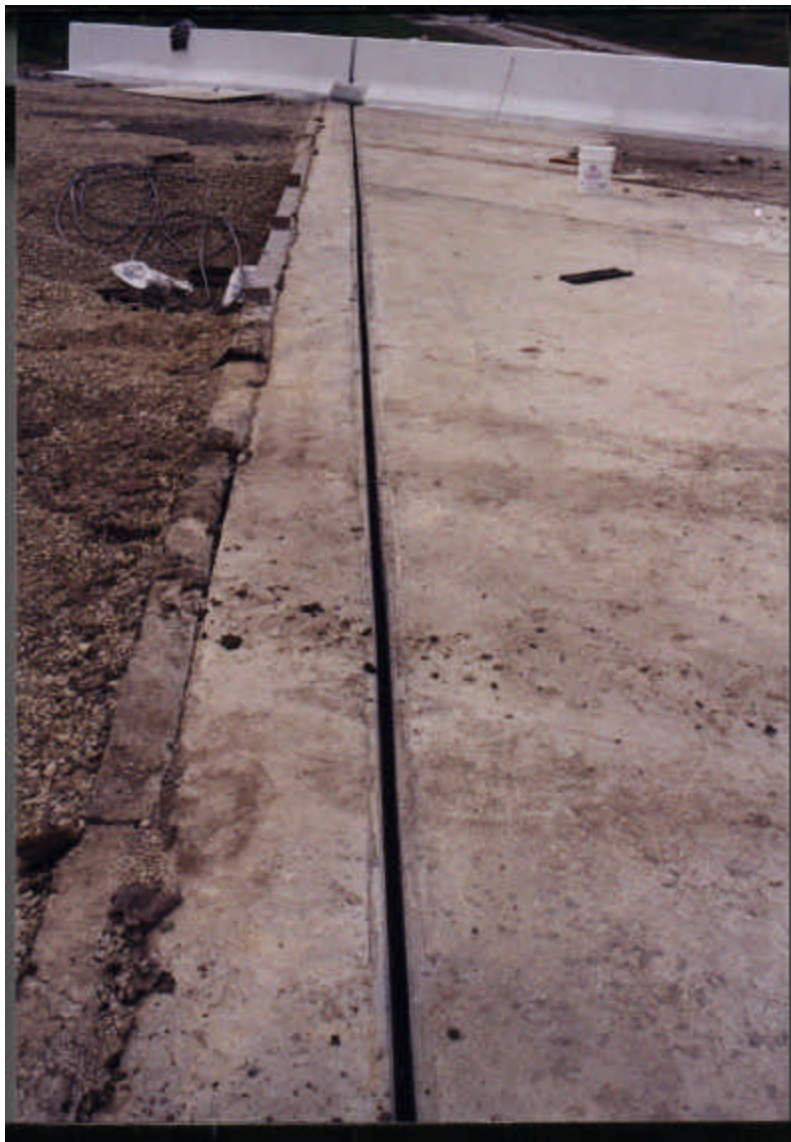
Figure 4.19 Installation of seal complete at east end
