Performance of Strip Seals in Iowa Bridges, Pilot Study

FINAL REPORT

Iowa Highway Research Board
Project TR-437

Iowa State University

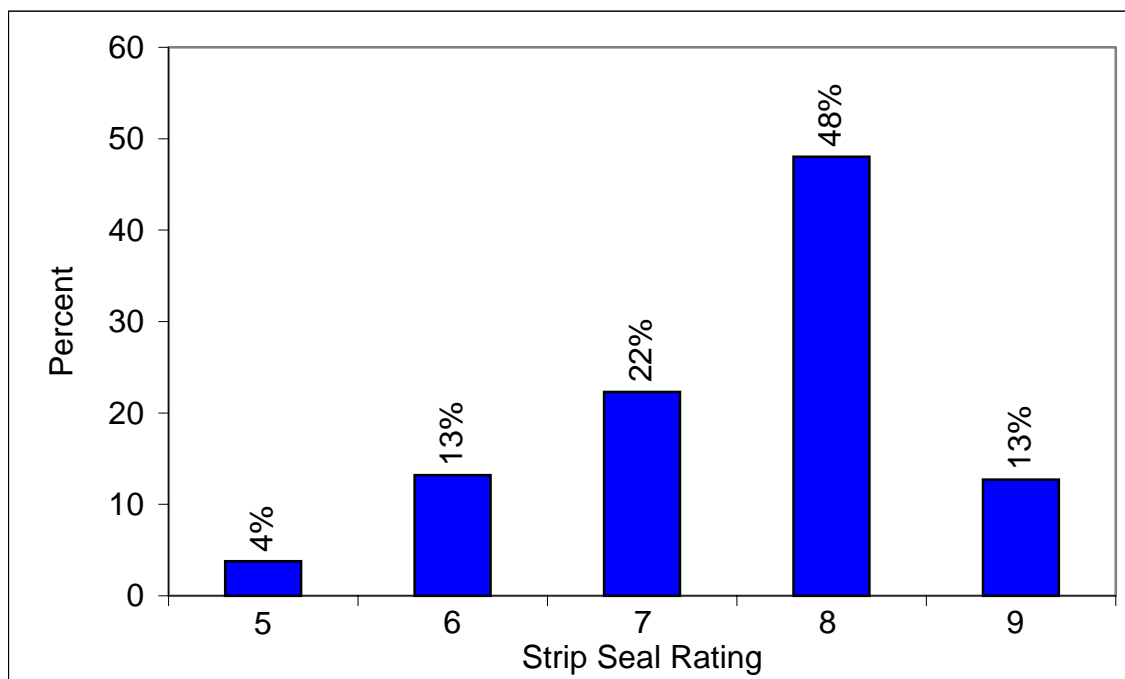
Figure 5.1 – Ratings of the end deck joint strip seals in Iowa bridges

volume (ADT) and a deduced “age” of the strip seal. The “age” of the strip seal was obtained by comparing the database items of year built, reconstruction year, resurfacing year and remodel year. The ISU researchers assumed that the strip seal (and expansion joint) was new on the date that any of these events occurred and, therefore, used the most recent of such events to calculate the “age” of the strip seal.

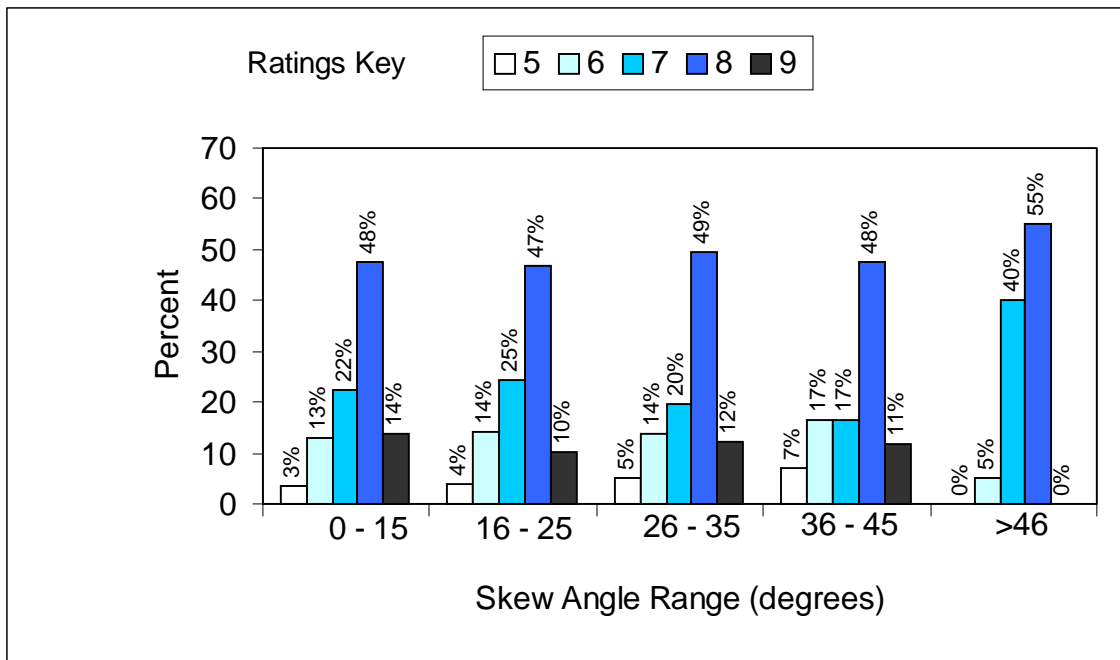
Figure 5.2 End deck joint strip seal rating versus skew angle of bridge

Figure 5.2 shows the distributions of ratings as a function of skew angle of the bridge deck. As shown in Figure 5.2, the combined percentage of strip-seal expansion joints with a rating of 5 or 6 increases slightly as the range of the skew angle of the bridge deck increases from 0°-15° to 35°-45°, but the evidence is not sufficient to draw any firm conclusion.

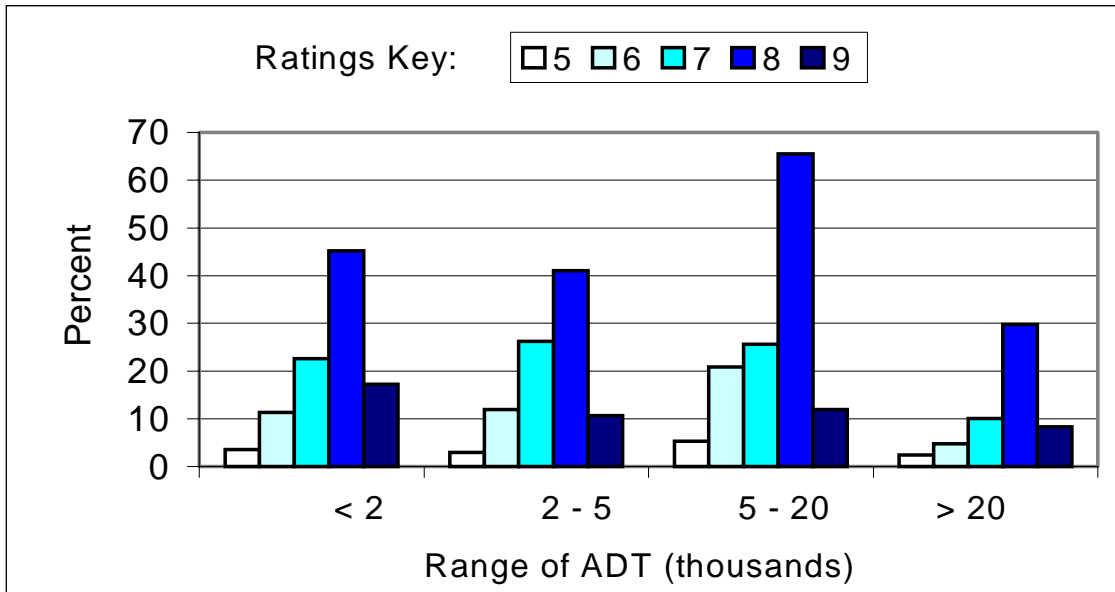
Figure 5.3 End deck joint strip-seal rating versus Average Daily Traffic (ADT)

Though large skew angles and large traffic volumes might be expected to adversely effect the service life of strip seals, information in the Iowa DOT databases does not seem to

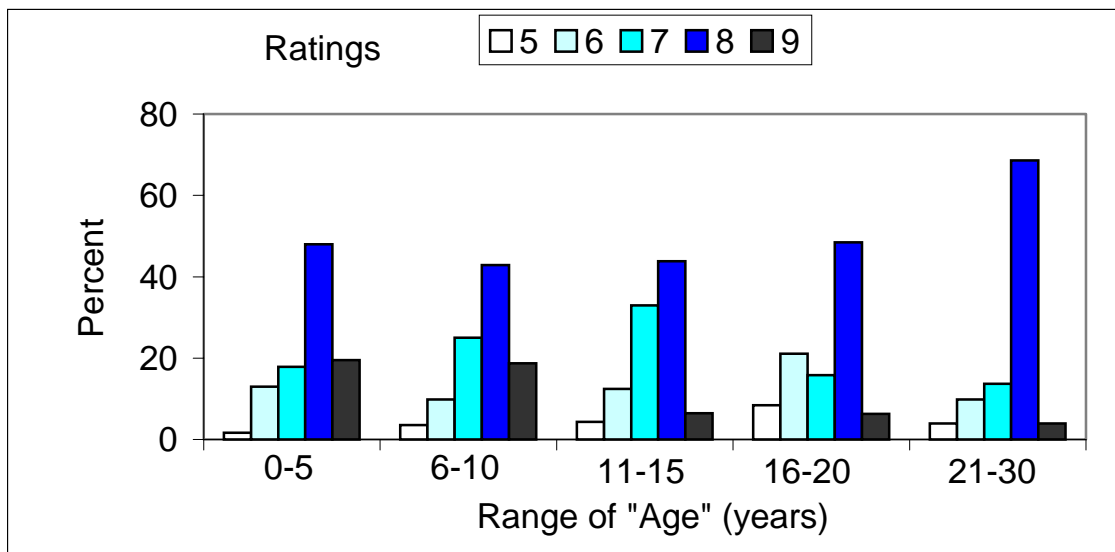
Figure 5.4 End deck joint strip-seal rating versus "age" of seal

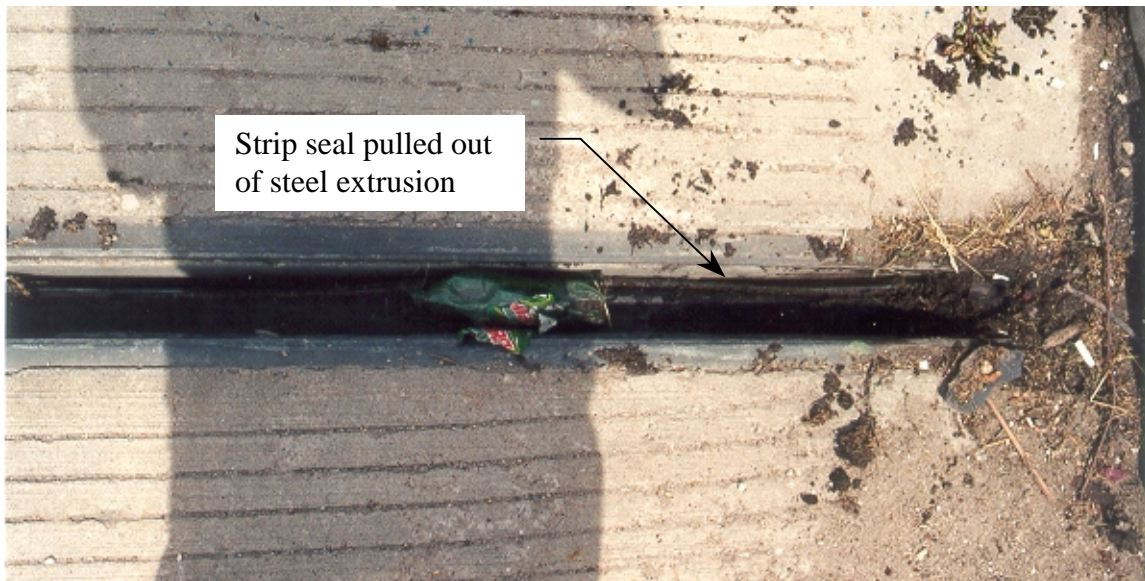
Figure 6.4 Strip seal at G2 for Bridge 1 (0781.1R218)

The air temperature and approximate gap openings were determined as part of the Iowa DOT intensive inspections and the ISU investigation, and are summarized in Table 6.4. The Iowa DOT inspection reports include gap measurements at both gutters and the roadway centerline for each joint; i.e., three measurements for each joint. Obtaining centerline measurements as part of this experimental work was not practical for the ISU investigators because of bridge traffic. Therefore, only the measurements near each gutter taken by Iowa DOT inspectors and ISU investigators are included in the table.

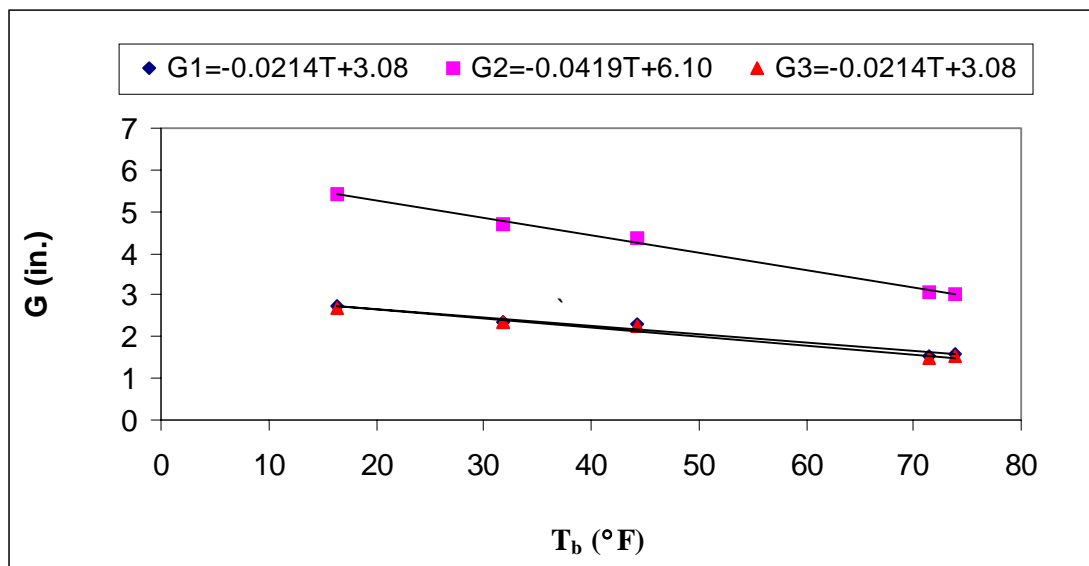
Figure 6.5 Gap openings vs. bridge temperature for Bridge 1 (0781.1R218)

on the chart and are also given in equation form at the top of Figure 6.5. Though no temperatures very near 0° F were recorded during this investigation, the linear plots are extended back to 0° F as a dashed line to show the gaps that could be expected at the minimum temperatures assumed in the Iowa DOT design procedure for concrete-girder bridges (Section 3.3).

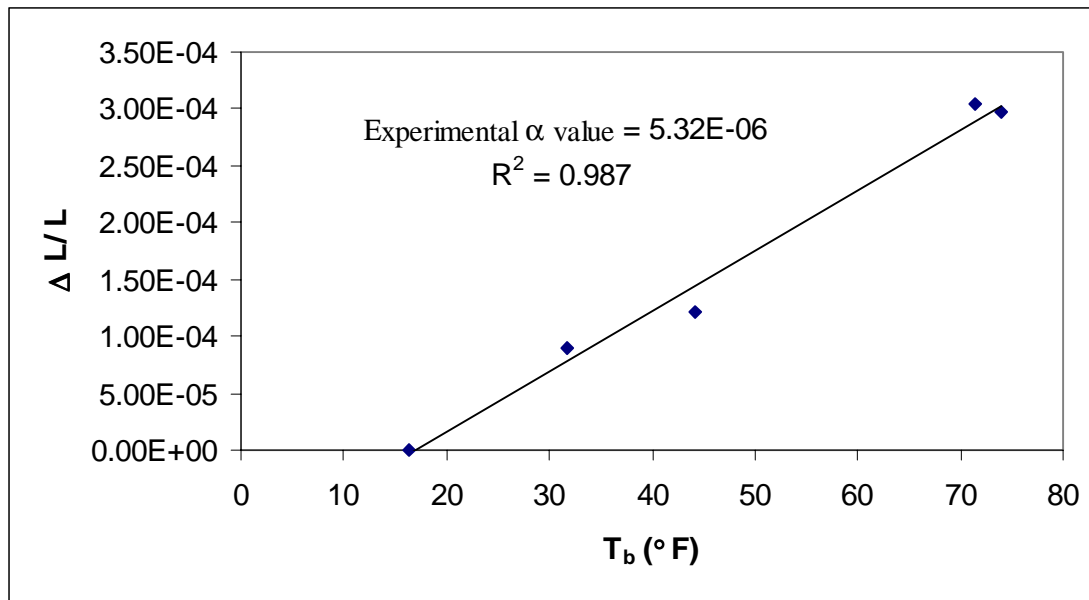
Figure 6.6 The experimental α -value for Bridge 1 (0781.1R218)

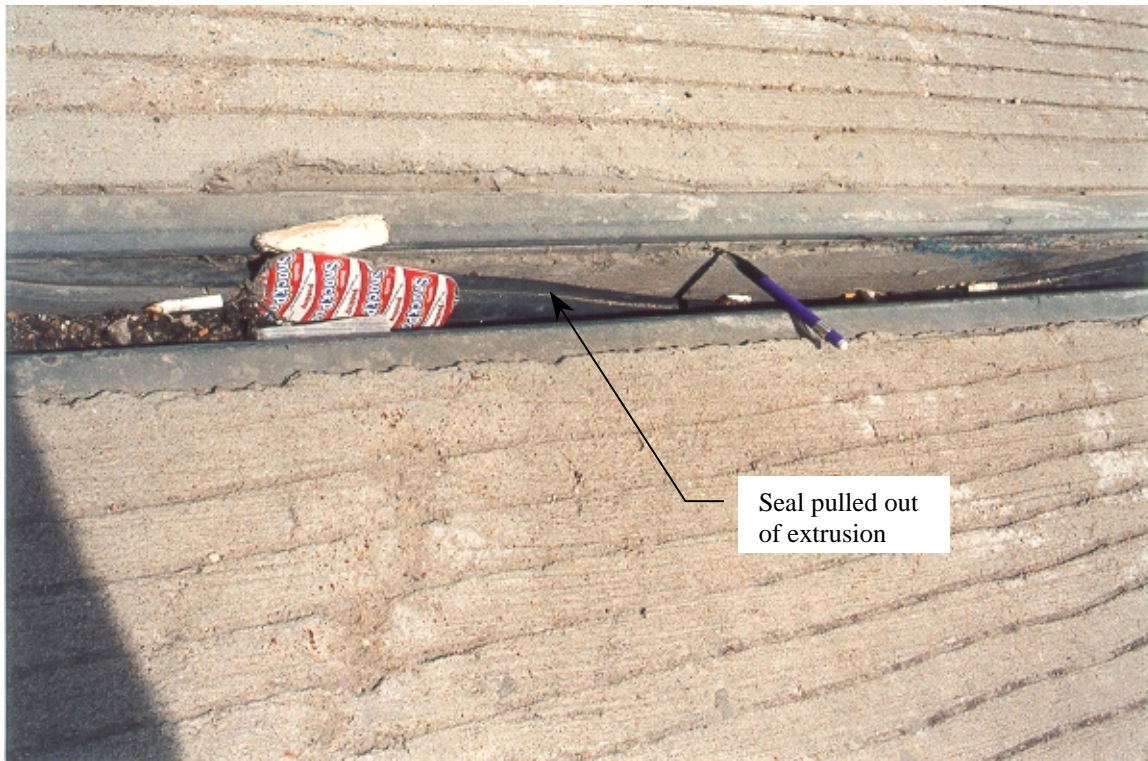
Figure 6.7 Strip seal at G2 for Bridge 2 (0781.1L218)

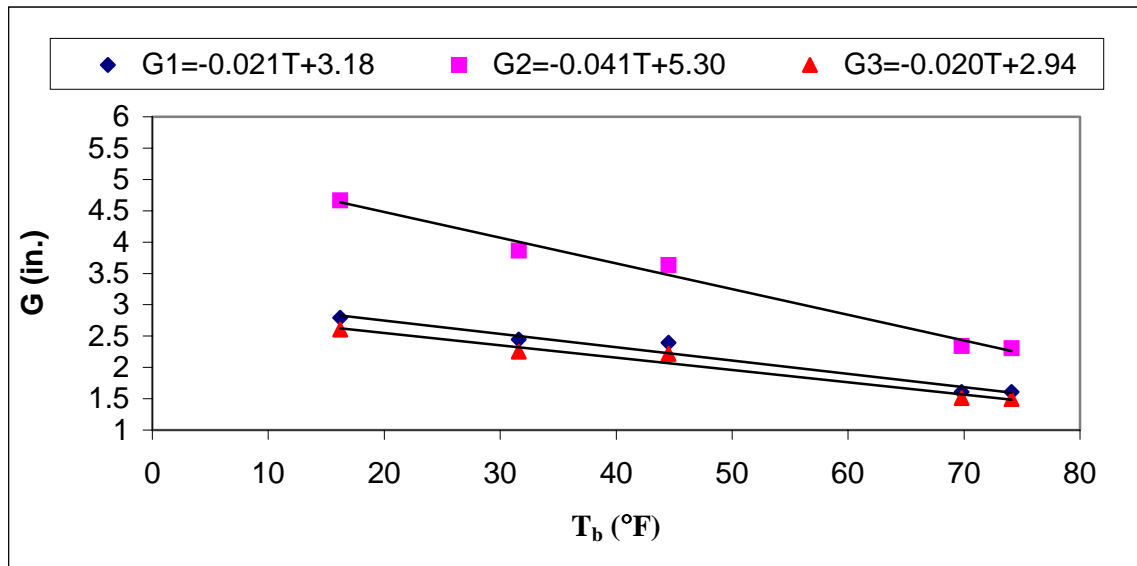
Figure 6.8 Gap openings vs. bridge temperature for Bridge 2 (0781.1L218)

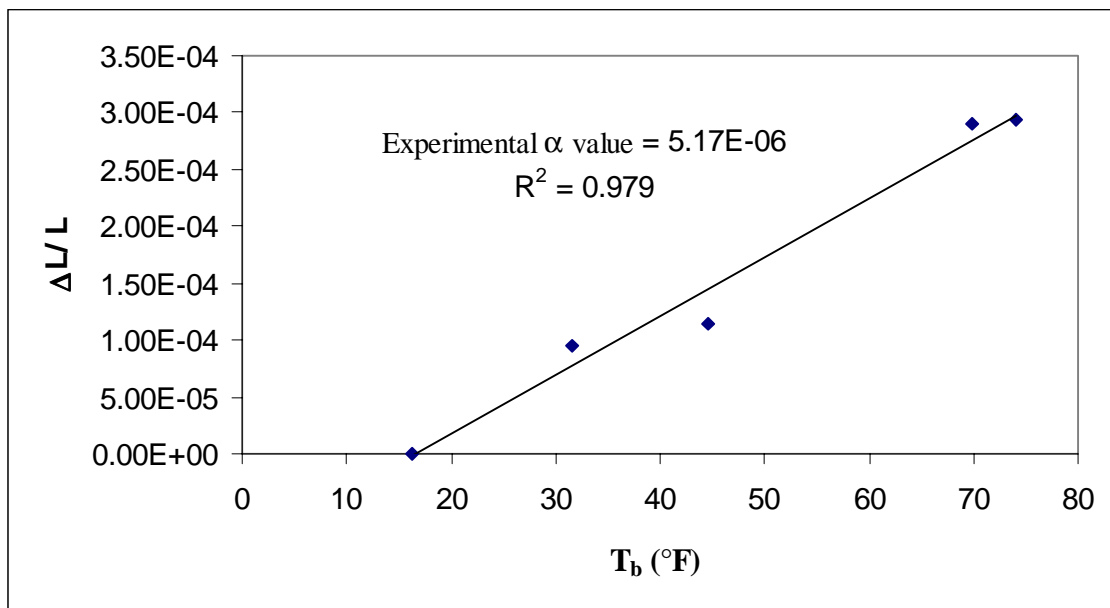
Figure 6.9 The experimental α -value for Bridge 2 (0781.1L218)

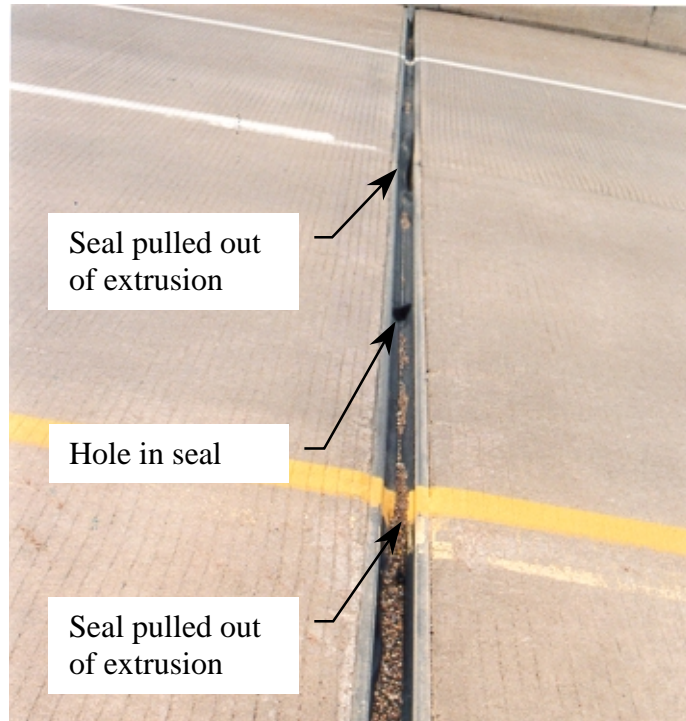
Figure 6.11 Strip seal at G3 for Bridge 3 (0996.0R218)

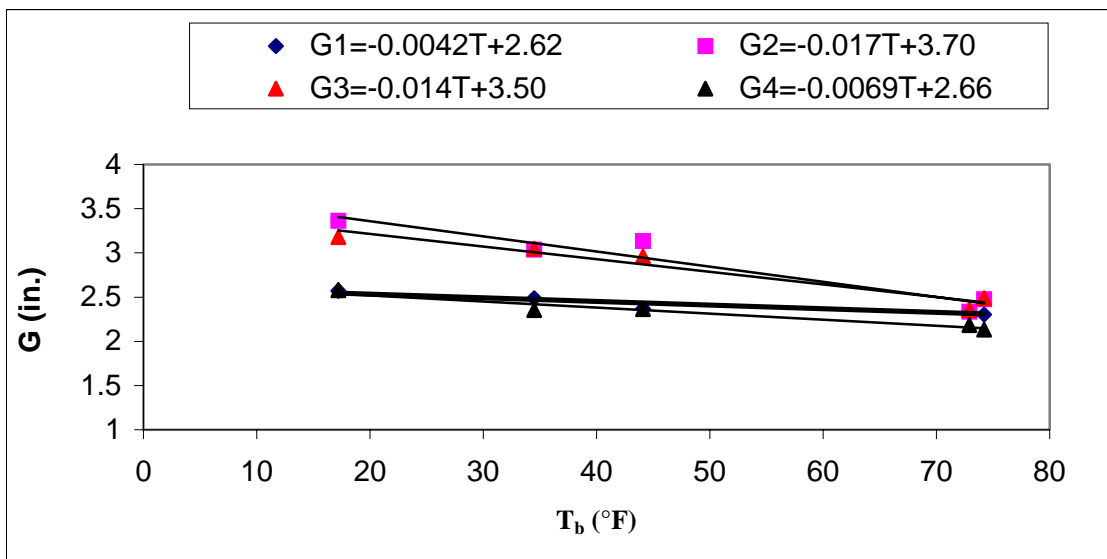
Figure 6.13 Gap openings vs. bridge temperature for Bridge 3 (0996.0R218)

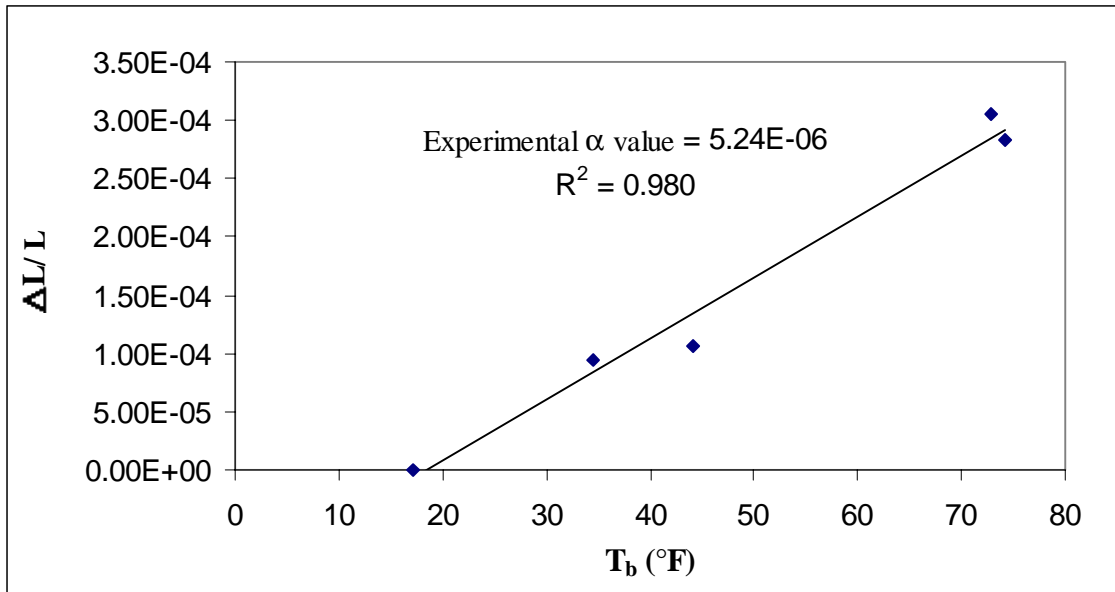
Figure 6.14 The experimental α -value for Bridge 3 (0996.0R218)

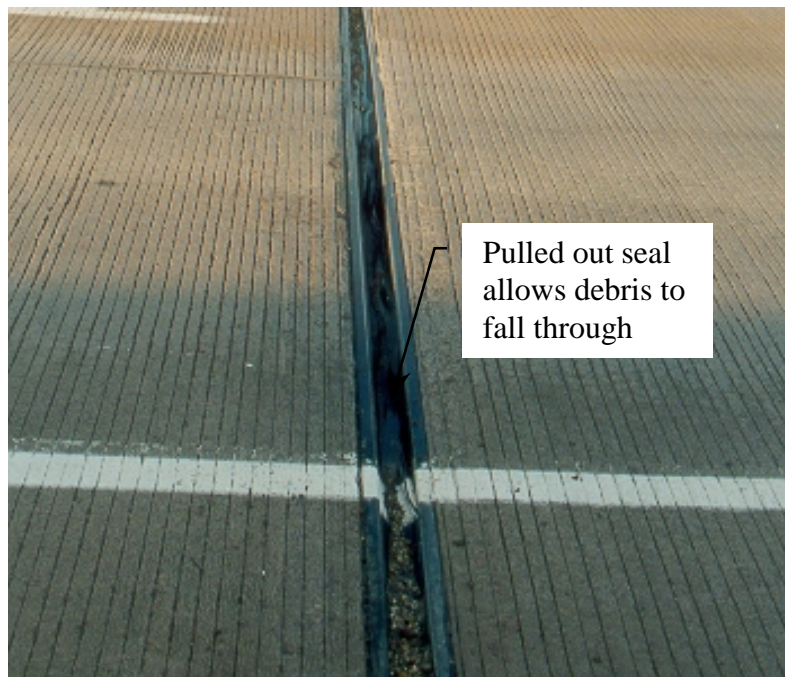
Figure 6.15 Strip seal at G2 for Bridge 4 (0996.0L218)

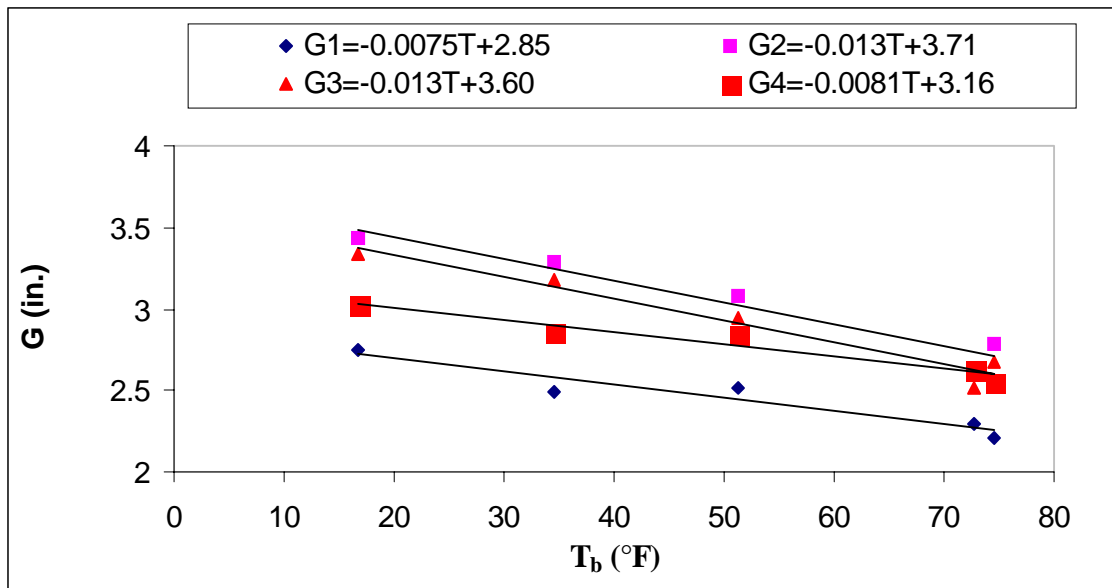
Figure 6.17 Gap openings vs. bridge temperature for Bridge 4 (0996.0L218)

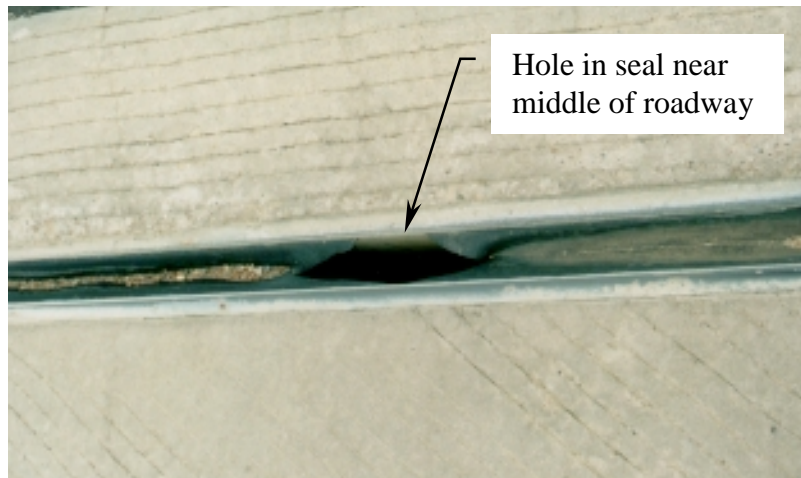
Figure 6.19 Strip seal at G1 for Bridge 5 (0787.7A218)

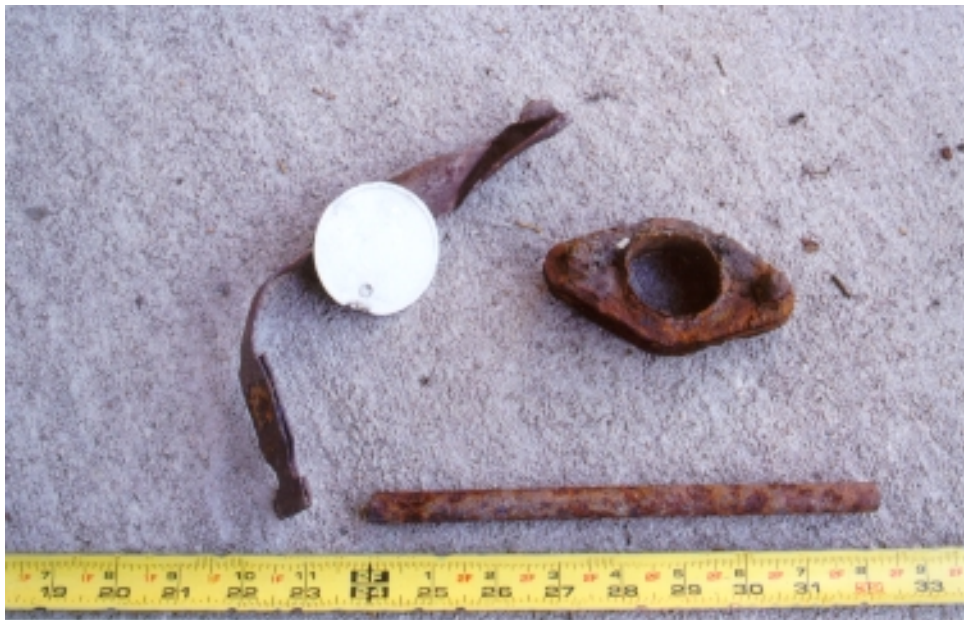
Figure 6.20 Road debris found on Bridge 5 (0787.7A218)

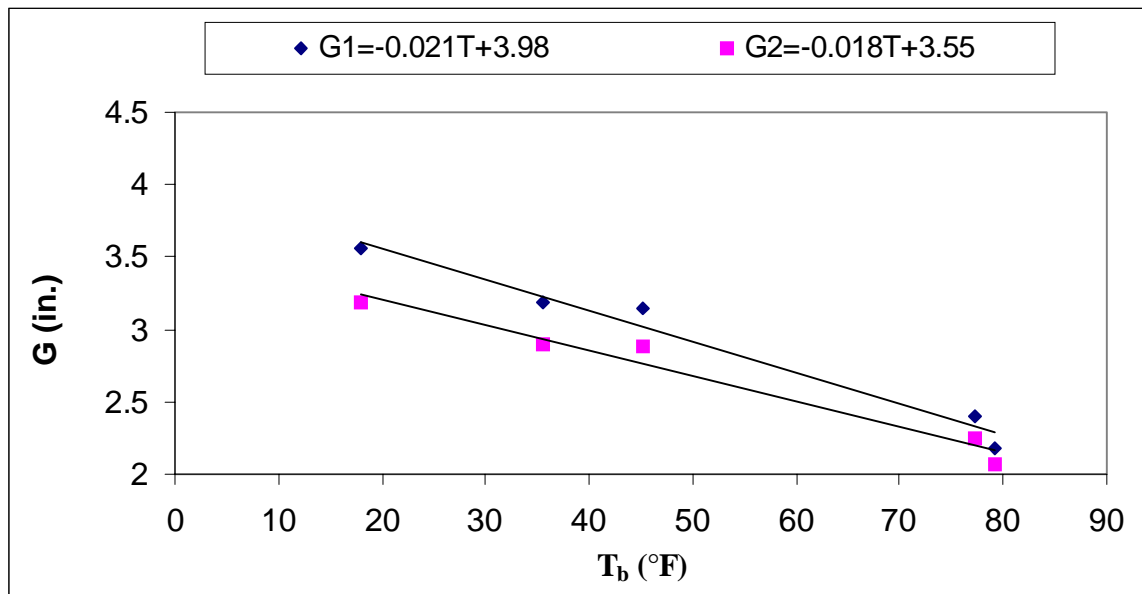
Figure 6.21 Gap opening vs. bridge temperature for Bridge 5 (0787.7A218)

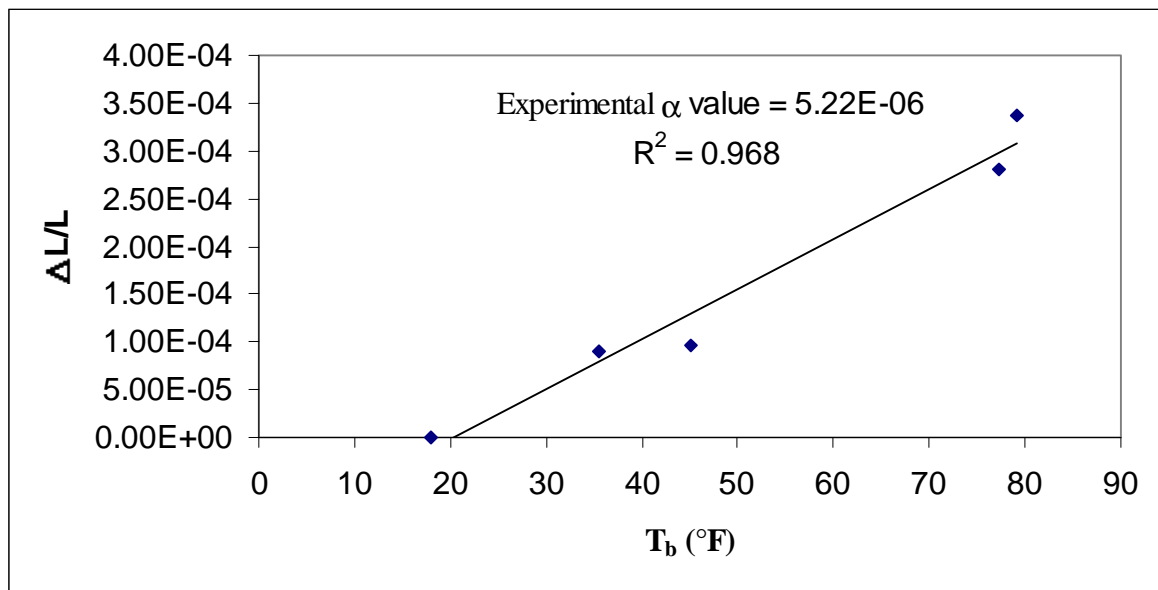
Figure 6.22 The experimental α -value for Bridge 5 (0787.7A218)

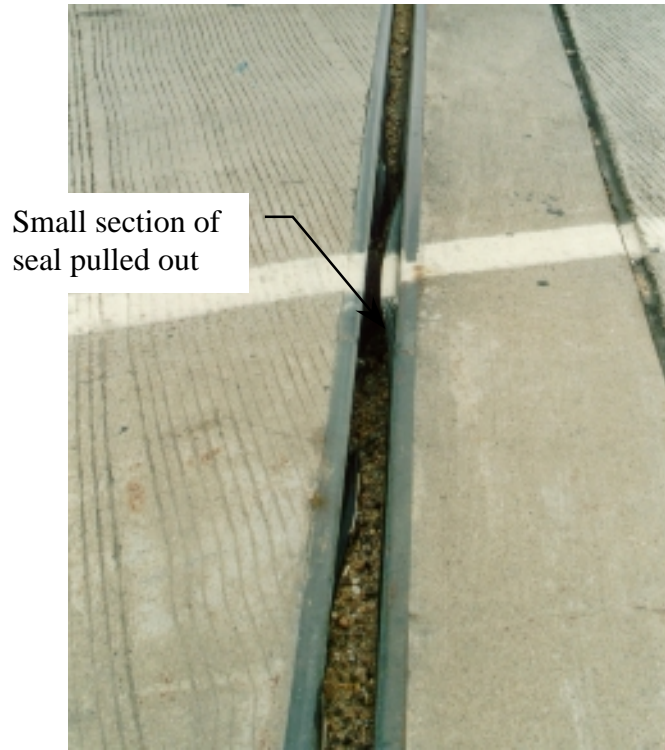
Figure 6.23 Strip seal at G1 of Bridge 6 (0784.8S218)

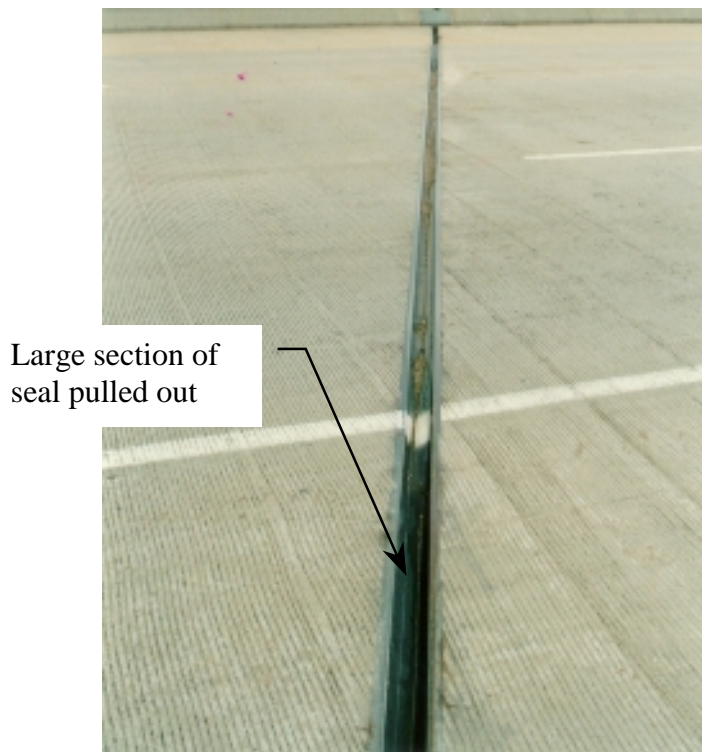
Figure 6.24 Strip seal at G2 of Bridge 6 (0784.8S218)

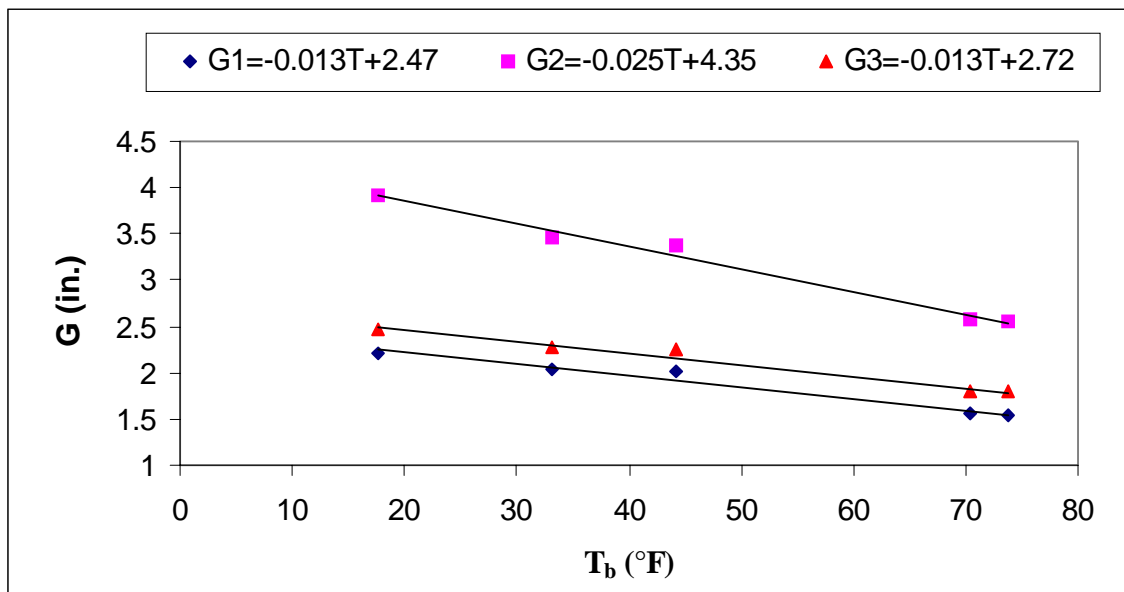
Figure 6.25 Gap openings vs. bridge temperature for Bridge 6 (0784.8S218)

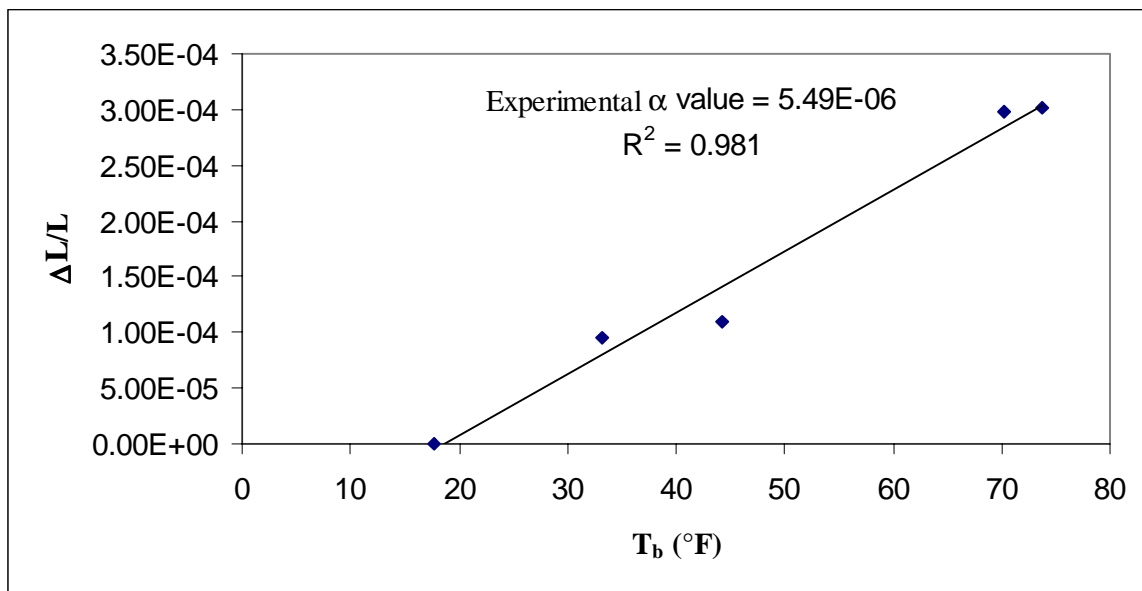
Figure 6.26 The experimental α -value for Bridge 6 (0784.8S218)

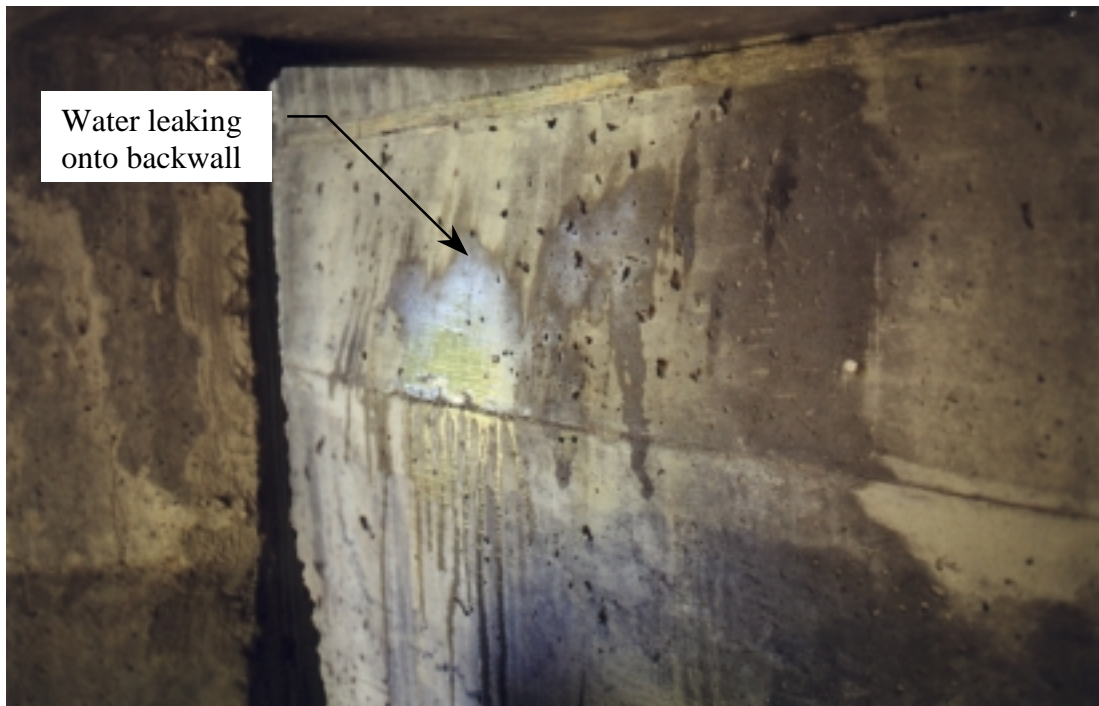
Figure 6.27 Backwall below left gutter at G2 of Bridge 7 (8561.5L030)

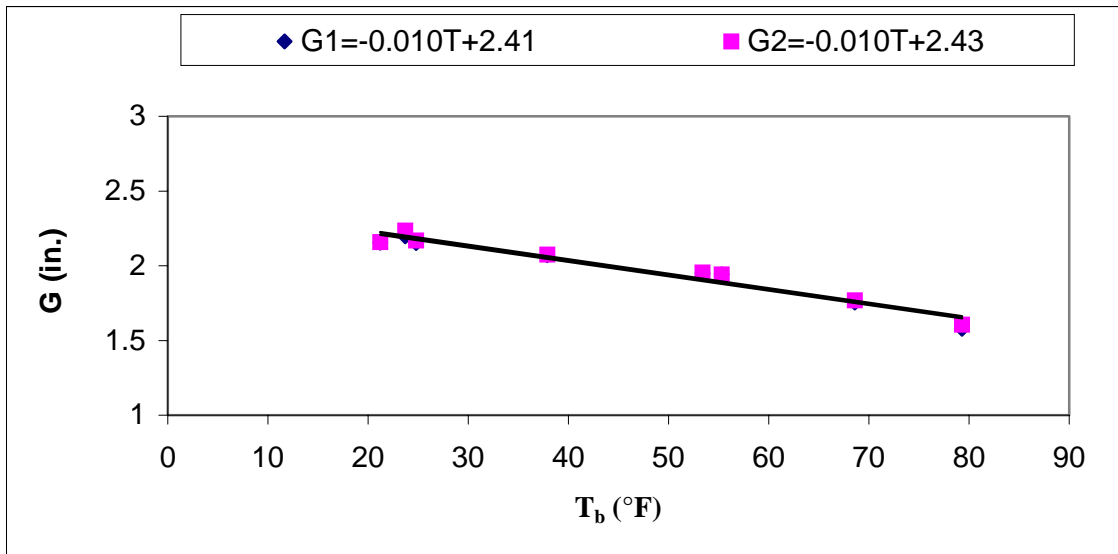
Figure 6.28 Gap opening vs. bridge temperature for Bridge 7 (8561.5L030)

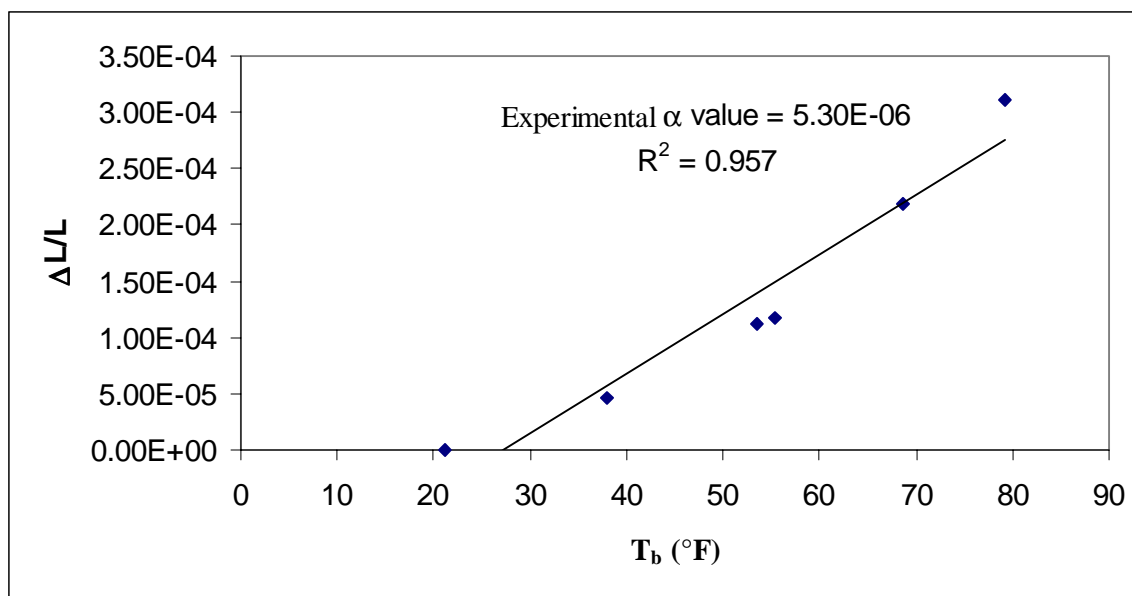
Figure 6.29 The experimental α -value for Bridge 7 (8561.5L030)

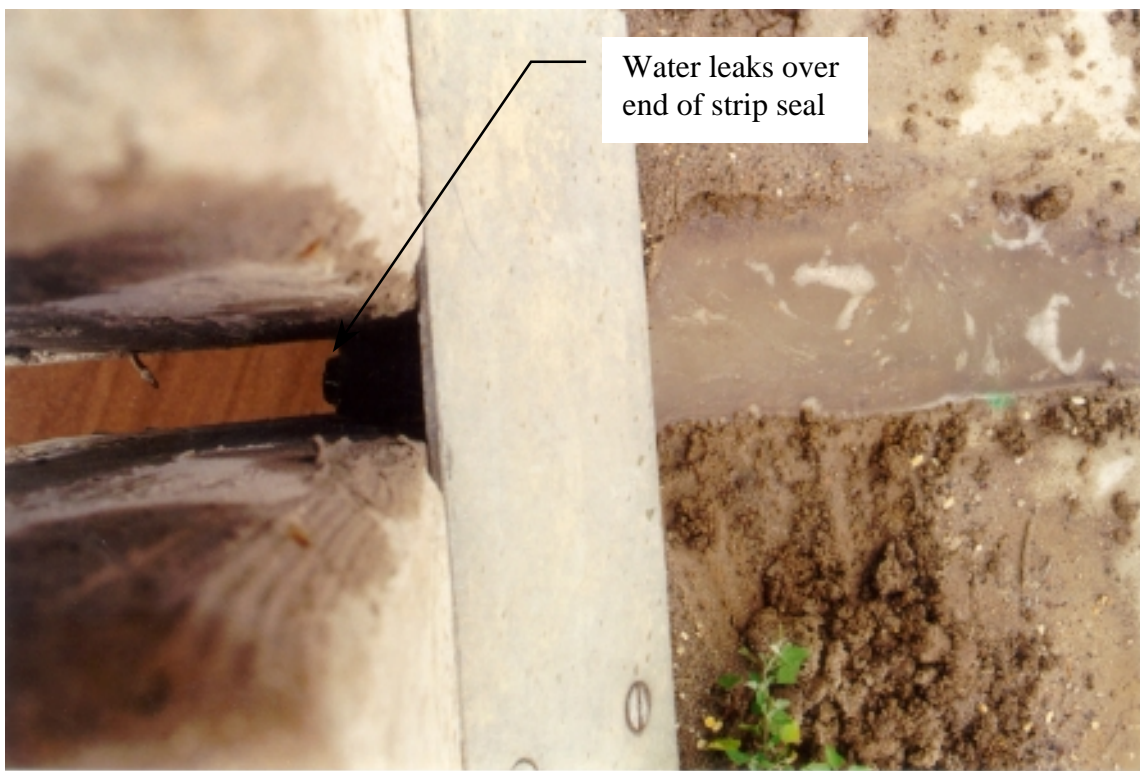
Figure 6.30 Strip seal at G3 for Bridge 8 (7776.8L065)

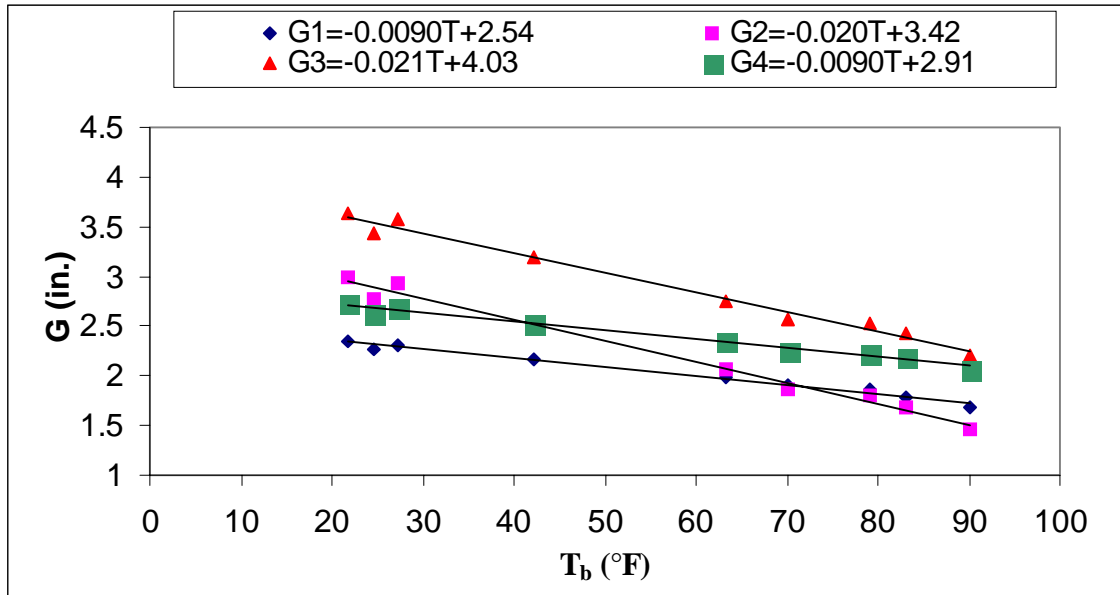
Figure 6.31 Gap opening vs. bridge temperature for Bridge 8 (7776.8L065)

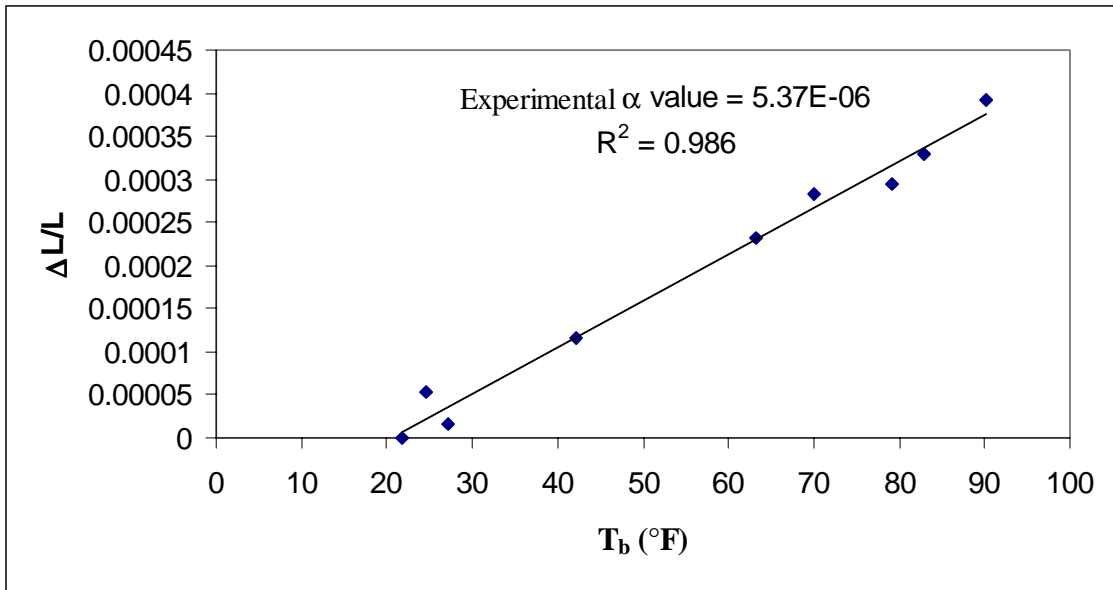
Figure 6.32 The experimental α -value for Bridge 8 (7776.8L065)

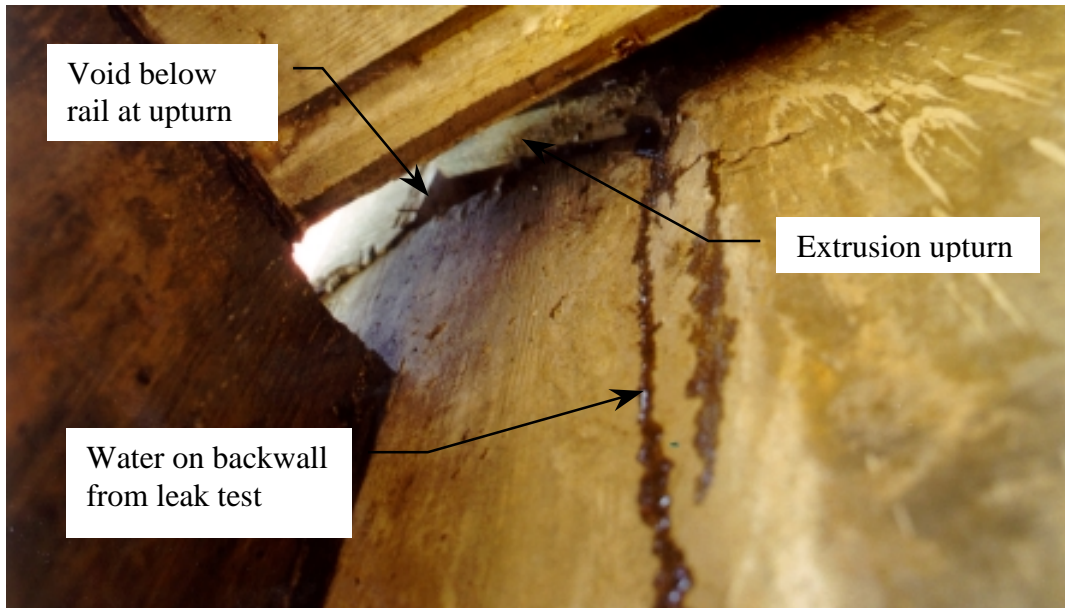
Figure 6.33 Leaking below the right gutter at G1 of Bridge 9 (6485.3L030)

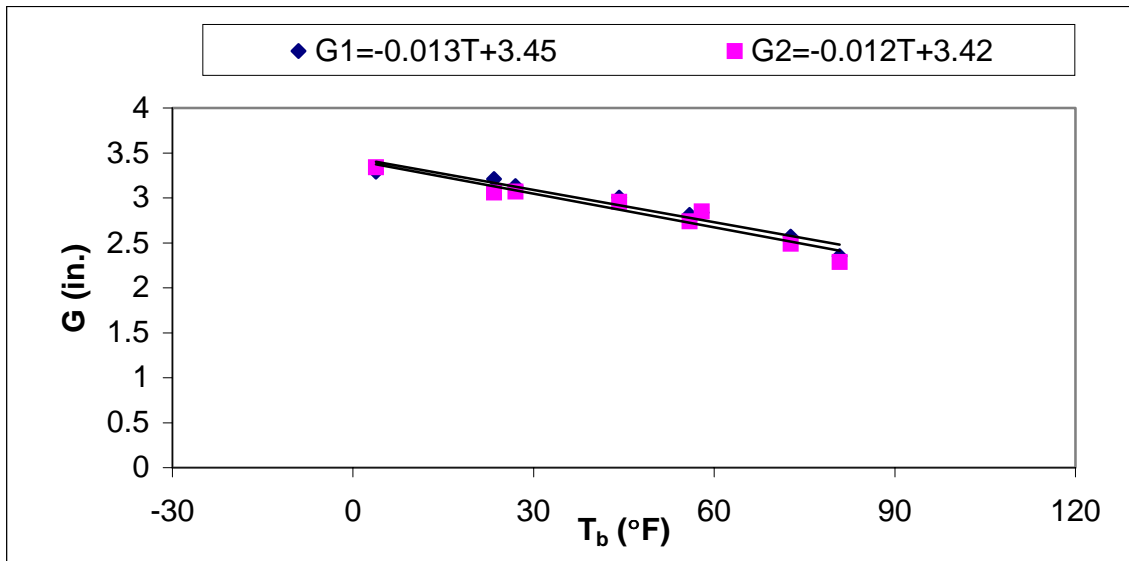
Figure 6.34 Gap opening vs. representative bridge temperature for Bridge 9 (6485.3L030)

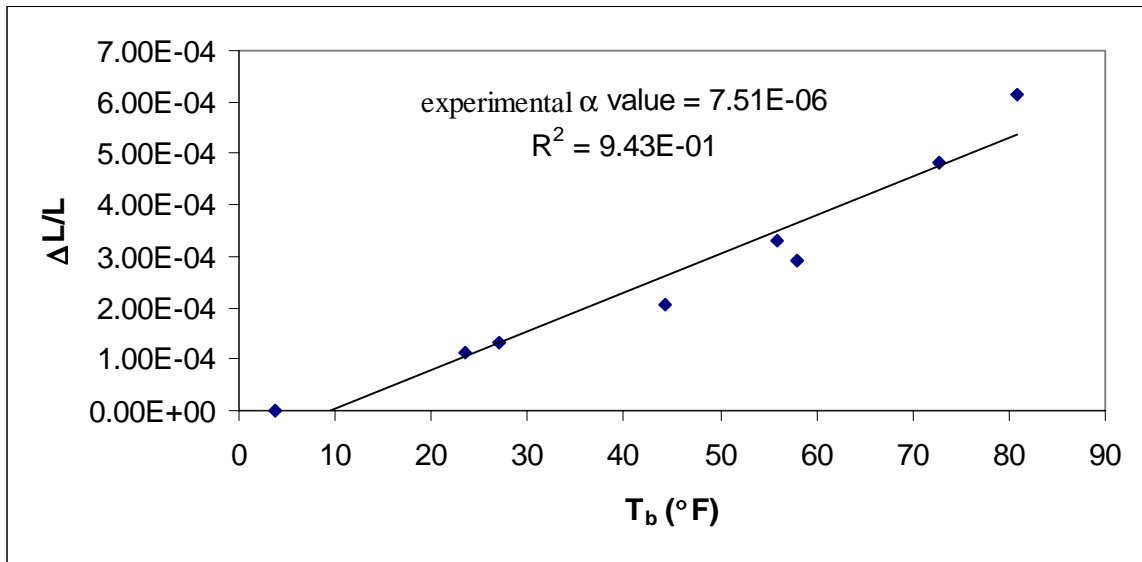
Figure 6.35 The experimental α -value for Bridge 9 (6485.3L030)

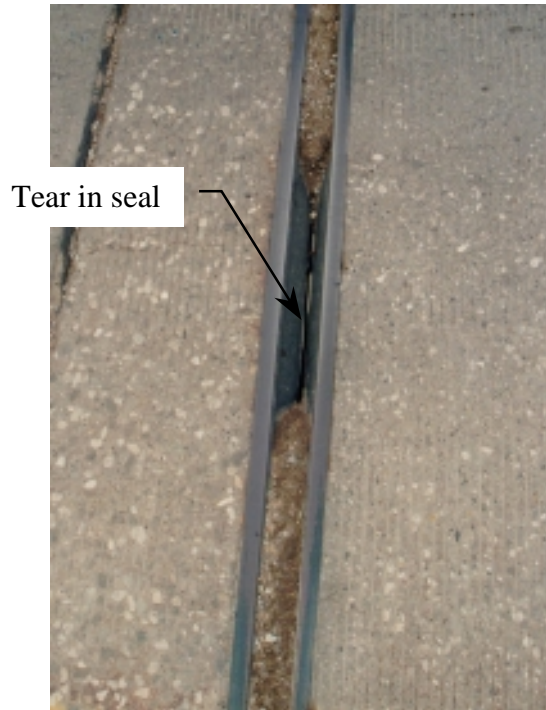
Figure 6.36 Strip seal at G1 for Bridge 10 (6402.0S014)

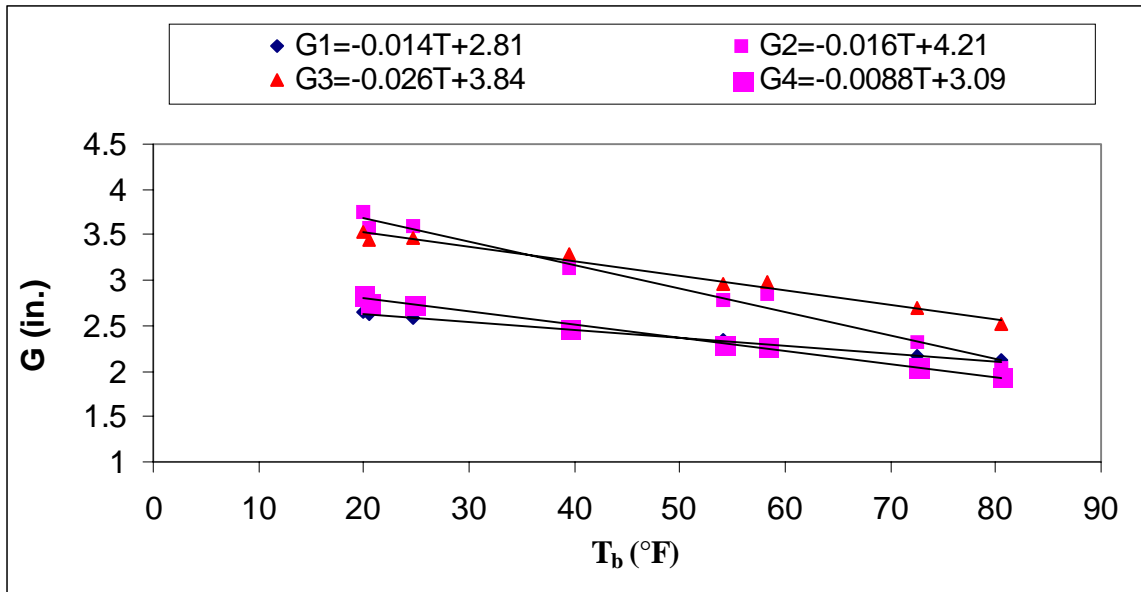
Figure 6.39 Gap openings vs. bridge temperature for Bridge 10 (6402.0S014)
