Performance of Strip Seals in Iowa Bridges, Pilot Study

FINAL REPORT

Iowa Highway Research Board
Project TR-437

Iowa State University

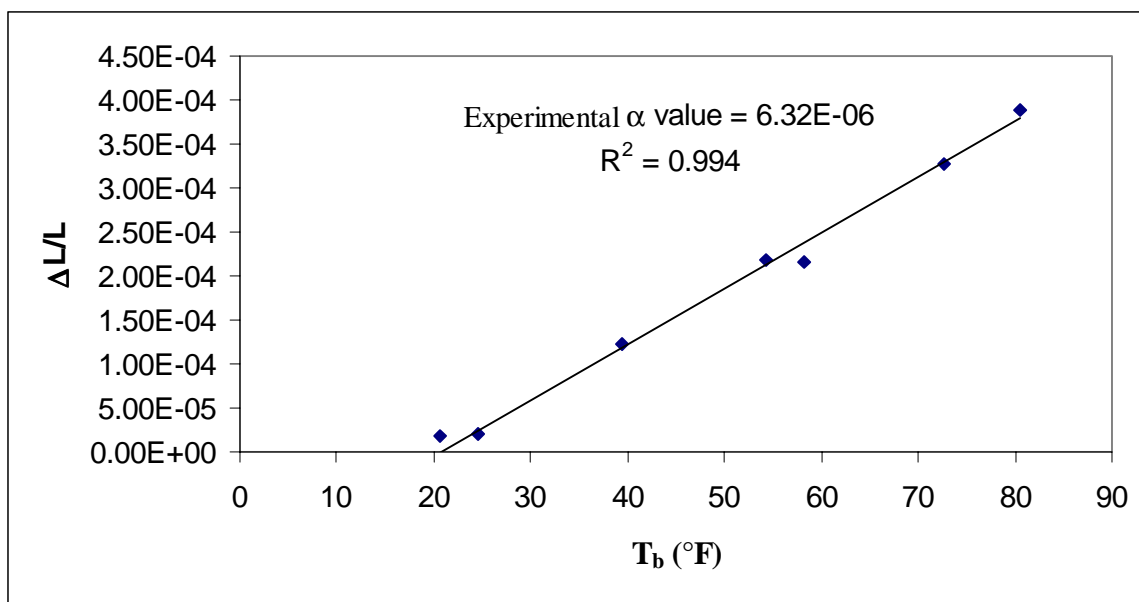
Figure 6.40 The experimental α -value for Bridge 10 (6402.OS014)

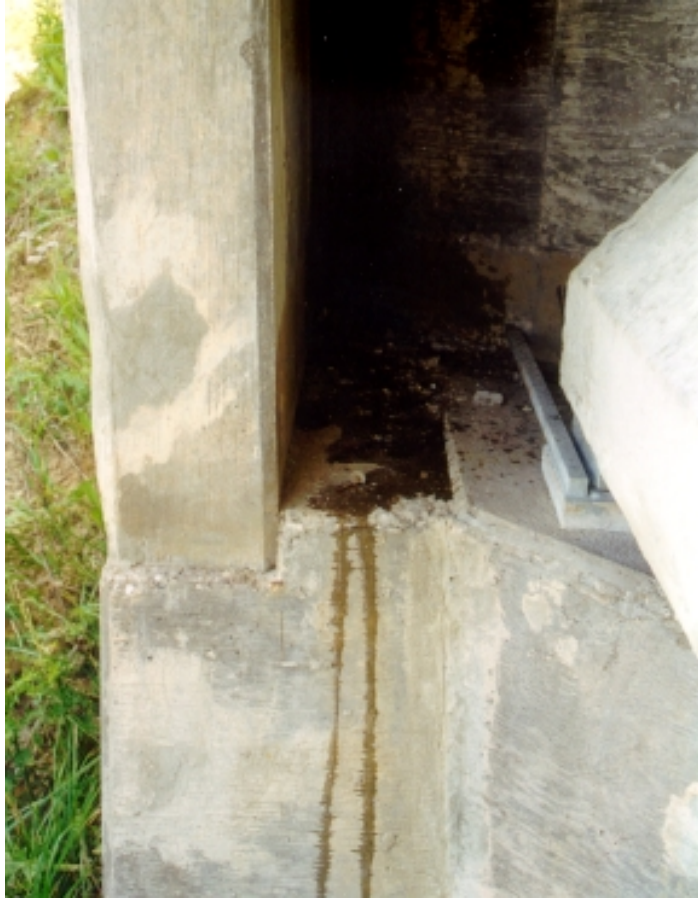
Figure 6.41 Leakage observed underneath G2 for Bridge 11 (6403.6L014)

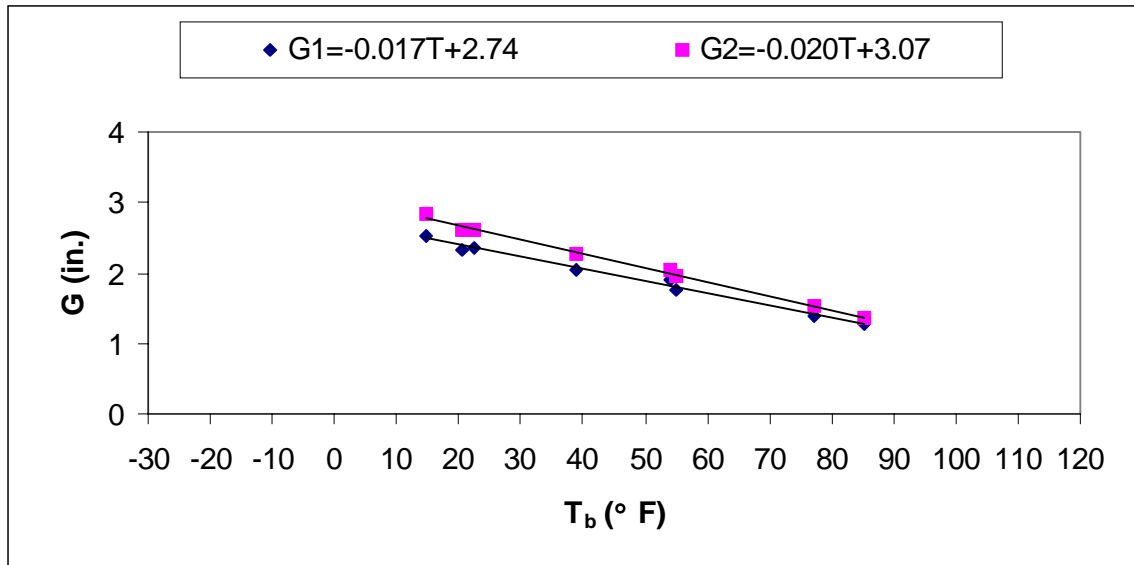
Figure 6.42 Gap opening vs. bridge temperature for Bridge 11 (6403.6L014)

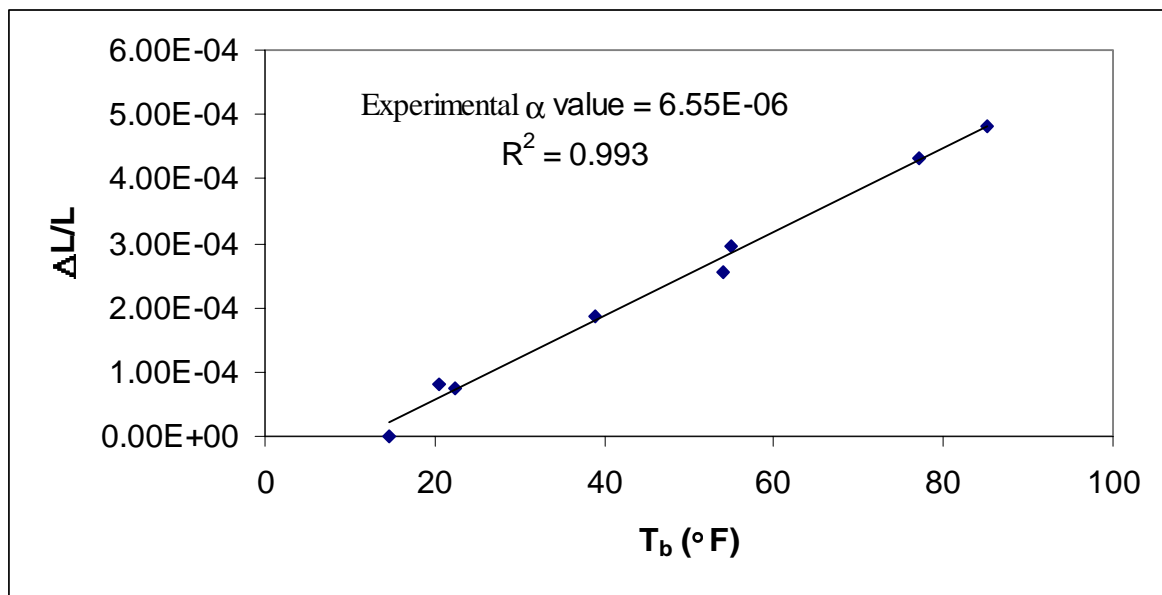
Figure 6.43 The experimental α -value for Bridge 11 (6403.6L014)

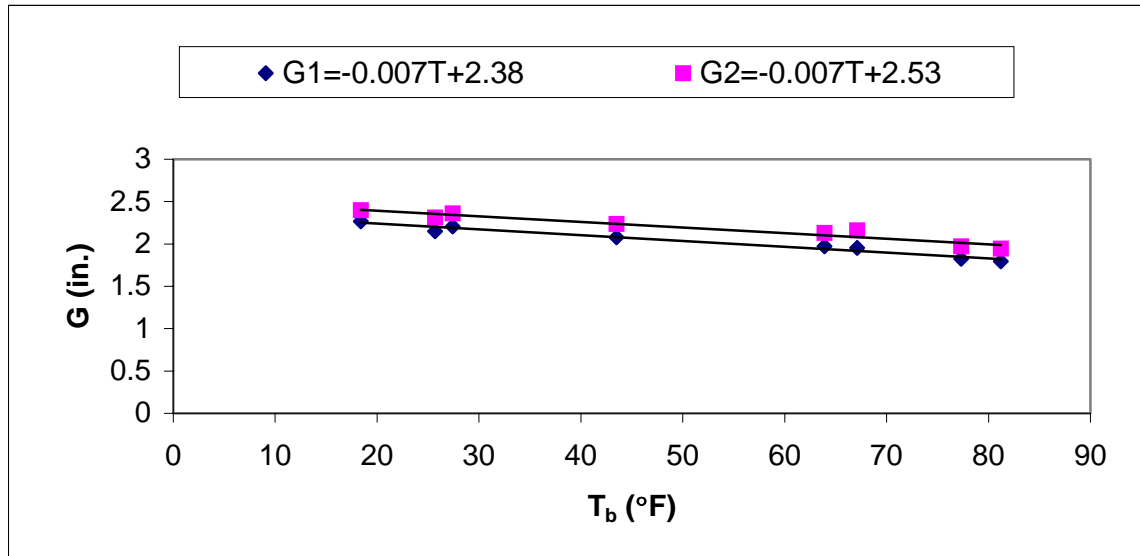
Figure 6.44 Gap opening vs. bridge temperature for Bridge 12 (6481.9L030)

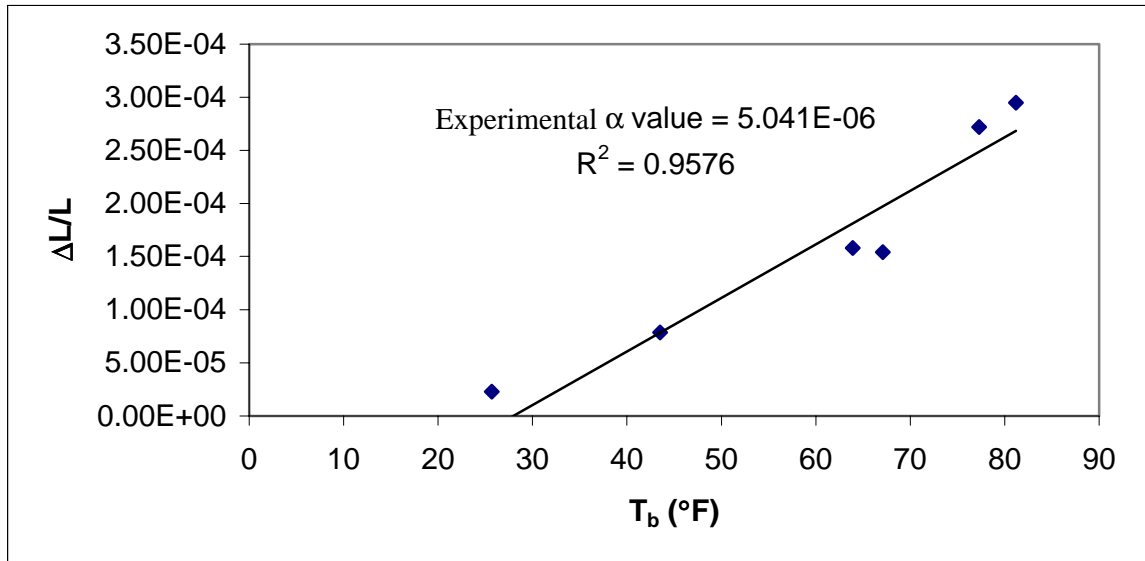
Figure 6.45 The experimental α -value for Bridge 12 (6481.9L030)

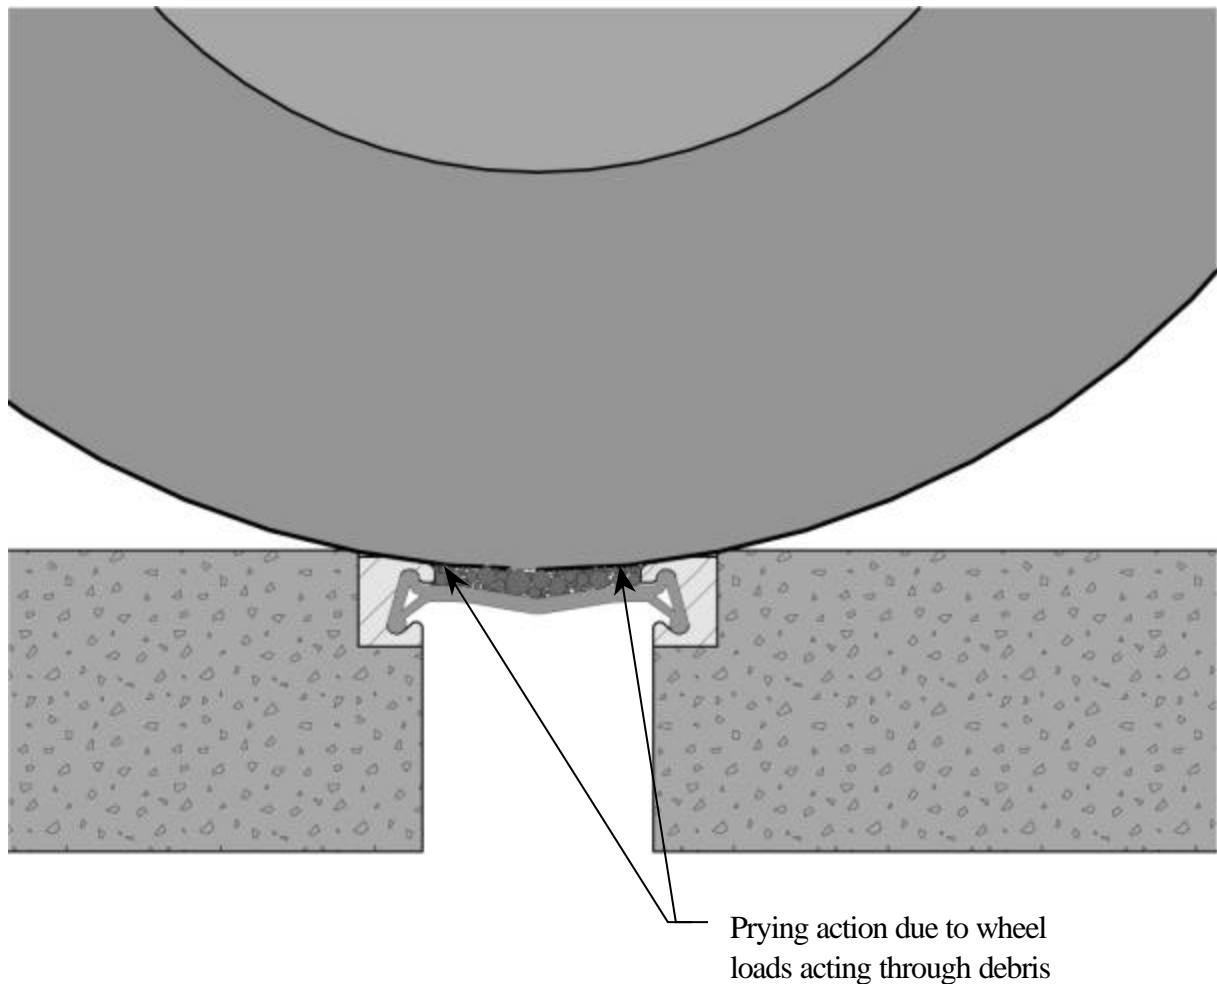
Figure 7.1 Interaction of wheel, seal, and debris when gap is near seal rating
