Evaluation of Rumble Stripes on Low-Volume Rural Roads in Iowa— Phase II

Final Report
November 2011

EVALUATION OF RUMBLE STRIPES ON LOW-VOLUME RURAL ROADS IN IOWA—PHASE II

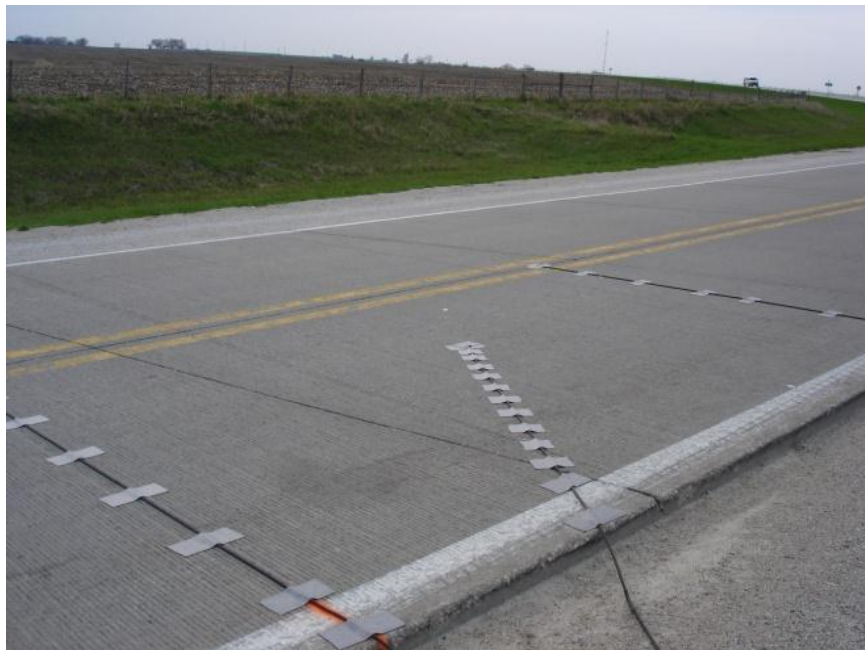
Using the time stamp of when each tire strikes a particular road tube and geometric relationships, the distance that the vehicle is from the edge of the roadway (O_x) can be determined. The tube configuration is set up so the right edge of the right lane line for tube 1 is the reference point (0,0). The road tube configuration in the field is shown in Figure 3.6.

Figure 3.6. Road tube layout to measure lateral displacement in the field
