# High Performance Concrete Pavement in Indiana

Tommy E. Nantung

Report Number: FHWA/IN/JTRP-2011/20

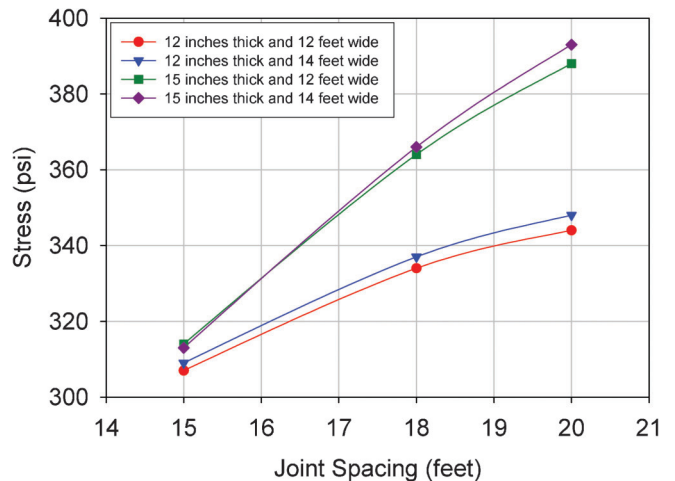
Figure 1.3 Curling Stresses Based on Joint Spacing

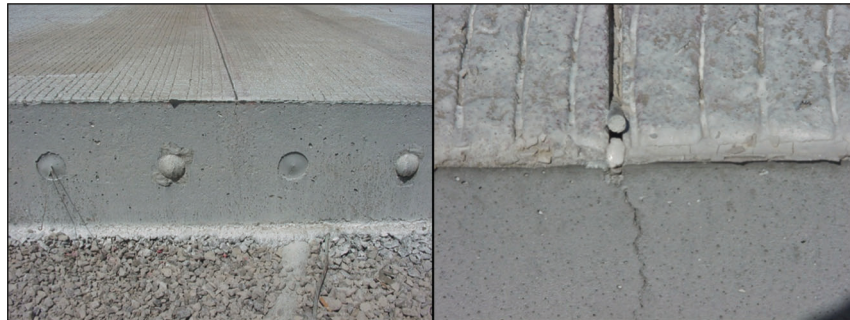
Figure 2.9 Joint saw cut conditions the day after saw cutting

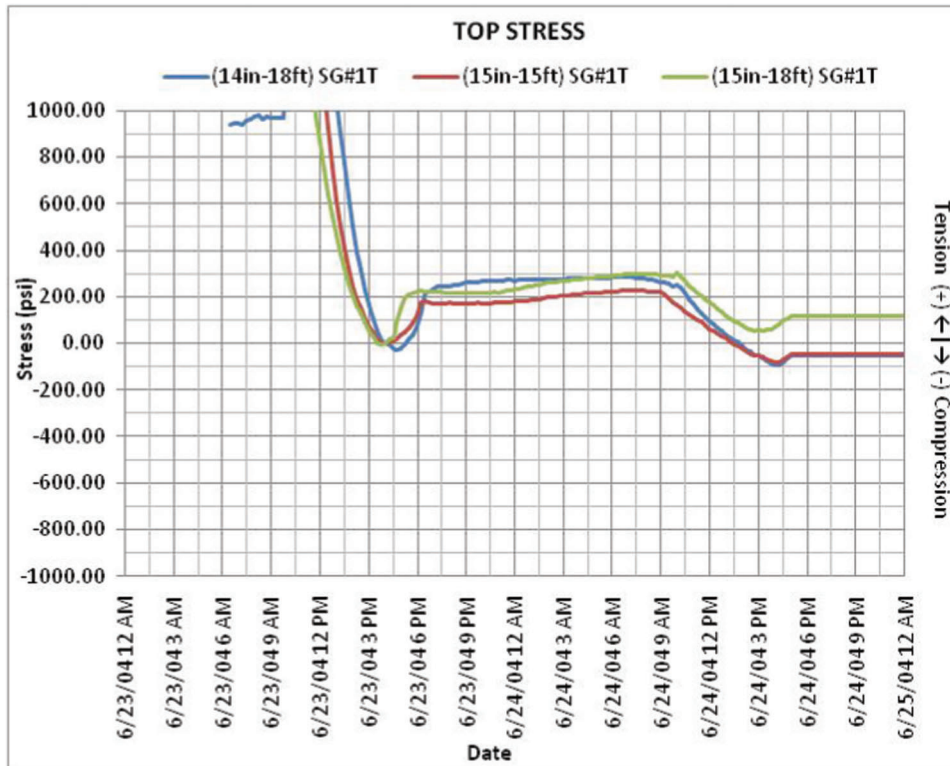
Figure 4.3 Stresses at the tops of slabs from strain gage LL1 calculations

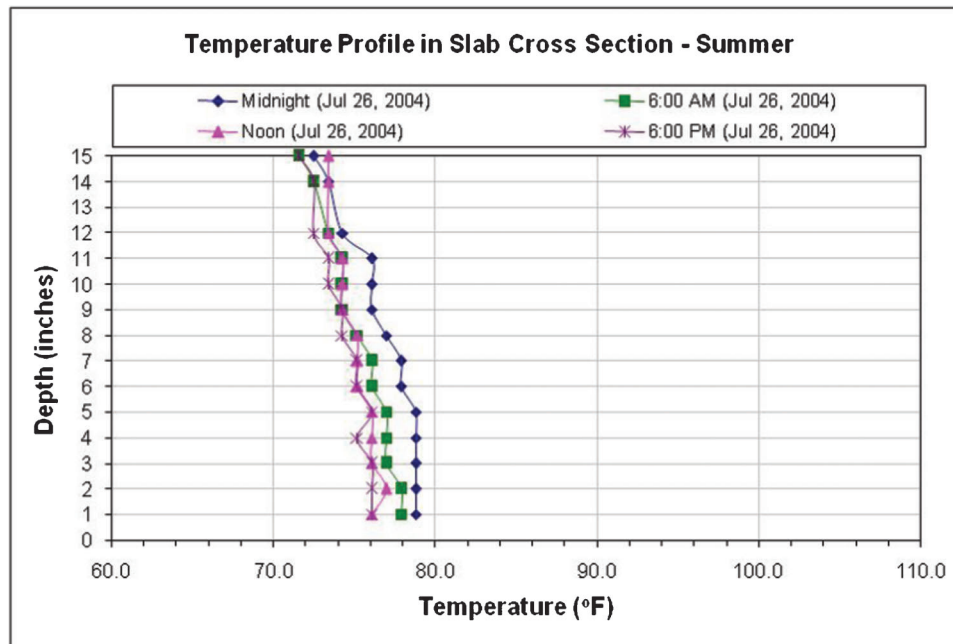
Figure 4.7 Temperature profile in a summer season at slab corner location

Figure 4.7 shows a typical temperature profile in the summer of 2004 when there were no drastic air temperature changes in three consecutive days. The iButtons, located on the corner of the slab, revealed that the temperature profile was almost constant night and day. Figure 4.8 shows the temperature profile at the mid-slab location, which was identical to that of the corner location.

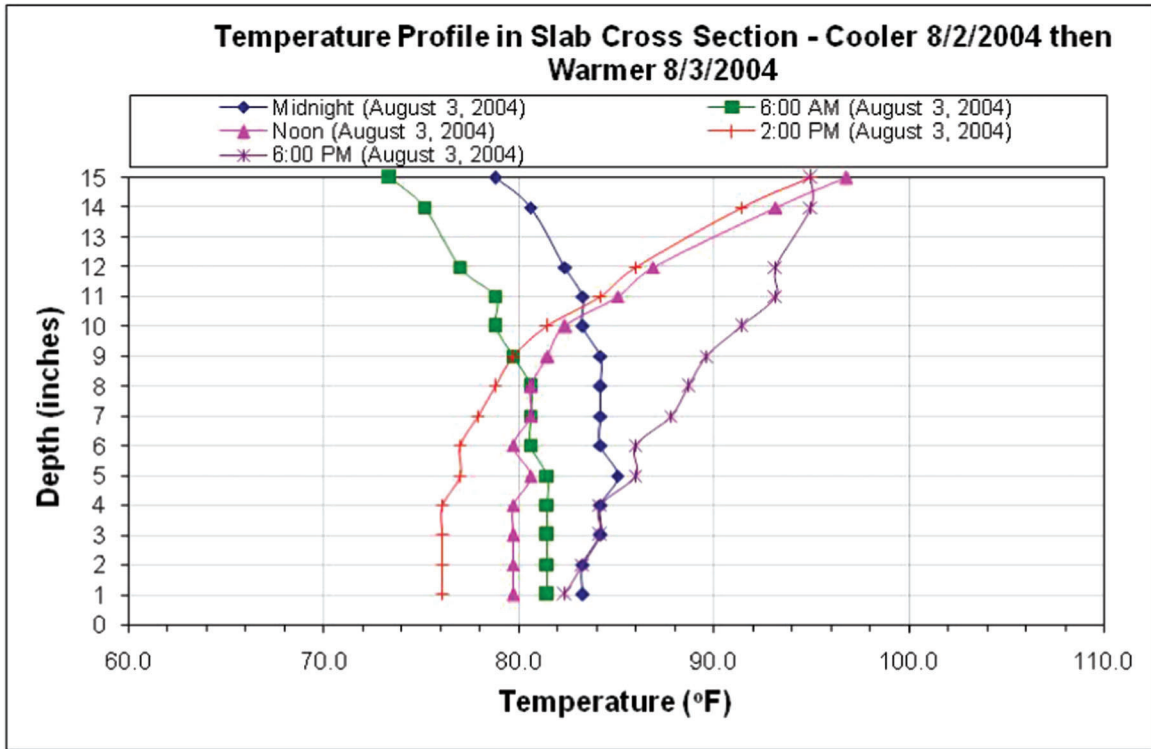
Figure 4.10 Temperature profile in a summer season with a sudden change in air temperature from cooler to warmer

Figure 4.10 shows the temperature profile of the slab when there was a sudden change of air temperature from cool to hot. The same phenomenon occurred in this scenario as with the change from hot to cool above. The temperature swing in the bottom half of the slab

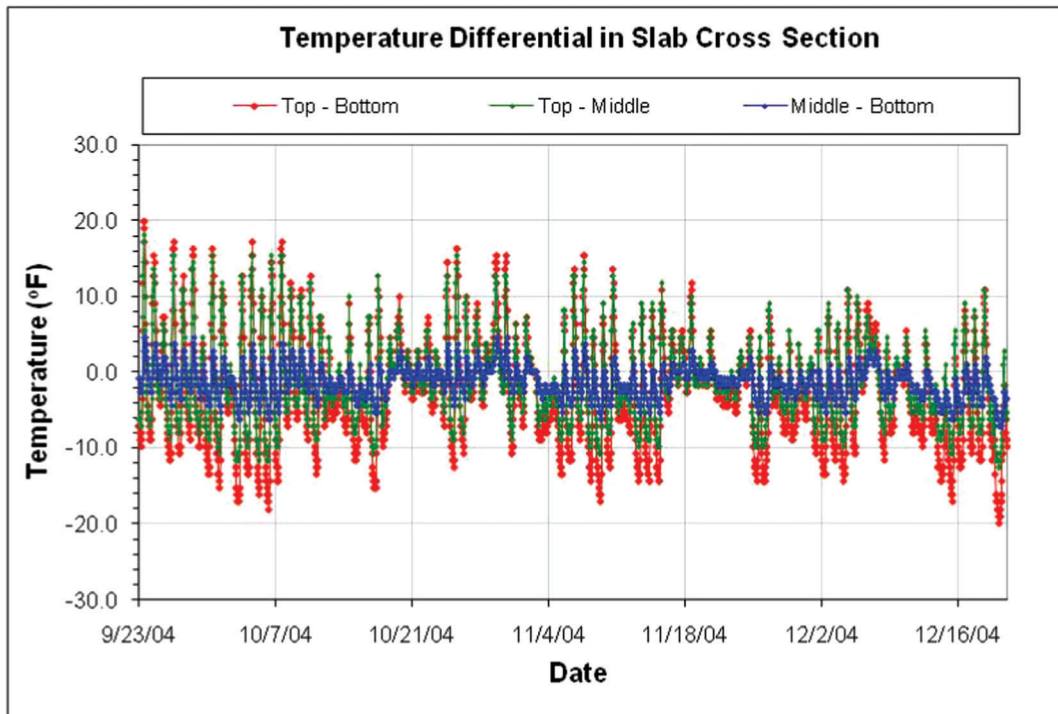
Figure 4.11 Temperature differentials between top, mid, and bottom slab, fall of 2004

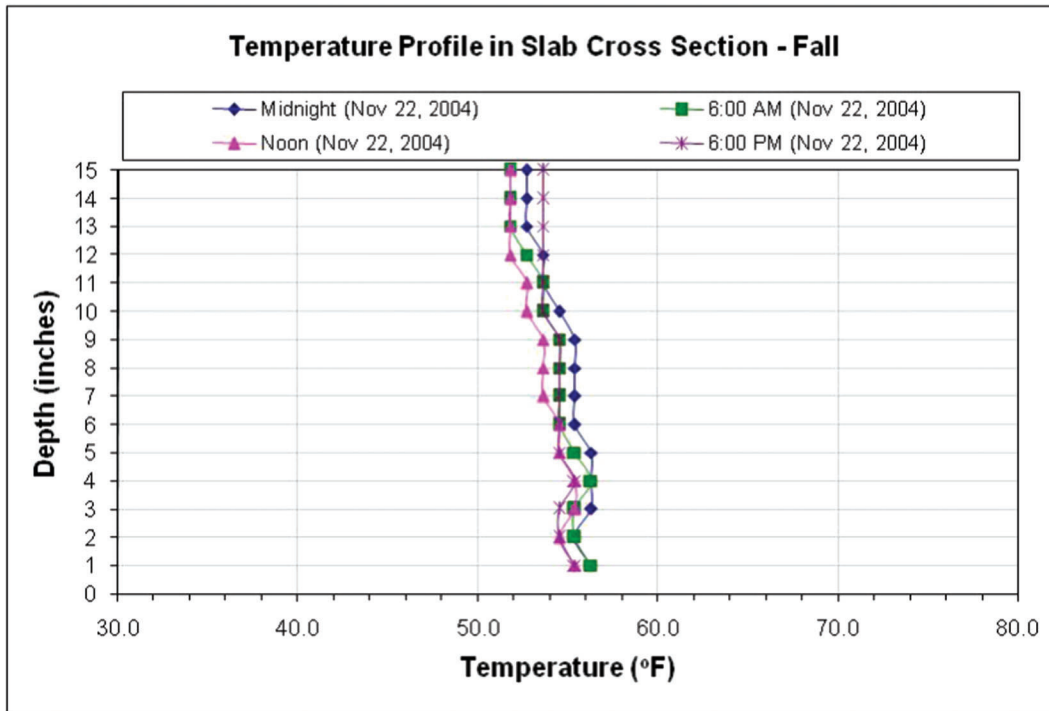
Figure 4.12 Temperature profile in a fall season at corner slab location

Figure 4.12 shows a typical slab temperature during the fall season from midnight to 6:00 PM the next day. The temperature differences between the top and

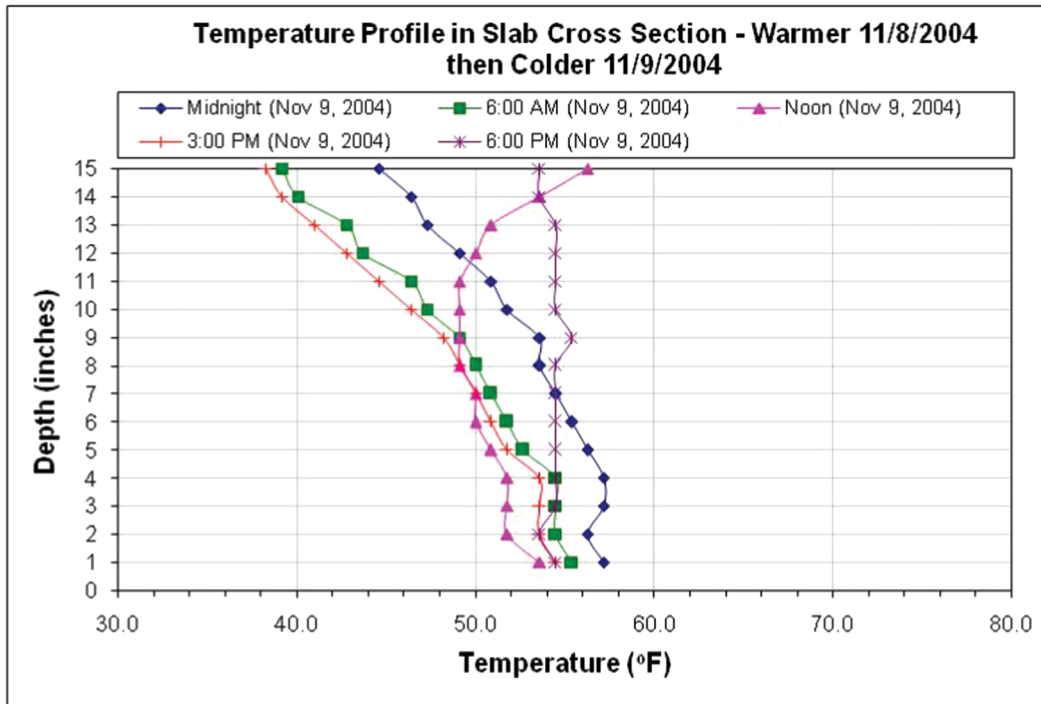
Figure 4.13 Temperature profile in a fall season with a sudden change in air temperature from warmer to colder

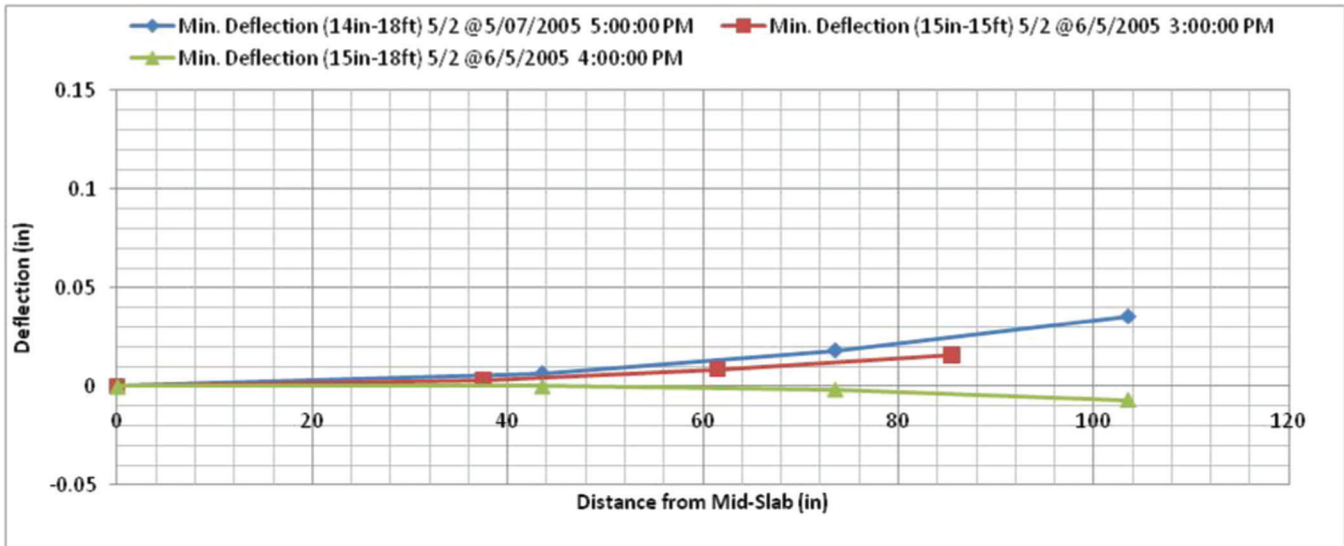
Figure 4.32 Comparison of minimum slab deflections in right-side longitudinal direction

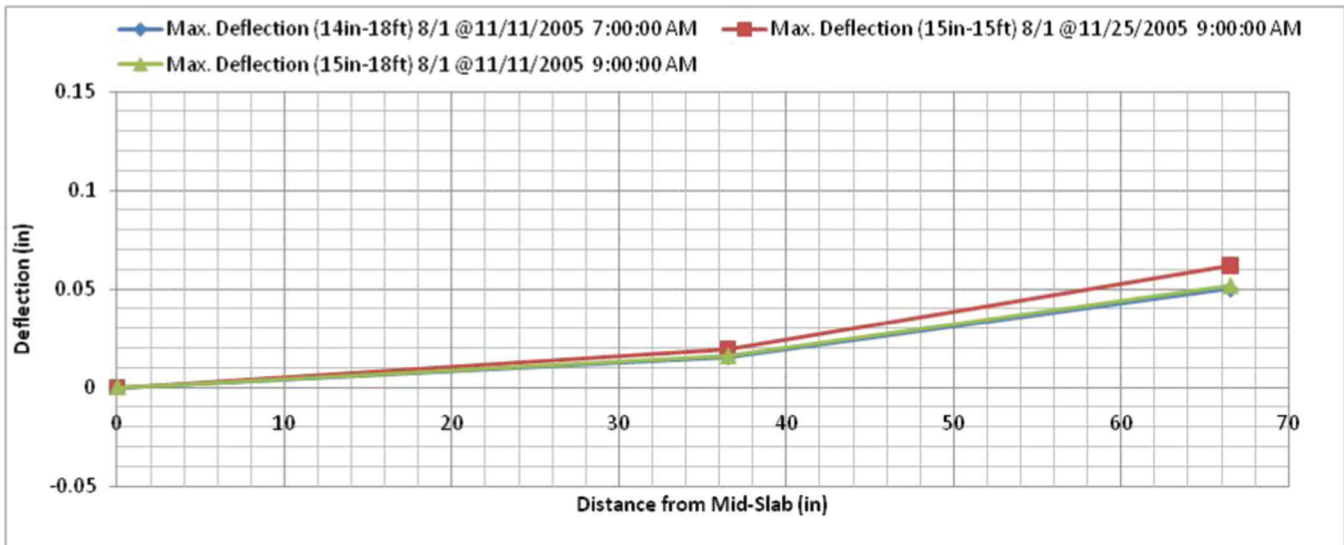
Figure 4.34 Comparison of maximum slab deflections in the right-half panel transverse direction

Figures 4.33 and 4.34 show the maximum deflections of the slab in the transverse directions on the left and right side of the slabs. There was no significant difference among the three experimental sections in this transverse direction because the width of the slab was only 12 feet. The deflections were minimal in this

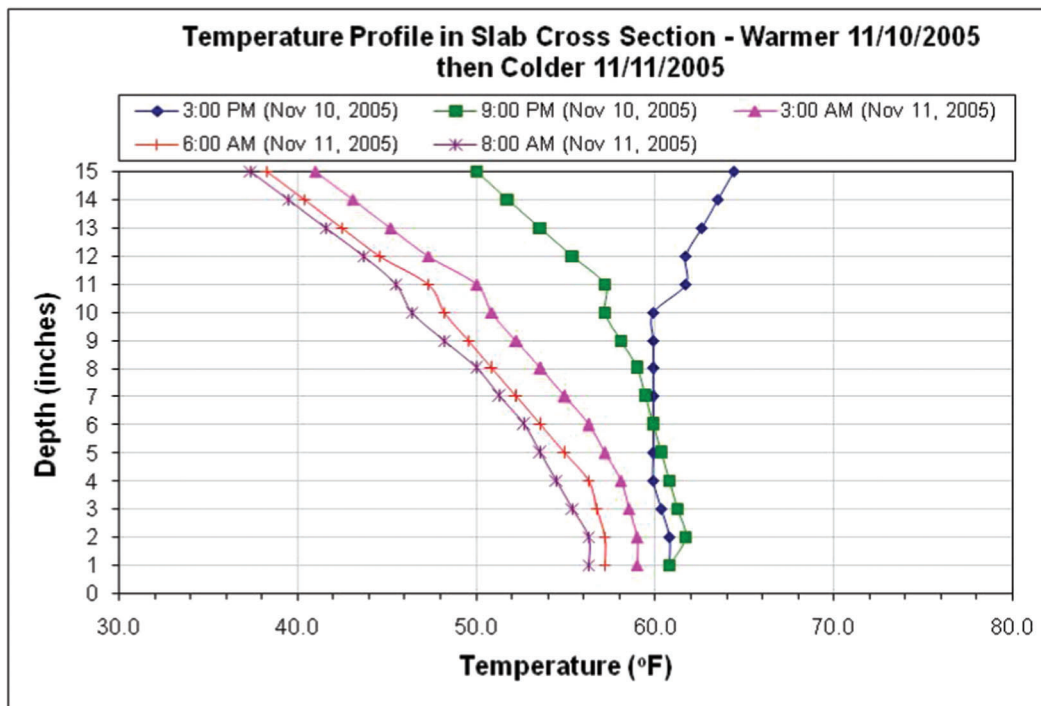
Figure 4.38 Temperature in the slab on November 11, 2005

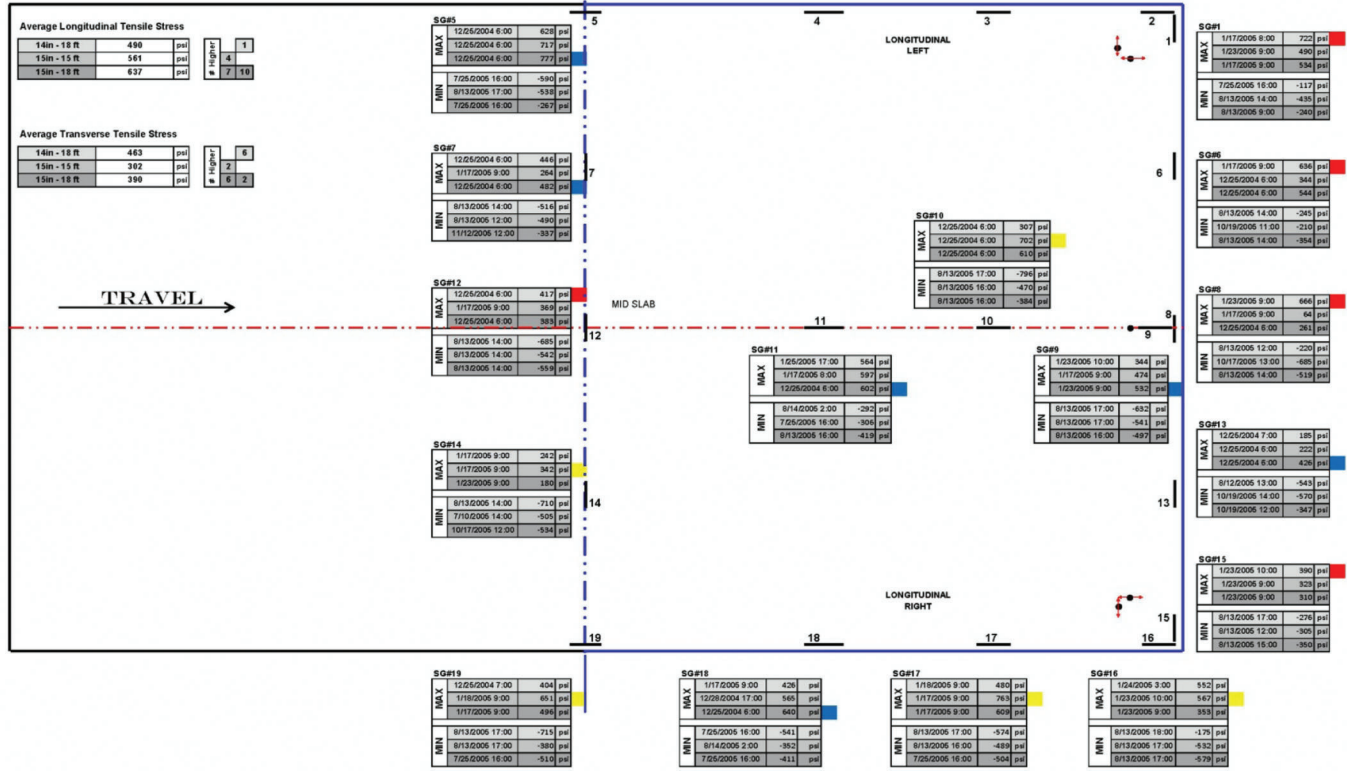
Figure 4.45 Maximum and minimum stresses on the top portions of slabs
