University of Florida
Civil and Coastal Engineering

Final Report

December 2011

Hillsboro Canal Bridge Monitoring

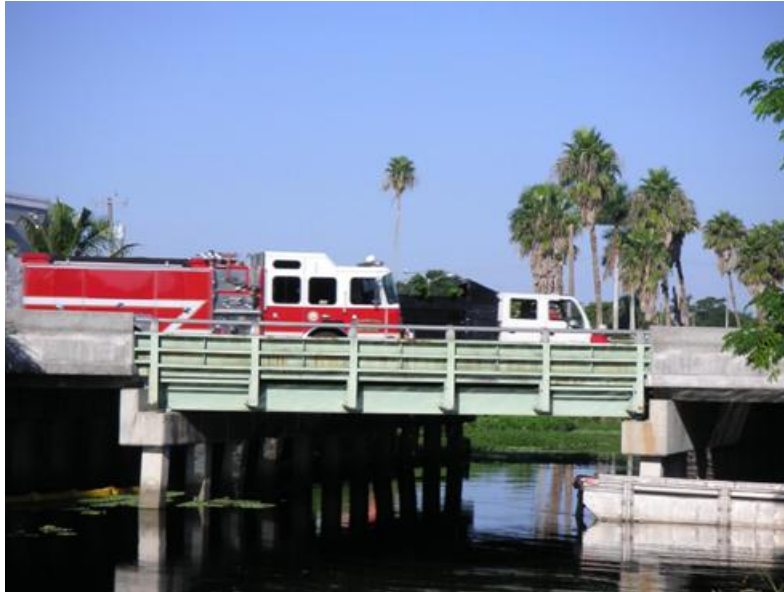
The superstructure crosses the canal with three short spans. Cast-in-place flat concrete slabs span 15 ft from the abutments to the pile bents (Figure 6). The middle span was a steel grid deck supported by structural steel framing.

Figure 6 – Elevation view of main span

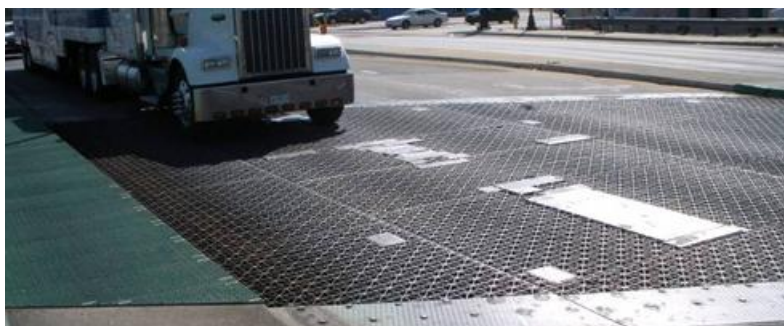
Heavy traffic occurs during the sugarcane harvesting season (from late October through mid-April). Sugarcane-laden trucks have been observed traveling in the two northbound lanes, noted as lane one and lane two in Figure 5. Figure 7 shows the local damage sustained by the steel grid deck and associated repairs using steel plates. This grid deck was replaced by the GFRP deck which is the focus of this study.

Figure 7 – Damaged and repaired existing steel grid deck

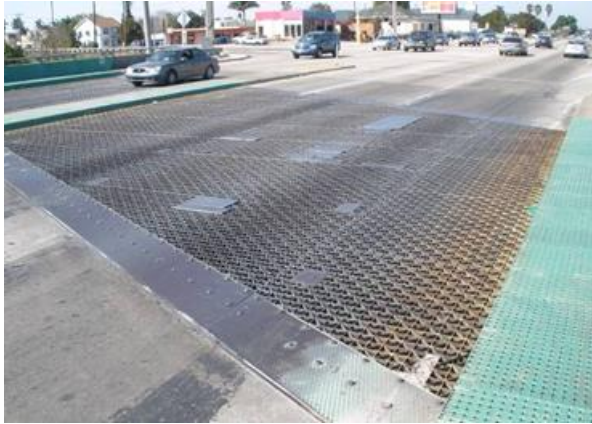
Figure 10 – Existing steel grid deck

The existing steel grid (Figure 10) was removed from the superstructure. A layer of leveling grout was placed between the top flange of the steel girders and the soffit of the GFRP deck to ensure that the finished wearing surface of the new deck aligned with the remainder of the bridge deck. Grout pads were poured using the formwork system shown in Figure 11.

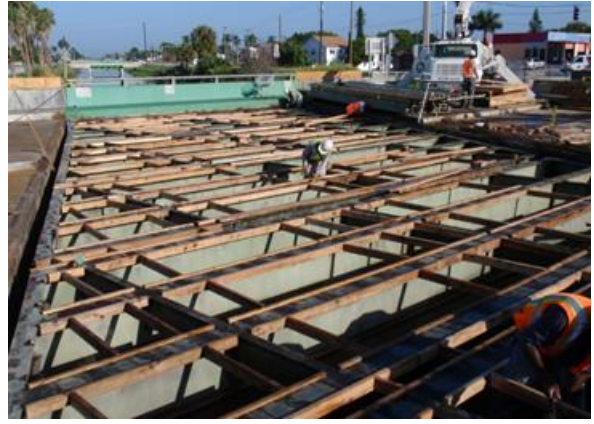
Figure 11 – Formwork for grout pads

Formwork was placed such that it created a nominal 0.5-in. gap for the grout to fill. This gap varied as needed to accommodate construction tolerances.

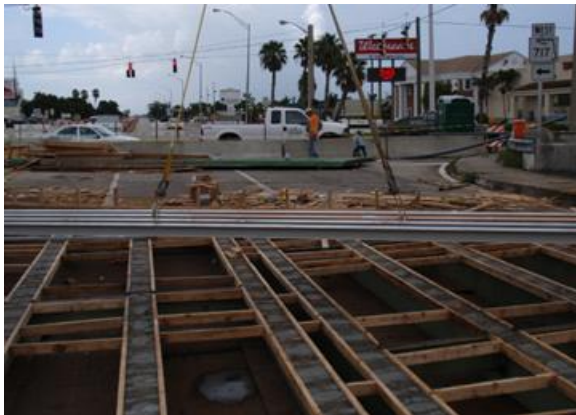
Figure 12 – Installation of bottom GFRP panels

Installation of the deck began with placement of bottom panels on the leveling formwork (Figure 12) perpendicular to the existing steel beams. Bottom panels had already been manufactured and cut to length and were stored on site. Each panel was custom fitted to a particular location within the bridge deck. As bottom panels were placed, they were mechanically interconnected using the protruding bottom deck flange.

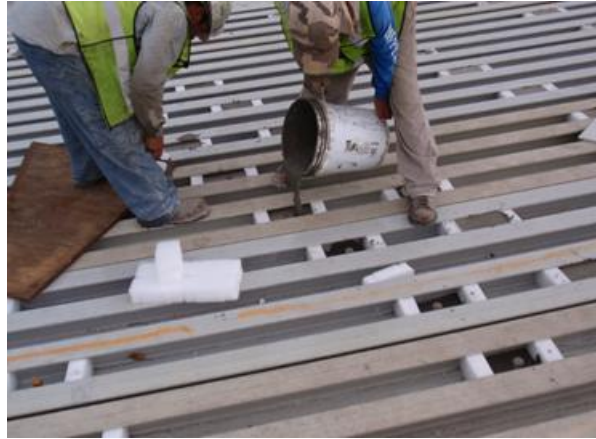
Figure 14 – Grout pockets being poured at each stud

The GFRP deck was connected to the existing steel stringers with welded headed studs. Holes were drilled through the bottom GFRP deck panels to accommodate the steel studs. The studs were then welded to the top flange of the existing girder through the holes in the GFRP deck (Figure 13b). Foam dams were placed adjacent to the studs to retain the grout. Grout (Figure 14) was then poured into the pockets. At first, the grout flowed through the hole and filled the space between the deck and the top flange of the steel girders. When this space was full, additional grout was placed to surround the stud. These grout pockets provided fixed connections between the GFRP deck and the steel girder superstructure.

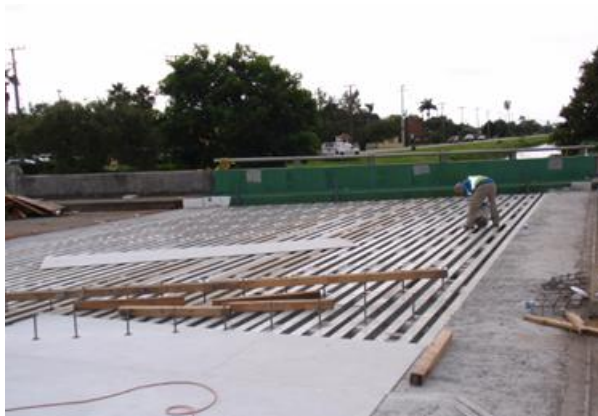
Figure 15 – Median anchors

Longer studs also were welded to the existing steel beams to anchor the median to the bridge deck (Figure 15). Figure 16 shows top plate installation; they were cut to length, stored on site, and attached using mechanical fasteners.

After top plate installation, the existing median was reattached using the median anchors. After the installation of the median, a 0.5-in. thick overlay of polymer concrete (Figure 17) was placed on the top plates to create the wearing surface. Figure 18 shows the completed deck system open to traffic.

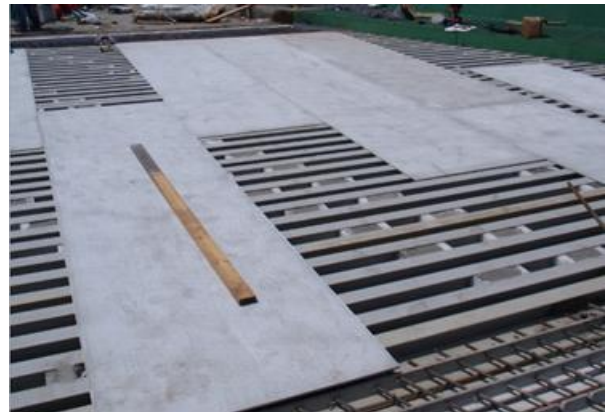
Figure 16 – Top GFRP plates

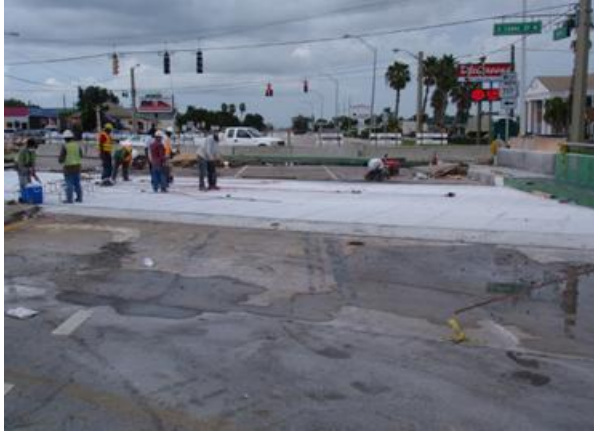
Figure 17 – Placement of polymer concrete wearing surface

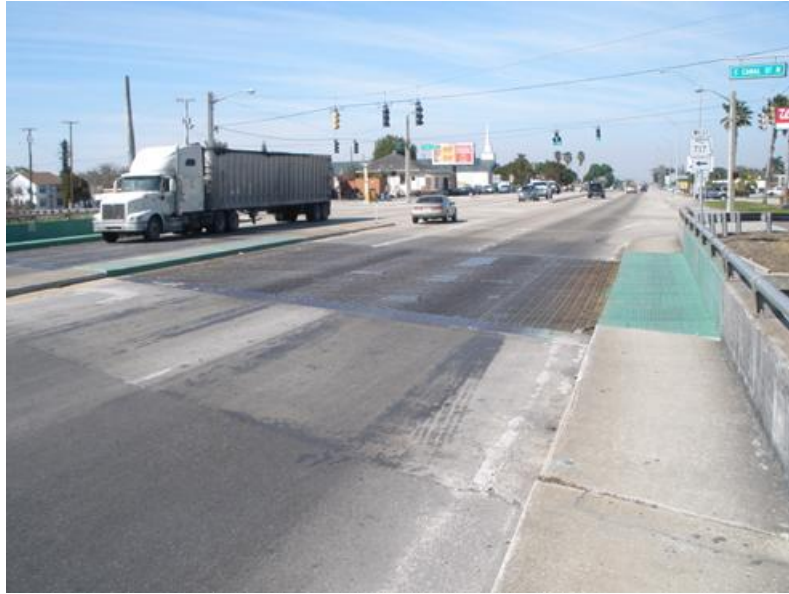
Figure 19 – Two northbound lanes showing truck traffic marks on the road surface.

Visual observation of the traffic and inspection of the steel grid repairs (Figure 19) indicated that the two northbound lanes were the most heavily used. Consequently, these lanes were chosen to receive the instrumentation for monitoring and bridge testing.

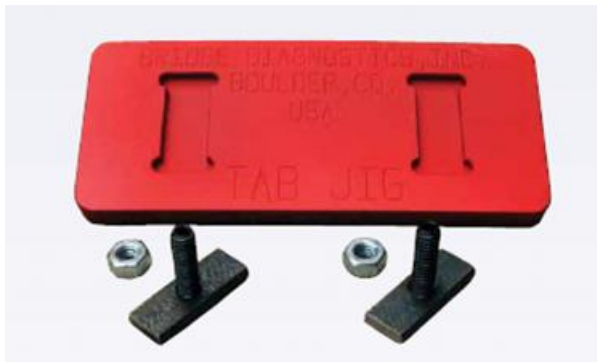
Figure 21 shows the mounting tabs and tab jig used for the installation of the FBS gages. Mounting tabs were adhered to the top of the bottom flange of the girder using a two part epoxy. Surfaces of the steel girders were cleaned using a hand grinder, sand paper and denatured alcohol. A 2-part epoxy was then applied on the steel girders to attach the transducer tab.

Mounting tabs and a tab jig (Figure 21 a) were used to install the FBS gage to the steel girders. First, the mounting tabs were placed in the tab jig slot. Slots in the tab jig were perpendicular to the axis of the FBS gage and served to align the tabs properly. The FBS gage was placed on and bolted to the through tabs. After this, the gage and tabs were removed from the tab jig and placed onto the epoxy. Figure 22 shows an installed FBS gage on the top of the girder bottom flange.

Figure 21 – FBS gage (a) Mounting tabs and tab jig (b) gage

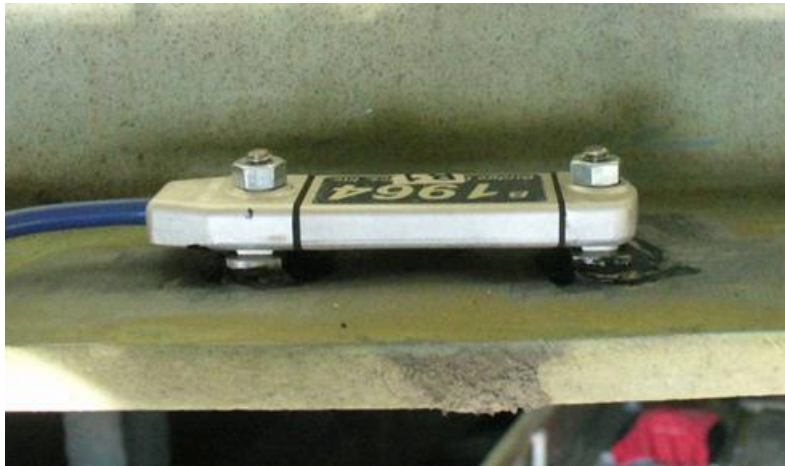
Figure 22 – Installed FBS gage on the steel girder

Visual inspection was performed on the four FBS gages by removing the PVC cover. Gage B1 had water intrusion that rusted the contact surface. B1 was removed from the beam surface, the surface was cleaned using a grinder, acetone and rag paper, and the gage was reattached at the same location using Loctite adhesive and an accelerator. Gage B2 had a strong bond to the monitored girder with no rust present. New wire was used to connect B2 to the monitoring equipment. Gages B3 and B4 likewise had strong bonds with no rust present. The wiring connection was redone at the gage end for B3 and at the monitored end for all FBS gages.

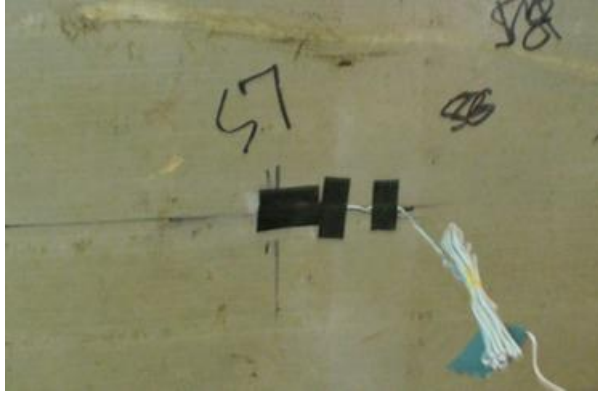
Four 5-mm (UFLA-5-350-11-5-LT) long bonded quarter bridge foil strain gages from TML Tokyo Sokki Kenkyujo Co., Ltd. (TML) were mounted on the soffit of each of the two instrumented panels (Figure 24). Gages were oriented to read strain parallel to the GFRP webs. Four strain rosettes (0-45-90) (UFRA-5-350-11-5LT) from TML were installed on the webs of each instrumented panel with the zero direction gage oriented along the longitudinal axis of the web. While rosettes were used for the first bridge test only, soffit gages were used for both of the bridge tests and monitoring. Figure 25 shows a bonded gage installed on the soffit of the GFRP deck while Figure 26 shows a bonded strain rosette installed on a GFRP deck web.

Figure 25 – Bonded strain gage

Soffit mounted strain gages originally installed for monitoring and the October 2009 bridge test were replaced prior to the October 2010 bridge test. The gage resistance was checked for each strain gage prior to replacement. Gages S1, S2, and S5 had malfunctioned while gages S3 and S8 had never functioned. Replacing all eight soffit gages was done to prevent errors due to variations in gage conditions. All new gages were covered with waterproof mastic tape for protection during long-term monitoring. New wire was used to connect the gages to the monitoring equipment.

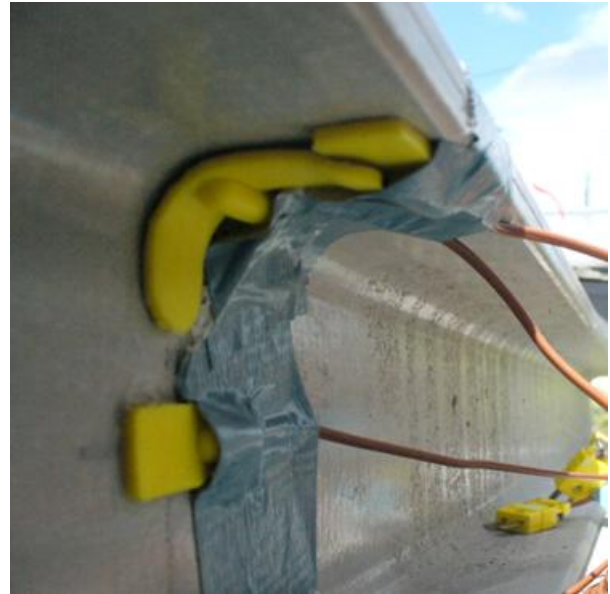
Figure 27 shows the location of the four general purpose type K thermocouples used to measure GFRP surface temperature. The thermocouples were arranged to provide continuous readings of the thermal gradient that develops during heating and cooling of the bridge deck.

Thermocouples were applied to the GFRP bottom panel before deck installation due to restricted access to the interior of the bridge deck. Panel B8 was chosen to receive thermocouples due to its nearness to the DAQ (Figure 28). To obtain the temperature gradient over the height of the GFRP deck section, thermocouples were evenly spaced over the height. Thermocouples (SA2F-K-K120-SMPW-CC) were installed at the top, mid-height, and bottom of the selected web. One additional thermocouple (SA2C-K-K120-SMPW-CC) was installed at the junction of the web and the top flange. The thermocouple used in this position was designed to be placed on curved surfaces. All thermocouples were purchased from Omega Engineering Inc.

Figure 27 – Surface-temperature-measuring thermocouples on panel B8

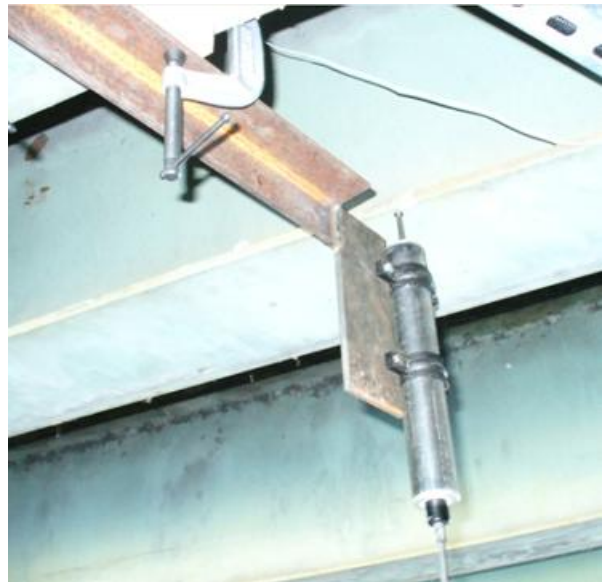
GFRP deck displacement was measured during the bridge tests and during long-term monitoring. The relative girder displacements were also measured during the 2009 bridge test. The location of the displacement gages is given in Figure 28. Relative girder displacements in two locations were measured using the fixture shown in Figure 29. The frame is attached rigidly to one of the girders with the displacement gage plunger contacting the adjacent girder. Relative displacements were measured between girders 3-4 and 7-8.

Figure 29 – Deflection gage on steel girder

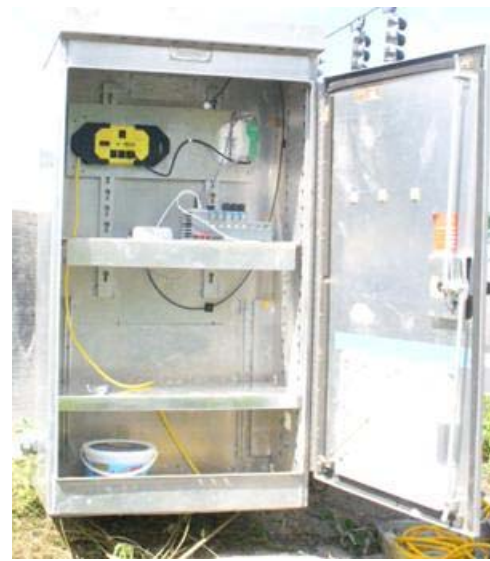
Figure 34 – Traffic box mounted on a sign post

Figure 33 shows the wiring diagram for the long-term monitoring system. Instrument wires were collected into a single bundle inside a unistrut tray that extended to the sidewalk. At the sidewalk, the bundle exited the unistrut tray, and entered a protective sleeve, turned north, and followed a steel girder to the pier. The bundle entered a flexible conduit at the pier, which followed the slab bridge span to the abutment and eventually terminated at the traffic box on the bank. C-clamps were used to attach the flexible sleeve to the steel girder. The rigid conduit was attached to the concrete slab of the sidewalk. A solar panel (Figure 35) was used to power the DAQ and was installed next to the traffic box.

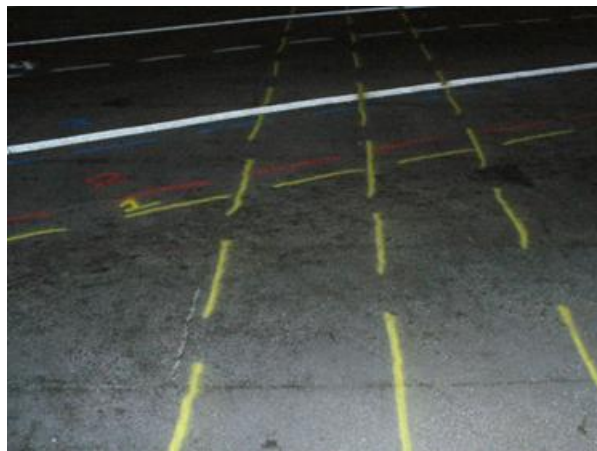
Figure 43 – Truck position reference marks on the bridge deck

The instrumentation needed for the bridge test and monitoring were installed during the two days prior to the bridge tests. The 2009 bridge test was performed at night from 9pm to 5am while the 2010 bridge test was performed from 9pm to 2am to avoid causing traffic delays. The FDOT DAQ and AE systems were placed on the east sidewalk of the bridge during the test. Truck position reference marks were painted on the bridge deck (Figure 43).

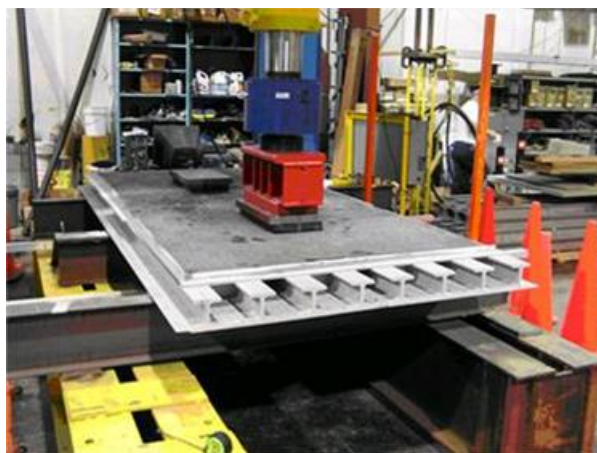
This section presents a comparison between laboratory tests conducted on the same type of GFRP deck that was installed on the Belle Glade bridge. Vyas et al. (2009) performed static and fatigue testing on the GFRP deck using the test setup shown in Figure 105. The specimen was supported in three locations and was continuous over the center support. The 4 ft spacing used for the supports was similar to that of the bridge. Load was applied over a 10 in. x 20 in. bearing pad; these are the same dimensions as the tire patch loading area specified in AASHTO Section 3.6.1.2.5.

Figure 105 – Structural test of GFRP deck used in Belle Glade bridge (Vyas et al. [2009])

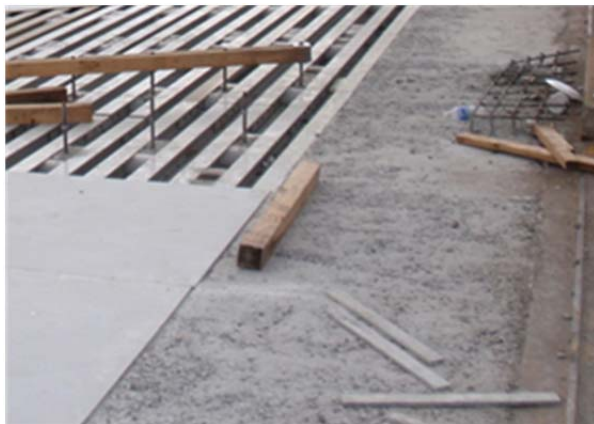
Figure 119 – Top plate free edge

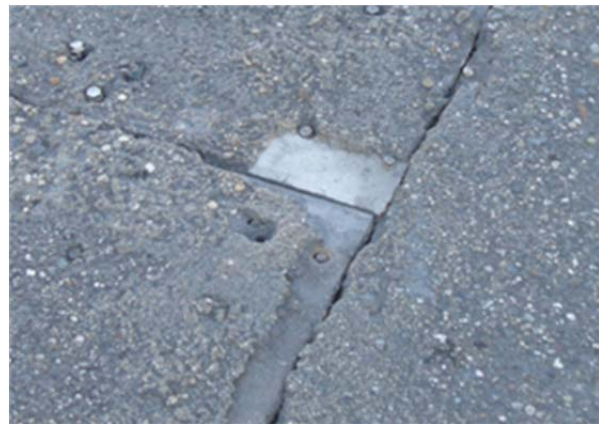
Figure 120 – Degradation at free edge

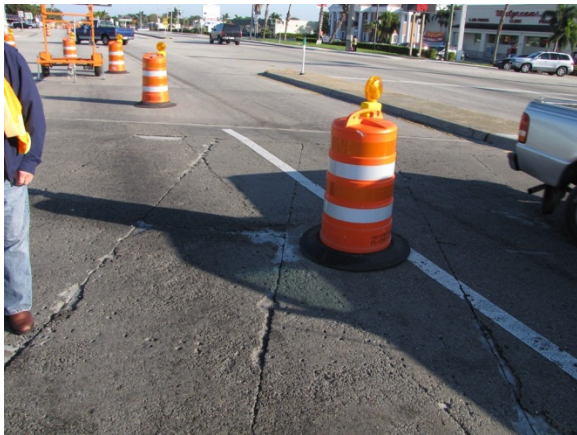
Figure 122 – Wearing surface damage at panel joints

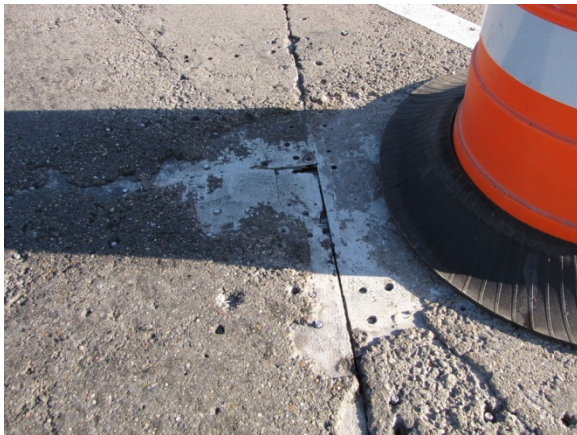
Figure 123 – Wearing surface damage at intersecting panels

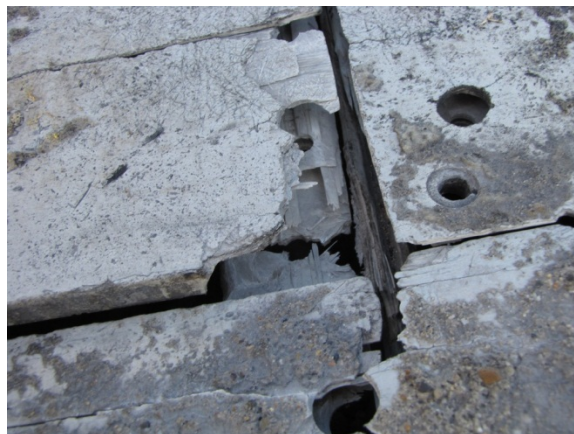
Figure 124 – Severe damage to top plates and webs
