**FHWA-WY-10/06F**

# **UTILIZING AUTOMATED DATA COLLECTION VEHICLES IN DETERMINING THE FORE SLOPES OF SHOULDERS**

**Department of Civil and Architectural Engineering  
University of Wyoming  
1000 E. University Avenue, Dept. 3295  
Laramie, Wyoming 82071  
December 2010**

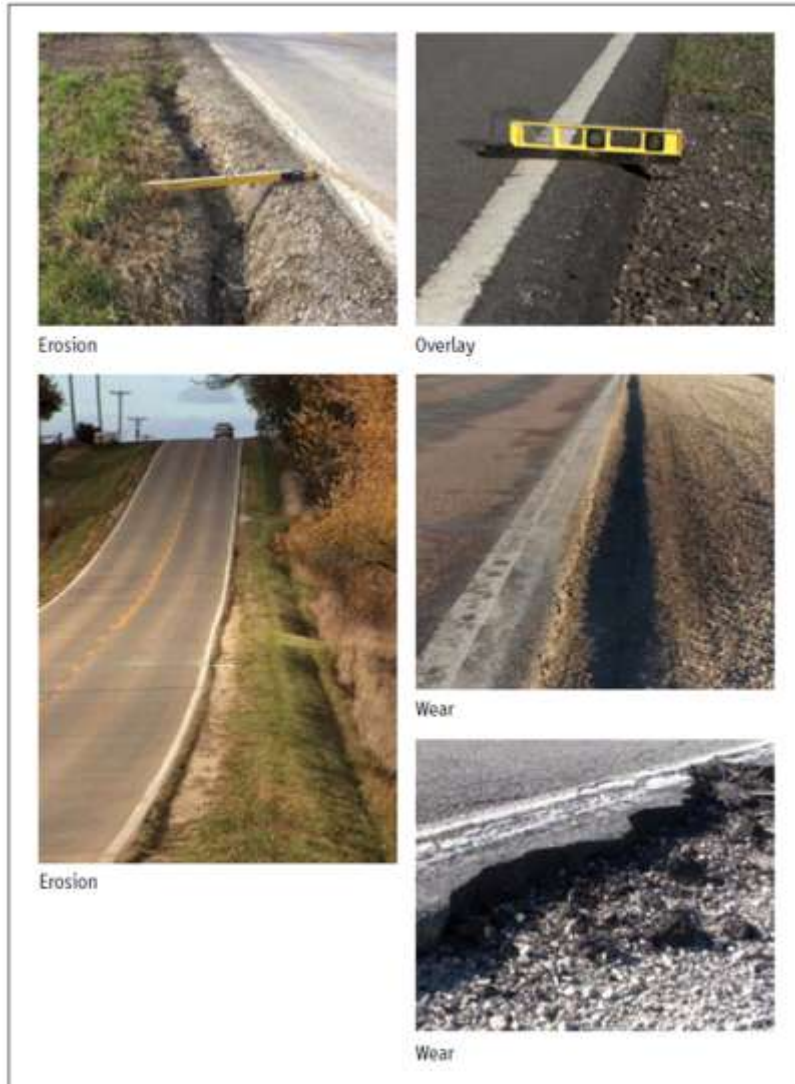
**FIGURE 2.2 Common Causes of Pavement Edge Drop-off [Hallmark et al. 2006].**

Pavement edge drop-off (PEDO) is the vertical difference between two adjacent road surfaces. Drop-offs can occur between two travel lanes, a travel lane and a paved or unpaved shoulder, or between a paved shoulder and an adjacent surface such as the sideslope. Drop-offs are typically caused by improper design, settling between the pavement surfaces, or roadway resurfacing. Shoulder material may also break off from the pavement edge from excessive wear or erosion [Hallmark et al. 2006]. See Figure 2.2.

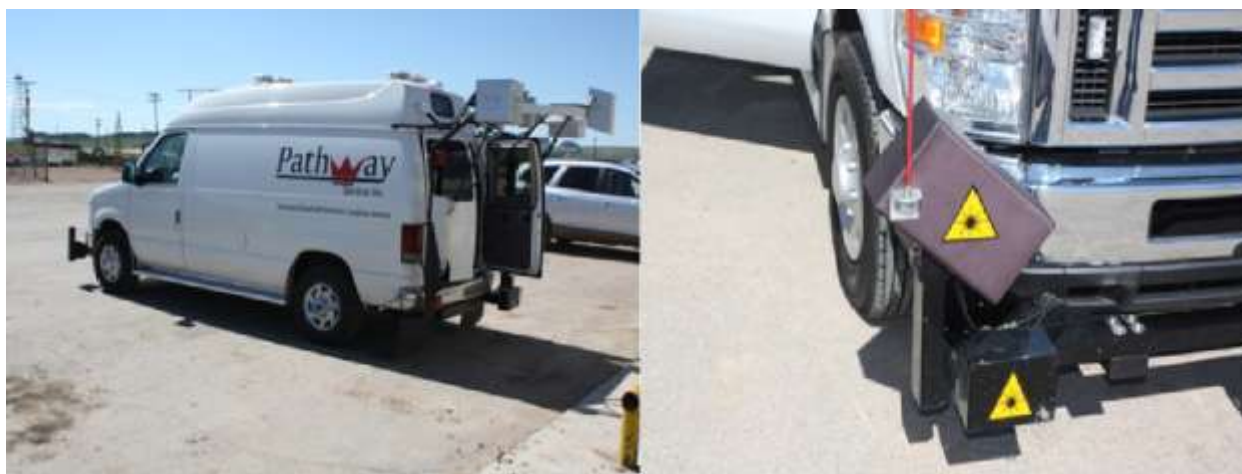
**FIGURE 3.1 Pathway Collection Van and Drop-off Sensor.**

Shoulder slope and drop-off data were collected by Pathway Services, Inc. using a high-speed automated data collection vehicle. This road profiler is a full-size van equipped with various cameras, lasers, and sensors. High-resolution cameras mounted on the front and back of the vehicle capture an image every 50 feet. Motion sensors are located inside the vehicle to measure the vertical movement of the vehicle. Scanning lasers are mounted on the front and rear bumpers to measure the rut depth and to detect and measure distress in the road surface. The sensor that was evaluated in this study was the drop-off sensor. This is a class 2 scanning laser that collects up to 300 points using time-of-flight technology. It is mounted on the front bumper about 3 feet above the ground and about 45 degrees from horizontal, as shown in Figure 3.1. This laser is a relatively new technology that has not been used by any state transportation department on a network level. This laser collects the transverse profile of a road shoulder and measures the maximum drop-off for each reading. According to Pathway Services, this laser may be able to take measurements at every 2 feet at highway speeds and capture a detailed edge drop-off as far as 10 feet from the vehicle's wheel path. Once Pathway collects this data, the information is tabulated using a program developed by Pathway. The program and collected data are then stored on an external hard drive and sent to the respective client.

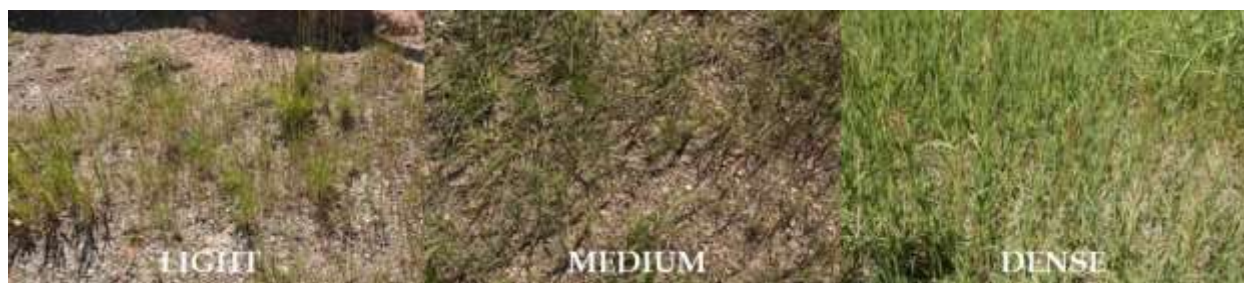
**FIGURE 3.2 Vegetation Density Scale.**

Because there has been concern whether roadside vegetation would affect the readings of the new drop-off sensor, a vegetation observation was conducted on all test sections. In this observation, the vegetation height and density was recorded for each section at every milepost, +0.3 milepost, and +0.6 milepost. Figure 3.2 below illustrates examples of light, medium, and dense vegetation patterns and shows the roadside vegetation was classified. In addition, three photographs were taken at each observation to document visual observations and allow for further investigation if the need arose. Photograph numbers were documented in the vegetation observation logs to keep all of the information in order. Vegetation observations were conducted the same day as Pathway Services' data was collected to ensure relevant vegetation height and density.

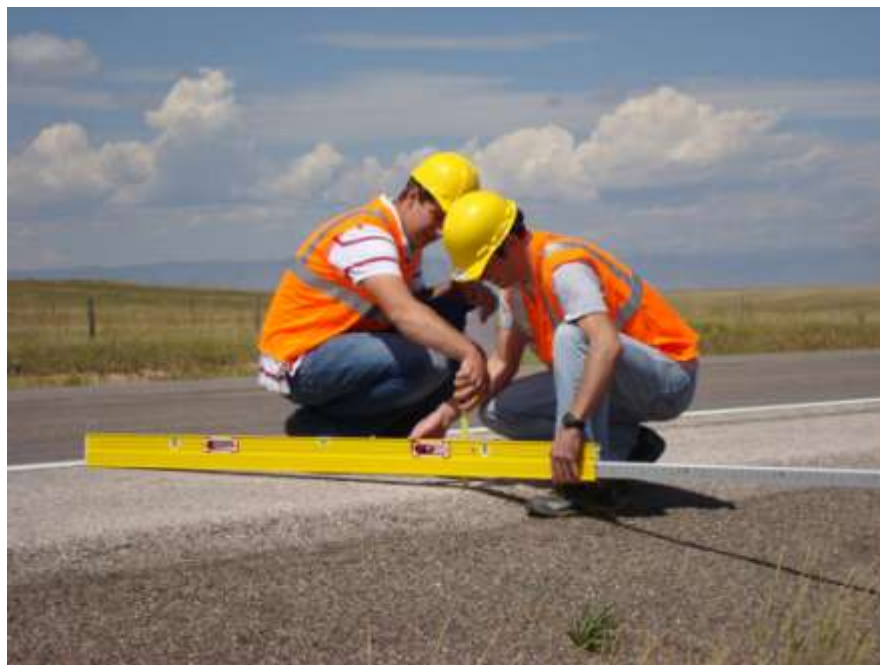
**FIGURE 3.4 Manual Data Collection Method.**

The slopes were determined by measuring the horizontal and vertical components of each section using a 12 foot level and measuring tape. The level was marked in feet and inches and in feet so that the horizontal component could be determined quickly. The vertical component was measured with a tape measure to the nearest  $\frac{1}{4}$  inch. Measurements were recorded in the field and slopes were calculated from those measurements once entered into database software. Figure 3.4 shows how these sections were measured using a 12 foot extendable level and measuring tape.
