Geosynthetic Reinforced Soil for Low-Volume Bridge Abutments

Final Report

Sponsored by
Iowa Highway Research Board
(IHRB Project TR-621)
Iowa Department of Transportation
(InTrans Project 10-380)

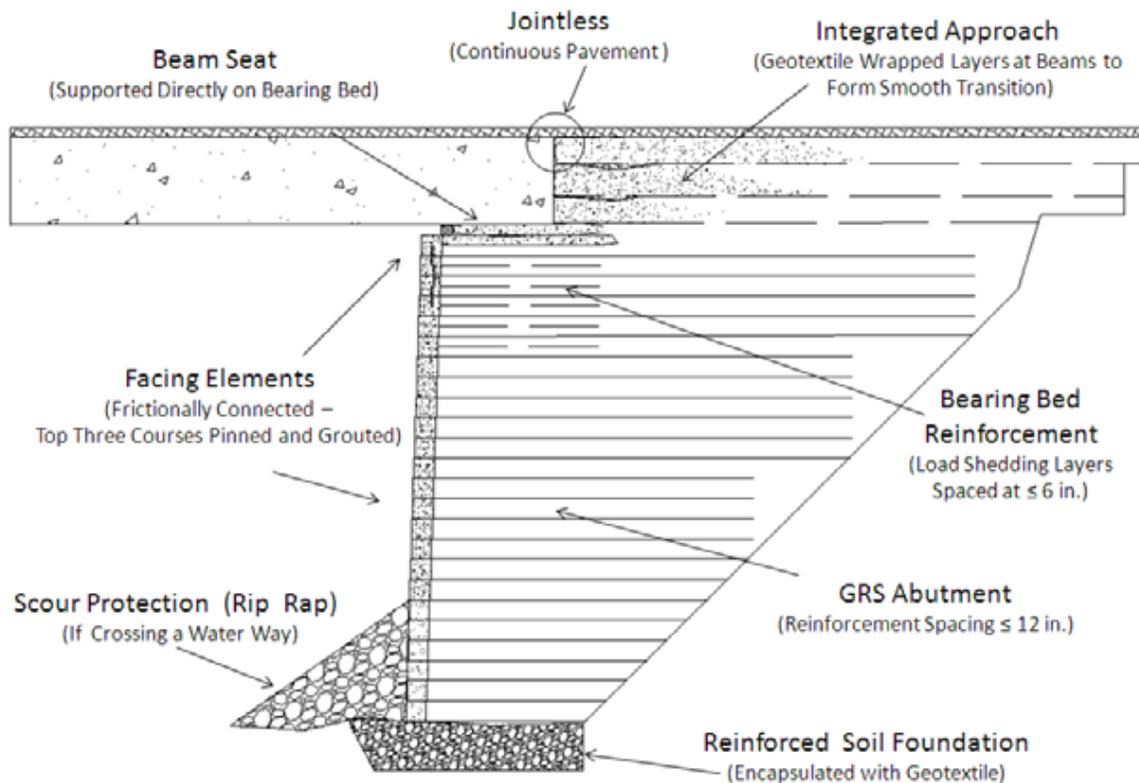
Figure 1. Typical cross-section of GRS-IBS with frictionally connected facing elements (from Adams et al. 2011a)

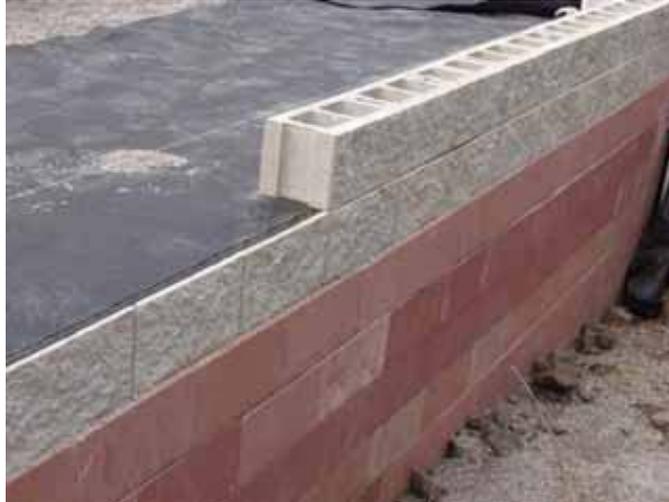
Figure 3. Concrete masonry unit facing for a GRS abutment wall (from Adams et al. 2011b)

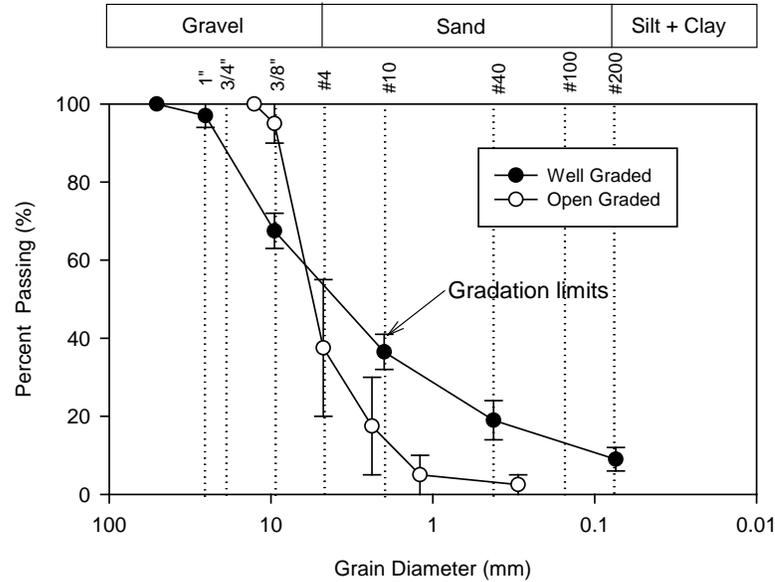
Figure 4. Recommended gradations for well-graded and open-graded granular backfill materials (data from Adams et al. 2011b)

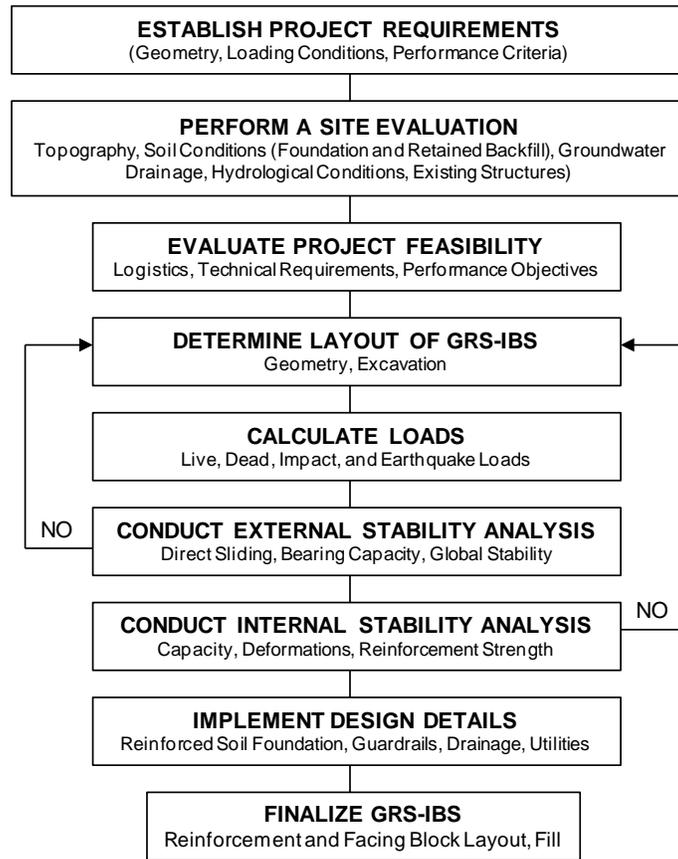
Figure 5. Recommended steps for GRS-IBS design (modified from Adams, et al. 2011b)

There are nine basic steps in the GRS-IBS procedure (Figure 5), which starts with establishing the project requirements from which the preliminary geometry is determined and then evaluated against external and internal modes of failure. An iterative process is used to assess the geometry and make adjustments as necessary to facilitate construction and assure long-term performance. The external stability in the GRS-IBS design method is similar to checking the external stability of any other abutment systems, i.e., checking for stability against direct sliding at the interface of GRS fill material and foundation soil, bearing capacity of the foundation soils supporting GRS fill material, and global stability (either wedge or rotational) against failure (see Berg et al. 2009). The recommended minimum factor of safety against sliding ($FS_{sliding}$) is 1.5, bearing capacity ($FS_{bearing}$) is 2.5, and global stability ($FS_{stability}$) is 1.5. The internal stability analysis, however, is different from other reinforced soil systems. Internal stability analysis of GRS abutment systems involve evaluating ultimate bearing capacity, deformations, and required reinforcement strength. Both analytical and empirical approaches to analyzing internal stability are provided in Adams et al. (2011b) and are briefly discussed in the following subsections of this chapter.

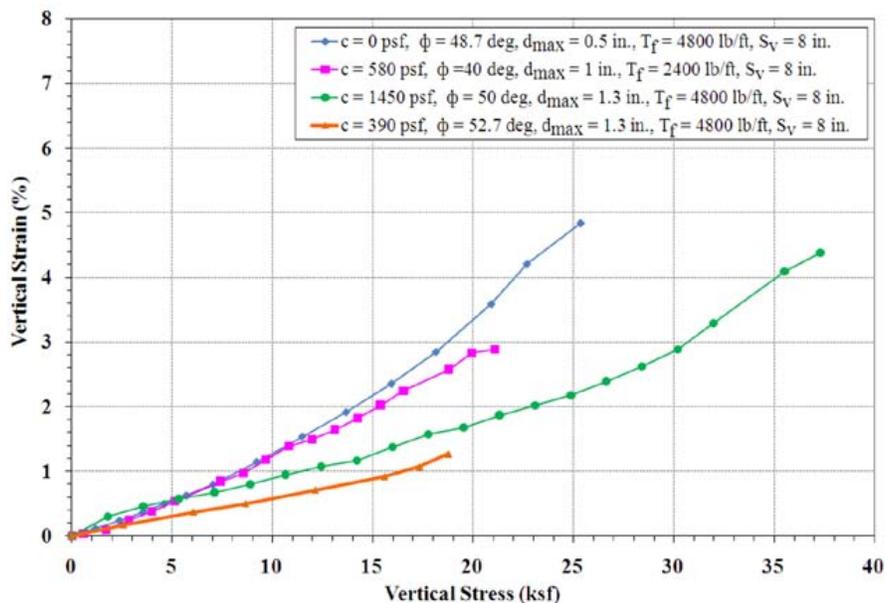
Figure 6. Performance test results for different compacted geosynthetic reinforced granular backfill materials (from Adams et al. 2011b)

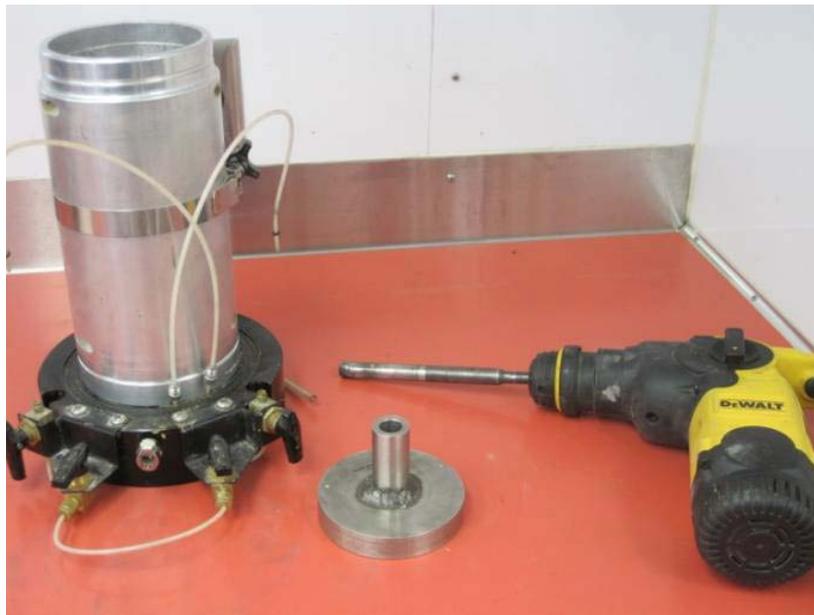
Figure 8. Split mold, steel platen (4 in. diameter), and vibratory hammer for compaction of granular materials

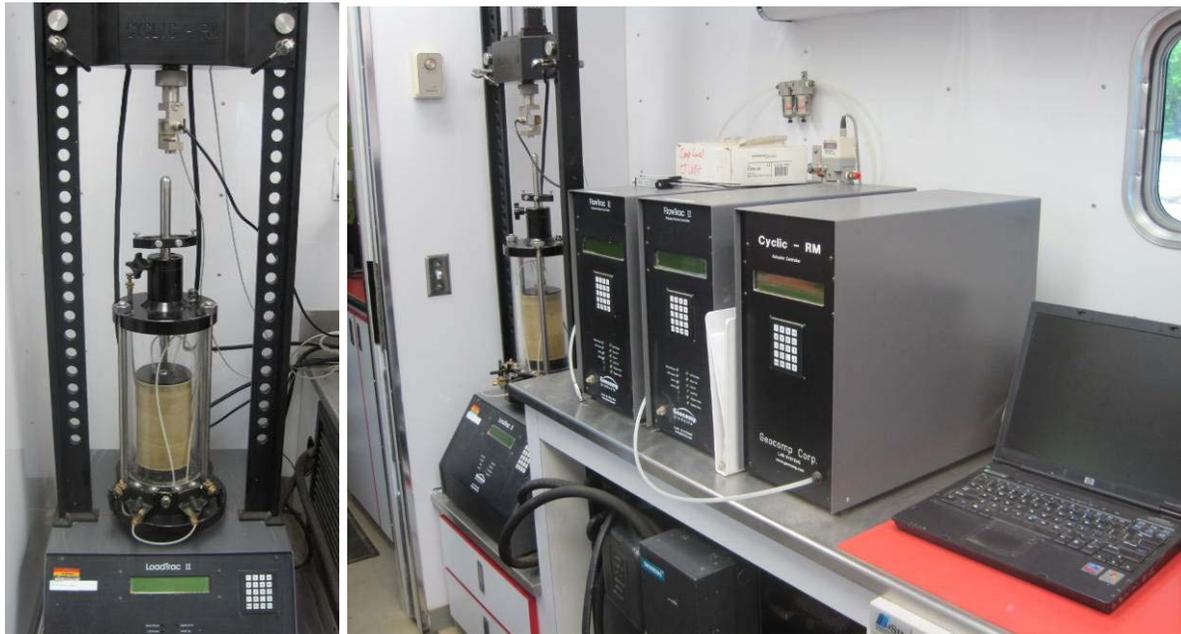
Figure 10. Triaxial chamber, load frame, and computer equipment for cyclic triaxial testing

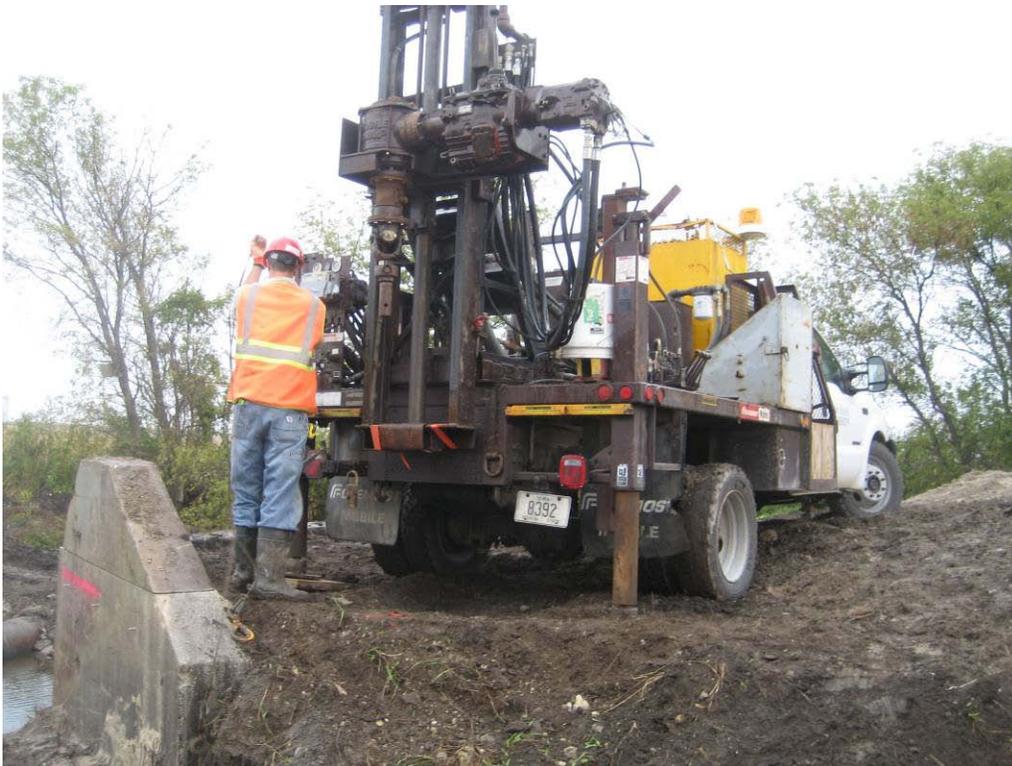
Figure 11. Iowa State University truck-mounted rotary drill rig

Soil borings were drilled with a truck-mounted rotary drill rig (see Figure 11) equipped with a hydraulic head, using continuous-flight solid-stemmed augers. Thin-walled shelby tube samples and bag samples were obtained from the soil borings. The shelby tube samples were obtained by hydraulically pushing a thin-walled seamless steel tube with a sharp cutting edge into the ground to obtain relatively undisturbed samples of cohesive or moderately cohesive soils. Where sandy soils were encountered, disturbed bag samples were obtained. Field logs were prepared on-site which included visual classifications of materials encountered during drilling as well as driller's interpretation of the subsurface conditions between samples.

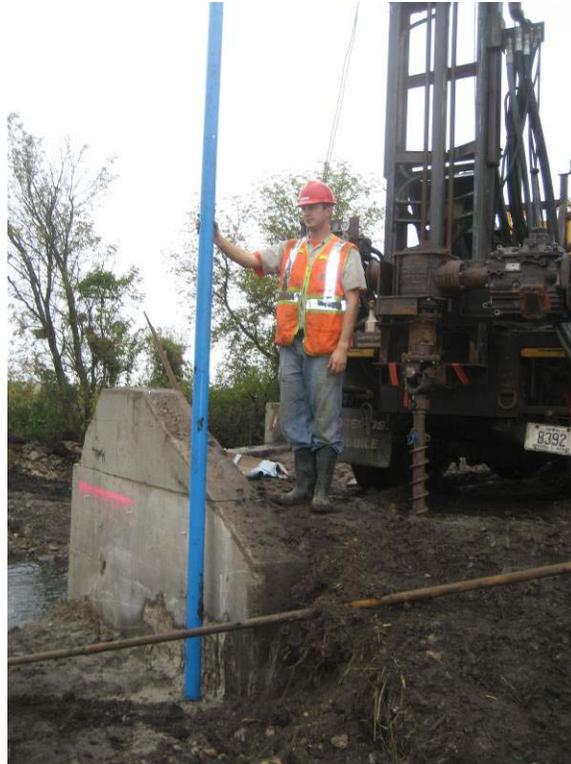
Figure 12. Three 5 ft long inclinometer casings snapped together ready for installation

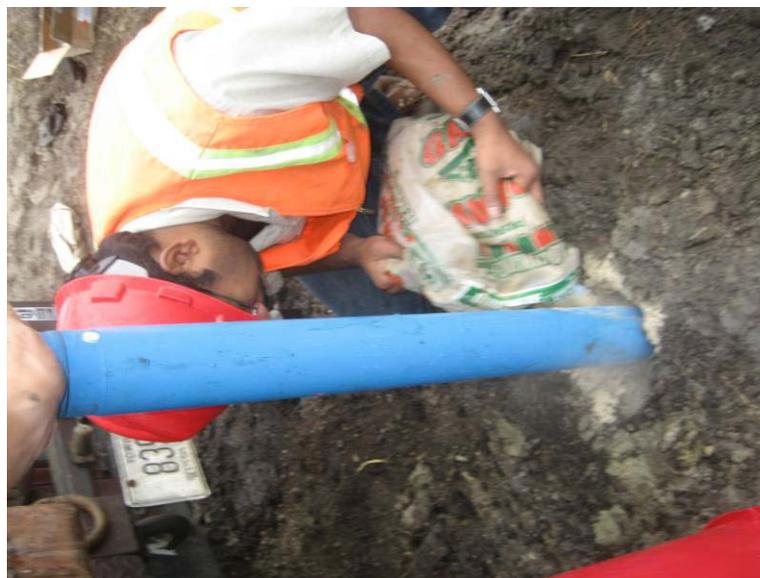
Figure 13. Sand used to fill the borehole cavity around the inclinometer

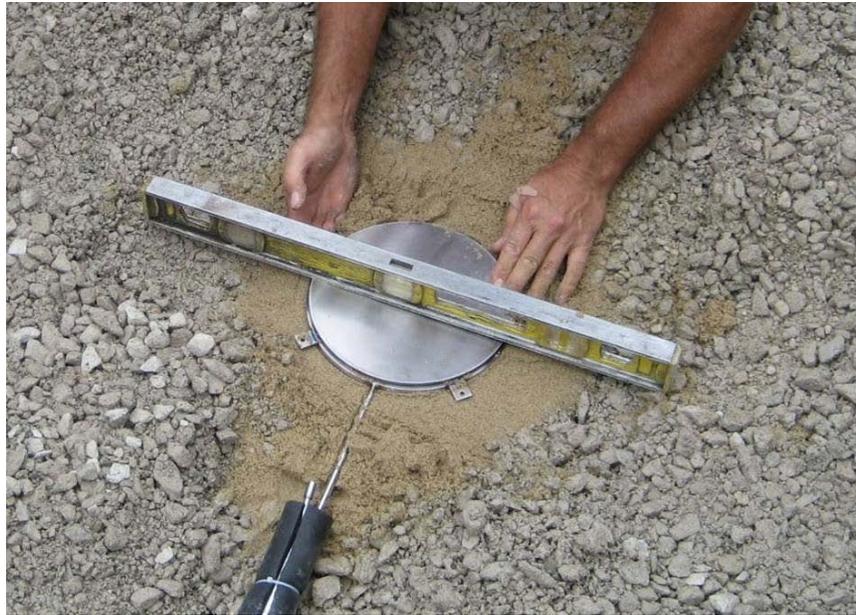
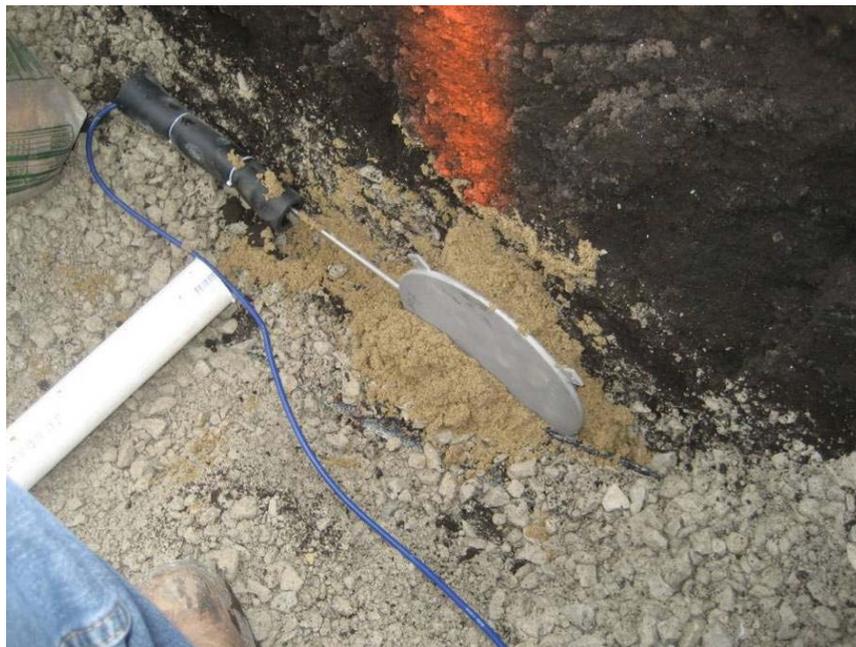
Figure 14. (a) Model 3510 semiconductor EPC installation to measure total vertical stresses, and (b) Model 4800 vibrating wire EPC installation to measure horizontal stresses

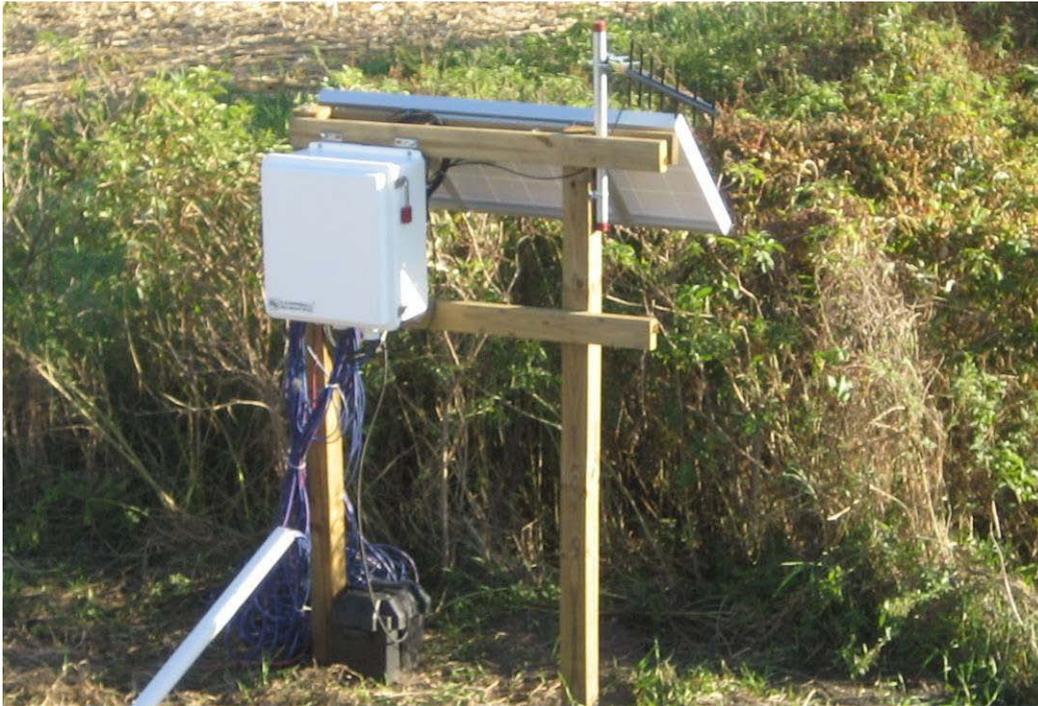
Figure 15. On-site datalogger system installed to continuously record EPC and piezometer readings

The semiconductor EPC, vibrating wire EPC, and vibrating wire piezometer readings were recorded using a weather resistant (-15°F to +122°F) Campbell Scientific CR5000 data logger system with piezoelectric and vibrating wire data logging components and 2GB data storage (Figure 15). The datalogger was secured in a weather resistant enclosure and was powered by a battery that was charged through a 70 watt solar panel. A Raven XTV cellular digital modem was attached to the datalogger. The datalogger was programmed to continuously record and store the data, and wirelessly transfer the data to the internet through the cellular phone modem.

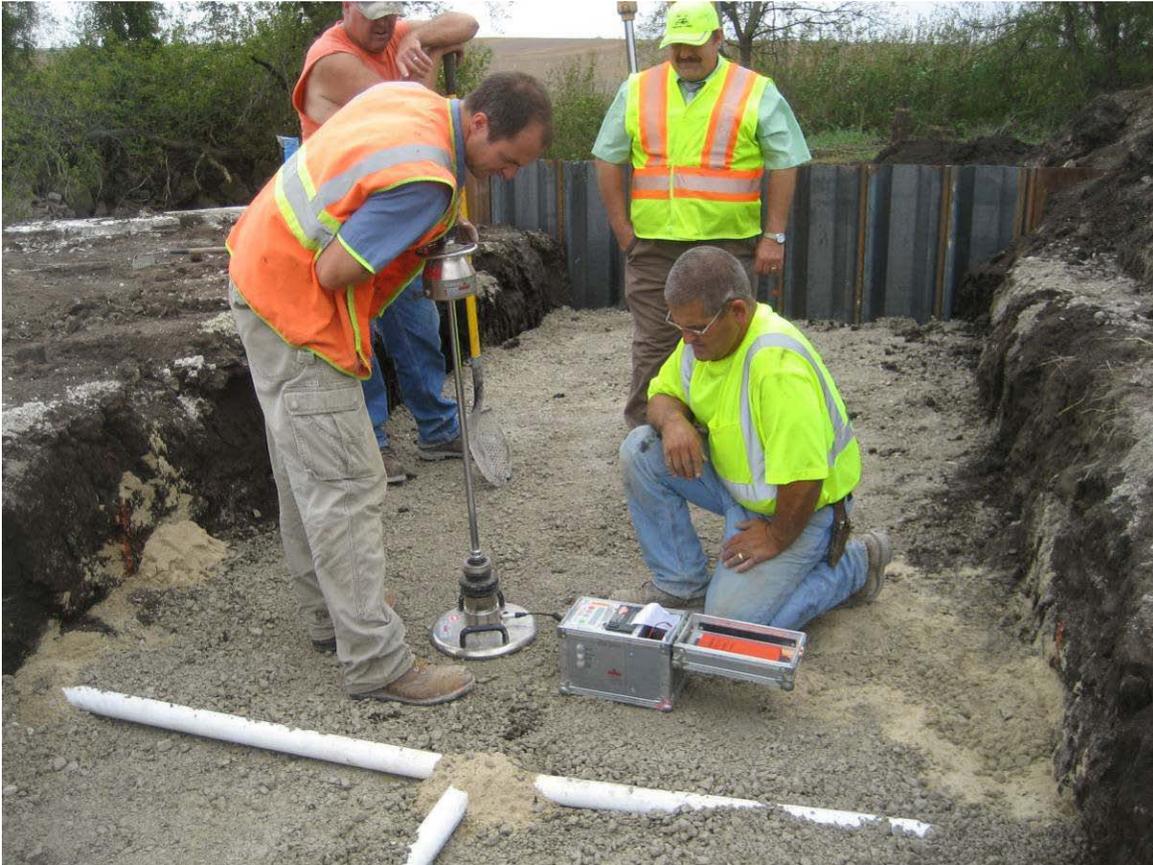
Figure 16. LWD testing during placement of GRS fill material

$$E_{LWD} = \frac{(1 - \eta^2) \sigma_0 r}{D_0} \times F \quad (10)$$

where, E_{LWD} = elastic modulus (MPa), D_0 = measured deflection under the plate (mm), η = Poisson's ratio (0.4), σ_0 = applied stress (MPa), r = radius of the plate (mm), F = shape factor depending on stress distribution (assumed as 8/3) (see Vennapusa and White 2009).

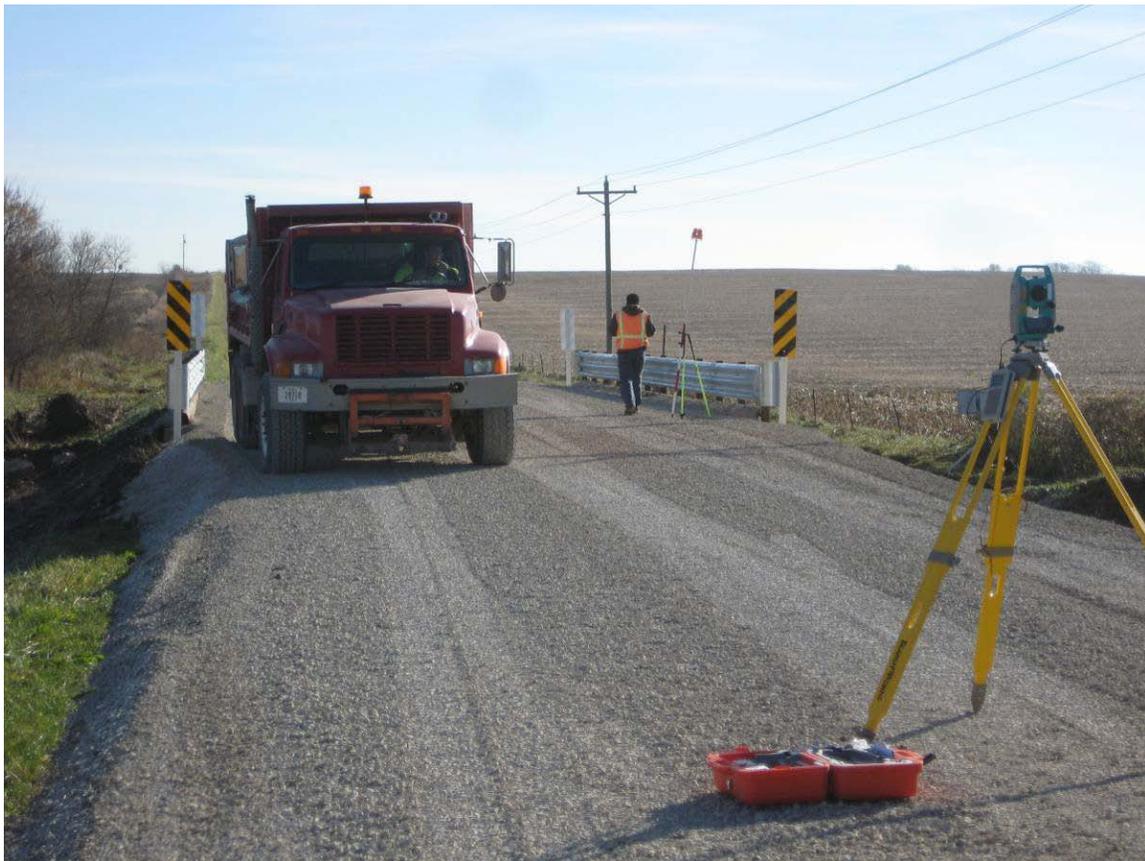
Figure 17. Loaded truck used for live load testing and total station equipment used for bridge deflection measurement under loading.

Bridge live load (LL) tests involved driving a loaded test truck with single axle at front and tandem axle in the back of known weight and axle spacing over the bridge and taking EPC readings by placing the truck (Figure 17) at specified locations along the bridge. The data obtained were used in bearing capacity analysis and also to compare with the estimated values. In addition, the loaded truck was placed at the center of the bridge and deflection of the bridge was measured using total station survey equipment. Bridge abutment elevations were also monitored using the total station survey equipment, by using two on-site benchmarks (nail placed on wooden electric poles).

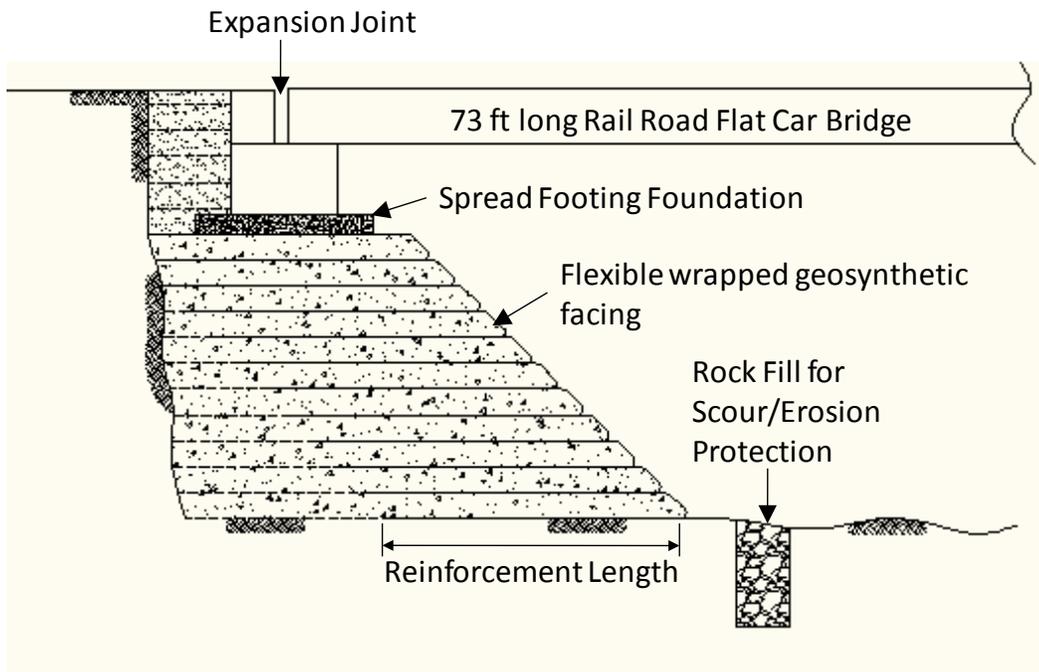
Figure 19. Bridge 1 — Schematic of GRS bridge abutment with geosynthetic wrapped sheets flexible facing

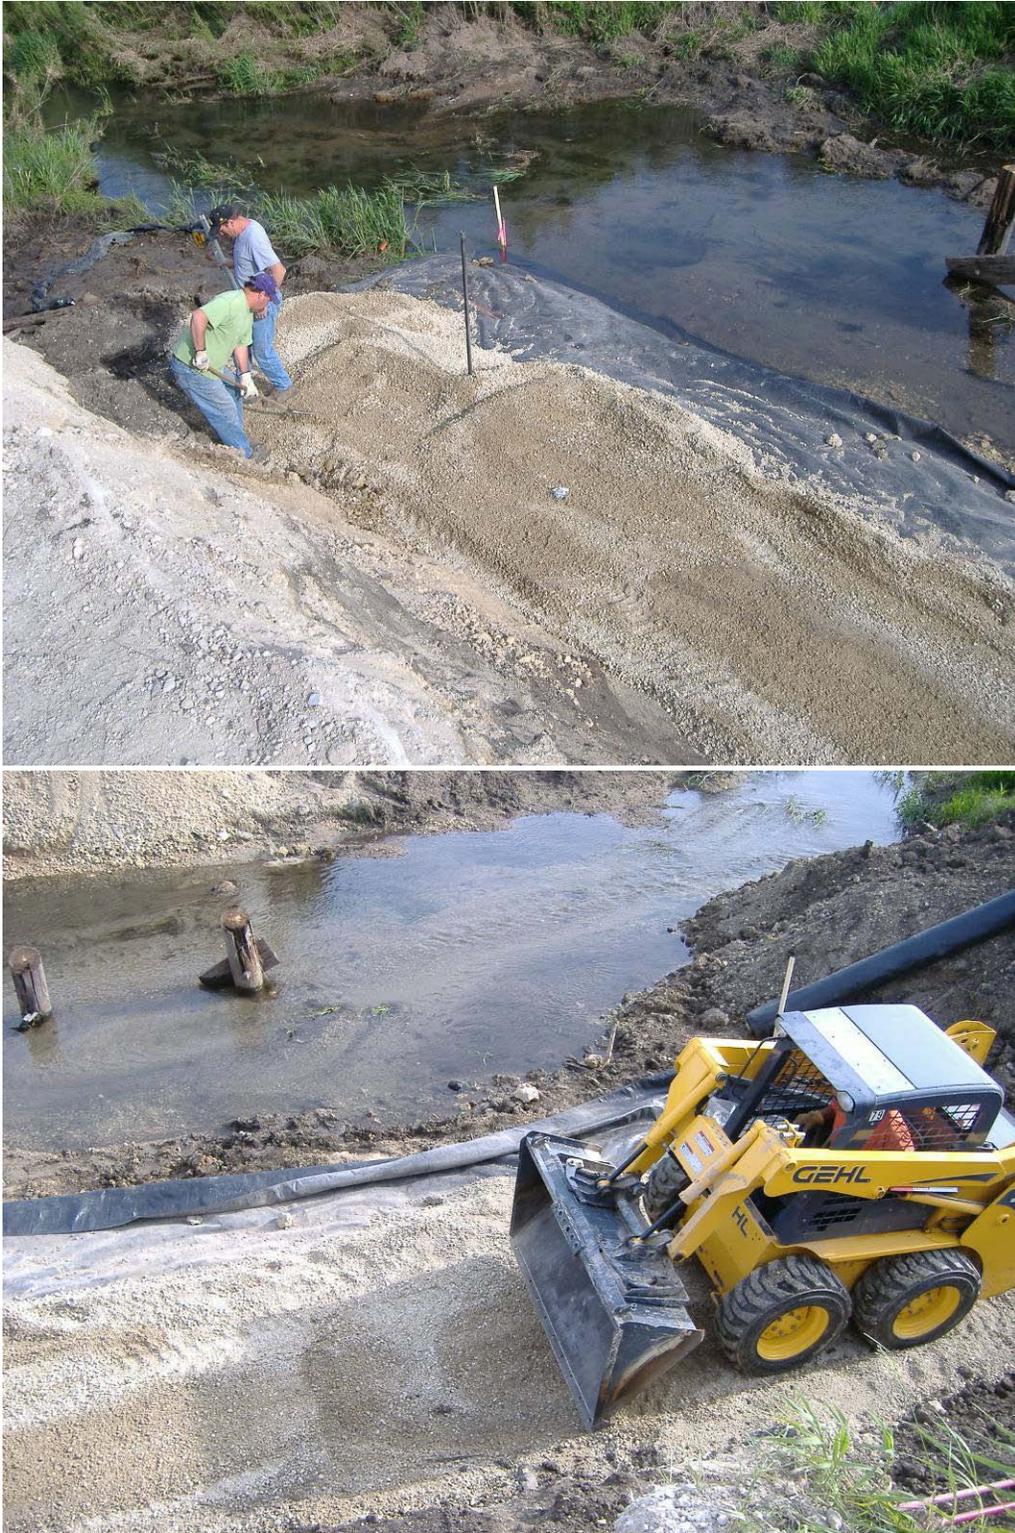
Figure 21. Bridge 1 — Building up of GRS fill material (Courtesy of Brian Keierleber)

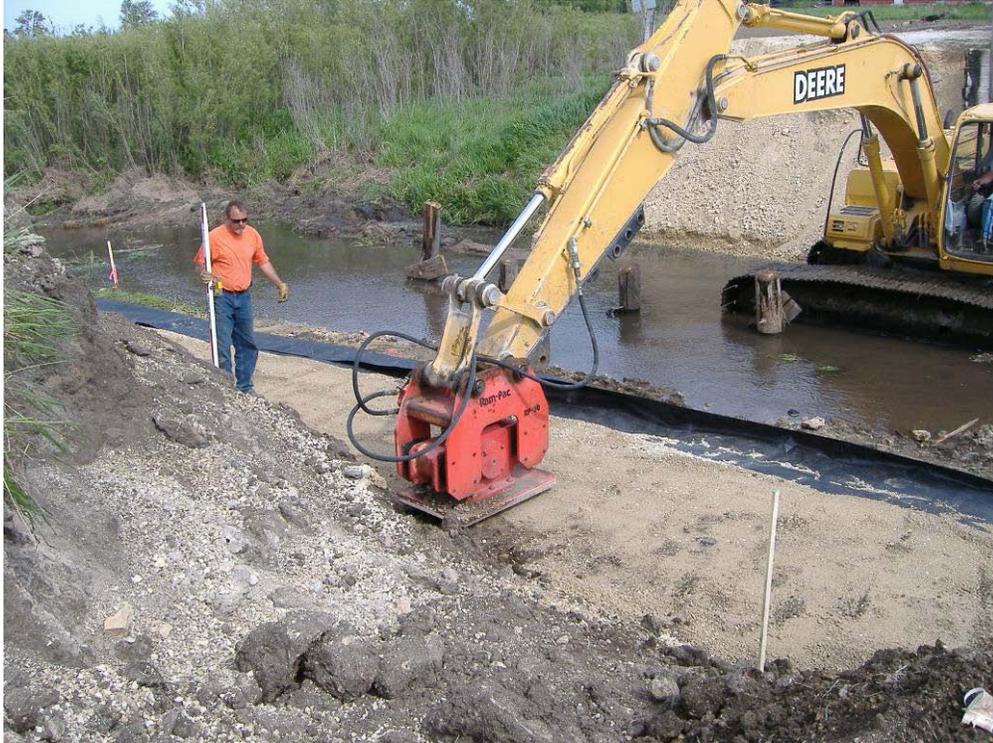
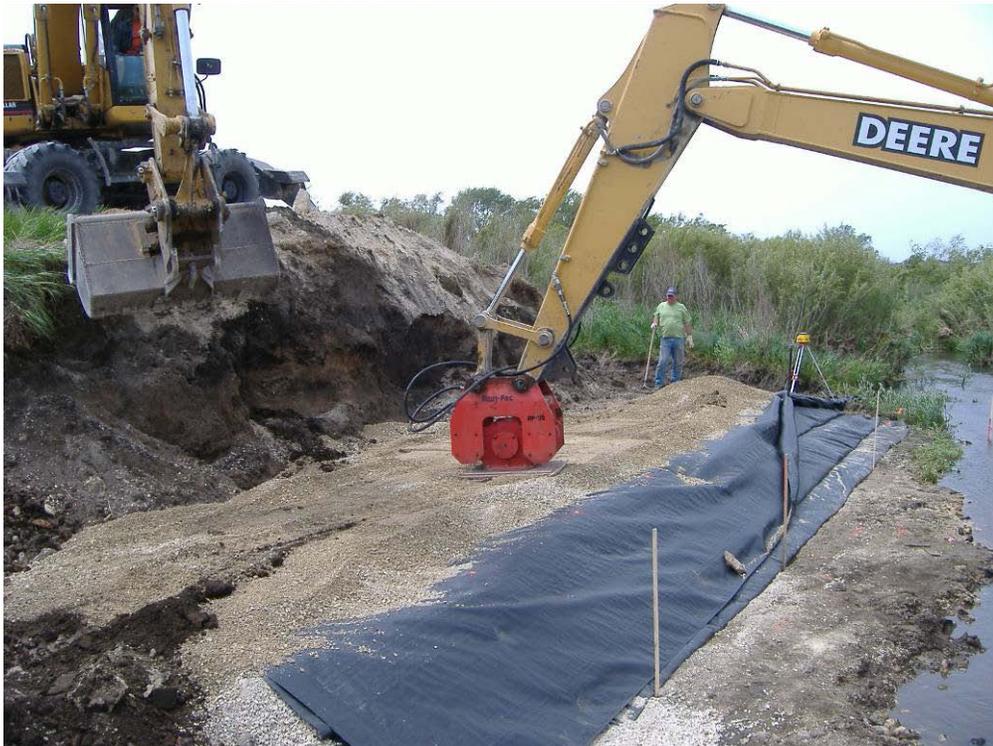
Figure 22. Bridge 1 — Compaction of GRS fill material (Courtesy of Brian Keierleber)

The geosynthetic was spread in the bottom of the excavation, crushed granular fill material was placed over the geosynthetic, and the fill was compacted using a vibratory plate attached to the excavator. The geosynthetic was installed by rolling out the material in the machine direction perpendicular to the bridge alignment. The geosynthetic was wrapped over the compacted fill, a new geosynthetic layer was placed, and then a new layer of fill was placed over the geosynthetic layers. A GEHL 3935 skid steer loader was used to spread the fill material over the geosynthetic layers. The loose lift thickness was targeted to be about 8 in. and compacted thickness was targeted to be about 7 in. Lift thickness was checked using a laser survey level during placement and compaction. Pictures of the construction operations are shown in Figure 21 and Figure 22. The backfill material behind the concrete footing footprint was also filled with GRS fill material (Figure 23). Pictures of the final wrapped around face slopes of the north and south abutments are shown in Figure 24. Excavation was performed at the toe of the north and south abutment slopes to install a rock fill wall for erosion protection (Figure 25). Rip rap was installed over the geosynthetic wrapped faces as scour protection during flooding (Figure 26) and cement grout

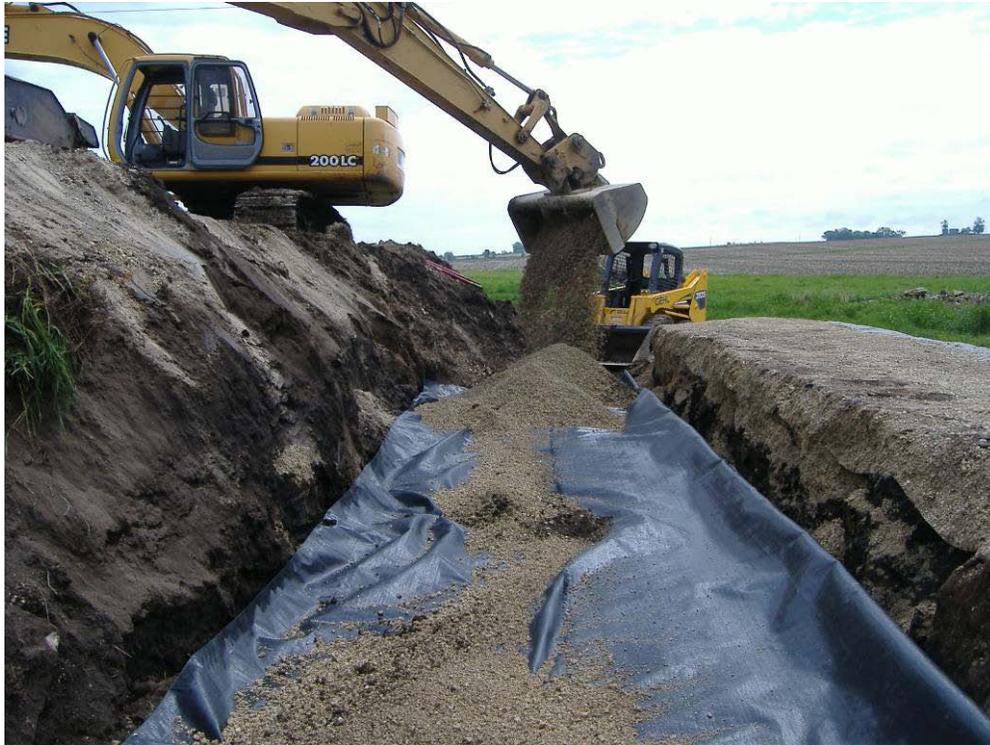
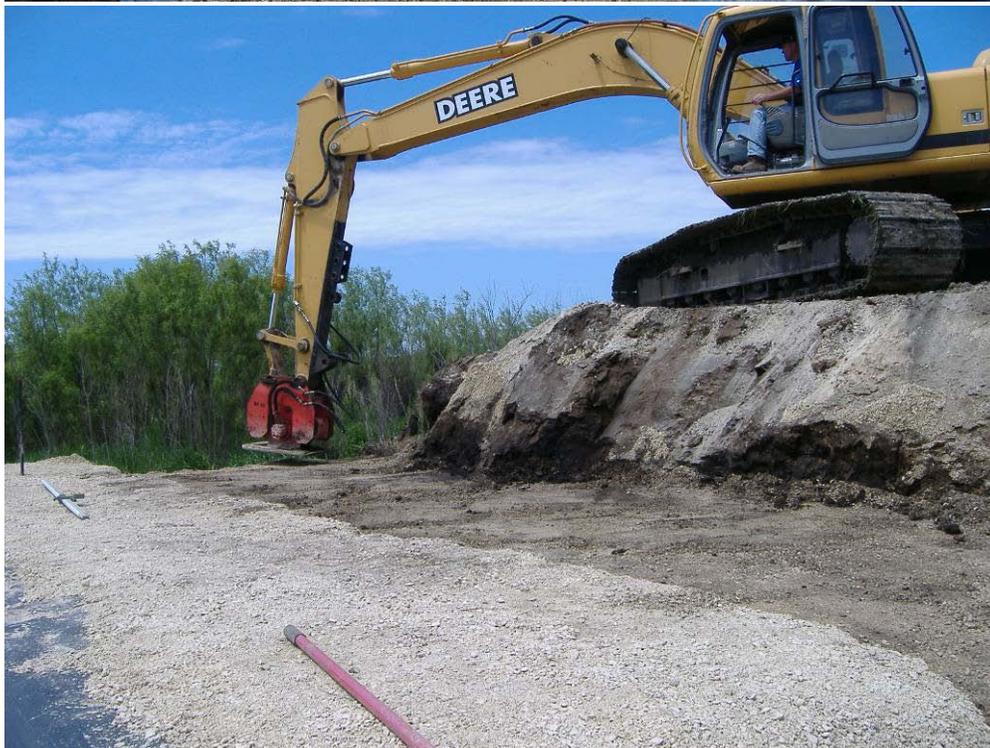
Figure 23. Bridge 1 — Building up of GRS fill material behind the footing (Courtesy of Brian Keierleber)

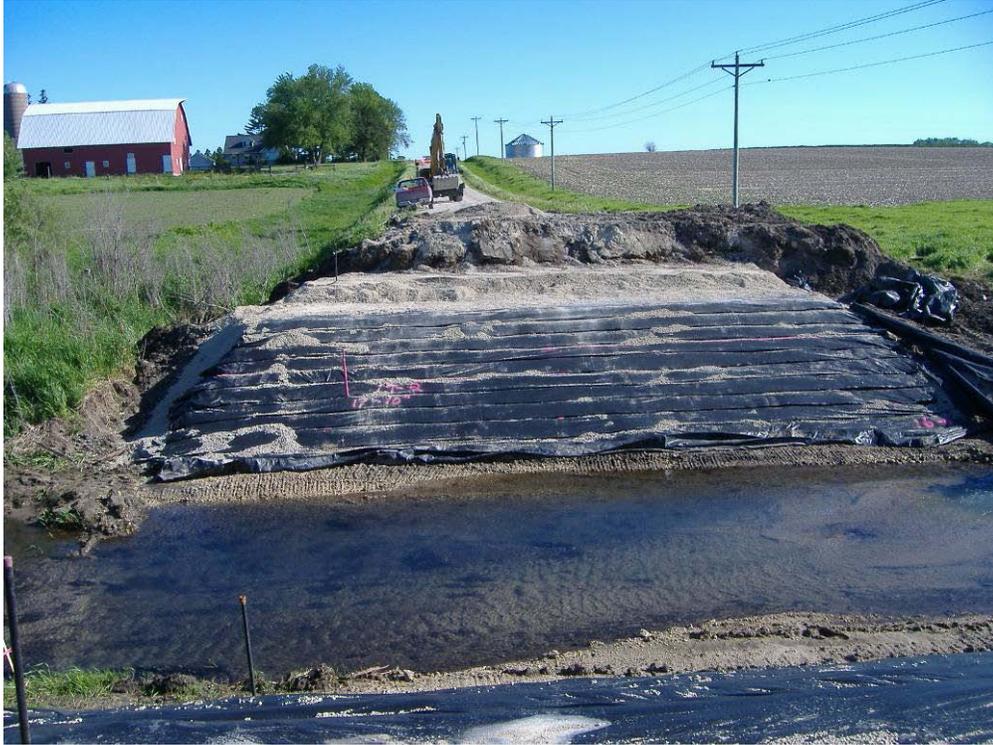
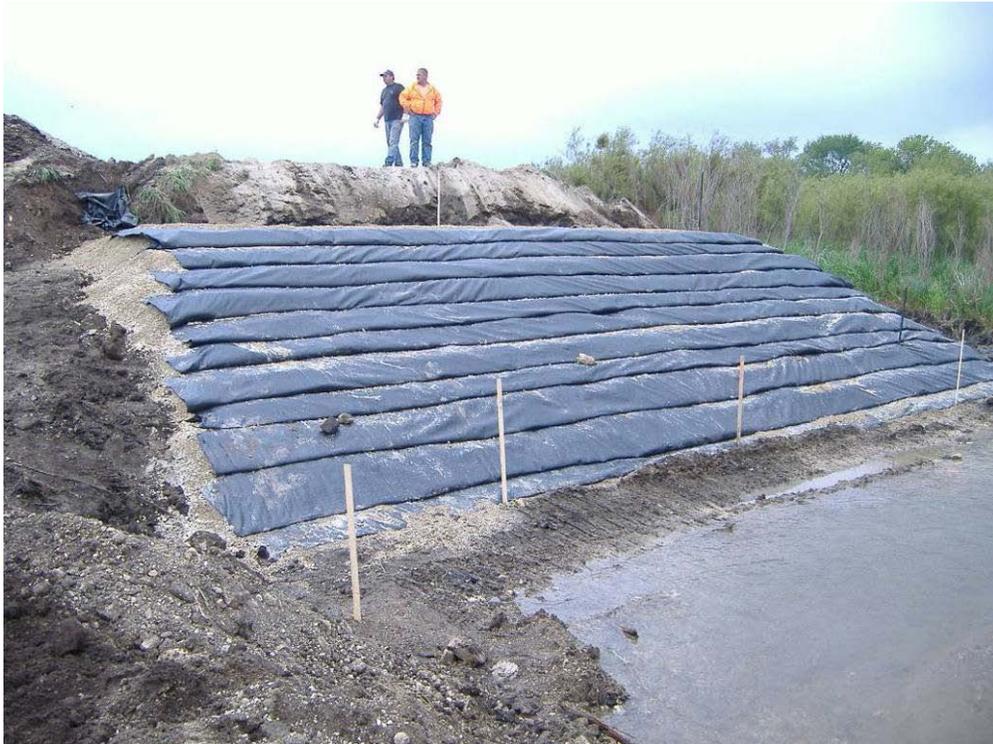
Figure 24. Bridge 1 — Pictures of north (top) and south abutments built up with flexible wrapped around facing (Courtesy of Brian Keierleber)

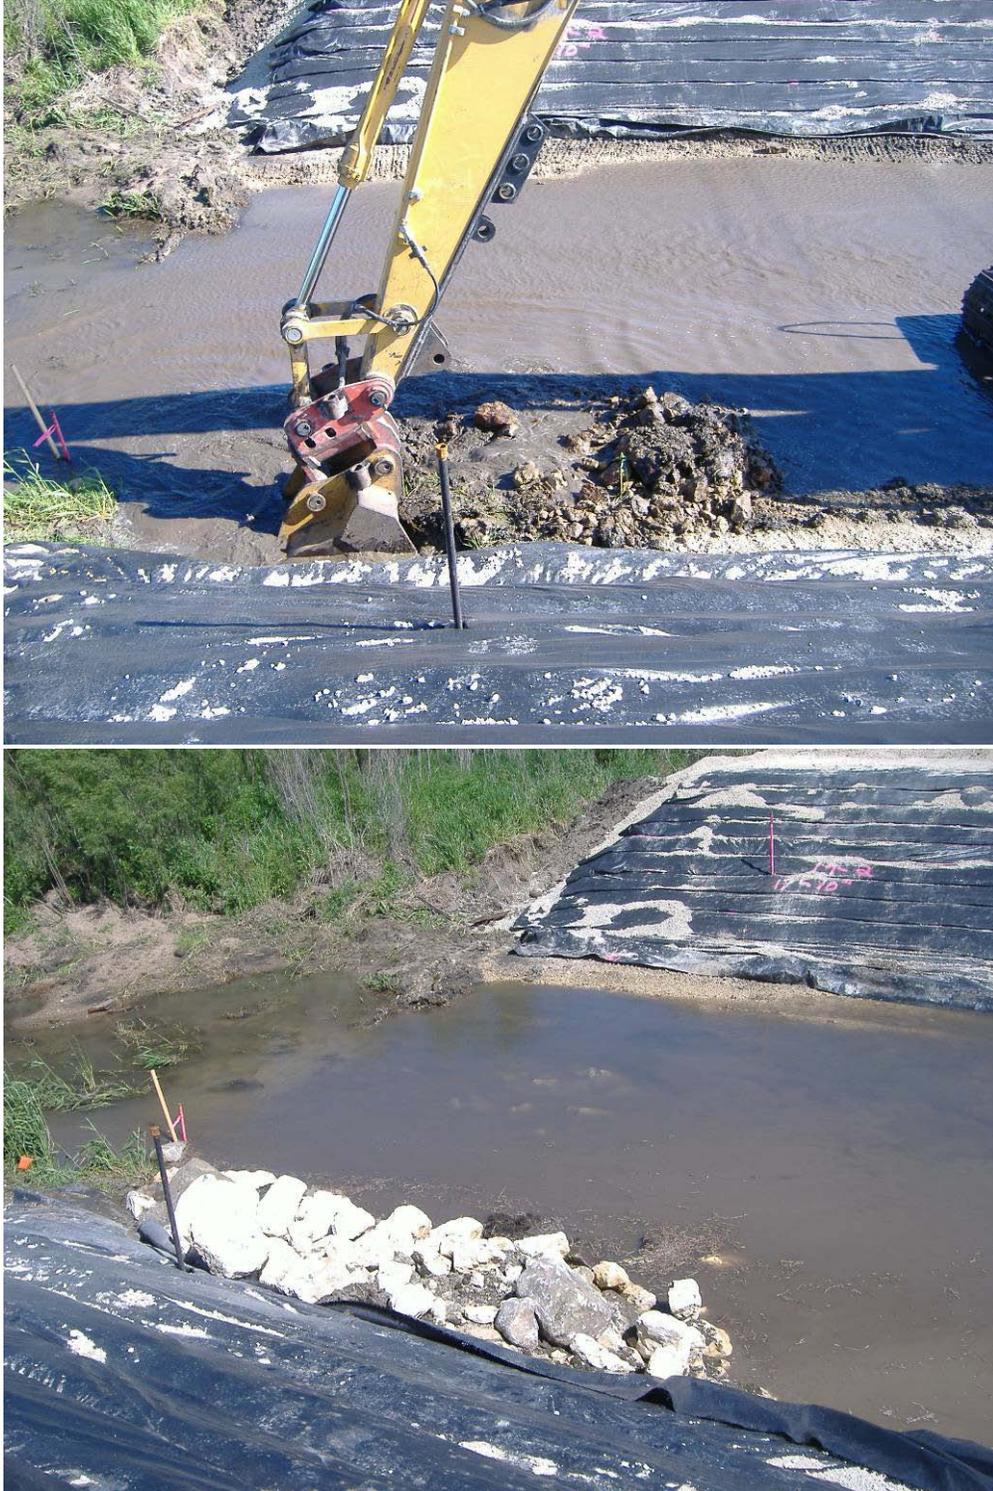
Figure 25. Bridge 1 — Excavation at the toe to install erosion stone (Courtesy of Brian Keierleber)

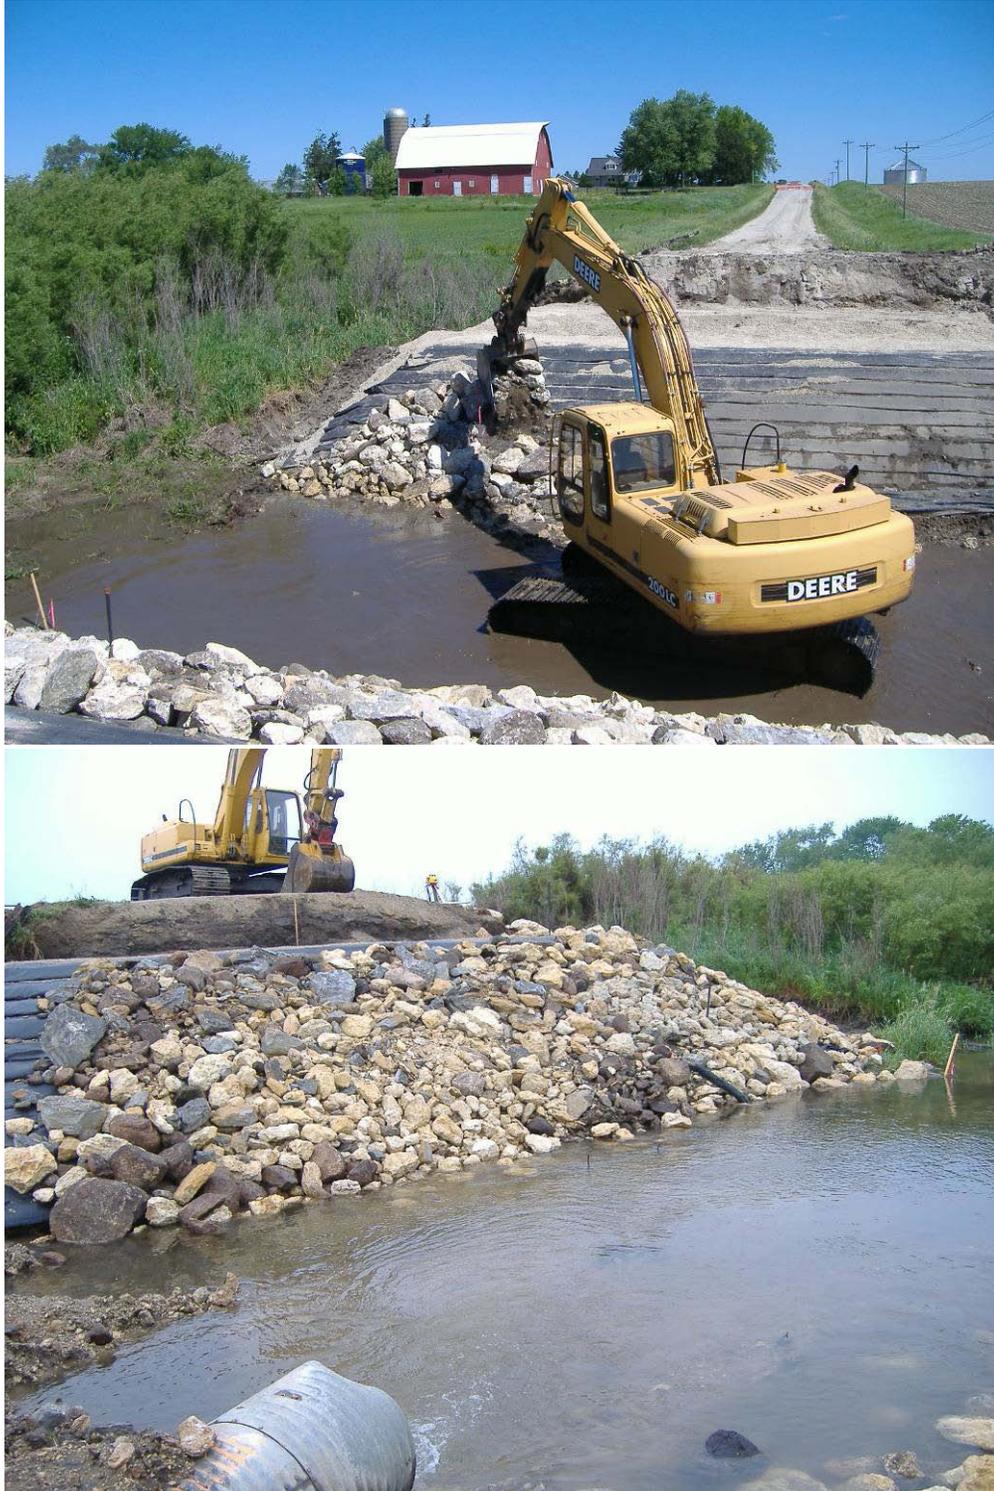
**Figure 26. Bridge 1 — Installation of riprap over the flexible geosynthetic wrapped facing
(Courtesy of Brian Keierleber)**

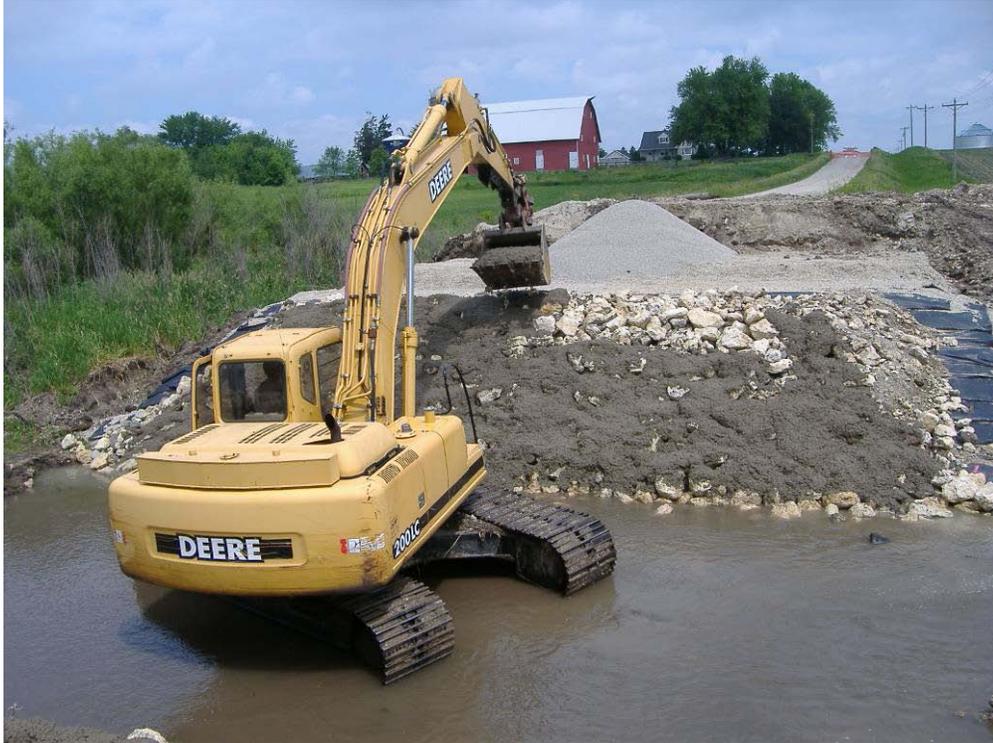
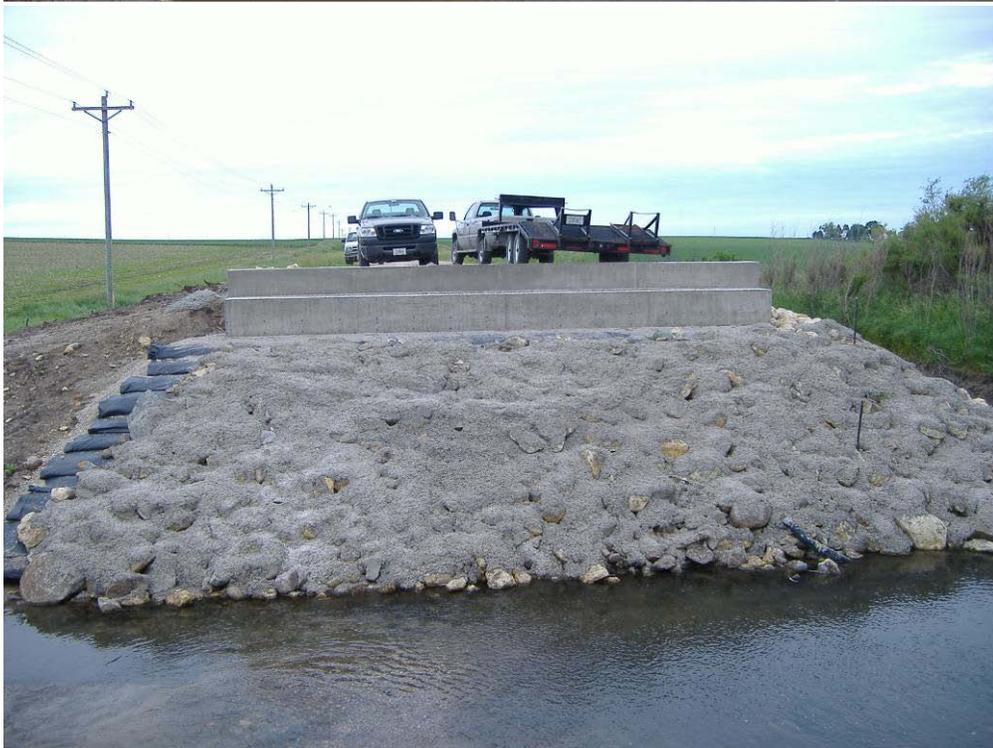
**Figure 27. Bridge 1 — Installing cement grout over riprap facing for scour protection
(Courtesy of Brian Keierleber)**

was placed over the rip rap to help seal the voids in the riprap (Figure 27). Reinforcement and form work for a 3 ft wide concrete spread footing was placed over the GRS fill material (Figure 28 and Figure 29). Three 73 ft long RRFC bridges were used for the bridge (Figure 30 and Figure 31). Cranes were used on both abutment sides to install the RRFCs over the footing. 5/8 in. diameter bolts were used to connect the RRFCs at the bottom webs.
