Geosynthetic Reinforced Soil for Low-Volume Bridge Abutments

Final Report

Sponsored by
Iowa Highway Research Board
(IHRB Project TR-621)
Iowa Department of Transportation
(InTrans Project 10-380)

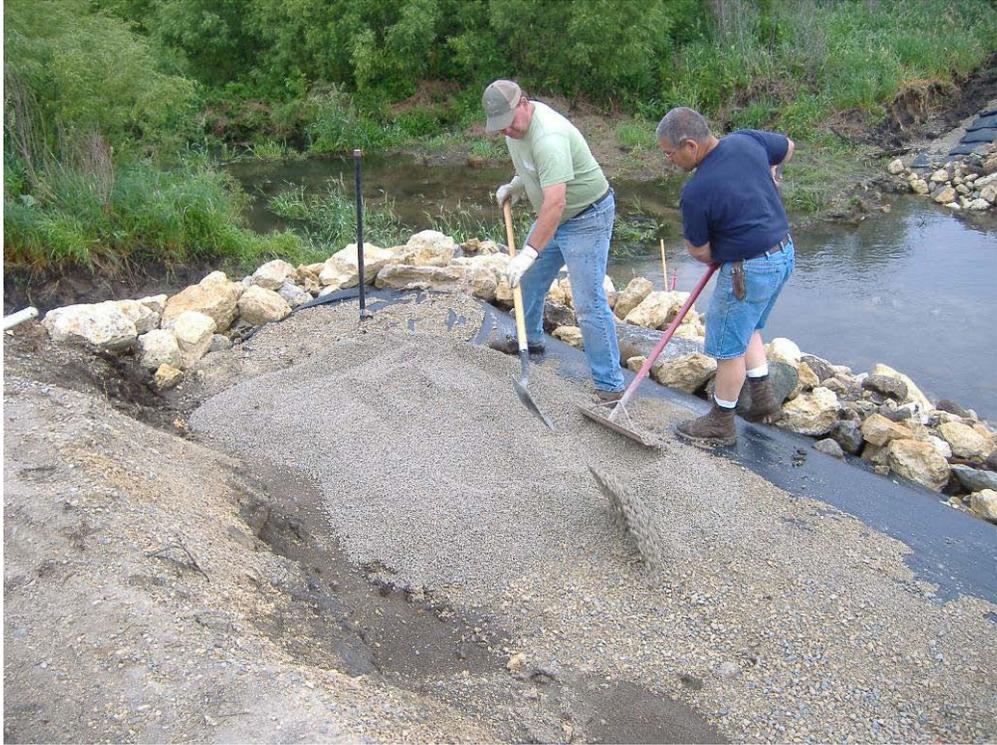
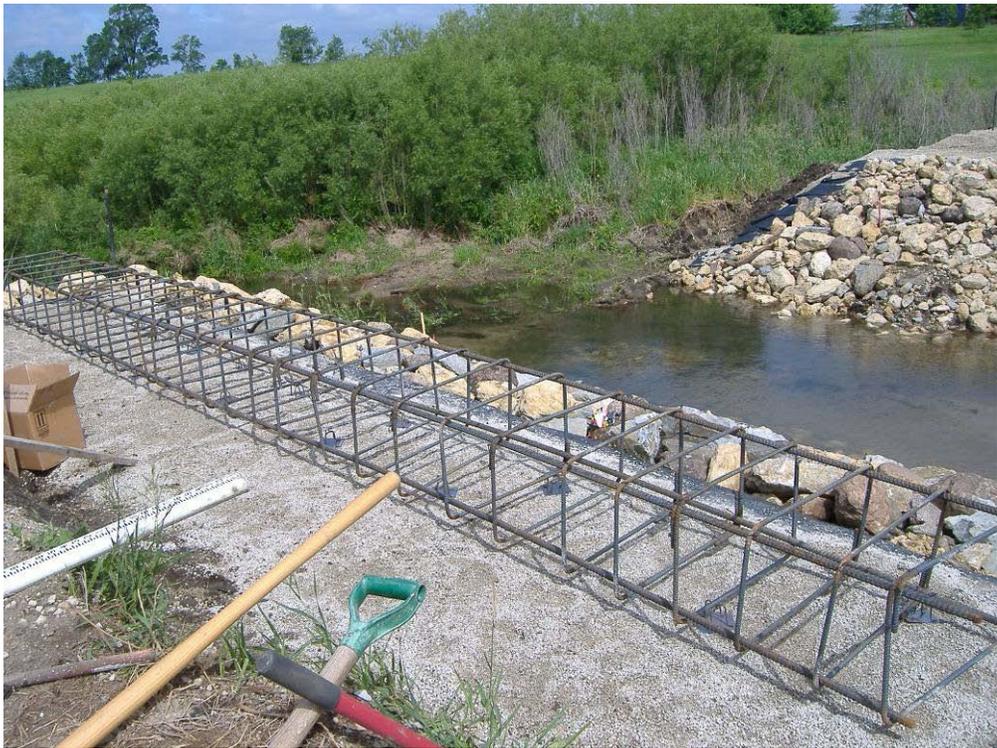
Figure 28. Bridge 1 — Leveling pad install concrete footing reinforcement (Courtesy of Brian Keierleber)

was placed over the rip rap to help seal the voids in the riprap (Figure 27). Reinforcement and form work for a 3 ft wide concrete spread footing was placed over the GRS fill material (Figure 28 and Figure 29). Three 73 ft long RRFC bridges were used for the bridge (Figure 30 and Figure 31). Cranes were used on both abutment sides to install the RRFCs over the footing. 5/8 in. diameter bolts were used to connect the RRFCs at the bottom webs.

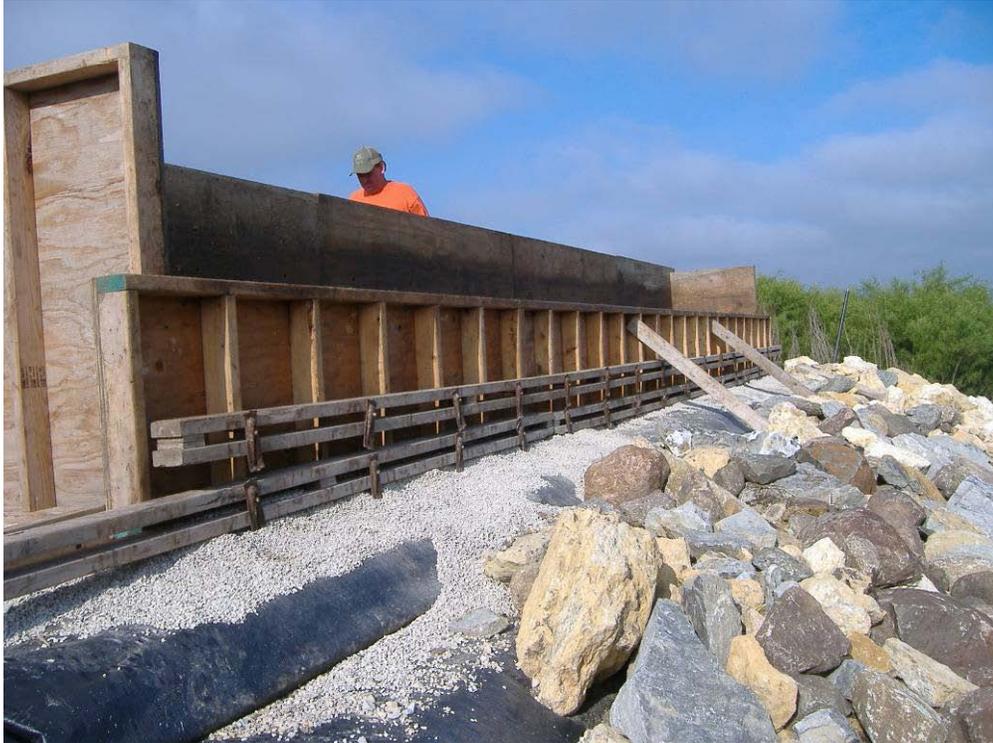
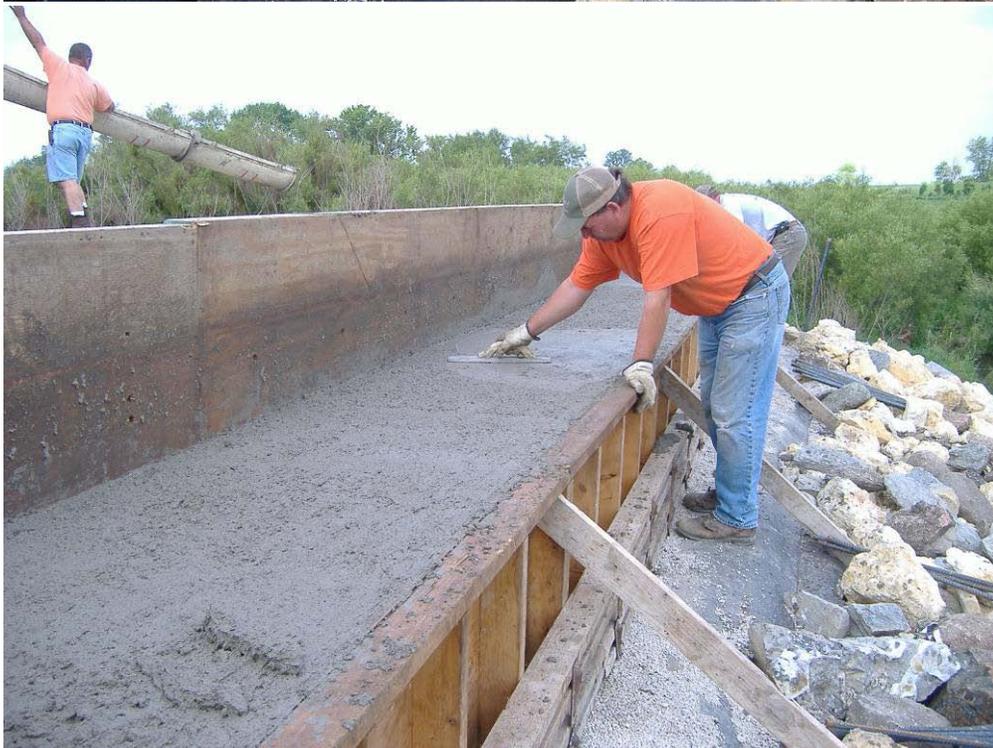
Figure 29. Bridge 1 — Installation of reinforced concrete footing (Courtesy of Brian Keierleber)

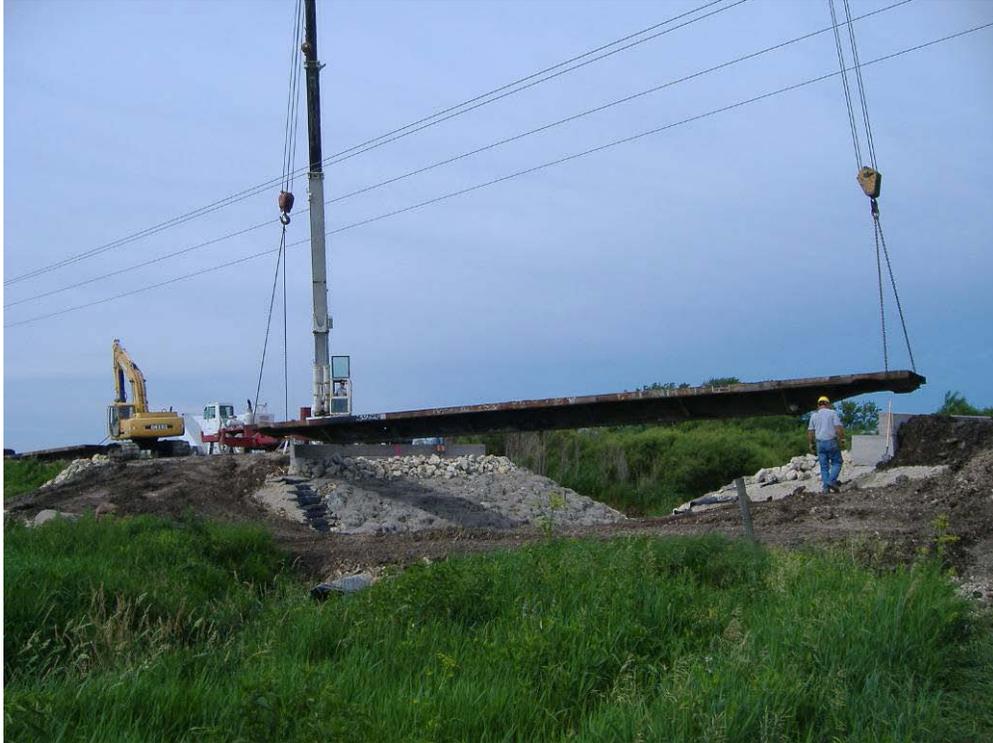
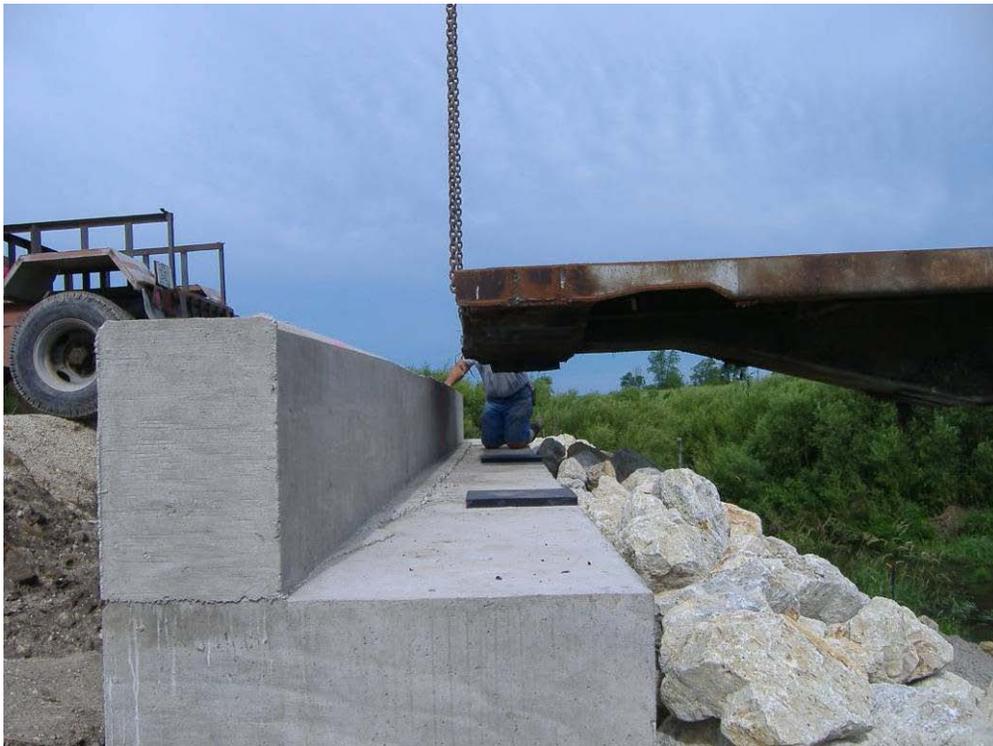
Figure 30. Bridge 1 — Installation of RRFC bridges (Courtesy of Brian Keierleber)

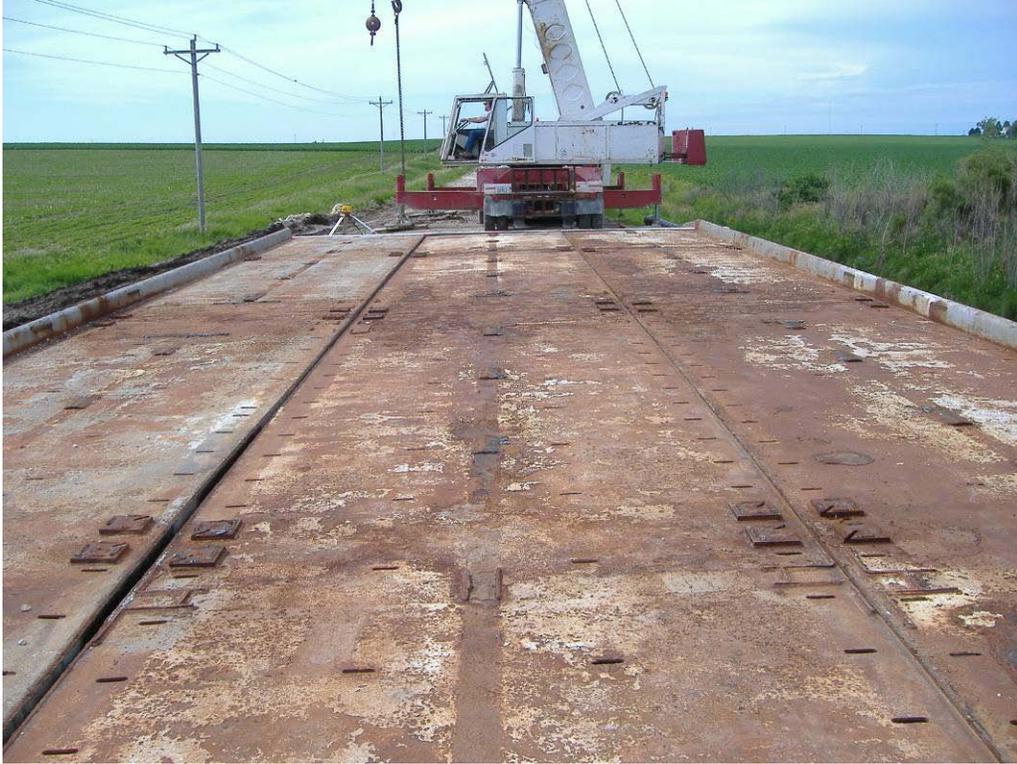
Figure 31. Bridge 1 — Installation of RRFC bridges (contd.) (Courtesy of Brian Keierleber)

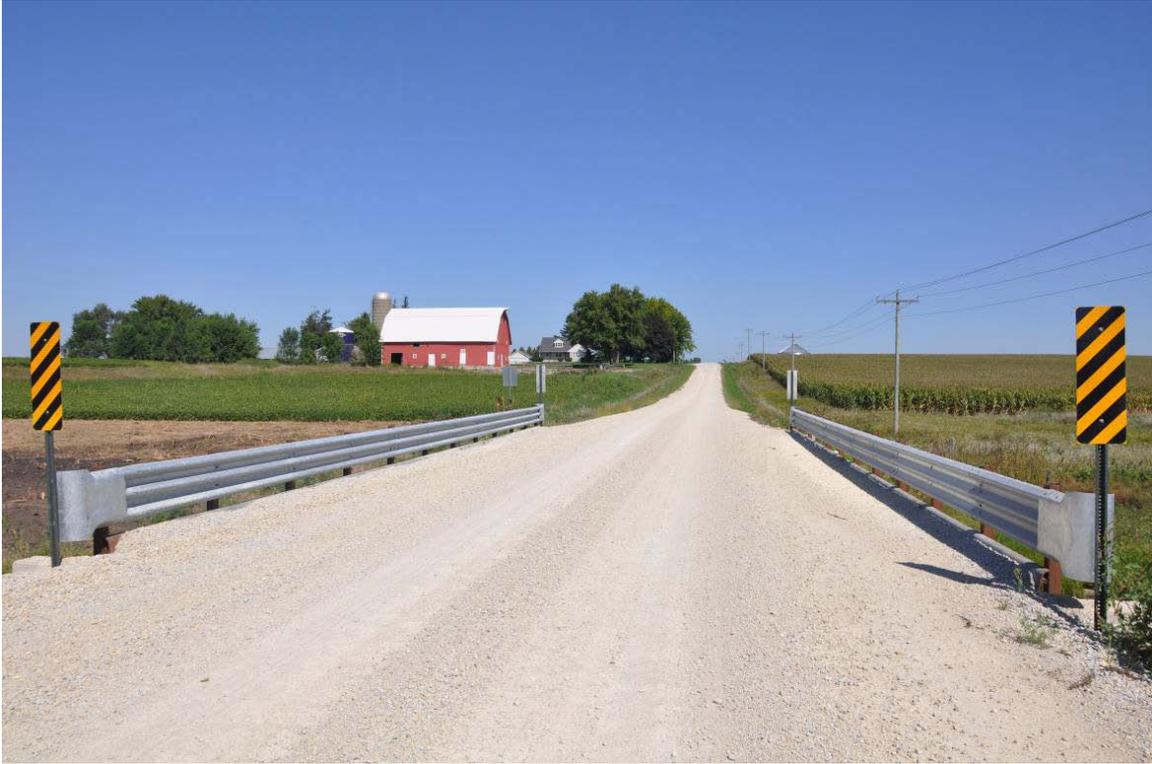
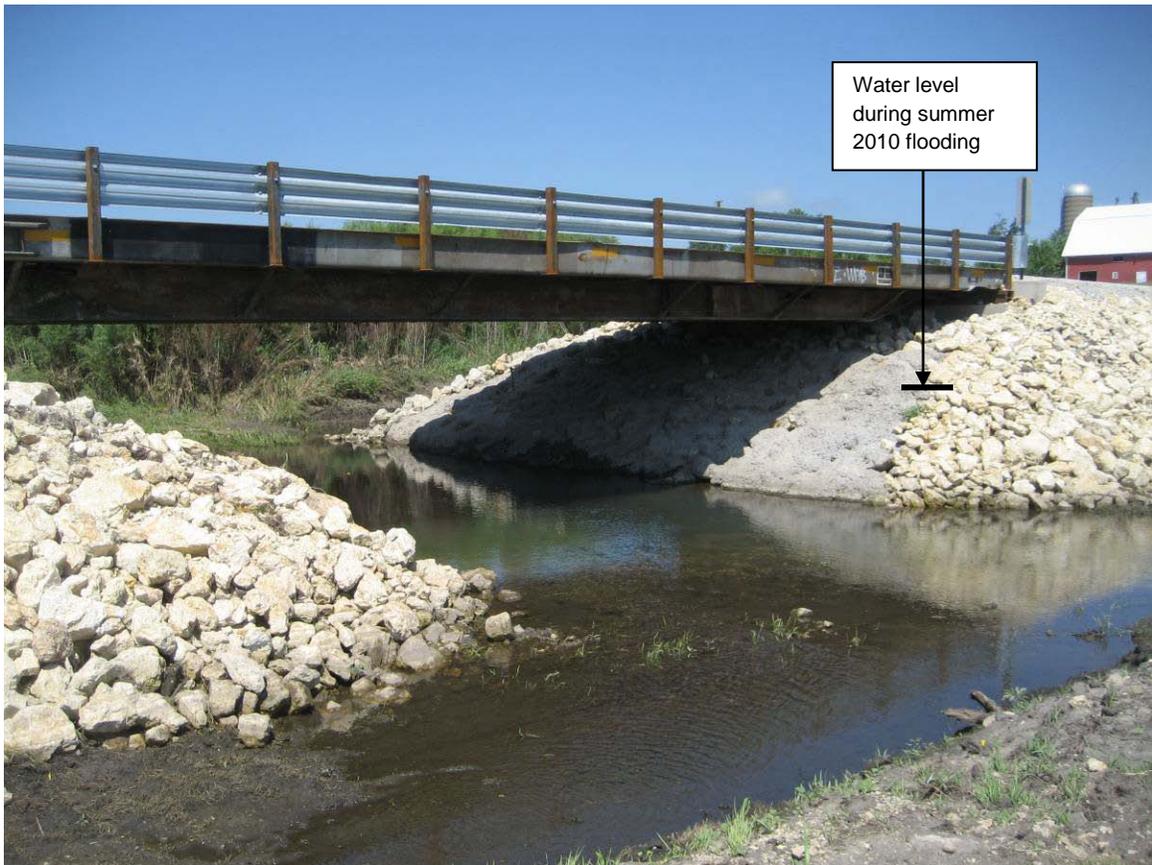
Figure 32. Bridge 1 — Pictures of the completed bridge (7/27/2010)

About 6 in. of crushed rock was placed over the bridge to finish the road. Steel guard rails were installed on both sides of the bridges. Pictures of the finished bridge are shown in Figure 32. Maximum flood water level during the summer 2010 flooding was at about 6 ft below the road elevation at this bridge location, which is at about the mid height of the GRS abutment (Figure 32). Reportedly, similar flood water elevations were observed during the summer 2011 flooding. Pictures of the abutments taken in September 2011 are shown in Figure 33, which indicated that the riprap facing installed for scour protection was still intact.

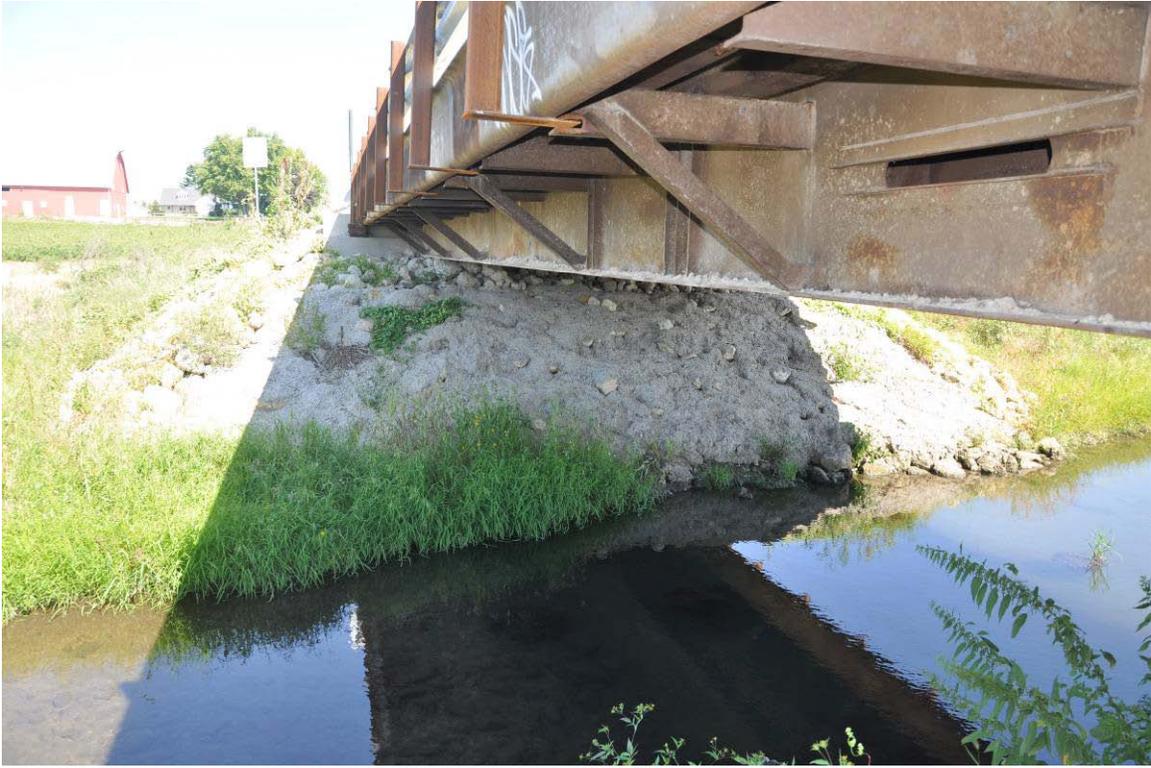
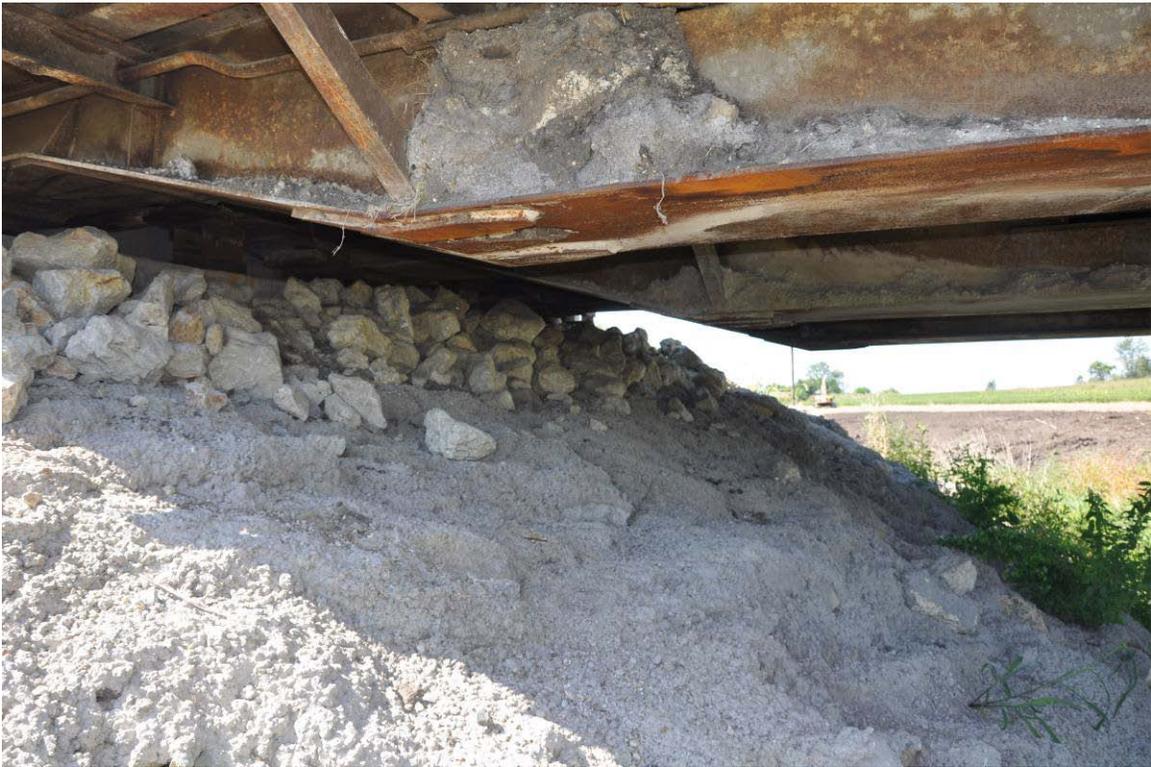
Figure 33. Bridge 1 — Condition of riprap one year after construction (9/8/2011)

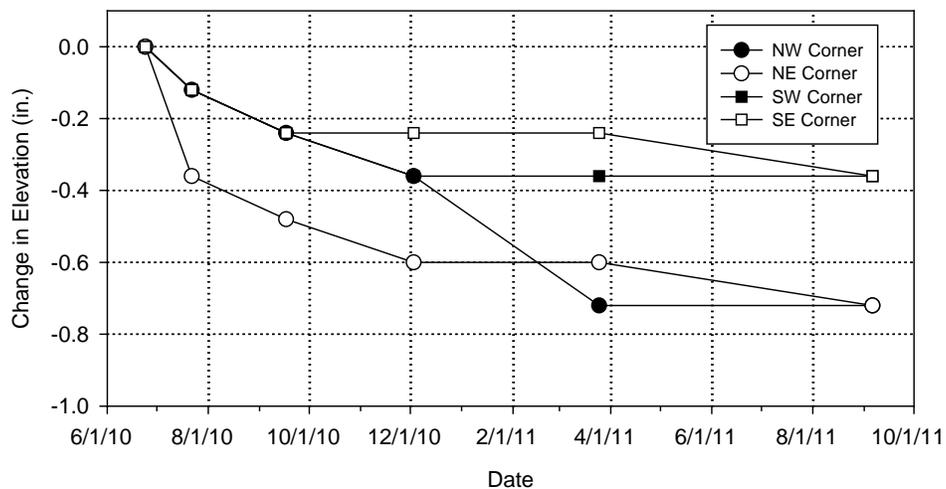
Figure 34. Bridge 1 — Abutment settlement readings

The bridge abutment elevations were monitored by Buchanan County personnel, from shortly after construction (06/24/2010) to about 1 year 2 months after construction (09/06/2011). The elevations were obtained on top of the north and south abutment footings from south west (SW), north west (NW), north east (NE), and south east (SE) corners. The results of change in elevations with time are shown in Figure 34. The results indicate that the maximum settlement is observed at the north abutment. The average settlement of the north abutment footing was about 0.7 in., and the average settlement of the south abutment footing was about 0.4 in. No transverse differential settlement was observed at either abutment at the conclusion of the monitoring phase. Settlements less than 1 in. are considered acceptable for these bridges.

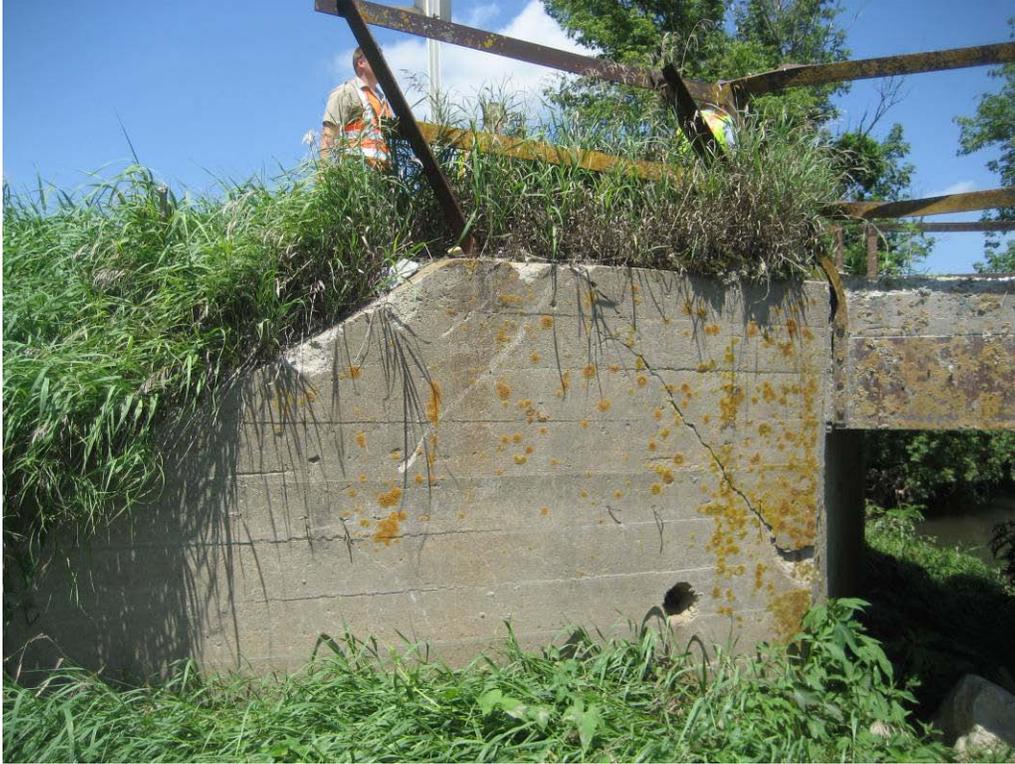
Figure 37. Bridge 2 — Cracks observed on the east abutment wing wall

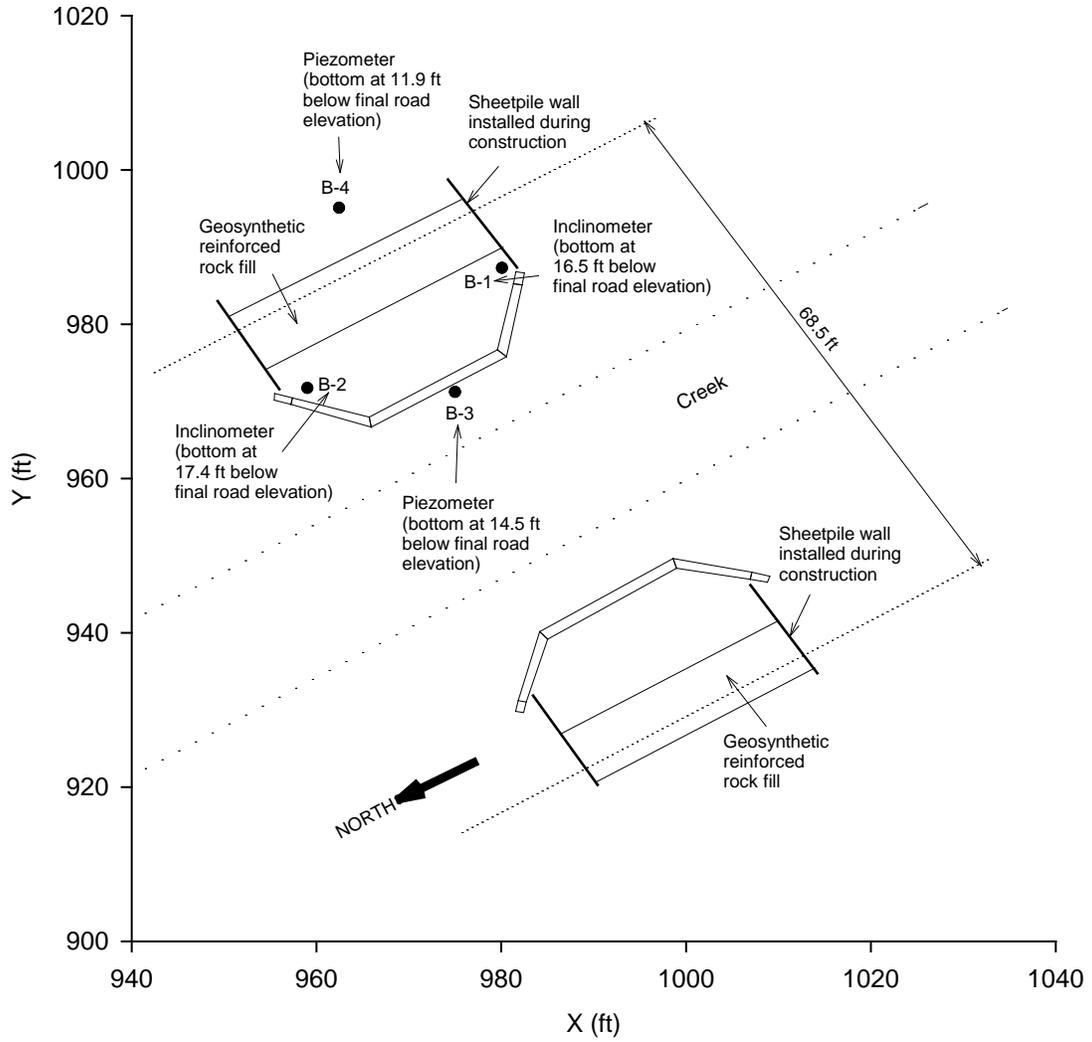
Figure 38. Bridge 2 — Plan view of the bridge abutments prepared for installation of the new RRF bridge

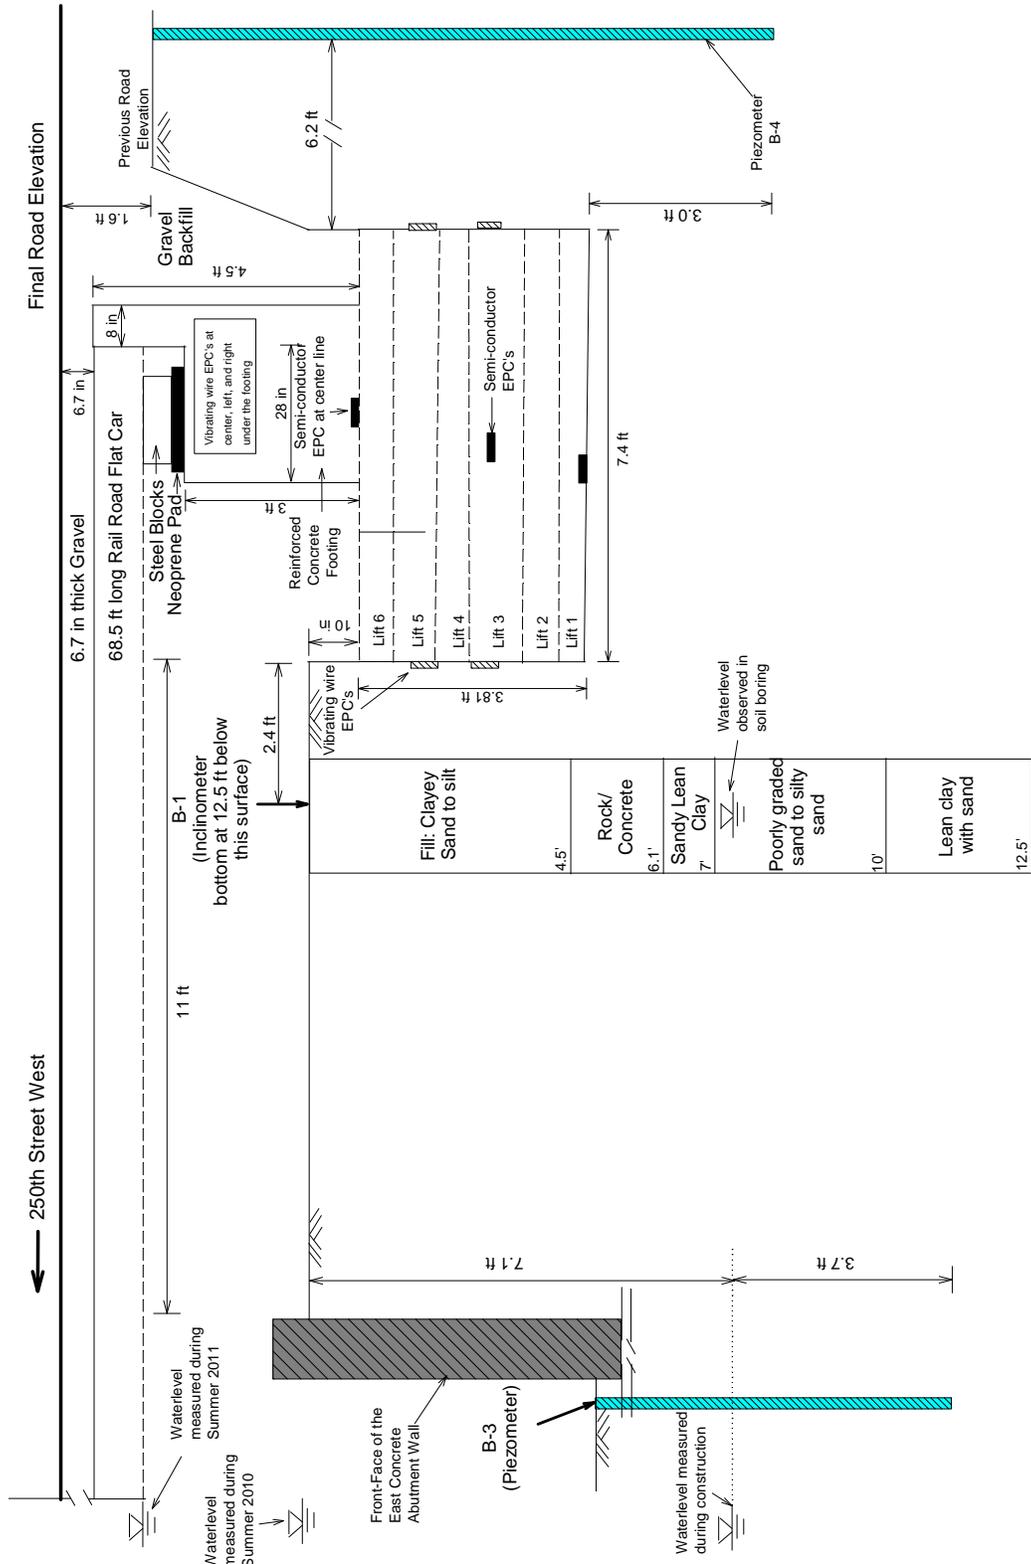
Figure 39. Bridge 2 — Cross-sectional view on the east abutment side of the bridge, subsurface soil profile, piezometer locations, details of GRS fill material, and EPC locations in GRS fill material

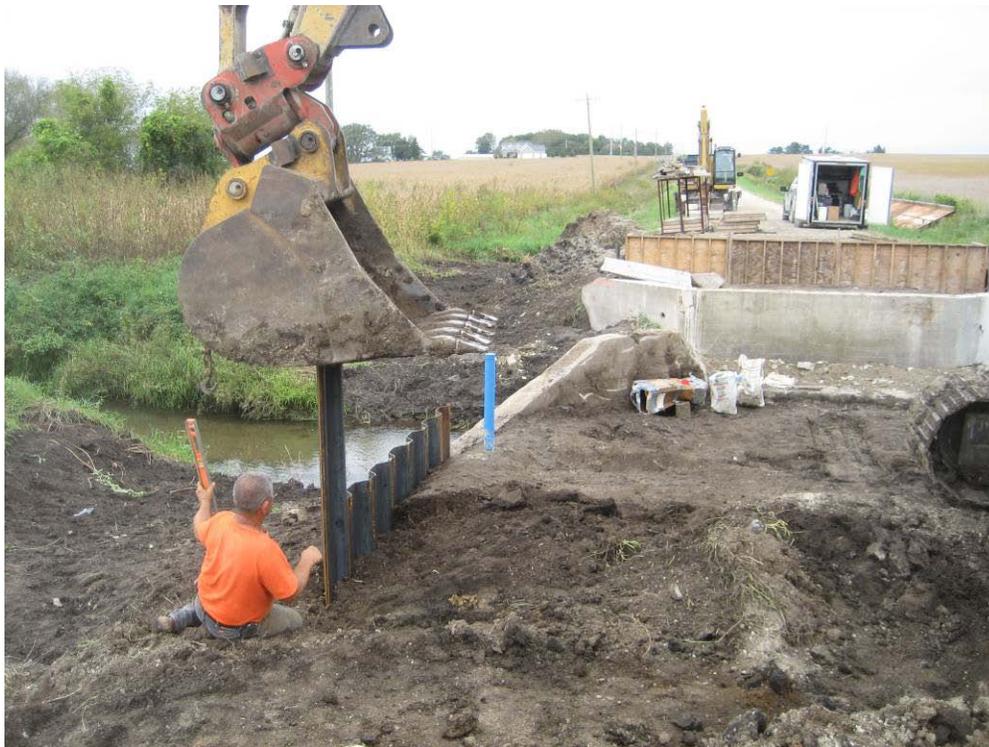
Figure 41. Bridge 2 — Installation of sheet piles on the north and south sides of each abutment for scour protection

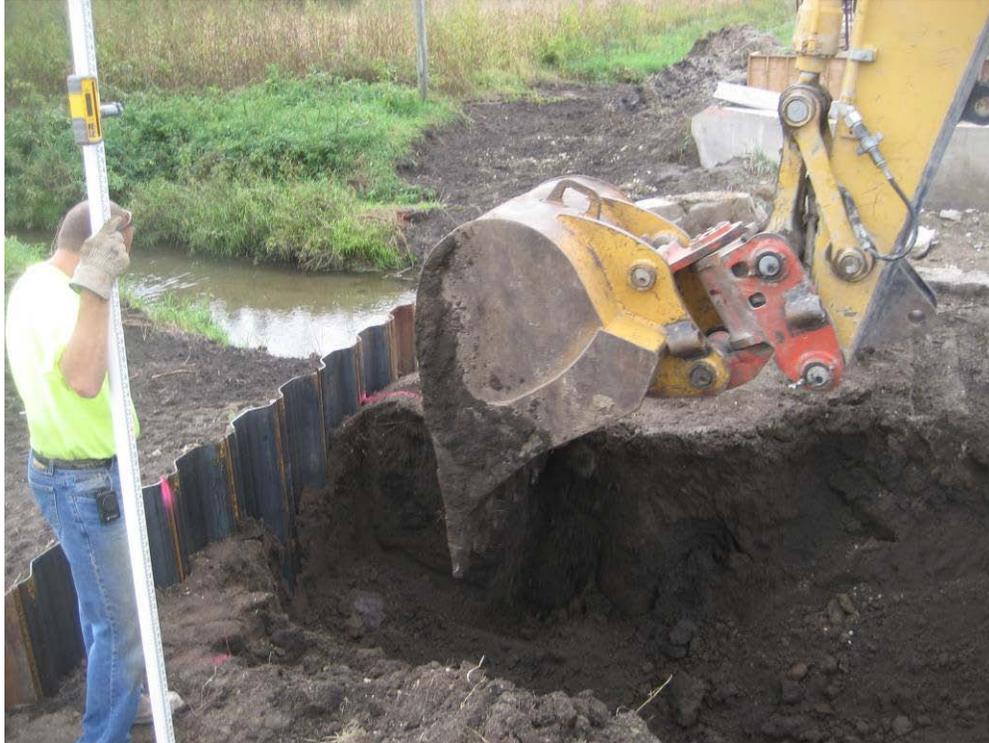
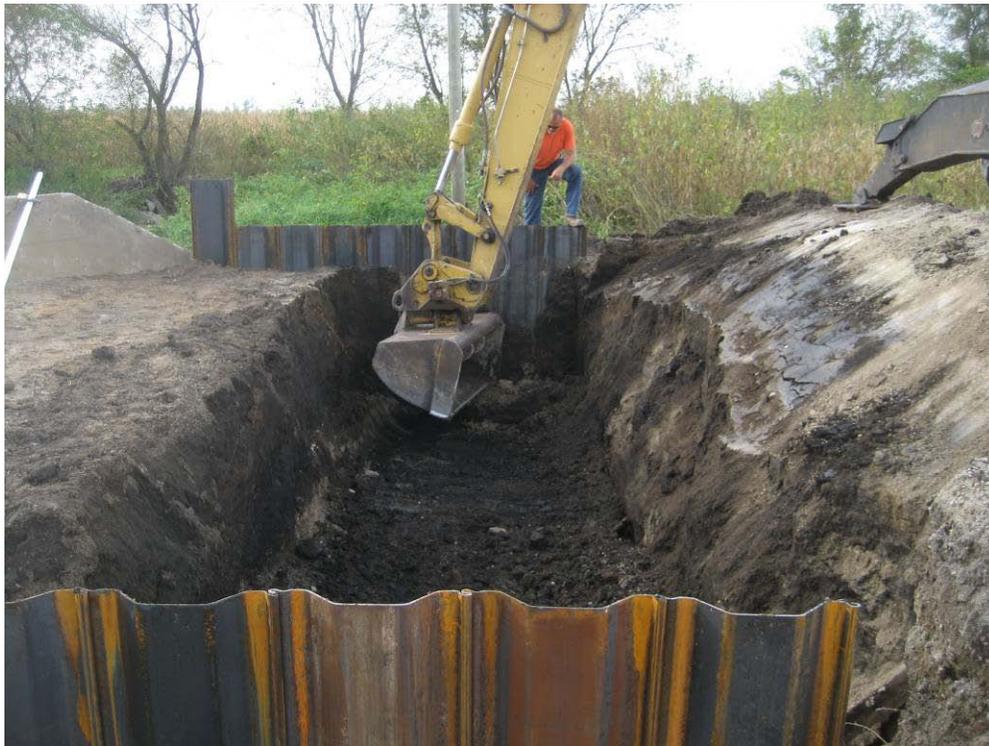
Figure 42. Bridge 2 — Excavation of a trench to place GRS fill material to support the bridge concrete footing

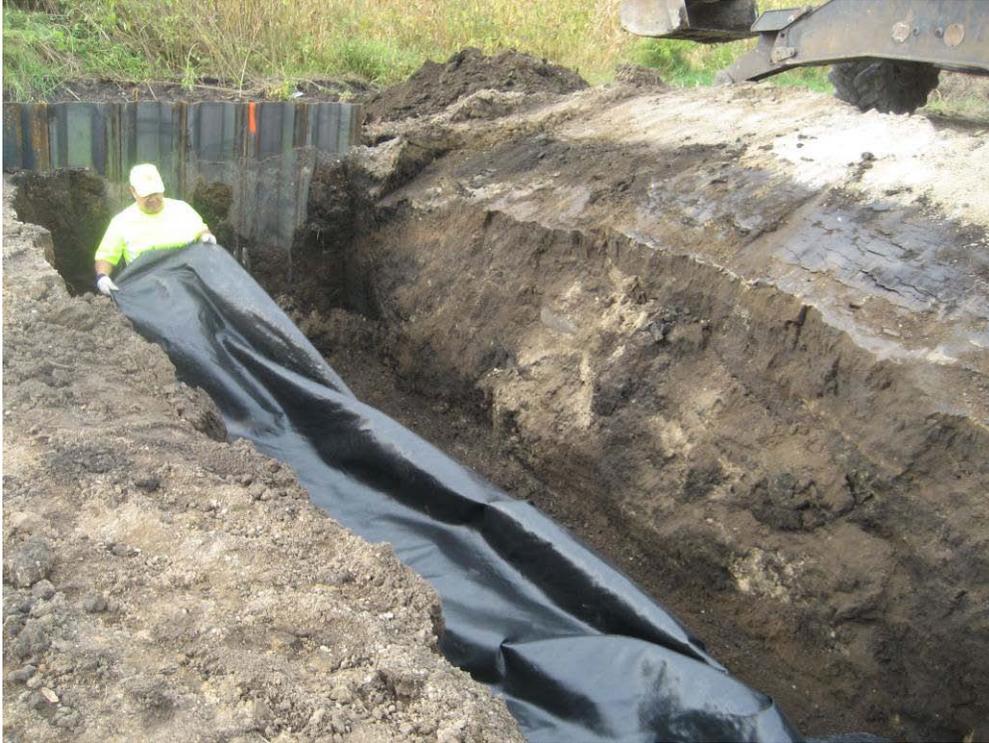
Figure 43. Bridge 2 — Placement of geosynthetic layer at bottom of excavation and granular fill over the geofabric

Mirafi® 500X woven geosynthetic, similar to the one used in Bridge 1, was used as the geosynthetic reinforcement in the fill material on this project. The geosynthetic was spread in the bottom of the excavation, crushed granular fill material was placed over the geosynthetic, and the fill was compacted using a vibratory plate attached to the excavator. The geosynthetic was cut to about 12.5 ft wide x 32 ft long and the excess geosynthetic on the edges was used to wrap over the surface of each lift. The loose lift thickness was targeted to be about 8 in. and compacted thickness was targeted to be about 7 in. Lift thickness was checked using a laser survey level during placement and compaction. Pictures of the construction operations are shown in Figure 43 to Figure 45. The fill was placed in six lifts and the final thickness of the GRS fill material was about 3.8 ft.

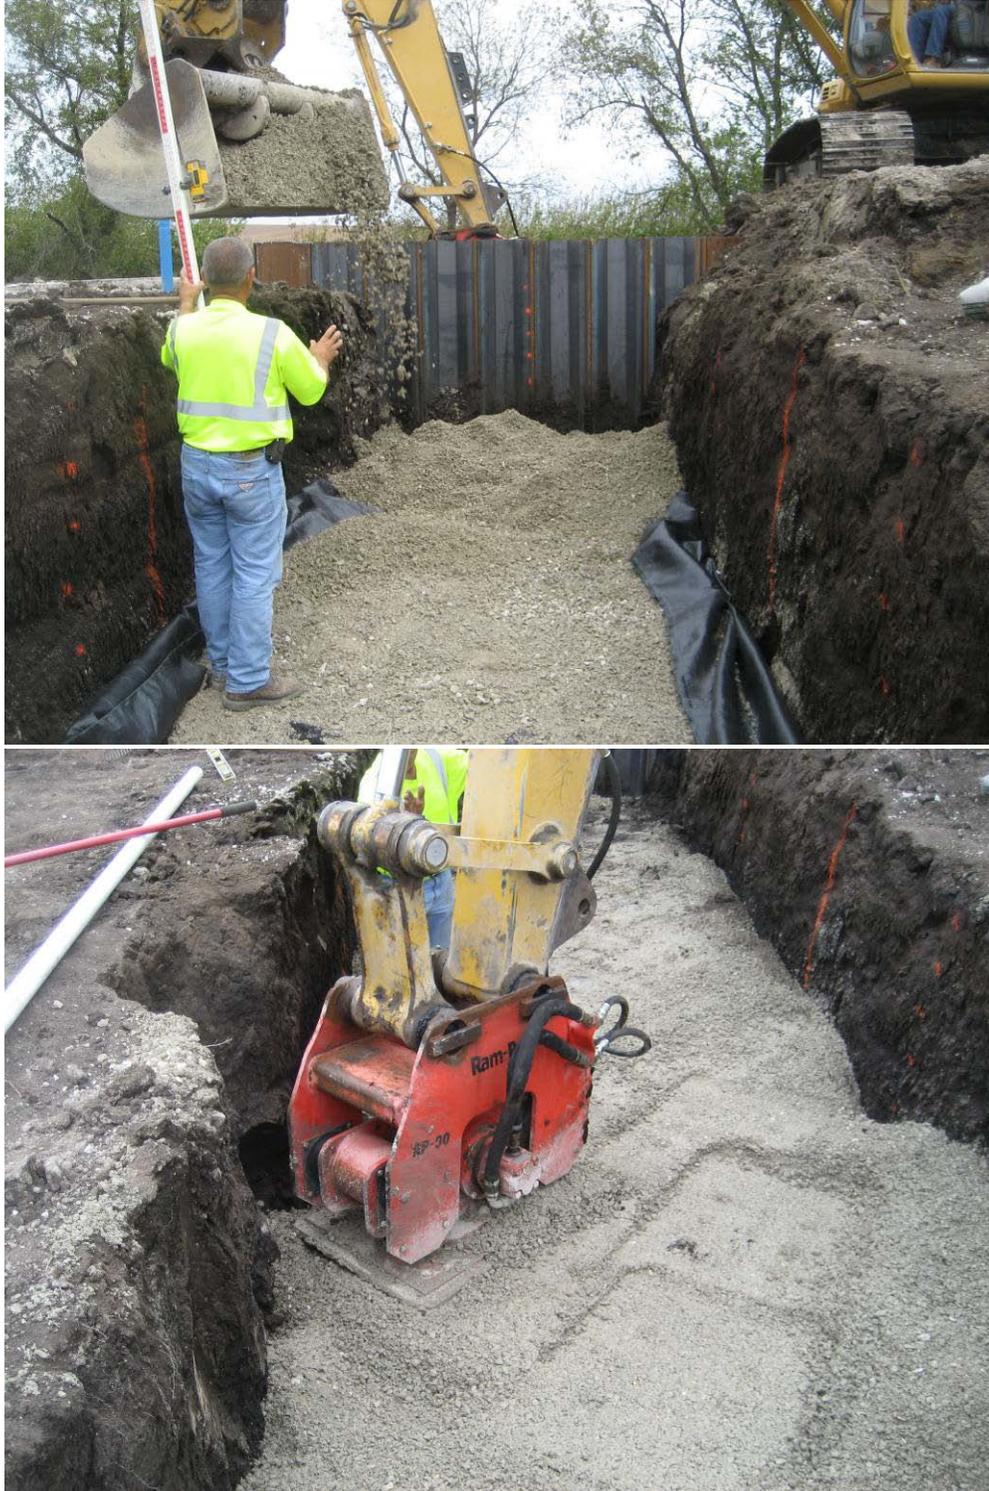
Figure 44. Bridge 2 — Placement and compaction of granular fill over geosynthetic layer using vibratory plate

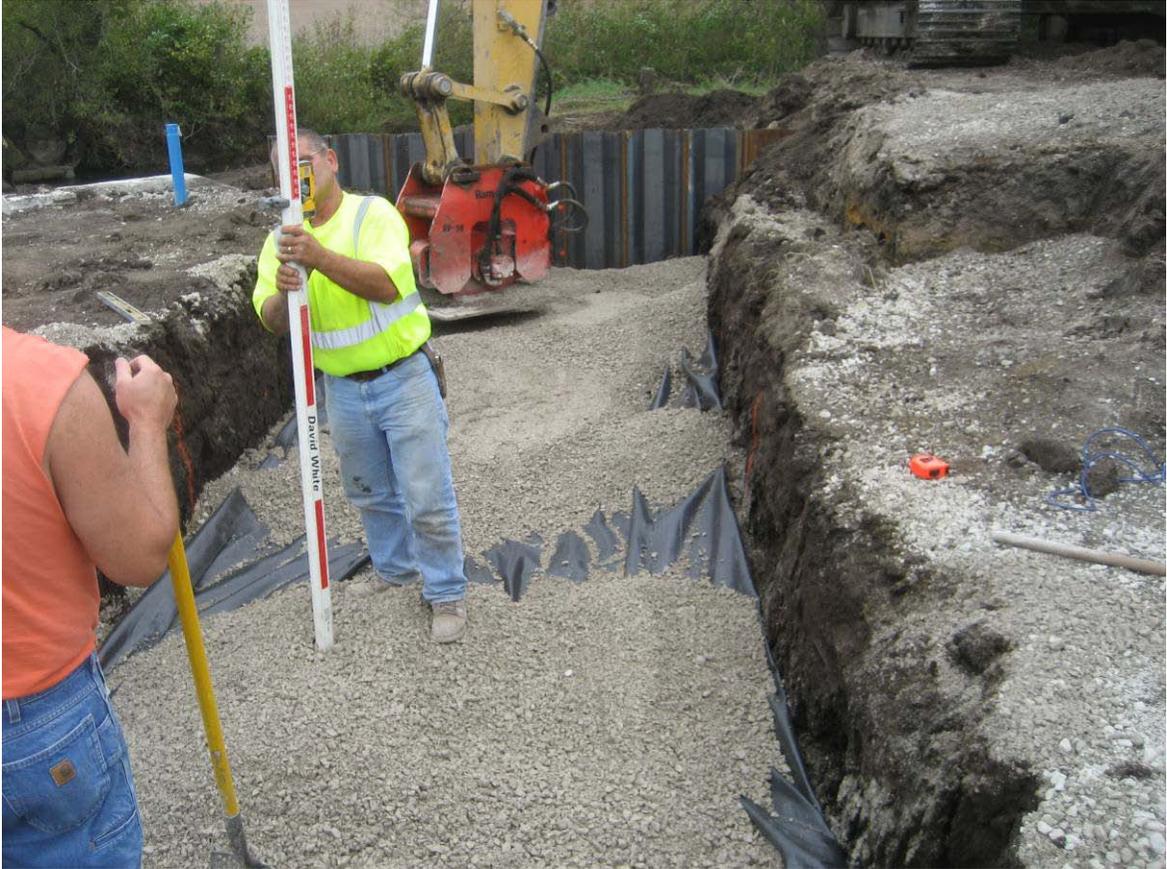
Figure 45. Bridge 2 — Lift thickness control using laser measurement

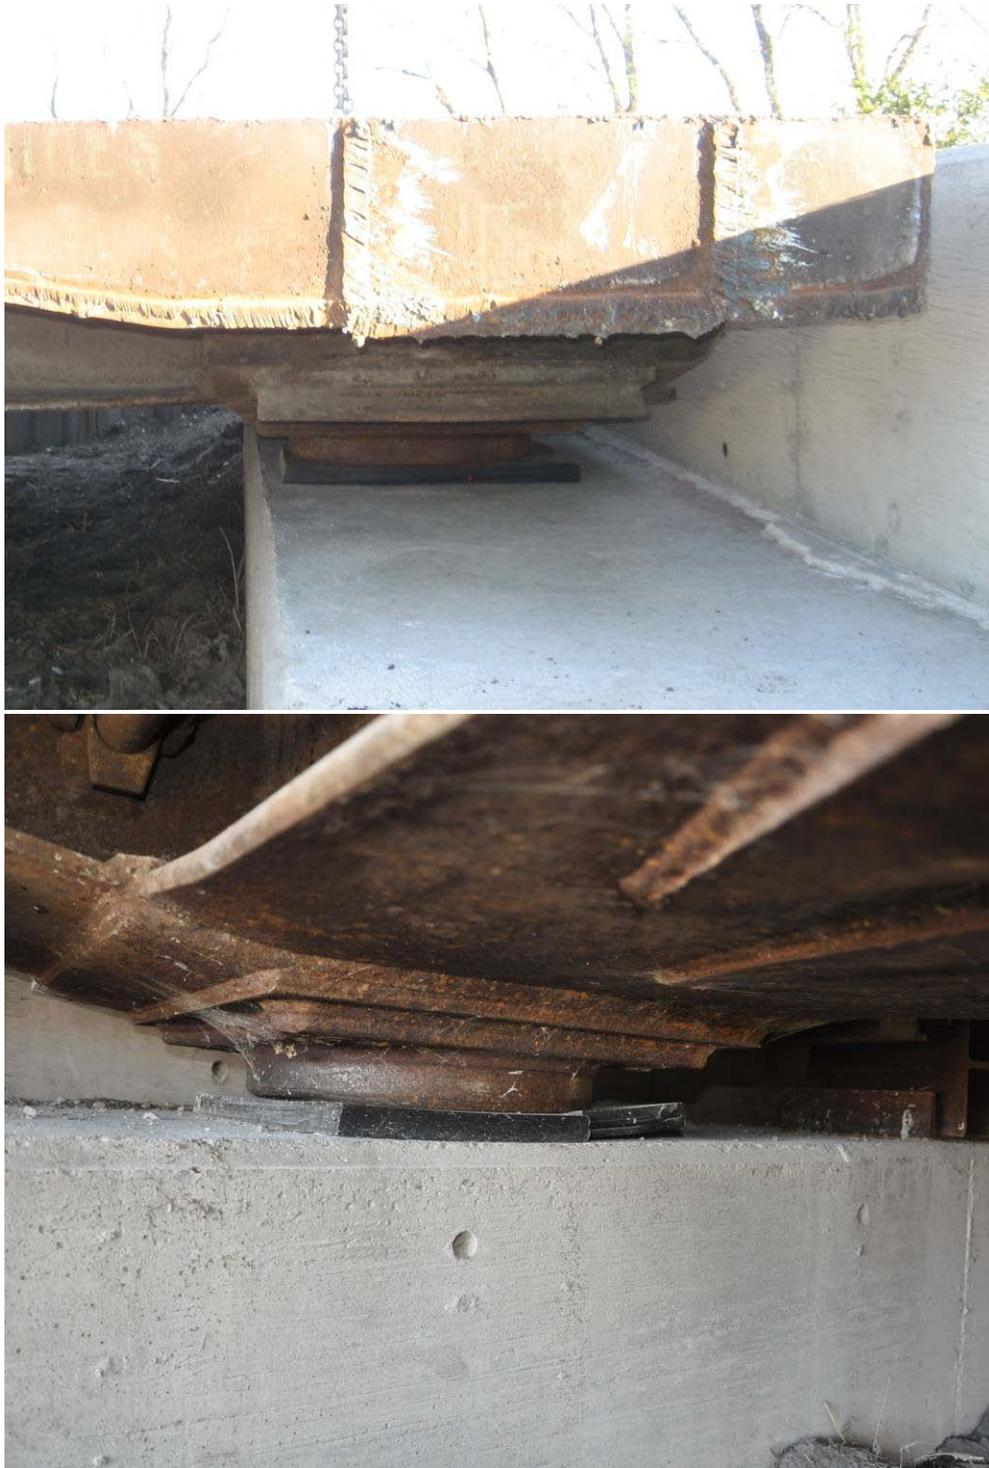
Figure 46. Bridge 2 — 1 inch thick neoprene pads placed over the footing prior to placement of the flat cars

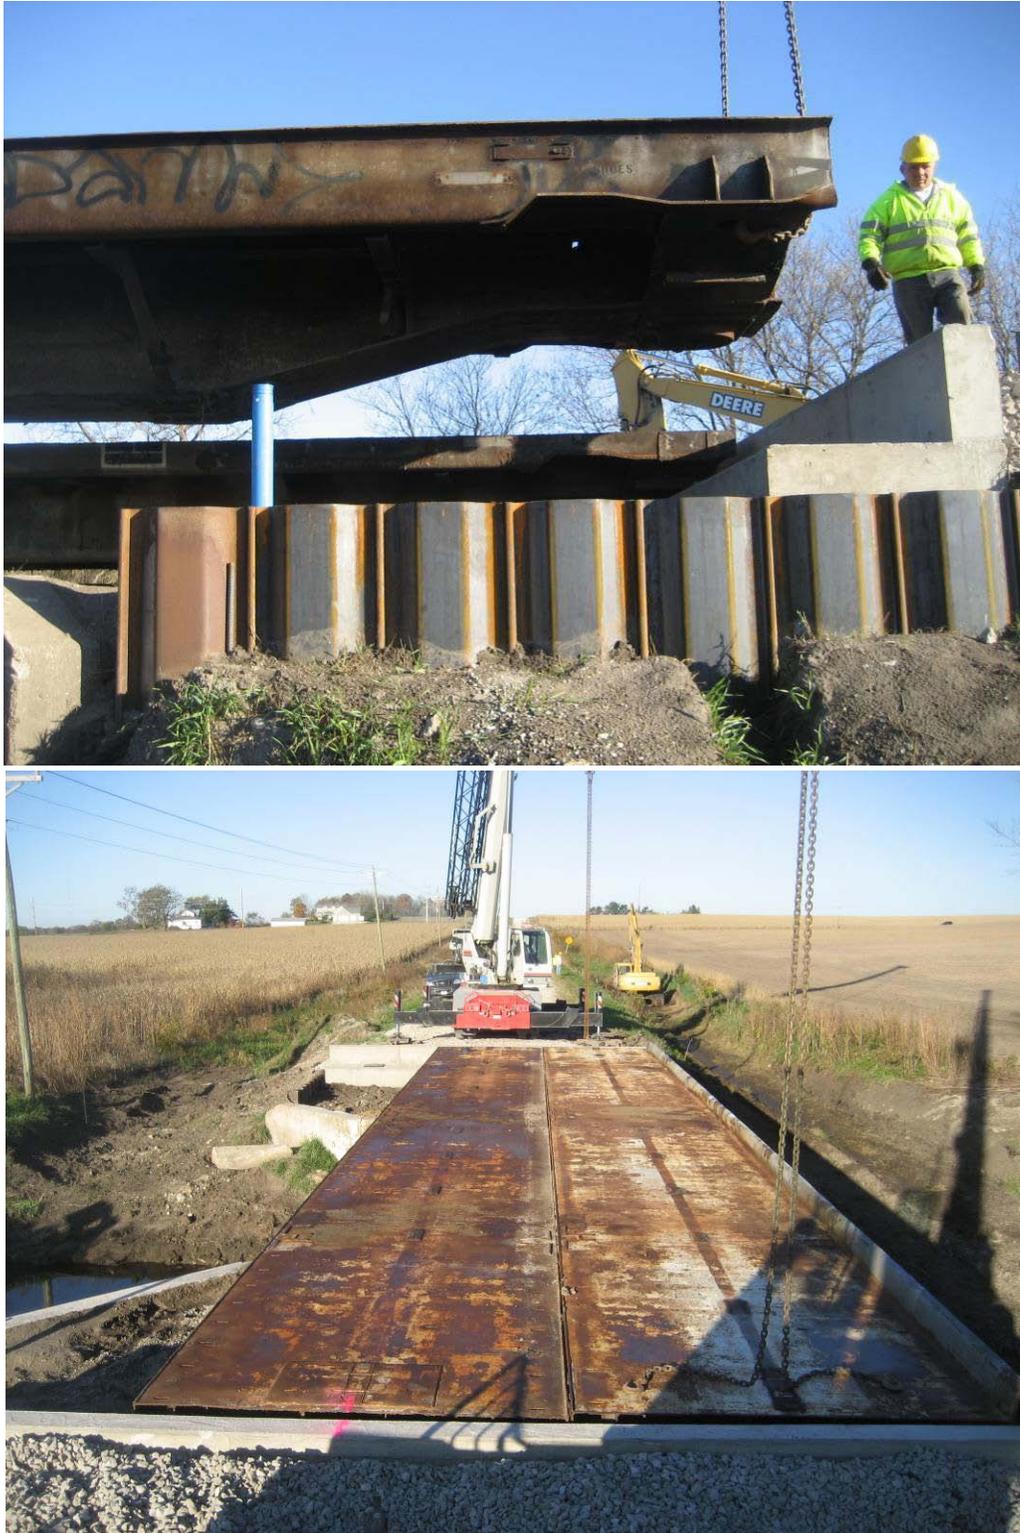
Figure 47. Bridge 2 — Placement of RRFCs on the footings

A 3 ft wide reinforced concrete spread footing was placed on the GRS fill material. The footing cross-section is shown in Figure 39. The trench behind the footing was backfilled with crushed granular fill material up to the existing surface. About 1 in. thick neoprene pads were placed on the footing to seat the RRFCs (Figure 46). Three 8.6 ft wide x 68.5 ft long RRFCs weighing about 40,000 lbs (email communication with Brian Keierleber, Buchanan County Engineer) each were used for the bridge (Figure 47, Figure 48). Cranes were used each end of the bridge to install the RRFCs on the footings. W-sections were placed under the RRFCs on footings for additional support (Figure 49). Bolts (5/8 in. diameter at approximately 5 ft centers) were used to connect the RRFCs at the bottom webs (Figure 50). About 6.7 in. of crushed rock was placed over the bridge to finish the road, and steel guard rails were installed on both sides of the bridges. A picture of the finished bridge is shown in Figure 51. A summary of the construction event timeline is provided in Table 4, and a summary of the bridge construction cost is provided in Table 5. The total cost of the bridge construction was about \$43k, which is slightly lower than Bridge 1 due to the lower amount of granular fill and geosynthetic materials used at this site.
